## **NATIONAL TRANSPORTATION SAFETY BOARD**

### **Weather Study**

WPR20LA170

Location: Lander, Wyoming  
Date: June 7, 2020  
Time: about 0830 mountain daylight time  
1430 Universal Coordinated Time (UTC)  
Aircraft: Experimental Kitfox 1; Registration: N595KF

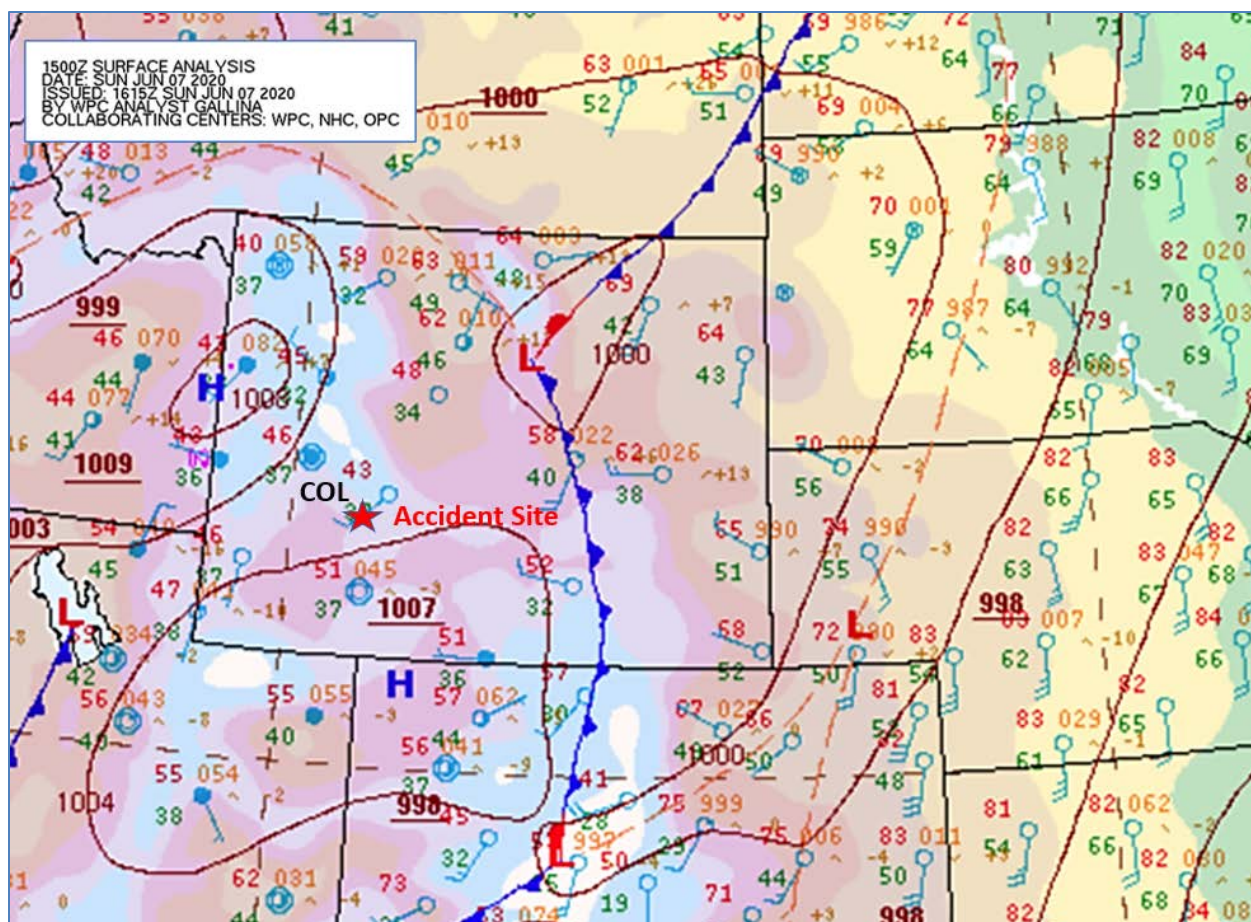
The northcentral section of the NWS Surface Analysis Chart for 0900 MDT is included as figure 1 with the approximate accident site marked by a red star. The chart depicted a low pressure system at 1000-hectopascals (hPa)<sup>1</sup> over northeastern Wyoming along a frontal wave with a cold front extending southward across eastern Wyoming into Colorado, and a warm front turning to a cold front to the northeast across Montana and North Dakota. A trough of low pressure extended northwest from the low across northern Wyoming and then westward across Montana, and then southwestward into Idaho. Another low pressure system at 1003-hPa with an associated cold front was depicted to the west-southwest of the accident site over northern Utah. Two high pressure systems at 1009-hPa and 1007-hPa were located over the Idaho and Wyoming border to the northwest and over the Wyoming and Colorado border to the south of the accident site. A col or saddle point in the pressure field was located over western Wyoming in the immediate vicinity of the accident site.

Figure 1 – The northcentral section of the NWS Surface Analysis Chart for 0900 MDT

The station model for Lander, Wyoming, northeast of the accident site indicated a wind from the southwest at 10 knots, clear skies, with a temperature of 43° Fahrenheit (F), and a dew point of 37° F. Several station models west and northwest of the accident site along the Wyoming and Idaho border depicted overcast clouds with rain and thunderstorms.

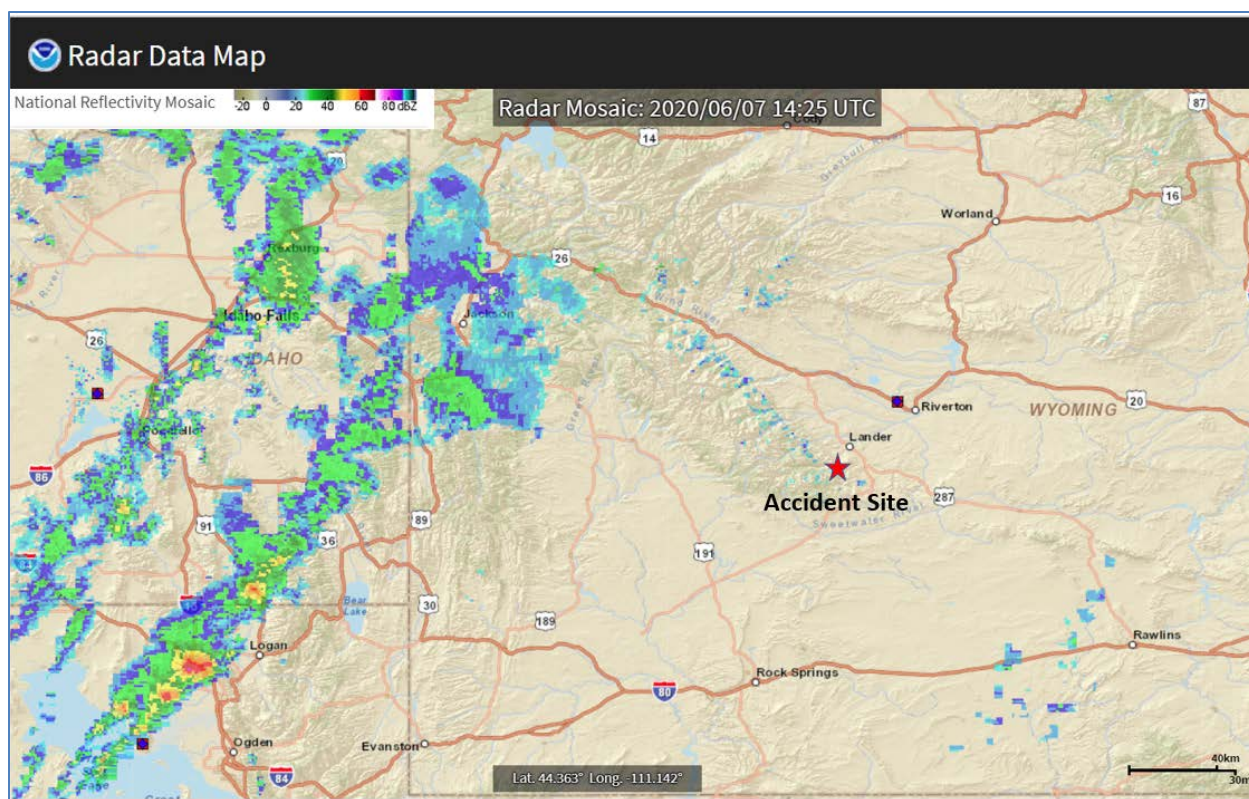
The National Composite Radar Mosaic for 0825 MDT over the region is included as figure 2 with the approximate accident site marked by a red star. The radar mosaic depicted a line of echoes extending from western Wyoming southwestward across Utah in the general vicinity of the low pressure system and associated front shown on the surface analysis chart. Several small very light intensity echoes were also identified along the eastern slopes of the mountains in the general vicinity of the accident site, these echoes were identified as ground clutter with the radar beam hitting terrain.

**Figure 2 - National Composite Radar Mosaic for 0825 MDT**

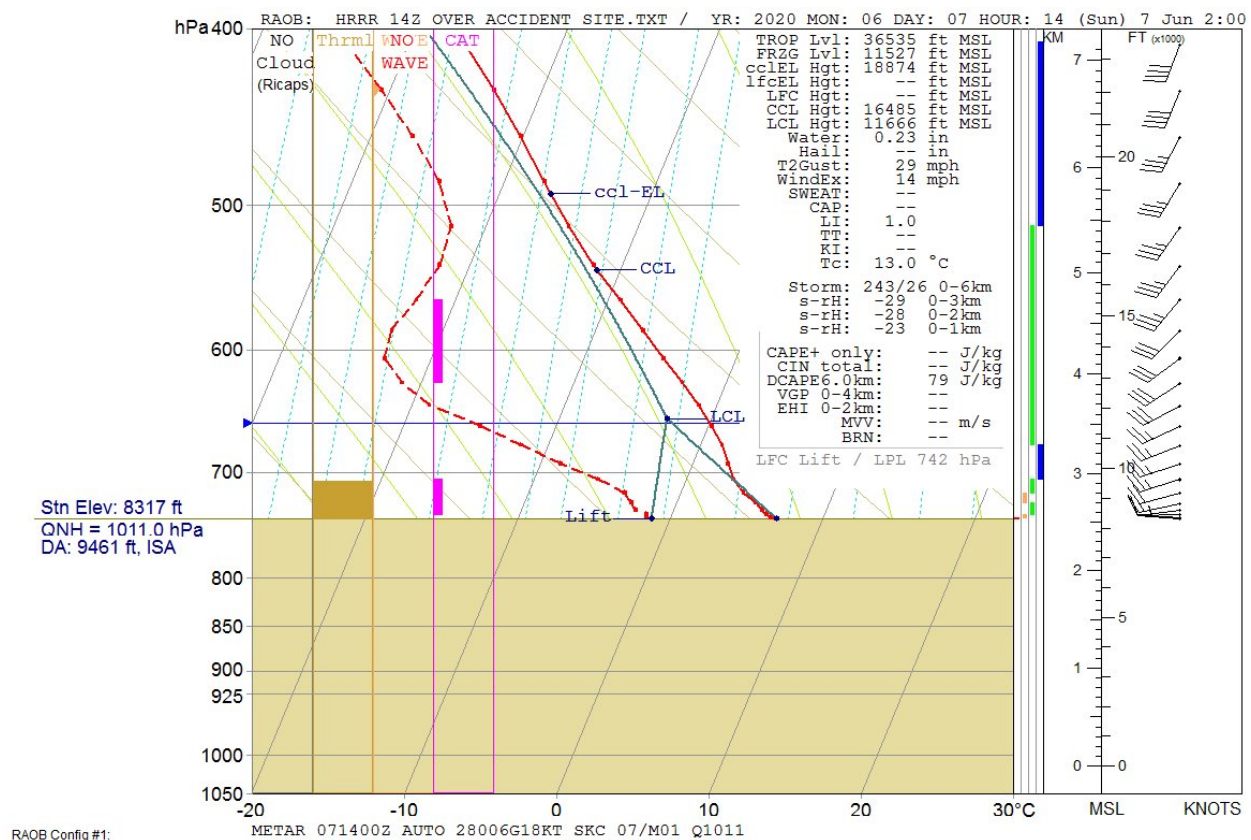
**Figure 3 - HRRR sounding over the accident site for 0800 MDT**

The HRRR 0800 MDT sounding estimated the surface elevation as 8,317 ft over the area, with a near surface temperature of 7° C (45° F), a dew point of -1° C (30° F), with a relative humidity of 55%, which resulted in a surface density altitude of 9,461 ft. The lifted condensation level (LCL)<sup>7</sup> was at 3,349 ft agl (11,666 ft msl) with the convective condensation level (CCL)<sup>8</sup> at 8,148 ft agl (16,465 ft msl). The precipitable water<sup>9</sup> content was 0.23 inches, and the lack of any significant layers of moisture vertically over the area, RAOB did not support clouds over the accident site. The sounding indicated a Lifted Index<sup>10</sup> of 1 with a conditional unstable atmosphere below 18,000 ft and supported strong surface thermals to approximately 1,200 ft agl

The HRRR wind profile indicated a surface wind from 280° at 6 knots with gusts to approximately 18 knots, with wind backing to the south with height. At approximately 1,000 ft

agl or 9,300 ft msl, the HRRR model indicated a wind from 260° at 25 knots. A potential for light turbulence was depicted below 15,000 ft in the sounding.

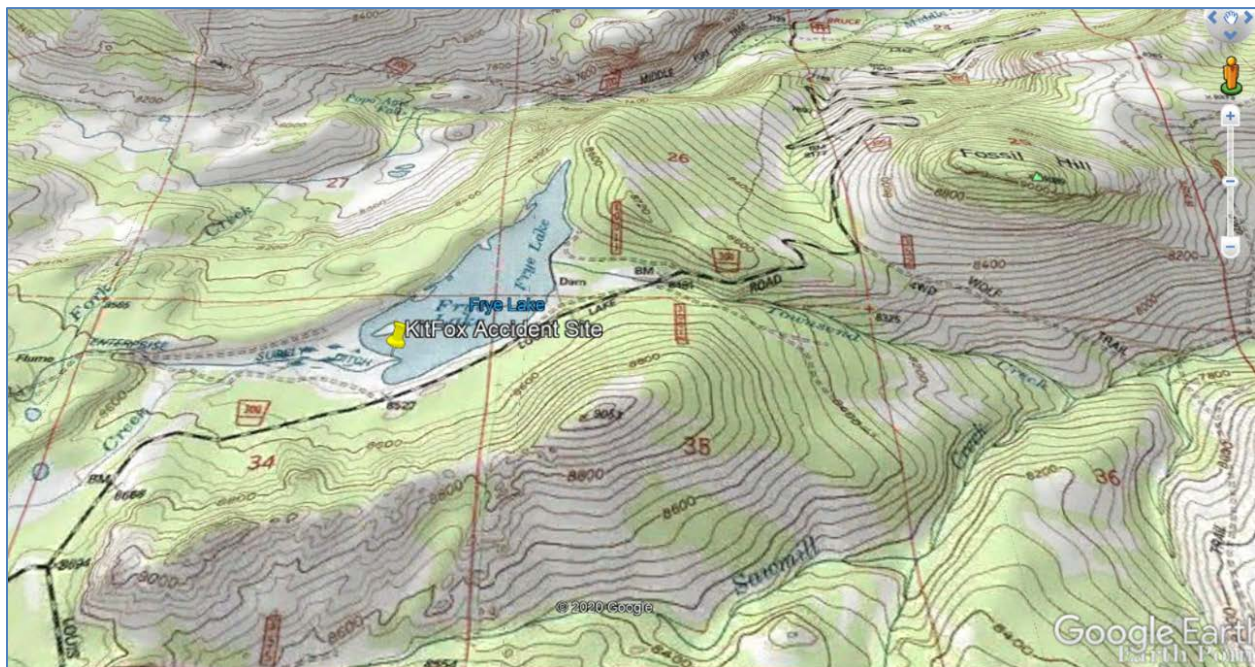
Figure 4 is a depiction of the topographic features in the vicinity of the accident site from Google Earth Pro. The accident site is noted on the western edge of Frye Lake with a west-southwest to east-northeast ridge less than 1/2 mile immediately south with terrain over 9,000 ft.

Figure 4 - Topographical features in the vicinity of the accident site

Based on the HRRR wind profile at 9,000 ft to 10,000 ft with winds from the west-southwest at 20 to 25 knots and the topography, would result in the general rising air or updrafts on the southern side of the ridge and downward flow over the Frye Lake area or downdrafts. The cooler temperatures of the lake would also negate any thermal activity or rising motion over the land and result in subsidence<sup>11</sup> over the lake.

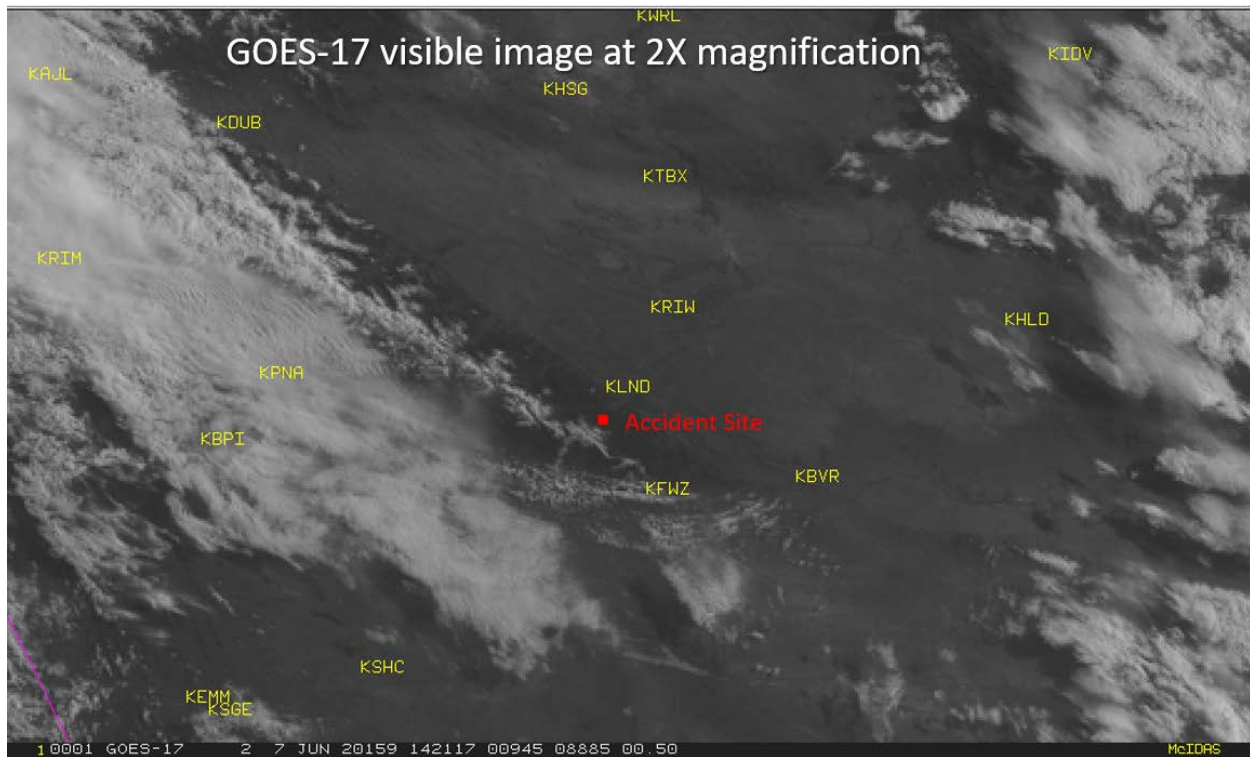
Figure 6 is the GOES-17 visible image for 0821 MDT at 2X magnification with the accident site marked by a red square. The image depicted clear skies over KLND and the accident site, with a band of snowcapped terrain approximately 4 miles west along the eastern slopes of the mountains and lower stratus type clouds over the basin west of the higher terrain.

Figure 6 - GOES-17 visible image at 0821 MDT at 2X magnification

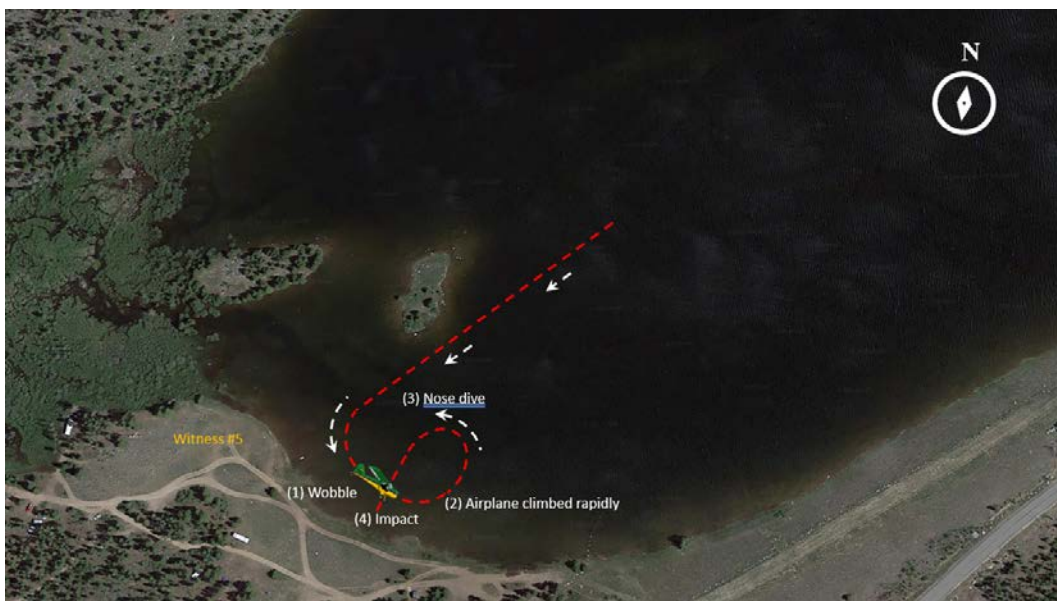
Witness 5 – also indicated that at approximately 0830 MDT he observed the airplane approach Frye Lake and provided a sketch of the low flight path, the left turn, and then an odd wobble, the aircraft rising left turn, and then a sharp nose dive into the lake. Figure 7 is a depiction of the witness depiction of the accident sequent and location relative to Lake Frye.

**Figure 7 - Witness depiction of the accident sequence**

Four of the five witnesses mentioned wind catching the aircraft, with one mentioning that it had been windy prior to the accident and one mentioning updrafts, which can also infer downdrafts. All described the accident airplane flying low and struggling, which could be an indication of the relatively high density altitude impacting aircraft performance.
