## **NATIONAL TRANSPORTATION SAFETY BOARD**

# **AIRFRAME & ENGINE EXAMINATION SUMMARY**

**WPR20LA170**

Location: Lander, Wyoming  
Date: July, 7, 2020  
Aircraft: Kitfox 1, N595KF  
NTSB Investigator-in-Charge: Stephen Stein

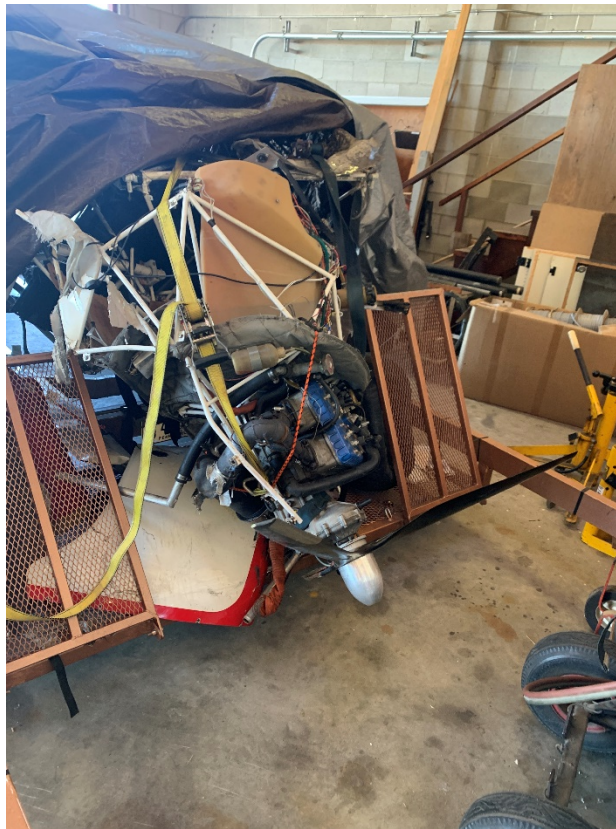
Examination of the recovered wreckage revealed that the wreckage was fire damaged from just behind the cockpit seats to the empennage. Most of the fabric covering was burned/melted, exposing the structure underneath. The wings remained attached to the airframe, however, were folded aft, in a manner consistent with transport. Both ailerons were separated from the wings and located within the recovered wreckage. The vertical stabilizer, rudder, horizontal stabilizers, and elevators remained attached to the airframe. The engine remained attached to the airframe structure.

**Figure 1: Recovered wreckage as observed.**

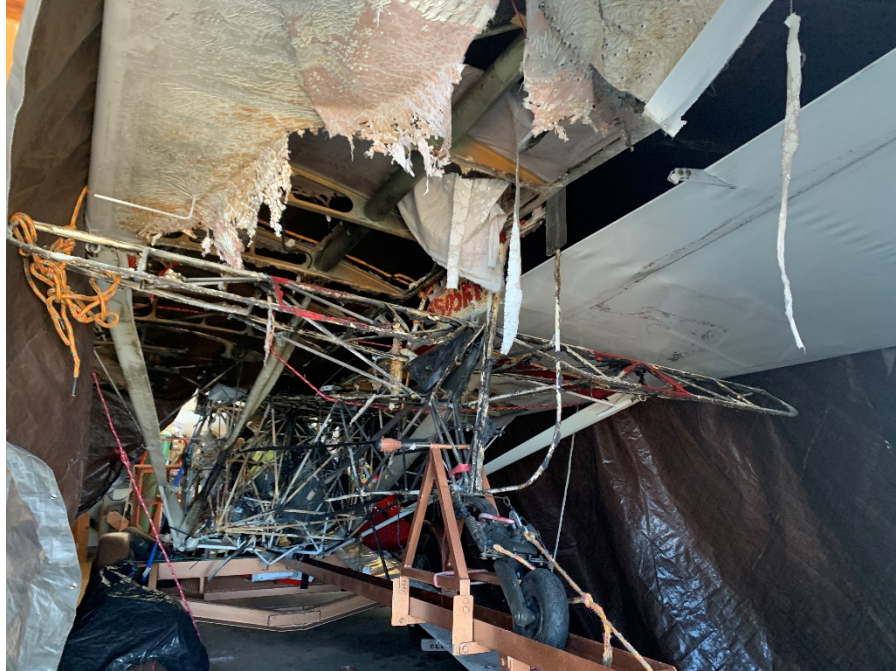
**Figure 2: Recovered wreckage as observed.**

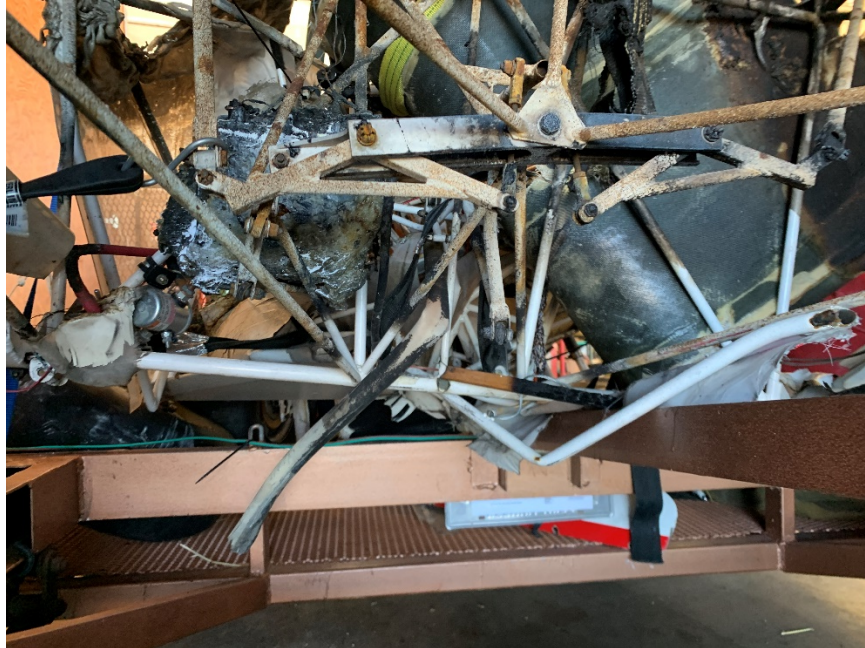
Flight control continuity was established throughout from the cockpit controls to all primary controls. The elevator torque tube was separated just aft of the seats and exhibited impact and fire damage signatures. Multiple torque tubes for aileron control were impact damaged.

**Figure 3: Control linkages, note the elevator torque tube damage.**

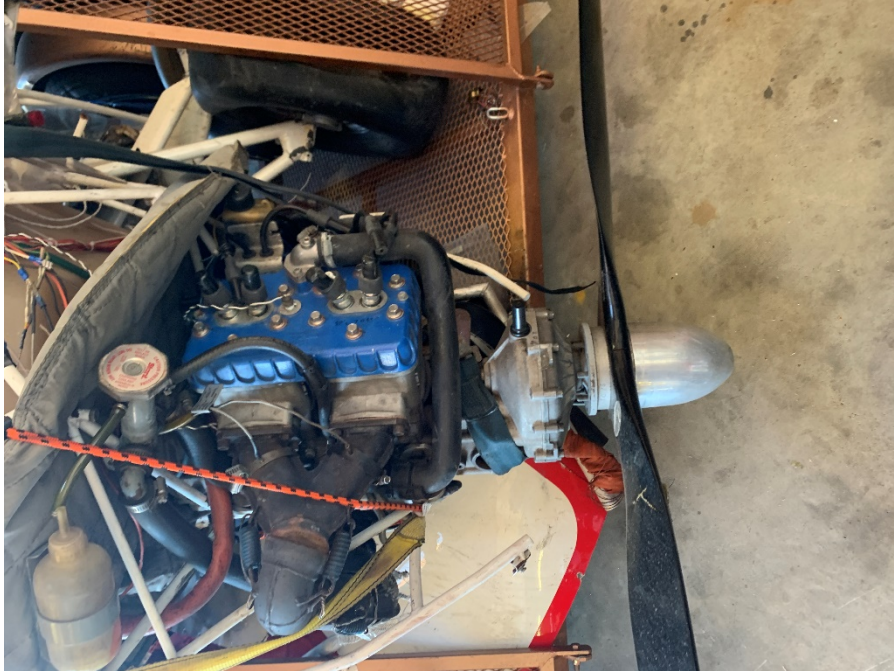
Examination of the Rotax 582 revealed that all engine accessories remained attached. The propeller assembly was removed, and the fly wheel/gear box rotated freely. Due to the engine being equipped with a clutch assembly, rotational continuity could not be established, as the disposition of the recovered wreckage prevented sufficient access to the rear of the of the engine to remove the starter.

**Figure 4: View of the engine.**

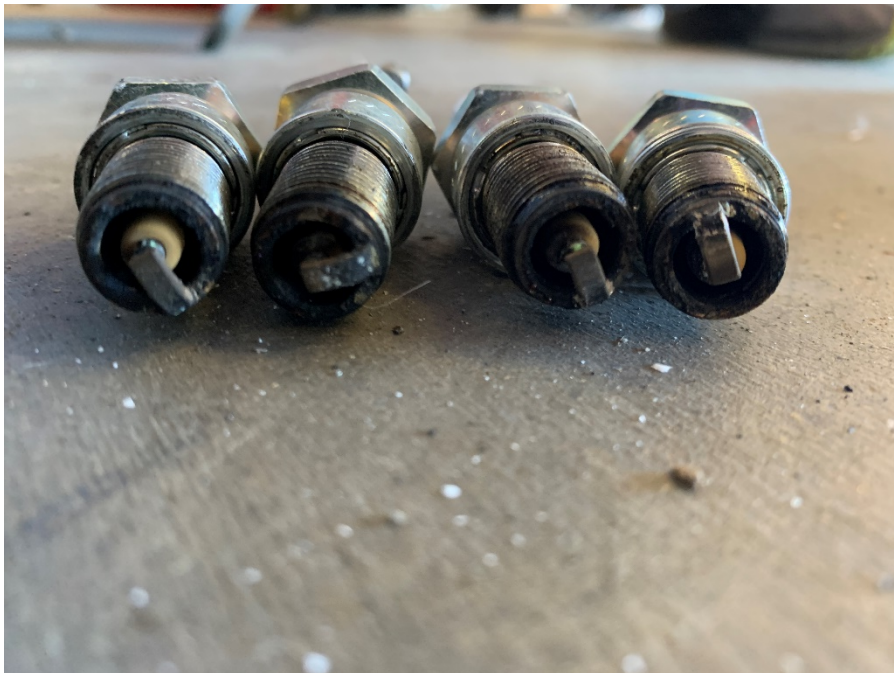
The spark plugs were intact and undamaged with the exception of the front cylinder, aft plug, which was impact damaged. The spark plugs were removed and exhibited dark/black deposits within the electrode area. The ignition harness was intact and appeared to be undamaged. The electronic ignition boxes were intact and not damaged.

**Figure 5: Removed spark plugs.**

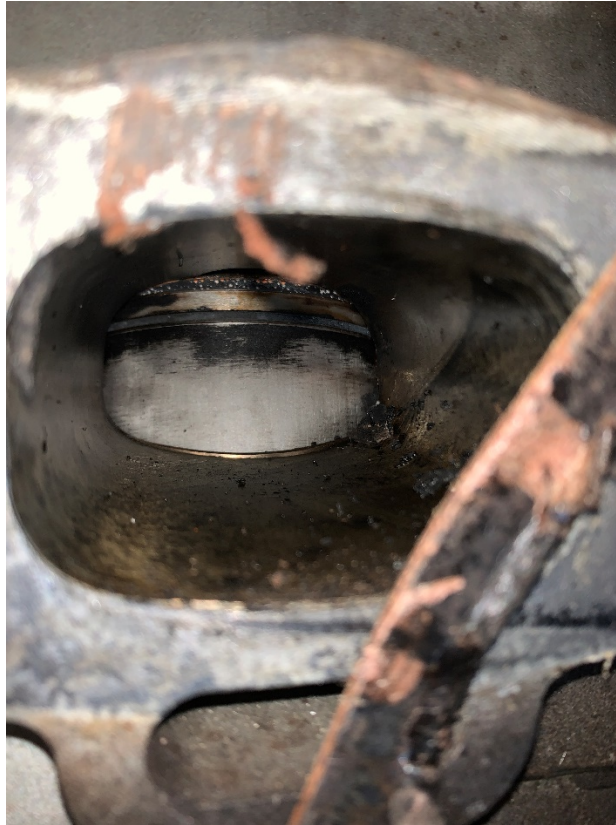
The exhaust Y pipe and cylinder head were removed to allow examination of the pistons. No evidence of any scoring or metal transfer was observed on either piston.

**Figure 6: View of one piston through the exhaust port.**

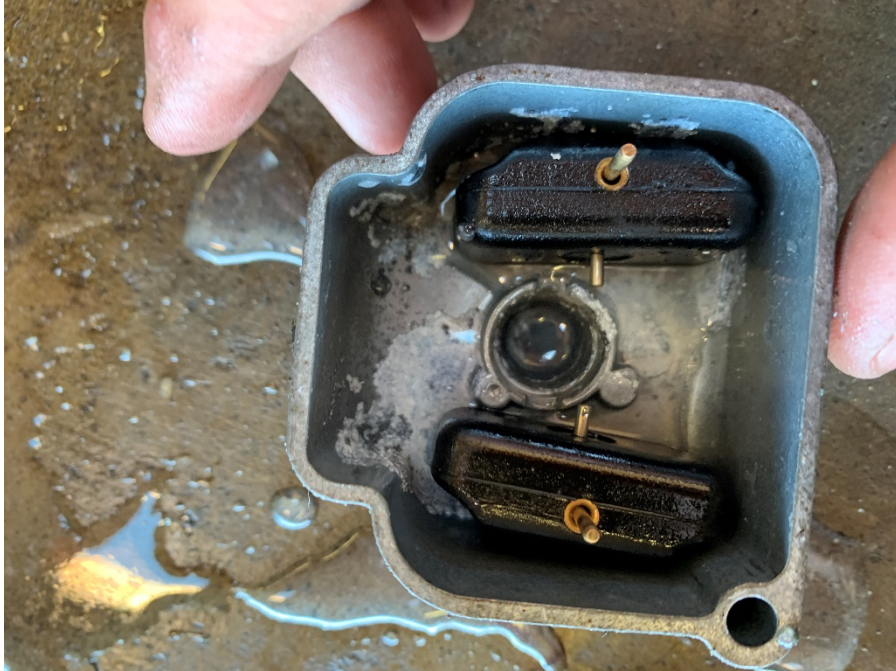
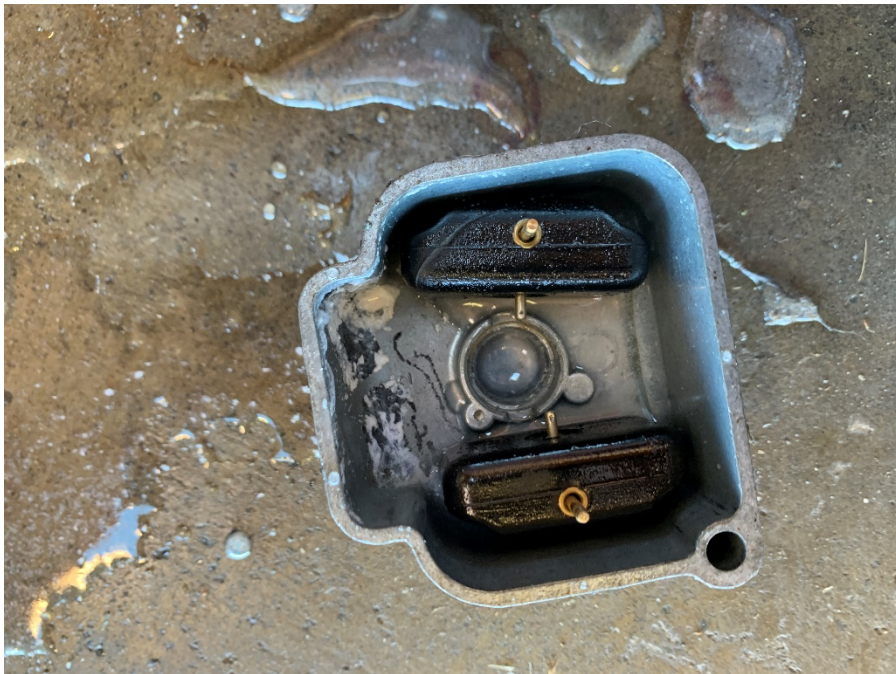
The carburetors remained attached to the engine. All fuel lines appeared to have remained secure. The carburetors were removed and disassembled. The internal screens were free of debris. The floats were intact on both carburetors. The needle valves on both carburetors were unremarkable. The internal areas of the carburetor were wet with water (verified with water finding paste). A small amount of white paste like substance was observed in both float bowls. According to a representative from Rotech Flight Safety, the substance is consistent with water contamination mixing with fuel.

**Figure 7: Debris within the carburetor float bowl.**

**Figure 8: Debris within the carburetor float bowl.**

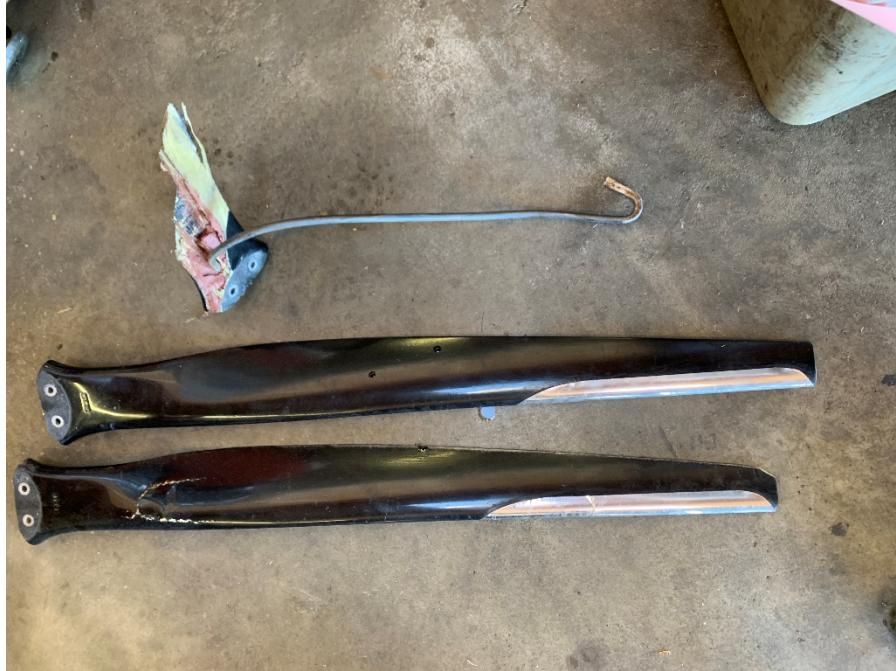
The propeller remained attached to the engine crankshaft. One of the three blades were was damaged, and separated from the metal blade spar about 6 inches from the blade root. The blade spar was bent about 90°. The remaining two propeller blades were not damaged. Some evidence of corrosion (rust deposits) were observed on the cylinder walls. A normal amount of combustion deposits were observed on the piston heads.

**Figure 9: Removed propeller blades.**
