## RECORD OF CONVERSATION

**Date: June 25, 2020**  
**Person Contacted: Mr. Fernandez**  
**NTSB Accident Number: WPR20LA172**

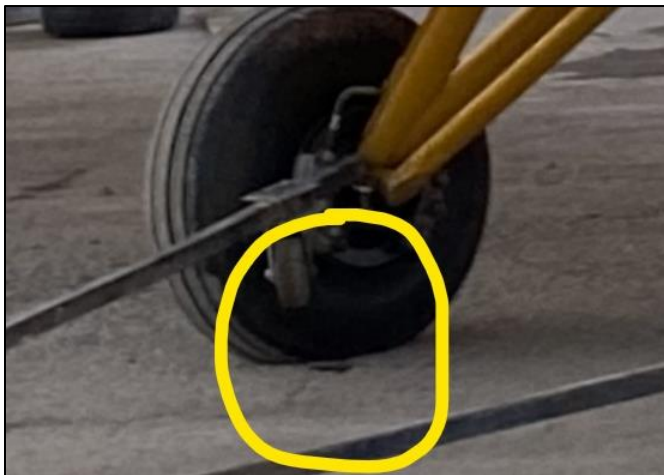
I interviewed Mr. Fernandez during a phone conversation to get more details on the brake examination. Mr. Fernandez was the pilot of the accident airplane, and the owner and operator of the company. He stated to me that before the wreckage was removed from the site, he was able to find a spare landing gear and replaced it with the damaged left landing gear. The wreckage was then towed to his hanger on the airport. Mr. Fernandez's mechanic disassembled both brake assemblies on the accident airplane. The left brake disassembly revealed no anomalies that would have prevented normal operation. The right brake was disassembled and the O-ring on the centered piston was damaged and no fluid was found in the right brake master cylinder reservoir. Mr. Fernandez concluded by stating that the right brake assembly had been leaking before the accident and sent a photo of right main landing gear showing a small puddle on the floor near the tire. (See Figure-1).

*Figure 1-Right main landing gear tire and brake fluid puddle.*
