## **NATIONAL TRANSPORTATION SAFETY BOARD**

### **AIRFRAME EXAMINATION**

**WPR20LA177**

Location: Maricopa, AZ  
Date: June 9, 2020  
Aircraft: Zenith 601HDS, N6402X, SN:6-3904  
NTSB IIC: Elliott Simpson

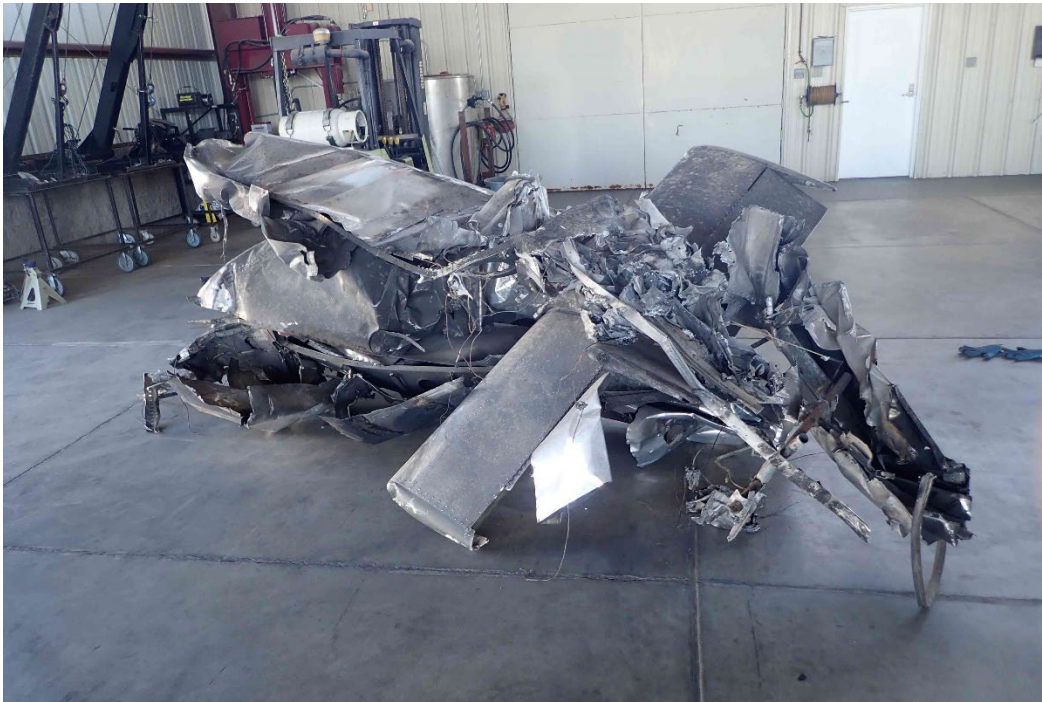
Photo 1 – Main cabin and tails section

The entire cabin had fragmented and was consumed by fire through to the aft fuselage bulkhead. All remaining structure was coated in a fine layer of black soot (photo 1).

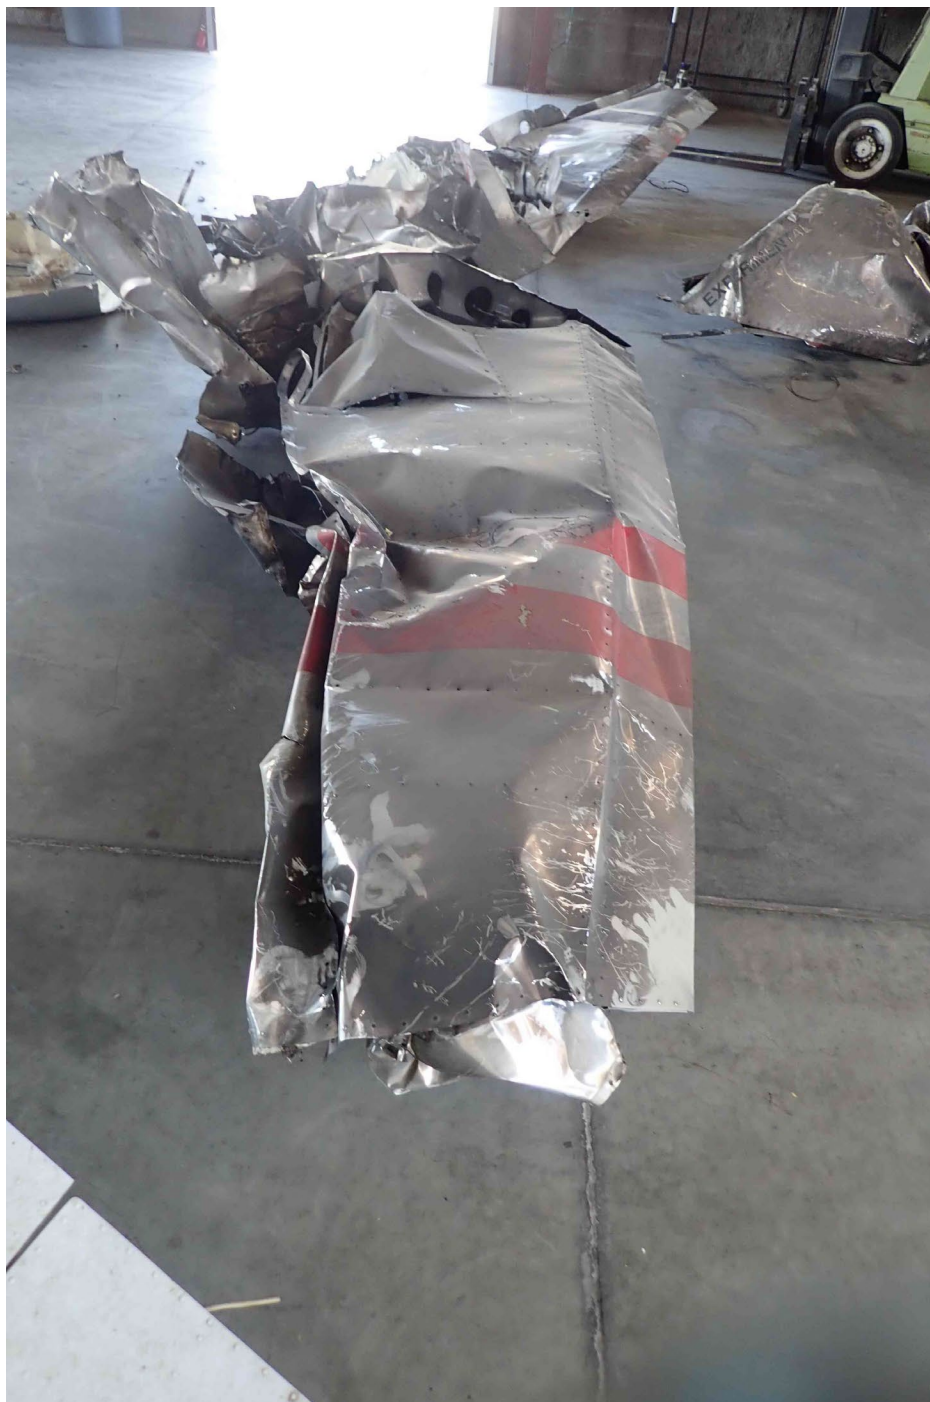
Photo 2 - Wings

The leading edges of both wings sustained crush damage through to the main spar, focused on the lower side of each wing, at an angle about 45° relative to the chord. Similar 45° aft bending was present on the spar (photo 2).

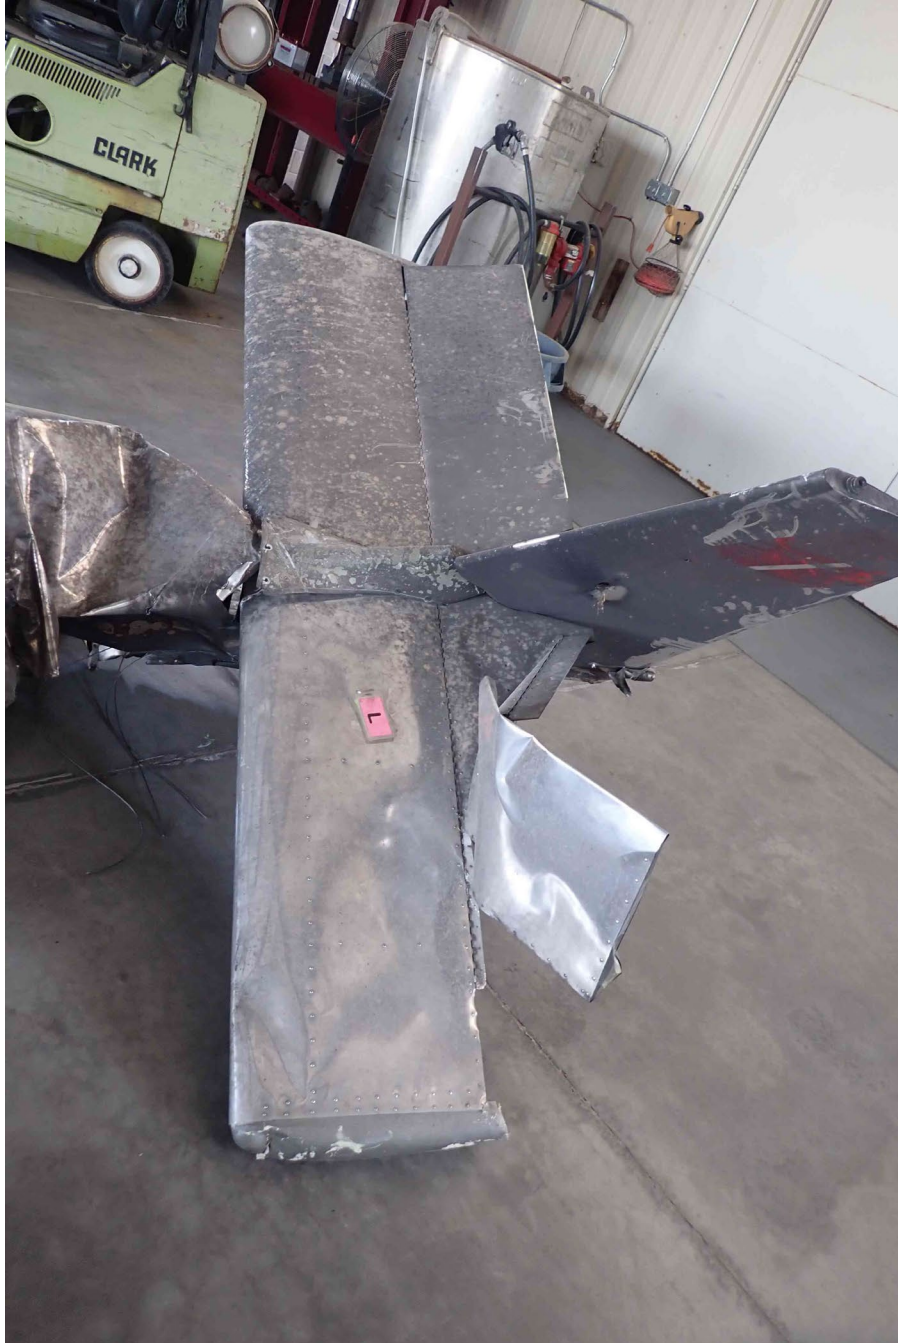
Photo 3 – Tail section

The horizontal stabilizer was largely undamaged and remained attached to the airframe on its right side by its forward and aft spar (photo 3). The left attach points had broken away, and exhibited fresh and bright separation features, and were not coated in soot.

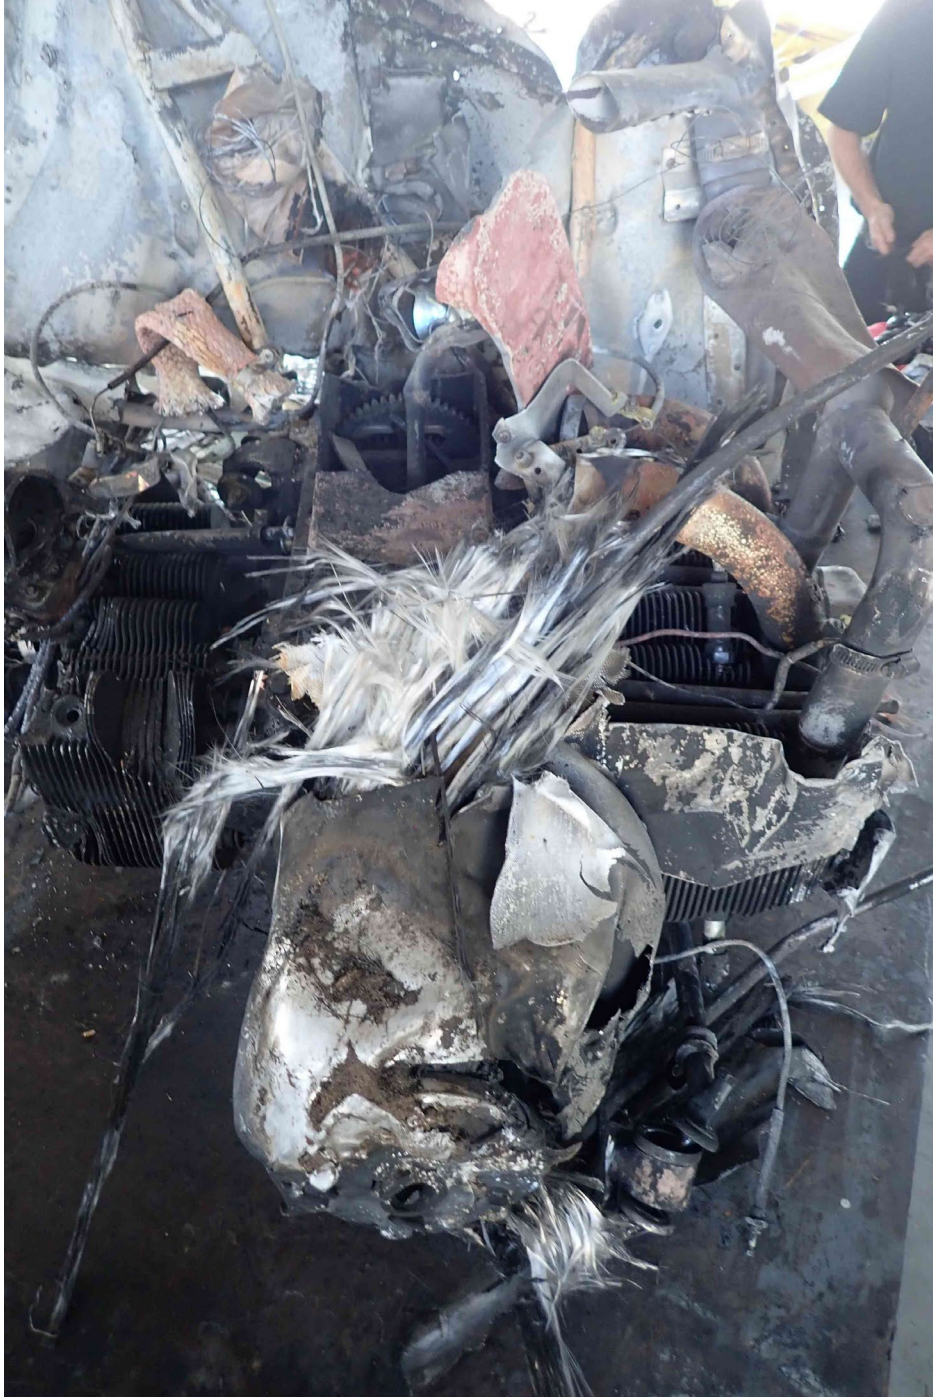
Photo 4 – Engine and propeller

The engine sustained impact damage liberating the carburetor, inlet manifold, engine driven fuel pump, alternator, gascolator, starter and both magnetos (photo 4).

The propeller hub and all composite blades remained attached to the crankshaft. The spinner exhibited compression and scoring damage, opposite the direction of rotation. The blades had been consumed by fire, but their internal torsional rods were intact and sustained bending damage opposite the direction of rotation (photo 4).

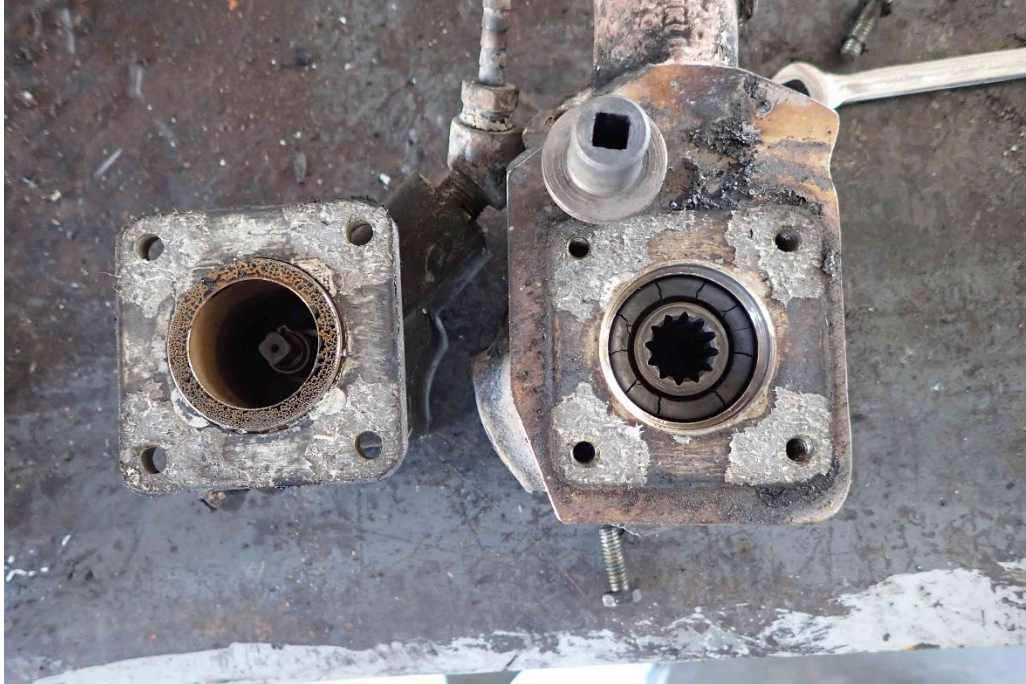
Photo 5 – Engine driven fuel pump

The air inlet screen was crushed, and no blockage was noted. The carburetor had fragmented, revealing a single crushed float. The engine driven fuel pump drive coupling was intact, and the pump could be rotated freely by hand (photo 5).

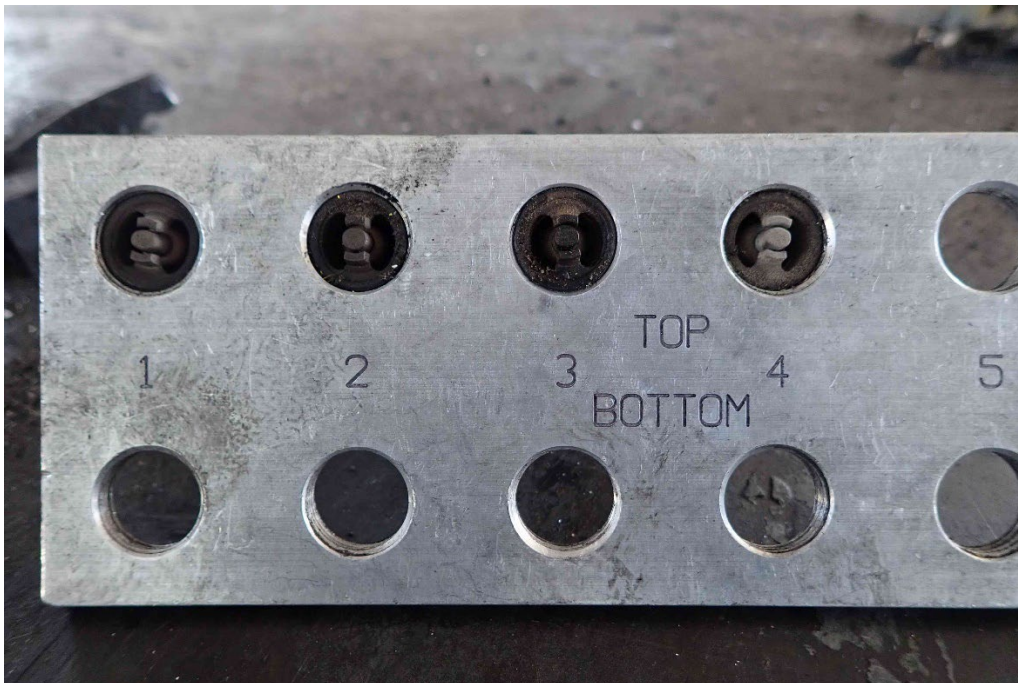
Photo 6 – Top spark plugs

Both magnetos sustained impact and heat damage, and all spark wires were consumed by fire. The top spark plugs were removed, and exhibited light grey to dark brown discoloration, and wear signatures consistent with normal operation (photo 6). There was no evidence of

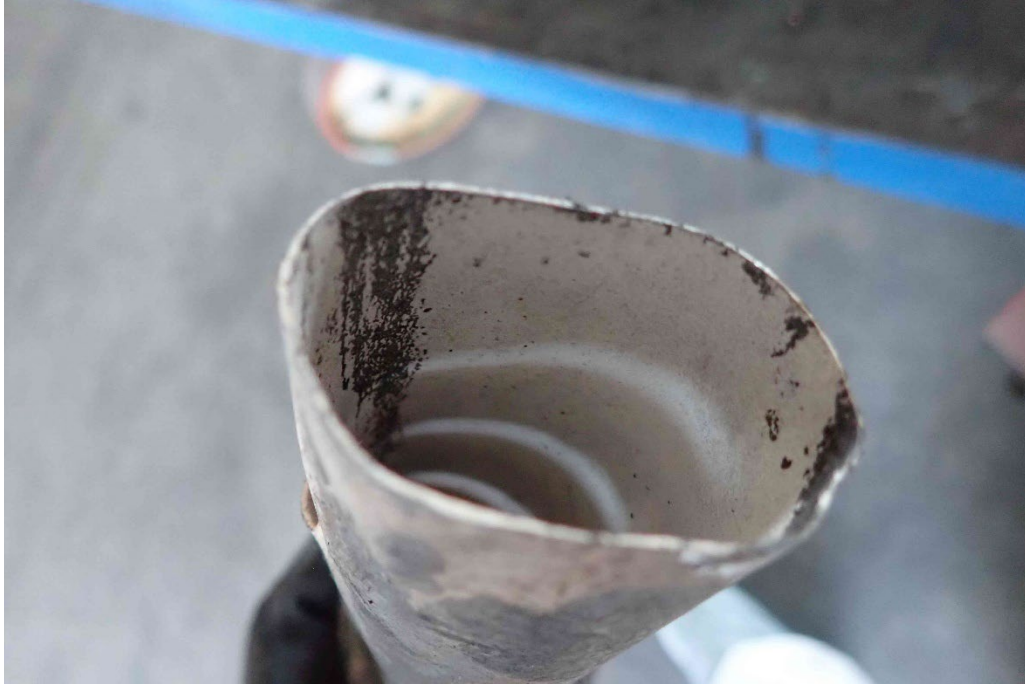
Photo 7 – Exhaust pipe outlet

catastrophic internal engine failure. The inner surface of the exhaust pipe outlet was coated in light tan deposits (photo 7).

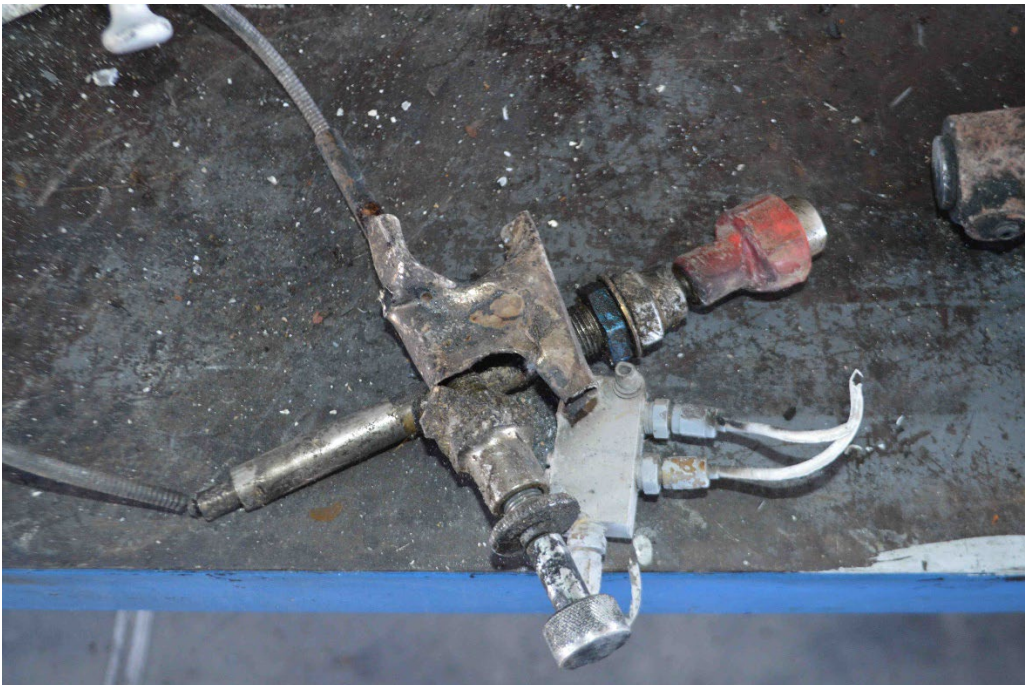
Photo 8 – Throttle and mixture controls

The throttle, mixture, and carburetor heat controls were found in the full forward position (photo 8).
