## **NATIONAL TRANSPORTATION SAFETY BOARD**

# **AIRFRAME AND ENGINE EXAMINATION**

**WPR20LA180**

| Aircraft: | Bellanca 7KCAB, N36339 |

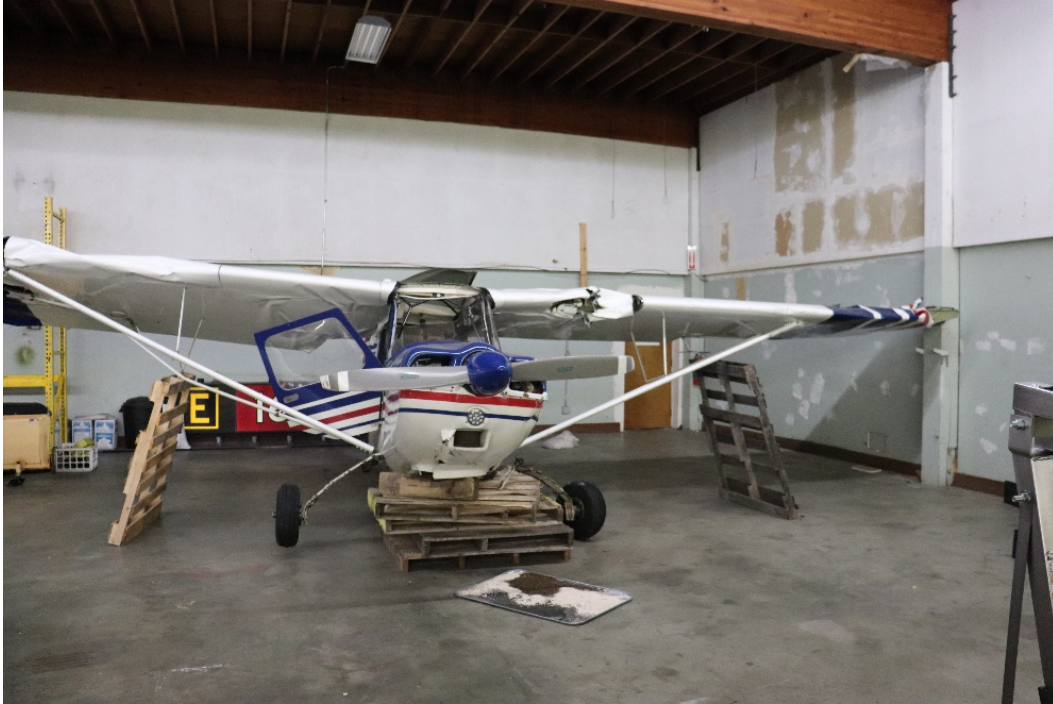
Examination of the recovered wreckage revealed that the left main landing gear was separated from the airframe. The right-wing fuel line was crimped closed near the wing root by recovery personnel to stop a fuel leak. Additionally, a portion of the left wingtip was removed by recovery personnel due to impact damage.

**Figure 1. View of airplane during examination**

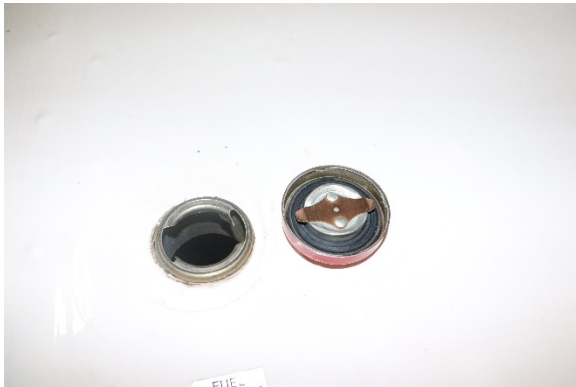
The left and right wings remained attached to the airframe and exhibited buckling of the fabric throughout. Visual inspection of the left and right fuel caps revealed that both fuel caps rubber seals appeared worn. The observed tachometer time was 5,961.1 hours and the HOBBS meter indicated 6,893.7 hours

**Figure 2. View of left fuel cap**

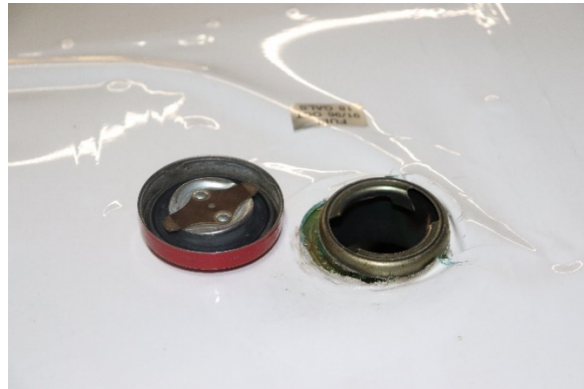
**Figure 3. View of right fuel cap**

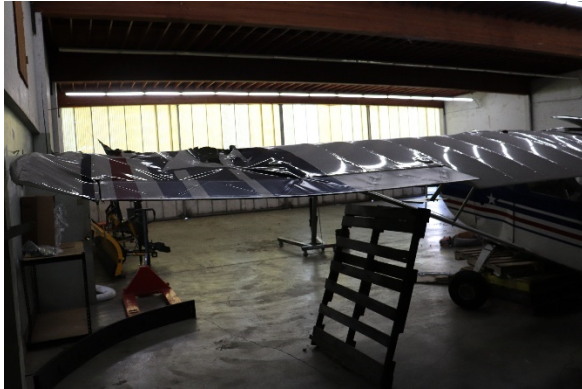
**Figure 4. View of left-wing**

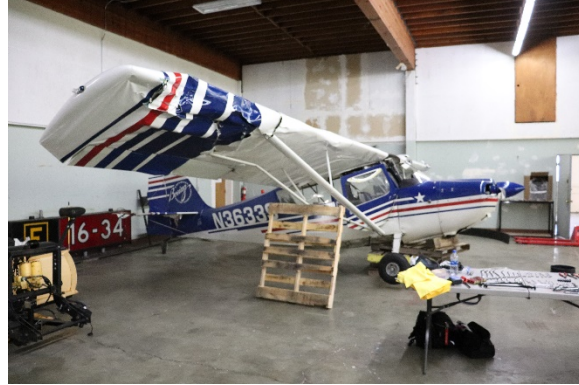
**Figure 5. View of right-wing**

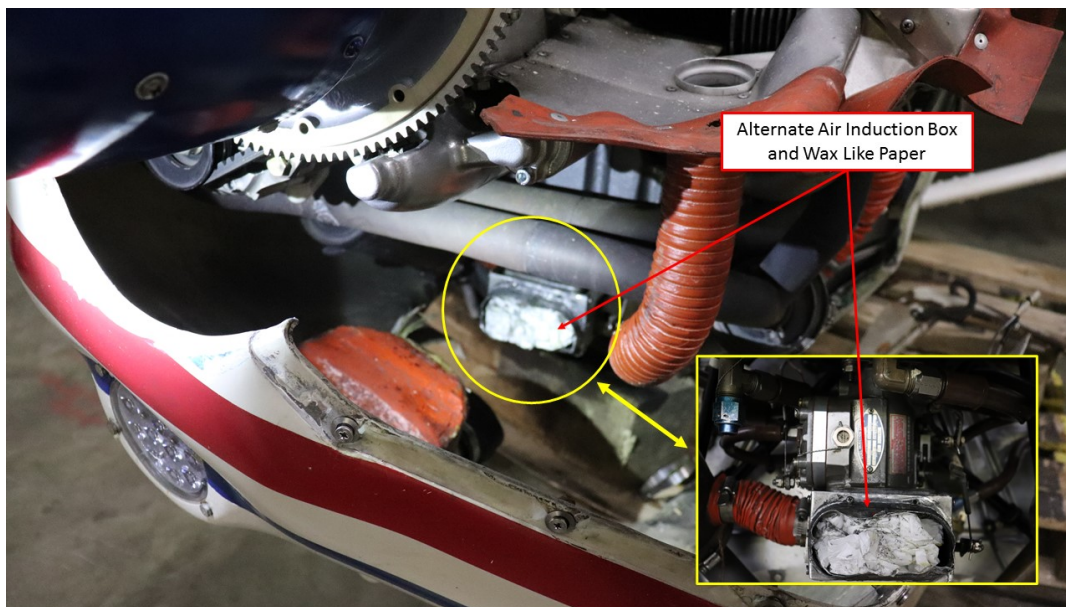
The examination of the recovered airframe and engine revealed a blockage of the alternate air intake induction airbox by a wax like paper. Further examination of the airframe and engine revealed no additional evidence of any mechanical anomalies that would have precluded normal operation.

During removal of the lower section of the engine cowling, a wax like paper was observed in the inlet cavity of the alternate air induction box. The paper appeared to have mostly restricted inlet cavity. When removed and laid out, the paper measured about 3 ft x 2 ft.

**Figure 6. View of wax like paper in the alternate air induction box**

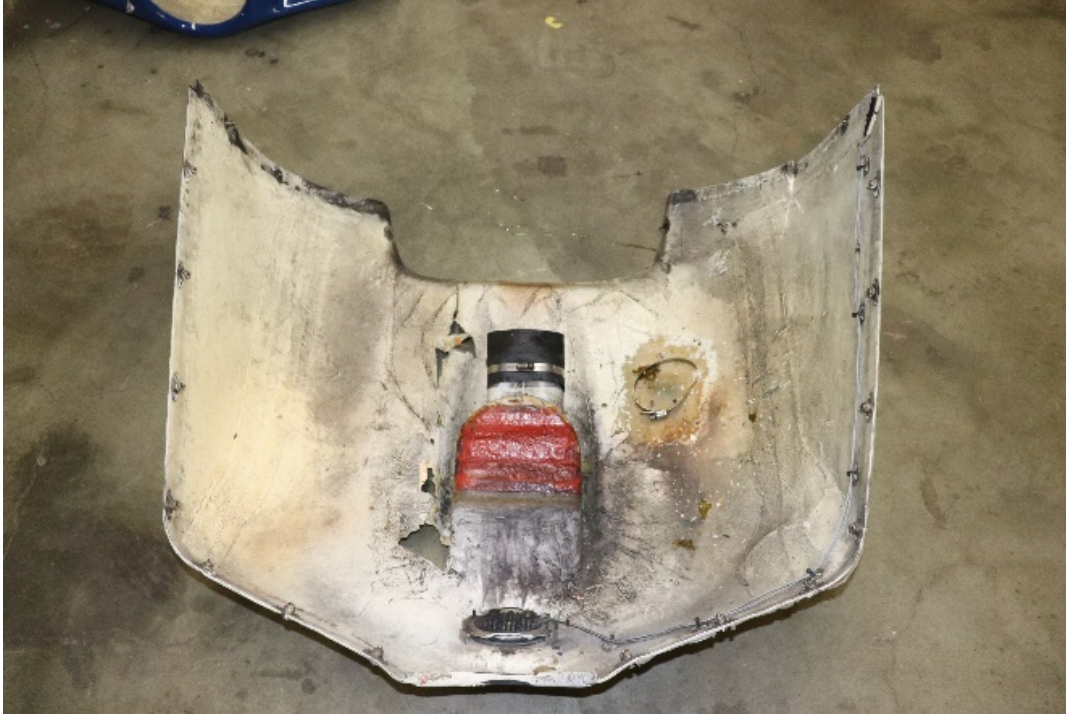
The rubber boot from the air intake box on the lower engine cowling had two breeze clamps in place, however, the aft clamp was located about mid depth on the rub. Additionally, the lower cowling exhibited impact damage to the lower right side.

**Figure 7. View of lower engine cowling and induction airbox**

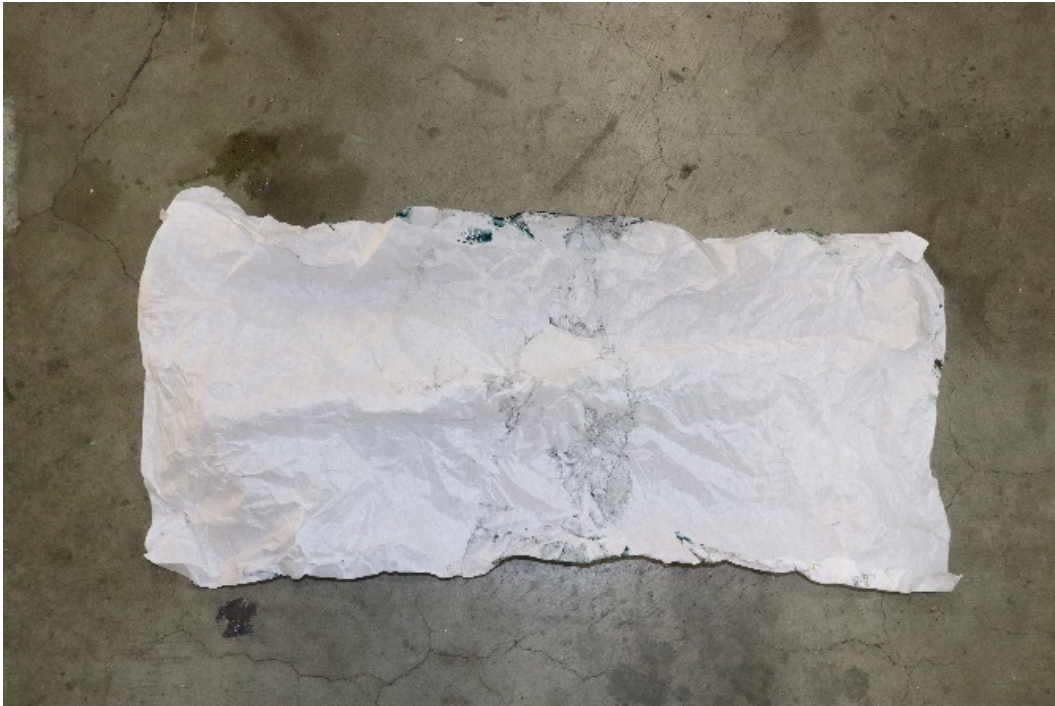
**Figure 8. View of wax like paper laid out**

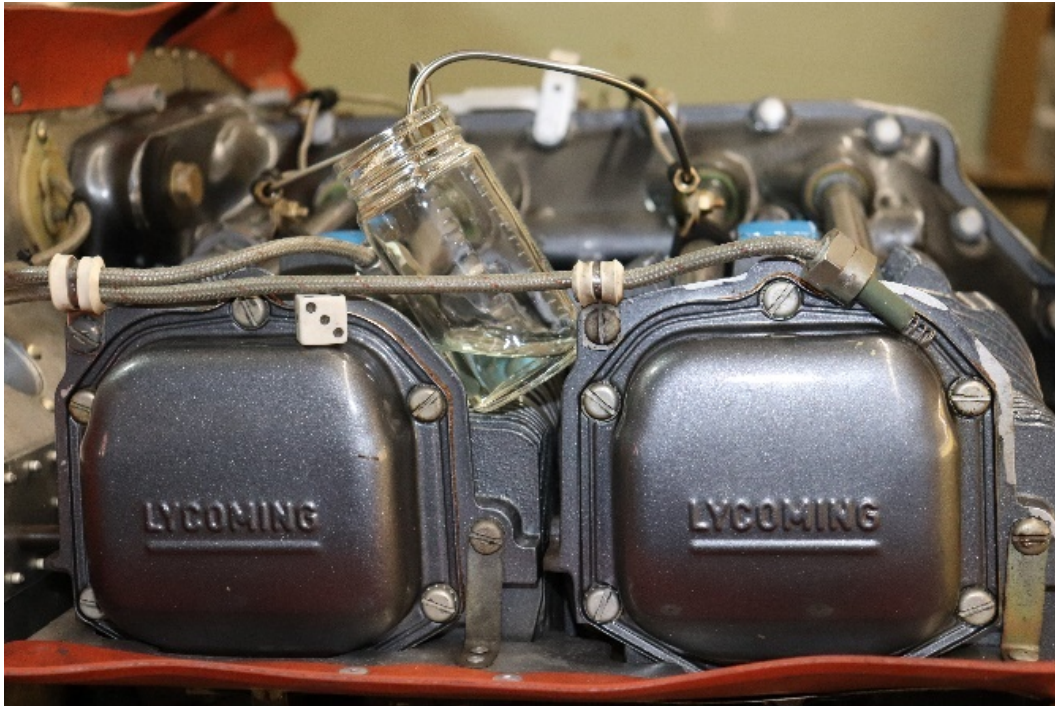
divider were disconnected from the fuel nozzles, and the airframe electric fuel pump was turned on. Fuel expelled from all four fuel injector lines when the electric fuel pump was operated. The fuel was tested for water using SAR-GEL water finding paste, with negative results.

Figure 9. View of fuel from fuel injector from cylinders 1 & 3

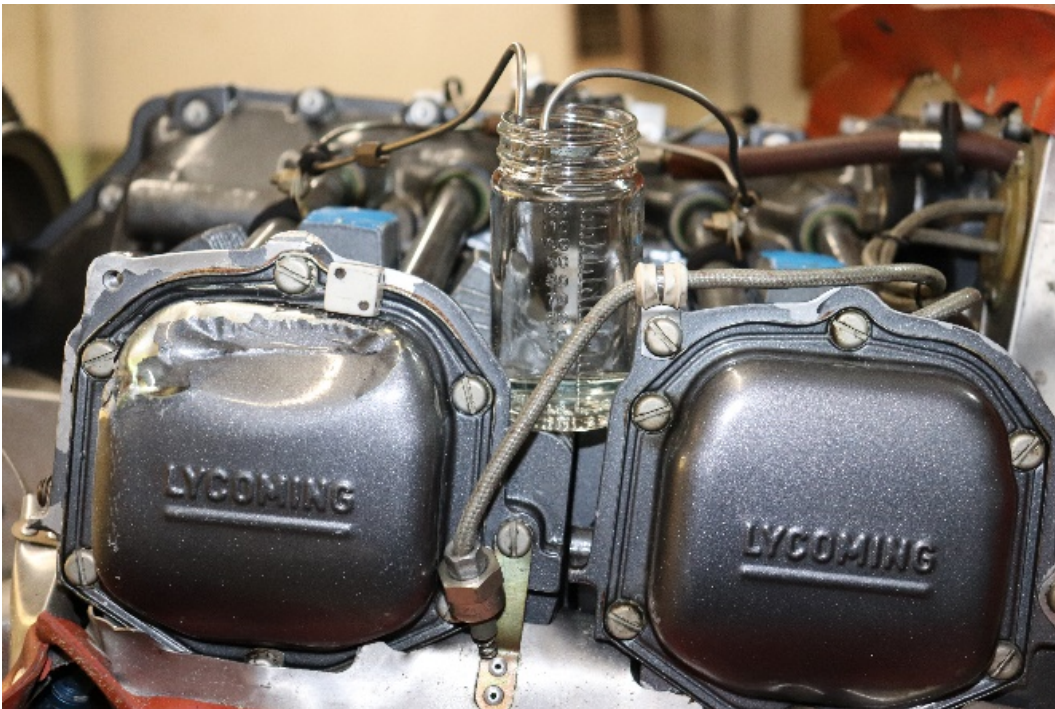
Figure 10. View of fuel from fuel injector from cylinders 2 & 4

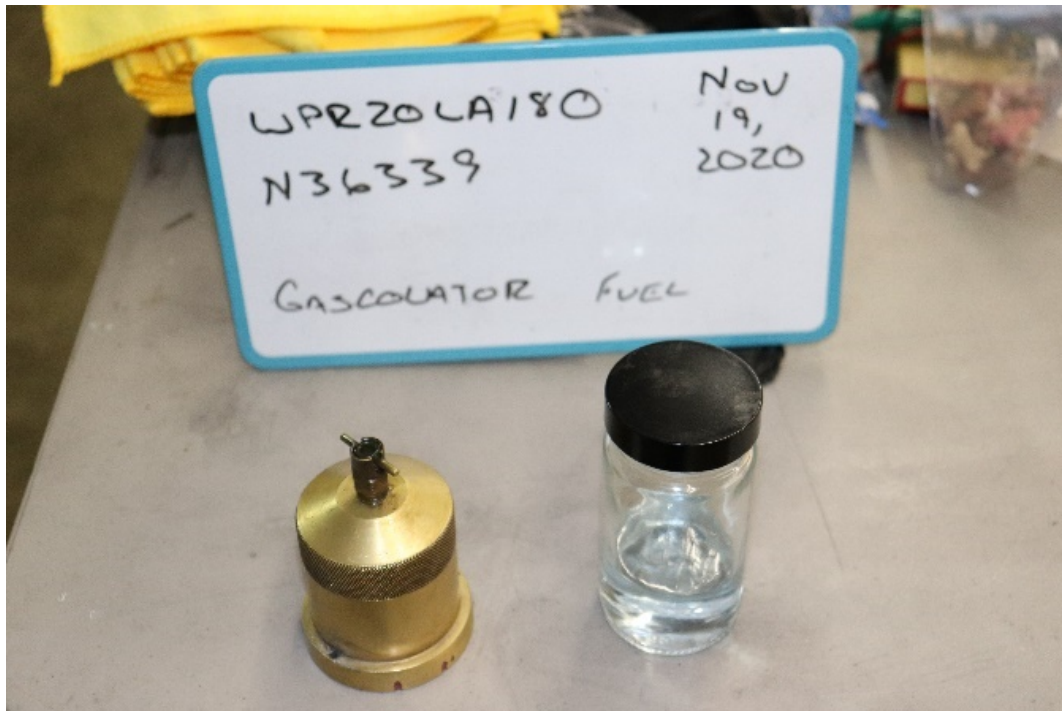
The gascolator was intact and undamaged. The gascolator bowl was removed and visually inspected. The bowl contained a blue liquid consistent with 100 Low Lead fuel and was free of debris. The gascolator screen was free of debris.

Figure 11. View of gascolator bowl and recovered fuel

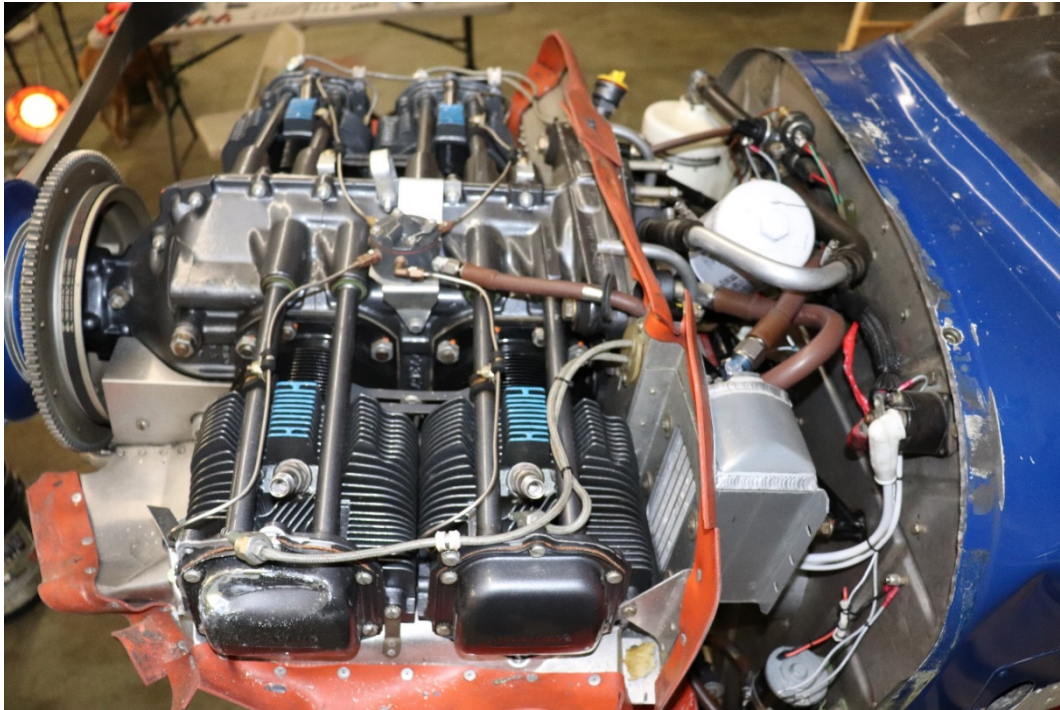
Examination of the recovered engine revealed that it remained attached to the engine mounts. All four cylinders and all engine accessories remained attached. All fuel and oil lines appeared attached to their respective fittings and were tight. No evidence of any mechanical damage was observed to the engine crankcase. The oil sump exhibited impact damage on the lower right side, in an area consistent with the impact damage observed on the lower cowling. Additional impact damage was observed to the upper area of the number two cylinder rocker box cover.

**Figure 13. Overview of the engine**

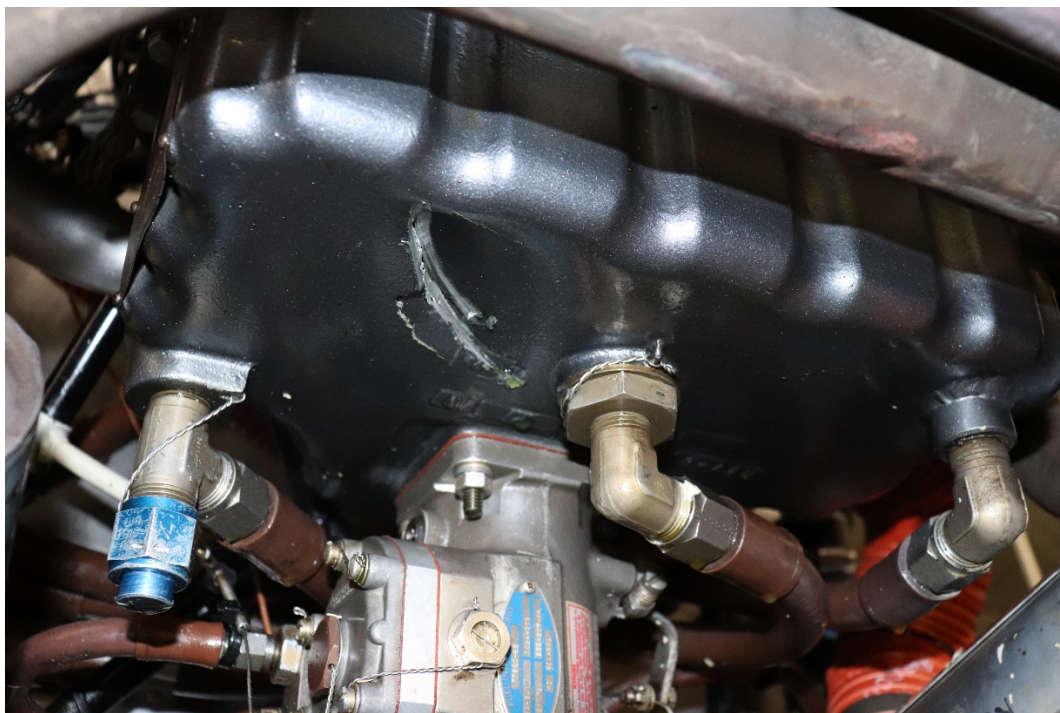
**Figure 14. View of damage to the oil sump**

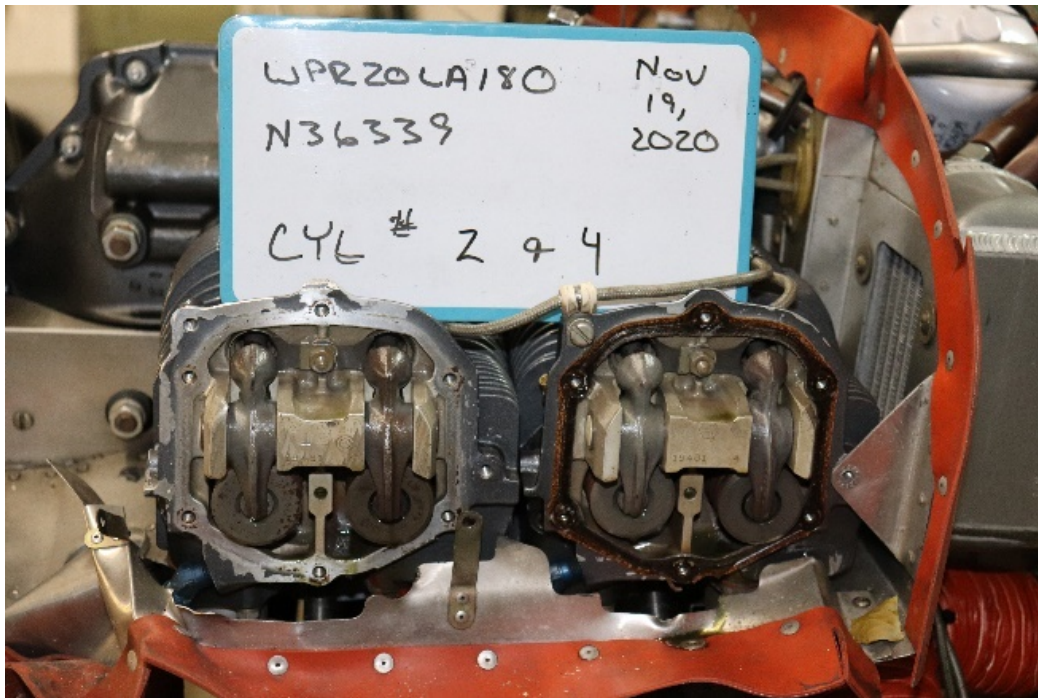
The rocker box covers were removed. The intake and exhaust rocker arms were intact and oil coated on all cylinders. All intake and exhaust valve springs were in place and visually appeared to be undamaged. The upper spark plugs were removed, and all four cylinders were examined internally using a lighted borescope. A normal amount of combustion deposits was observed within the combustion dome of each cylinder and piston face. All of the intake and exhaust

Figure 15. View of number 2 & 4 cylinders rocker arms

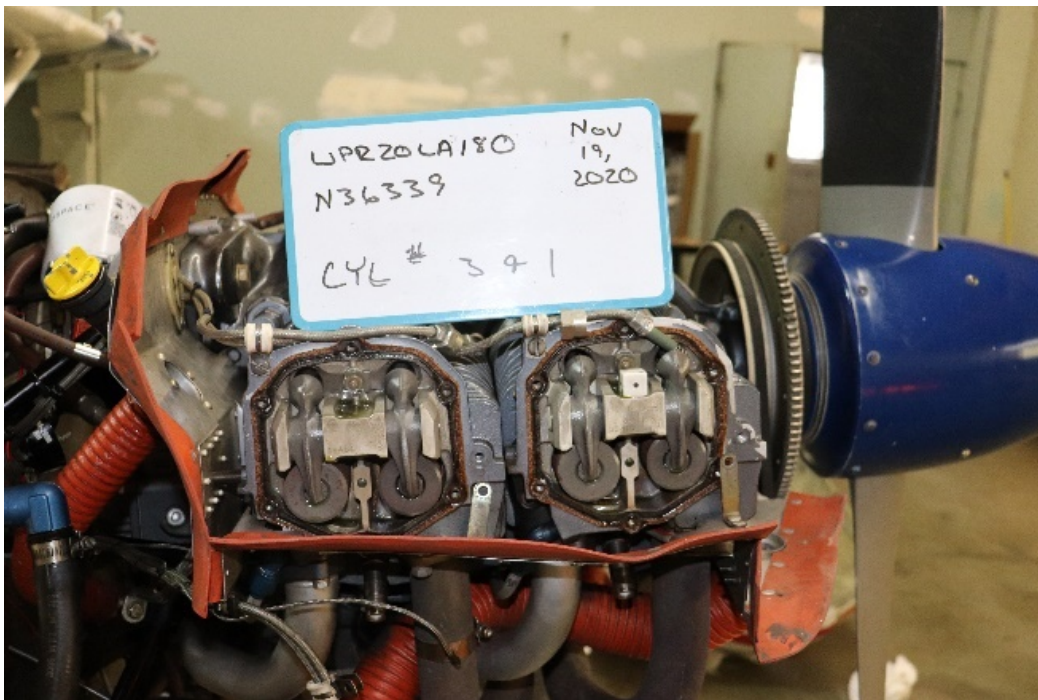
Figure 16. View of number 3 & 1 cylinders rocker arms.

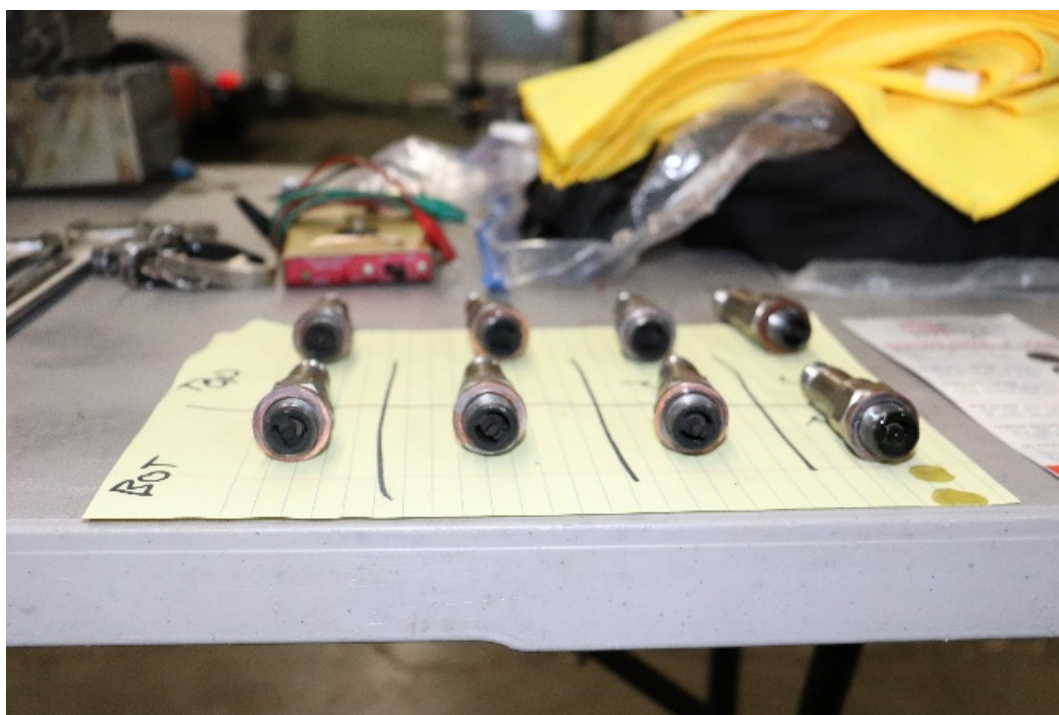
The top and bottom spark plugs were removed from the engine and they were the massive electrode type. When compared to the Champion Check-A-Plug chart, the sparkplugs had the following signatures:

Except for cylinder number 4 bottom spark plug, all spark plugs had black deposits within the electrode area. The bottom spark plug for cylinder number 4 was oil soaked.

Figure 17. Upper and lower spark plugs

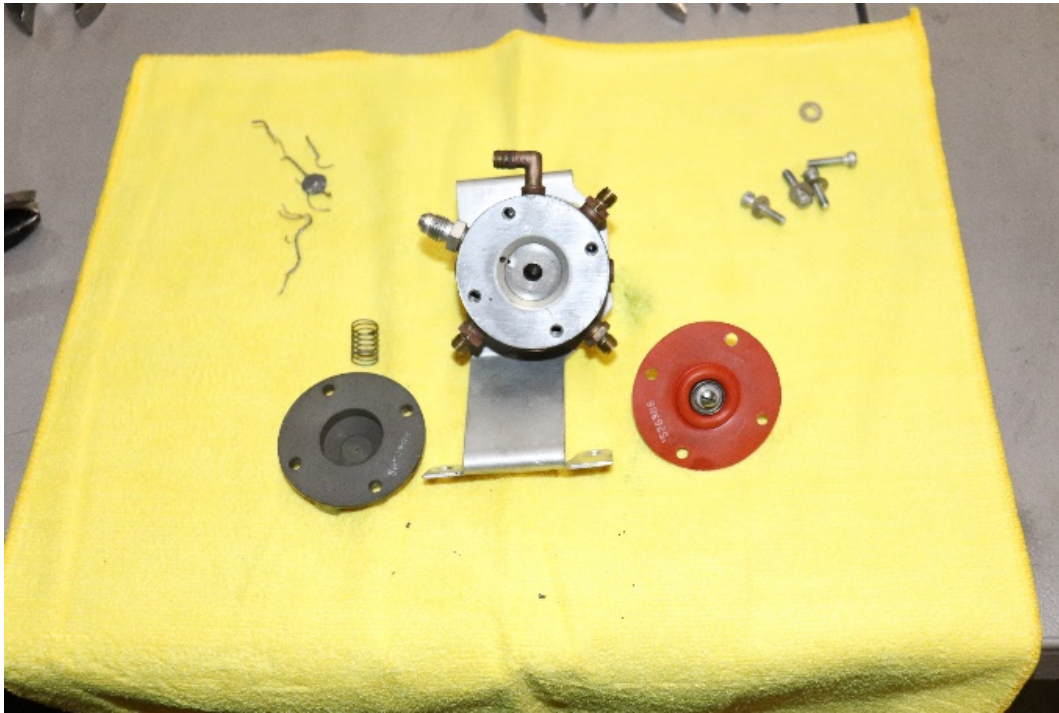
The fuel flow divider was intact and undamaged. The fuel flow divider was removed and disassembled. The spring and diaphragm were intact and undamaged.

**Figure 12. Overview of disassembled fuel divider**

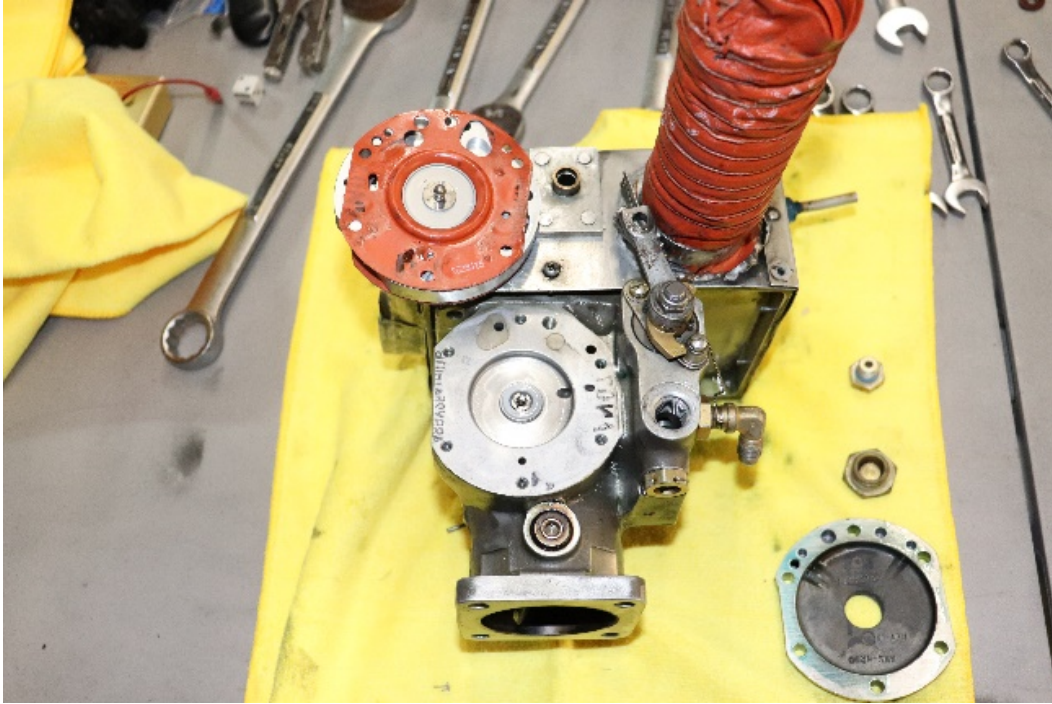
The fuel servo was intact and undamaged. The fuel servo inlet fuel screen was free of debris. The throttle valve and throttle lever were intact and undamaged. The fuel servo was removed and disassembled. the air and fuel diaphragms were intact, and undamaged. The mixture shaft was removed and found unremarkable.

**Figure 18. Overview of disassembled fuel servo**
