## **NATIONAL TRANSPORTATION SAFETY BOARD**

### **RESPONSE NOTES**

WPR20LA180

Location: Renton, Washington  
Date: June 12, 2020  
Aircraft: Bellanca 7KCAB, N36339  
NTSB Investigator-in-Charge: Zoe Keliher

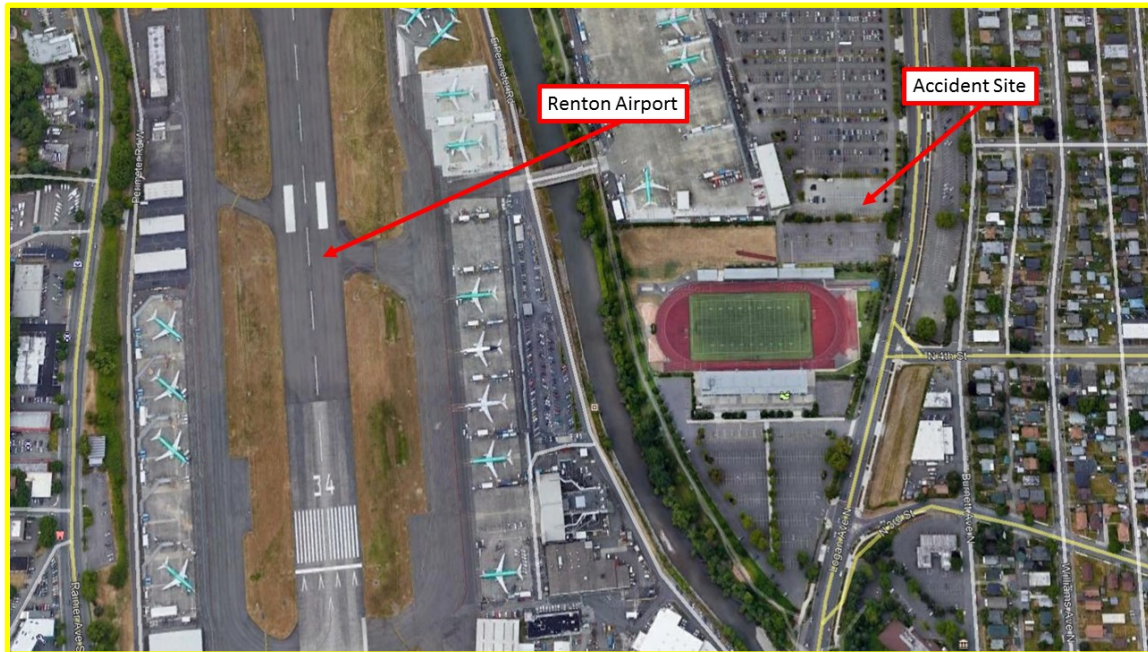
Photo 1 - Overview of accident site (Google Earth)

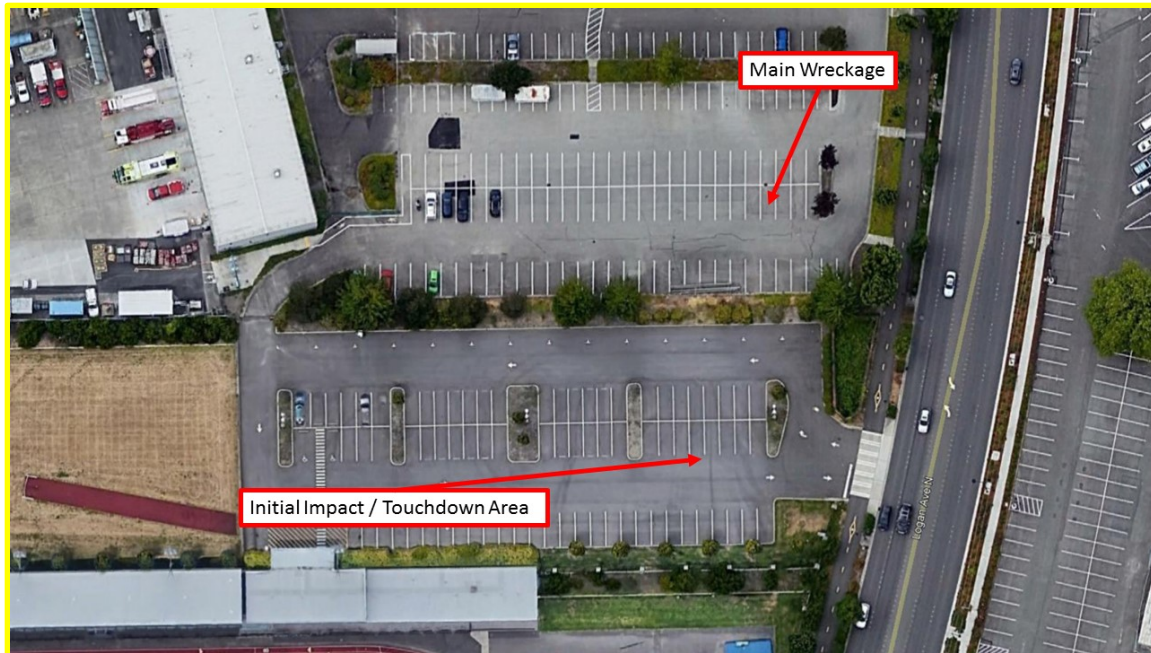
Examination of the accident site revealed that the airplane landed in a parking lot about 1700 ft east of the Renton Municipal Airport. The first identified point of contact (FIPC) with the ground was tire skid marks, about two feet in length. During the landing roll, the airplane impacted vegetation, a construction equipment container, and 2 portable construction light generators. The airplane came to rest about 100 ft from the FIPC, and the debris path was oriented on a heading of about 195°.

Photo 2 - Overview of initial impact point and main wreckage location (Google Earth)

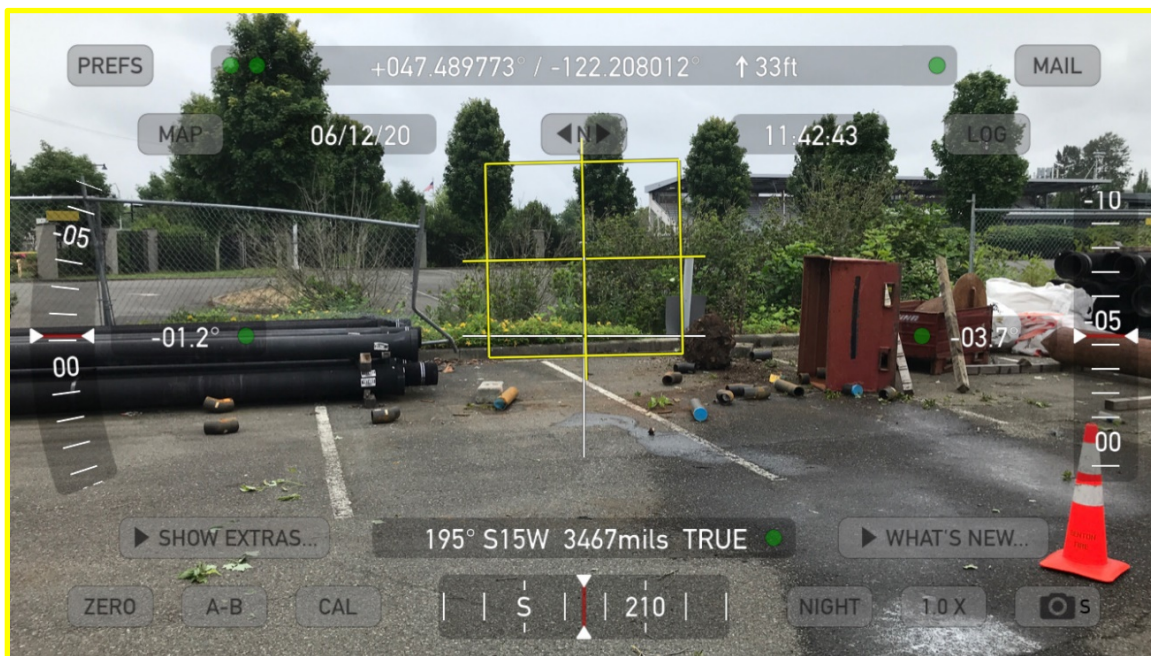
Photo 3 – View of the direction of travel from the airplane

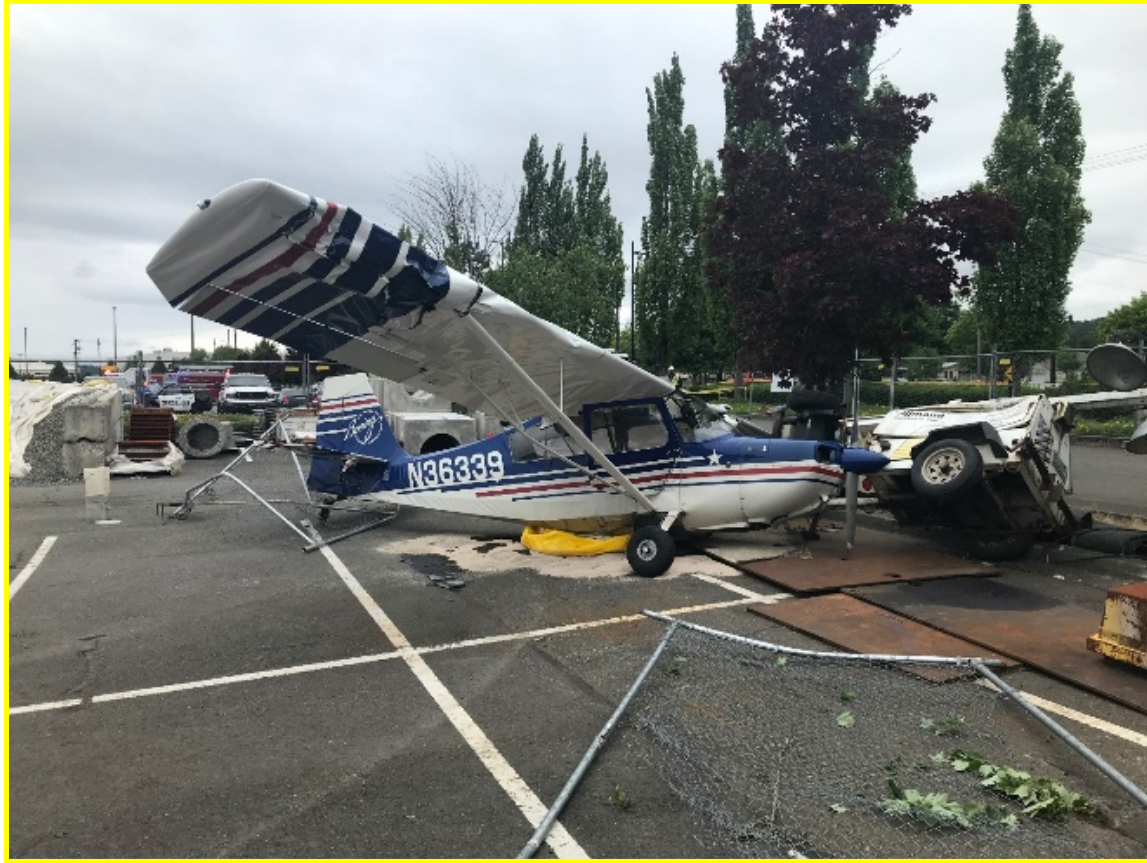
The fuselage exhibited impact damage with rippling of the fabric covering. The engine remained attached to the fuselage. The right wing had impact damage to the leading edge from the jury strut outboard to the wingtip. The aft lift strut was buckled at the jury strut attach point. The right-wing fuel tank was leaking near the wing root. The left wing had impact damage on the leading edge from an area in front of the fuel filler cap and extended outboard to the wingtip. The left main landing gear had collapsed and was displaced underneath the fuselage. The right horizontal stabilizer was impact damaged. A tare was observed in the fabric near the root of the horizontal stabilizer. The right elevator remained attached, however, exhibited impact damage to the outboard edge. The left horizontal was not damaged. The left elevator exhibited impact

Photo 4 - View of right-wing damage

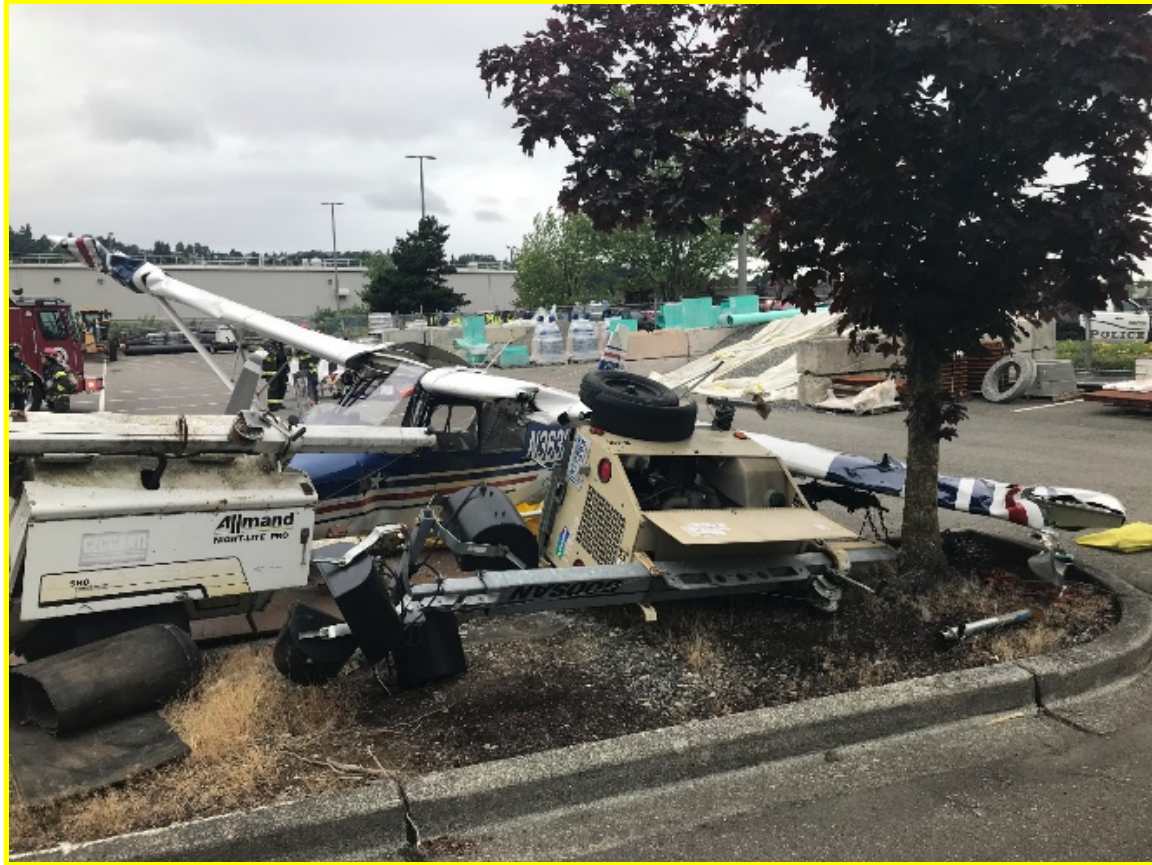
Photo 5 - View of right-wing damage

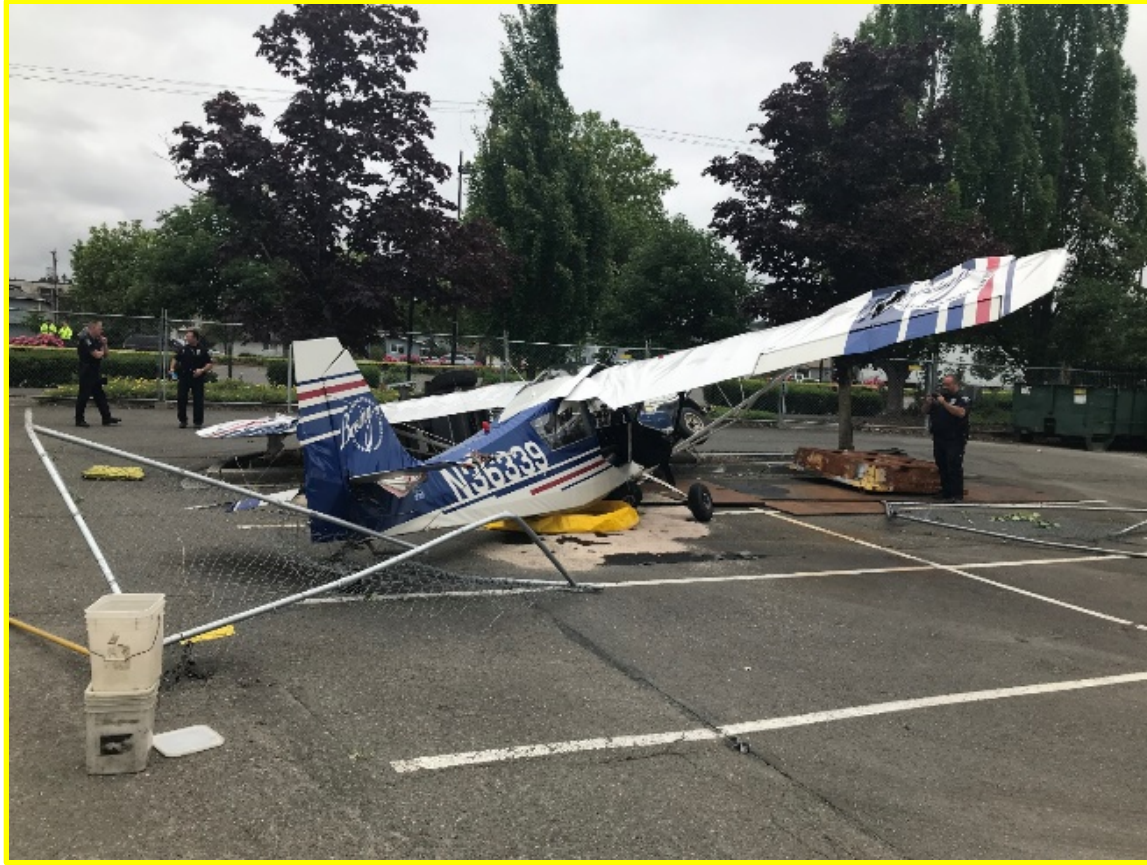
damage to the outboard tip. The rudder remained attached to the vertical stabilator and was buckled about mid height.

**Photo 6 - View of empennage damage**
