# NATIONAL TRANSPORTATION SAFETY BOARD

## MATERIALS LABORATORY FACTUAL REPORT

Report No. 20-055

Place : Coeur D'Alene, Idaho  
Date : June 18, 2020  
Vehicle : Cessna 310B, N6602B  
NTSB No. : WPR20LA187  
Investigator : Maja Smith, AS-WPR

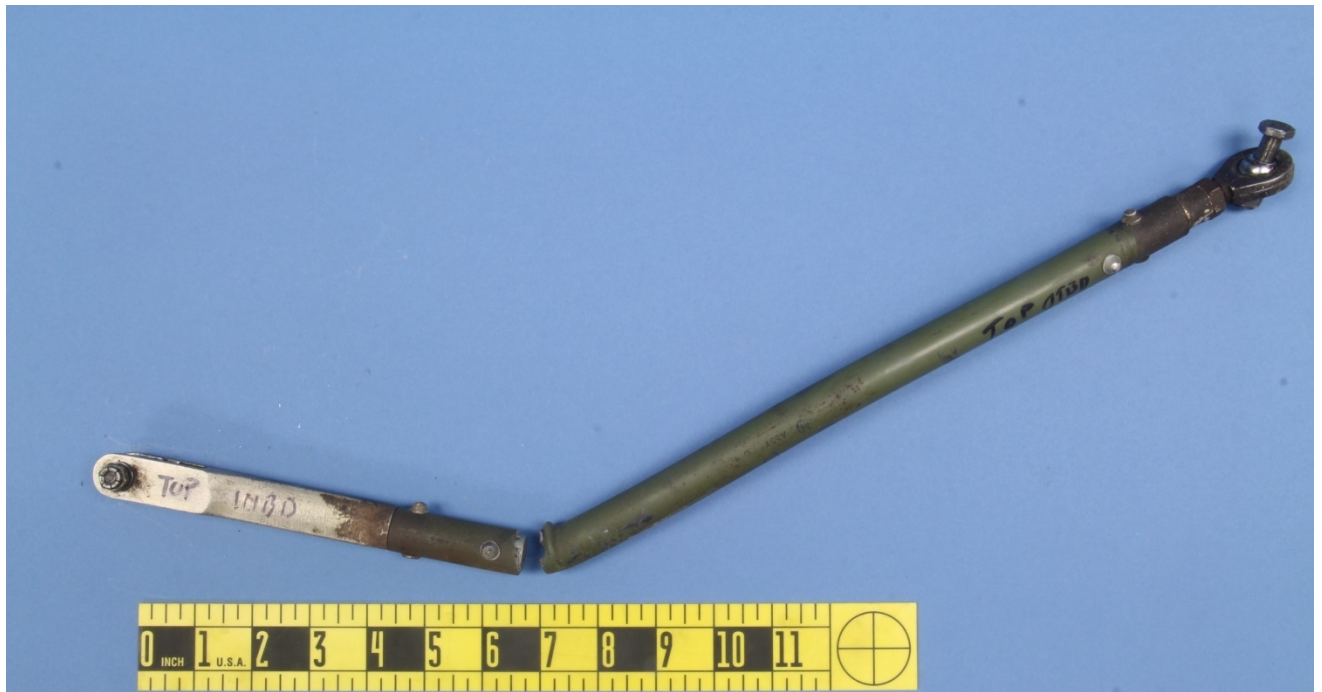
Figure 1 and Figure 2 show the fractured drive tube, as received. In these figures, the tube was positioned to show the mating fracture surfaces in their positions prior to fracture. Not pictured in Figure 1 were a bolt, washer, and nut submitted separately from the fractured tube.

Figure 1 – The left hand MLG drive tube remnants, viewed as received and positioned in their orientations at final fracture.

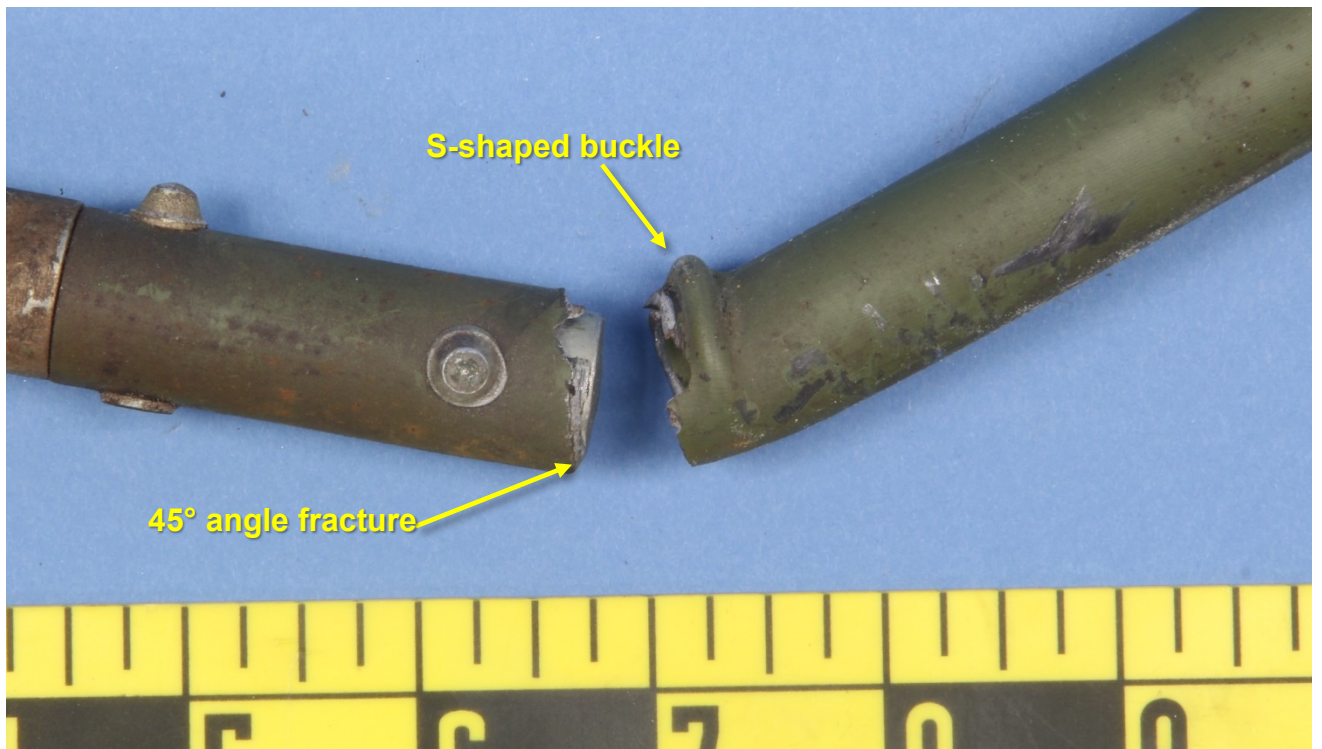
When positioned so that the fracture surfaces faced each other, the normally straight tube exhibited a V-shaped bend. Figure 2 and Figure 3 show closer views of the mating fracture surface and local plastic deformation features as annotated. The concave side exhibited an S-shaped buckle outward, consistent with compression-loaded fractures of ductile materials. The opposite, convex side of the fracture surface exhibited localized necking, microcracking in the paint parallel to the fracture, and a 45° slanted fracture surface. These features were consistent with tension-loaded fractures in ductile materials.

Figure 2 – Closer view of the mating tube fracture surfaces.

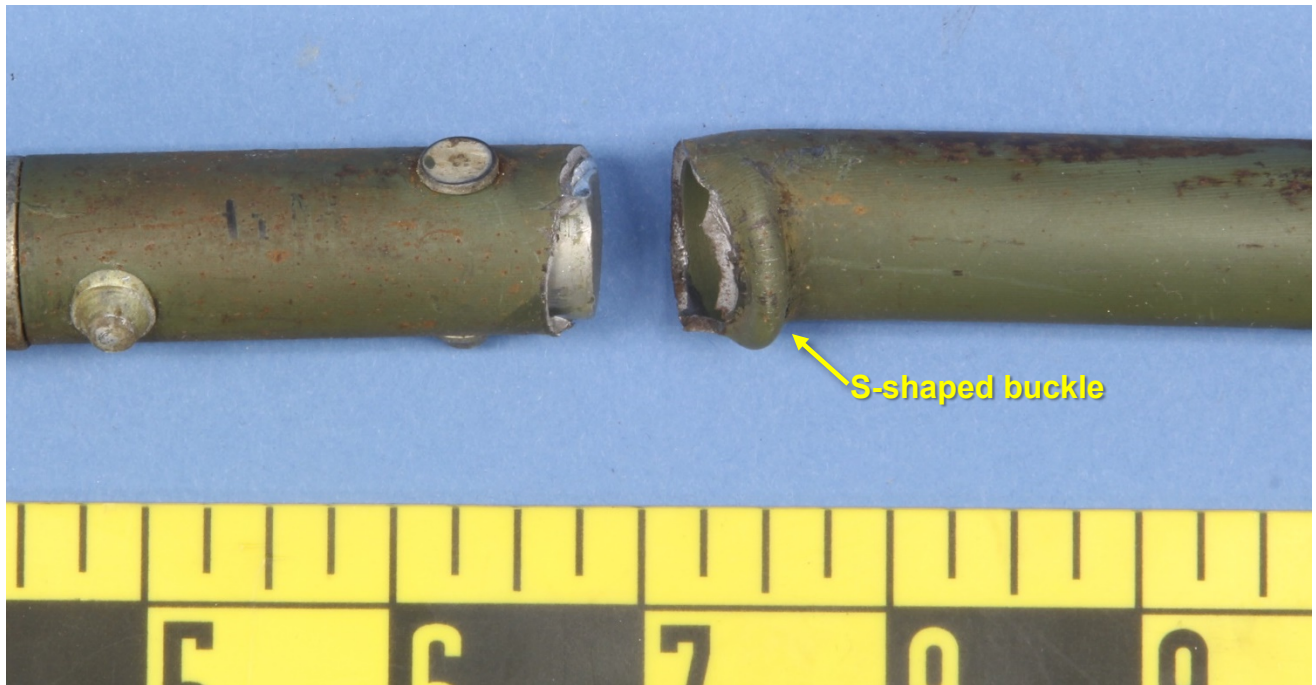
Figure 3 – View of the mating fracture surfaces, viewed from the compression side.

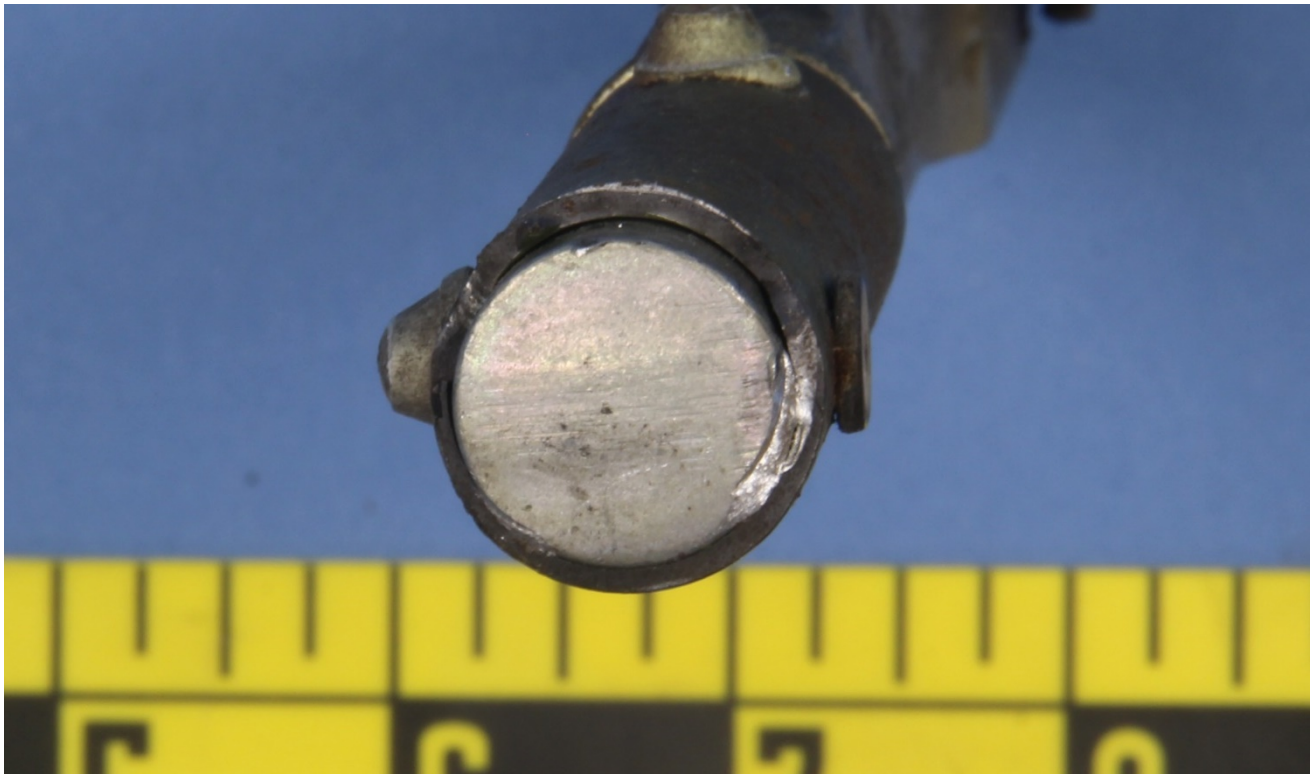
As shown in Figure 4, the tension side of the tube fracture was located at the terminus of the inboard clevis shaft. The compression side of the fracture was a few millimeters recessed from the shaft end. The opposite, outboard fracture surface of the

The observed features were consistent with fracture of the landing gear drive tube from bending overstress at the end of the inboard clevis shaft. There were no indications of pre-existing fracture features or cracking.

Figure 4 – View of the fracture surface from the inboard side, showing the clevis base.

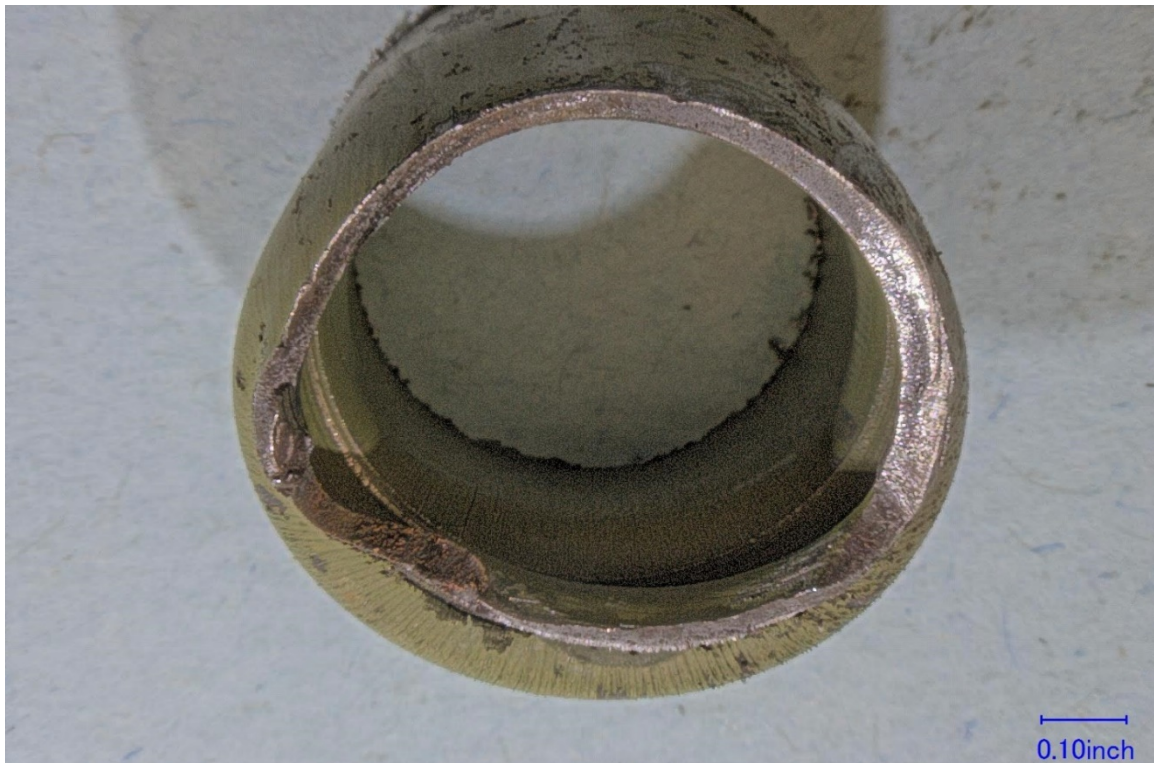
tube is shown in Figure 5, and from the side in Figure 6, after sectioning the fracture surface and cleaning it using acetone in an ultrasonic bath. Figure 6 shows a general bend in the tube towards the compression (buckled) side. As shown in Figure 5, the tube diameter was flattened, with parts of the tube wall bulging outward between the tension and compression sides. This was consistent with this portion of the tube being unconstrained, whereas the inboard side of the tube was constrained by the shaft of the clevis.

Figure 5 – Closer view of the outboard fracture surface, after sectioning and cleaning.

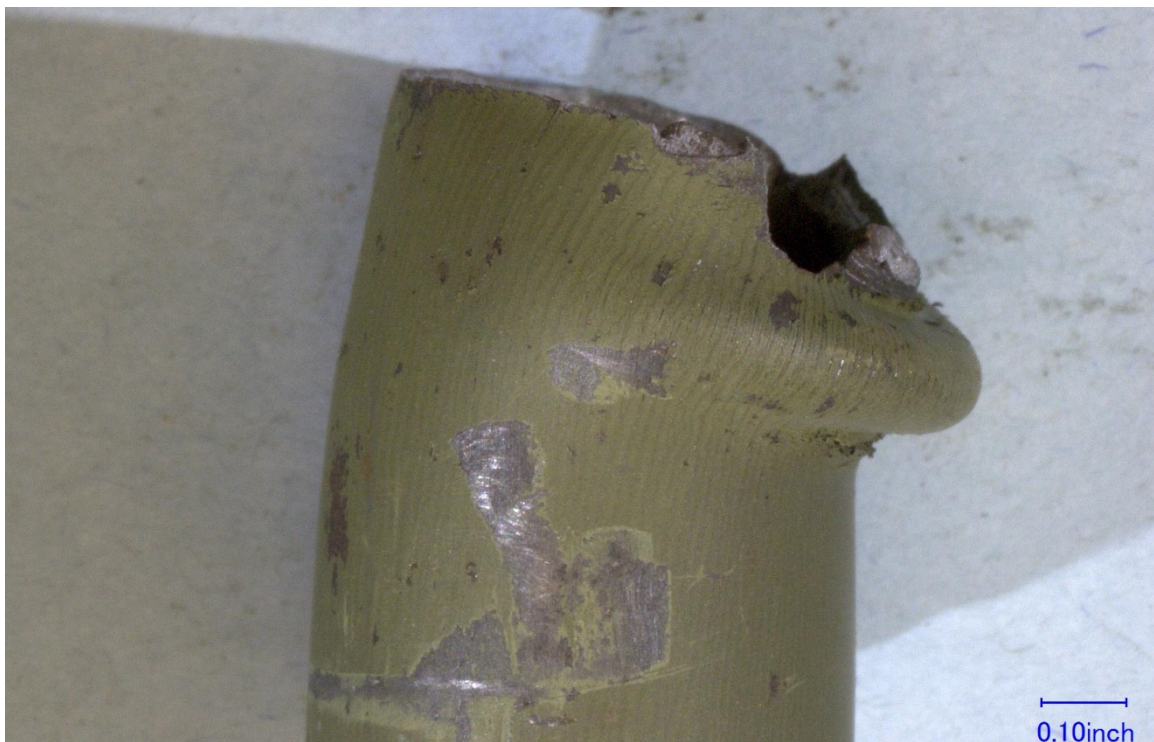
Figure 6 – View of the outboard tube fracture surface from the side.

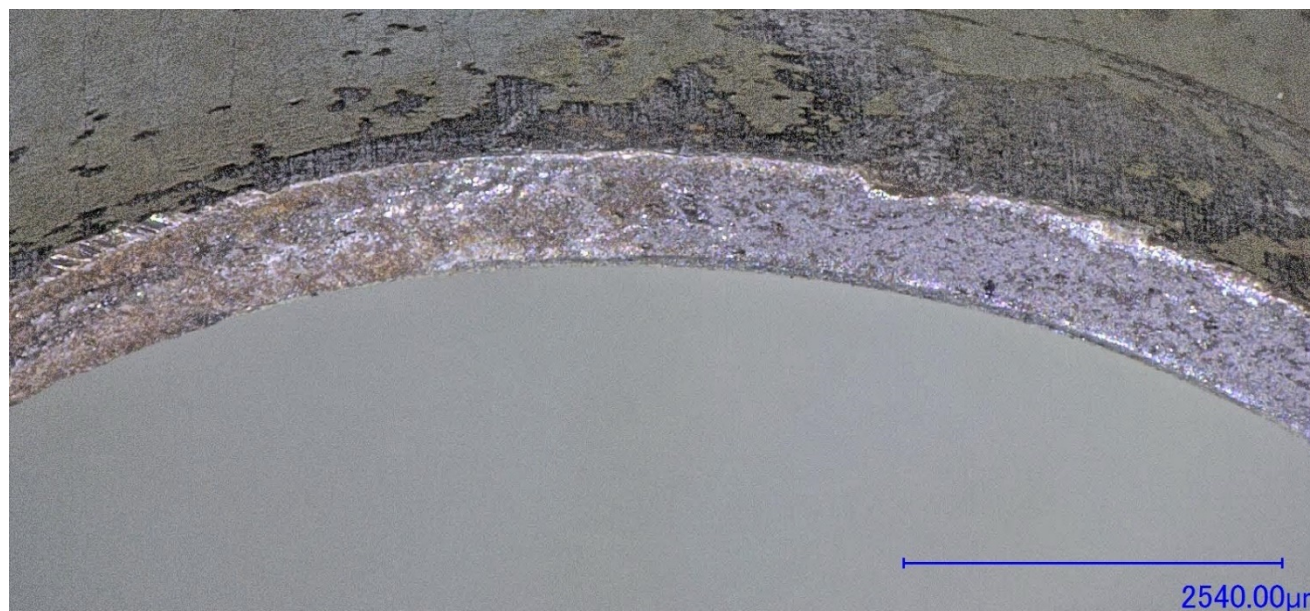
Figure 7 shows the tension side of the tube fracture surface. While oriented 45° from the tube direction, the surface itself was relatively flat, with dull, fibrous features. Some areas of the fracture surface had been damaged by smearing, particularly along the outer edge. In addition, surface corrosion, consistent with iron oxide (rust) was present—this was consistent with post-fracture corrosion and not consistent with a pre-existing fracture feature.

Figure 7 – Closer view of the outboard fracture surface from the tension side.

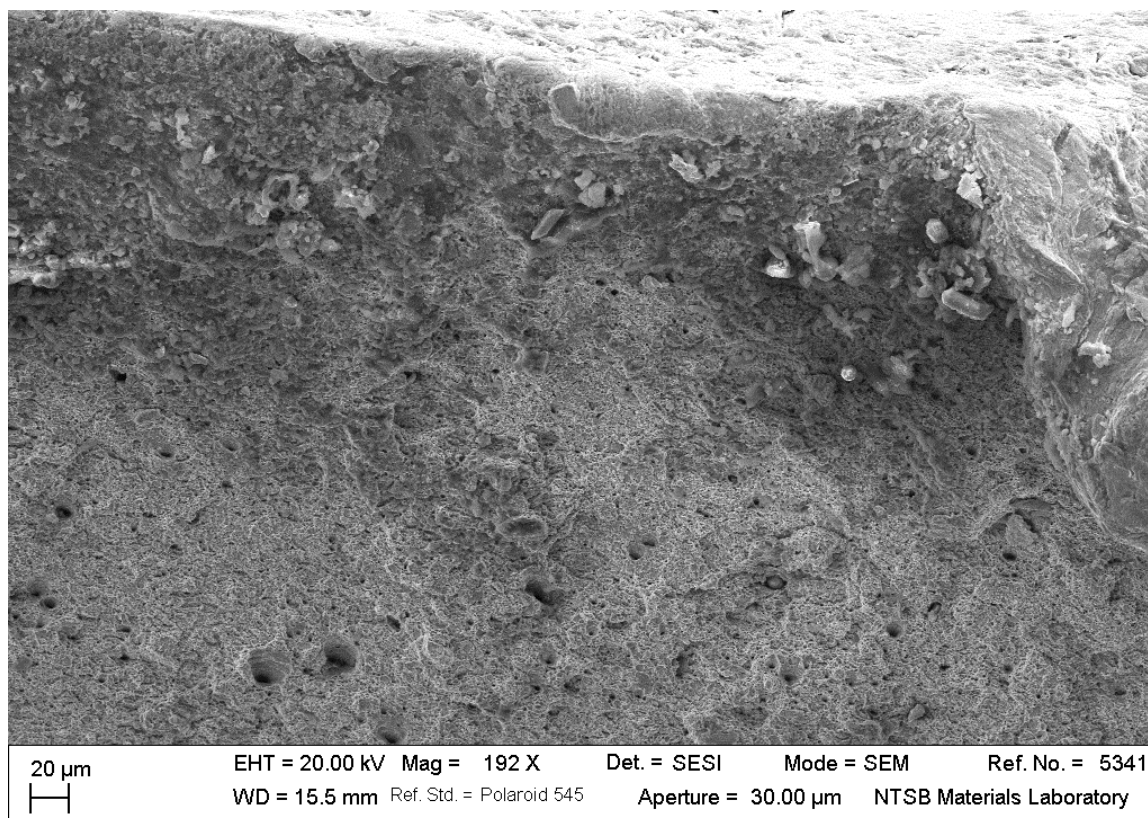
The outboard fracture surface was examined using a scanning electron microscope (SEM). Figure 8 shows a typical area of the tension side of the tube fracture surface. A closer view of this area showed dimpled rupture, as typified in Figure 9. Figure 10 shows a typical area of the compressive side of the fracture surface. This side of the tube fracture surface exhibited a local tension side and a local compressive side, consistent with the macroscopic bending direction. As shown in Figure 11, most of the fracture surface exhibited dimpled rupture, consistent with overstress fracture. The outermost portion or outer edge of the compressive side fracture surface exhibited wide-stepped banded features (Figure 12). These were consistent with the final remnant of the tube bending back and forth before complete separation. Close examination in this area found isolated areas of dimpled rupture.

Figure 8 – Secondary electron (SE) micrograph of the outboard fracture surface, tension side.

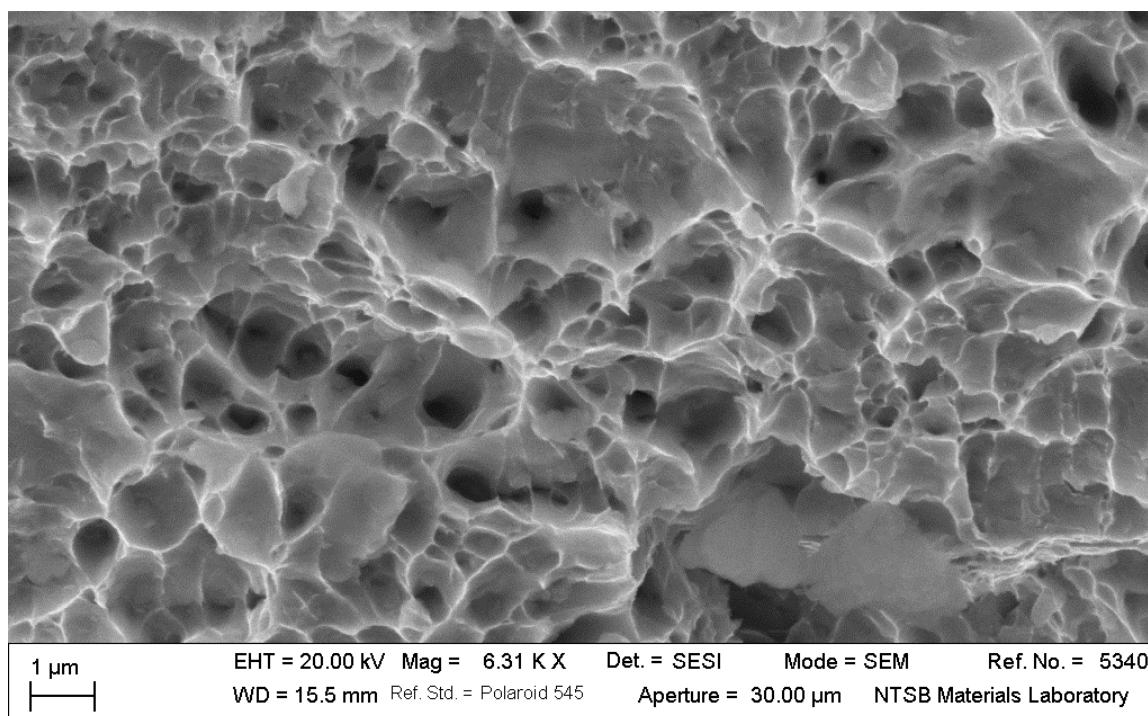
Figure 9 – SE micrograph of dimpled rupture on the tension side.

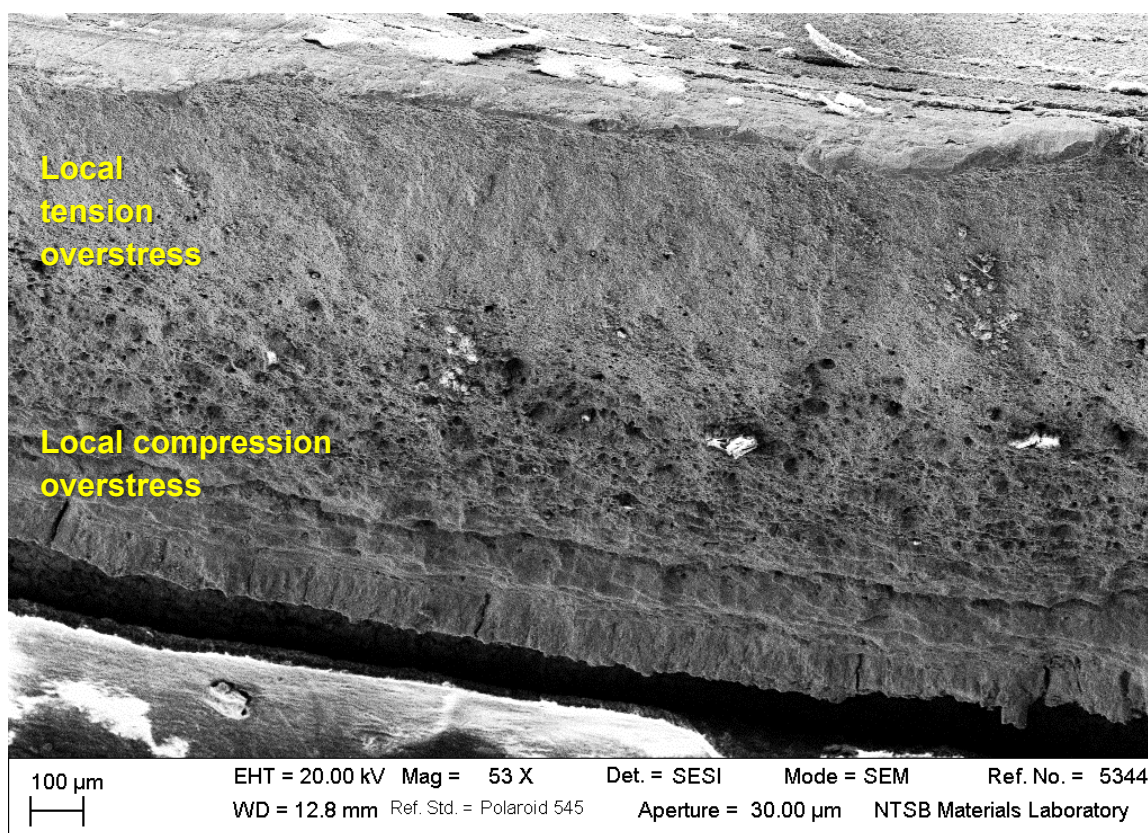
Figure 10 – SE micrograph of the compressive side of the outboard fracture surface, annotated to show the localized tensile and compressive overstress regions.

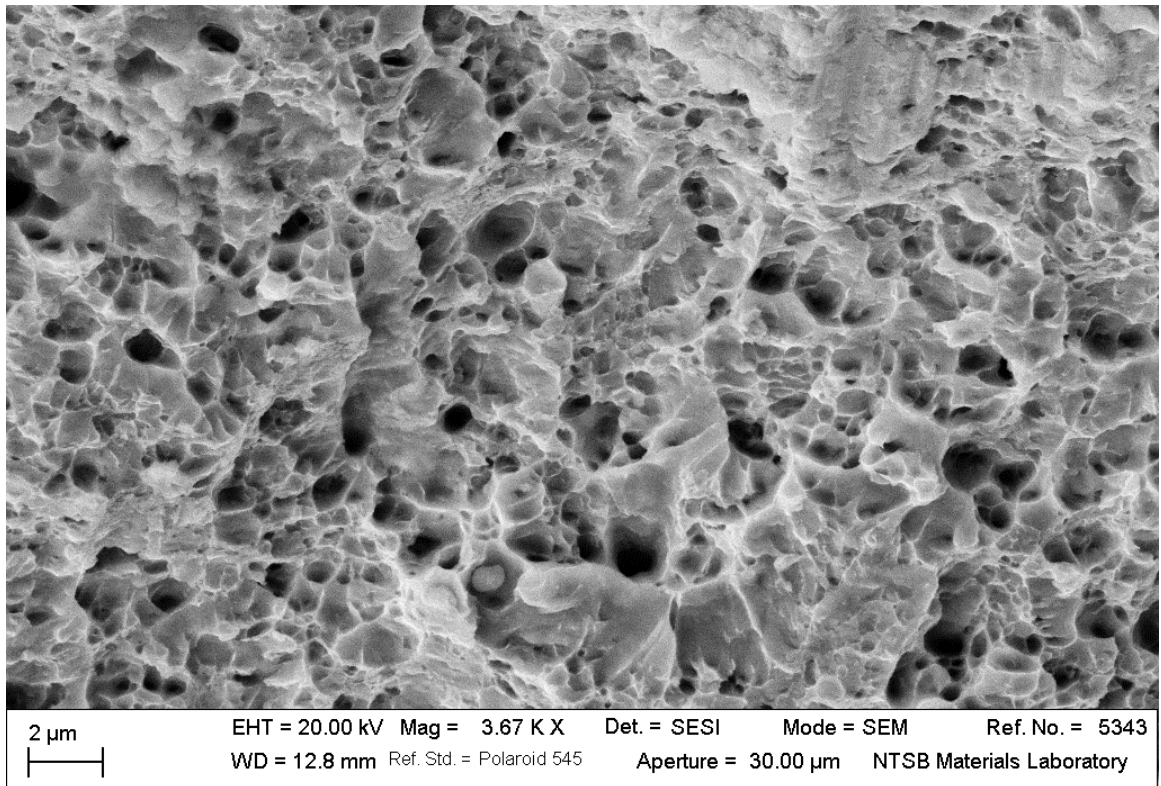
Figure 11 – SE micrograph of dimpled rupture on the tension side.

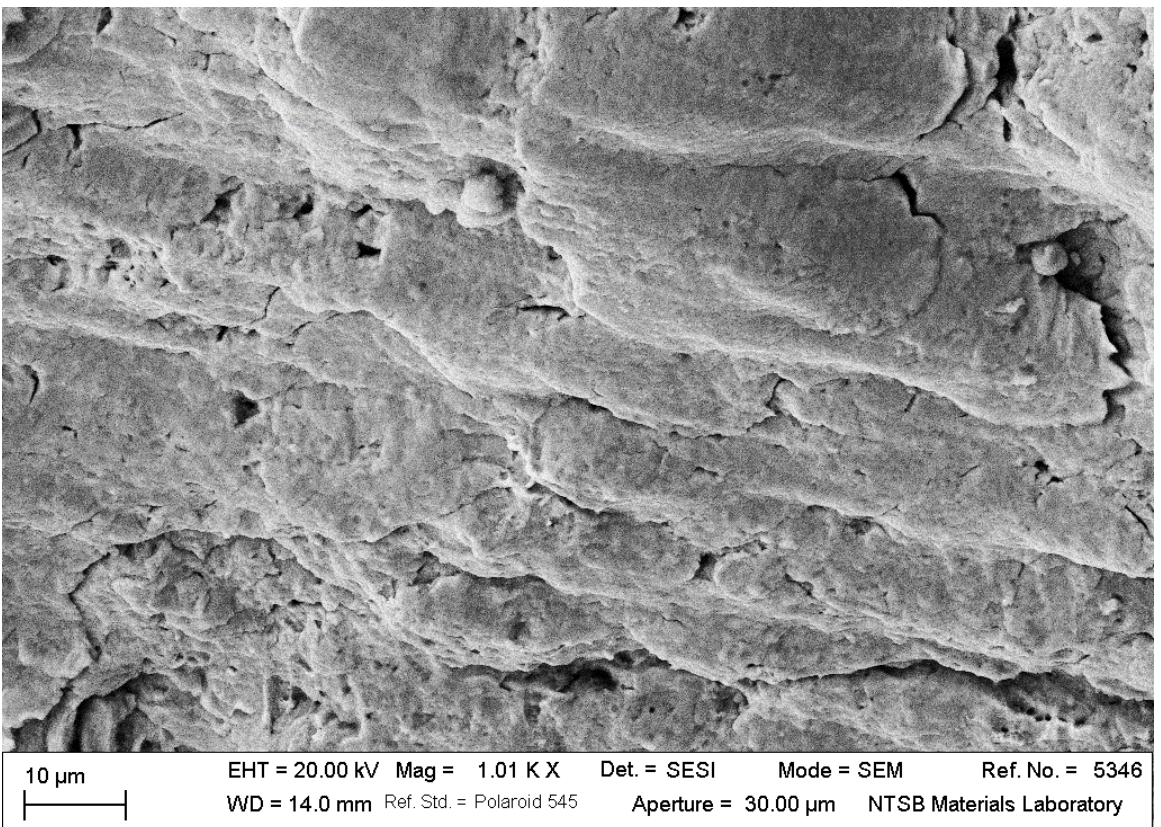
Figure 12 – SE micrograph of the outer edge of the compressive side fracture.
