# **Landing Gear Failure**

**Cessna 310B, N6602B**

**Accident Number:WPR20LA187**

**Gear Examination Report**

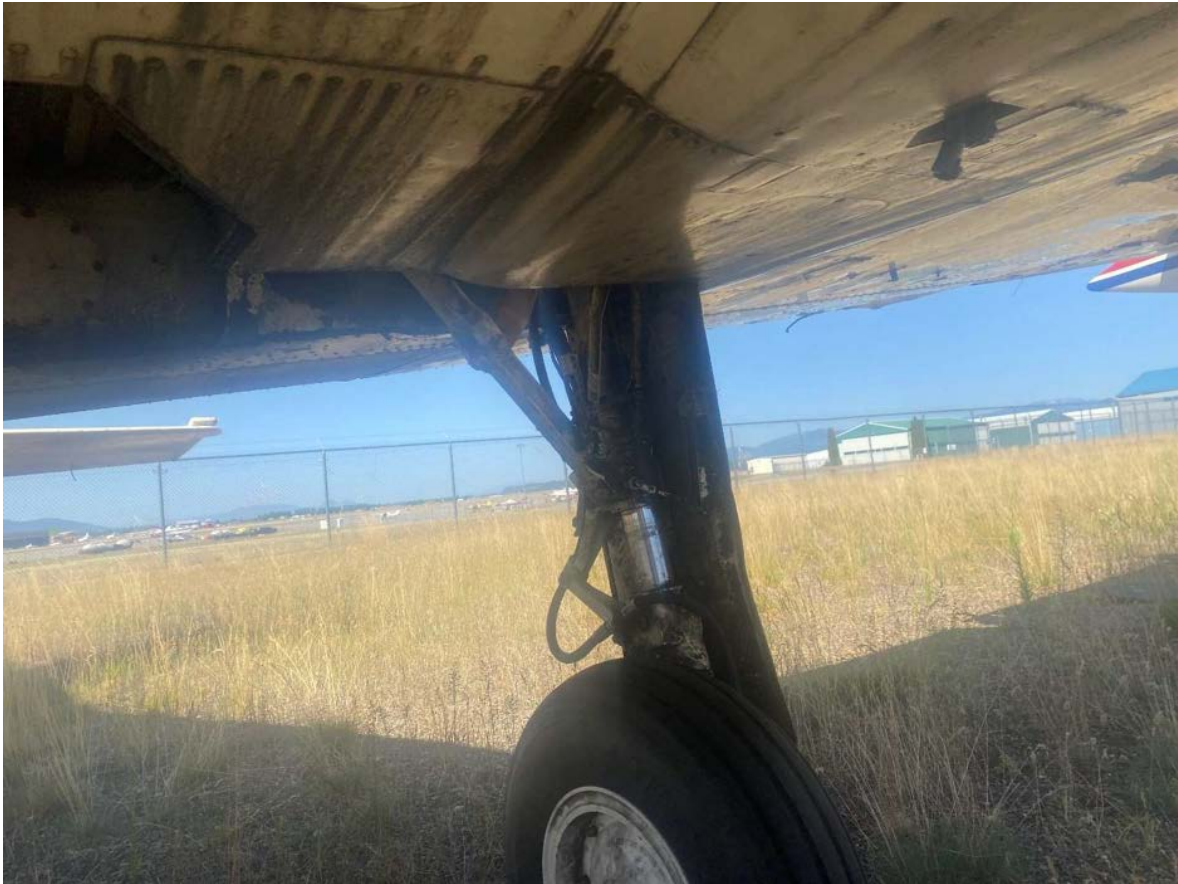
- Post-accident exemption revealed that the landing gear compartment was extremely dirty and covered in oil and debris.
- L/H MLG door was ripped from plane, damage was indicative of the door being in the open or partially open position upon contact with the ground. Normal state of the door with the gear configured for landing would be closed.

General Condition of Oil and Dirt throughout gear wells

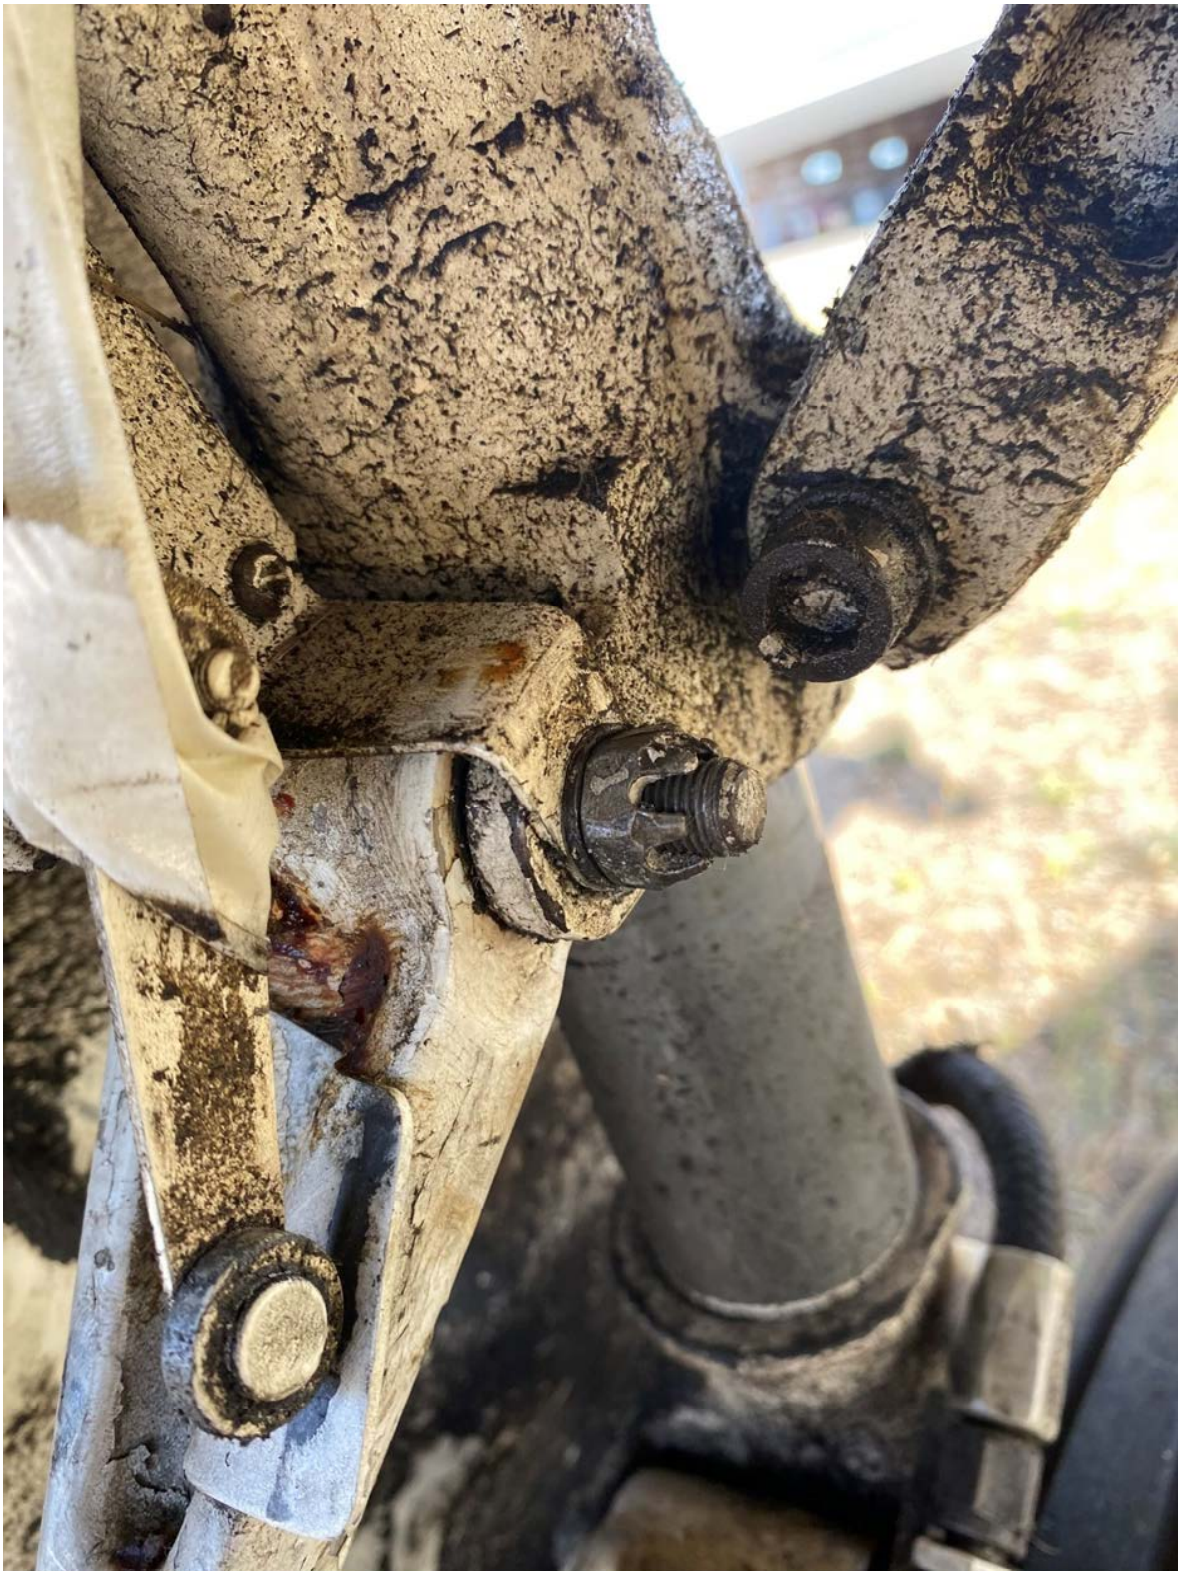
- L/H MLG torque link (scissor link) hardware lacking proper safety devices. (All castellated nuts lacking cotter pins.)
- L/H MLG missing grease zerks, no damage noted to threads on zerk boss, appears to be missing pre-accident.

Missing Cotter pins

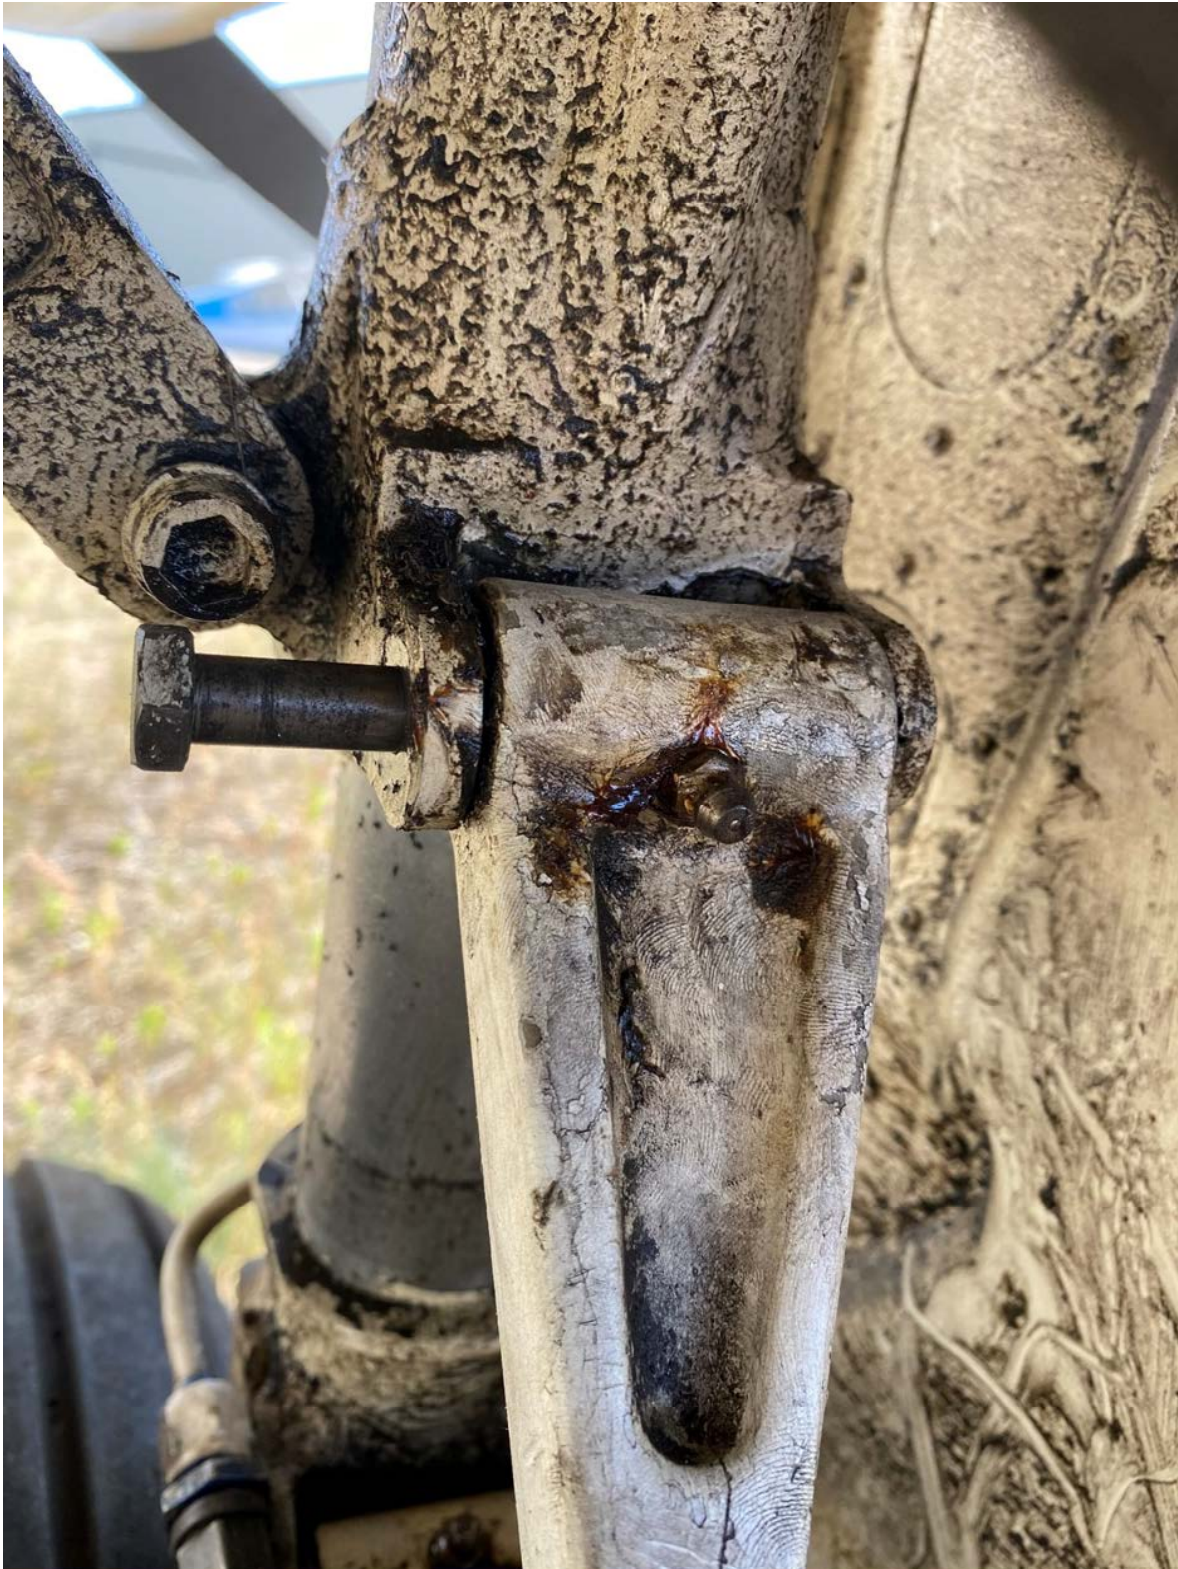
- L/H MLG torque tube intact with no damage noted.
- R/H MLG torque link (scissor link) center bolt missing nut and appx. 2/3 backed out. No wrench marks noted on bolt and grime on bolt, suggests this condition existed prior to accident.

Backed out bolt on r/h Gear

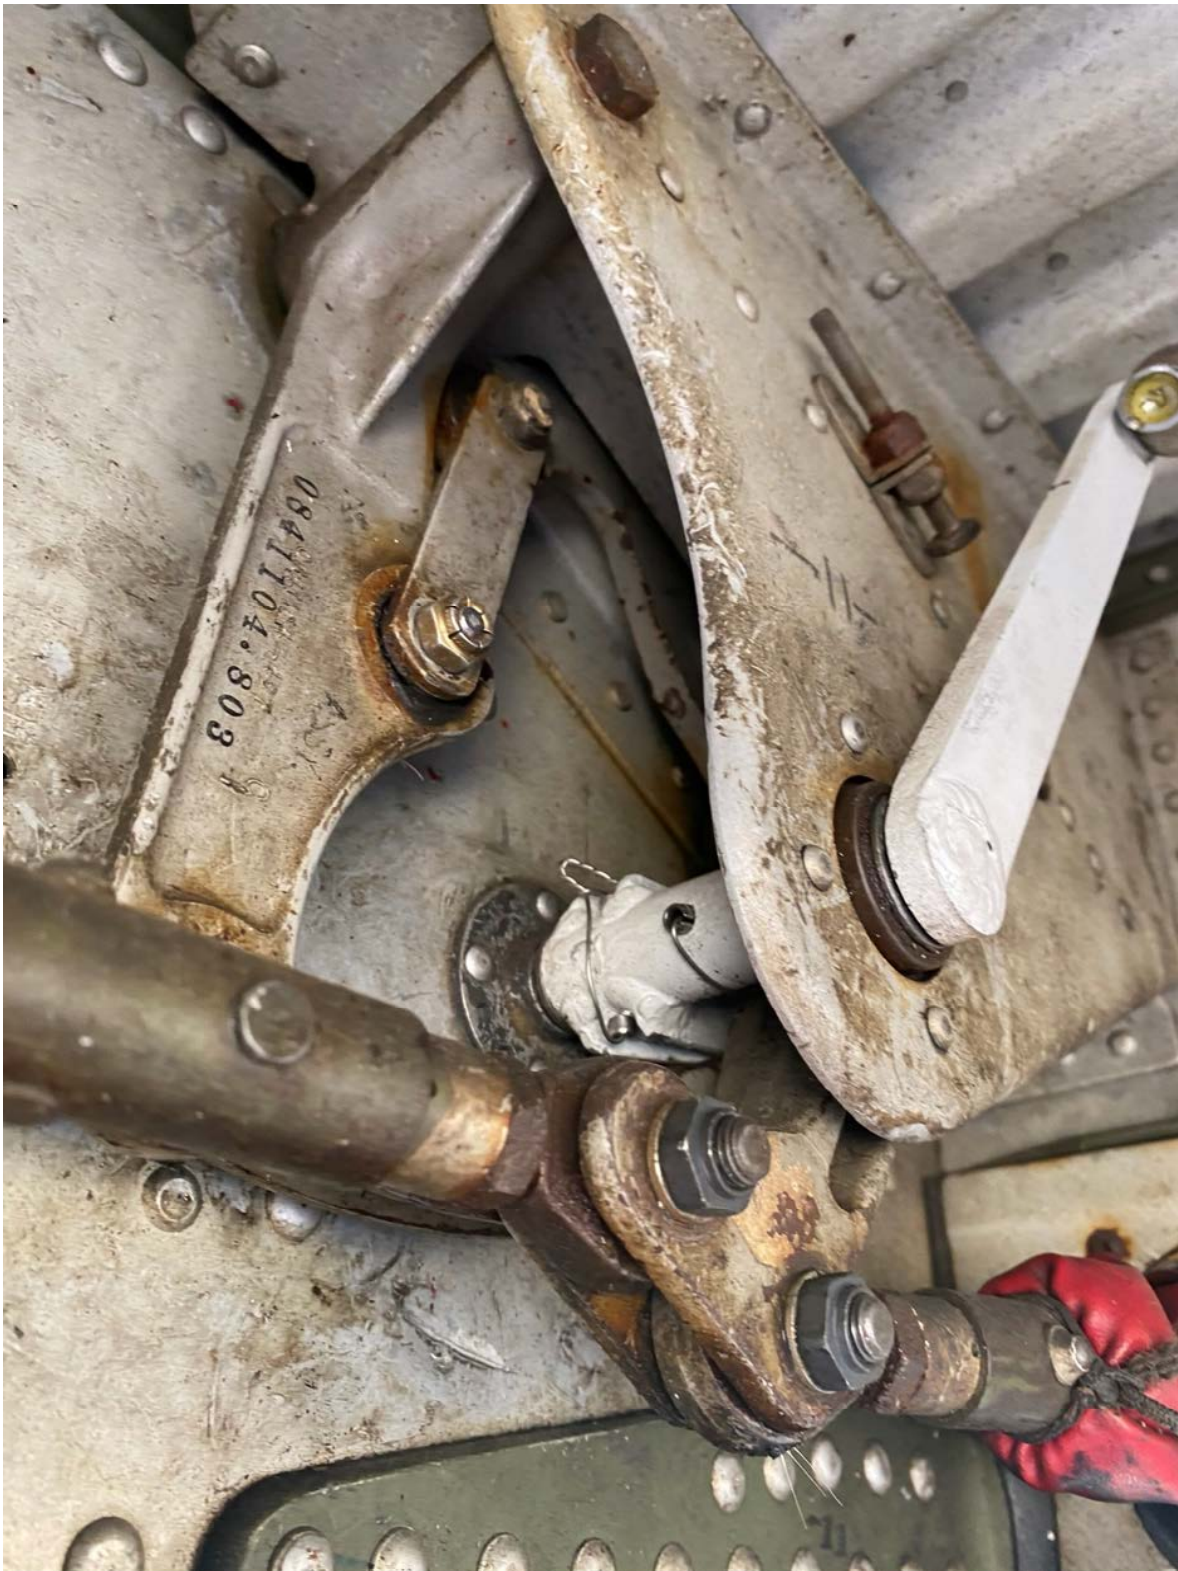
- L/H Door Actuator Arm (Item 19 Fig. 2-51) appears to be recently replaced due to cleanliness of part along with clean swarf located in L/H gear well. No notation of part replacement in Airframe log books from 1990 to present. Asked Latitude Aviation's chief mechanic Dustin Wise about recent arm replacement he stated that it was not replaced that he knew of, but that roll pins (Item 21 Fig. 2-51) were recently found sheared and replaced prior to the accident. However no record of replacement was noted in maintenance logs.

*L/H Gear showing new hardware and new parts(door actuating arm)*

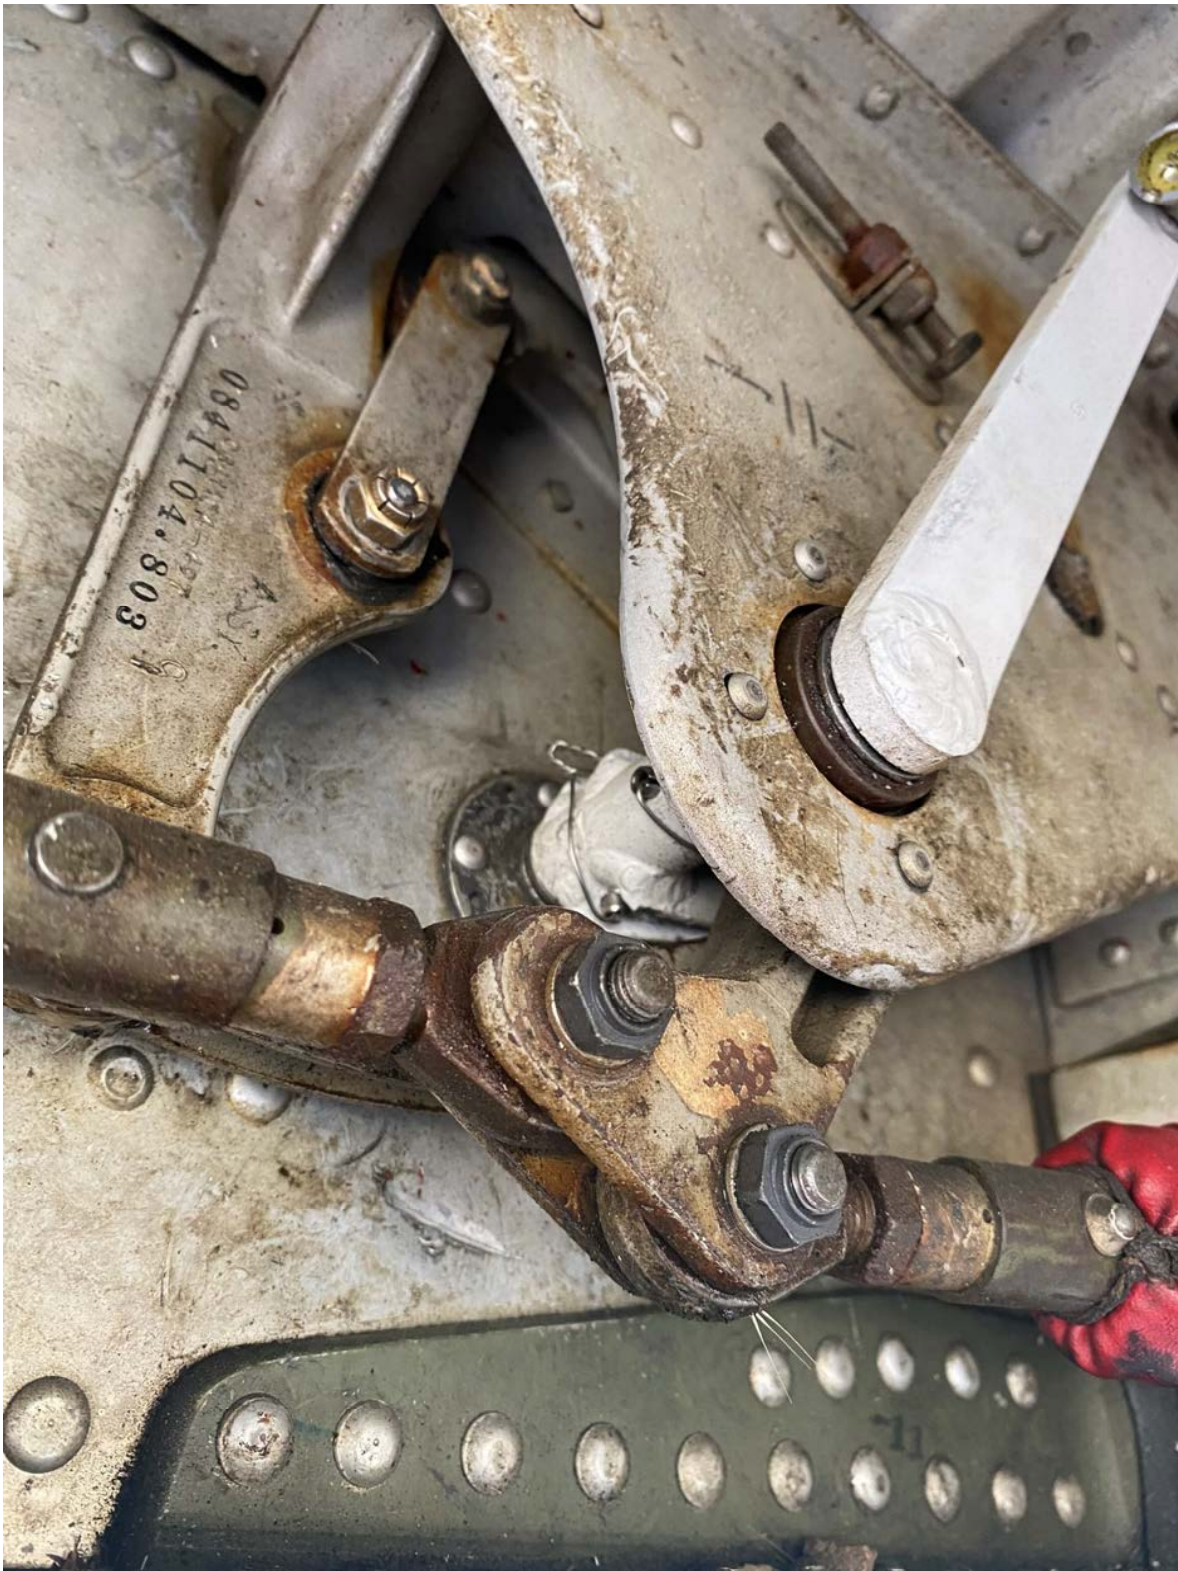
*L/H Gear showing mechanism binding in as found condition*

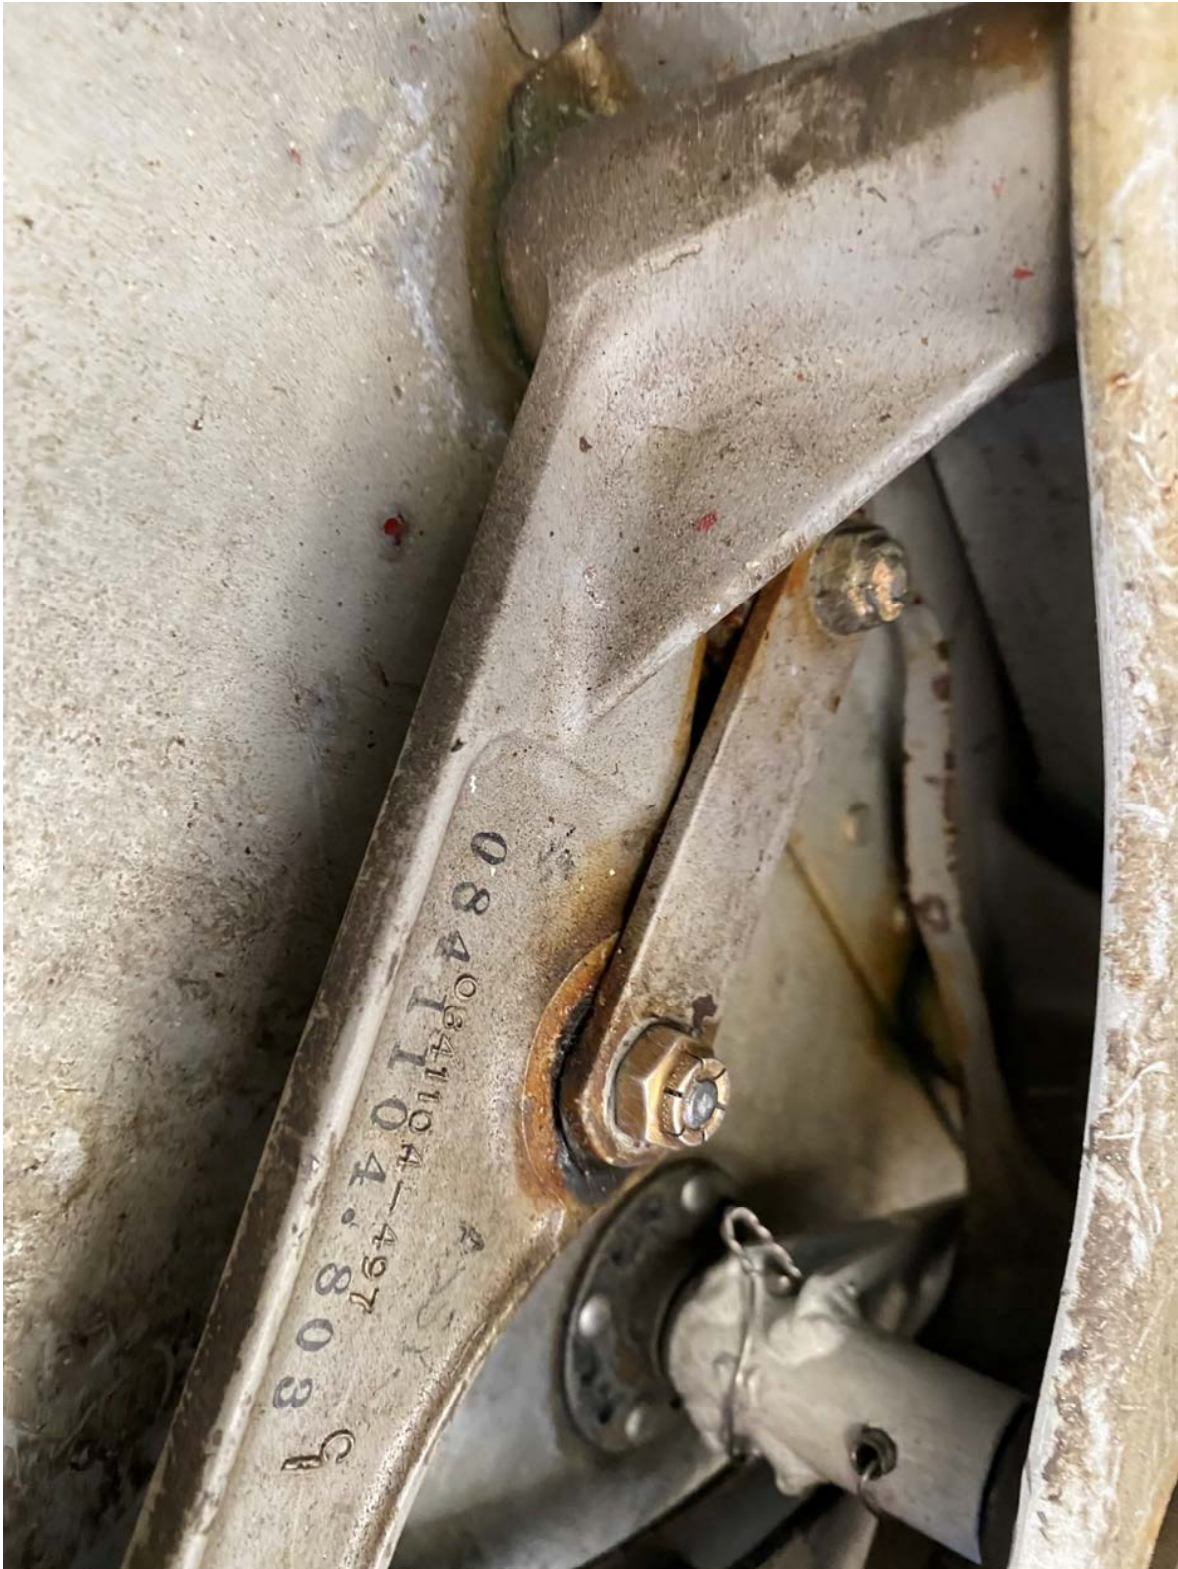
- Multiple instances of recently replaced hardware with no thread protrusion through lock nuts (Not in accordance with *Service Manual, AC43.13-1B* or standard practices) nor found in maintenance log books.

L/H Gear no bolt protrusion

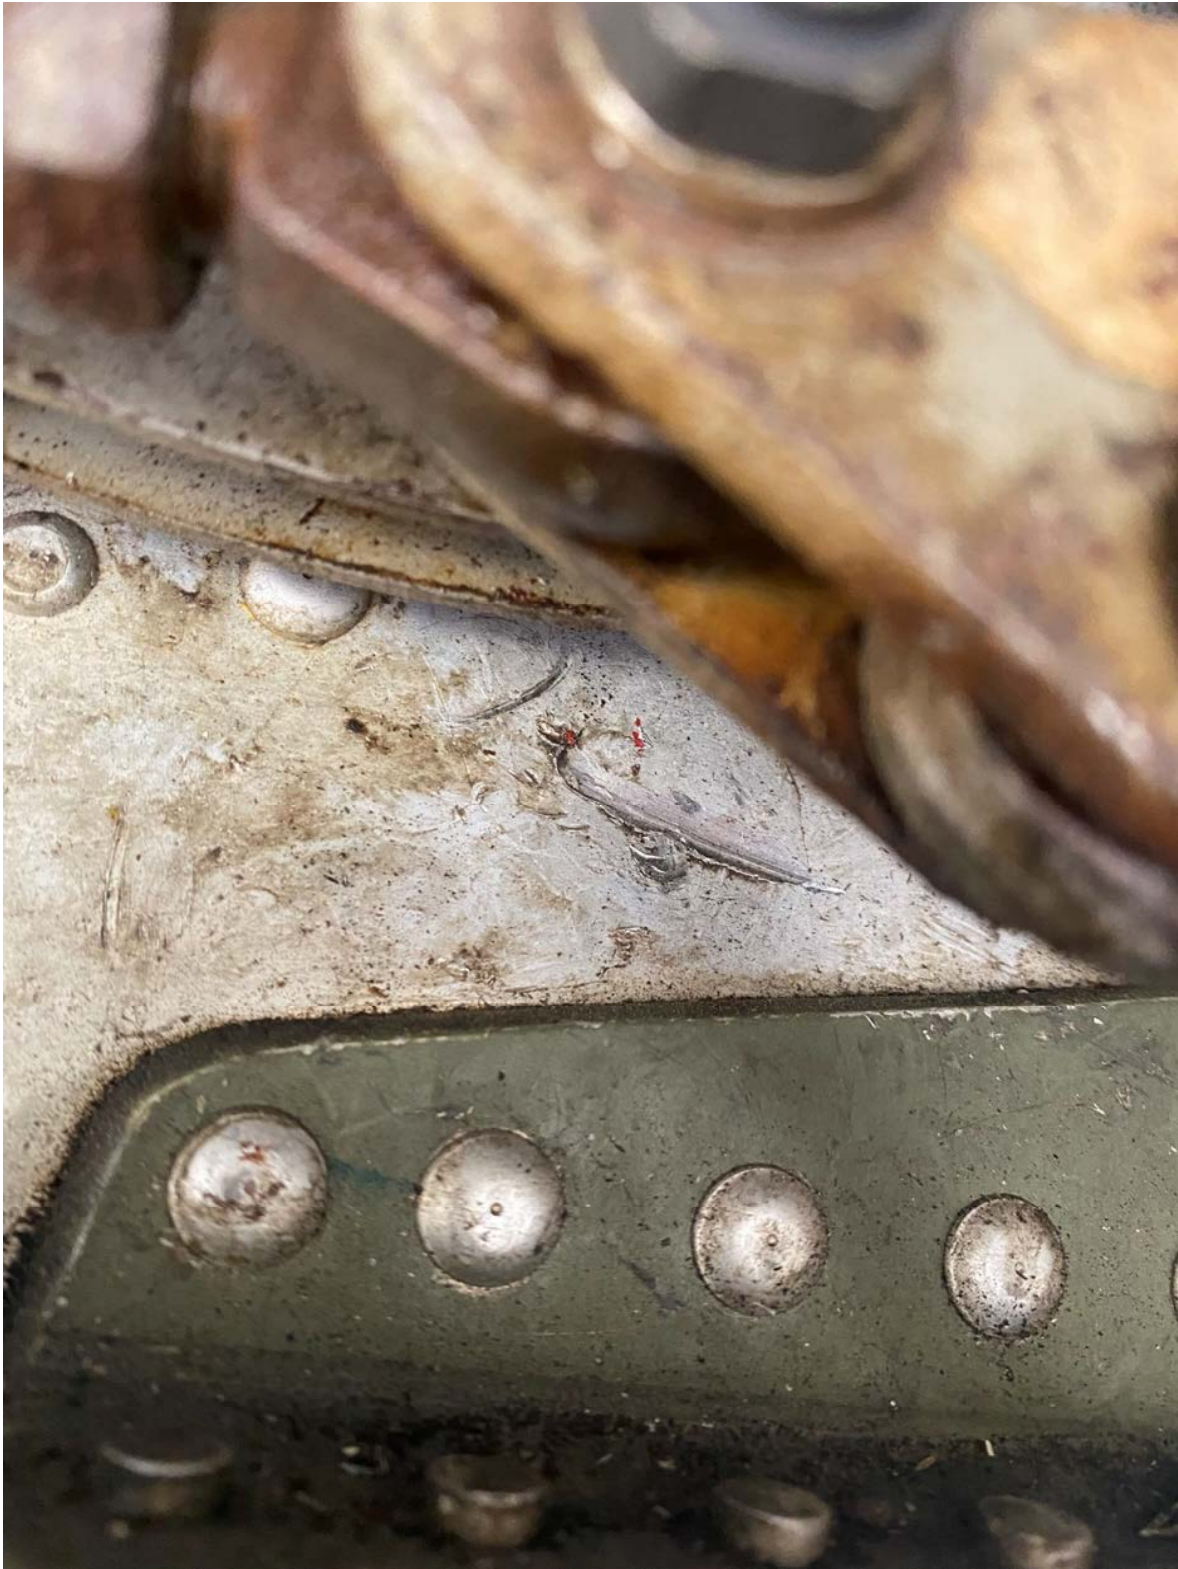
*L/H Gear recent gouge in bulkhead behind idler arm undetermined cause*

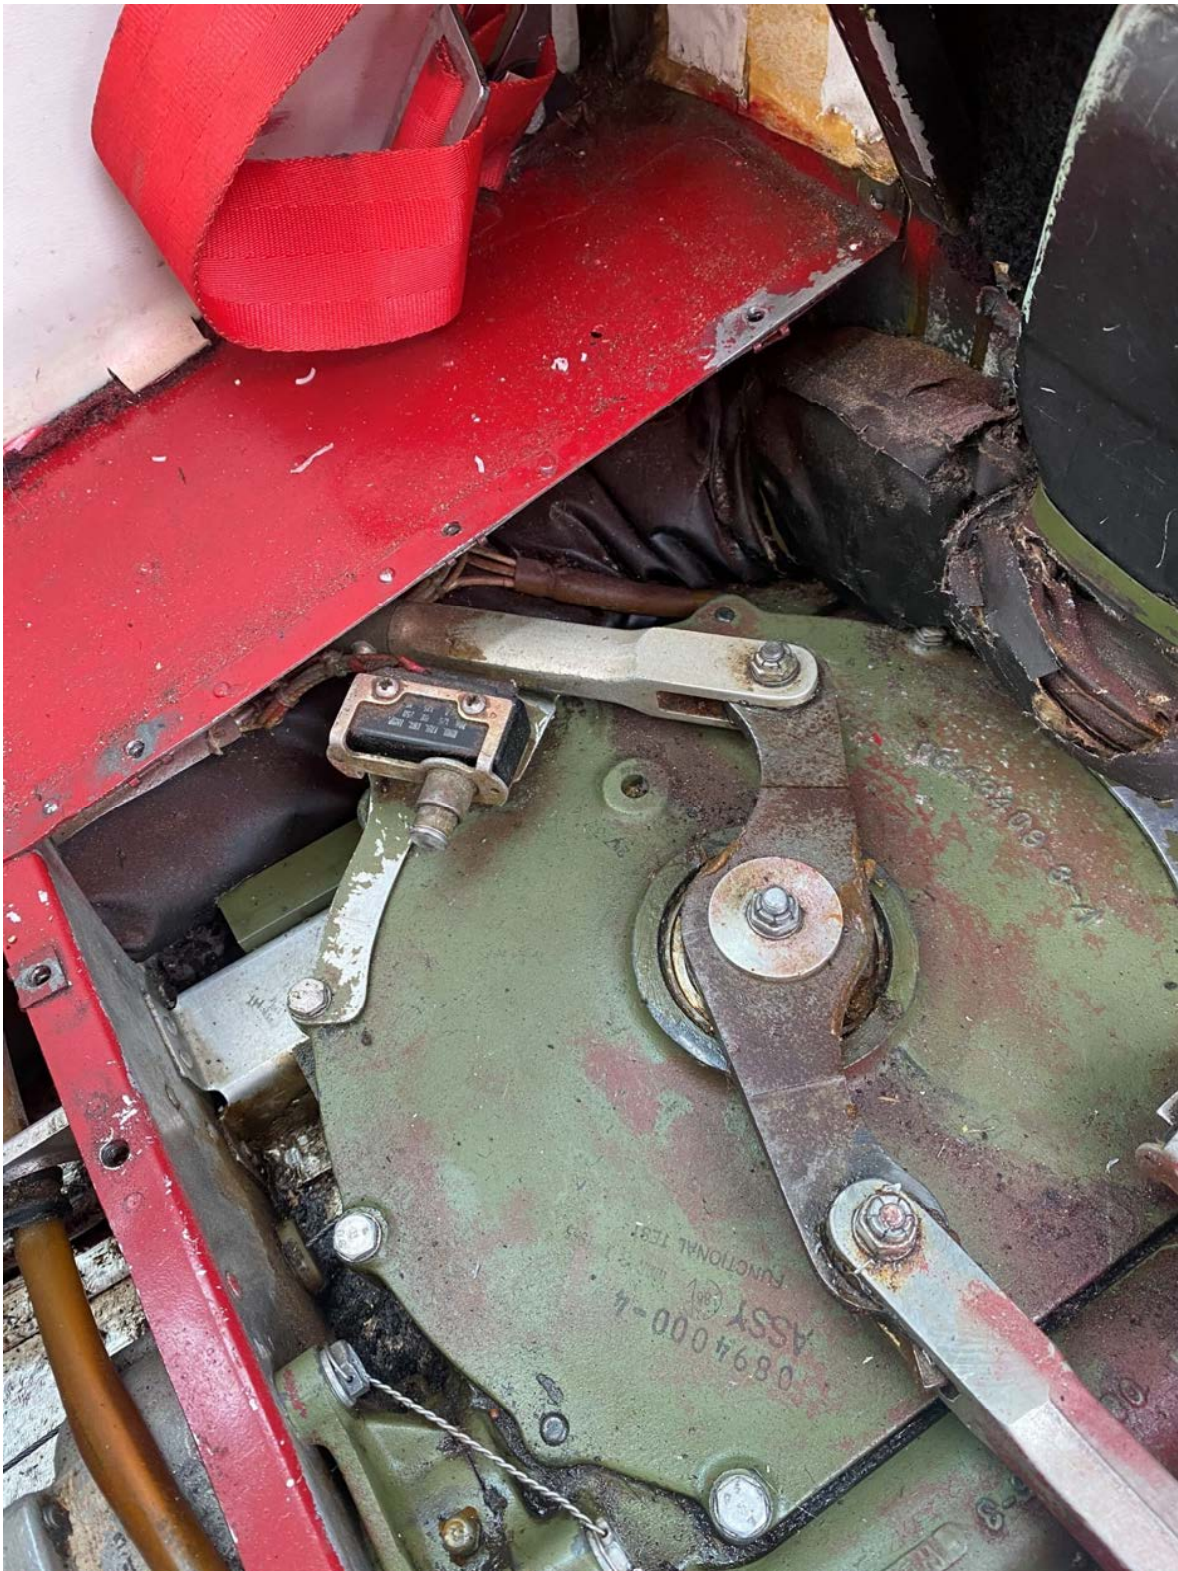
performed normally. Gear Acuator found to be mis-rigged, *Cessna 310-310D Service Manual* (p/n P-150C) Sec.2-315 states emergency crank should be backed off two turns and DOWN limit switch adjusted to just actuating at this point. Subject aircraft found emergency crank backed off three (3) turns after actuation.

*Gear actuator in mid position*

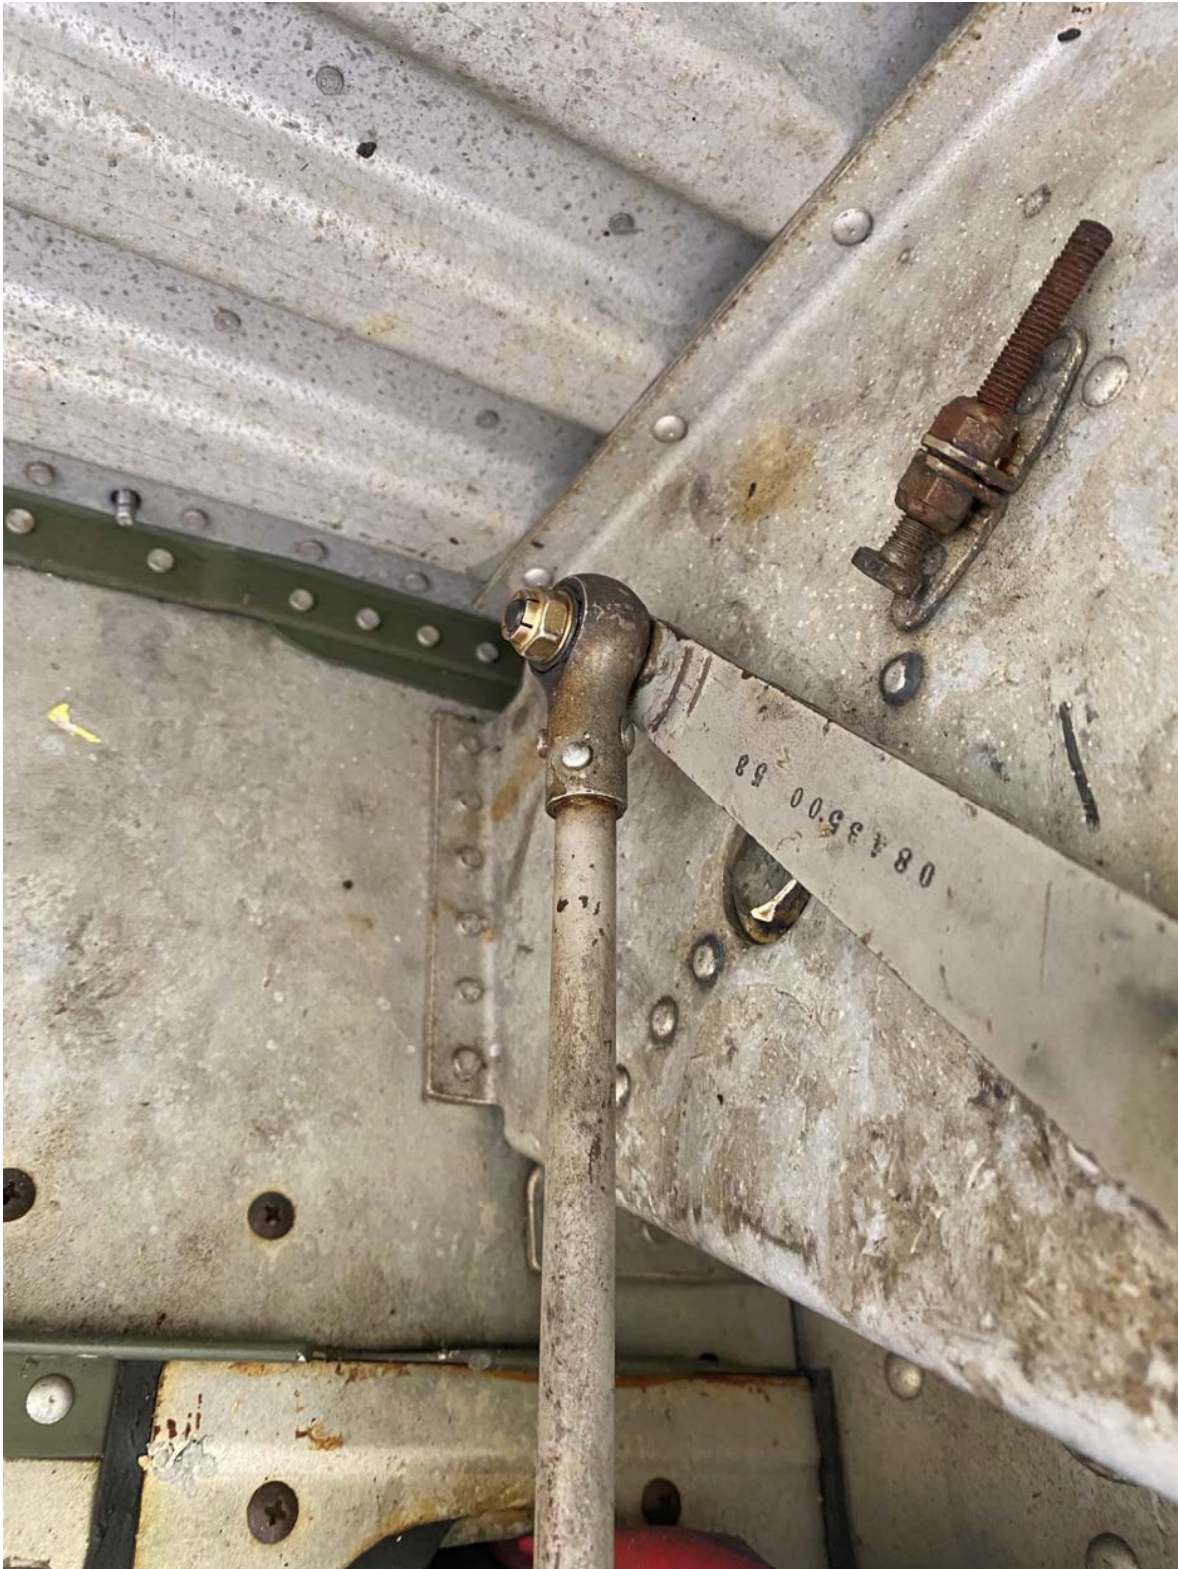
R/H Gear new "short" hardware on gear door

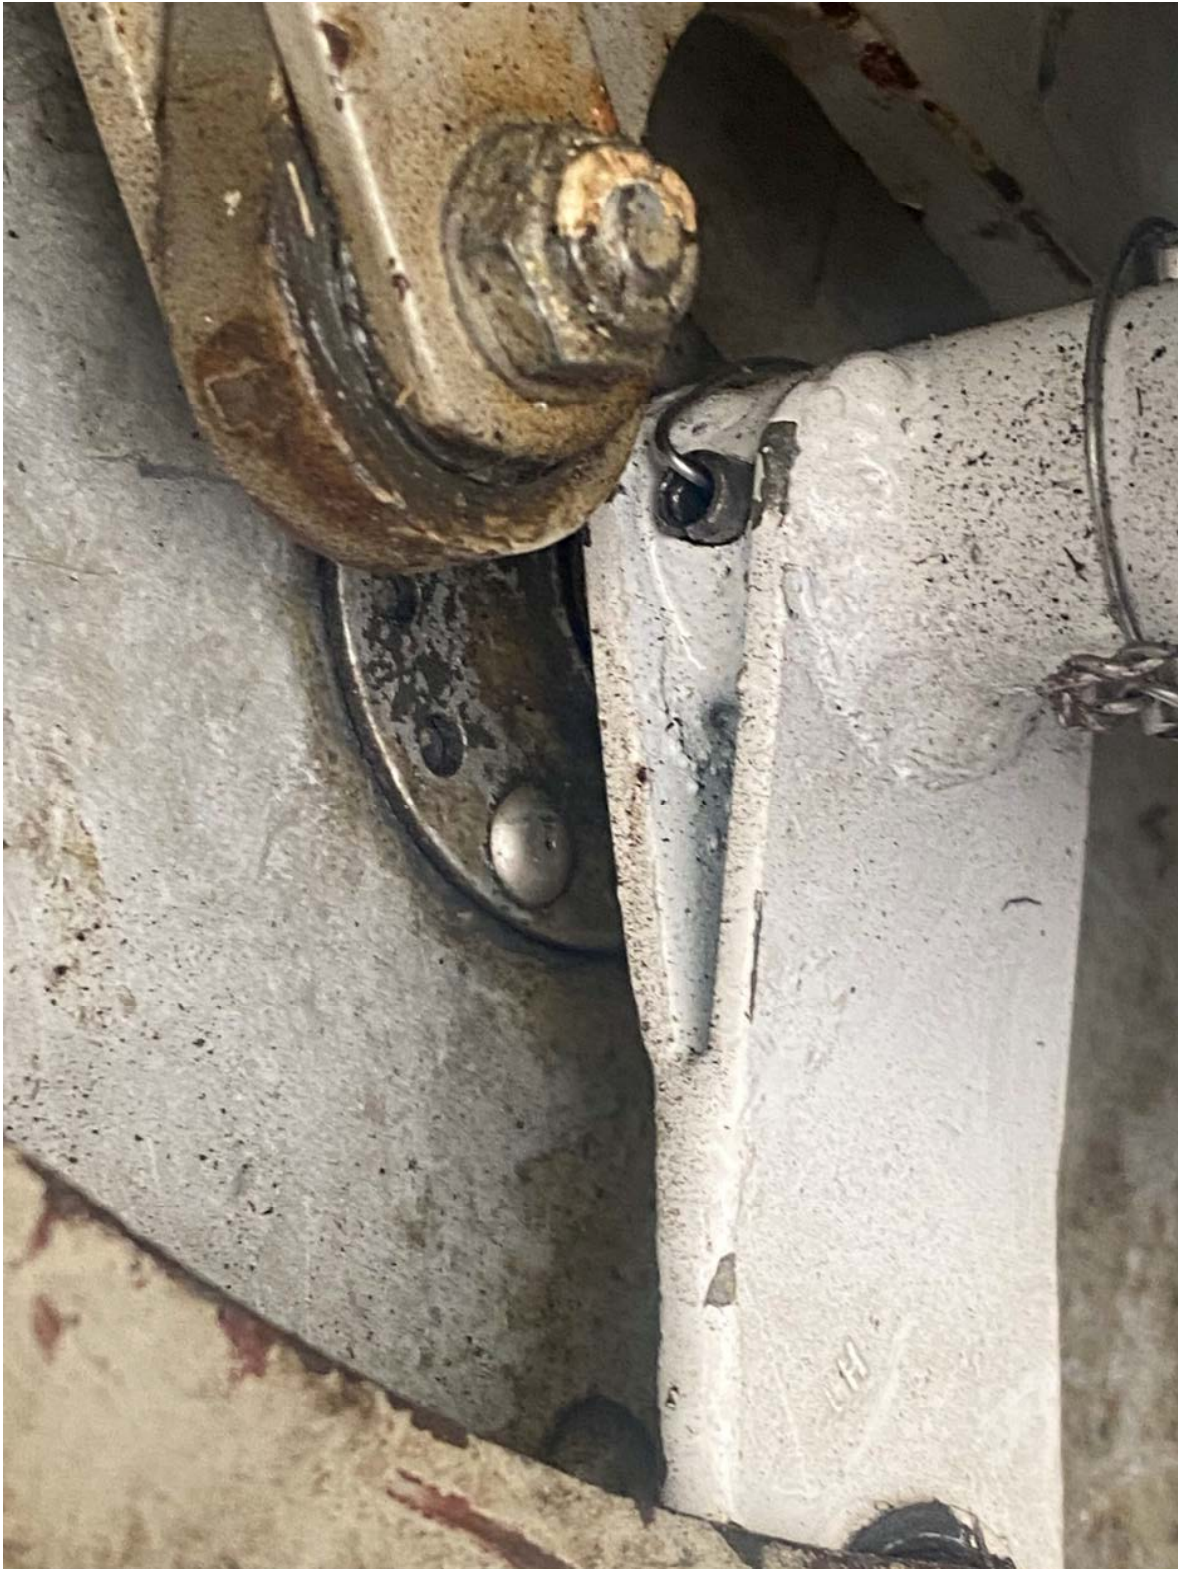
*L/H Gear close up of replaced roll pins*

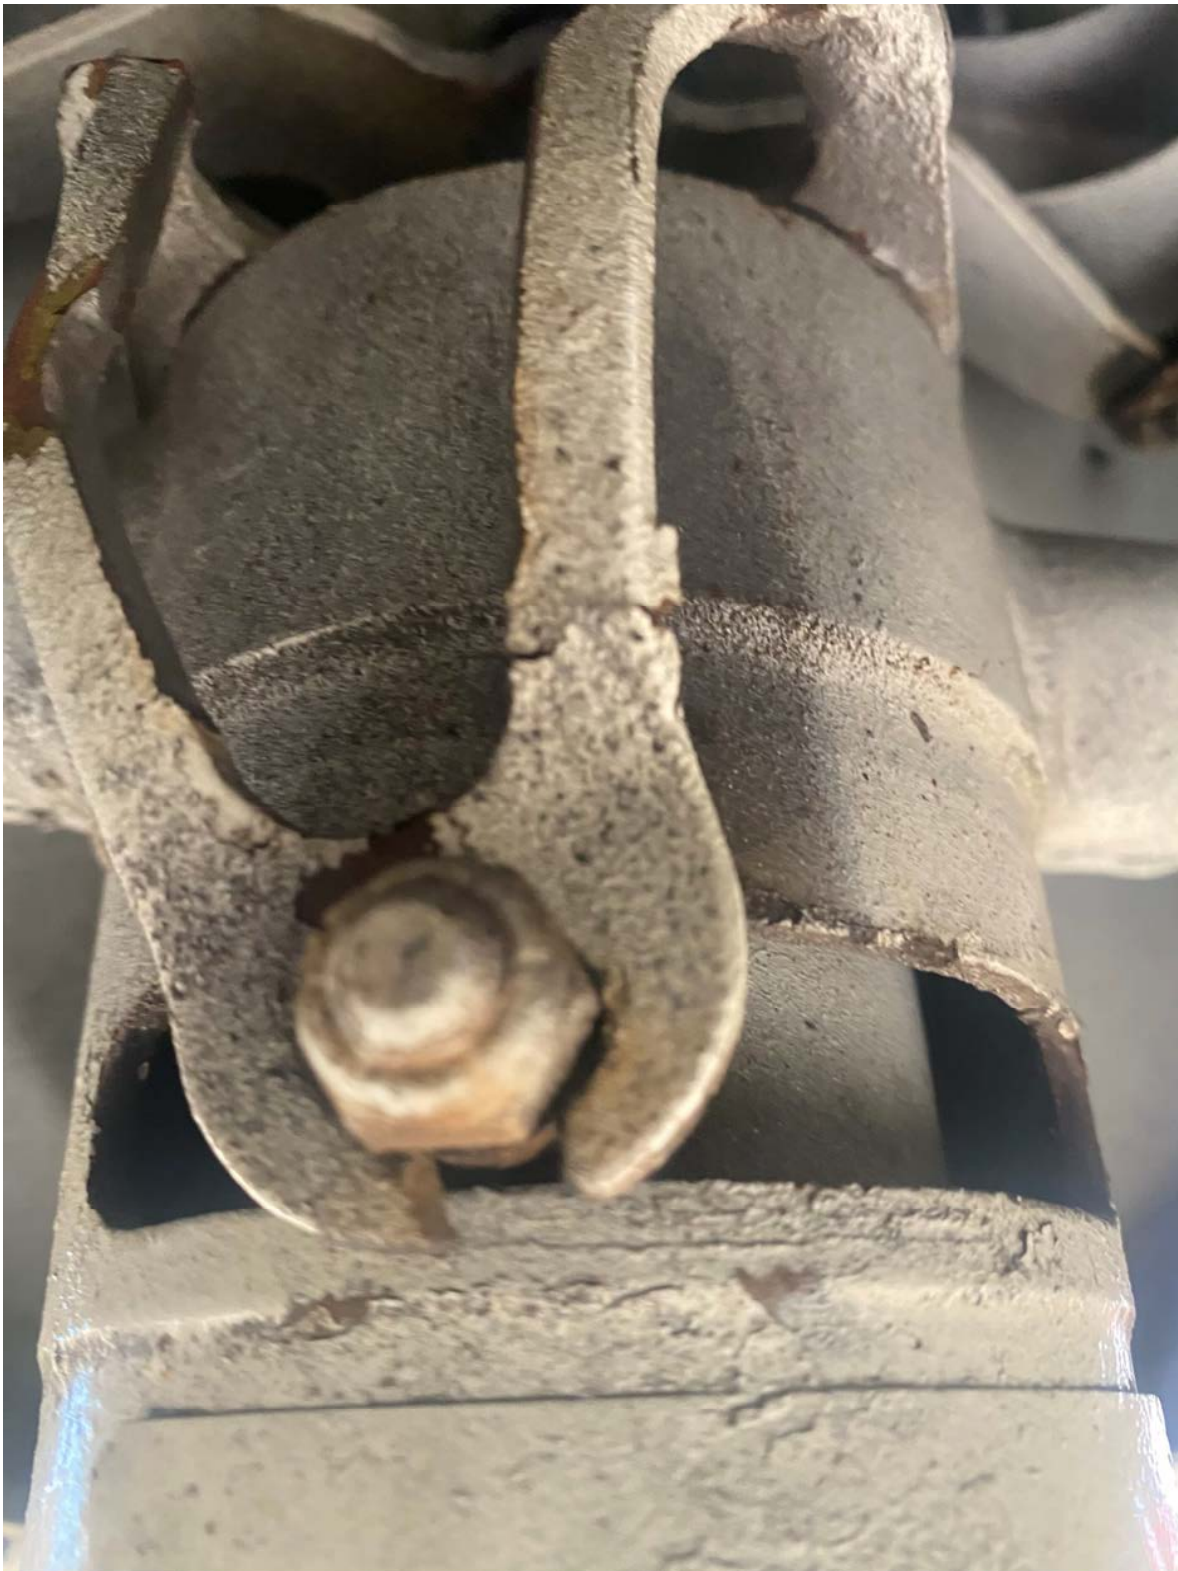
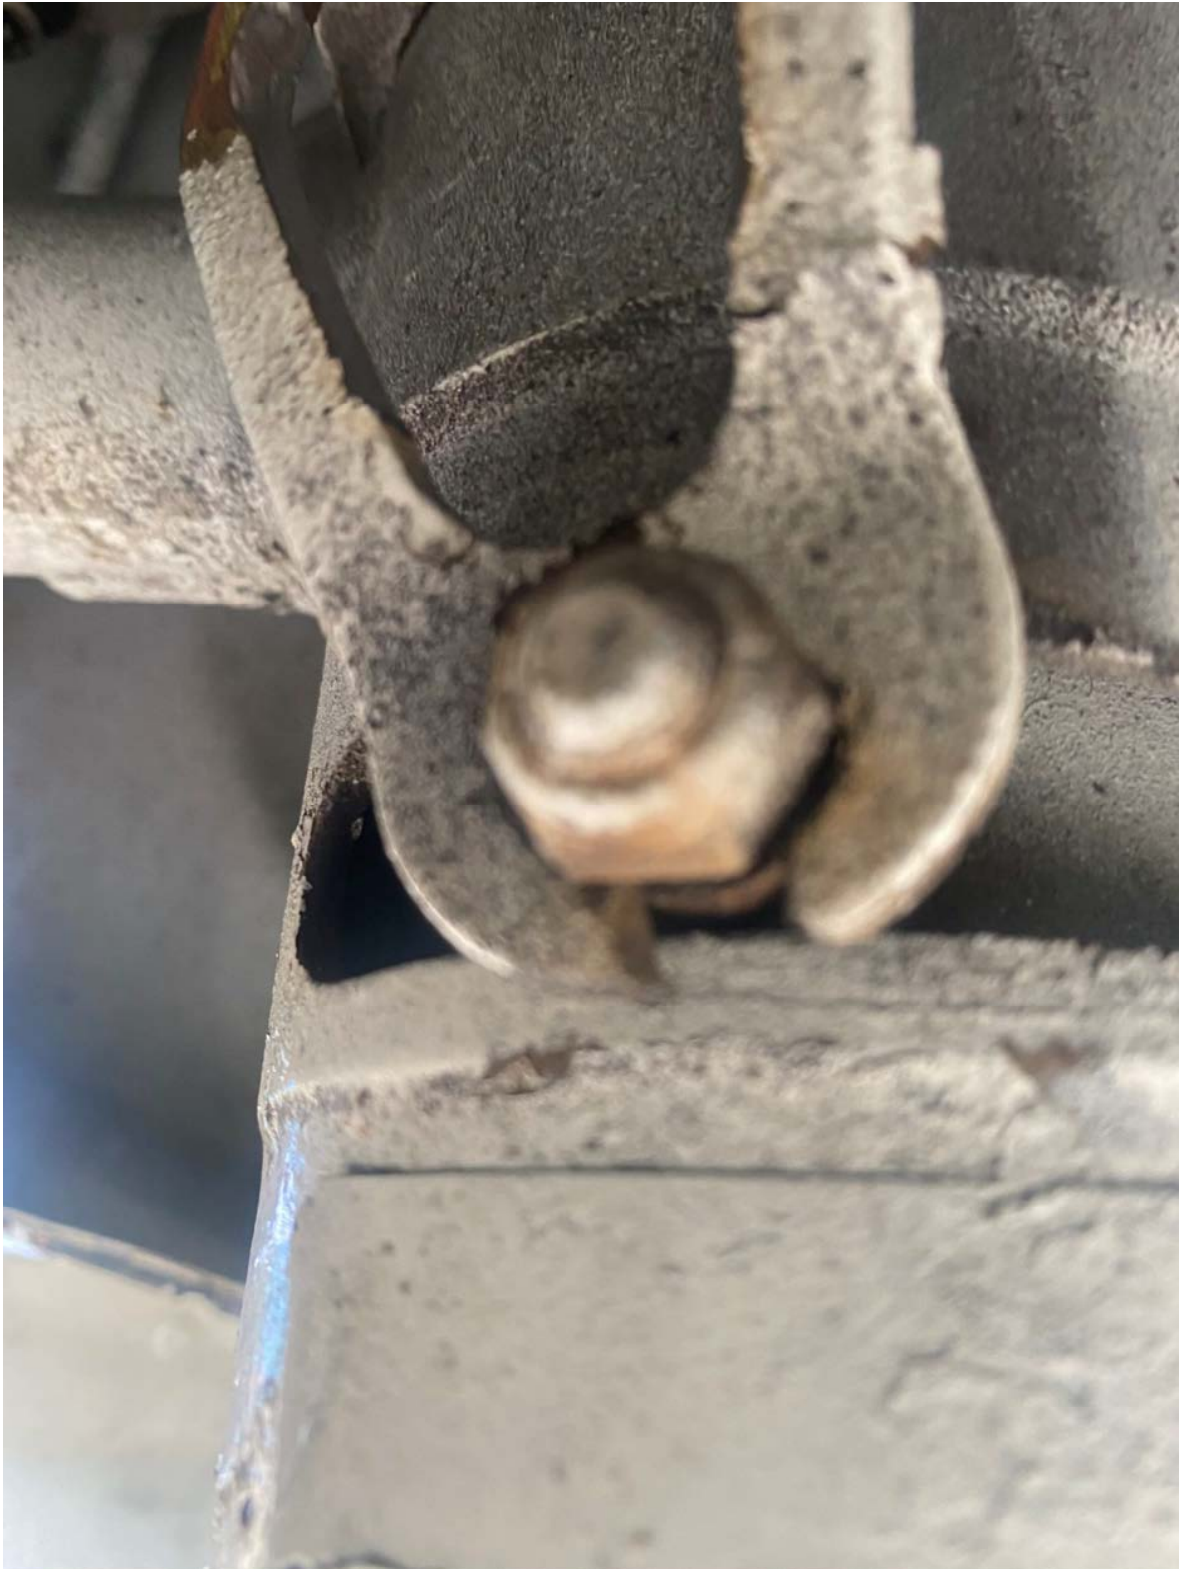
- NLG centering mechanism broken and rusty, may have been pre accident condition give amount of corrosion in break compared to items broken during accident.

*NLG Centering Mechanism*

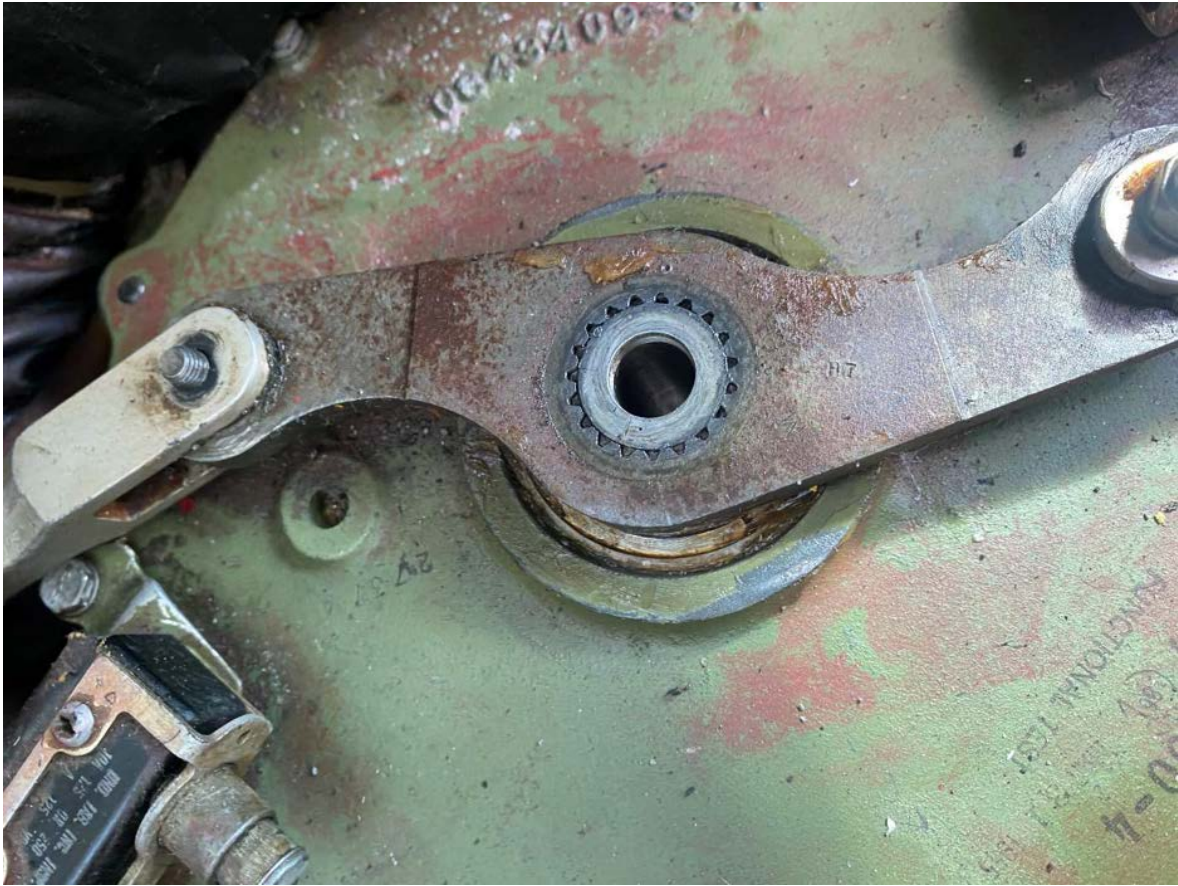
*Actuator splines intact*
