# **Landing Gear Failure**

**Cessna 310B, N6602B**

**Accident Number:WPR20LA187**

**Gear Examination Report**

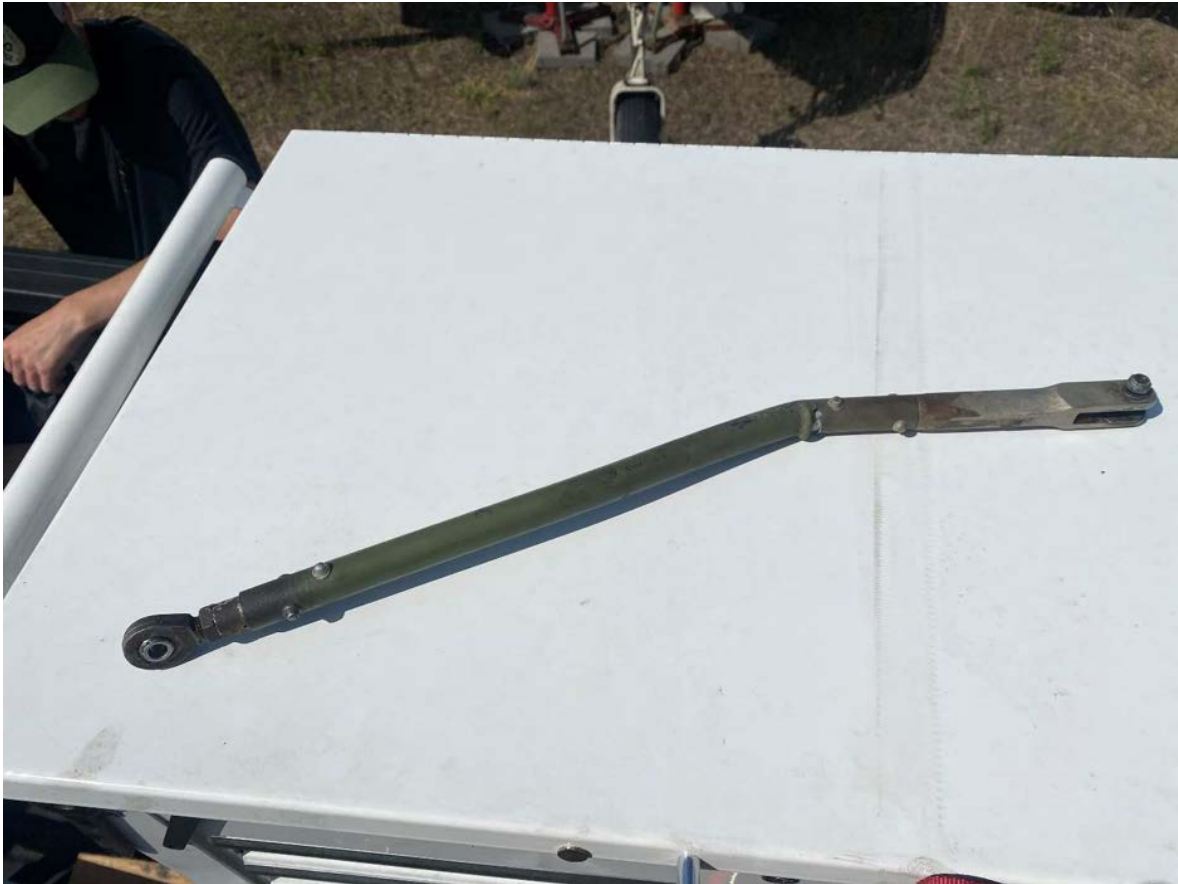
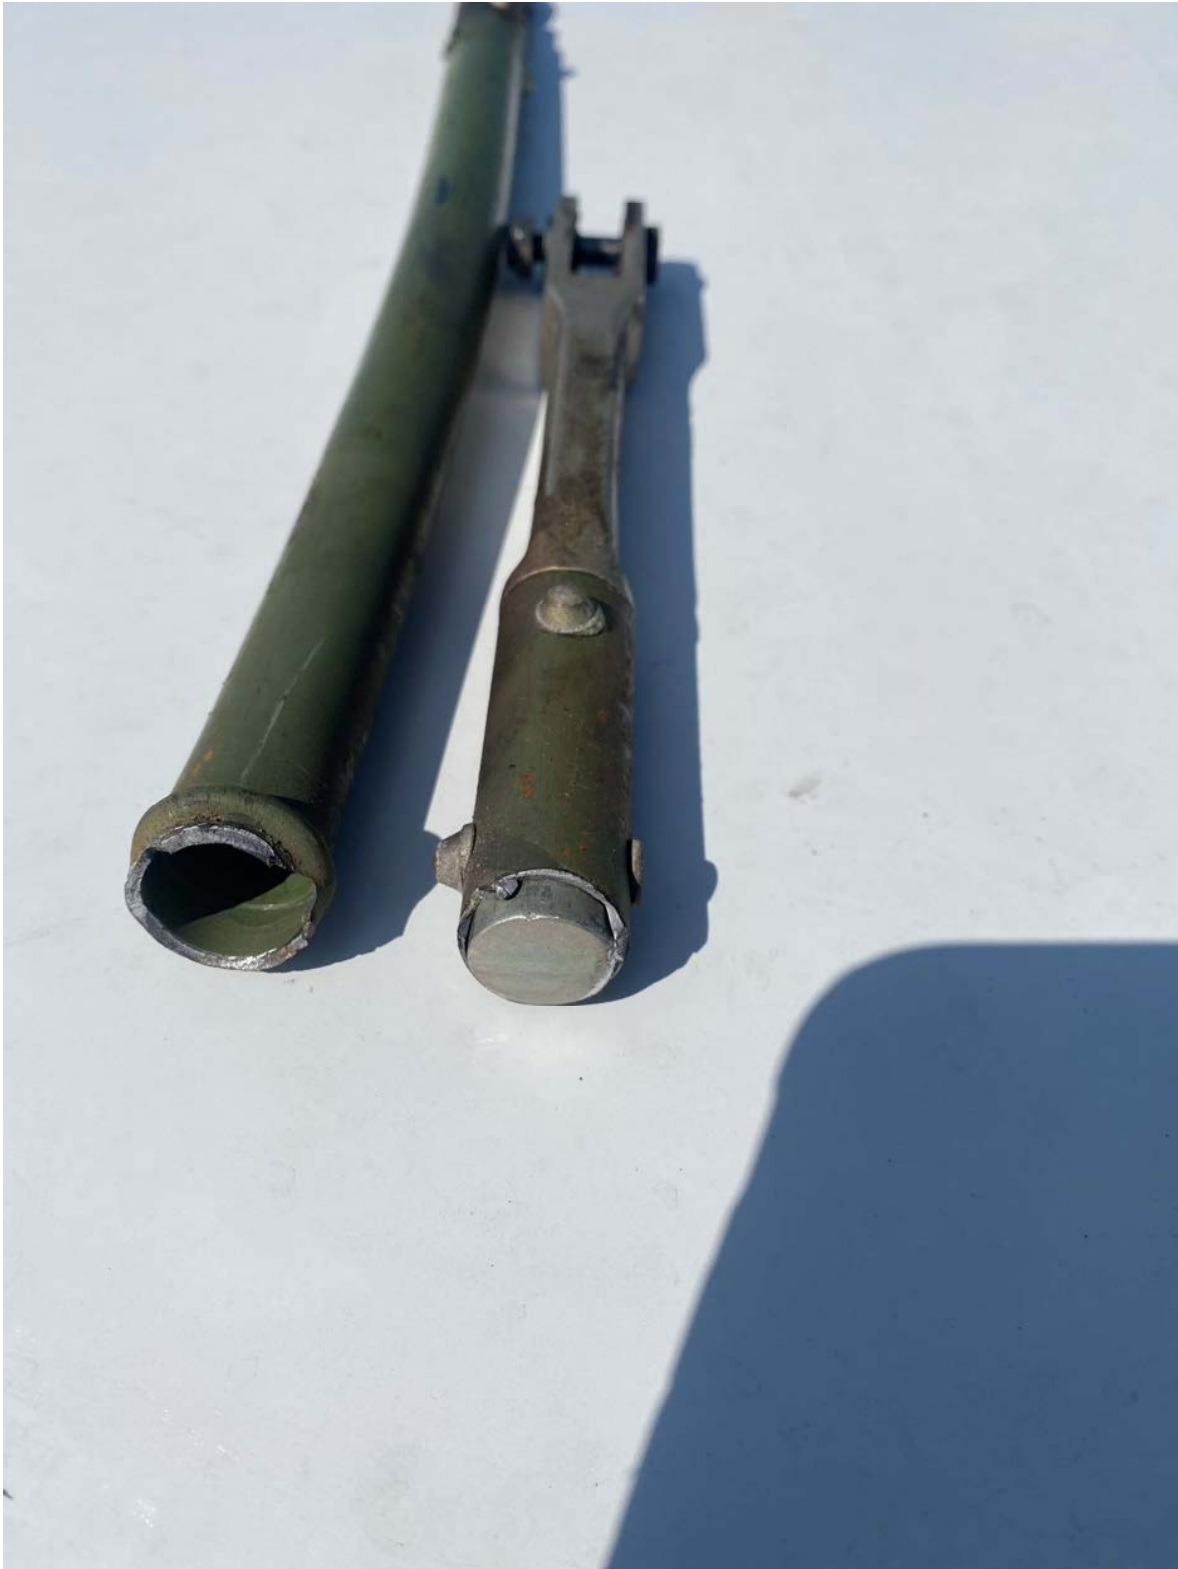
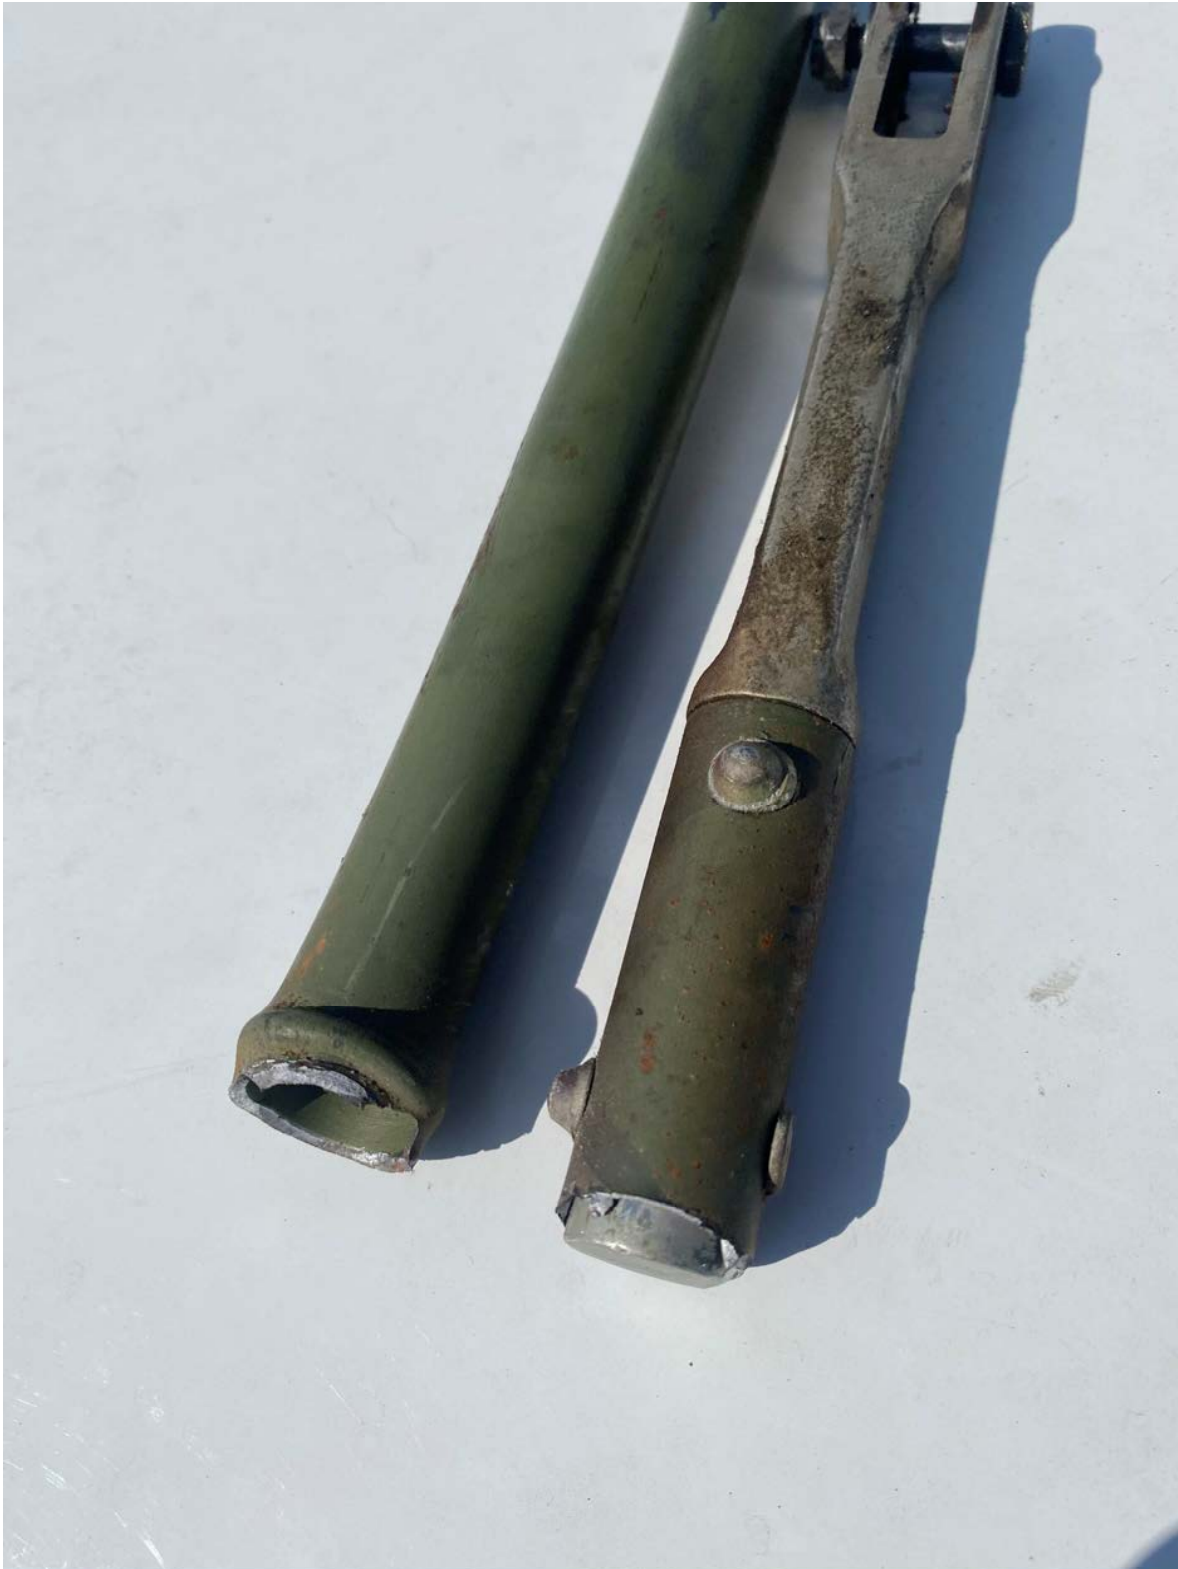
- Gear warning system appears to be operating properly, although is it possible L/H down lock switch just out of rig. Green light indicator flickes with R/H gear down and locke NLG switch mechanically bypassed and L/H gear in as found condition (lock link in almost locked position).
- L/H MLG Main Drive Tube found failed at actuator attachment lug. Failure mode appears to be compressive in nature. Tube was retained and sent to Maja Smith for metallurgy testing.

*L/H Gear Main Drive Tube removed from A/C*

*L/H Gear close up of broken drive tube*

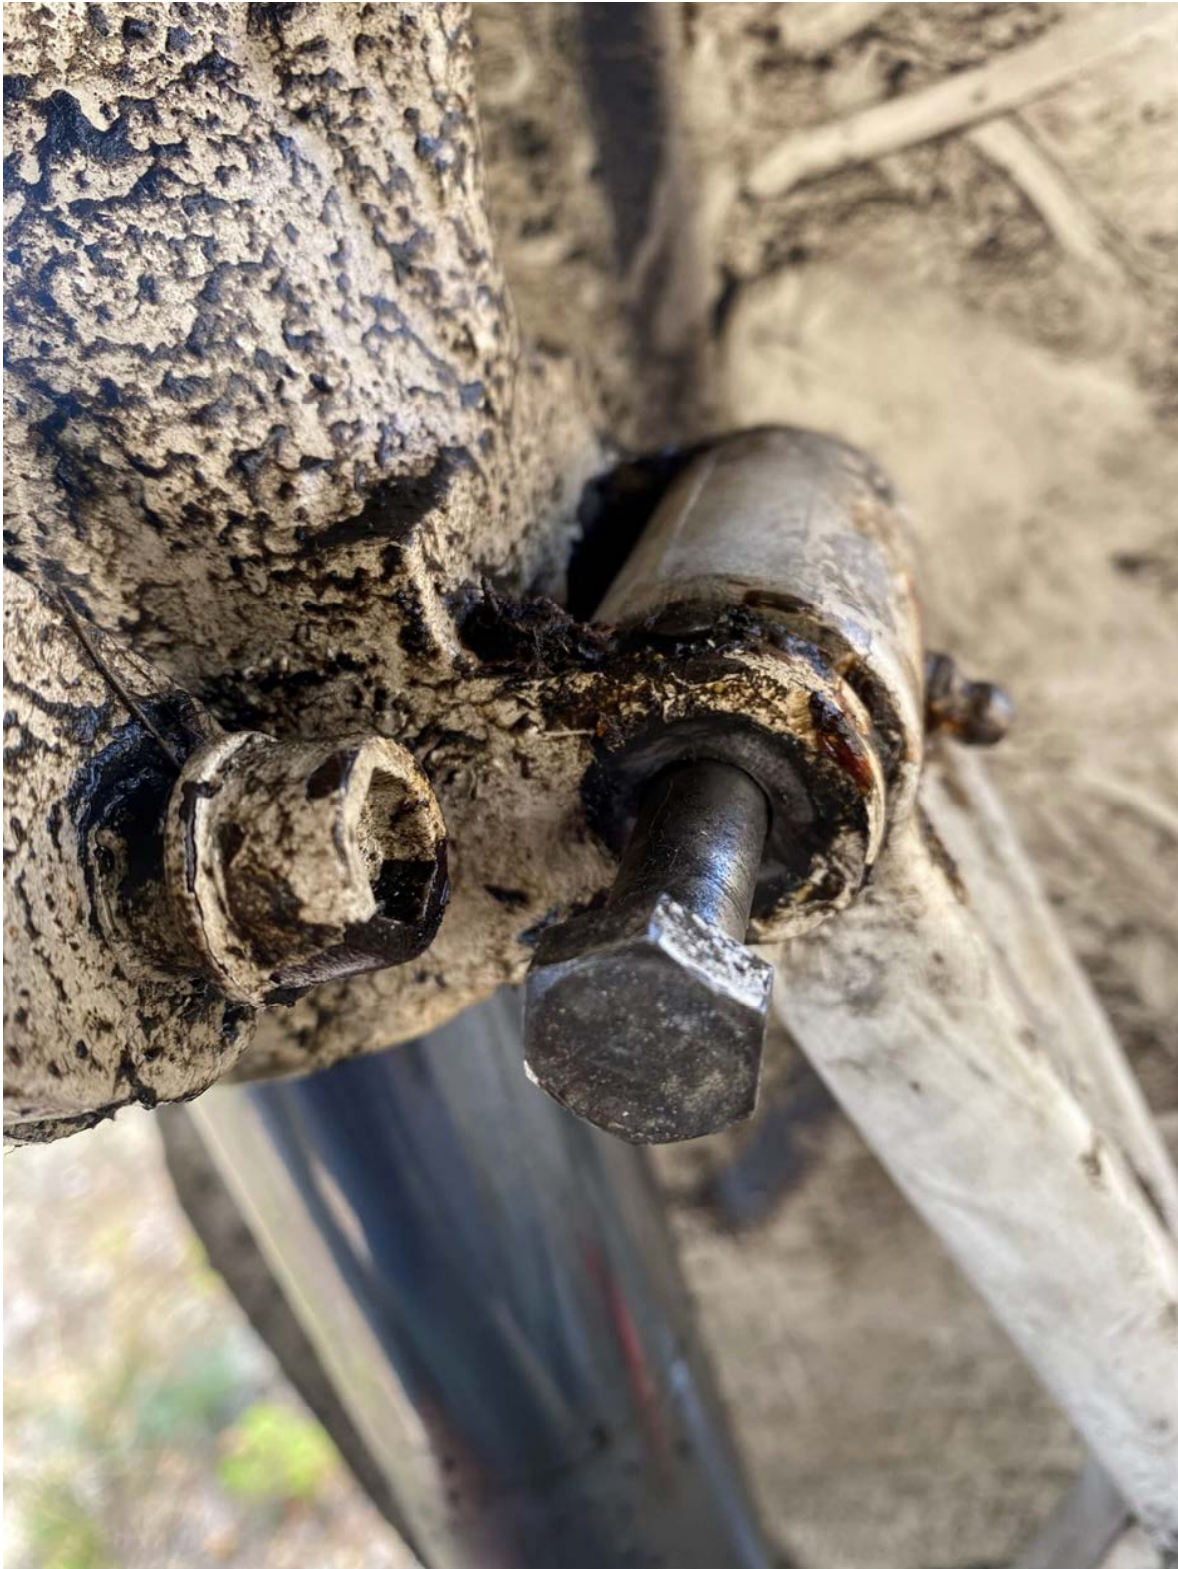
- L/H MLG torque tube intact with no damage noted.
- R/H MLG torque link (scissor link) center bolt missing nut and appx. 2/3 backed out. No wrench marks noted on bolt and grime on bolt, suggests this condition existed prior to accident.

*R/H Gear Torque Link center bolt*

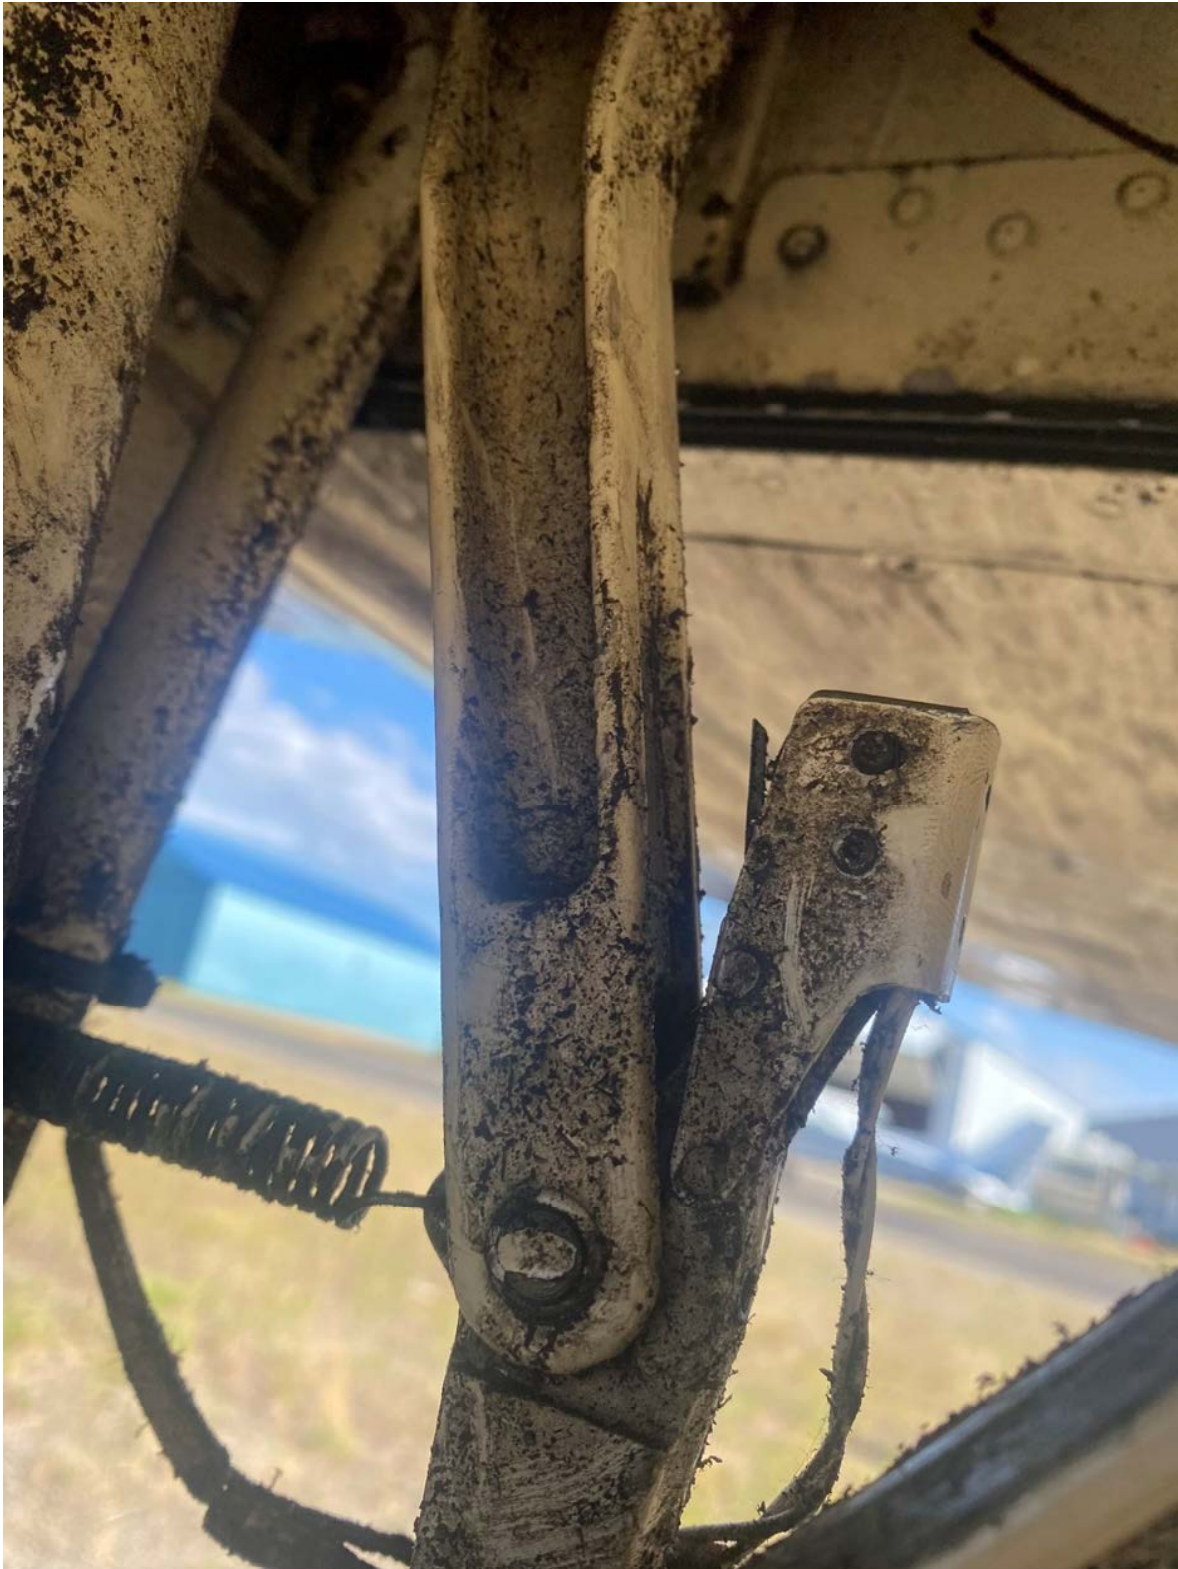
- L/H MLG Lock Link not in over-center "locked" condition. When Intermediate Push-Pull Tube removed from idler link (which is attached to door actuator arm mechanism) Lock Link cammed over-center and "locked". Visually intermediate tube appeared to be 2-3 "turns" out of rig.

*L/H Gear Lock Link as found condition (unlocked)*

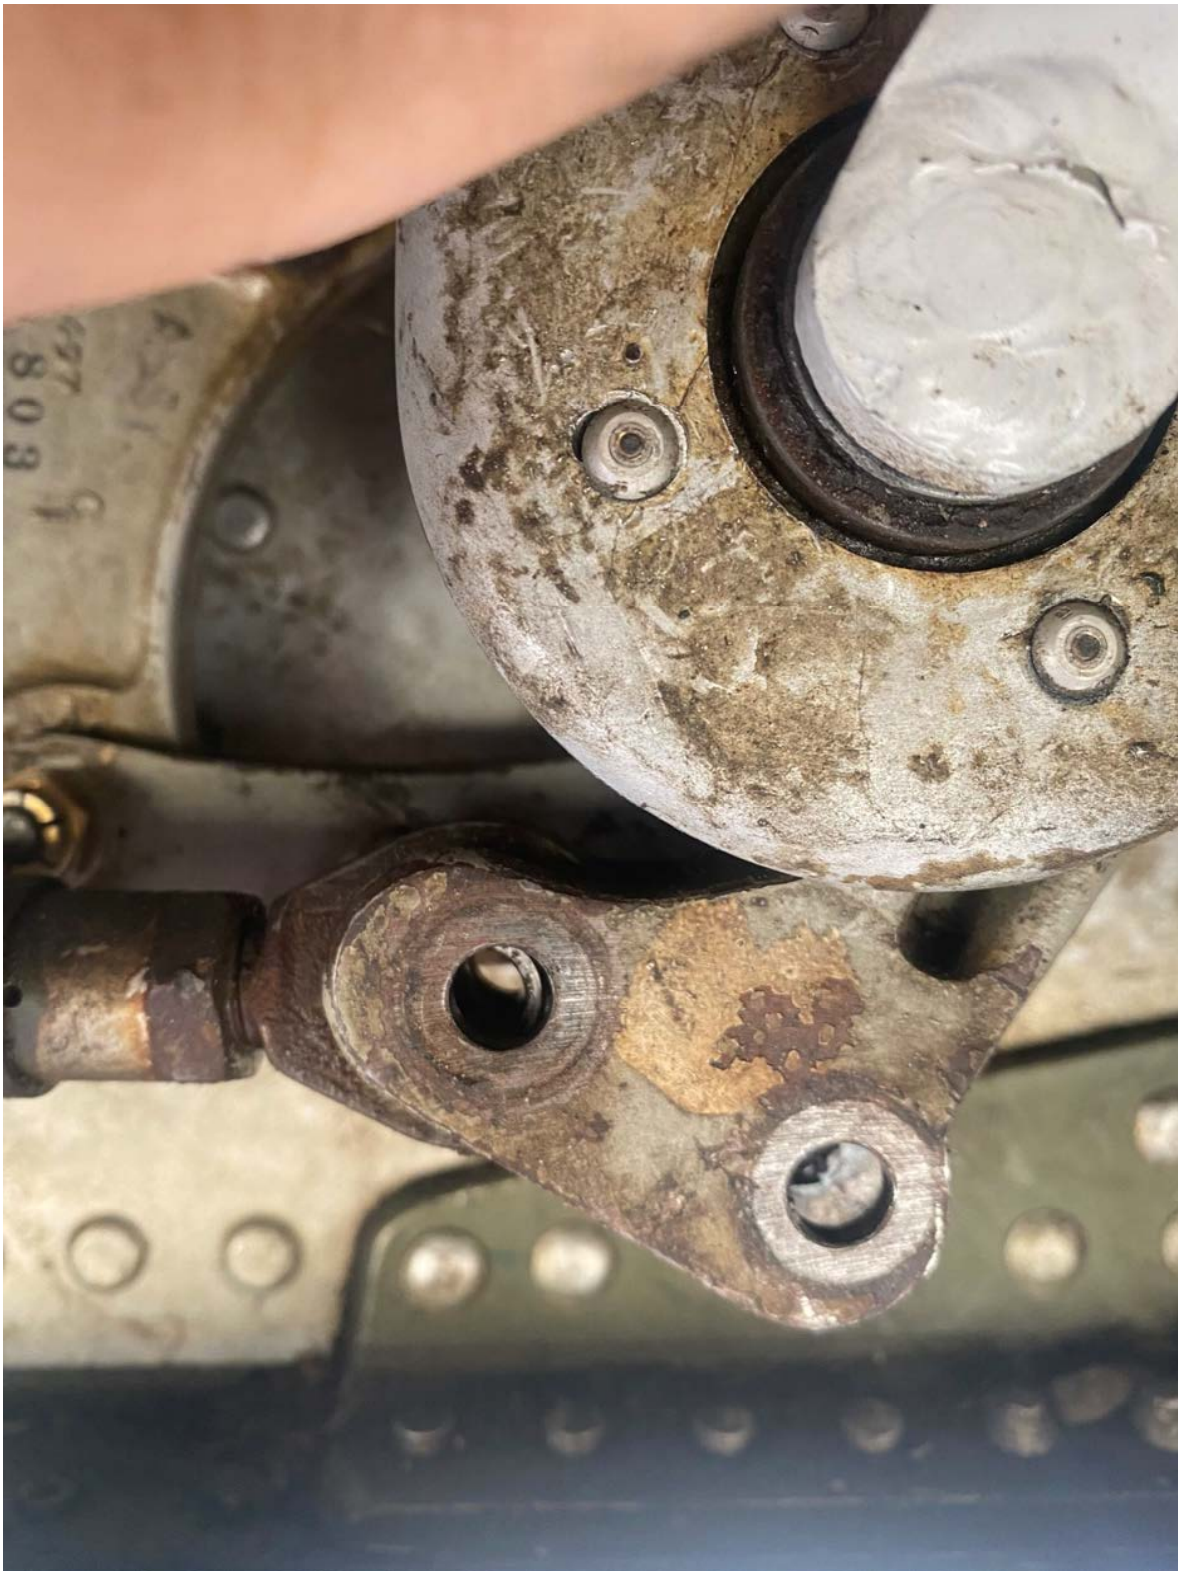
*L/H Gear newer Cherry rivets*

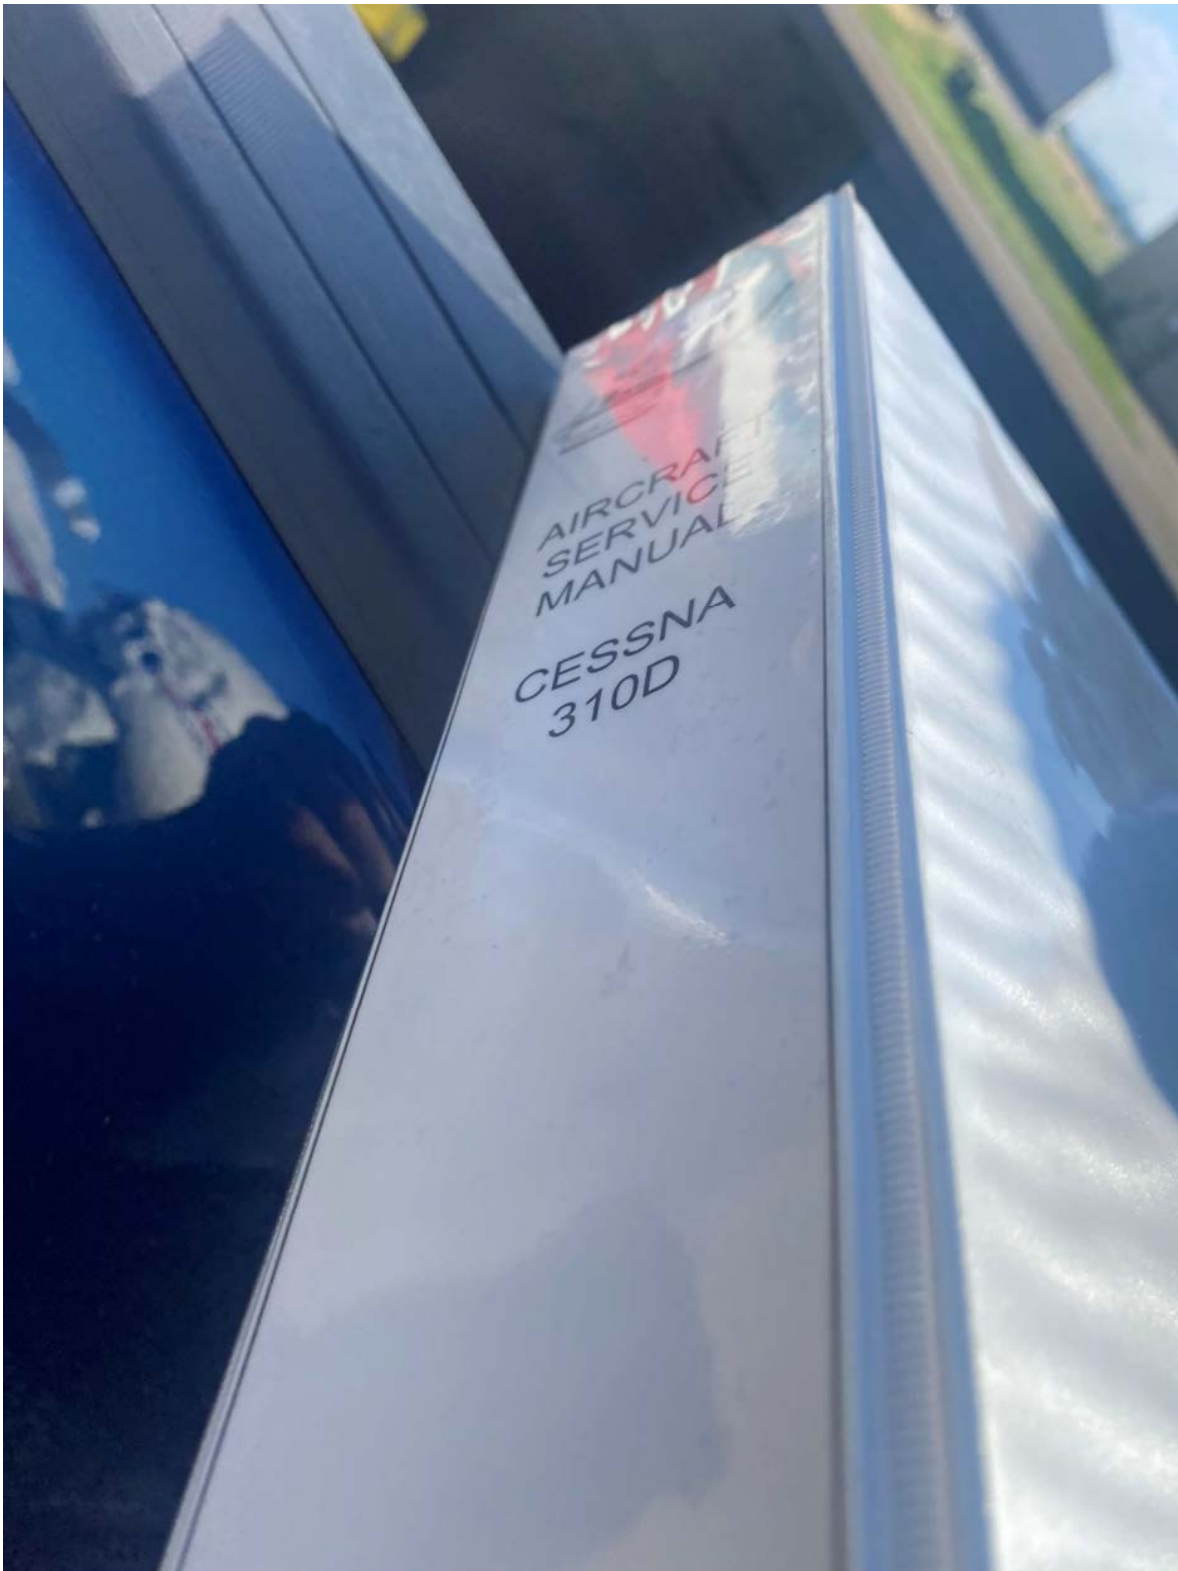
- When asked to see 310 B Service manual Latitude Aviation mechanics spent time shuffling thru various boxes until a binder marked 310 D matching all other service documents for Latitude's newly acquired replacement 310 was found and given to Vulcan Aero. I suspect that they did not have a proper manual prior to that time.

*Latitude's Copy of Service Manual*
