## **NATIONAL TRANSPORTATION SAFETY BOARD**

# **AIRFRAME AND ENGINE EXAMINATION**

**WPR20LA189**

Location: Minden, Nevada  
Date: June 21, 2020  
Aircraft: N342J / Aerospatiale SA-342J  
NTSB IIC: Fabian Salazar

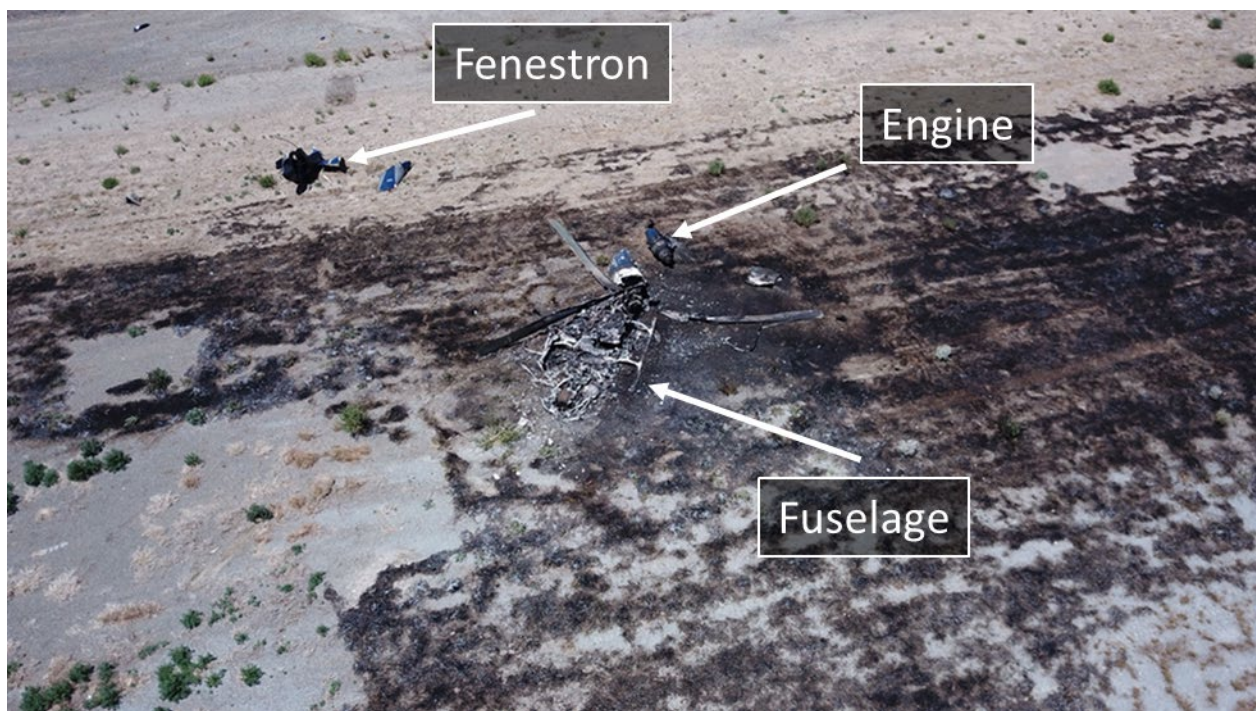
Figure 1. Overhead view, showing the layout of the wreckage. Photo courtesy of the airport manager.

Fuselage. Unless identified differently, all components were thermally damaged and reduced to ash. The fuselage was oriented on a heading of about 160° magnetic, consistent with rotating away from the ingress direction. A small section of the windshield frame was resting at the nose of the wreckage. The instrument panel was consumed by fire. The seats and seat belts were consumed by fire.

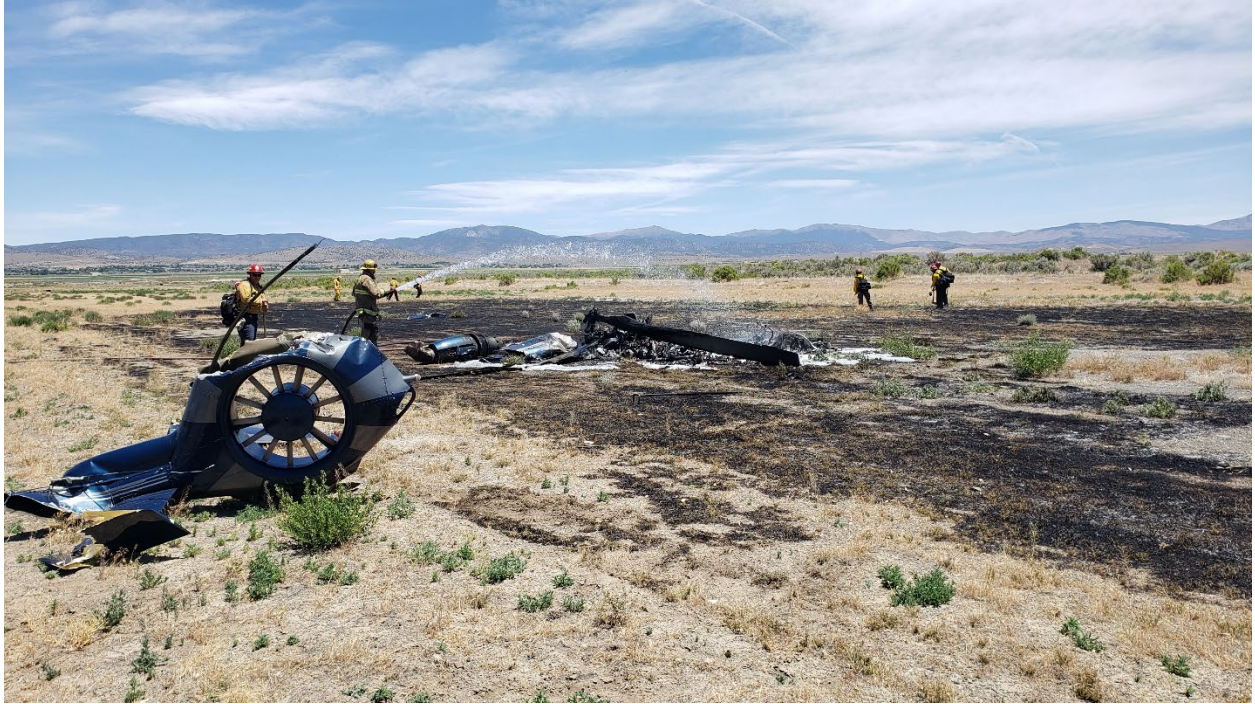
Figure 2. Right-side view. Photo courtesy of the airport manager.

Main Landing Gear (MLG). The main landing gear consisted of skids and cross tubes. The right-side landing gear appeared to have remained attached to the fuselage and exhibited thermal damage but remained mostly intact. The cross tubes appeared separated from the fuselage by thermal consumption of the fuselage. The cross tubes did not appear to have been spread or deformed. The skid retained its shape and appeared to be aligned correctly with the fuselage debris.

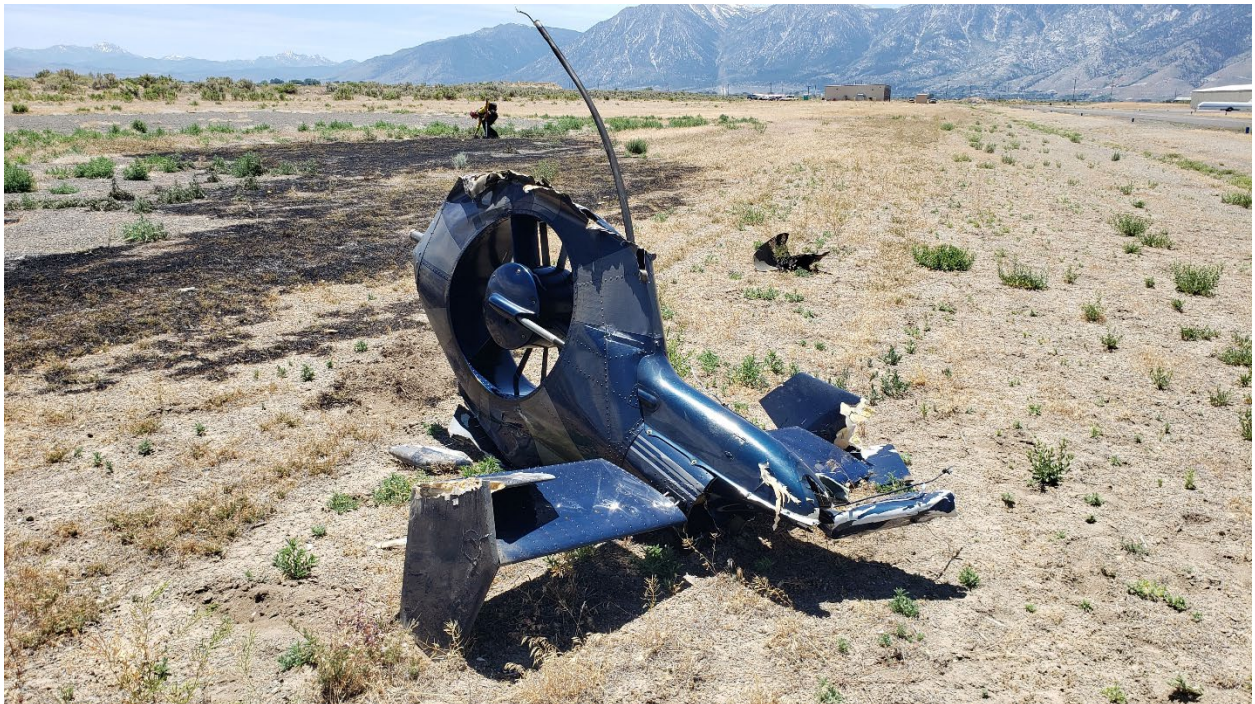
Tailboom. The aft section of the tailboom, housing the fenestron, was not thermally damaged and located away from the fuselage about 50 feet. This section came to rest upright. The vertical stabilizer, above the fenestron, separated and was located close by. The right vertical stabilizer, located on the outboard end of the right elevator (horizontal stabilizer) was partially separated and exhibited damage. The right elevator exhibited damage to the leading edge and top side sheet metal. The left vertical stabilizer, located on the outboard end of the left elevator remained attached to the left elevator, and exhibited damage to the upper half. The left elevator remained attached to the tailboom and exhibited minor damage to the top side sheet metal.

The forward end of the separated tailboom exhibited a jagged cut, with the sheet metal oriented to the left, consistent with contact from the clockwise rotation of the main rotor system.

Anti-Torque Assembly (Fenestron): The fenestron assembly remained attached to the end of the tailboom. The drive shaft remained attached to the fenestron. The fenestron gearbox did not exhibit damage. The fan blades remained attached to the hub and exhibited no damage to the any of the blades.

Figure 3. Photo of the fenestron and tailboom end. Photo courtesy of the airport manager.

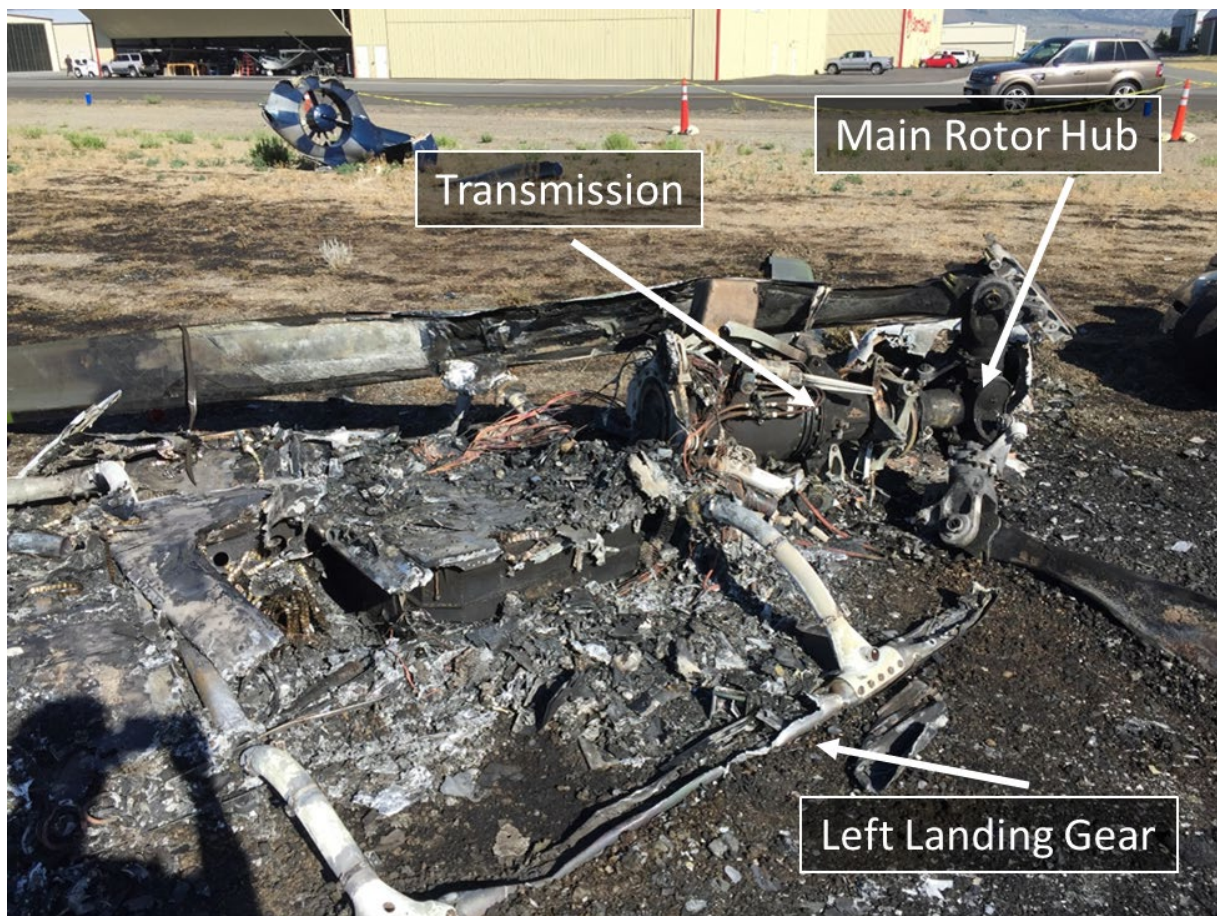
Figure 4. Left-side view. Photo courtesy of the airport manager.

The left cross tubes appeared to have remained attached to the fuselage. The front cross tube appeared collapsed at the area where it met the fuselage, although this could be the result of thermal energy melting the cross tube. The skid exhibited major thermal damage but appeared to align with the fuselage.

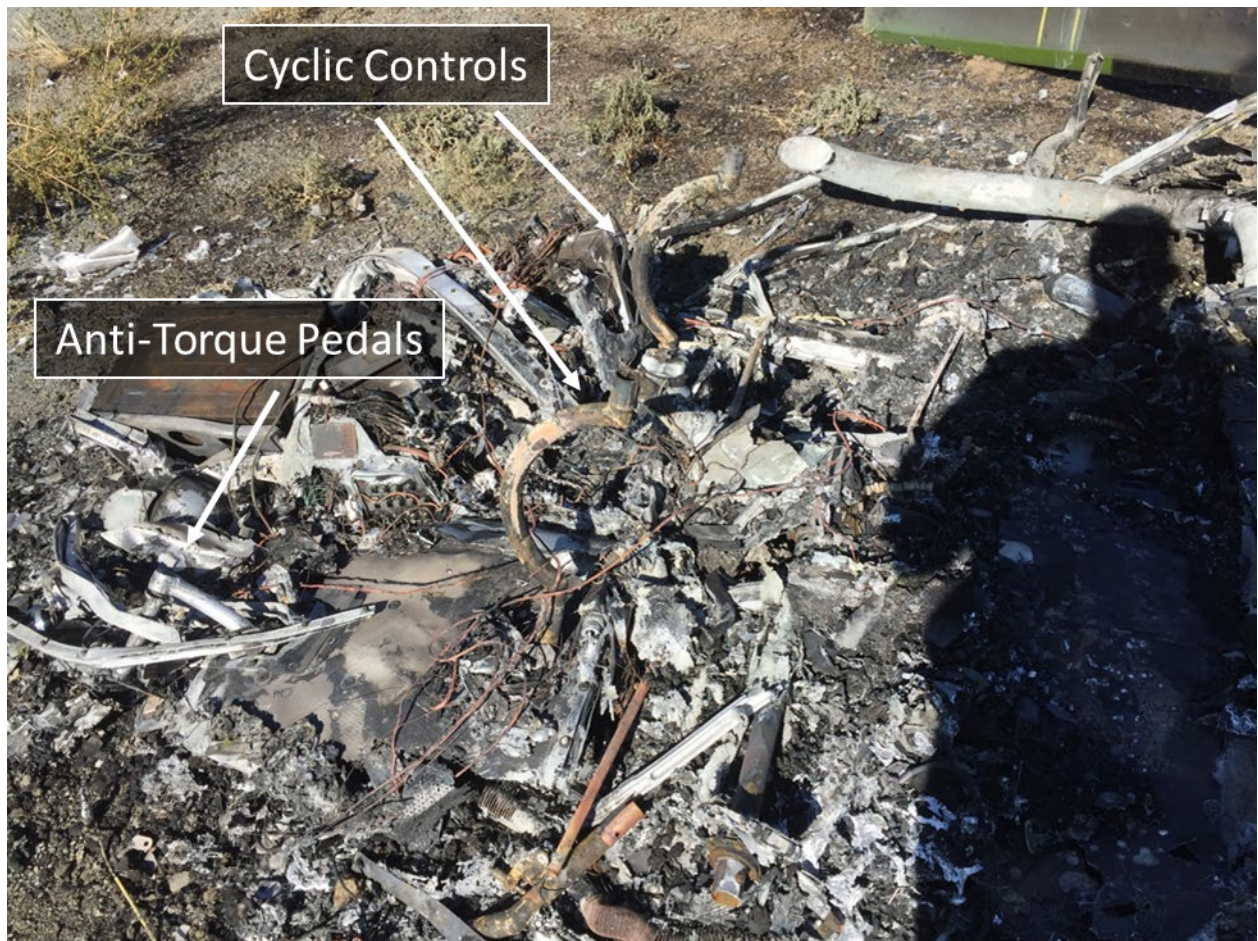
Flight Control Continuity. Flight control continuity was not established due to the wreckage being discarded. The cyclic control sticks were visible in the fuselage area, as were the left-seat anti-torque pedals. The pilot did not report flight control anomalies.

Figure 9. Cockpit view. Photo courtesy of the airport manager.
