Tealeye Cornejo  
Air Safety Investigator (Field)  
AS-WPR

**Date:** September 2, 2020

**Subject:** WPR20LA190

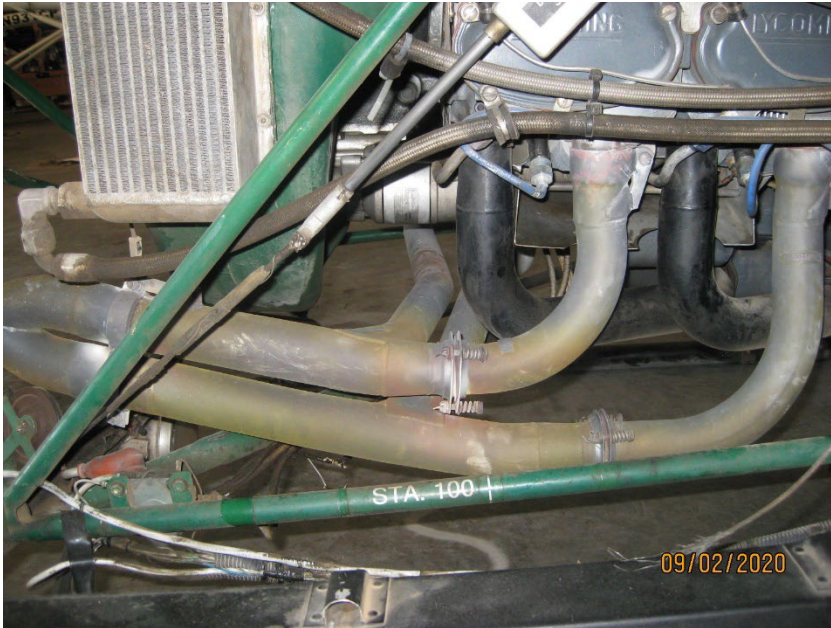
Photo 1 - Side View of Engine

There were no obvious holes in the engine case. Both magnetos remained attached at their respective mounting pads on the engine. They found the idle stop, idle mixture settings and throttle rigging to be unremarkable. Two of the spark plugs were removed and exhibited to be in a worn out - normal condition. The fuel gascolator bowl contained fuel as well as unidentified metallic debris.
