## Main Rotor Transmission Tear-down Inspection

Enstrom Model 280FX S/N 2099 N280MM, NTSB Investigation: WPR20LA191

Accident Date: 23 June 2020

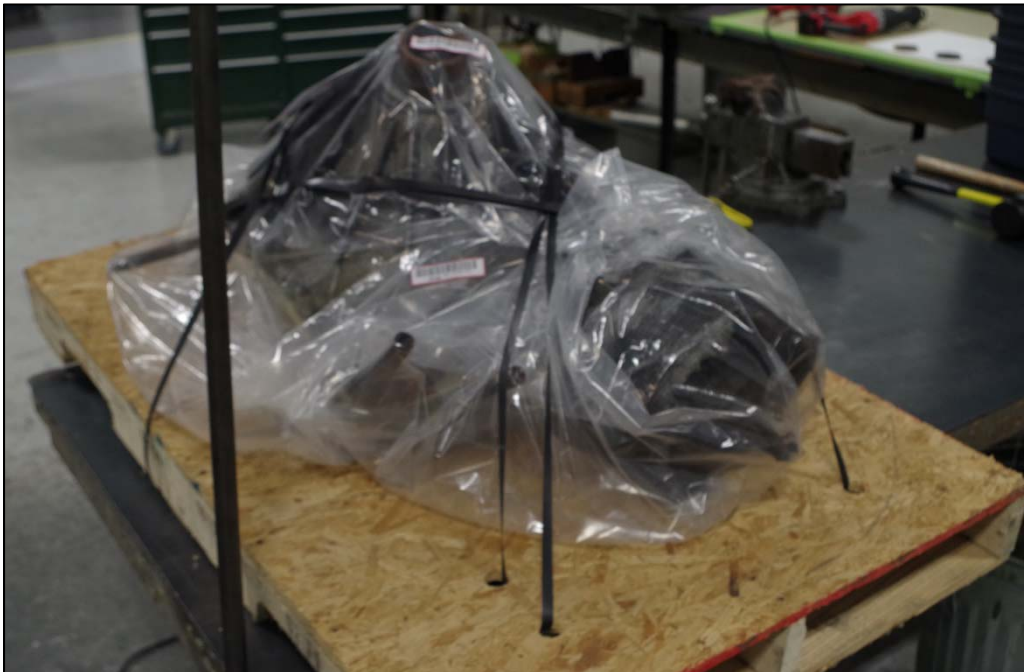
Figure 1. Un-Opened Transmission.

The main rotor mast and two of the three control tubes had been cut off 2 – 3 inches above the transmission housing. The third control tube was not present. The transmission was bolted to a section of the pylon; the pylon tubes had been cut 6 – 12 inches below the transmission. The upper pulley, tail rotor drive shaft coupling, and swashplate were still attached. The whole assembly exhibited damage consistent with a significant fire.

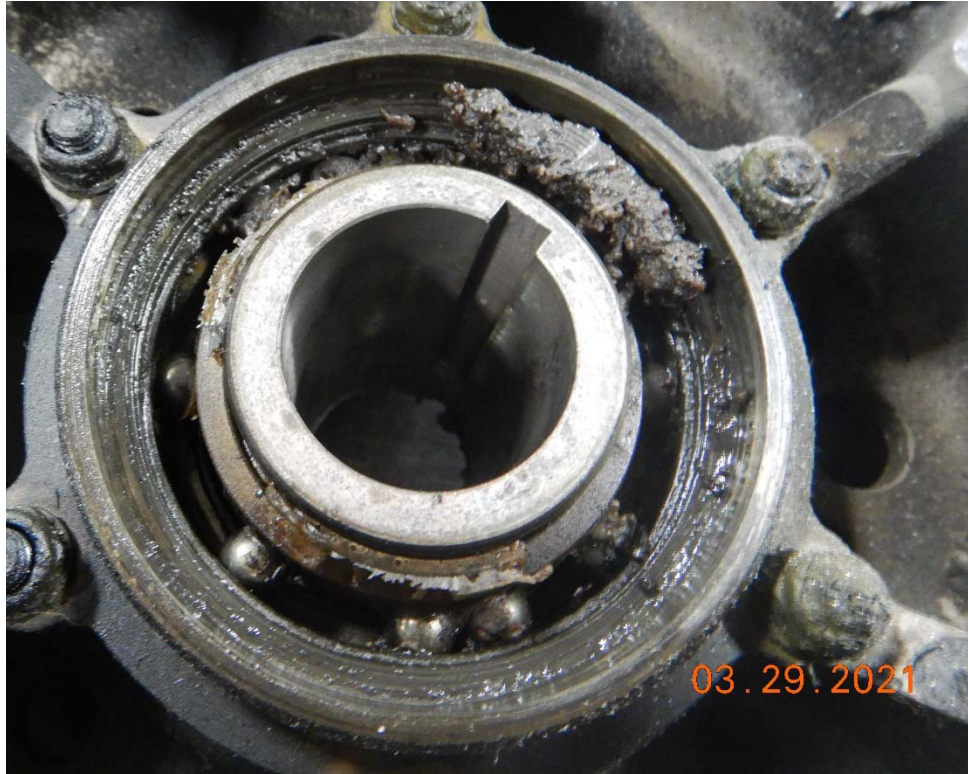
Figure 2. Overrunning Sprag Clutch - Forward Side

The overrunning clutch able to turn freely in the correct direction and lock-up in the correct direction. The clutch had burnt grease still packed around the ball bearings. The clutch was not removed from the pulley. There was no indication of any pre-impact problem with the overrunning sprag clutch.

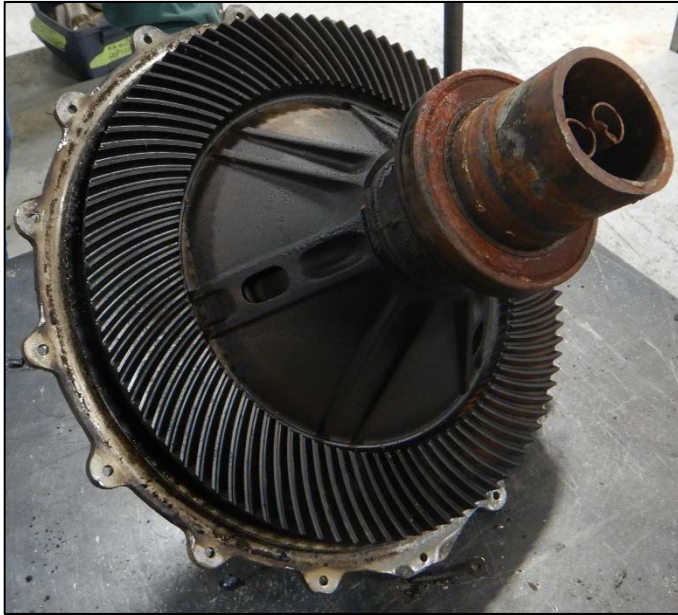
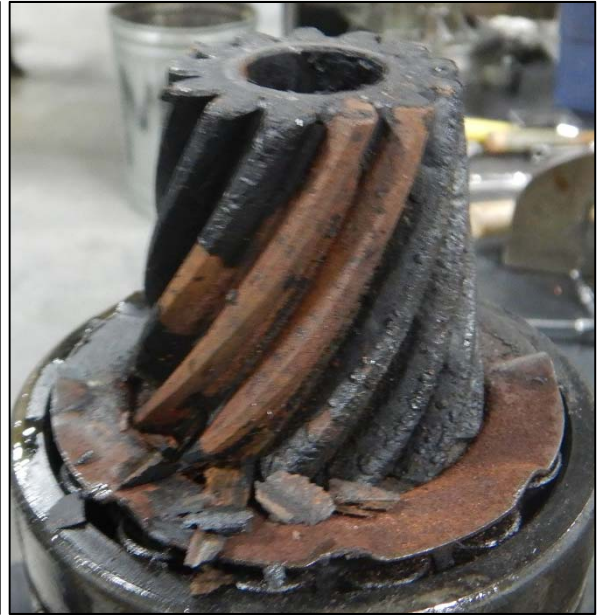
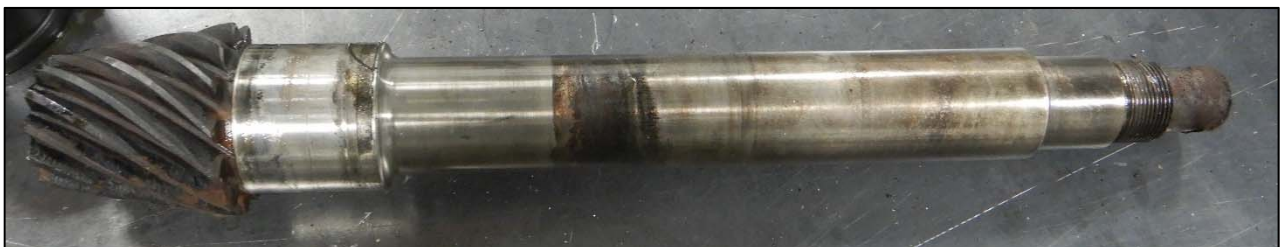
Figure 3. Ring Gear and Pinion

No gear teeth were missing and none of the gear teeth looked to be damaged. The teeth were coated in a brittle layer of soot and corrosion. The corrosion was assumed to have formed after the post-crash fire. The shaft of the pinion did not show any evidence of spalling or wear under the bearings. The ring gear and pinion are shown in Figure 3.

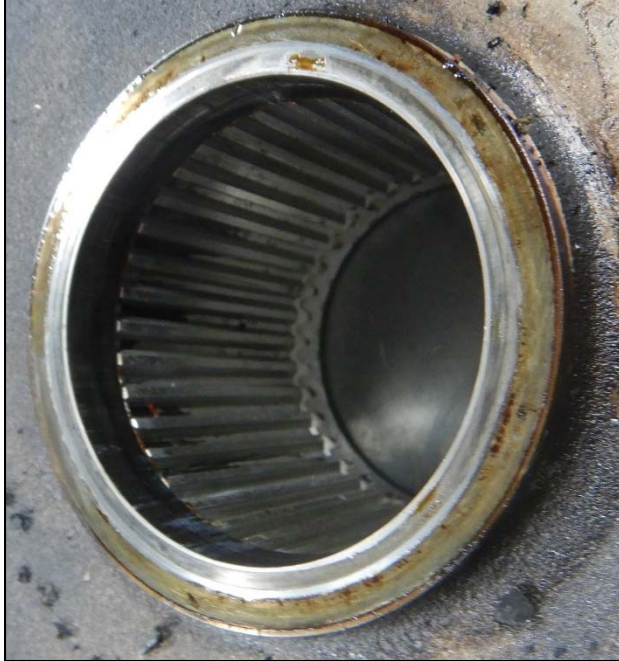
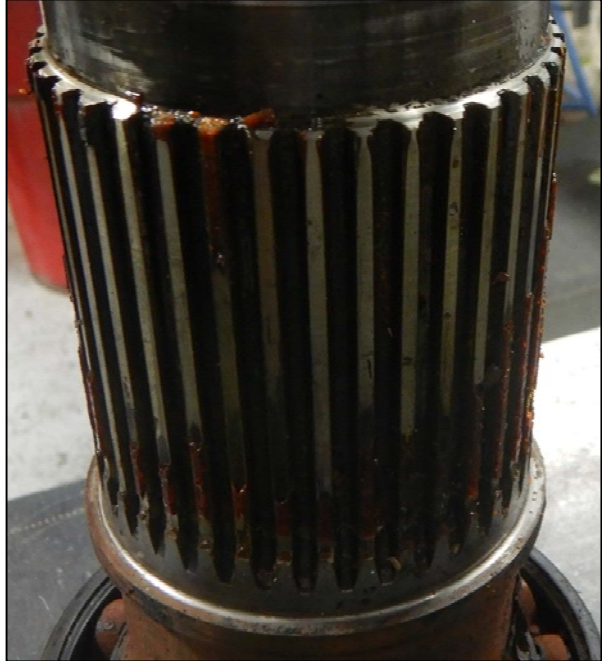
Figure 4. Main Rotor Splines

The splines on the ring gear carrier and main rotor shaft (Figure 4) were not missing any teeth and did not show any evidence of damage.

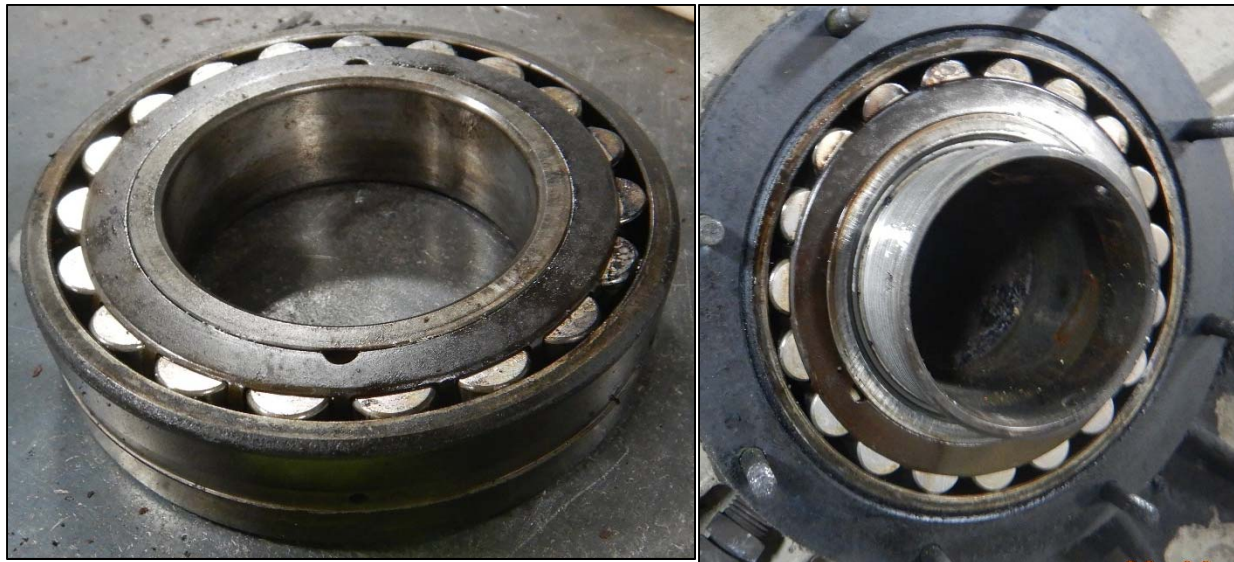
Figure 6. ECD026 Bearing

The bearing was coated burnt oil and some soot. The bearing was not able to turn which was attributed to the fire damage. There were no indications of wear or spalling on the inside of the outer race. The bearing is shown in Figure 6

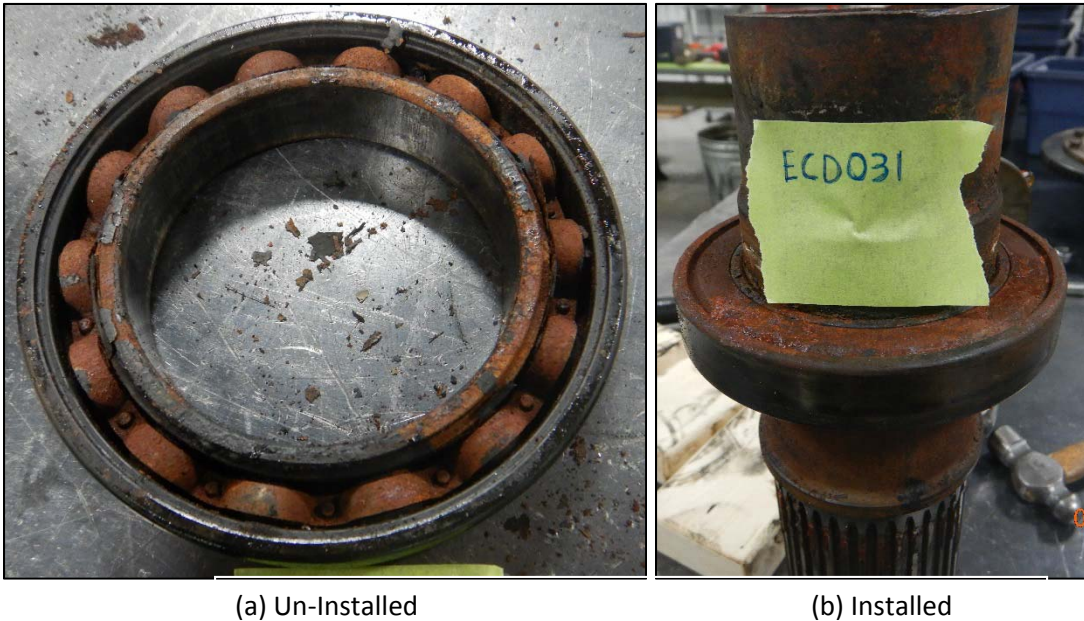
Figure 7. ECD031 Bearing

The top of the bearing was heavily corroded, this was attributed to the post-crash fire. The bearing was not able to turn. The bearing's cage was not broken, but it was corroded and coated in soot. There were no indications of wear or spalling on the inside of the outer race. The bearing is shown in Figure 7.

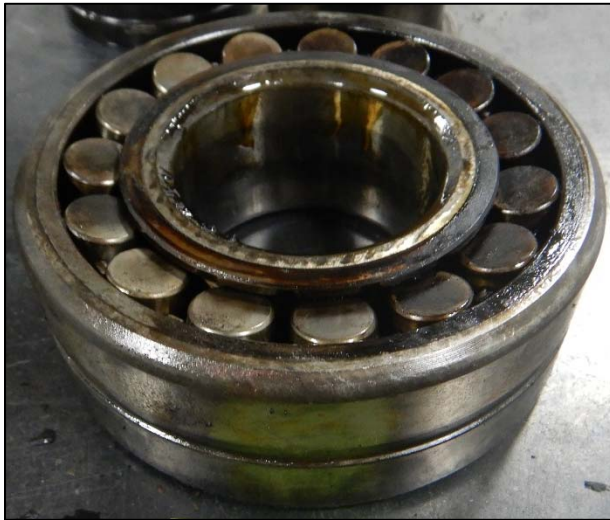
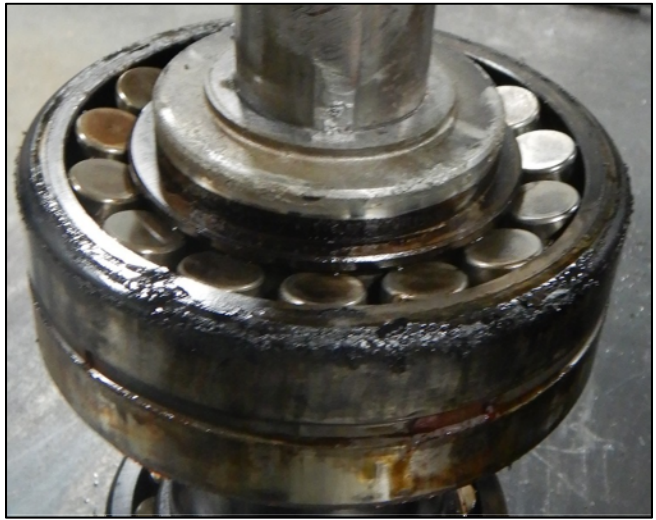
Figure 8. ECD025 Bearing

The bearing was coated in burnt oil and some soot. The bearing was not able to turn which is attributed to the fire damage. There were no indications of wear or spalling on the inside of the outer race. The bearing is shown in Figure 8.

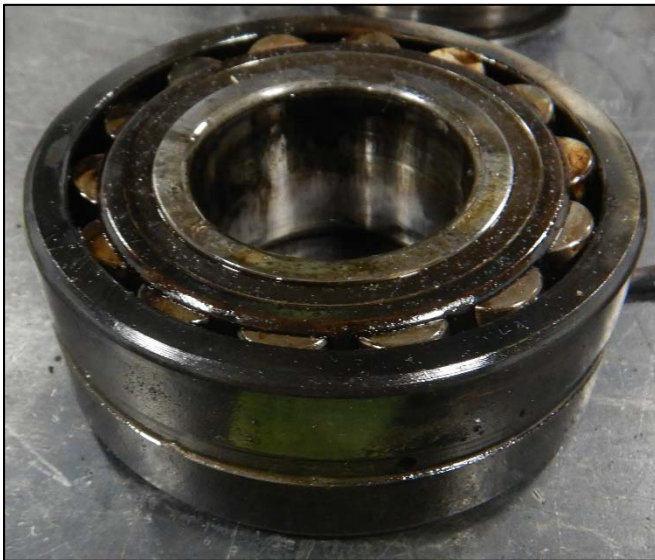
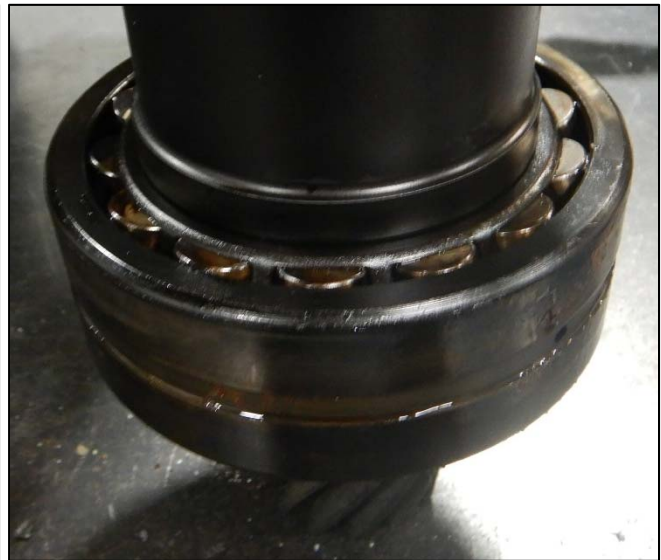
Figure 9. ECD023 Bearing

The bearing was coated in burnt oil and some soot. The bearing was not able to turn which is attributed to the fire damage. There were no indications of wear or spalling on the inside of the outer race. The bearing is shown in Figure 9.

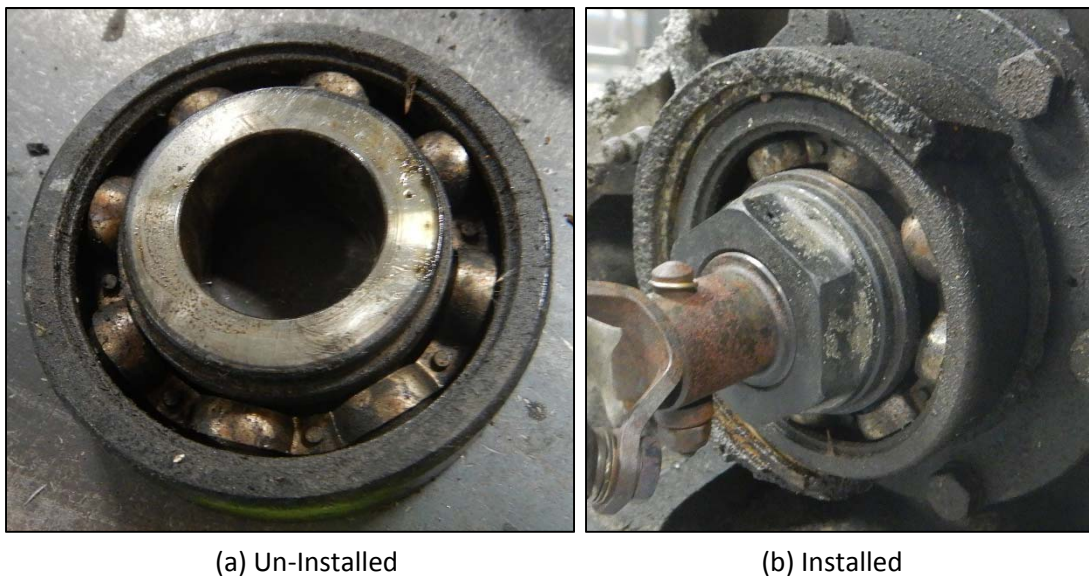
Figure 10. ECD014 Bearing

The nut on the aft end of the pinion was removed, the nut was tight on the pulley. The P/N ECD014 upper jackstrut bearing was removed, and the pulley was pulled off the transmission. There was burnt grease and oil in the upper jackstrut bearing.

The bearing was coated with soot and burnt grease. The bearing was not able to turn which is attributed to the fire damage and corrosion. The bearing's cage was not broken, and there were no indications of wear or spalling on the inside of the outer race. The bearing is shown in Figure 10.
