## **NATIONAL TRANSPORTATION SAFETY BOARD**

### **Engine Examination Summary**

**WPR20LA191**

Location: Hayden, ID  
Date: June 23, 2020  
Aircraft: Enstrom 280FX., Registration Number: N280MM, Serial #: 2099  
NTSB IIC: Albert Nixon

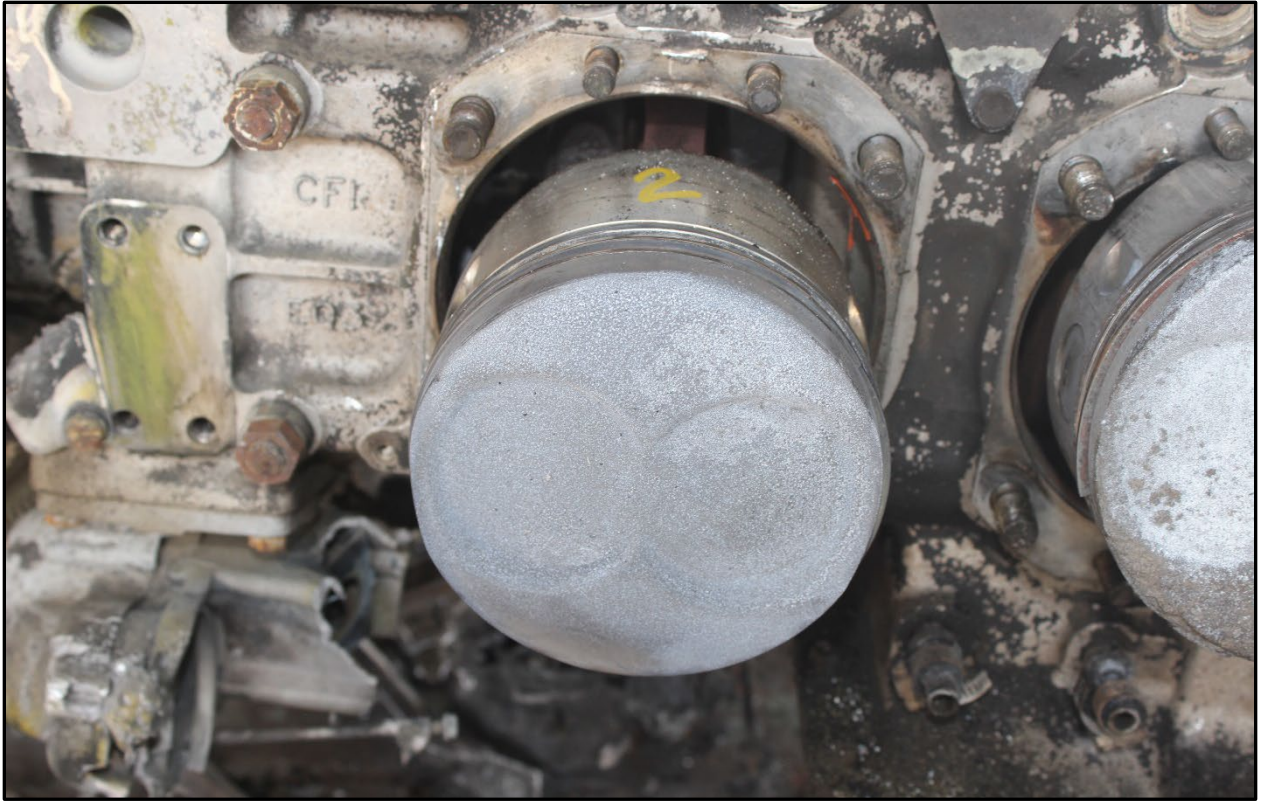
The cylinders were removed and examined. Examination revealed that the Nos. 1 and 3 cylinder's combustion chambers exhibited signatures consistent with sustaining thermal damage and being exposed to firefighting suppression. The No.1 cylinder's piston rings were intact but were frozen from corrosion within their respective ring lands. The No. 3 cylinder's piston rings were intact and moved within their respective ring lands and no anomalies were noted. The No. 2 cylinder's head was observed to be absent of any carbon build-up and exhibited a sand blasted appearance consistent with detonation. The piston rings remained intact and moved within their respective ring lands. The No. 4 cylinder exhibited severe signatures of detonation to the cylinder head and piston. The piston was noted to have melted along its edge which compromised the ring lands and rings. Additionally, the piston skirt material was smeared.

**Figure 1: No. 2 cylinder piston head as viewed from the top.**

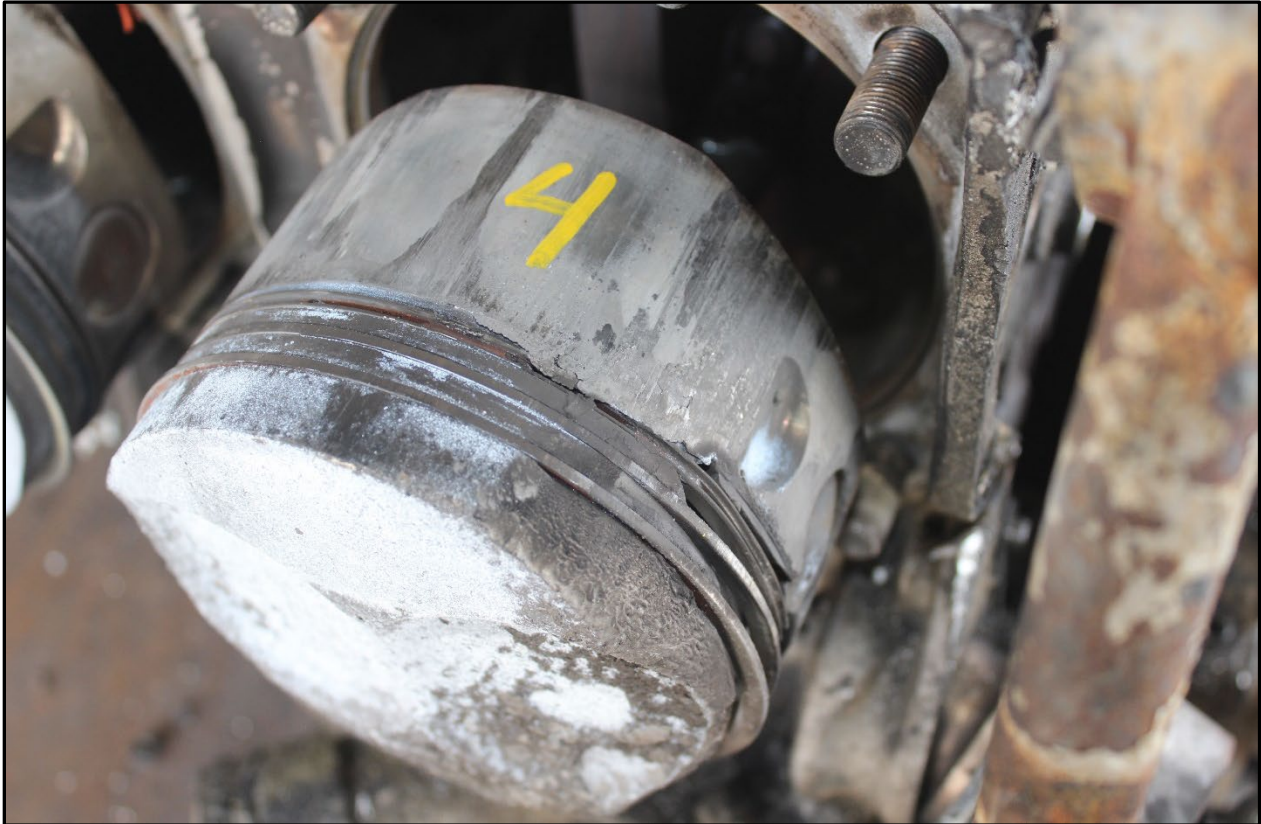
**Figure 2: No. 4 cylinder piston head as viewed from the top side.**

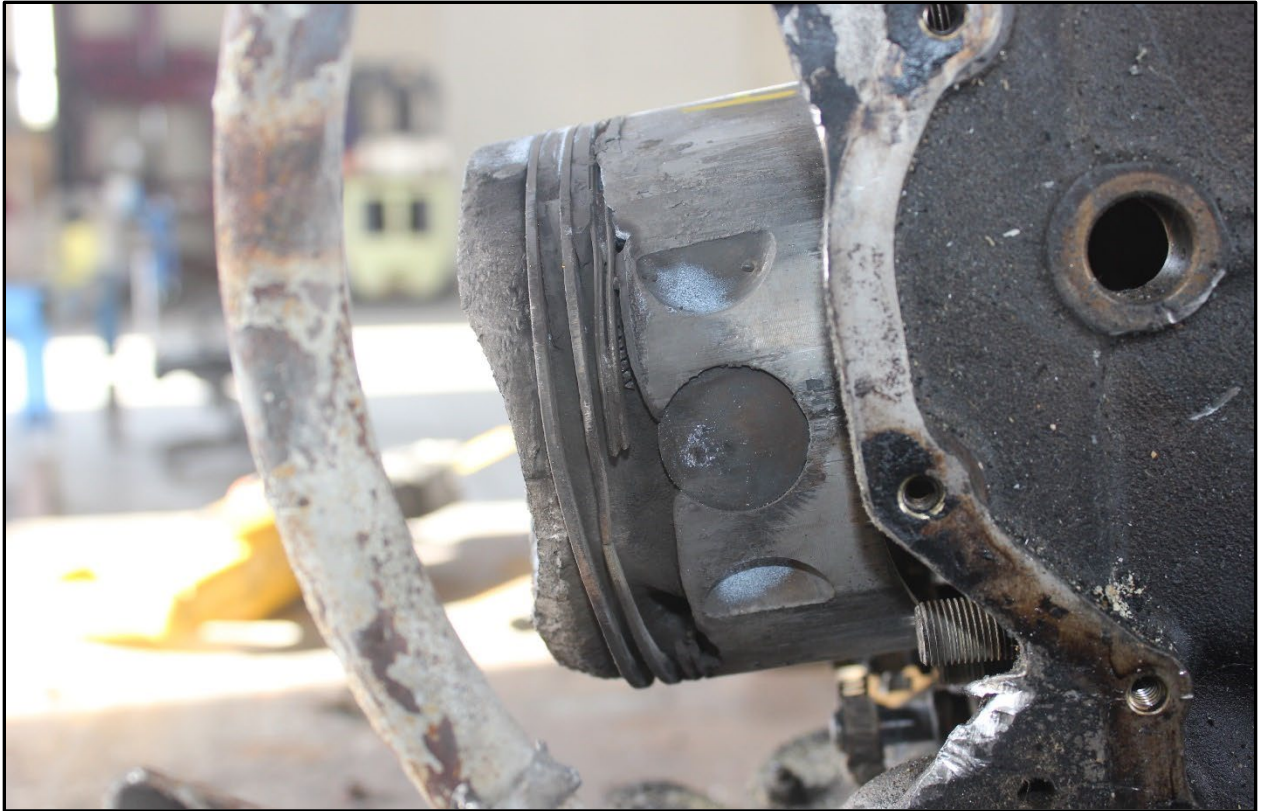
**Figure 3: No. 4 cylinder piston head as viewed from the side.**

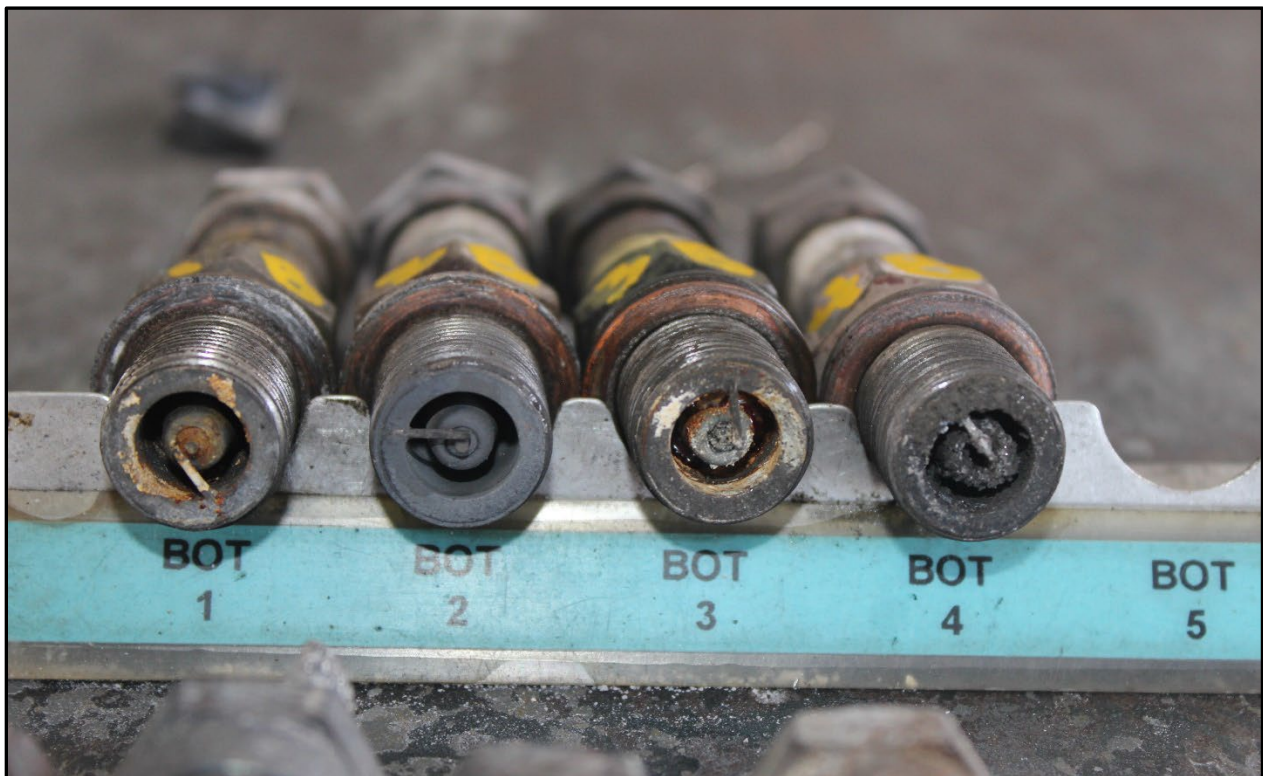
The engine examination was accomplished at the facilities of Air Transport in Phoenix, Arizona, on April 5, 2021. The examination revealed that the No. 3 cylinder's bottom spark plug was missing a portion of its center electrode and the No. 4 cylinder's bottom spark plug was missing its center electrode. Additionally, the No. 2 cylinder exhibited a sandblasted appearance consistent with detonation and the No. 4 cylinder exhibited signatures and damage consistent with detonation on the cylinder head and piston. No other additional anomalies that would preclude normal operation were observed during the examination of the engine.

**Figure 4: The bottom spark plugs electrodes.**
