# NATIONAL TRANSPORTATION SAFETY BOARD

## MATERIALS LABORATORY FACTUAL REPORT

Report No. 21-007

Place : Upland, California  
Date : 06/24/2020  
Vehicle : Reser Thacher CX4 (N274DR)  
NTSB No. : WPR20LA193  
Investigator : Joshua Cawthra

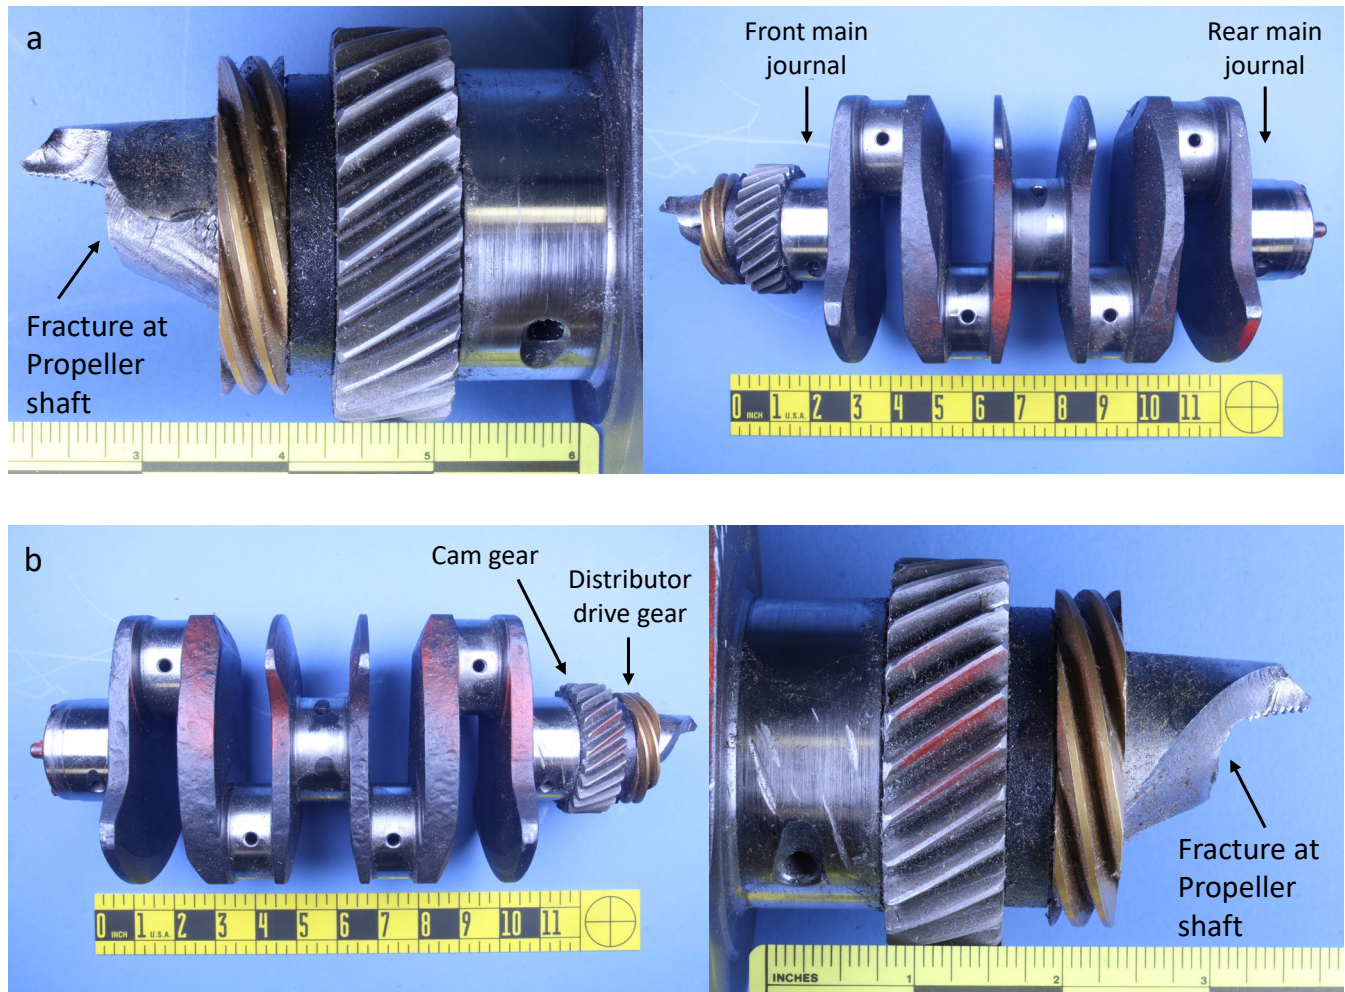
The as-received crankshaft portion is shown in Figure 1. Profile views of the fracture at the propeller shaft end are identified in the images. Top-down views of the fracture surface are shown in Figure 2. The fracture origin regions are identified, and the directions of fracture propagation are noted.

Figure 1 Images of the as-received fractured crankshaft.

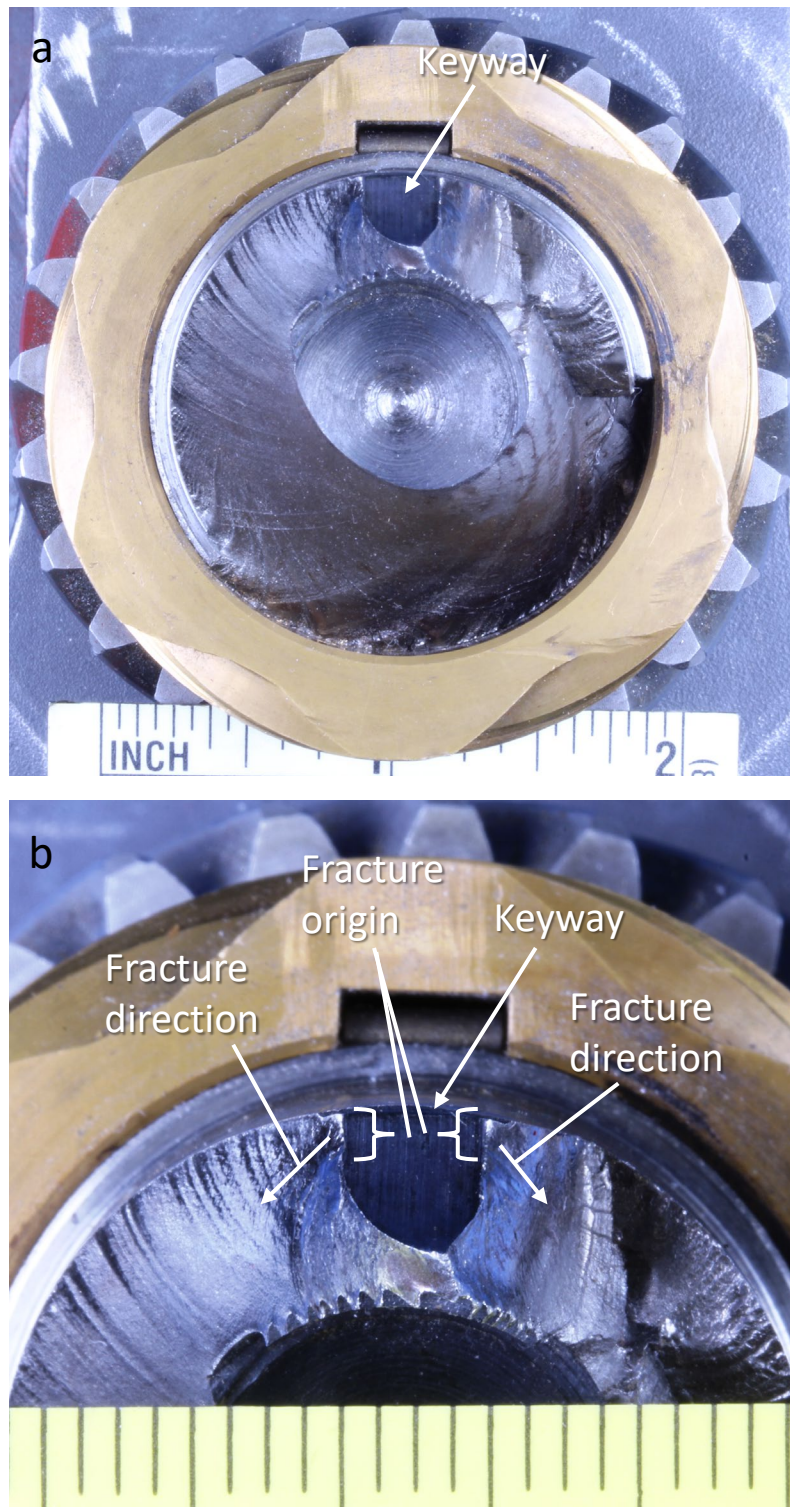
Figure 2 Top-down views of the fracture surface in the crankshaft.

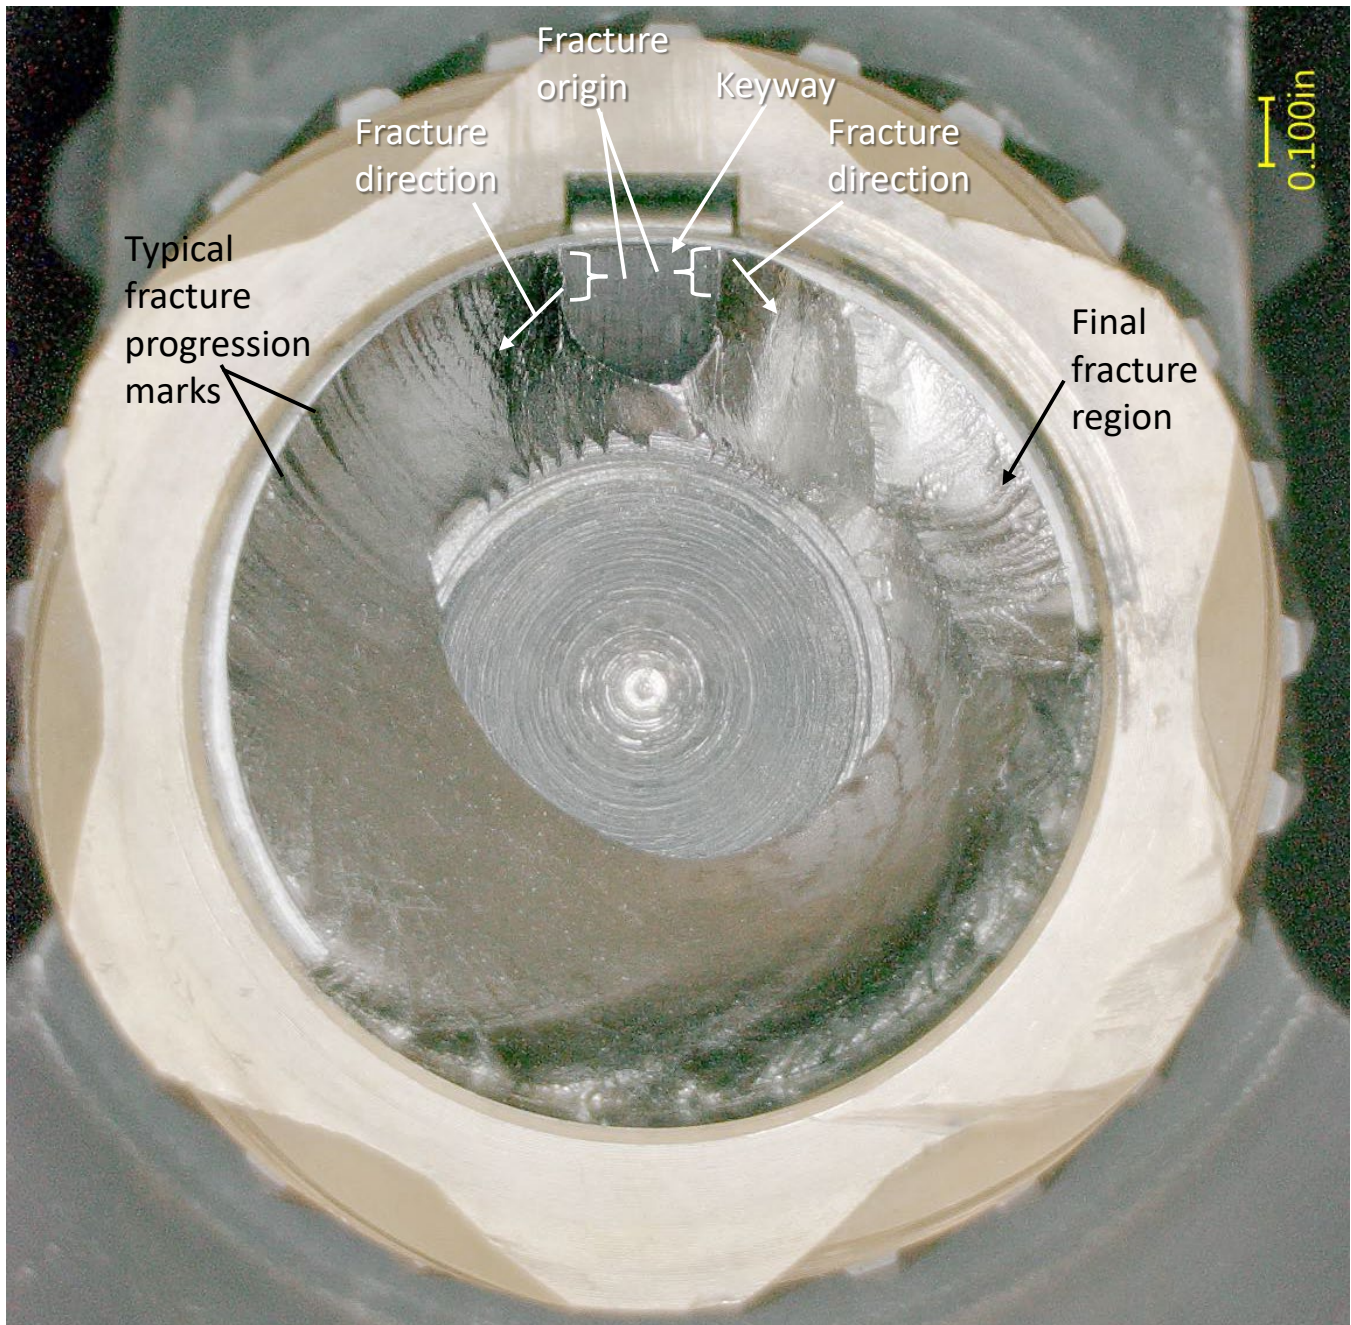
A higher magnification digital microscope image of the fracture surface is shown in Figure 3 with the fracture origin regions identified, and the directions of crack propagation noted. As indicated in the image, two fractures initiated at the termination of a square keyway slot in the shaft. Closer views of the keyway slot are shown in Figure 4 with the locations of the fracture origins indicated. Profile views of the fracture origin regions are documented in Figure 5. The presence of ratchet marks at the fracture origins and the presence of progressions marks along the fracture path are indicative of fatigue fracture initiation and growth. A small region of final fracture is noted in Figure 3.

Figure 3 Digital microscope image showing a top-down view of the crankshaft fracture surface. The fracture origins at the termination of the square keyway are identified. Typical fracture progression marks are noted.

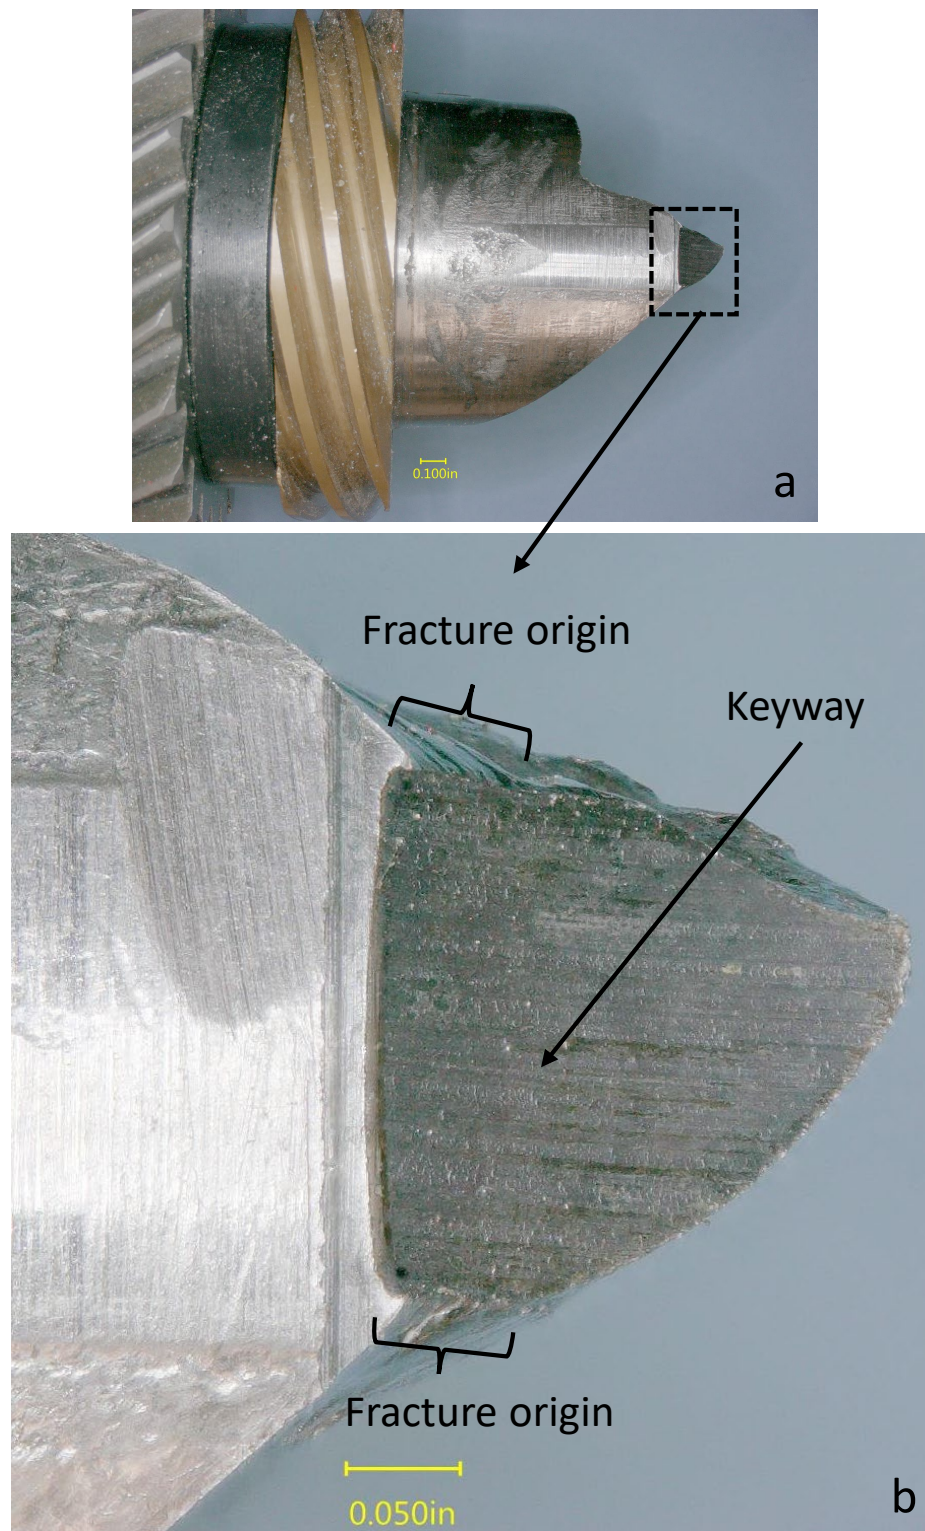
Figure 4 Digital microscope images of the keyway termination area on the crankshaft. The two fracture origin sites are noted. Ratchet marks were observed at the origin sites.

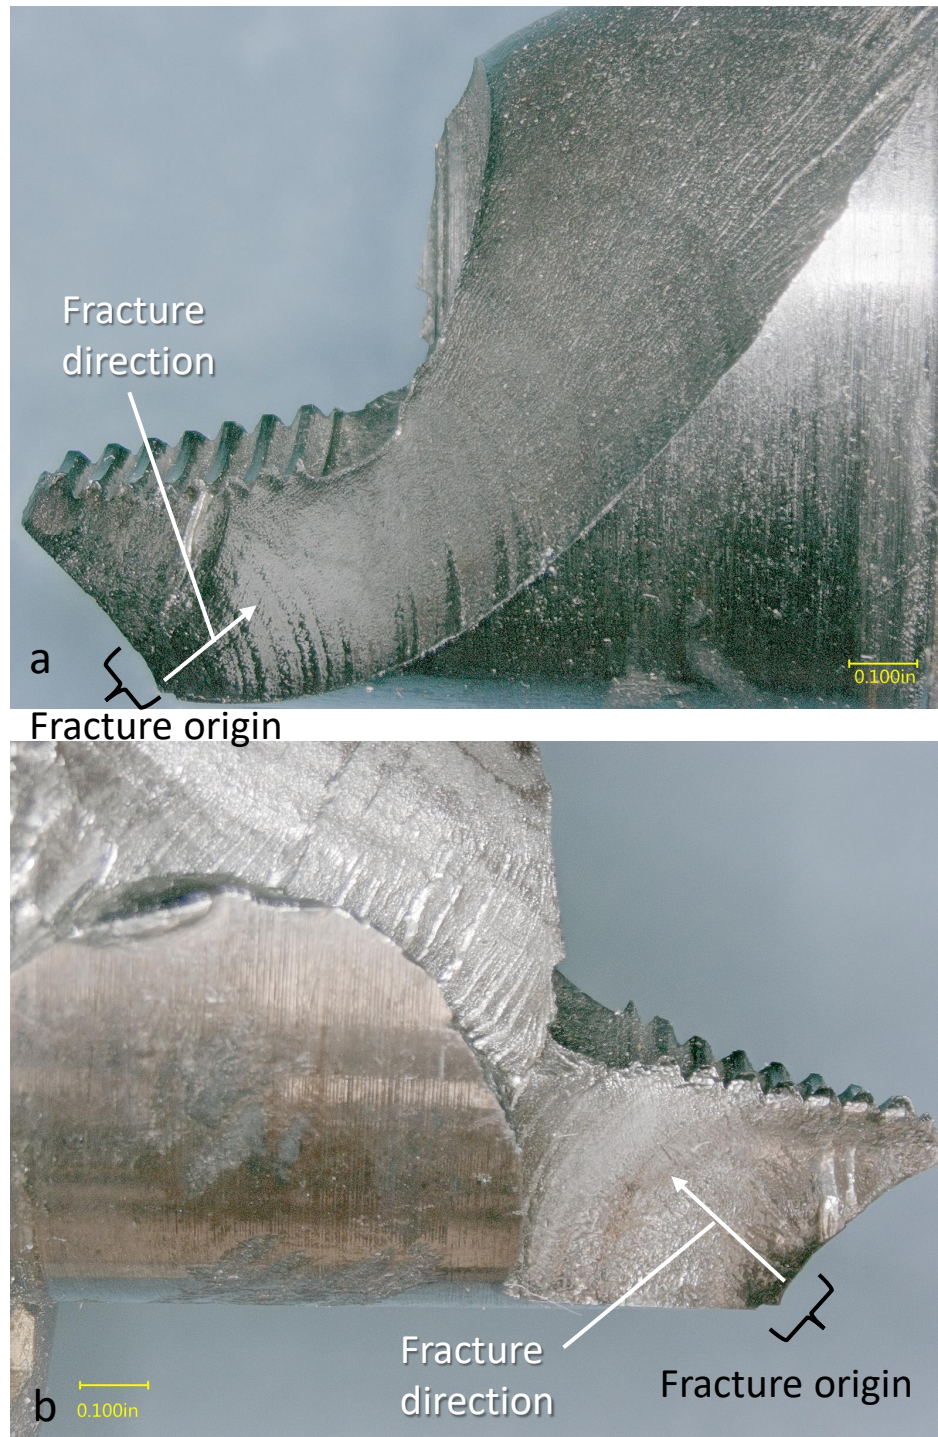
Figure 5 Digital microscope images showing profile views of the crankshaft fracture with the fracture origin regions identified.
