## **NATIONAL TRANSPORTATION SAFETY BOARD**

# **ENGINE AND AIRFRAME EXAMINATION SUMMARY**

**WPR20LA196**

Location: Centerville, Utah  
Date: June 25, 2020  
Aircraft: N9774U, Gumman AA-5A

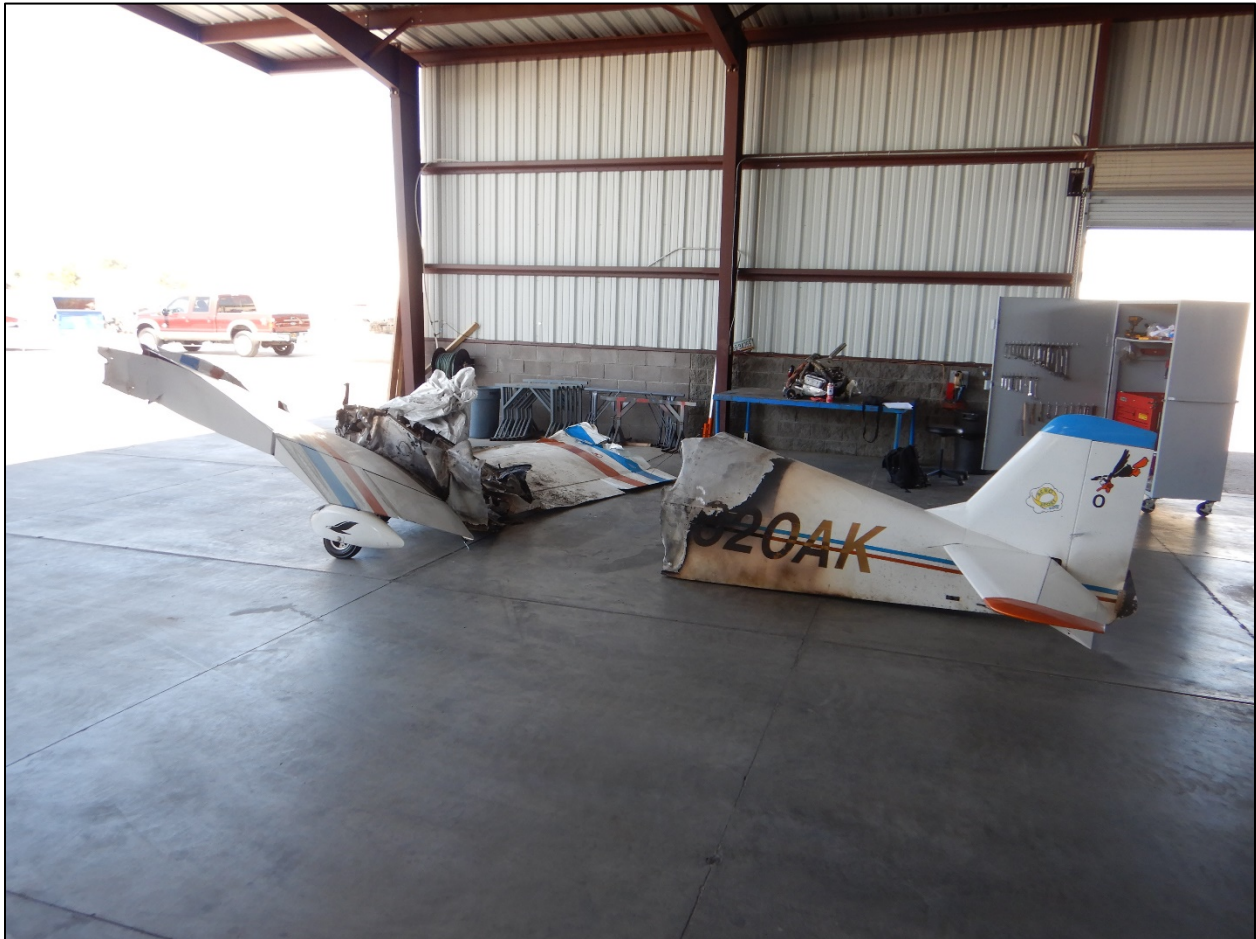
Figure 1-Main wreckage displayed on the floor.

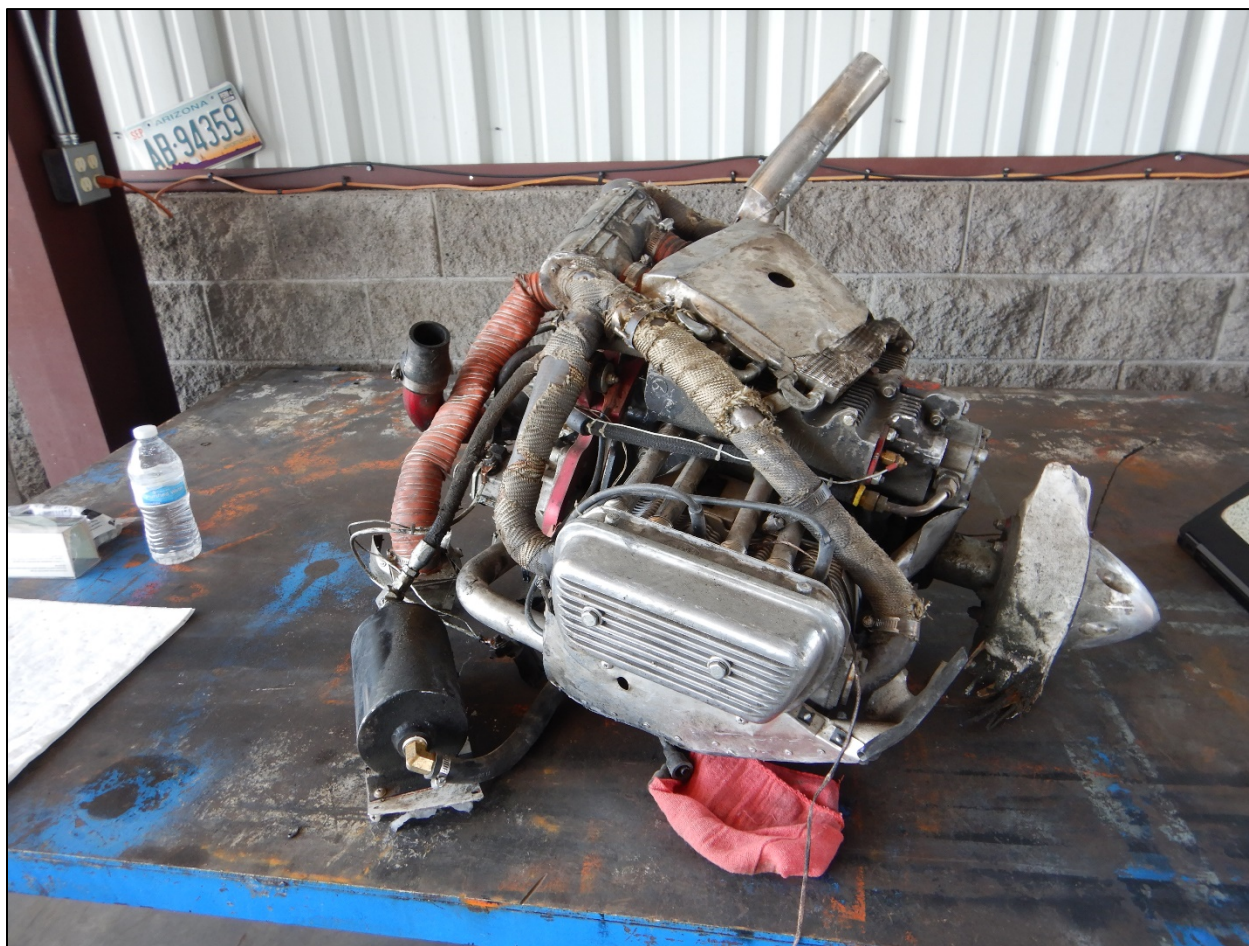
The AeroVee Turbo Engine Kit, serial number unknown, is rated at 100 hp at 3,400 rpm. Serial number on the magneto timing flywheel structure, read 0833. The engine separated from the main wreckage and had impact damage throughout. The propeller assembly had impact damage and both blades separated near the hub. The engine mounting carriage remained attached to the main wreckage. The crankcase showed impact damage near the crankshaft forward oil seal area. The exhaust remained attached to the engine and had impact damage. The turbocharger had impact damage to its housing and was moved from its original position. The turbocharger compressor blades were visible and undamaged. The compressor turned freely by hand. Heat tape attached to the exhaust stacks was damaged. The induction tubes had impact damage. The induction fitting for the right set of cylinders had impact damage and was loose. The right valve cover separated from the right set of cylinders. The left valve cover was removed, and all cylinder overhead components were undamaged and had a light residue of oil. The magneto timing structure had impact damage and missing material. The upper spark plugs were removed and undamaged.

Figure 2-Engine displayed on a table (inverted).

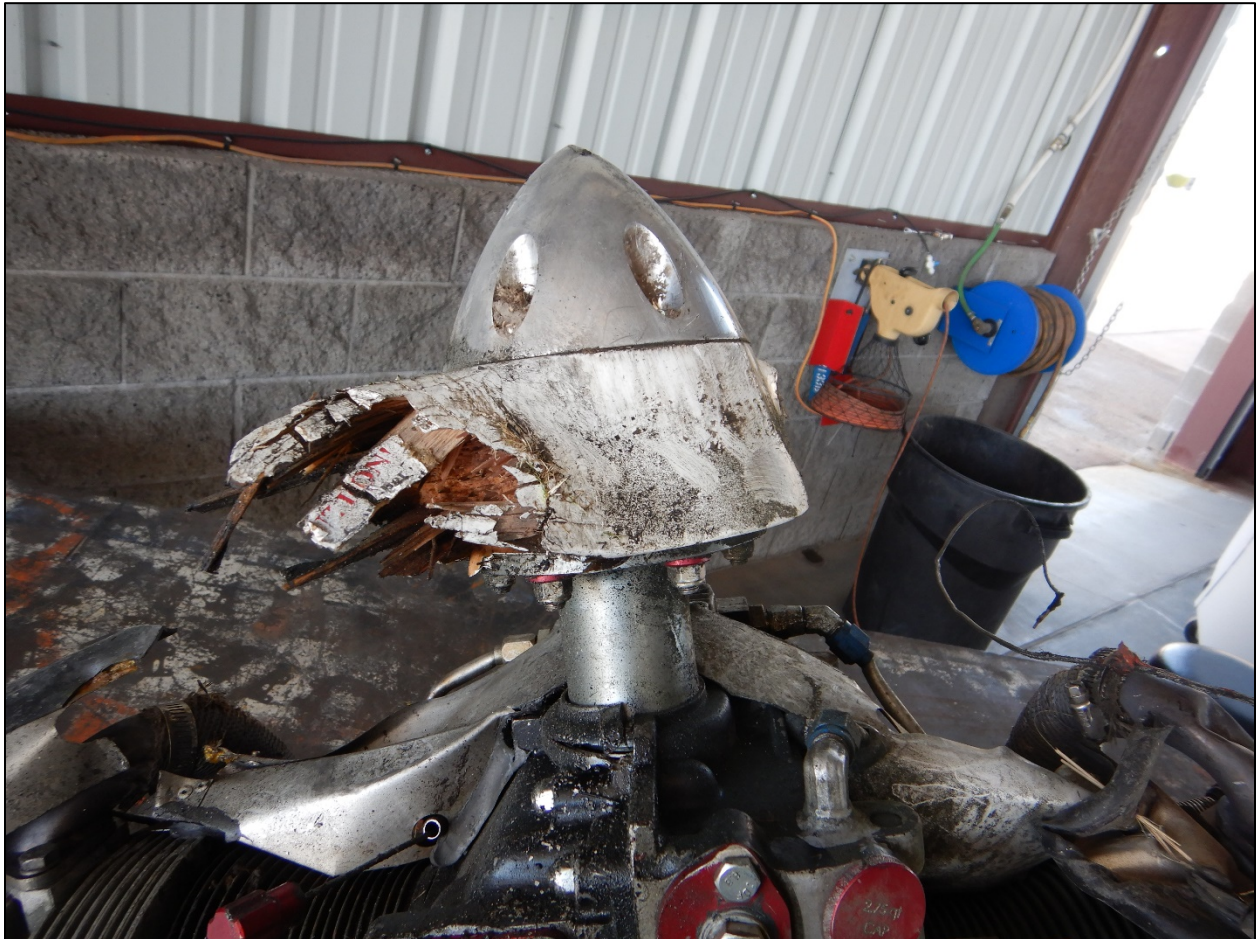
The crankshaft was rotated at the propeller hub and would only rotate 180°. The forward section of crankshaft was loose near the forward oil seal area. Several cylinder rockers moved during the crankshaft rotation and compression was noted in two cylinders.

**Figure 3-Forward crankshaft and propeller hub.**

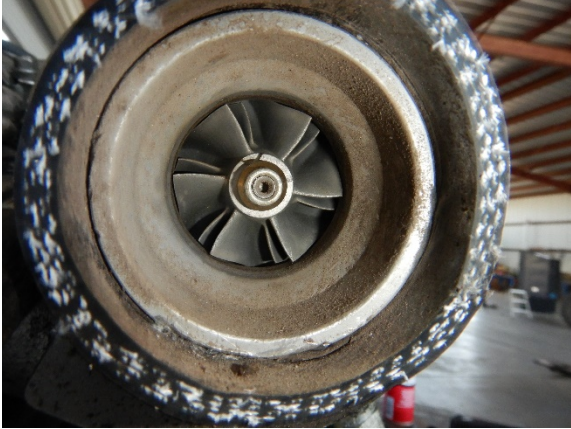
**Figure 4-Turbocharger compressor blade section.**

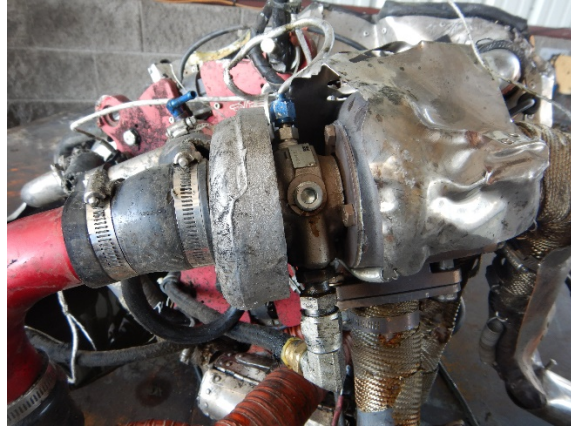
**Figure 5-Turbocharger and induction tube.**

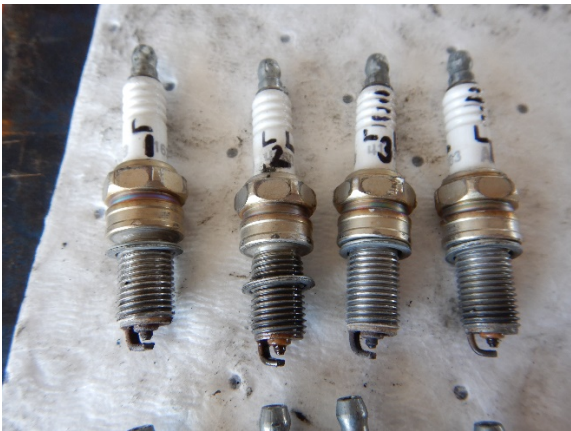
The lower spark plugs were removed and were undamaged. The electrode areas on the upper and lower spark plugs showed normal wear conditions.

**Figure 6-Lower spark plugs.**

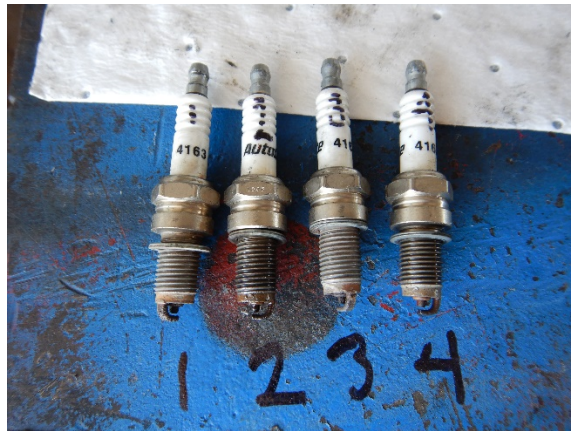
**Figure 7-Upper spark plugs.**

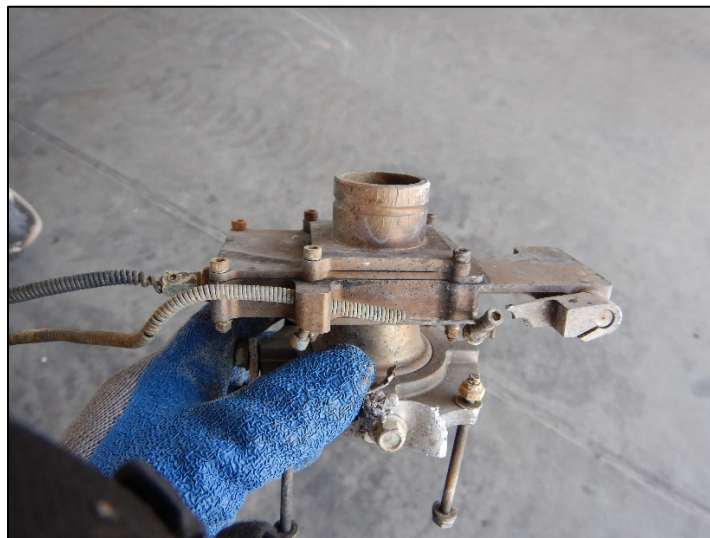
The vacuum carburetor separated from the engine and was found with the main wreckage. The control cables remained partially attached to the carburetor and had impact damage.

**Figure 8-Vacuum carburetor found at the firewall.**

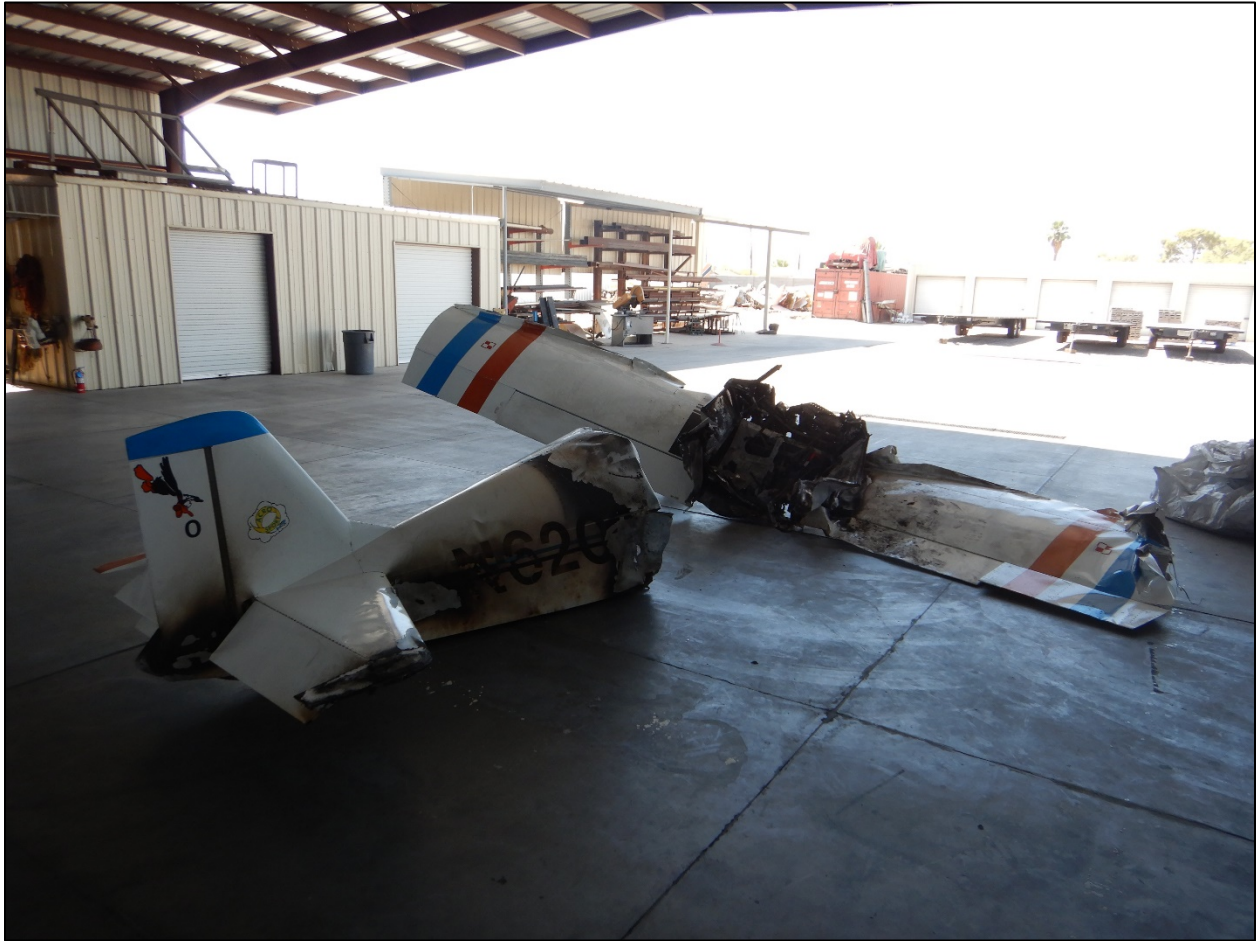
The main wreckage consisted the wings, cabin area and separated rear fuselage and empennage. Thermal damage and discoloration was found throughout the main wreckage. The cabin area was mostly consumed by postimpact fire.

Figure 9-Main wreckage.

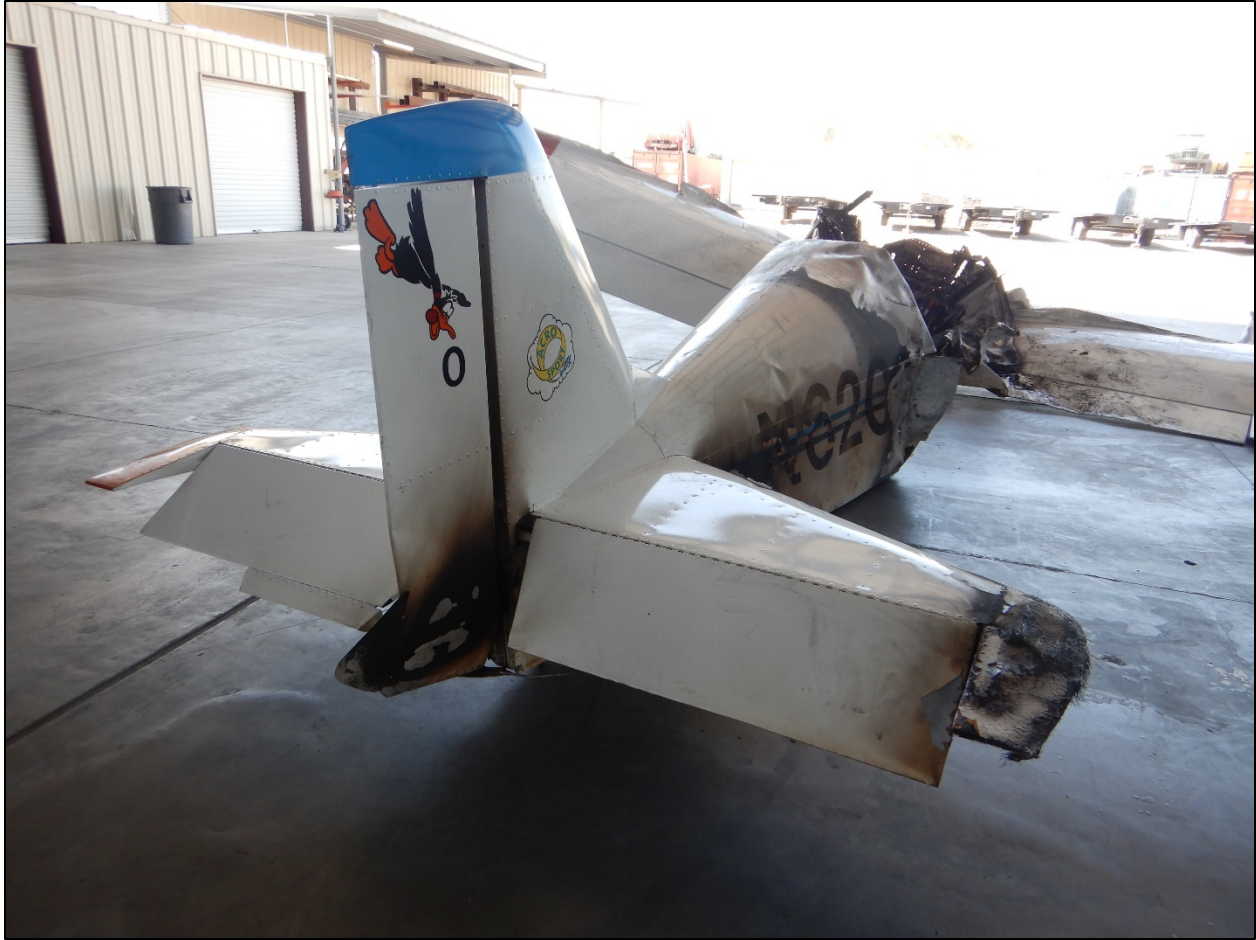
**Figure 10-Empennage and aft fuselage.**

The rudder was crushed on the lower side and control cable continuity was attained to the cabin area. The control cables were cut to facilitate the relocation of the wreckage. The elevators were undamaged and control tube continuity was obtained to the cabin area. The center section of the control tube had impact damage at two locations. The right horizontal stabilizer had thermal damage near the outboard end.

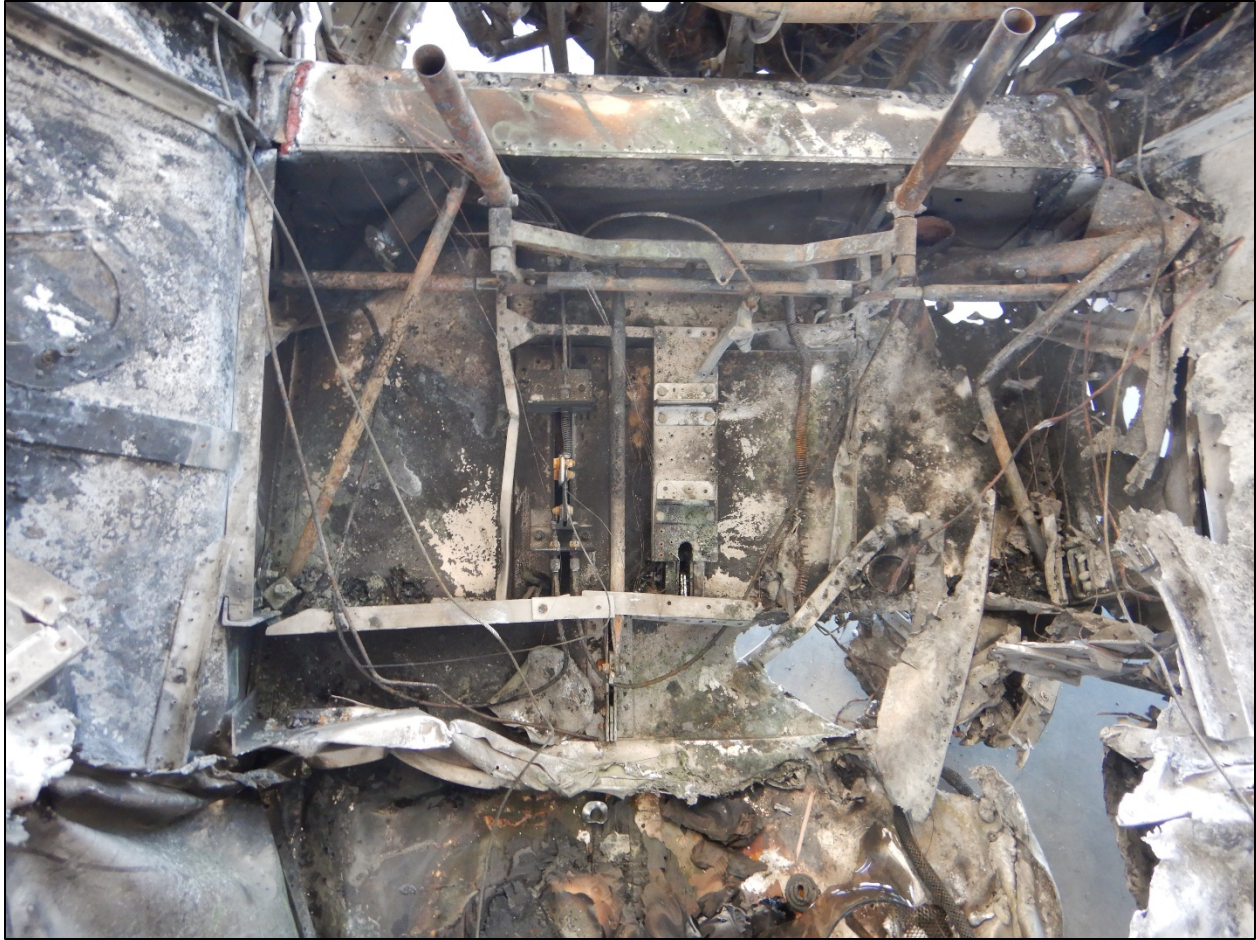
**Figure 11-Cabin area.**

The cabin area was mostly consumed by post-impact fire. The rudder pedal assembly was crushed and had thermal discoloration. Rudder control cables were secured to the rudder pedal assembly. The elevator control tube assembly remained attached to the control stick assembly. The elevator bellcrank located in the midsection of the cabin area had impact damage and separated. The ailerons and flaps on both wings moved during a flight control check.

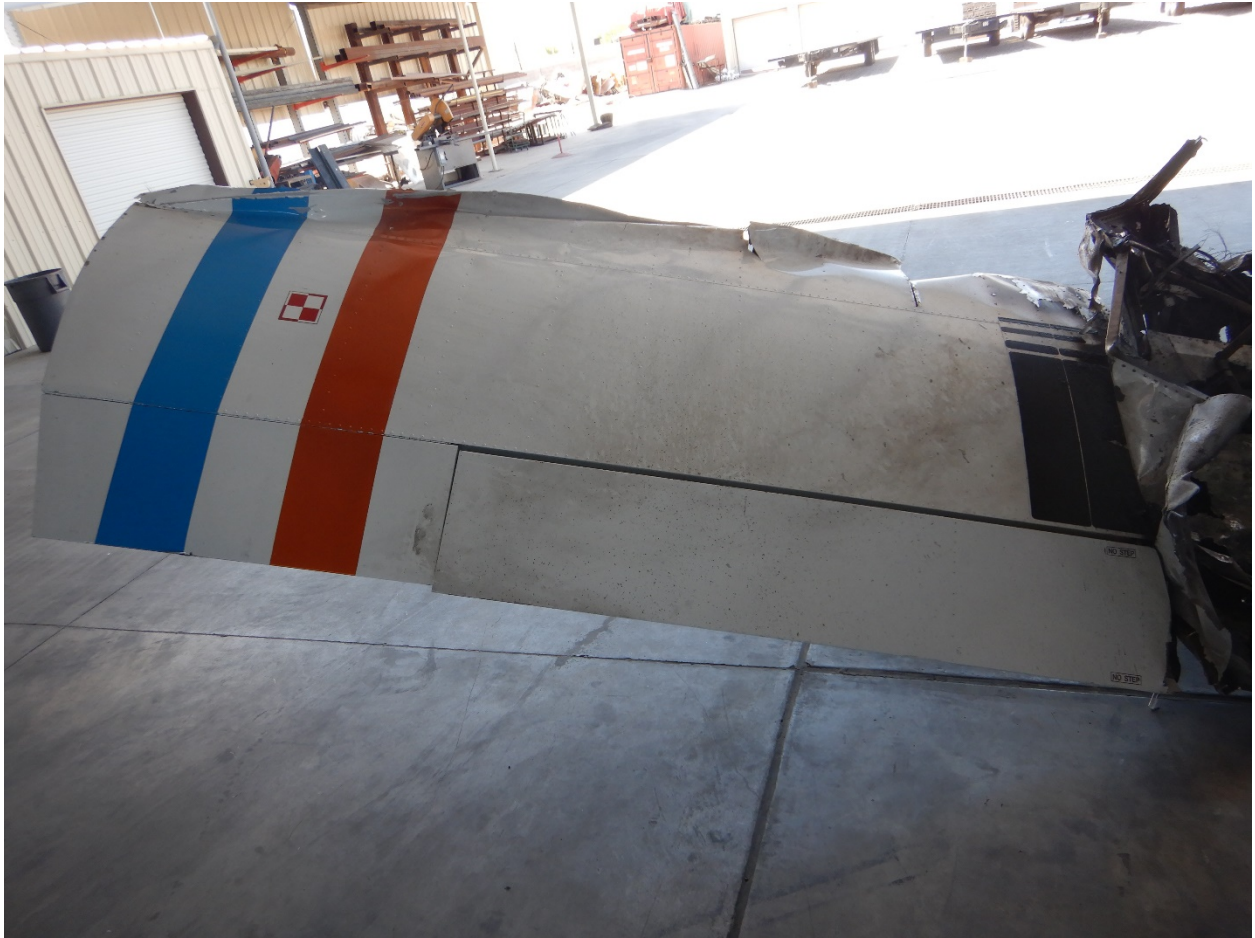
**Figure 12-Left wing.**

The left wing remained attached to the fuselage attach points and had leading edge crush damage throughout its length. The aileron and flap remained attached to the wing and were undamaged. Flight control continuity was attained from the cabin area.

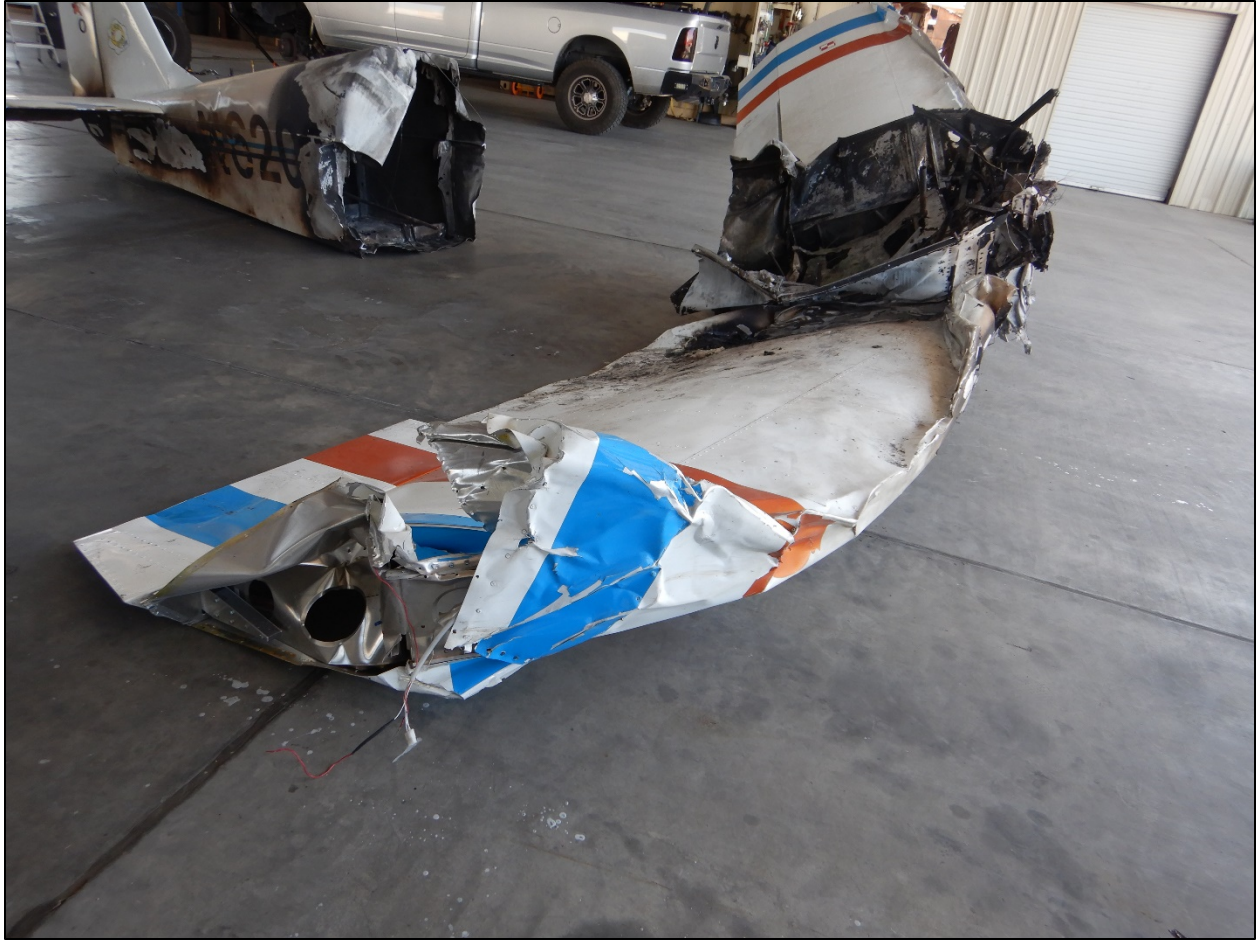
**Figure 13-Right wing.**

The right wing remained attached to the fuselage attach points and had leading edge crush damage. The wing was crushed upwards near the tip. The aileron and flap remained attached to the wing and were undamaged. Flight control continuity was attained from the cabin area.
