## Air Safety Investigations Aircraft Incident/Accident Technical Report

| Aircraft Incident/<br>Accident Information | Year: 1975 | Make: Cessna | Model: 172M |
| | Serial number: 17265650 | | Registration: N6929H |
| Air Safety Investigator: Jennifer D. Barclay | | Report #: ASI-20-CO-T | Report date: 01-04-21 |

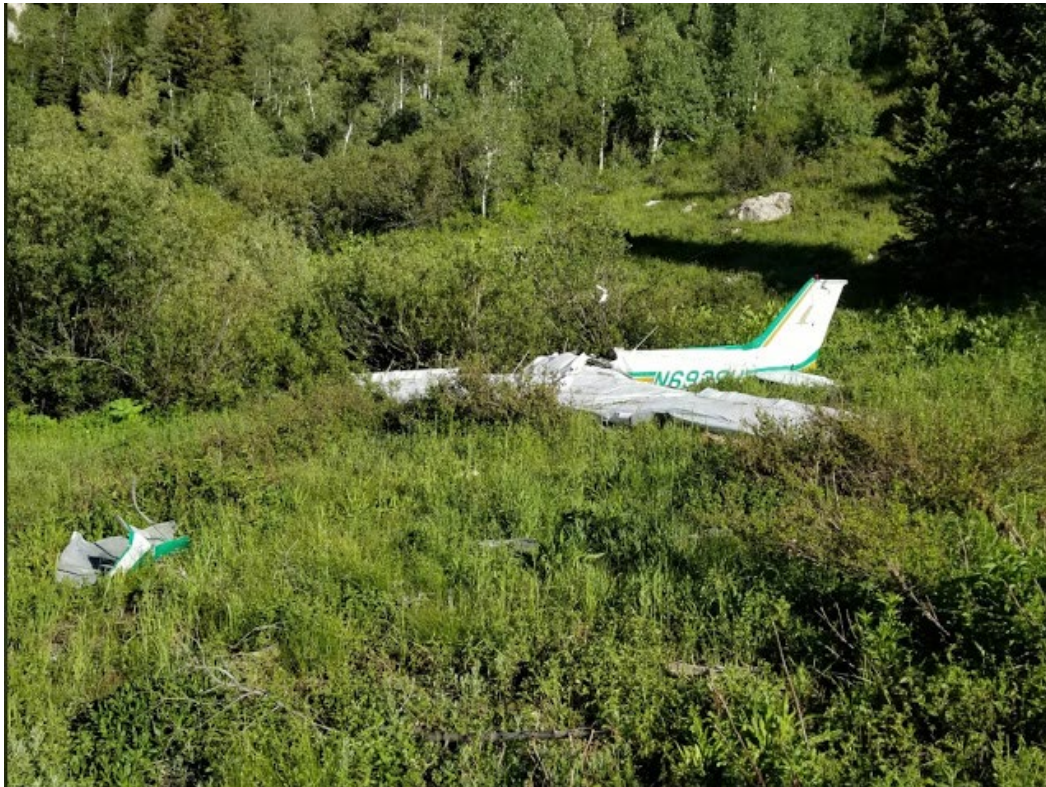
The aircraft impacted terrain in a wings level, nose-down attitude. The engine was forced aft but did not penetrate the firewall. The cockpit volume was reduced in an accordion type fashion. The leading edge of both wings exhibited fore-aft compression particularly to the outboard sections. The empennage appeared undamaged. First responder photographs show the wreckage site was contained to the footprint of the aircraft.

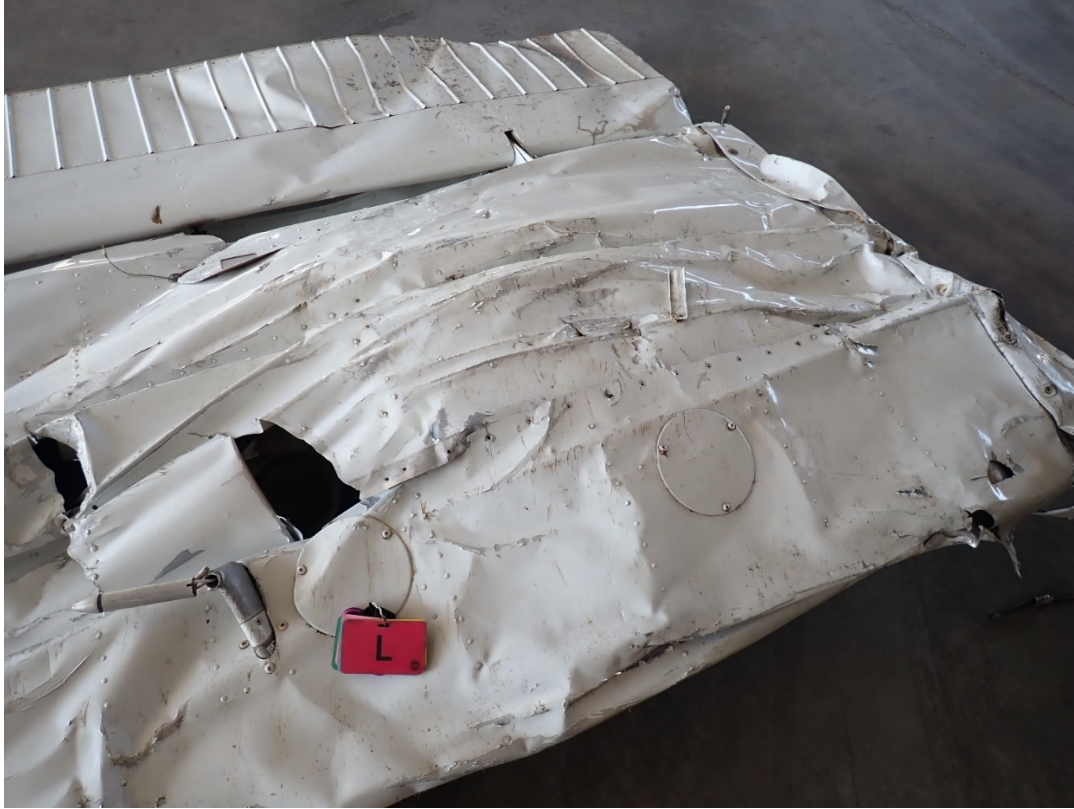
Left wing fuel tank area, ASI-20-CO-055

Both wing tanks exhibited evidence of hydraulic deformation.

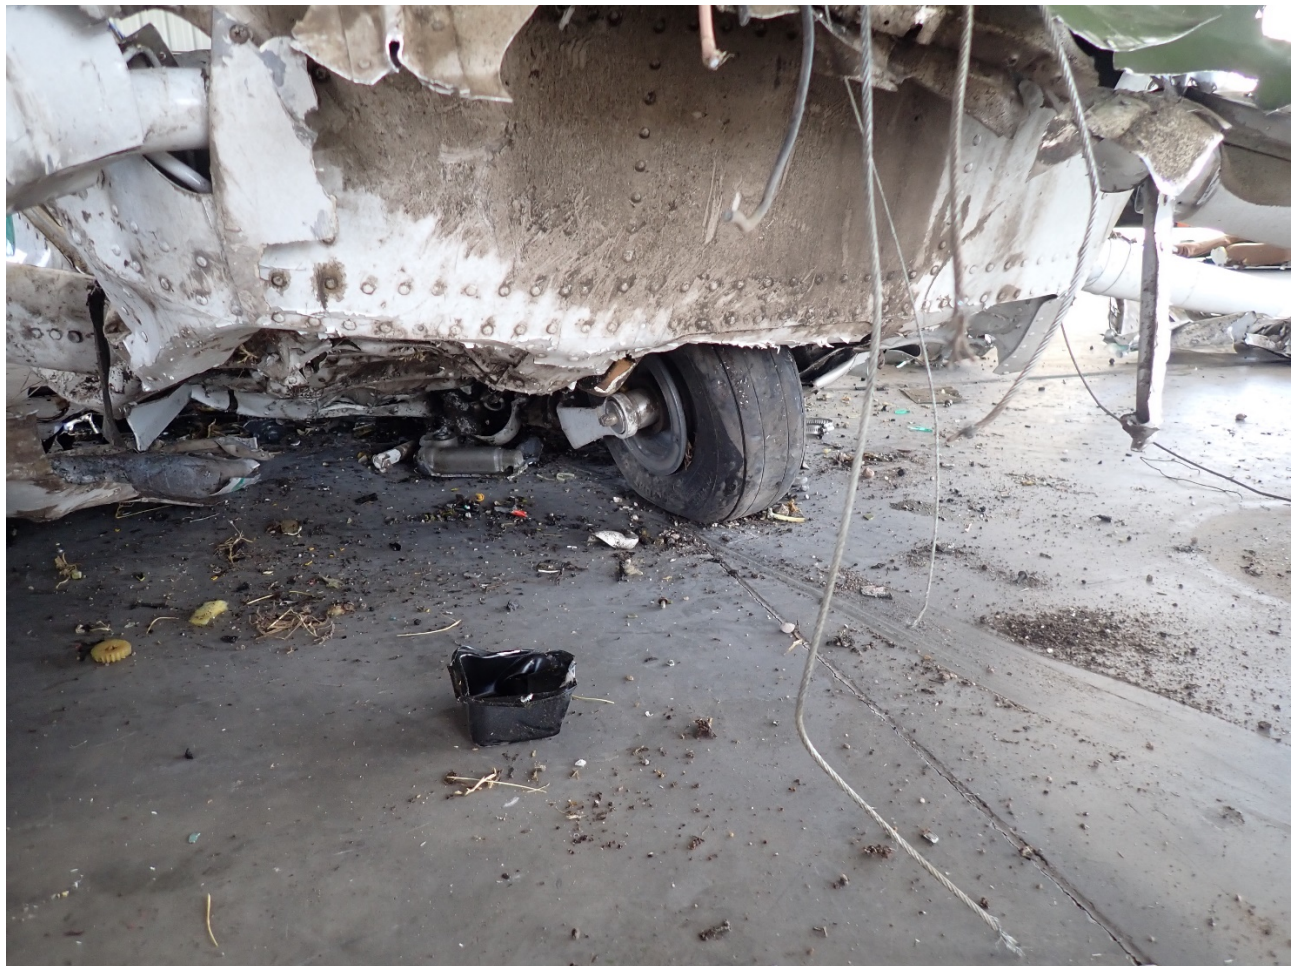
Nose landing gear forced aft through cabin floor, ASI-20-CO-012

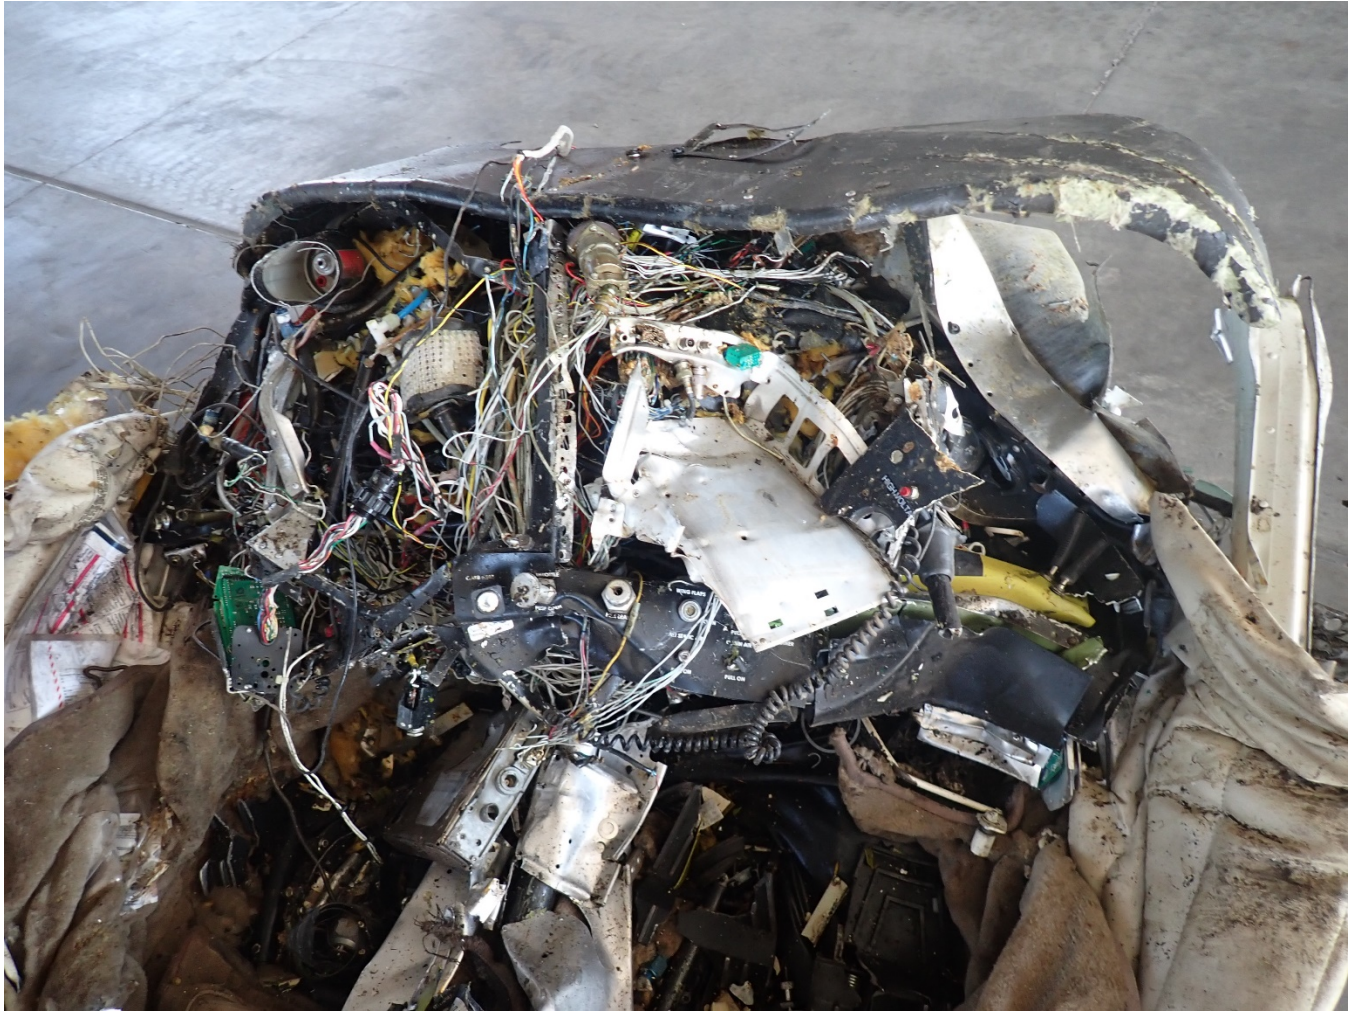
The instrument panel was destroyed during the impact sequence.

Instrument panel, ASI-20-CO-013

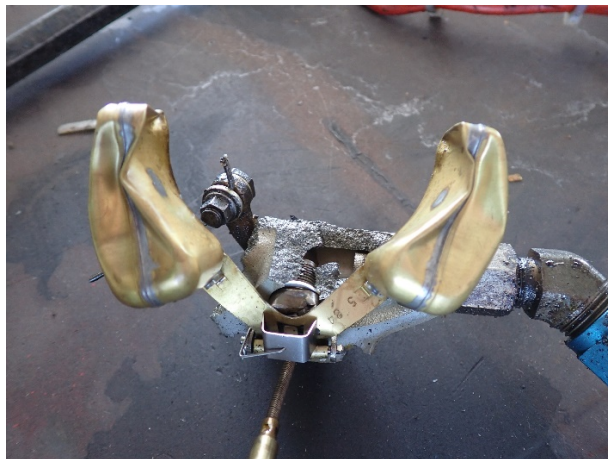
The carburetor float exhibited hydraulic deformation.

Carburetor float, ASI-20-CO-096

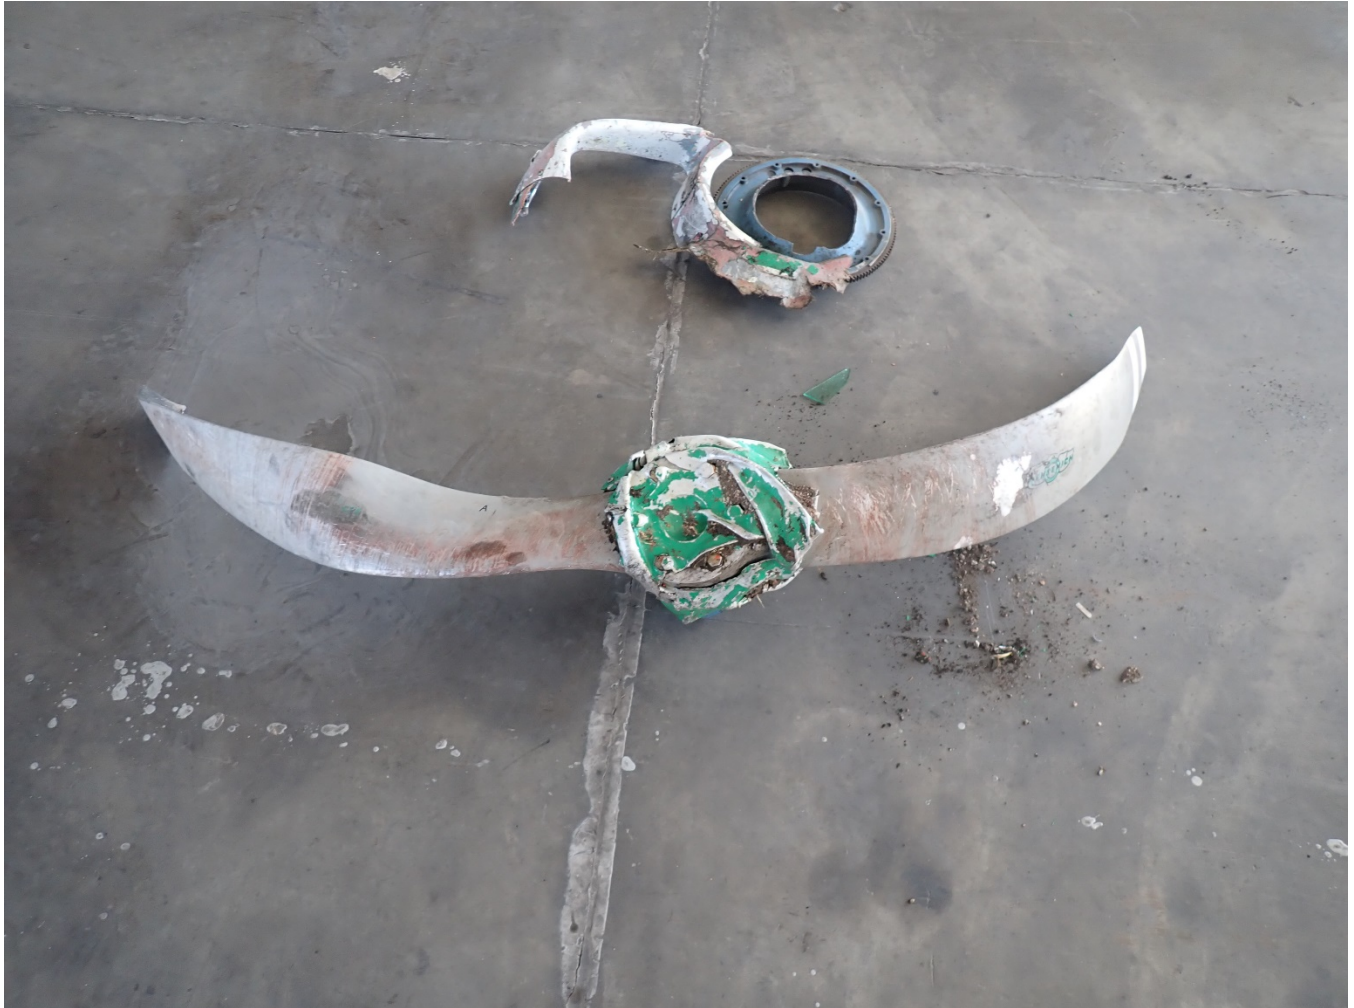
Propeller, ASI-20-CO-034

The propeller separated from the engine. Blade A was twisted with significant chordwise scratches along the length of the blade and gouges at the tip. Blade B was bent aft midspan with chordwise scratches from the root to midspan. The spinner was crushed aft around the propeller hub.
