**NATIONAL TRANSPORTATION SAFETY BOARD**  
**Office of Aviation Safety**  
**Washington, D.C. 20594**

**HELICOPTER WRECKAGE EXAMINATION REPORT**

**NTSB No: WPR20LA211**

Operator    Airwest Helicopters LLC  
Aircraft:    Bell UH-1H Iroquois (Huey), N623PB  
Location:    Payson, Arizona  
Date:        July 7, 2020  
Time:        1213 MST

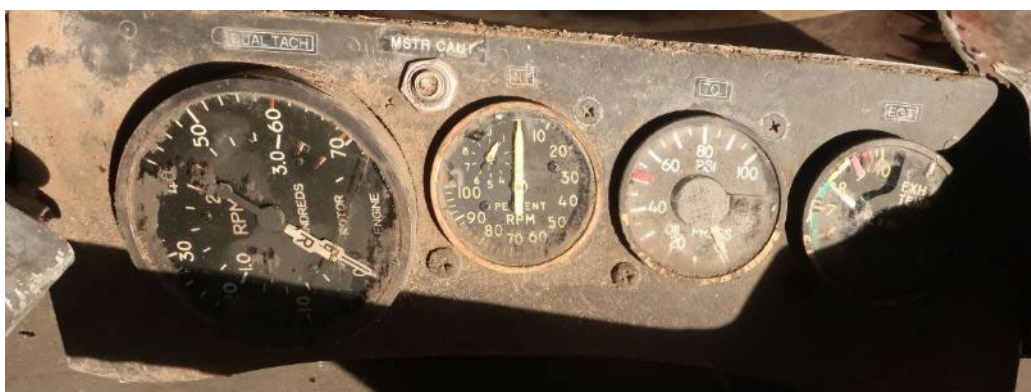
A group of instruments had been installed in the lower portion of the left door (Photo 1 and Table 2). The purpose of these instruments was to allow the pilot to view critical helicopter systems information while looking left and below the helicopter when conducting external load operations.

**Photo 1.** Instruments installed in the left door.

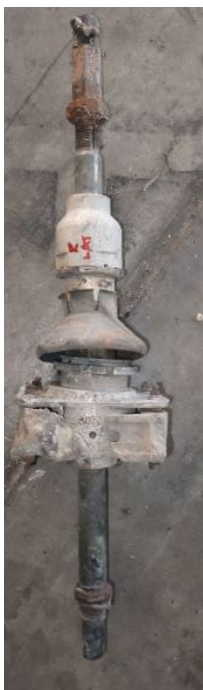
All flight control tubes and connections in the cockpit were fragmented or destroyed. The flight control tubes leading up to the upper deck were destroyed. Three hydraulic servos had been separated from their respective connections. Table 3 provides location and serial numbers of the servos and Photos 2 to 4 show their as-recovered condition.

**Photo 2 .** Right Lateral Servo

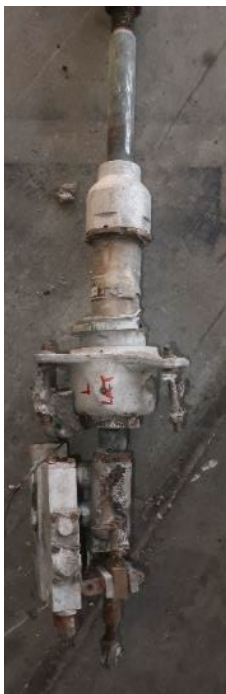
**Photo 3.-** Left Lateral Servo

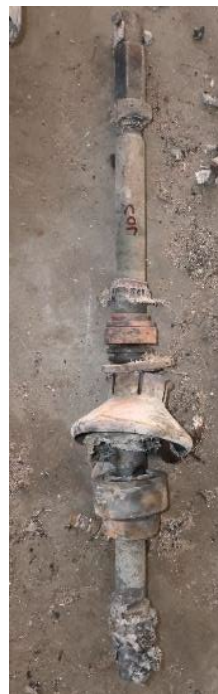
**Photo 4.-** Collective Servo

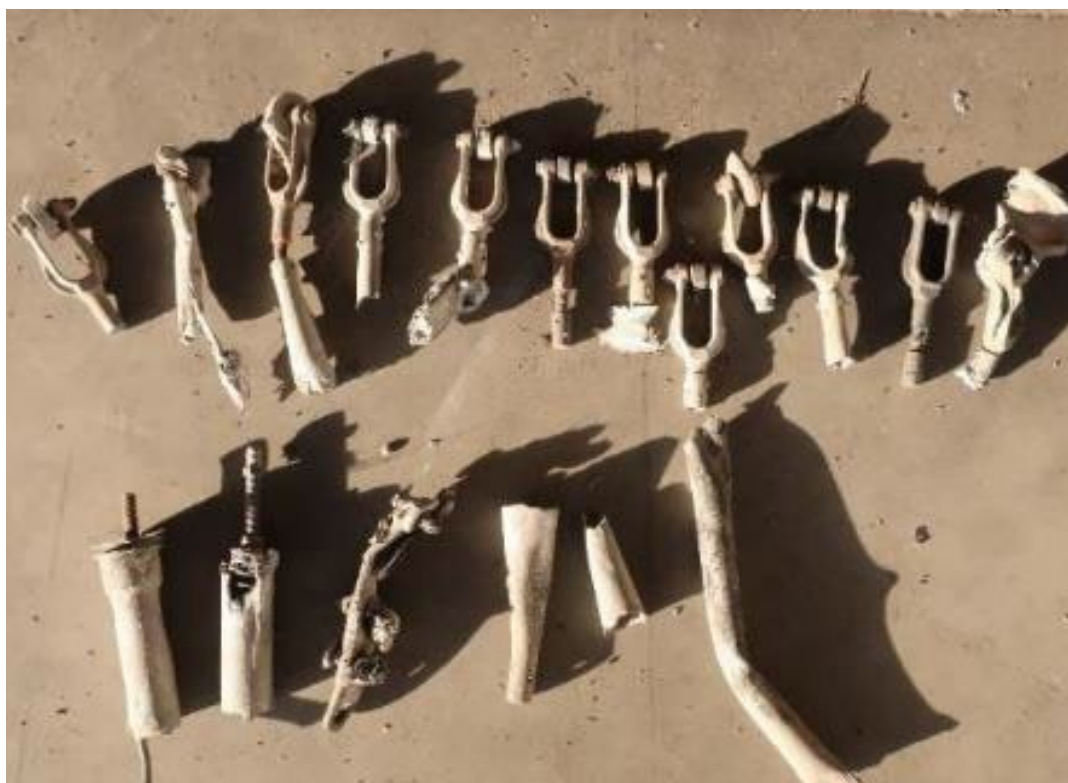
Eleven distinct flight control clevis assemblies were identified, each one had its associated connecting hardware attached (Photo 5).

**Photo 5.** Flight control tube rod ends (clevis assemblies).

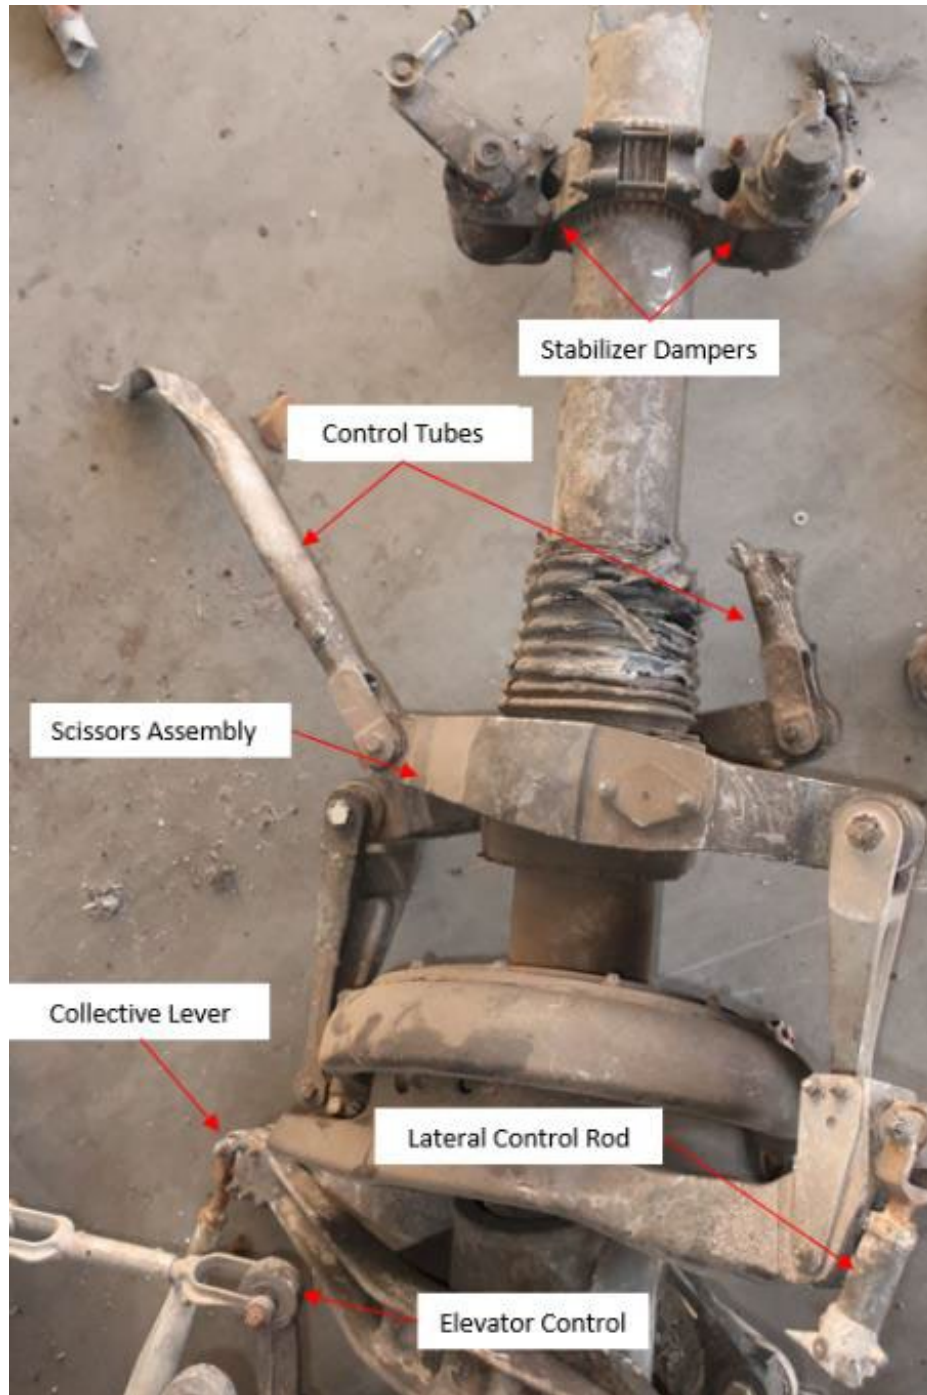
The control rod ends remained attached to the collective lever (below the stationary swash plate). The left & right lateral control rods were connected to the stationary swash plate. The swash plate elevator trunnion link was connected but the horn was fractured. Both main rotor blade pitch change links were attached to the rotating swash plate. Both scissor drive links had separated at the rotating swash plate connections (Photo 6).

**Photo 6.** Upper flight controls

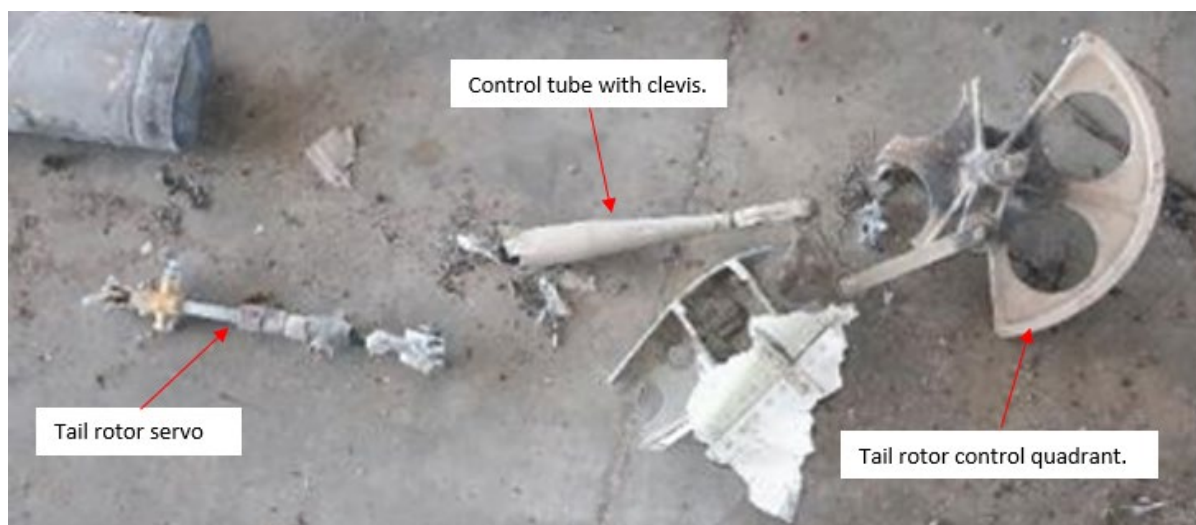
The tail rotor control tube rod end to the control cable quadrant was attached (Photo 7). One half of the quadrant was present. Both cables from the quadrant had been cut by the recovery crew. The cables ran continuously to the tail rotor gear box pitch change sprocket (Photo 9). The tail rotor gear box case was fractured and had liberated the tail rotor assembly (Photo 7 & 8).

**Photo 7.** Tail rotor control quadrant, control rods, and hydraulic servo.

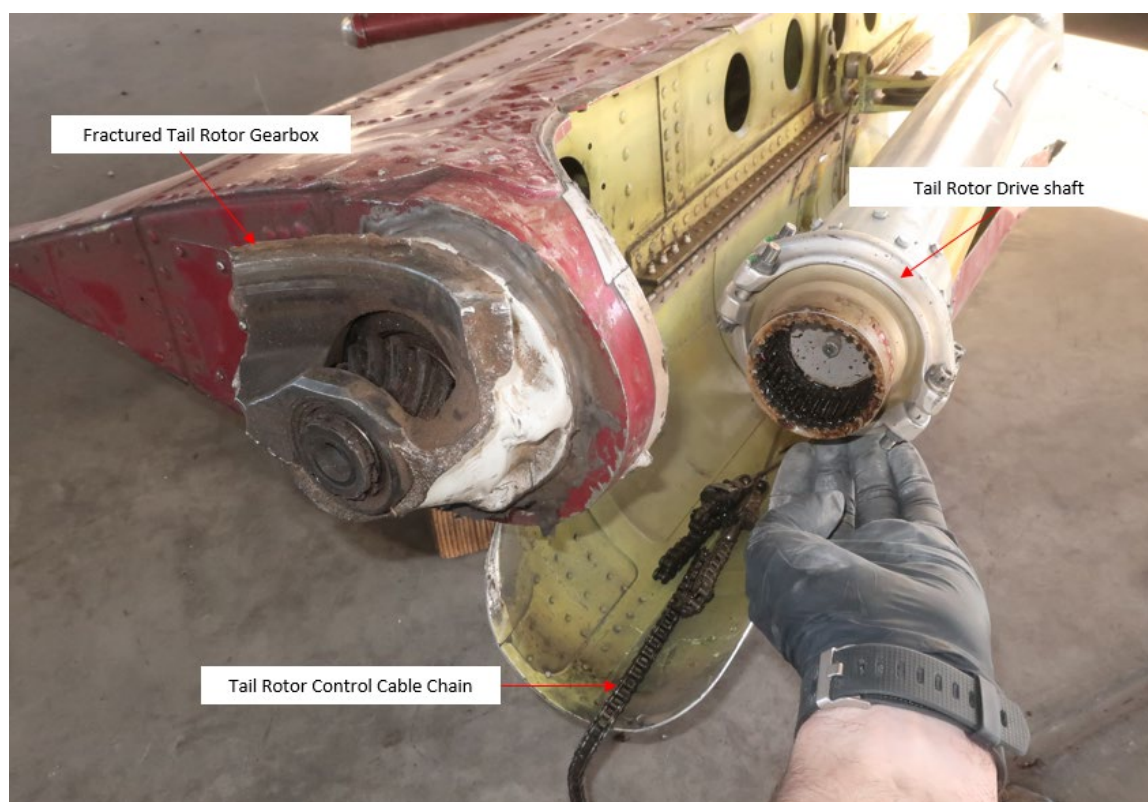
**Photo 8.** Tail rotor drive shaft, 90° gear box, and control cable/chain.

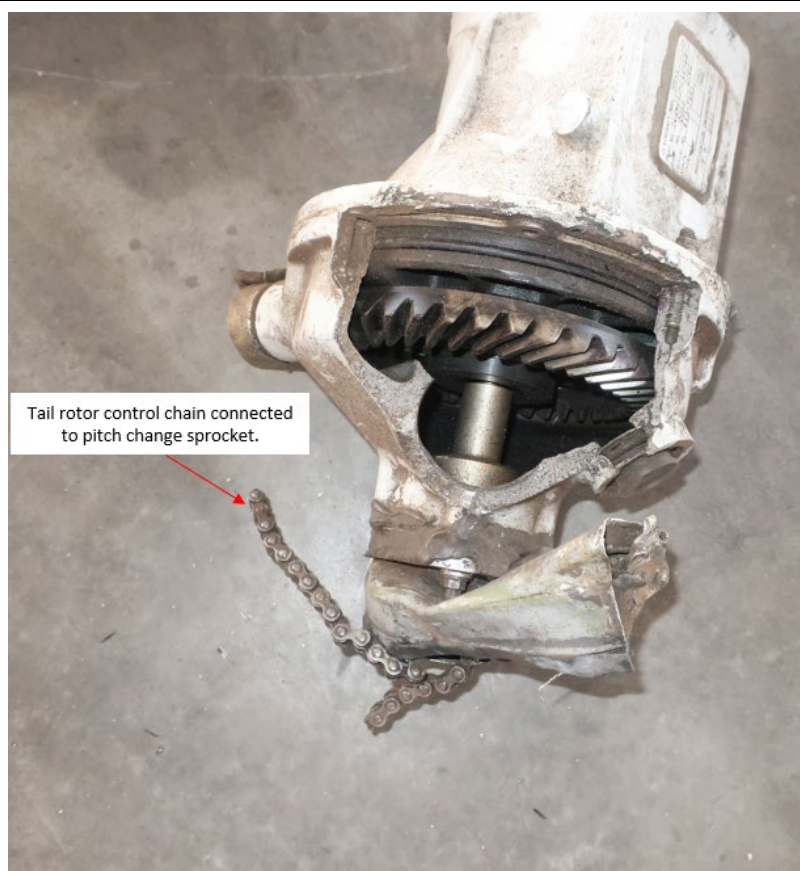
**Photo 9.** Tail rotor gear box and control chain segment connected to the pitch change sprocket.

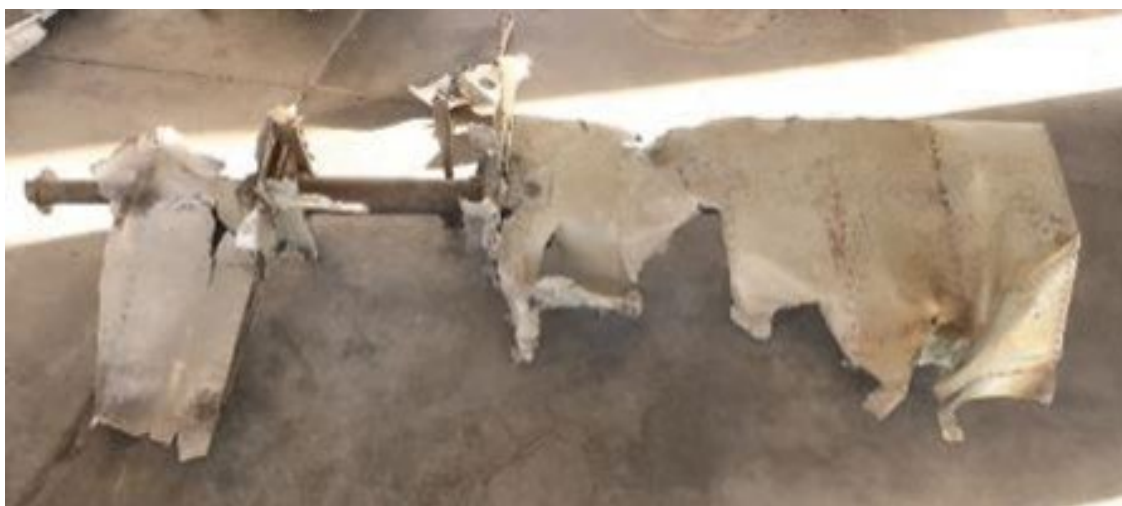
The elevator had separated from the tail boom and had fire damage (Photo 10). The left side elevator spar was fractured mid span, no elevator skin outboard of the fracture. The control tube rod end remained attached the elevator pitch horn. Three elevator control bell cranks were identified, all with the rod ends attached.

**Photo 10.** Elevator remnants.

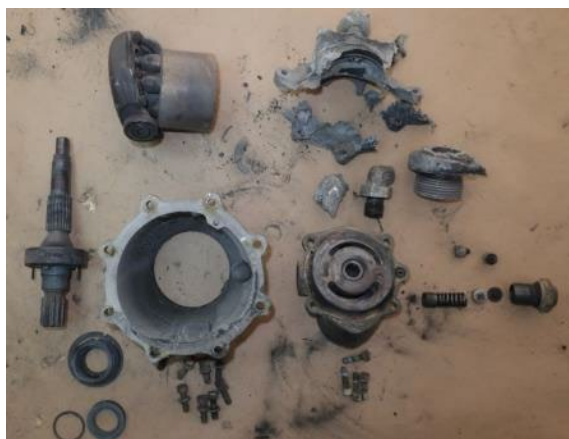
The hydraulic pump had separated from the main transmission. The upper cover of the pump, where the drive shaft protrudes, had been thermally damaged. The outer case of the pump had also been exposed to extreme heat and exhibited some deformation. The pump was disassembled (Photo 11). The drive shaft was intact and the splined area had no deformation or smearing of the spline ribs. All 6 pistons were attached to the swash plate. No unusual wear marks or scoring was observed on the pistons or their respective cylinder barrels. The port plate was discolored but otherwise undamaged. The bias spring was intact. Both sets of shaft bearings were unremarkable other than heat damage.

**Photo 11.** Hydraulic pump disassembled.

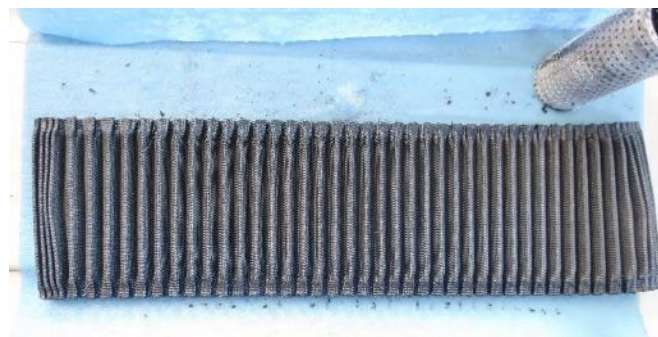
The hydraulic filter assembly had been liberated from its mount and the IN & OUT port lines had fractured. The filter bowl was removed by unscrewing it from the base. The metal mesh screen filter located within the filter bowl was removed and examined. The bowl contained black brittle debris consistent with carbon like material. Visual examination of the filter screen identified a small number very small shiny specs within the filter element. The filter screen was stretched flat (Photo 12), pulled open, and flushed with alcohol. Small black particles were captured by a blue towel. None of the captured particles responded when probed with a magnet. No obstruction to the flow of fluid by the filter element was observed.

**Photo 12.** Hydraulic filter disassembled.

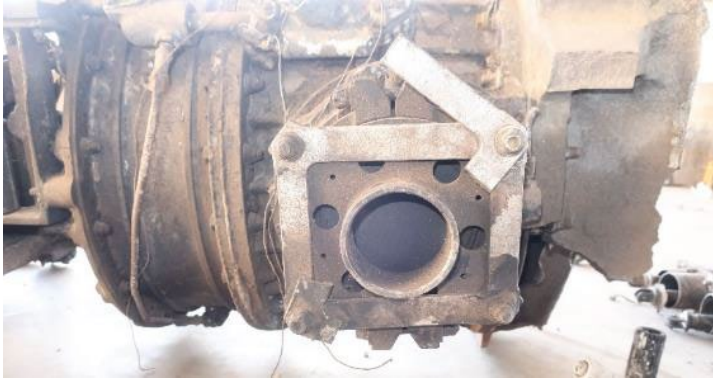
The transmission had liberated from its mounts. All five transmission main mounts had been separated from structure, including the 5th pylon mount. The elastomeric material in each mount had been consumed by fire. The transmission power input quill (Photo 13) rotated freely in the counterclockwise (CCW) direction and was not movable by hand in the clockwise (CW) direction. The rotor mast had fractured just below the main rotor head attachment location. Both rotor blade dampers were present on the mast with arms and rod ends attached. Engine-to-transmission drive shaft was not present. Fragments of the KAflex coupling on both ends (engine and transmission) were present (Photos 16 & 17). Rotational

**Photo 13.** Transmission Power Input Quill

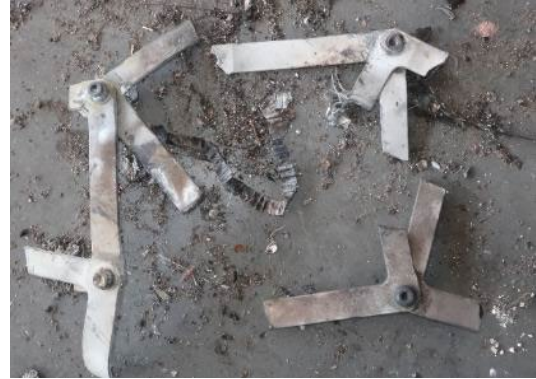
**Photo 14.-** KAFlex fragments

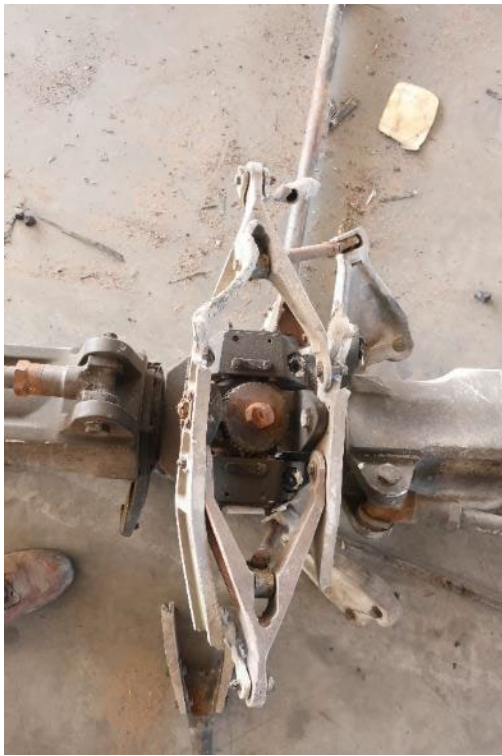
**Photo 15.** Rotor Head with Stabilizer Bar

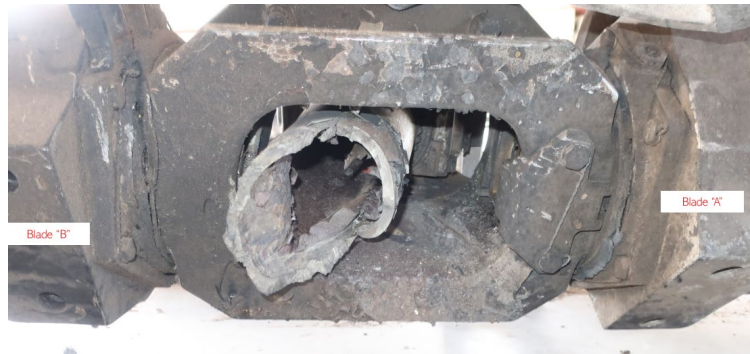
Main rotor blades were labeled "A" & "B" for identification purposes. The main rotor had separated from the mast just below the rotor head (Photos 18 & 19). The portion of mast remaining attached to the rotor head fractured in overload and the deformation direction aligned with blade "B" (Photo 19). Both arms of the stabilizer bar had fractured outboard of the hub. Both blades "A" & "B" pitch horns had separated from the blade grip, and both pitch change links remained attached at both ends. The blade retaining bolts were in place on both blade grips. Both blades drag links remained attached at both ends. Multiple fragments of blade skin and honeycomb core had been recovered. These fragments could not be associated directly with a main rotor blade.

**Photo 16.** Rotor Head Main Mast Fracture

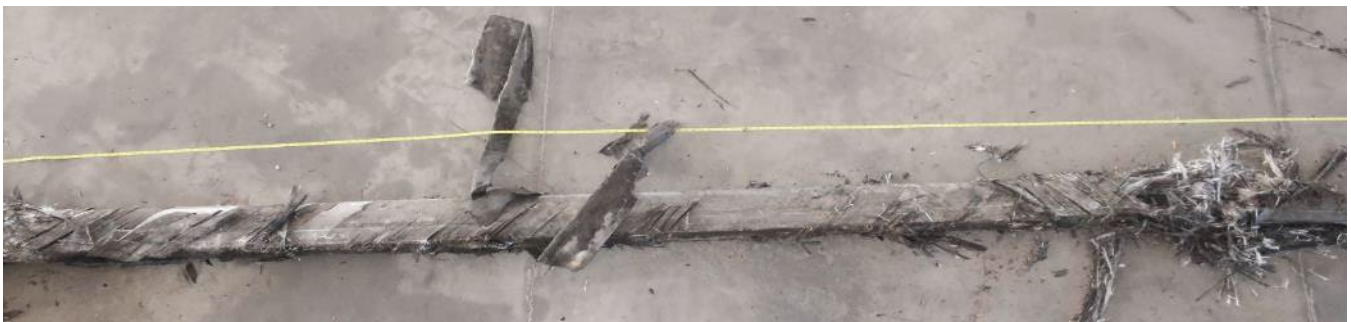
The entire main spar was missing the honeycomb core, blade skin, and trailing edge (Photo 20). The spar had been exposed to fire. The spar was fractured 2 feet outboard of the blade grip, and it extended 22 feet from the center of the hub. The tip of the spar was fragmented and thermally damaged, leaving loose glass fibers with no matrix. The blade tip weight had separated from the blade.

**Photo 17.** Overhead View of Blade "A"

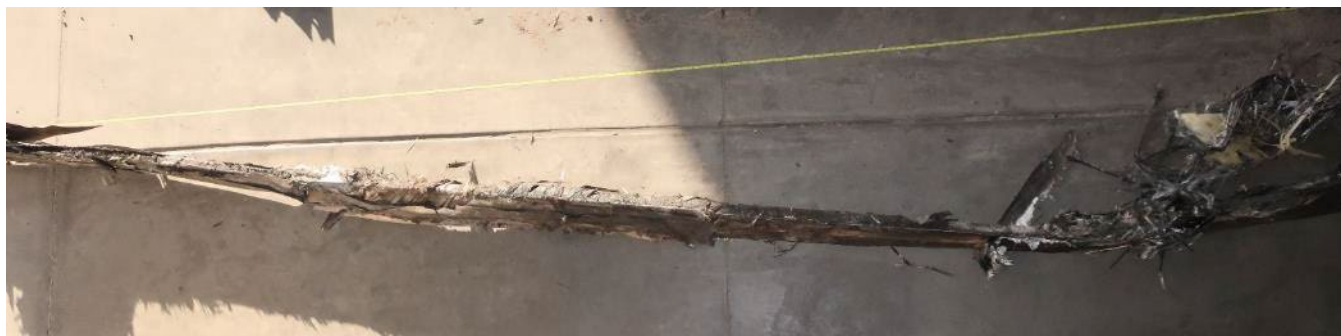
Entire main spar was missing the honeycomb core, blade skin, and trailing edge (Photo 21). The spar had been exposed to extreme heat. The spar was fractured 6 feet

outboard of the blade grip and the spar extended 23 feet 4 inches from the center of the hub. The blade end cap was present with the blade tie down fitting attached.

**Photo 18.** Overhead View of Blade "B"

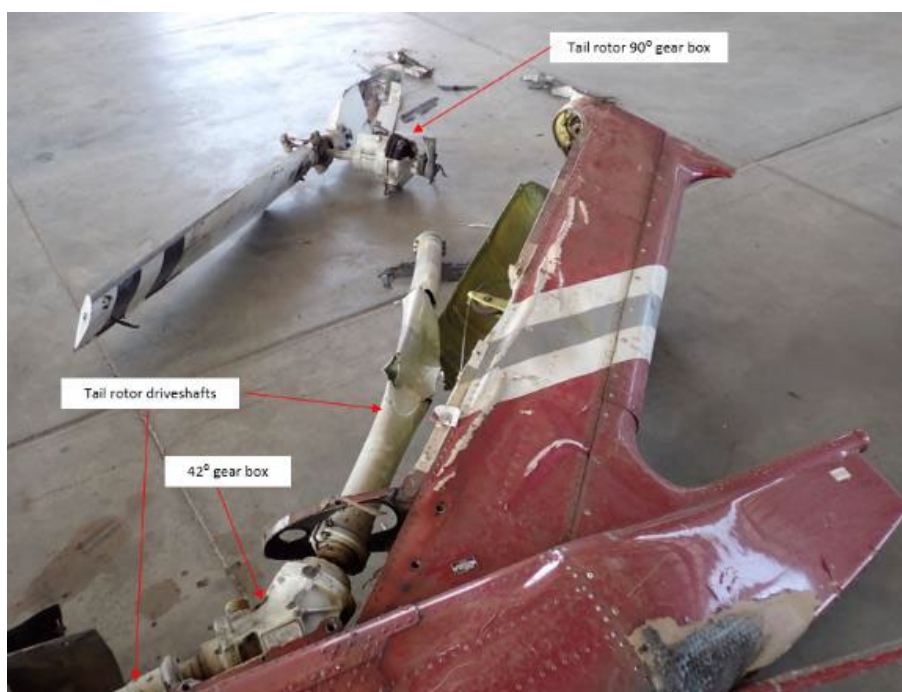
The tail rotor drive quill was recovered separated from the lower transmission housing. For reference purposes, the tail rotor drive shafts were numbered 1 through 6, with the No. 1 shaft connecting to the transmission. The tail rotor drive shaft located directly beneath the engine (No. 1) was not present. The connecting ends and hanger bearings of drive shaft No. 2 were identified. Drive shaft No 3 had torsionally sheared 1 foot forward of its aft end. Drive shaft No. 4 was sheared about 6 inches from its forward end. The aft end and bearing were attached to the remnant tail boom structure. Drive shaft No. 5 remained attached to the tail boom structure and connected to the 42° gear box; the 42° gearbox was part number 212-010-003-23, serial number AHP-52133.

**Photo 19.** Tail section and tail rotor drive system.

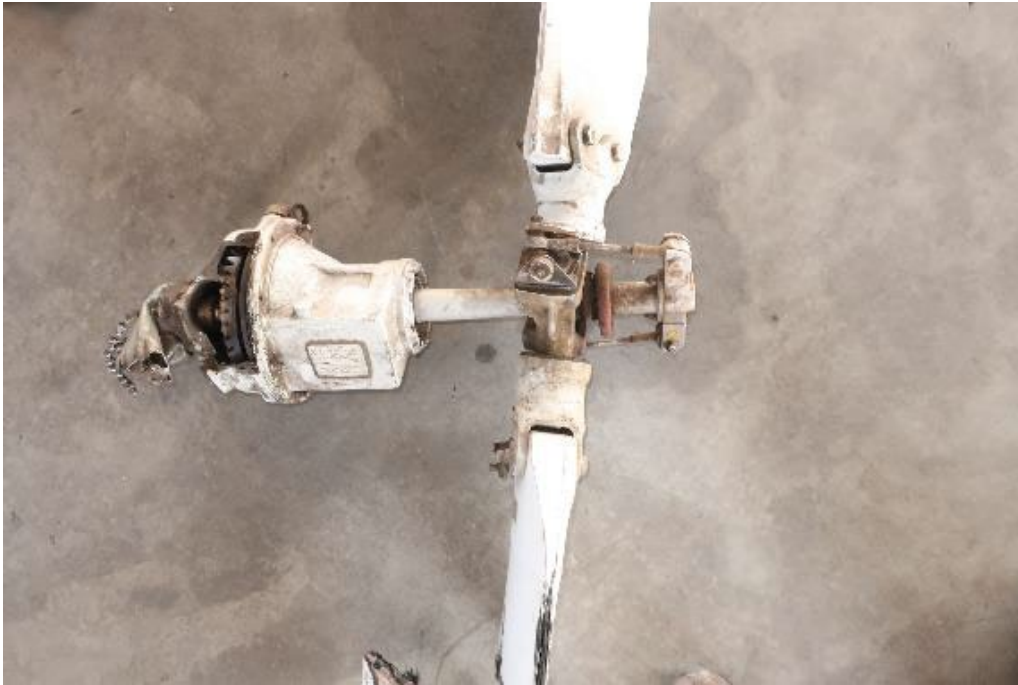
The 42° gear box was undamaged (Photos 22 & 23), and the input and output drives rotated in unison, smooth, with no binding. Drive shaft No. 6 was connected to the 42° gear box. It was buckled and split in 2 locations along its length. The shaft had disconnected from the tail rotor gear box input (Photo 23); the tail rotor gearbox was PN 204-040-012-13, SN B137894, model number TT2936. Tail rotor gear box lower case had fractured, liberating the gear box and tail rotor assembly.

**Photo 20.** Tail rotor gearbox, rotor hub and blade assembly.

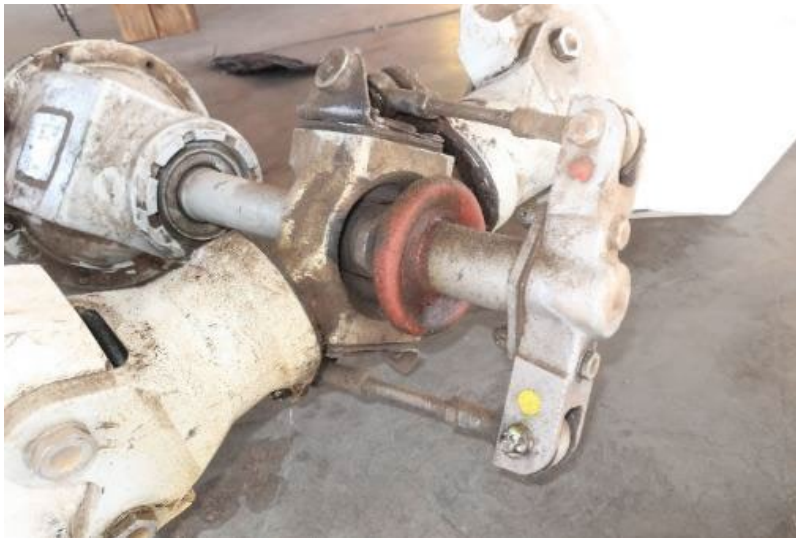
The tail rotor gear box and tail rotor mast remained intact (Photo 24). Both tail rotor blades were attached to the tail rotor hub. Tail rotor blades were labeled "red" & "yellow" for identification purposes. Both pitch change links were attached to their respective blades and the pitch change cross head.

**Photo 21.** Tail rotor head.

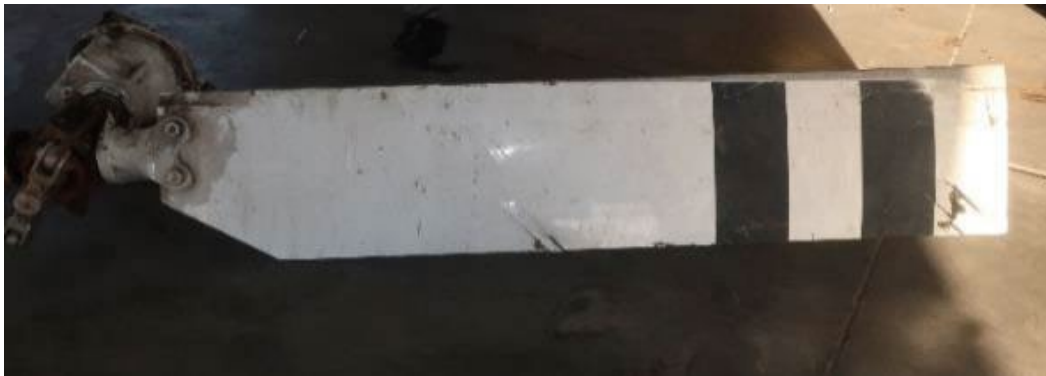
Entire blade was attached to the hub (Photo 25). Blade tip damage, and chord wise scoring evident. A half inch strip of the trailing edge was delaminated at mid span.

**Photo 22.** Red blade

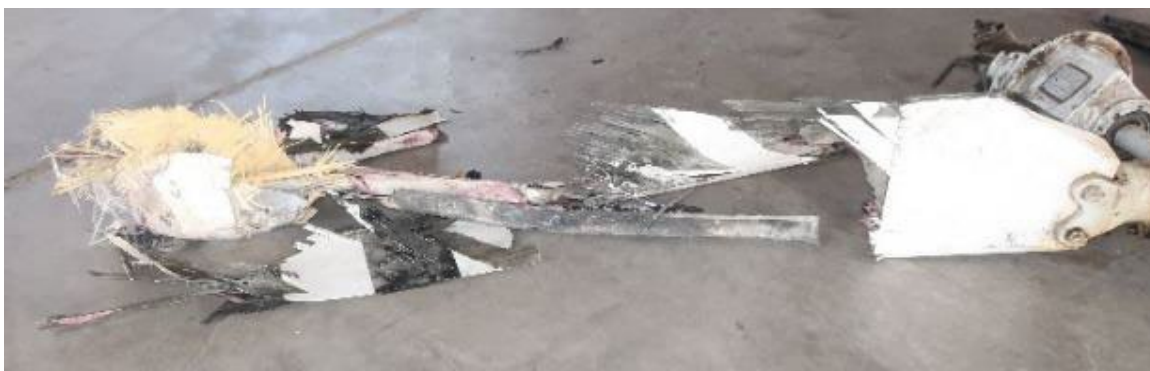
The blade root was attached to the hub. The outboard 2 feet of blade was fragmented (Photo 26). Blade skins minus the foam core were recovered.

**Photo 23.** Yellow blade.

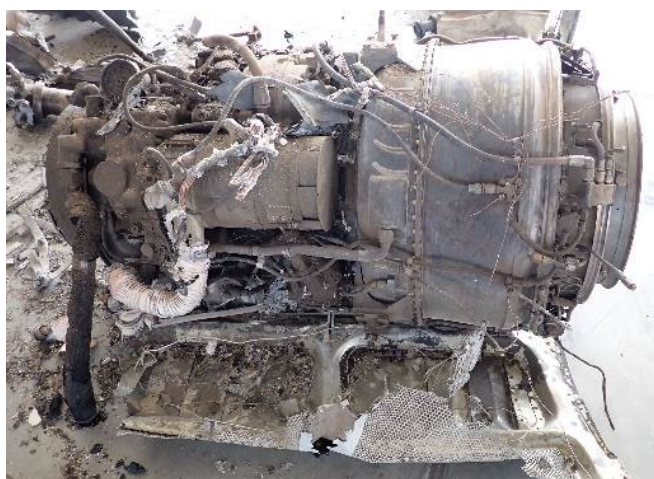
The accident helicopter is equipped with a Honeywell, formerly Lycoming, T53-L-703 (LTC1K-4G) turboshaft engine (Photo 27). The accident engine was SN L-12053Z. The portion of the KAflex coupling on the transmission side was fractured at multiple locations. The portion of the KAflex coupling on the engine side was fractured at multiple locations. The center section of the KAflex coupling between the engine and transmission was not located during the wreckage exam, but photographs show it present at the accident scene. There was rotational score marks around 360 degrees of the KAflex coupling on the engine side, where the drive shaft section would have connected (Photo 28). There was thermal damage all around the engine, but the engine itself wasn't burnt, but was covered in soot. The left rear engine mount was attached to the engine and the airframe with some impact damage present on the strut. The left front engine mount was attached to the engine, but the strut was crushed/broken approximately 8 inches from the engine mount connection point. The right rear engine mount was attached to the engine but separated at the strut attachment. Rotation of the output shaft produced a corresponding rotation of the power turbine rotor. The power turbine spool rotated without resistance.

**Photo 24.** - External view of the engine.

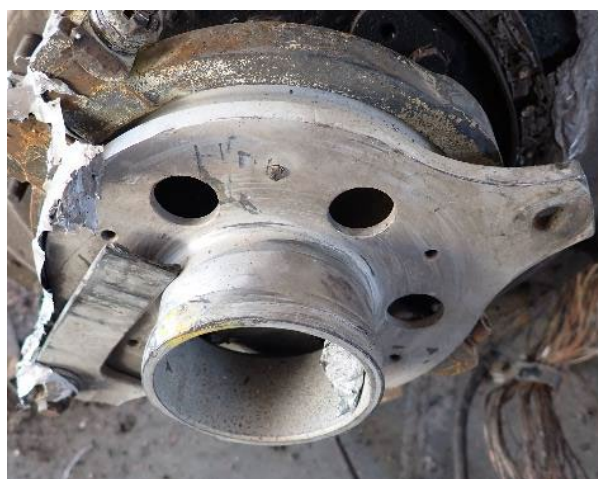
**Photo 25.** - Rotational scoring on the engine output flange.

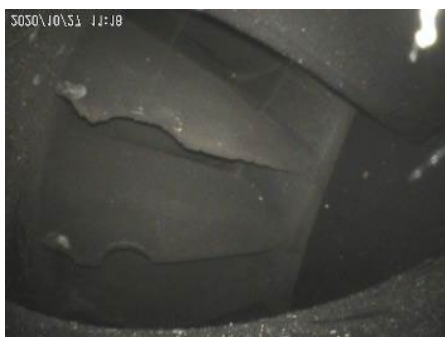
Borescope inspection revealed that the trailing edge of the inlet guide vanes and the leading edge of the 1<sup>st</sup> stage axial compressor blades displayed tearing and battering damage (Photo 29). The oil filter housing assembly was not equipped with a bypass indicator. The fuel control indicator still had a partial control lever arm attached. The indicator could be moved from stop-to-stop with some resistance in one location that could be overcome by hand strength. The power turbine control governor lever input arm was broken off at the base of the arm. The indicator could be moved from stop-to-stop without resistance. The accessory gearbox chip detector had some debris adhering to the chip detector that appeared to be coked oil, but no obvious metal chips were present. The 2<sup>nd</sup> stage power turbine blades were all present and appeared undamaged. There was metal spray present around 360 degrees of the 2<sup>nd</sup> stage power turbine nozzle vanes (Photo 30). Oil was found dripping from the No. 3/No. 4 bearing cavity scavenge line. Oil was found dripping from a line connecting the diffuser to the accessory gearbox.

**Photo 26.** Borescope image of axial compressor damage.

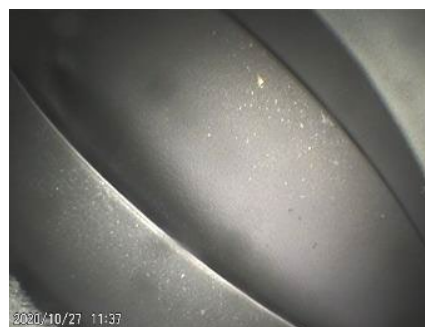
**Photo 27.** Metal spray on 2nd stage power turbine nozzle vanes.
