**NATIONAL TRANSPORTATION SAFETY BOARD**  
Office of Aviation Safety

**Lateral Servo Study Field Notes**

**A. ACCIDENT**      **WPR20LA211**

Location: Payson, Arizona  
Date: July 7, 2020  
Time: 1213 MST  
Operator: Airwest Helicopters  
Aircraft: UH-1H  
Registration: N623PB

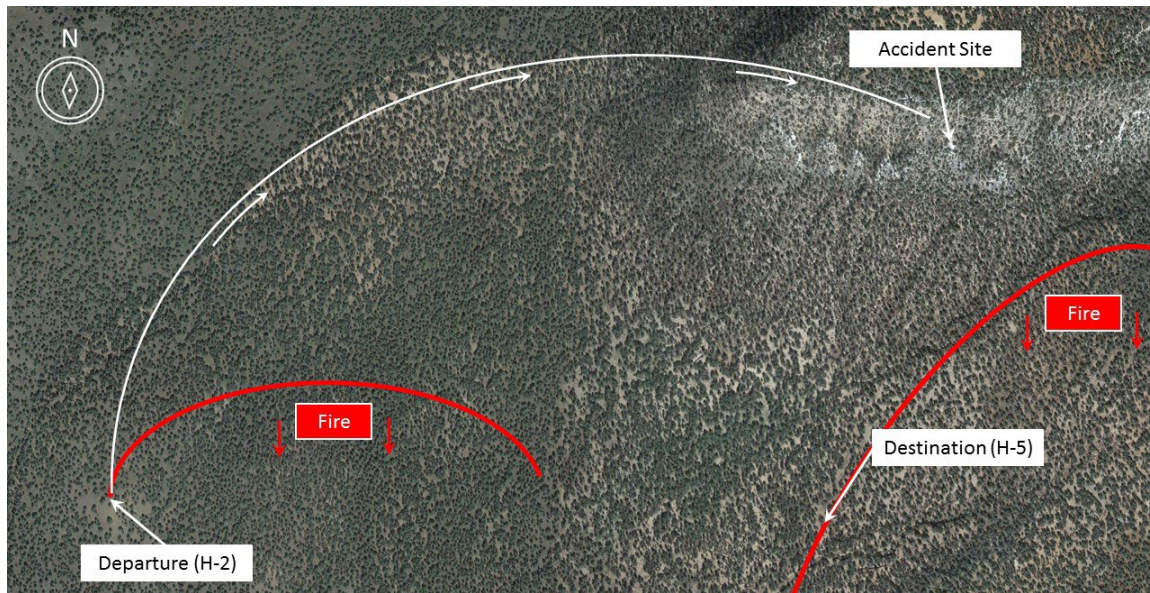
Figure 1: Depiction of helicopter flight path based on witness statements

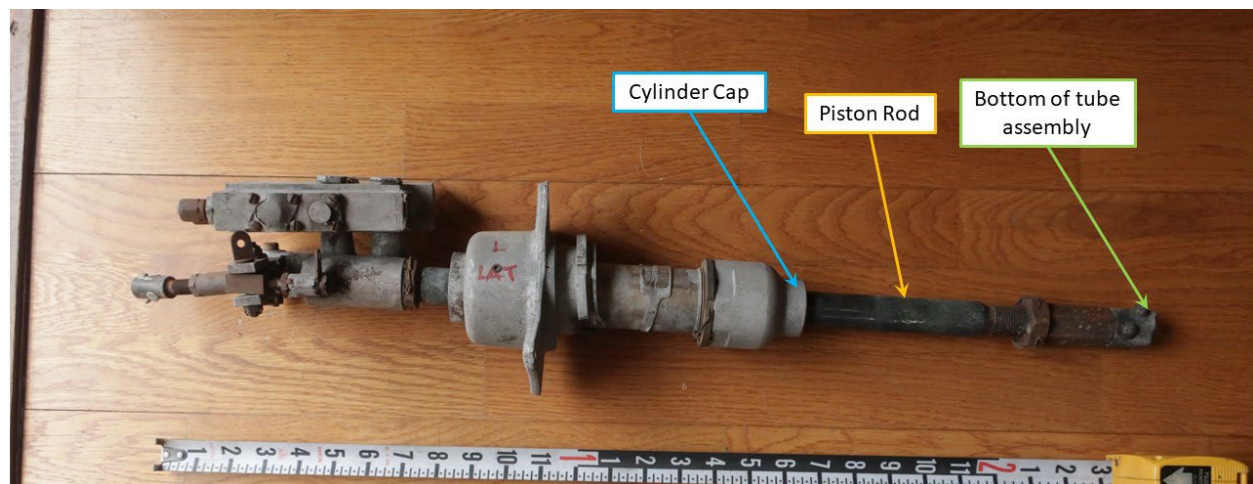
Photograph 1: Left lateral servo from N623PB

The servos from the accident helicopter were found with 7 inches of extended piston on the right lateral servo and 10 inches of extended piston on the left lateral servo. The study was unable to recreate these specific measurements with the exemplar helicopter's lateral servos despite several attempted movements at the cyclic control. When cyclic inputs were made to reach 7 inches of extended piston for the right lateral servo, the left lateral showed 9 inches of extended piston. The right servo exhibited 8.5 inches of extended piston when cyclic inputs were made to reach 10 inches of extended piston for the left lateral piston.

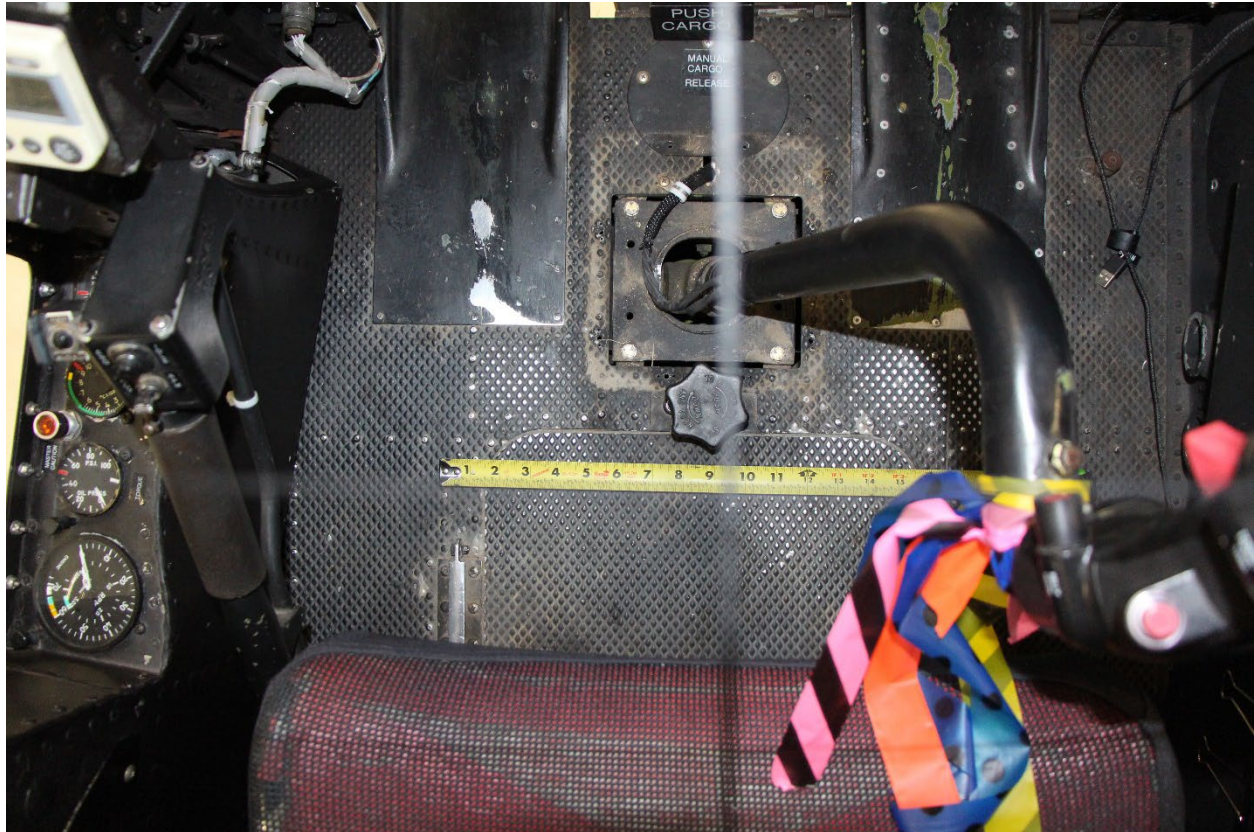
During both inputs, the cyclic was at full right deflection with the cyclic aft of the lateral baseline.

*Photograph 2: Cyclic position of exemplar UH-1H when right servo shows 7 inches, left servo 9 inches*

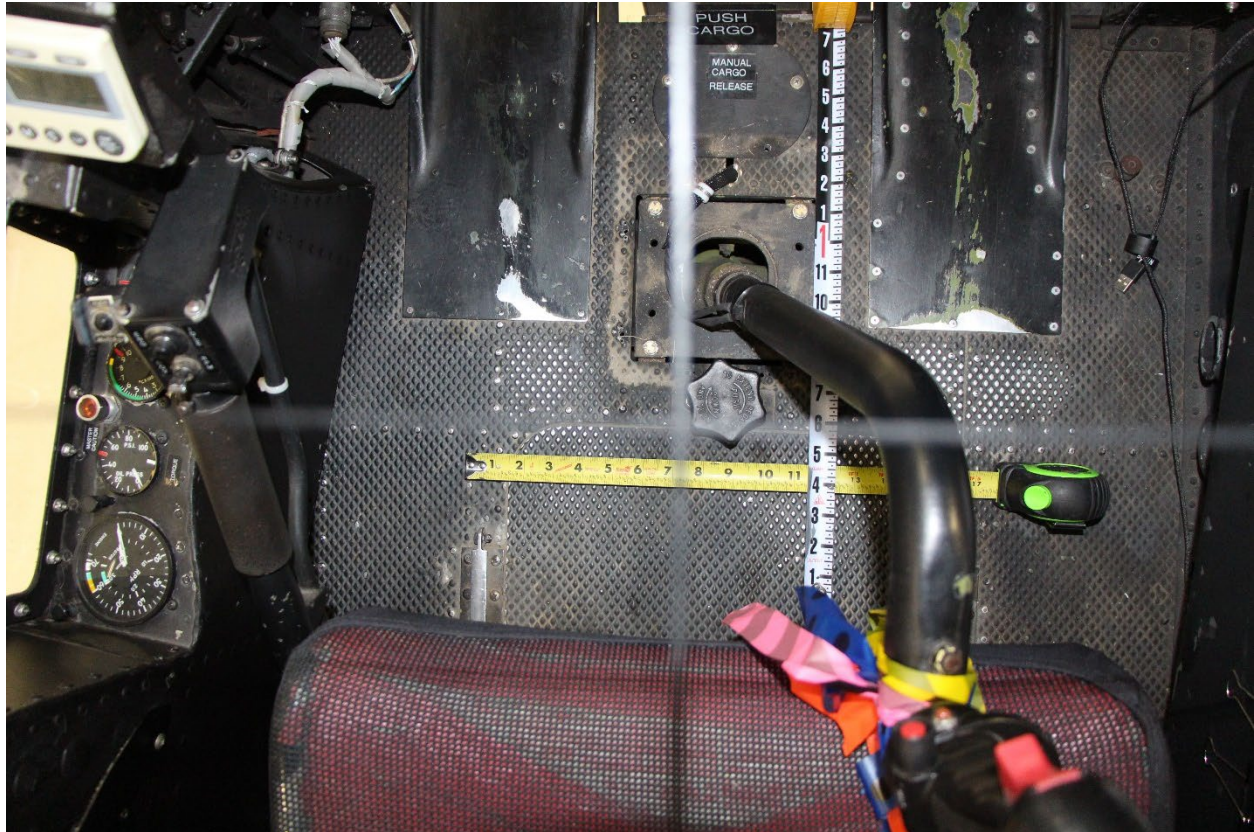
*Photograph 3: Cyclic position of exemplar UH-1H when right servo 8.5 inches, left servo 10 inches*
