**Honeywell Aircraft Accident Field Notes Prepared for the NTSB**  
**Accident Number: WPR20LA211, Payson, AZ, July 07, 2020**  
**Bell UH-1H, Registration: N623PB, S/N: 64-13689**

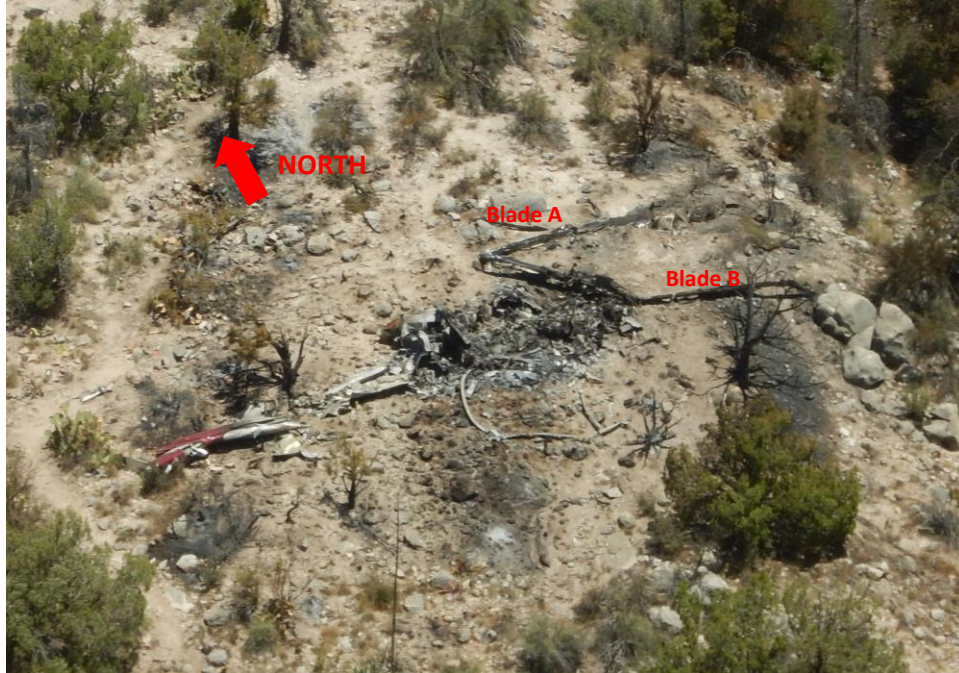
An aerial view of the helicopter wreckage is in [Figure 1](#). The helicopter wreckage was on an approximately east-west heading, with the nose pointing to the east and the tail pointing to the west. The main rotors were on the north side of the main wreckage and the skids were on the south side of the main wreckage. The helicopter in general was heavily fire damaged, the tail had less fire damage than the fuselage. The fuselage of the helicopter appeared to have impacted on its left side. The tail

Figure 1. Overall View of Wreckage from Above

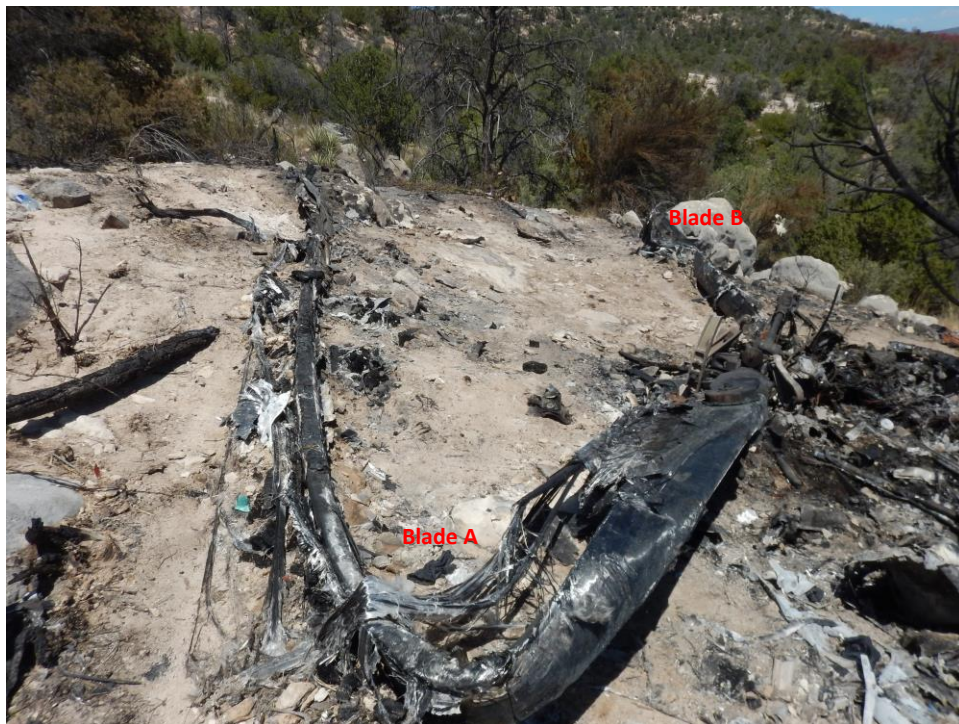
Both blades of the main rotor sustained fire damage ([Figure 2](#) and [Figure 3](#)). The main rotor section was the northern-most portion of the debris field (furthest uphill). The two blades remained attached at the hub ([Figure 4](#)). One of the main rotor blades (Blade A) was bent approximately 130° back on itself in the uphill direction ([Figure 5](#)). There was a ground scar near the tip of Blade A ([Figure 6](#), [Figure 7](#), [Figure 8](#), [Figure 9](#), and [Figure 10](#)). The ground scar was on a 026°/206° heading. [Figure 11](#) attempts to illustrate the angle of attack in which the blade impacted the sloping terrain, using a notebook for a visual reference. The main rotor blade on an approximate east-west heading (Blade B) was broomstrawed at the tip ([Figure 12](#) and [Figure 13](#)). There was what appeared to be scarring and fracturing on the rock that the Blade B tip was located by ([Figure 14](#)). The transmission was separated from its mounted location, it was heavily impact and fire damaged ([Figure 15](#)). The mast was fractured and the main rotor blades were not attached ([Figure 16](#)). The transmission was oriented on an approximate 100° heading. The free-wheeling portion of the transmission input rotated without resistance.

Figure 2. Main Rotor Blades (Looking East)

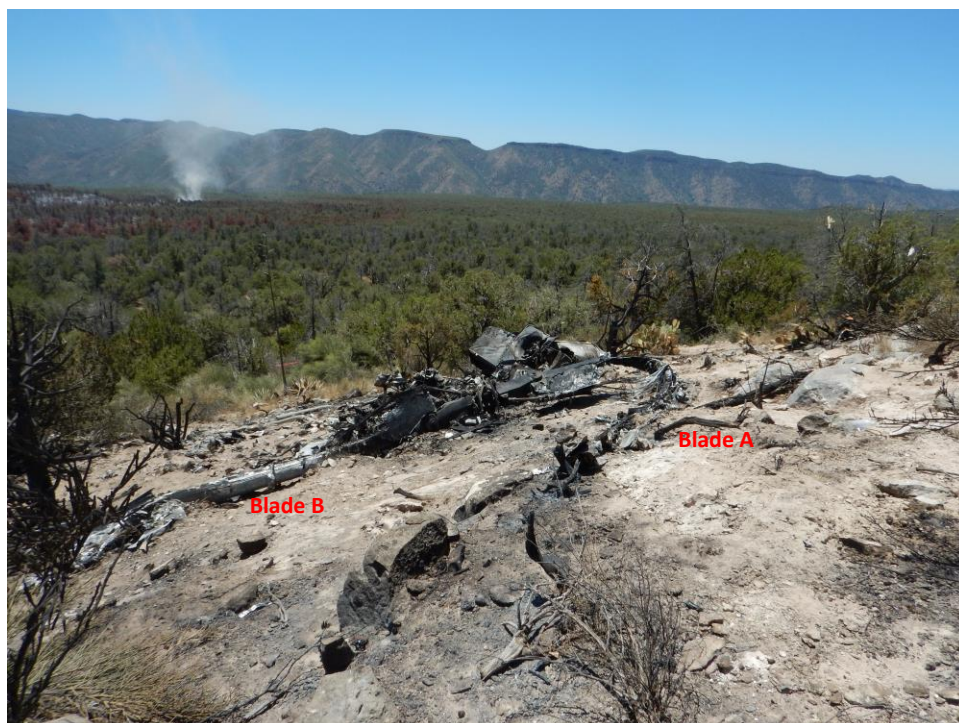
**Figure 3. Main Rotor Blades (Looking Southwest)**

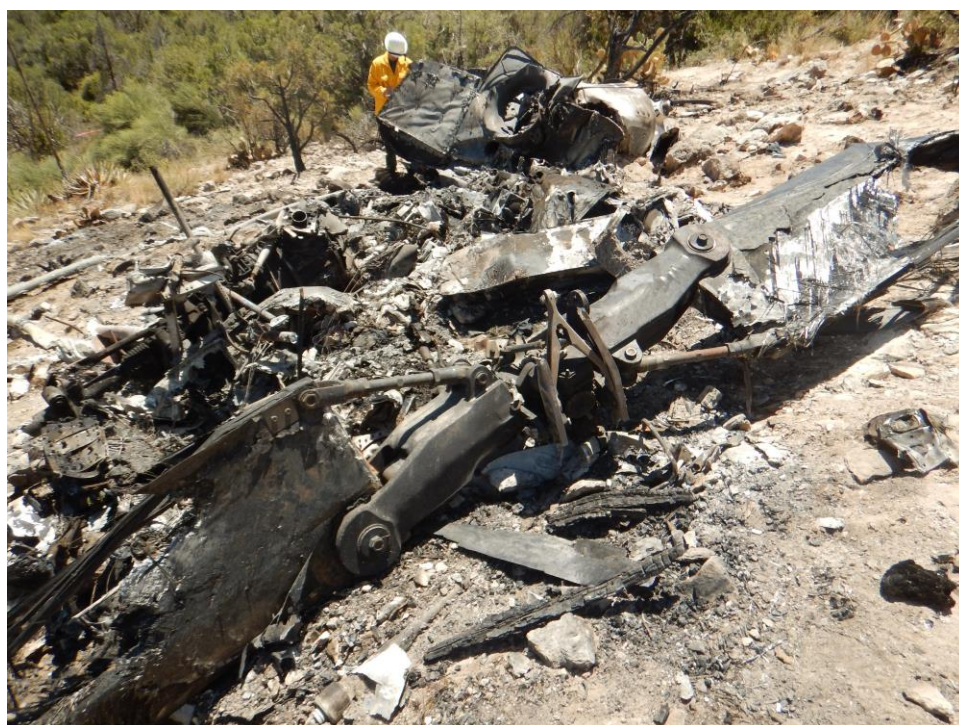
**Figure 4. Main Rotor Blades Attached at Hub**

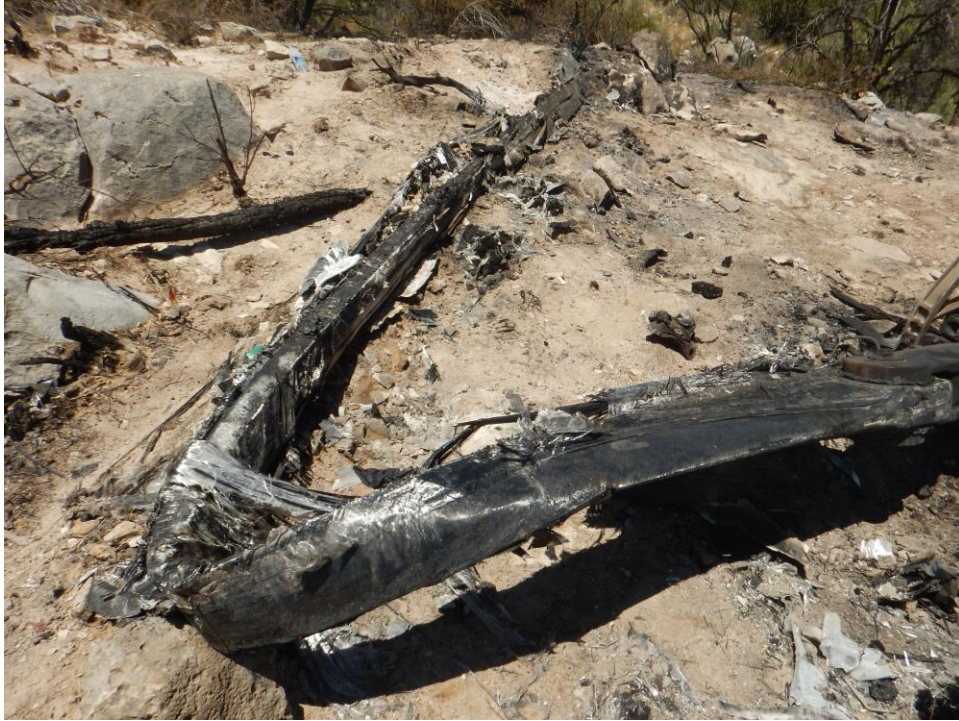
**Figure 5. Main Rotor Blade A**

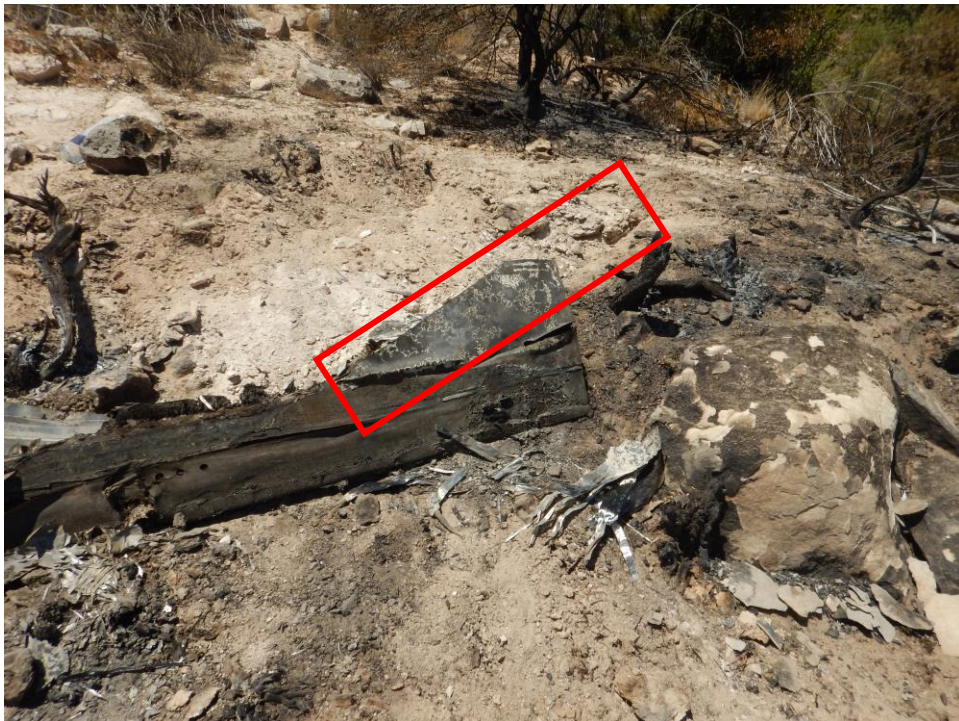
**Figure 6. Ground Scar Near Tip of Main Rotor Blade A**

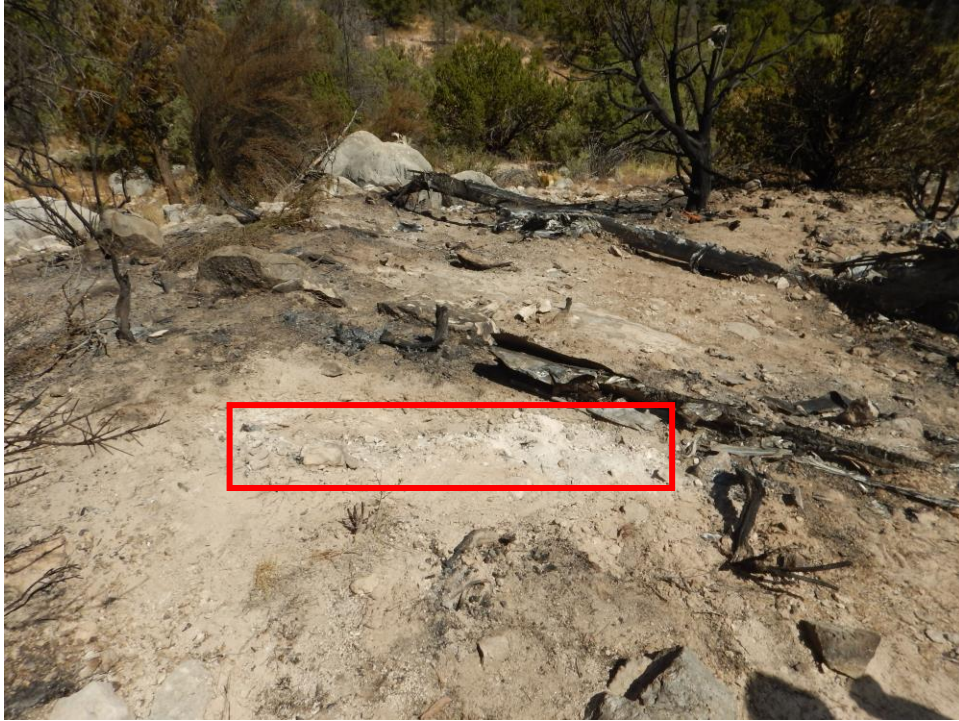
Figure 7. Ground Scar

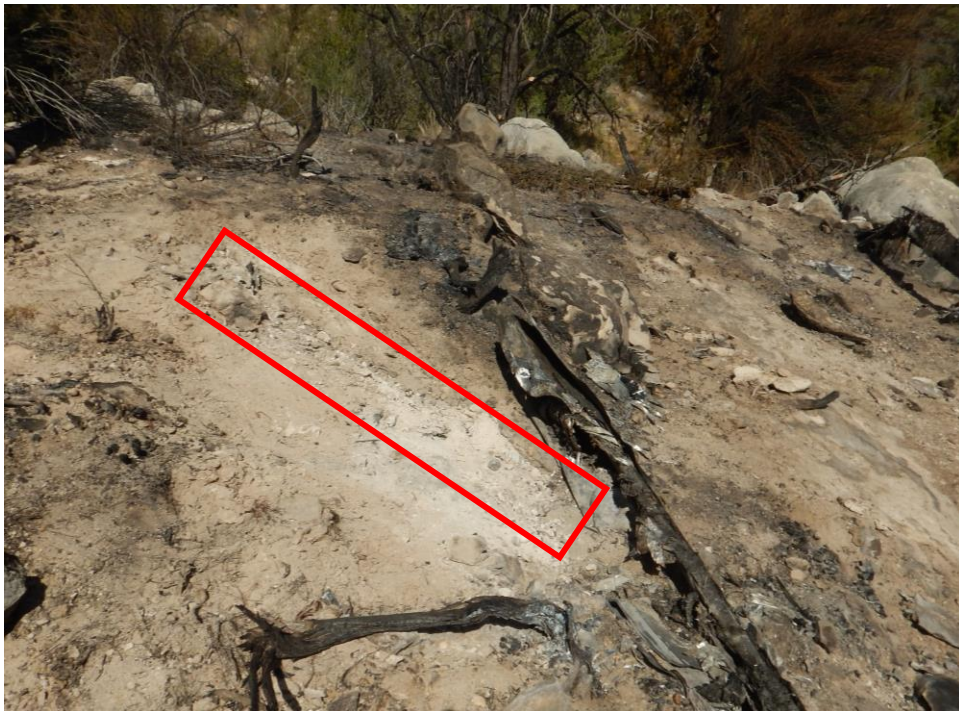
Figure 8. Ground Scar

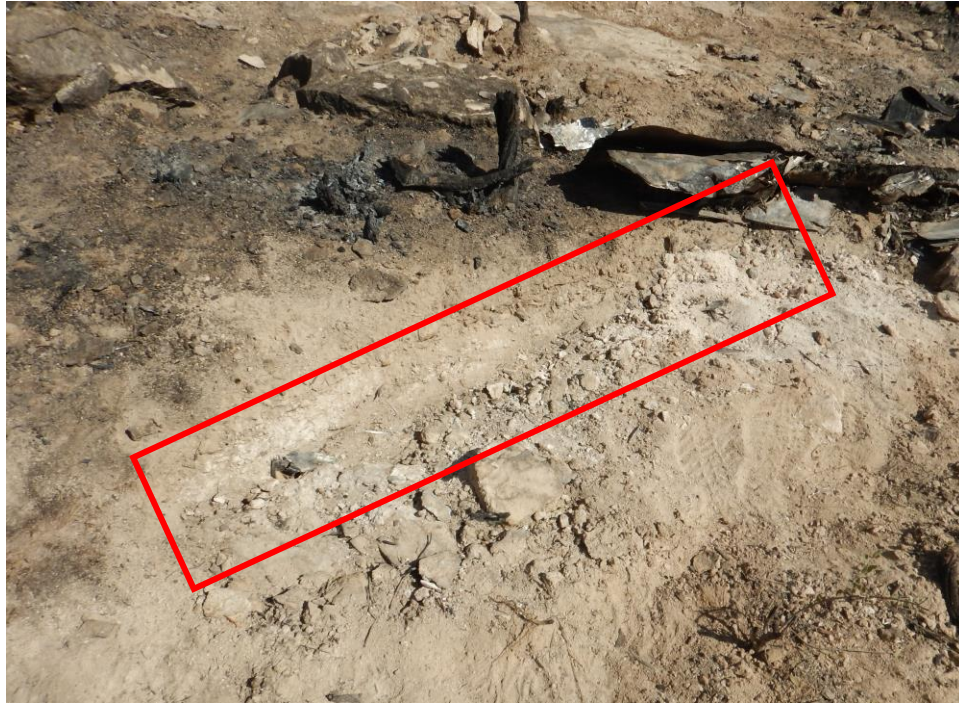
Figure 9. Ground Scar

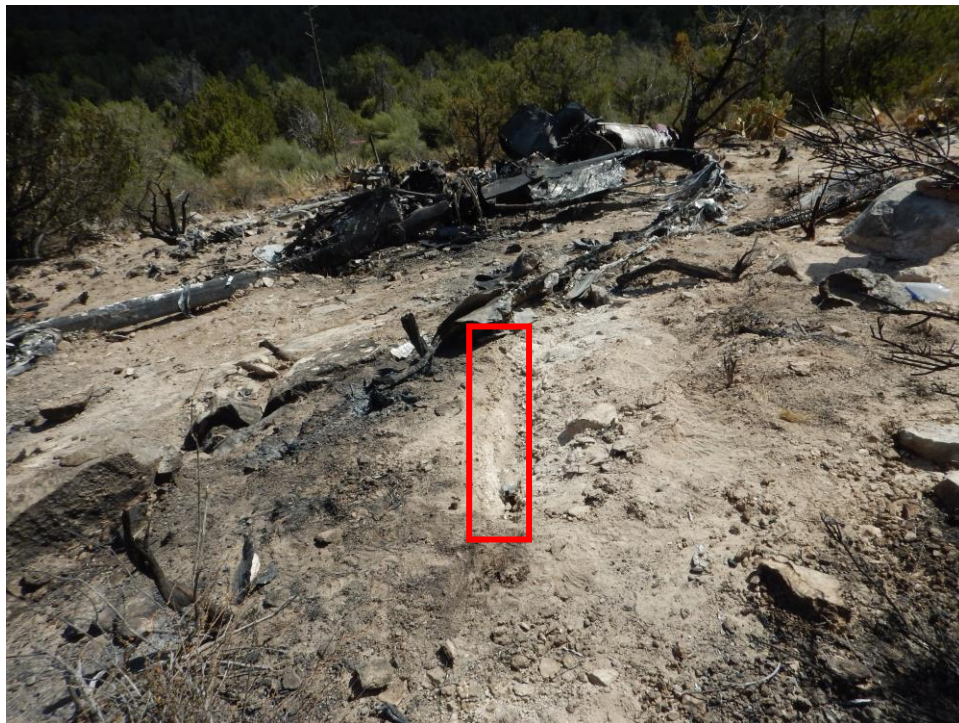
Figure 10. Ground Scar

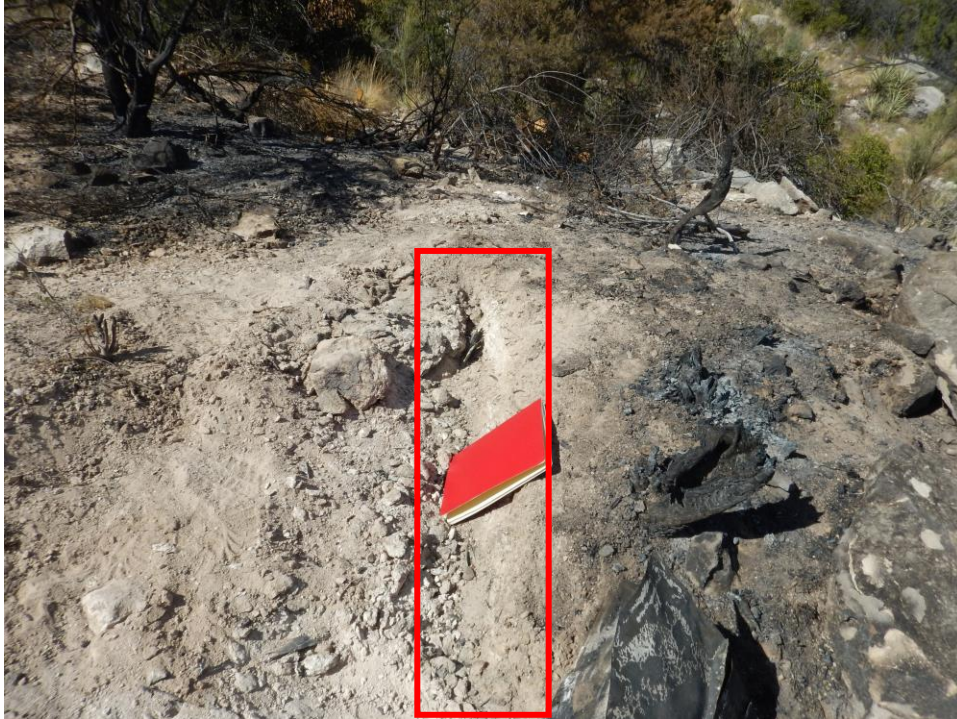
**Figure 11. Ground Scar with Notebook Showing Angle**

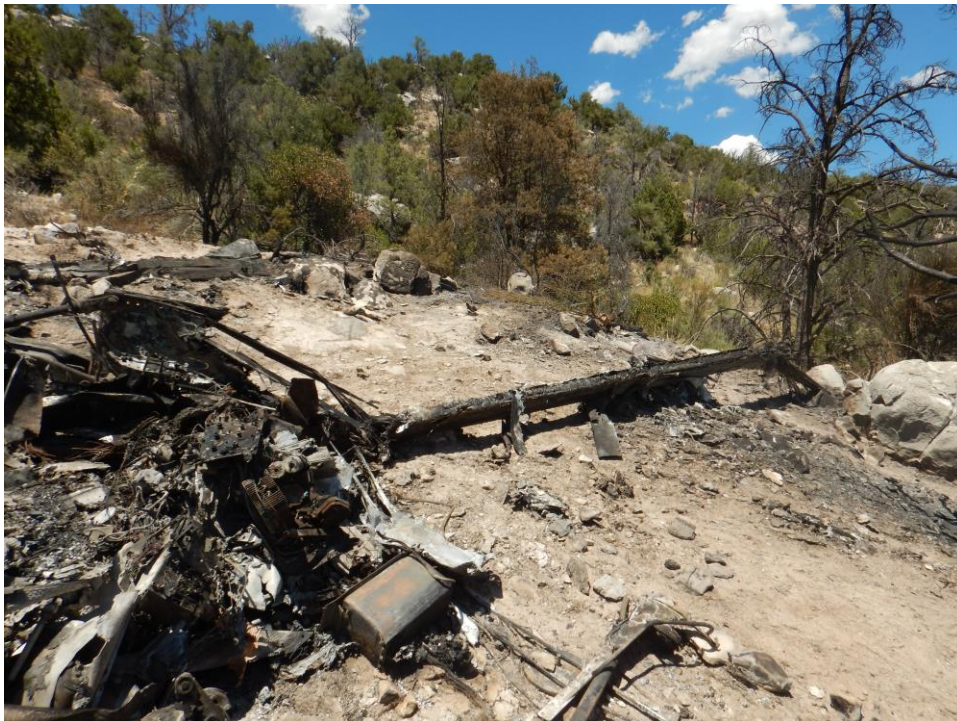
**Figure 12. Main Rotor Blade B**

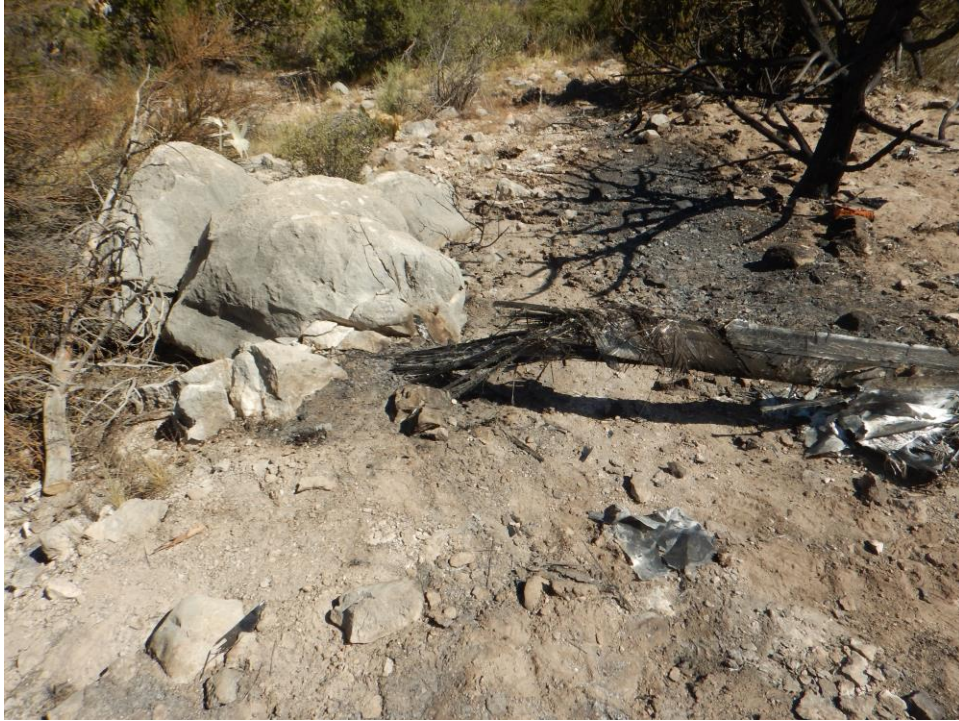
**Figure 13. Broomstrawed Tip of Blade B**

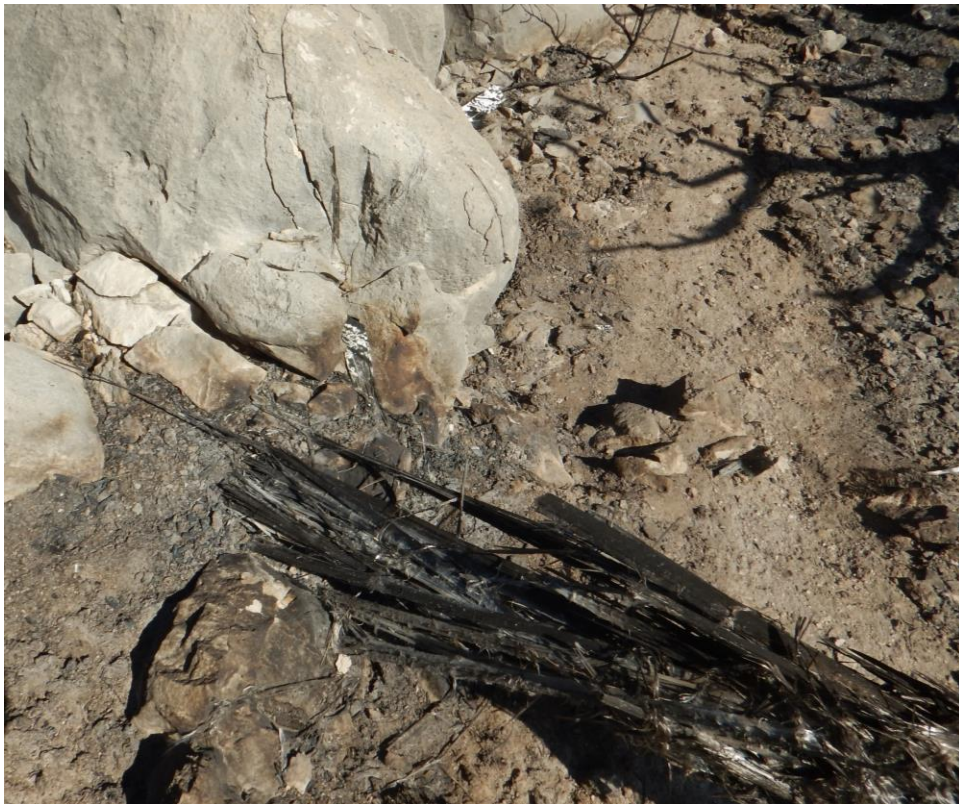
**Figure 14. Scarring and Fracturing on Rock by Blade B Tip**

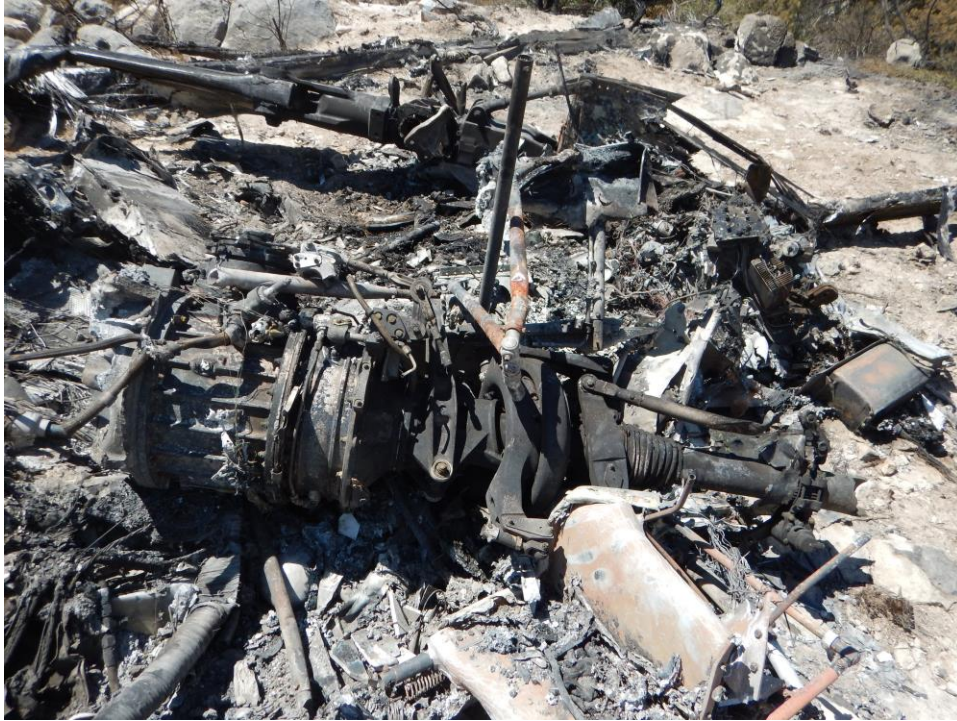
**Figure 15. Transmission Position**

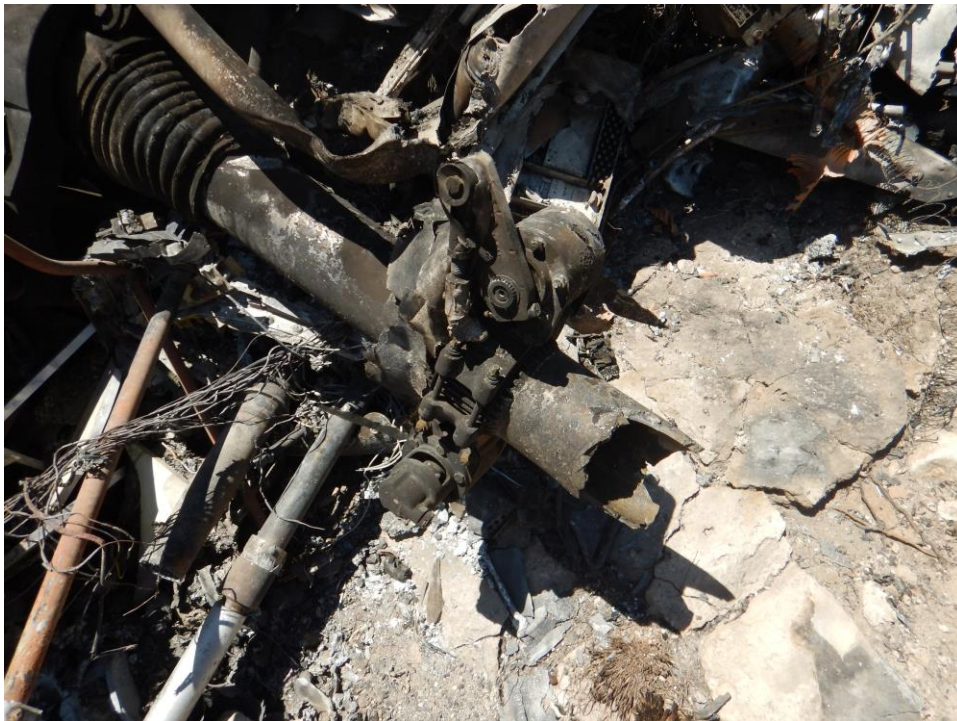
**Figure 16. Transmission Mast**

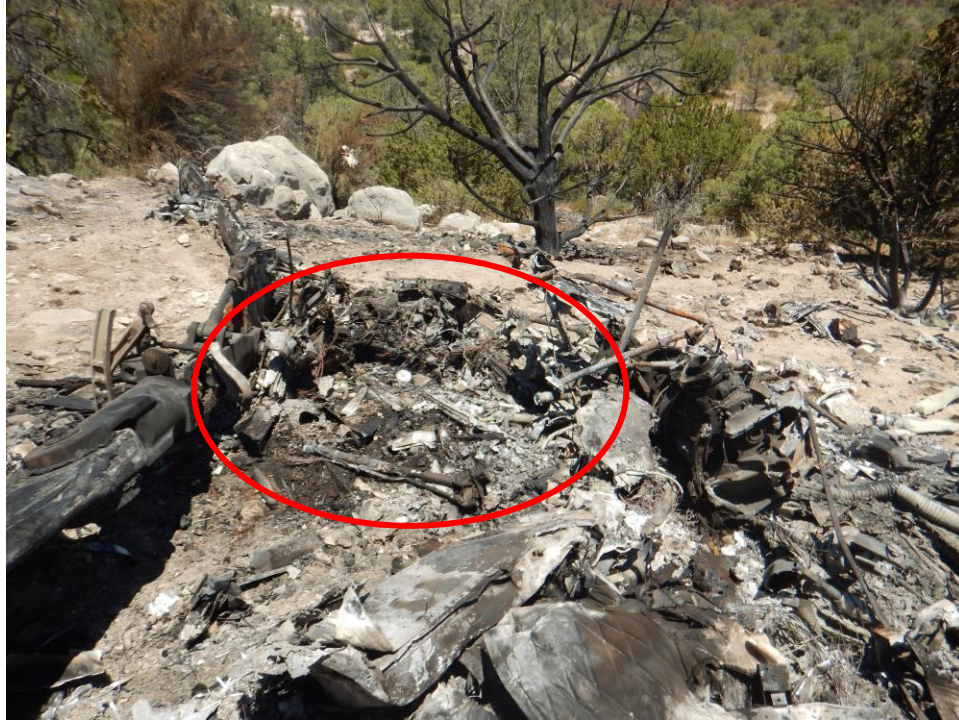
The cockpit section was heavily fire and impact damaged ([Figure 17](#), [Figure 18](#), and [Figure 19](#)). The cockpit was located due south (downhill) of the main rotor blade attachments.

**Figure 17. Cockpit, Approximate Area Circled (Looking East)**

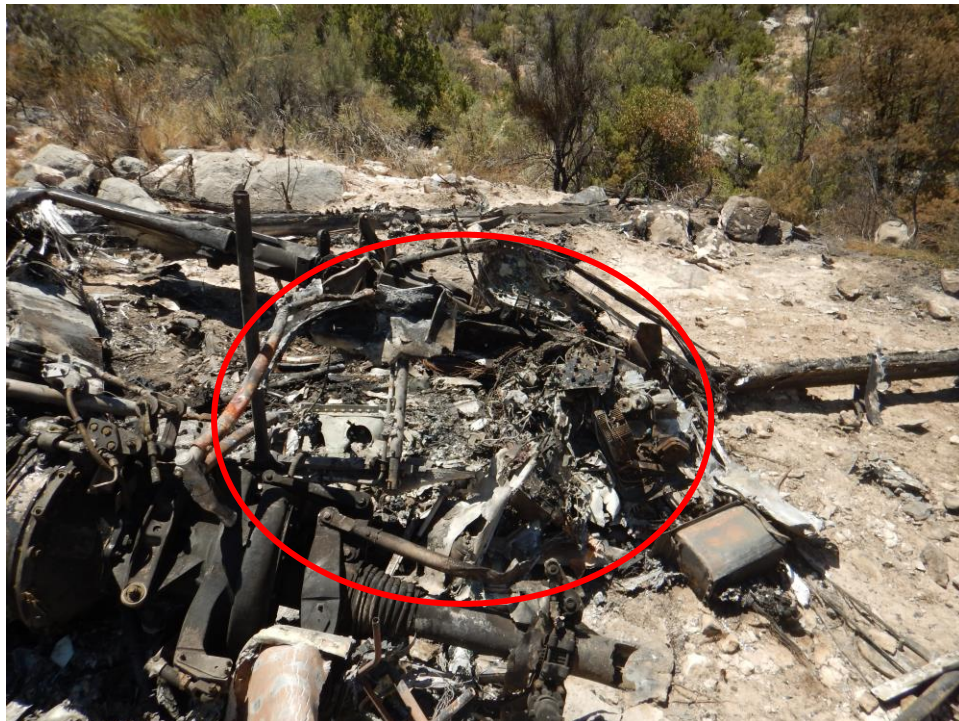
**Figure 18. Cockpit, Approximate Area Circled (Looking North)**

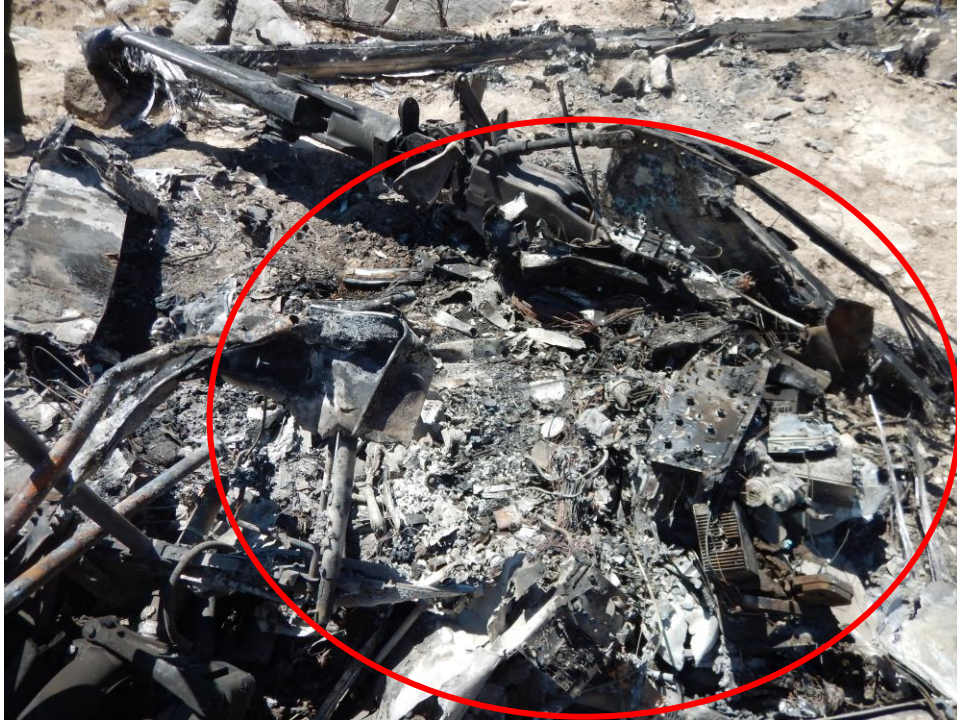
**Figure 19. Cockpit, Approximate Area Circled**

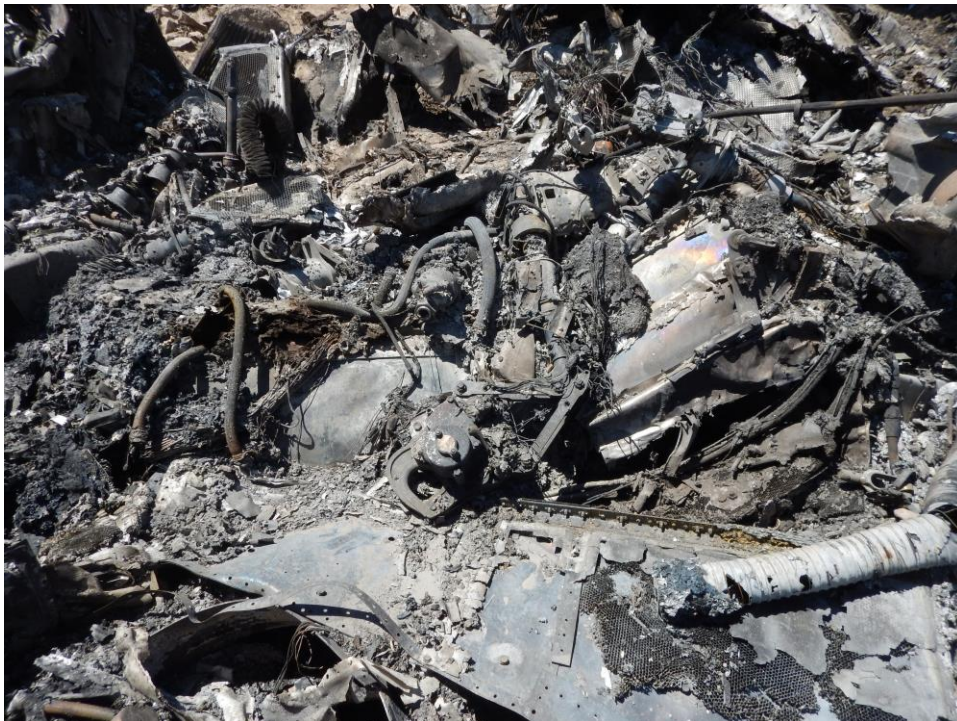
The cargo area was heavily impact and fire damaged ([Figure 20](#)). The cargo hook was found in the closed position ([Figure 21](#)). The k-flex coupling was fractured from its attachment points and found in the cargo section.

**Figure 20. Cargo Area**

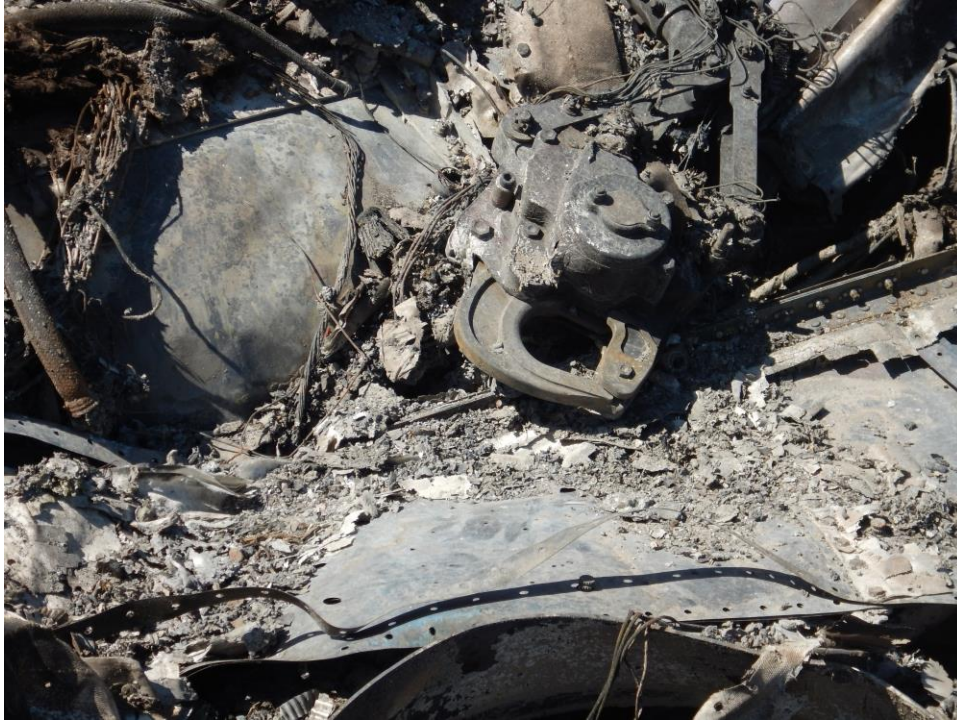
**Figure 21. Cargo Hook in Closed Position**

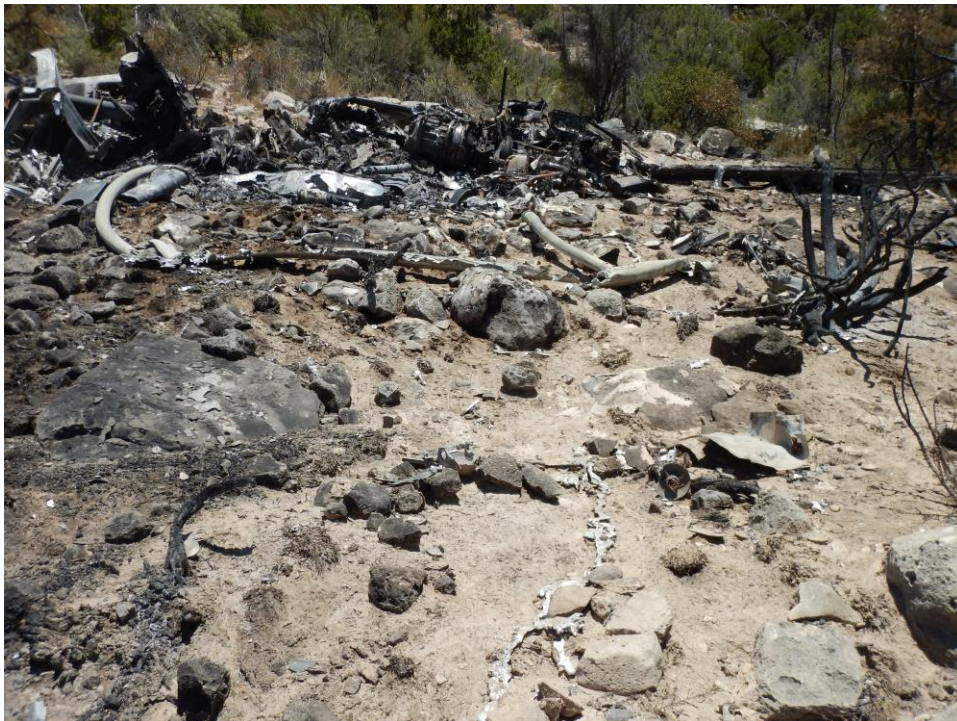
There was re-solidified melted metal running downhill from where the skids were located ([Figure 22](#) and [Figure 23](#)). The skid crossmembers appear to be rotated aft of their normal position ([Figure 24](#)) and appear to have been displaced to the right side of the helicopter ([Figure 25](#)). The left side skid was located under the right-most section of the fuselage, with the crossmembers and right skid all visible and downhill (South) of the main wreckage. The crossmember mounting brackets on the aft crossmember appear to have been displaced and were not visible. There was metal scraping visible on the left side of where the aft left-hand mounting brackets appeared to have been located ([Figure 26](#)).

**Figure 22. Re-Solidified Melted Metal Running Downhill**

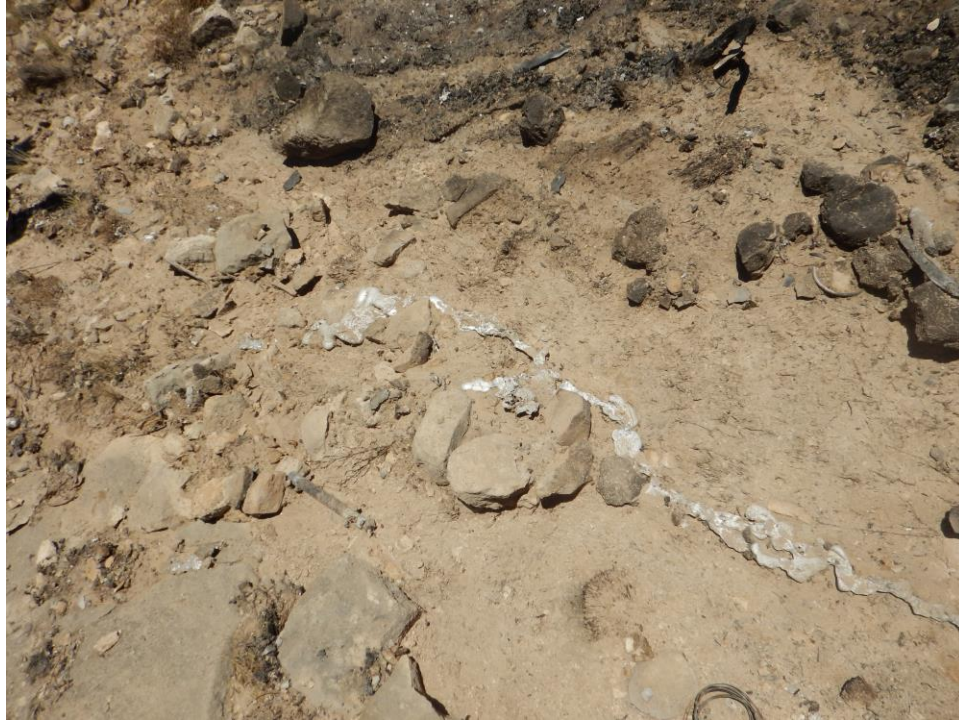
**Figure 23. Close-Up of Re-Solidified Melted Metal**

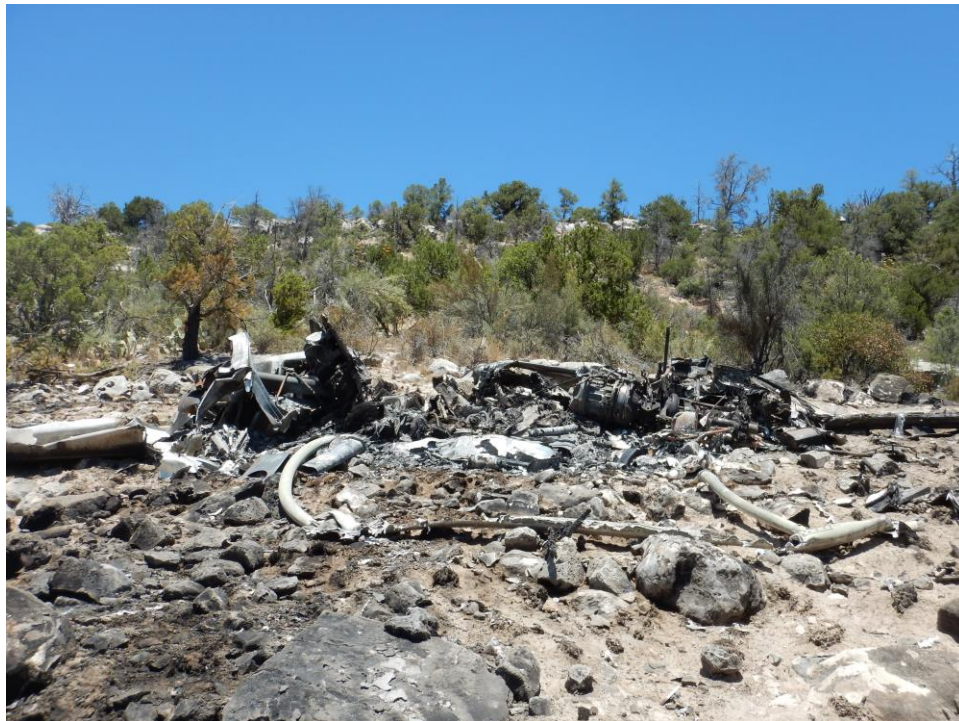
**Figure 24. Skid Crossmembers Rotated Aft**

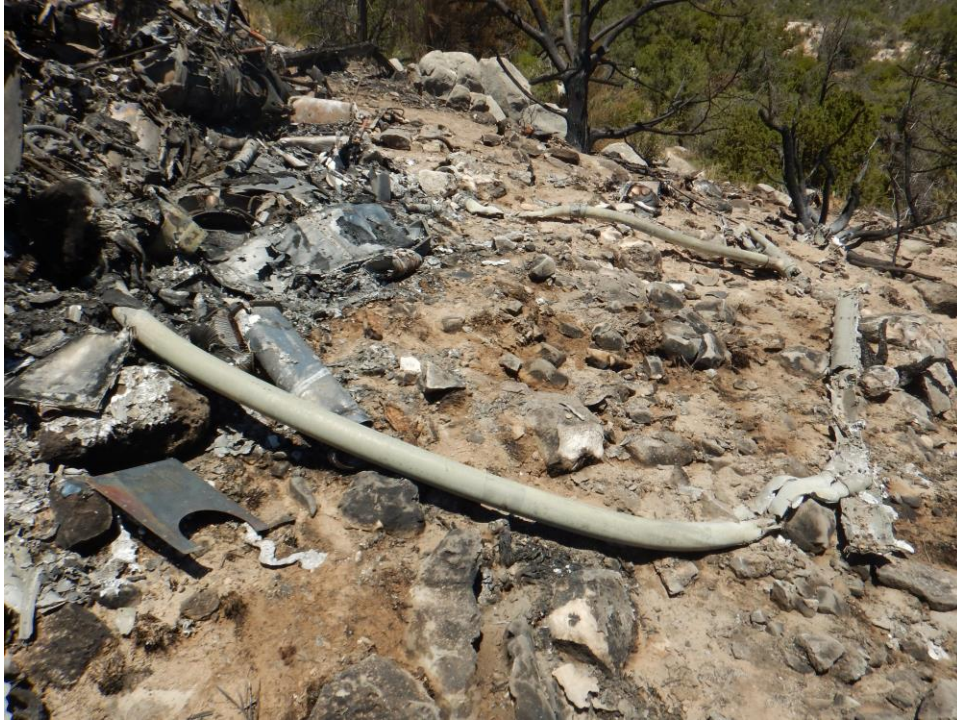
**Figure 25. Skids Displaced on Right Side of Helicopter**

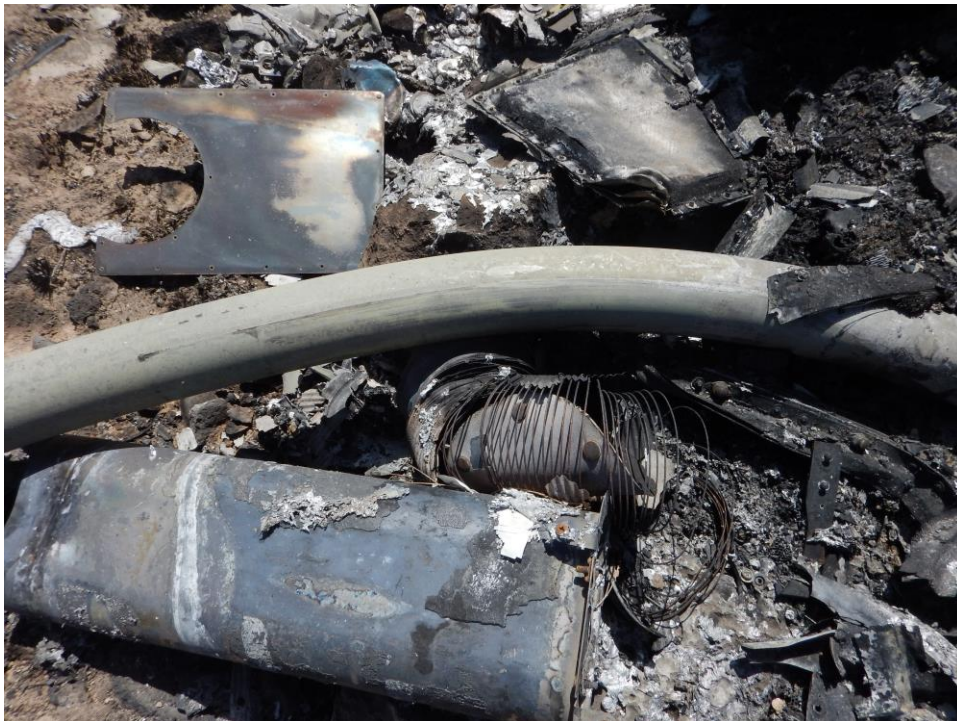
**Figure 26. Scrape Marks on Aft Skid Crossmember**

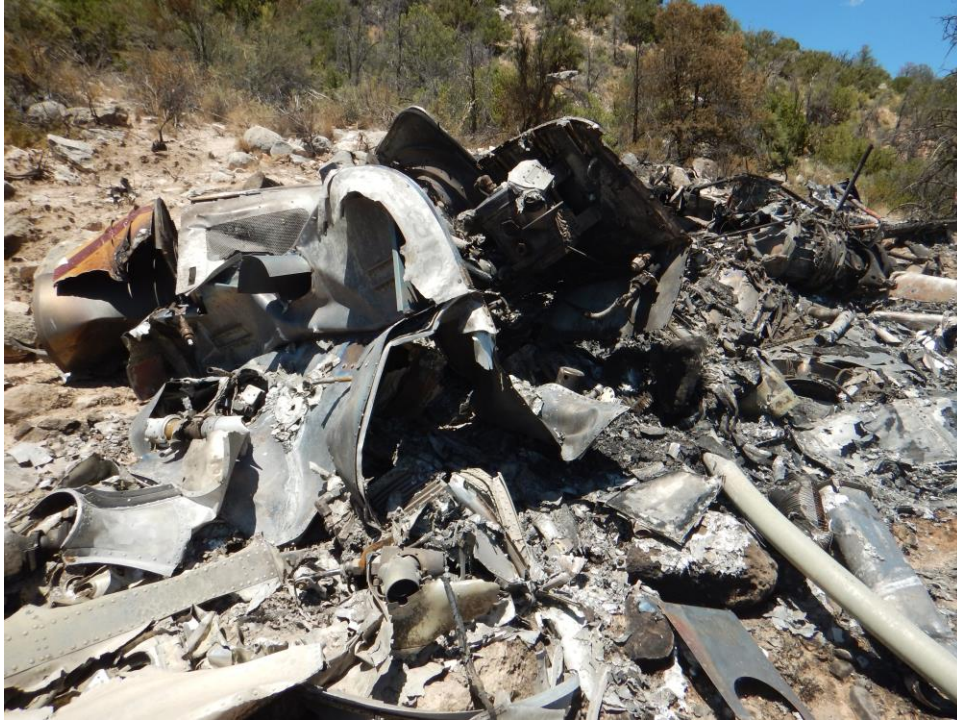
The left side of the forward firewall was partially crushed. The left side of the aft firewall was partially crushed. The firewalls can be seen in [Figure 27](#), [Figure 28](#), and [Figure 29](#). One of the lines attached to the oil tank displayed a wet appearance. The fluid's identity was not confirmed through analysis but was assumed to have been engine oil.

**Figure 27. Firewalls with Engine**

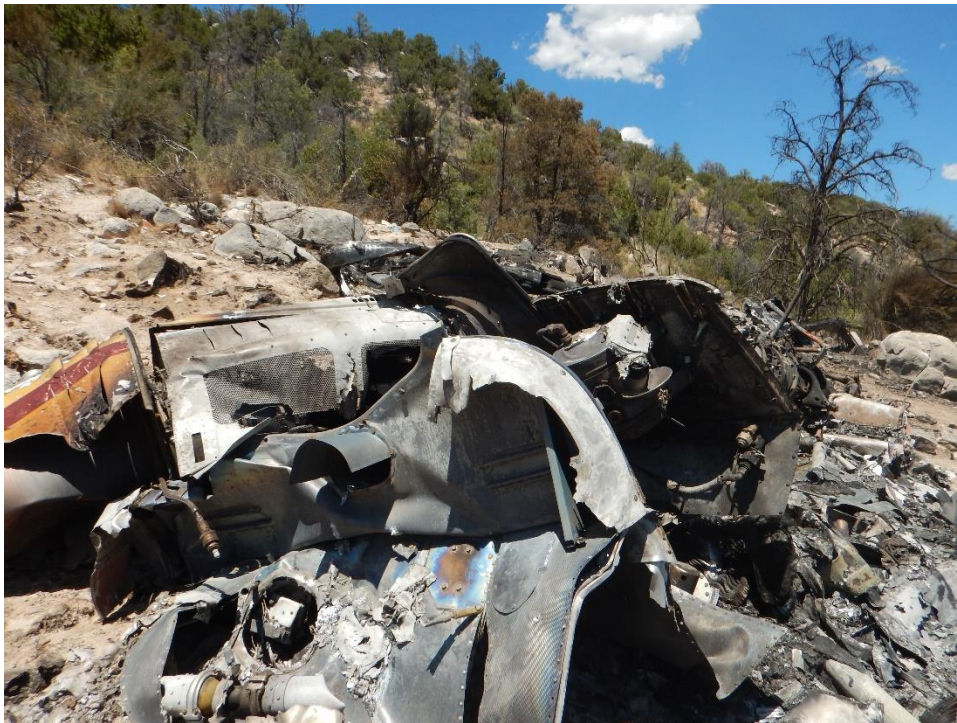
**Figure 28. Firewalls Aft Looking Forward (Looking East)**

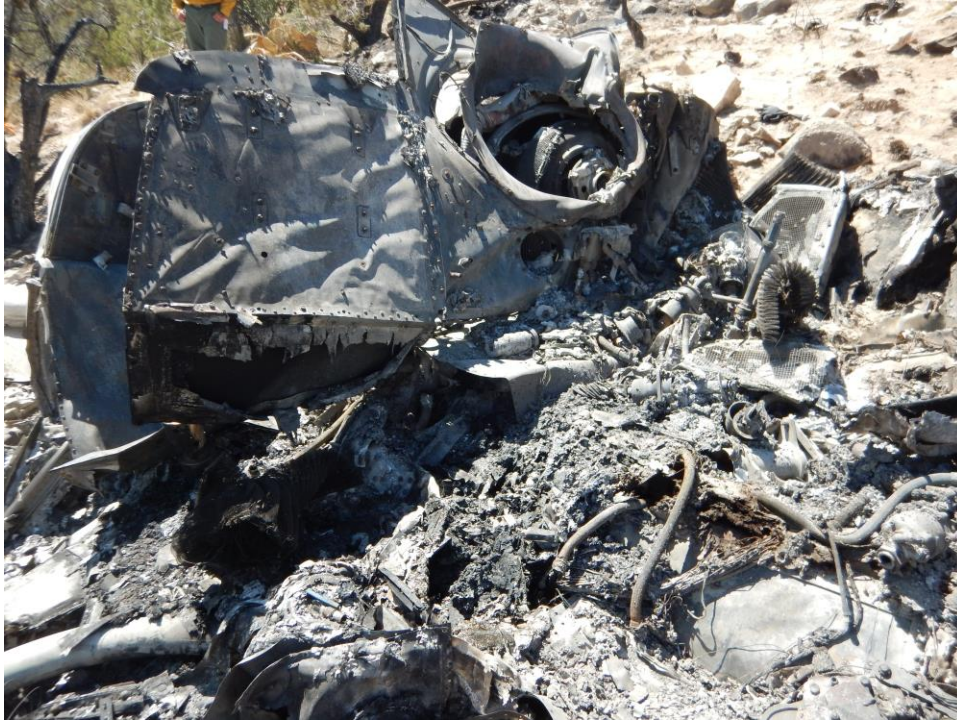
**Figure 29. Firewalls Forward Looking Aft (Looking West)**

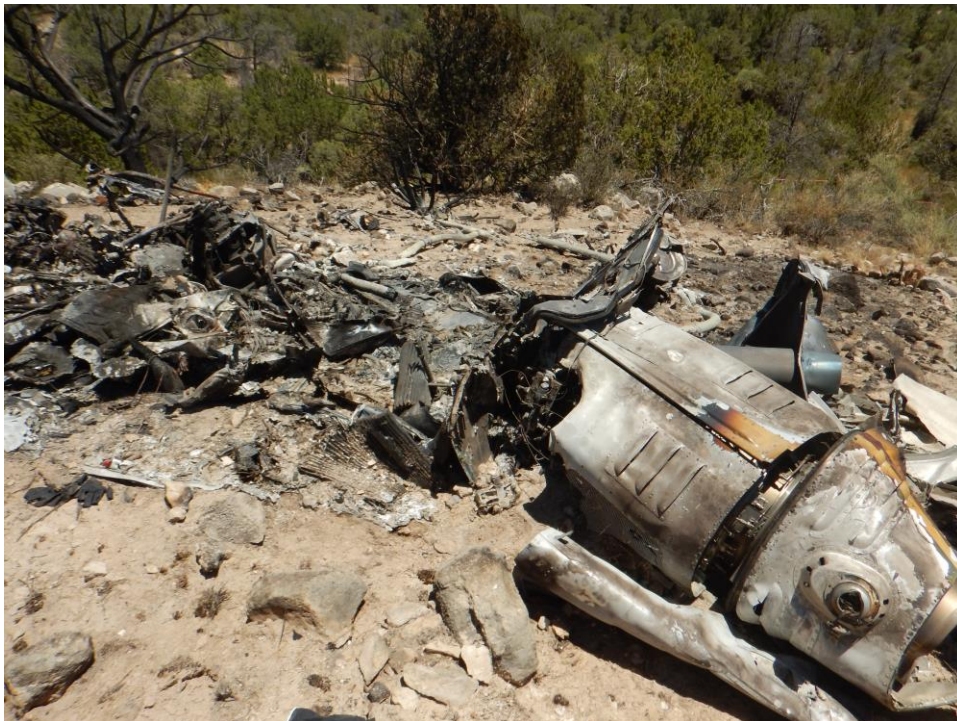
The engine was displaced and separated from its mounts. It was positioned slightly uphill (north) and rolled CCW aft looking forward (Figure 30 and Figure 31). The inlet guide vanes (IGVs) displayed battering and impact damage (Figure 32). The first stage compressor blades displayed tearing and battering damage with portions of the blade material bent opposite the direction of rotation (Figure 32). Rotation of the output shaft produced a corresponding rotation of the power turbine rotor. There was a faint squeal during the rotation of the power turbine section, that appeared to be the result of contact between the output shaft and the displaced and damaged static structure around the engine inlet. There was no visible damage to the 2<sup>nd</sup> stage power turbine blades or stator vanes (Figure 33).

**Figure 30. Engine Displaced and Separated from Mounts**

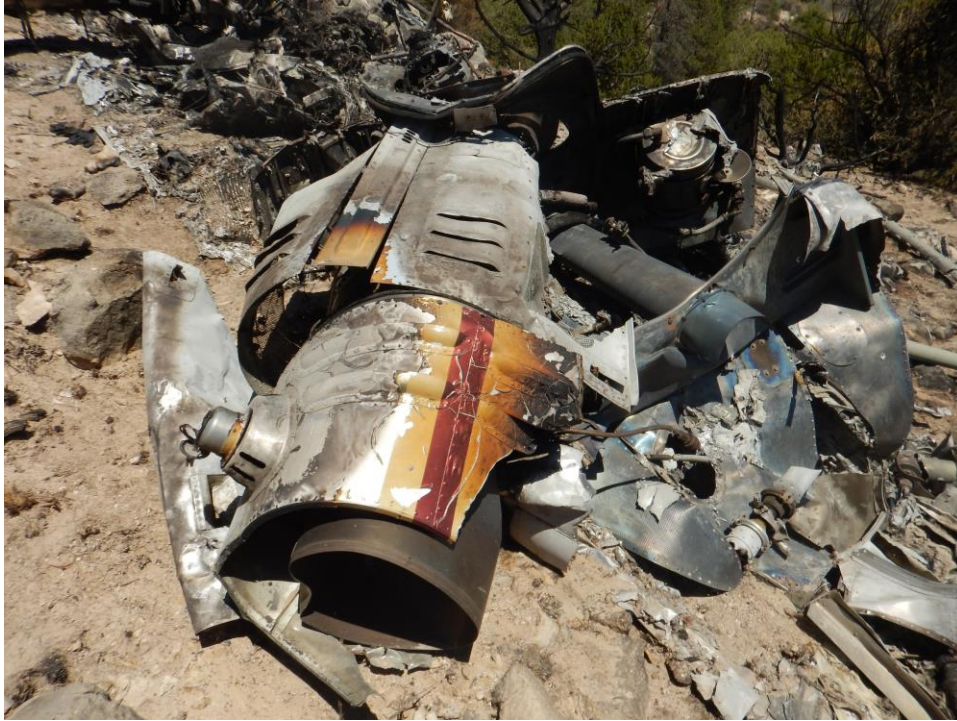
**Figure 31. Engine Rolled CCW (Aft Looking Forward) Slightly Uphill**
