**Honeywell Aircraft Accident Field Notes Prepared for the NTSB**  
**Accident Number: WPR20LA211, Payson, AZ, July 07, 2020**  
**Bell UH-1H, Registration: N623PB, S/N: 64-13689**

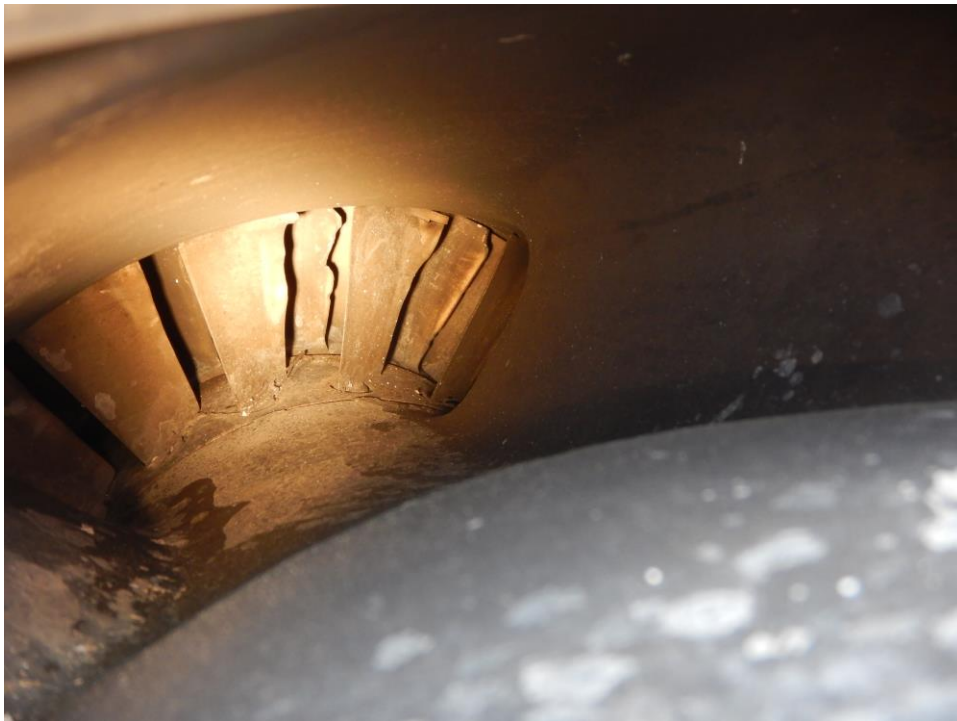
The engine was displaced and separated from its mounts. It was positioned slightly uphill (north) and rolled CCW aft looking forward (Figure 30 and Figure 31). The inlet guide vanes (IGVs) displayed battering and impact damage (Figure 32). The first stage compressor blades displayed tearing and battering damage with portions of the blade material bent opposite the direction of rotation (Figure 32). Rotation of the output shaft produced a corresponding rotation of the power turbine rotor. There was a faint squeal during the rotation of the power turbine section, that appeared to be the result of contact between the output shaft and the displaced and damaged static structure around the engine inlet. There was no visible damage to the 2<sup>nd</sup> stage power turbine blades or stator vanes (Figure 33).

**Figure 32. IGV and Compressor Damage**

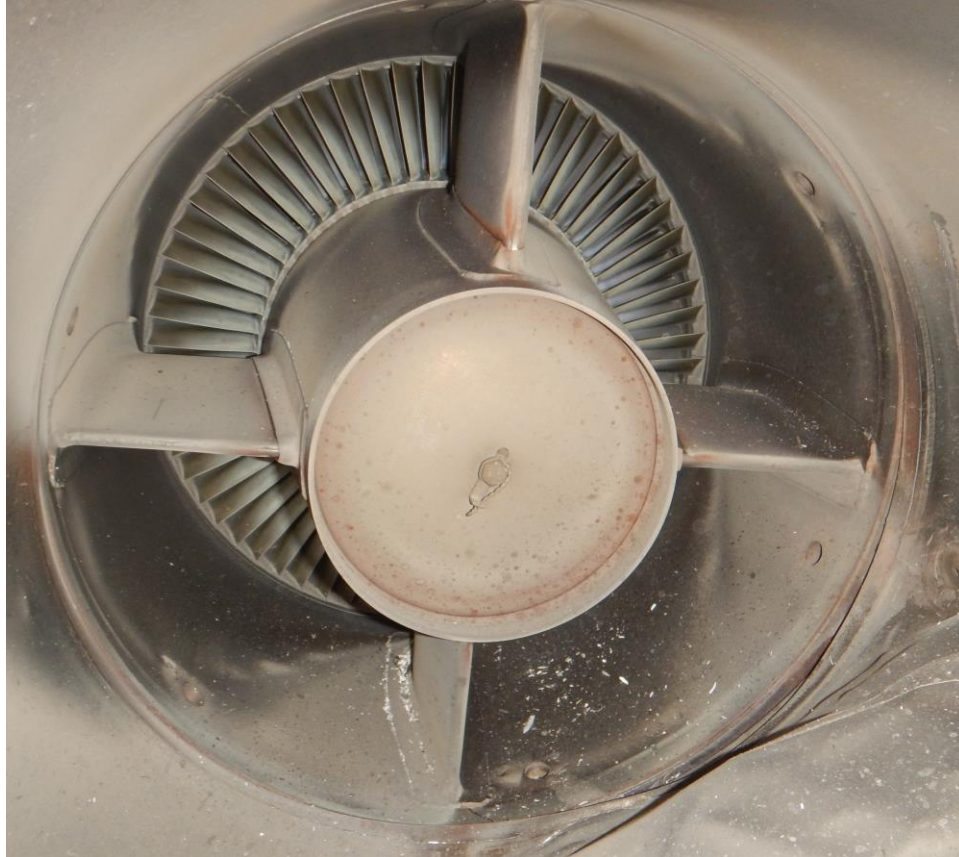
**Figure 33. No Visible Damage to 2nd Stage Power Turbine Blades or Stator Vanes**

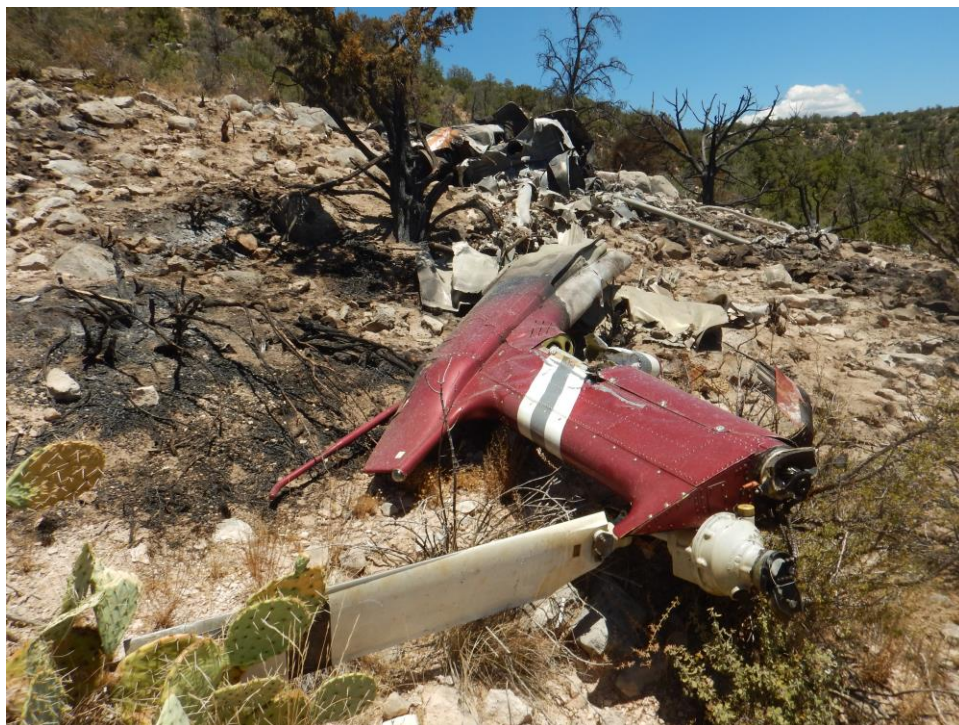
The tail boom was impact damaged and fragmented (Figure 34). There was partial fire damage – not as much as the rest of the wreckage. It was separated from the rest of the helicopter just forward of the horizontal stabilizer mount (Figure 35 and Figure 36). The horizontal stabilizer was displaced from the tail boom. The left-hand stabilizer was torn from its structural arm attachment and exhibited compression/crushing damage (Figure 37). The tail rotor drive shaft was fractured and fragmented along its length, there was thermal damage in some places (it was completely melted between the forward and aft firewalls, shown in Figure 38). The tail rotor drive shaft input into the 45° gearbox could be minimally rotated. The control cable inputs were present but continuity was not verified (Figure 39). One of the tail rotor blades was fractured, partially separated, and a portion of the leading edge remained within the vertical fin (Figure 40) where it appears as if it was driven into the tail rotor drive shaft between the 45° gearbox and the 90° gearbox (Figure 41). The other tail rotor blade was intact but exhibited impact damage (Figure 42 and Figure 43). The 90° gearbox was separated from its mount and fractured, it was oriented on the opposite side of the tail boom from its normal position (Figure 44). The vertical fin exhibited crushing/buckling along the structural section.

**Figure 34. Overall Tail Section (Looking East)**

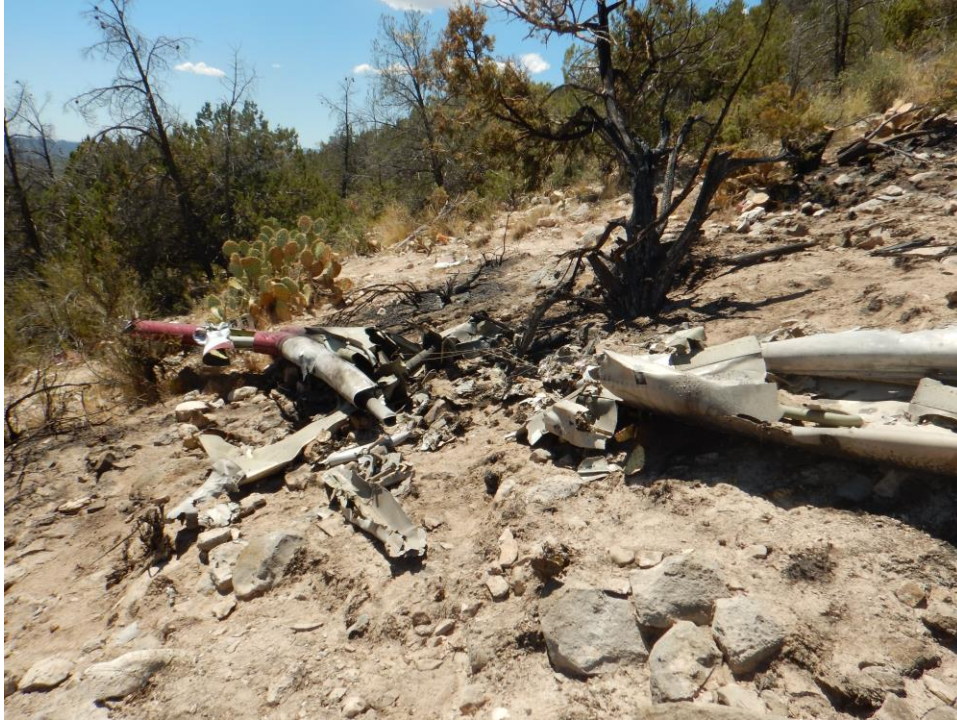
**Figure 35. Overall Tail Section (Looking West-Northwest)**

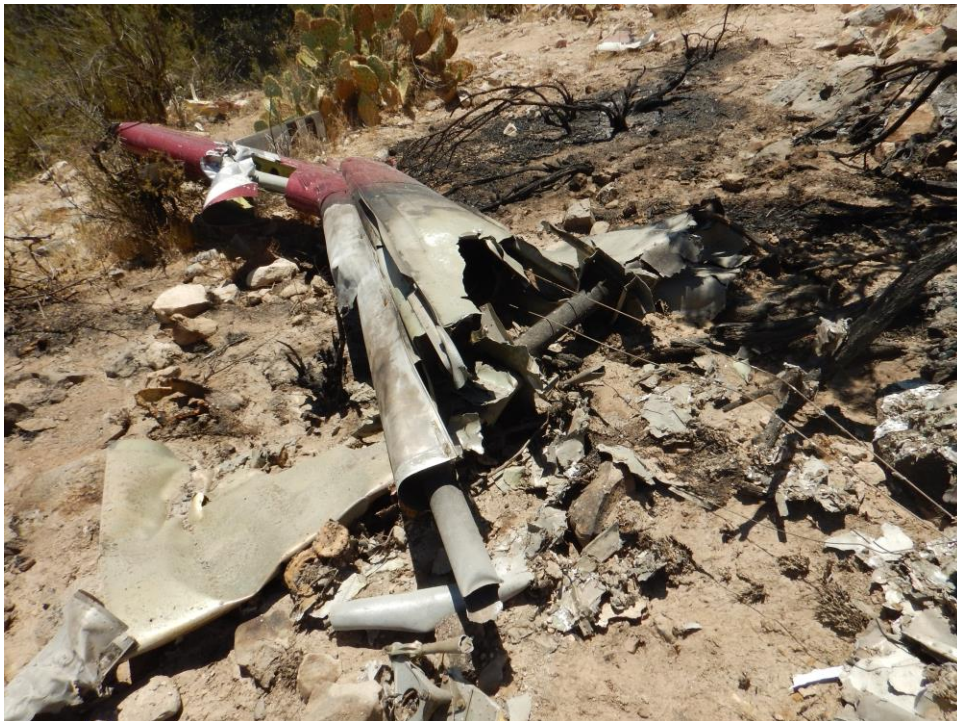
**Figure 36. Tail Section Separation**

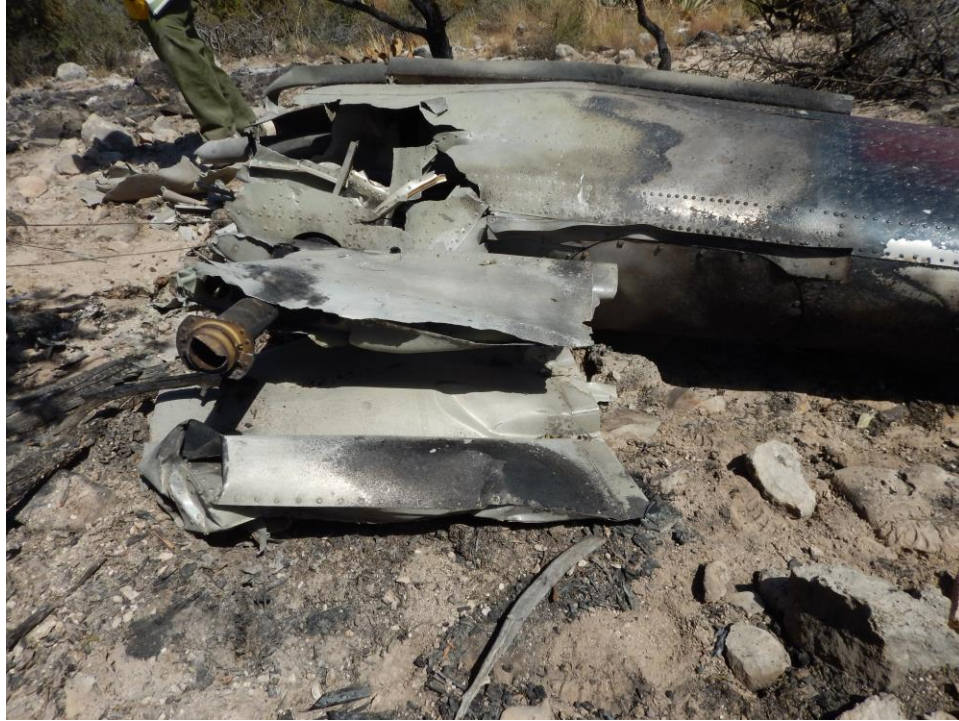
**Figure 37. Left Hand Stabilizer**

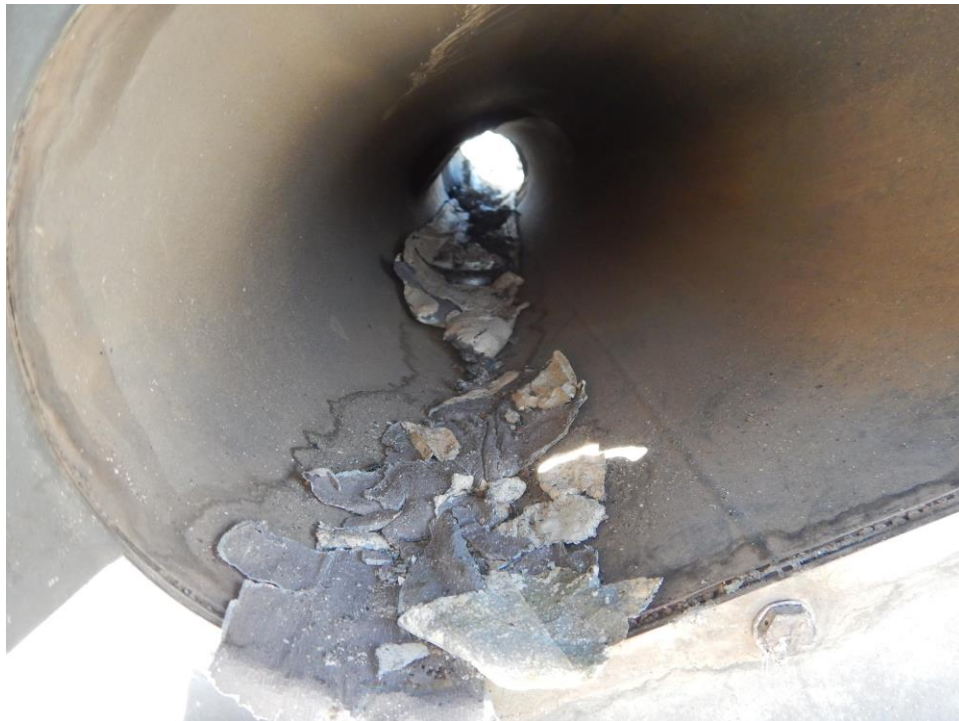
**Figure 38. Melted Tail Rotor Drive Shaft**

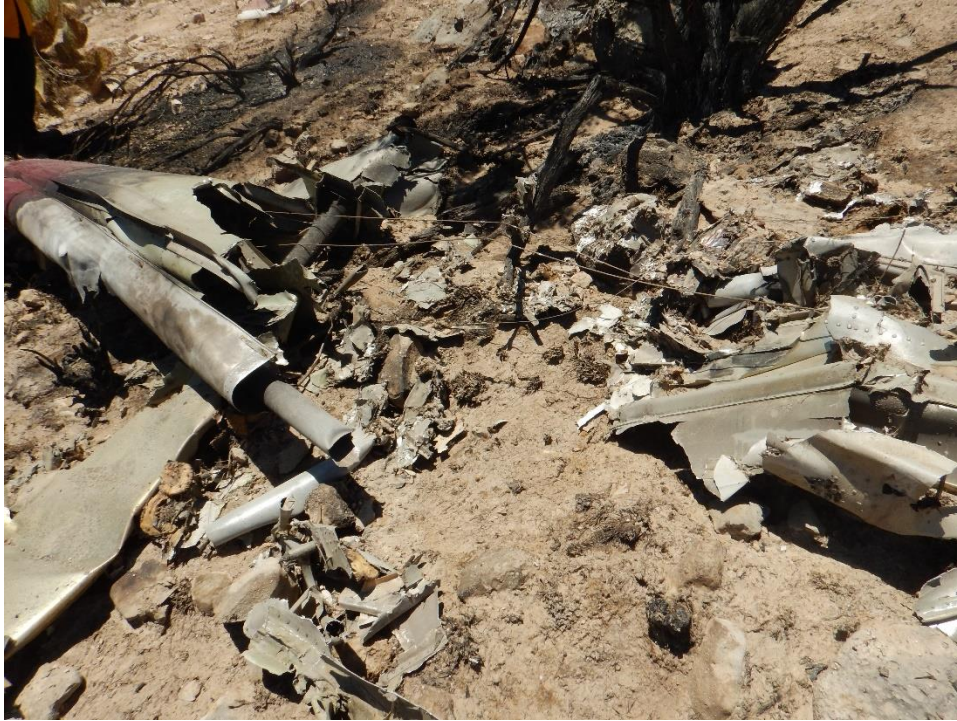
**Figure 39. Control Cables Present**

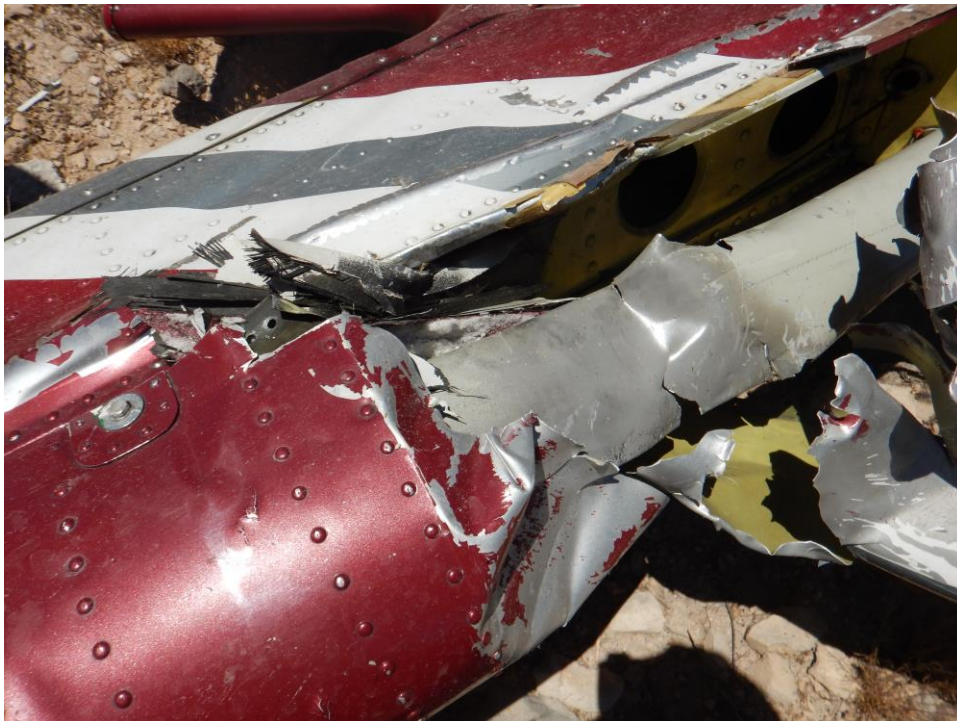
**Figure 40. Piece of Tail Rotor Blade Embedded in Vertical Tail**

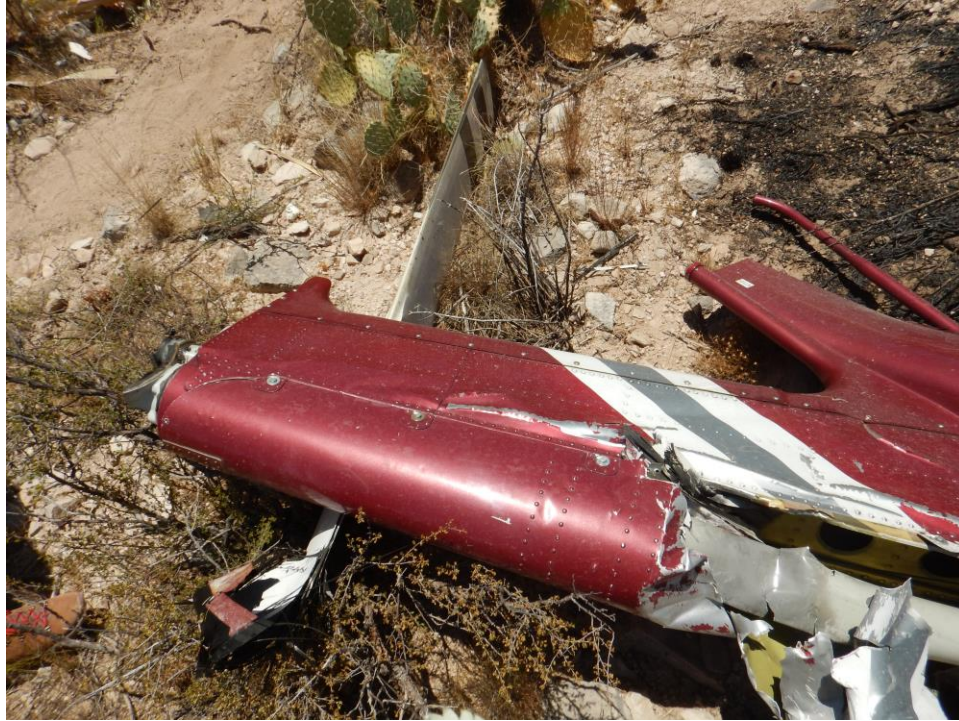
**Figure 41. Damage between 45° Gearbox and 90° Gearbox and Damaged Tail Rotor**

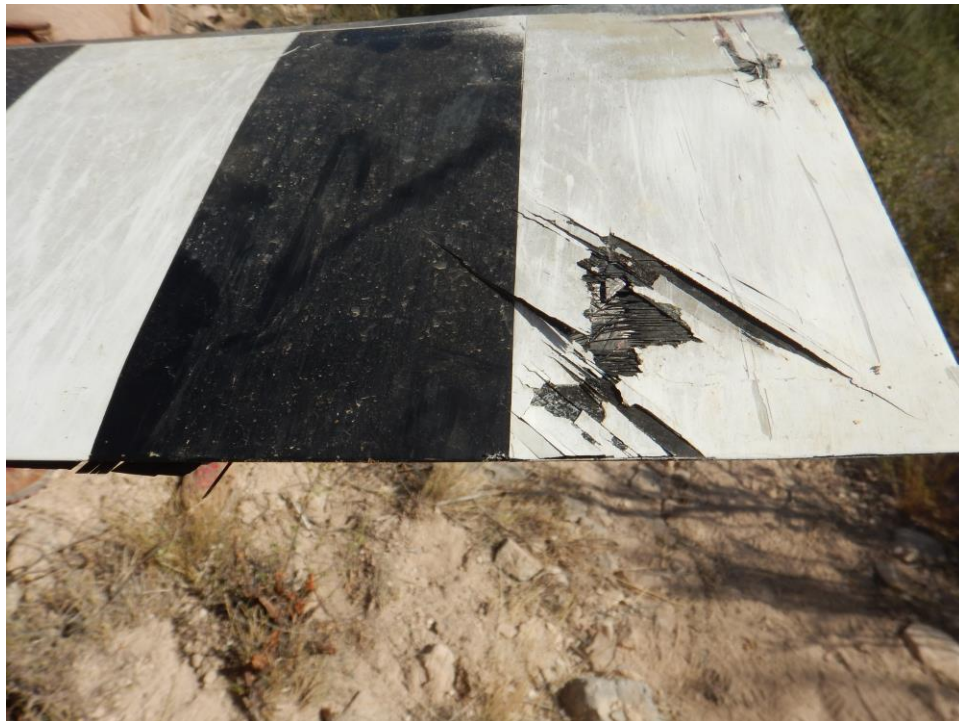
**Figure 42. Impact Damage on Intact Tail Rotor Blade Side 1**

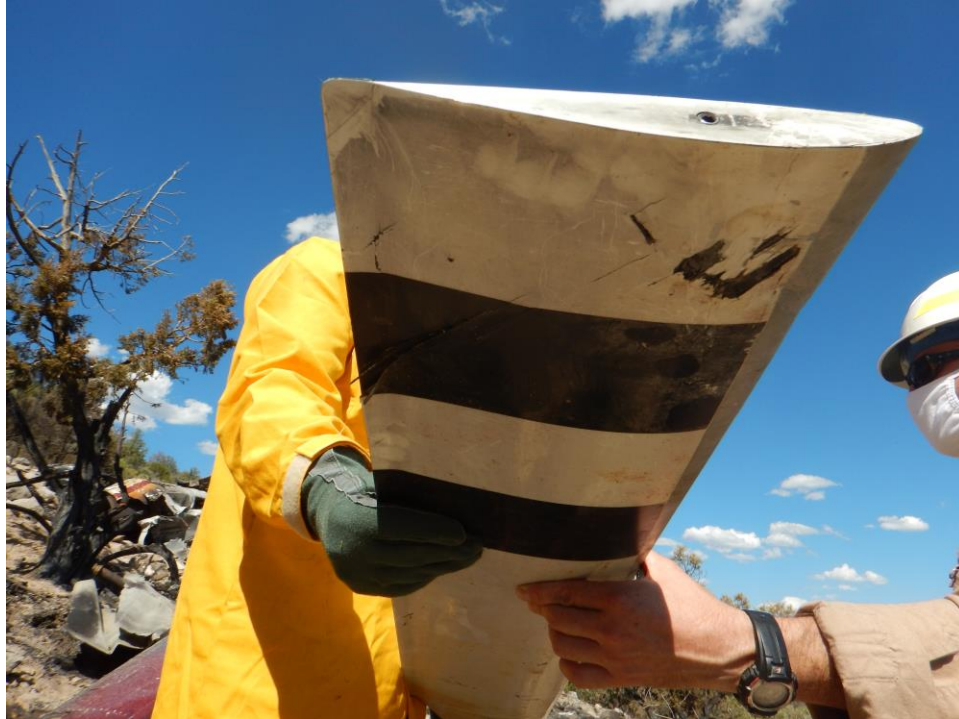
**Figure 43. Impact Damage on Intact Tail Rotor Blade Side 2**

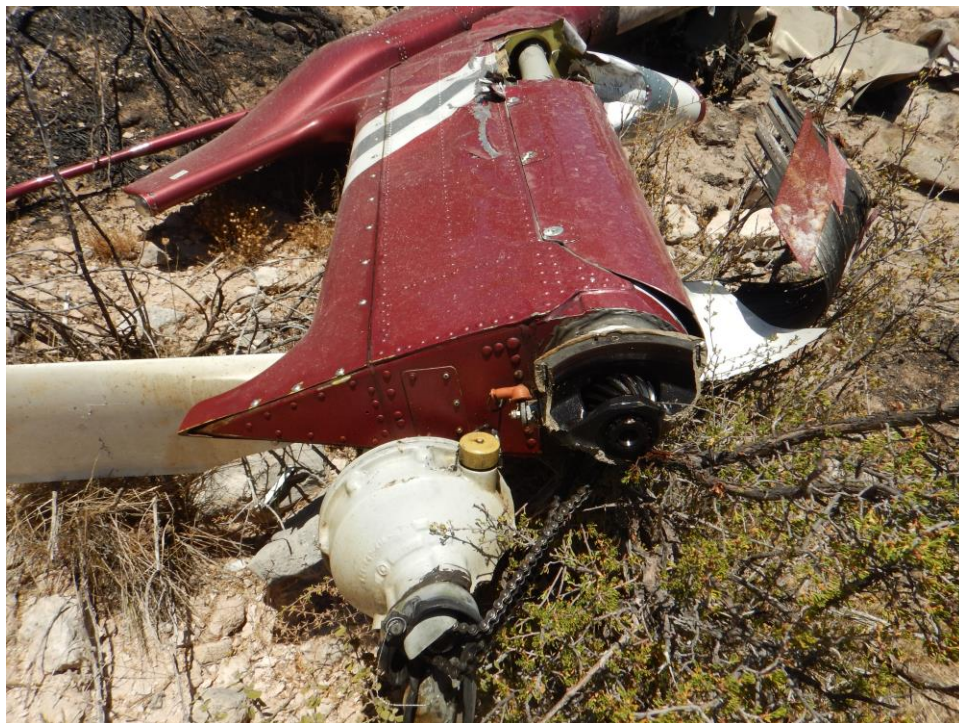
**Figure 44. 90° Gearbox Separation**

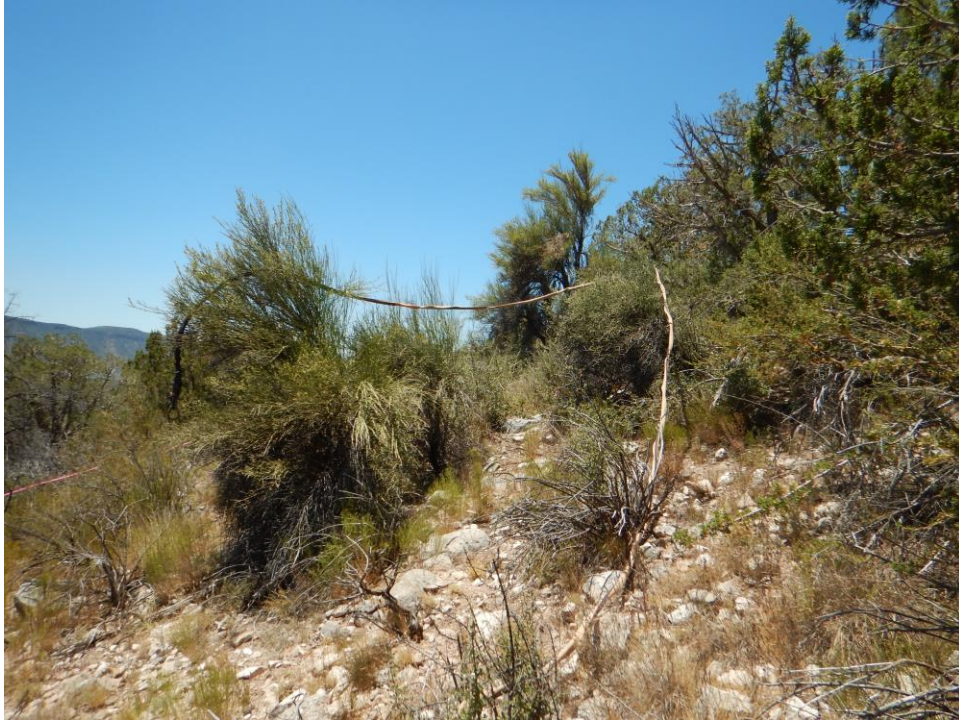
**Figure 47. Long-Line Draped Over Trees**

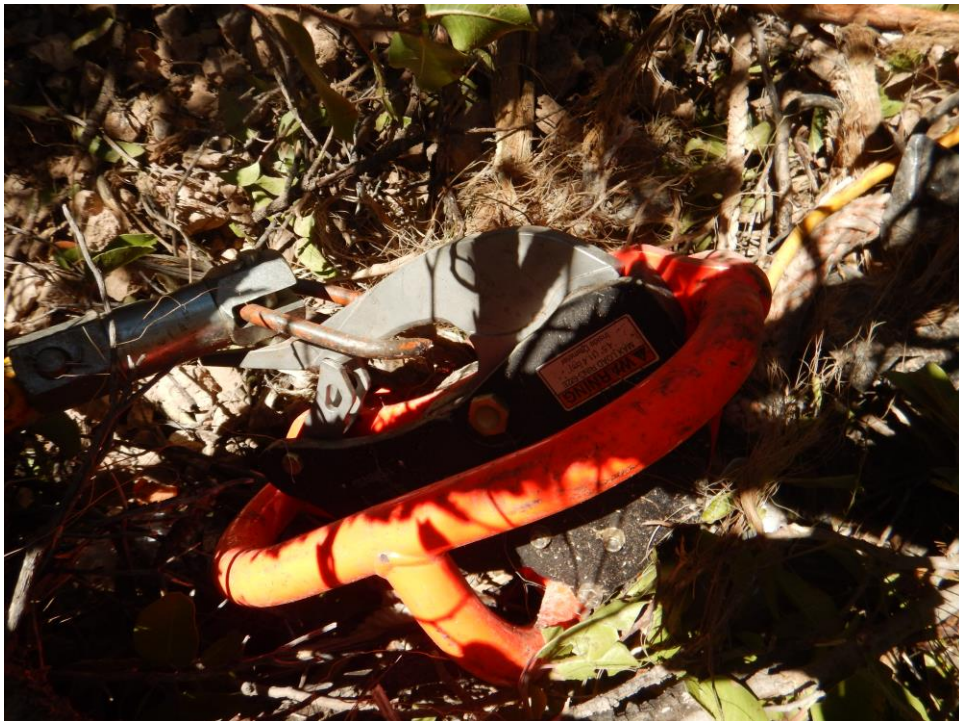
**Figure 48. Long-Line Load Attachment Hook Closed**

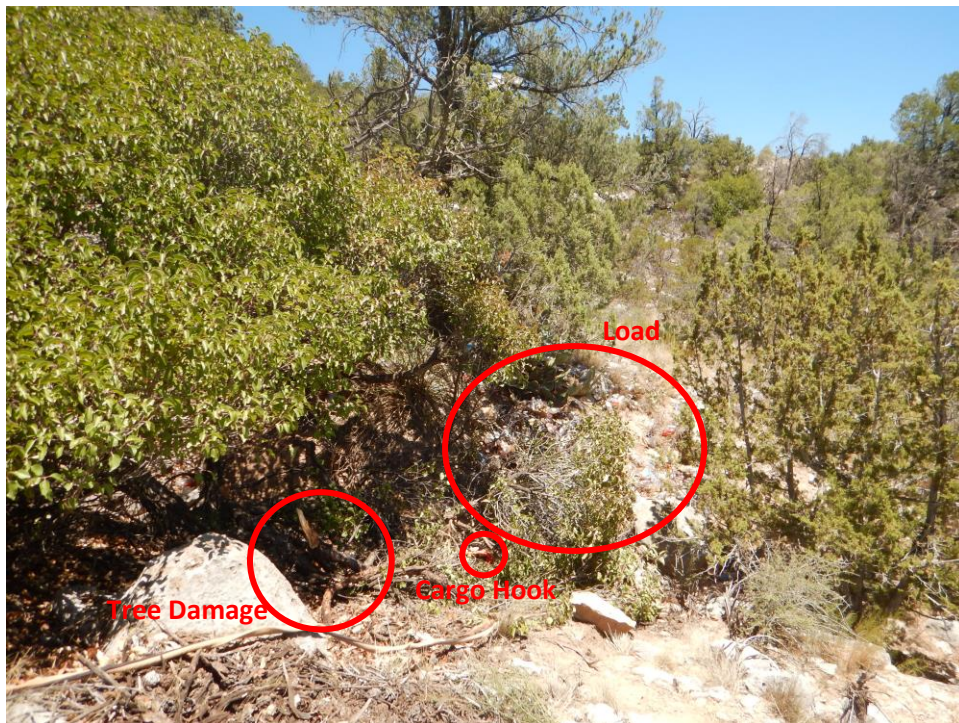
Figure 50. Damage to Tree from Cargo Load (Looking East)

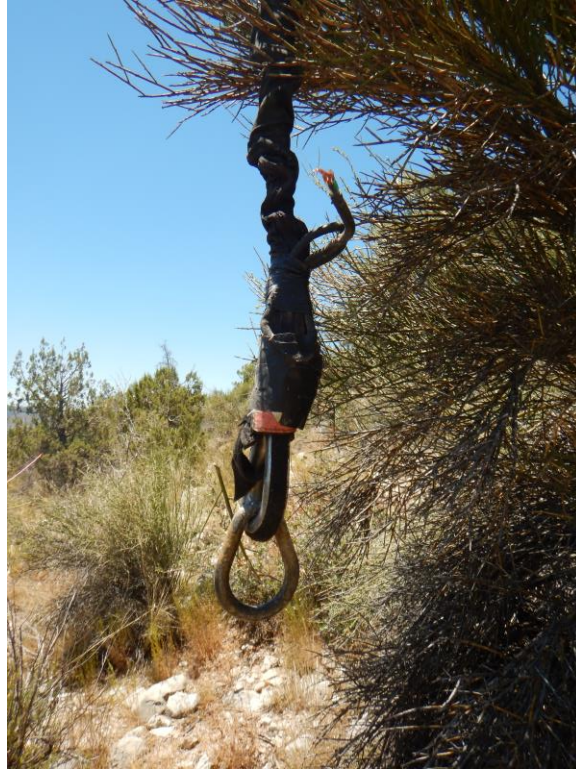
The long-line and cargo load were found southeast of the wreckage. Using GPS coordinates, the distance from the center of the wreckage to the cargo load location was approximately 123 feet on a 111° heading. Figure 46 shows the view uphill to the wreckage from the resting place of the long-line top fitting. The long-line was laying on top of some trees (Figure 47) and the load was found still attached to the bottom hook (Figure 48 and Figure 49). The load appeared to have impacted some trees in an east-northeast direction (Figure 50). The top fitting appeared to be undamaged and there was a wire with exposed ends present (Figure 51).

**Figure 51. Long-Line Top Fitting**
