# NATIONAL TRANSPORTATION SAFETY BOARD

## MATERIALS LABORATORY FACTUAL REPORT

Report No. 21-044

Place : Lake Tahoe, California  
Date : July 7, 2020  
Vehicle : Cessna 172N, N6328D  
NTSB No. : WPR20LA212  
Investigator : Maja Smith, AS-WPR

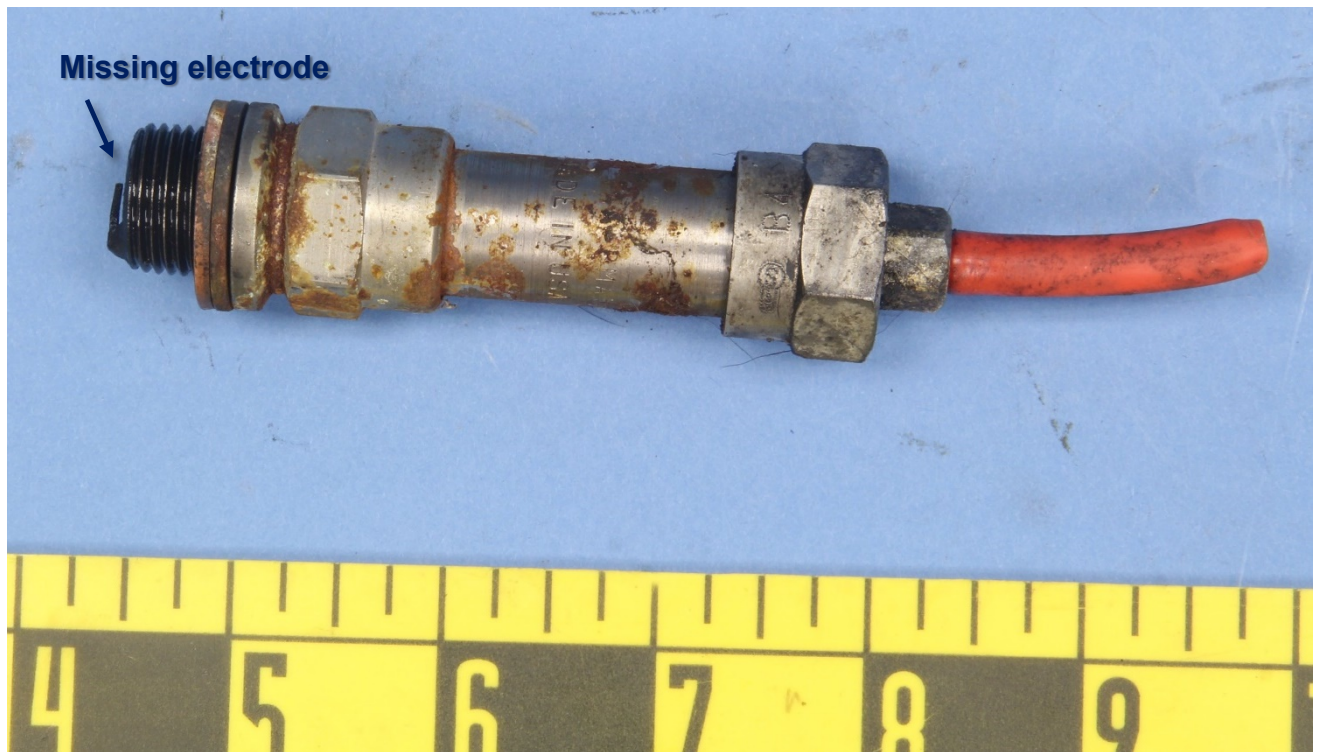
Figure 1 and Figure 2 show the spark plug as received, viewed from the side and firing head respectively. Not pictured was the separated center electrode tip, shown absent in Figure 3. The markings on the side of the spark plug housing indicated the part was a Tempest URHM38S iridium fine wire spark plug.<sup>2</sup> A remnant of the spark plug ignition wire was still inserted into the plug terminal well barrel, and the rubber coated wire exhibited a flat, angled appearance, consistent with having been cut or sectioned.

Figure 1 – View of the spark plug and wire remnant, as received.

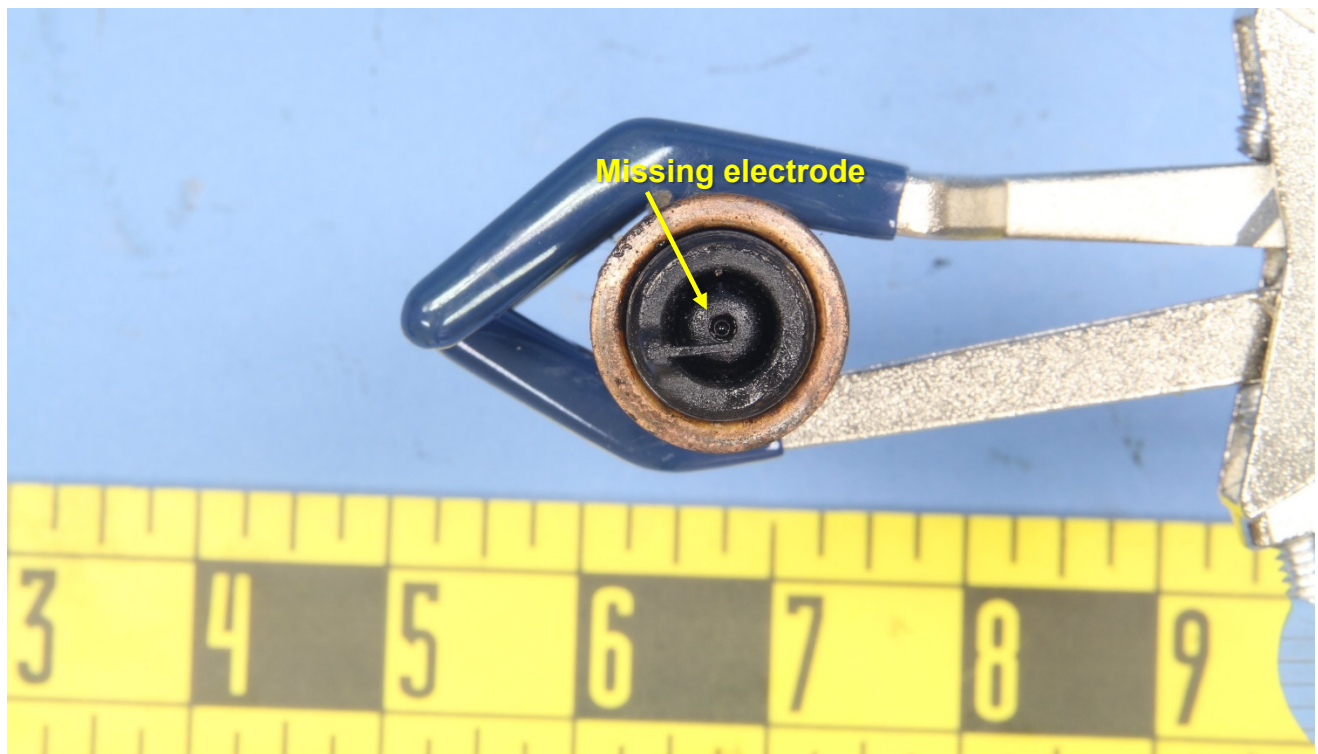
Figure 2 – View of the spark plug head, showing the lateral electrode and the empty slot with the missing central electrode.

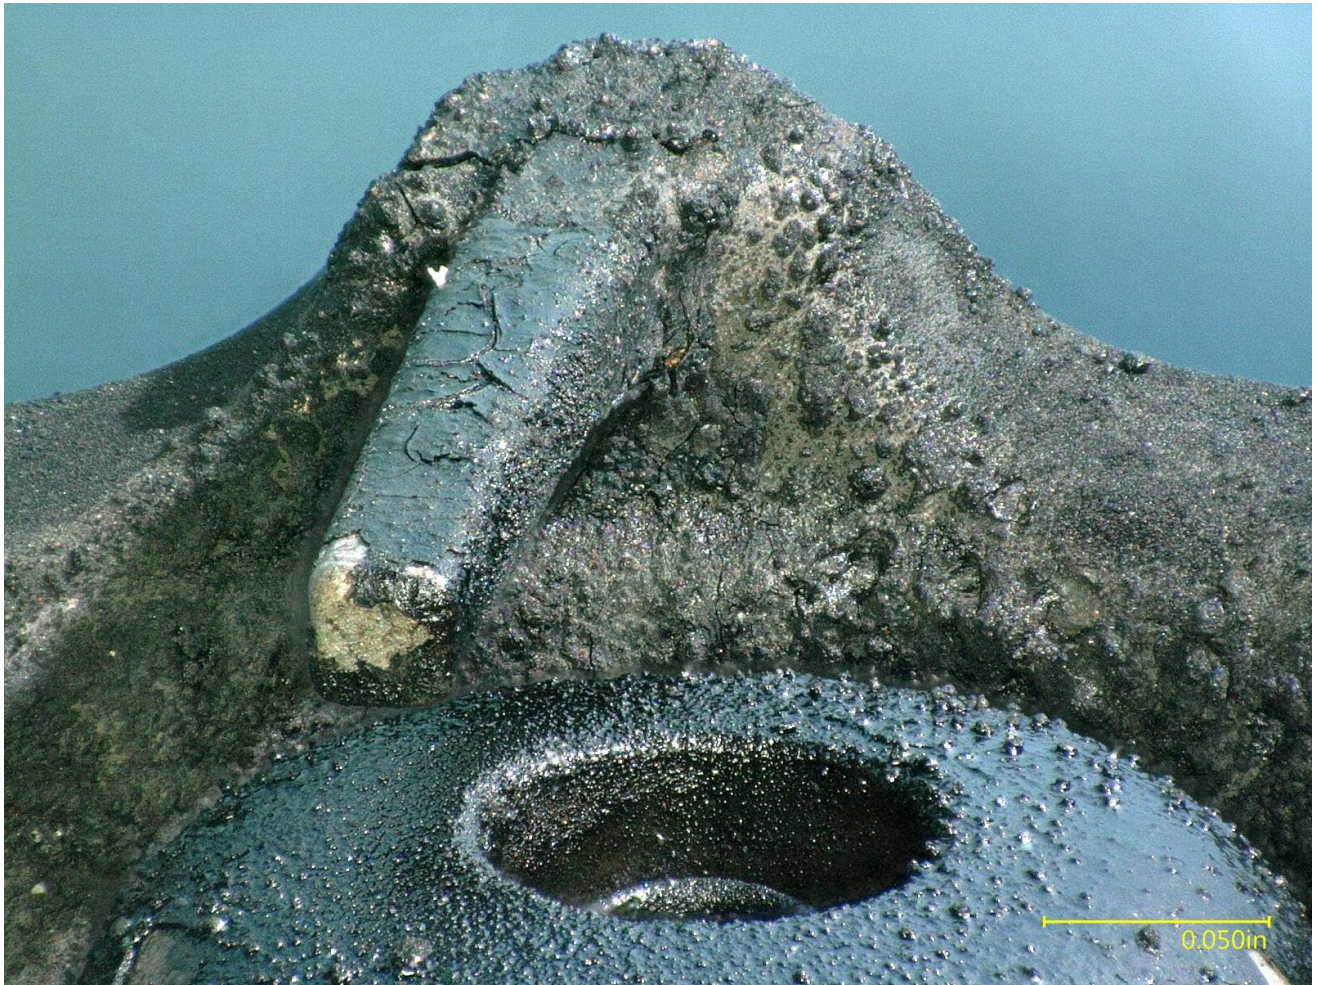
Figure 3 shows an angled view of the firing head of the spark plug, demonstrating the offset of the ground electrode. As shown in this figure, the center electrode tip was no longer attached. All these surfaces exhibited a thick layer of deposits and compounds, consistent with combustion products from inside the cylinder. The deposits were thick enough that they had begun to crack and spall from the spark plug surfaces that had been inside the combustion chamber (see Figure 4 and Figure 5). The deposit thickness was measured up to 0.01 inches.

The ground electrode, shown in a side profile in Figure 5, did not exhibit any upward or downward deformation. Likewise, the position shown in Figure 3 and Figure 4 were consistent with the offset shown in the manufacturer's exemplar catalog and was inconsistent with plastic deformation that would have indicated movement of the subcomponent.

Figure 3 – Side view of the ground electrode of the spark plug head, showing its offset position.

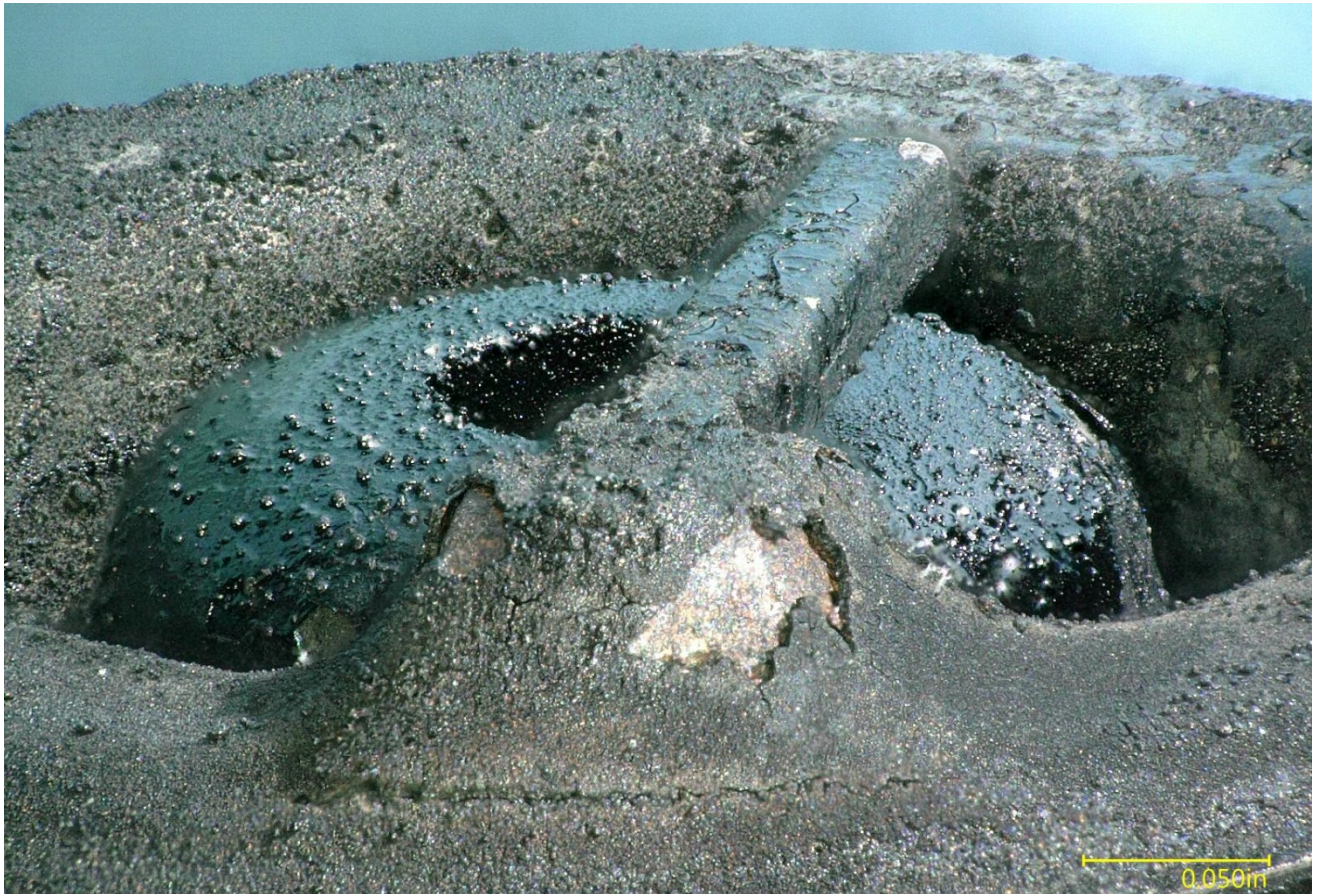
Figure 4 – View outside looking inward of the ground electrode, showing spalling of the deposits.

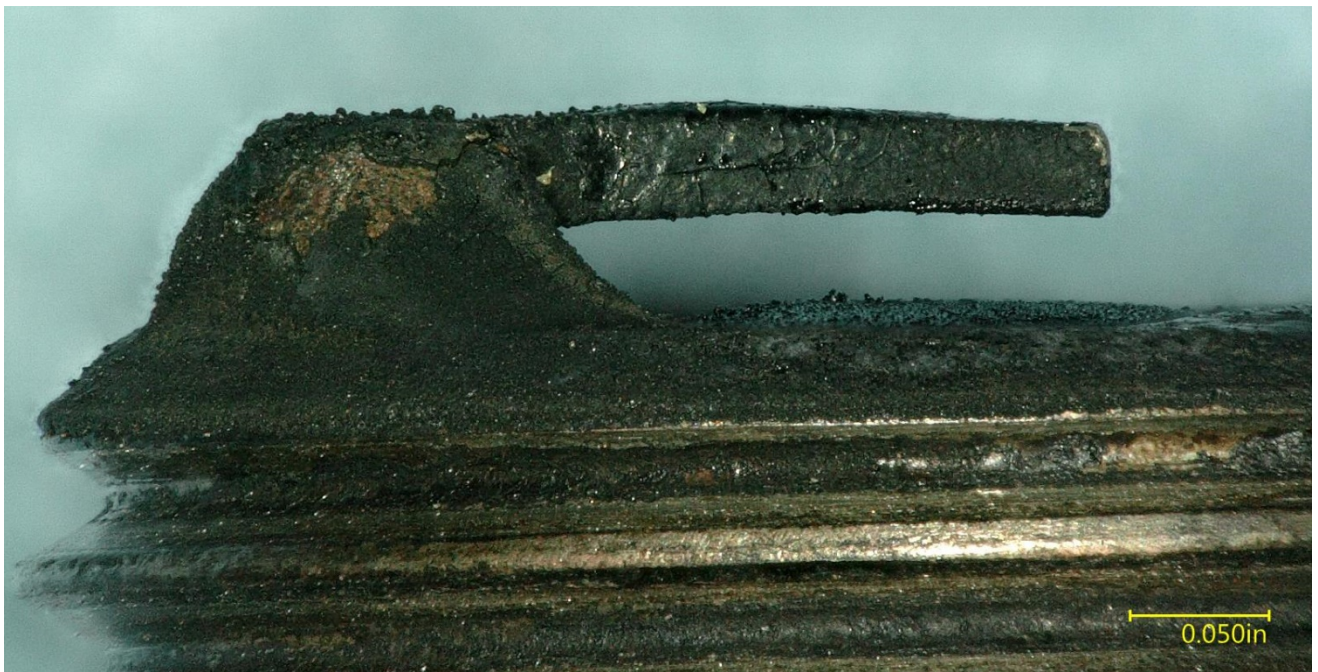
Figure 5 – Side view of the ground electrode.

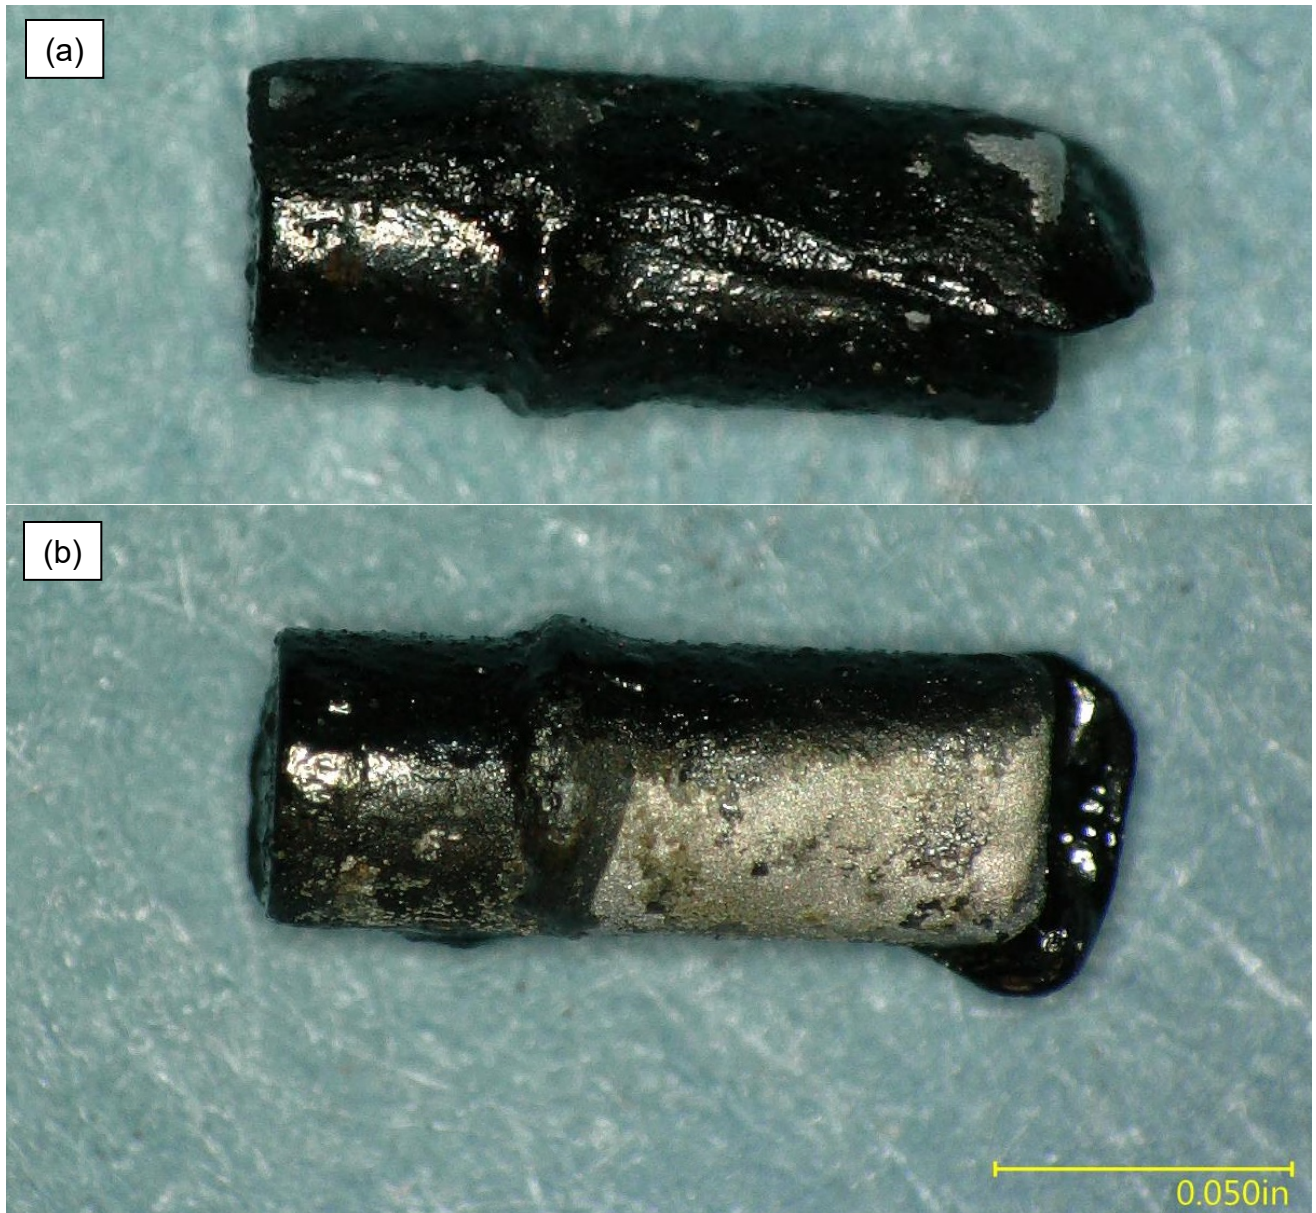
The loose and separated center electrode tip was recovered and was shown from opposite sides in Figure 6. The electrode tip was almost completely covered in dark, reflective compounds, consistent with deposits from the engine combustion. The upward face of the tip surface is positioned to the right in the figures, and the inward facing base surface faces towards the left. The middle of the electrode exhibited a circumferential tapered protrusion, consistent with the position of the weld material where the part had been affixed to the electrode body.

Figure 6 – View of the center electrode, found separated from the spark plug assembly, viewed from 180° rotations (a) and (b). The remnant was covered with dark, glassy deposits.

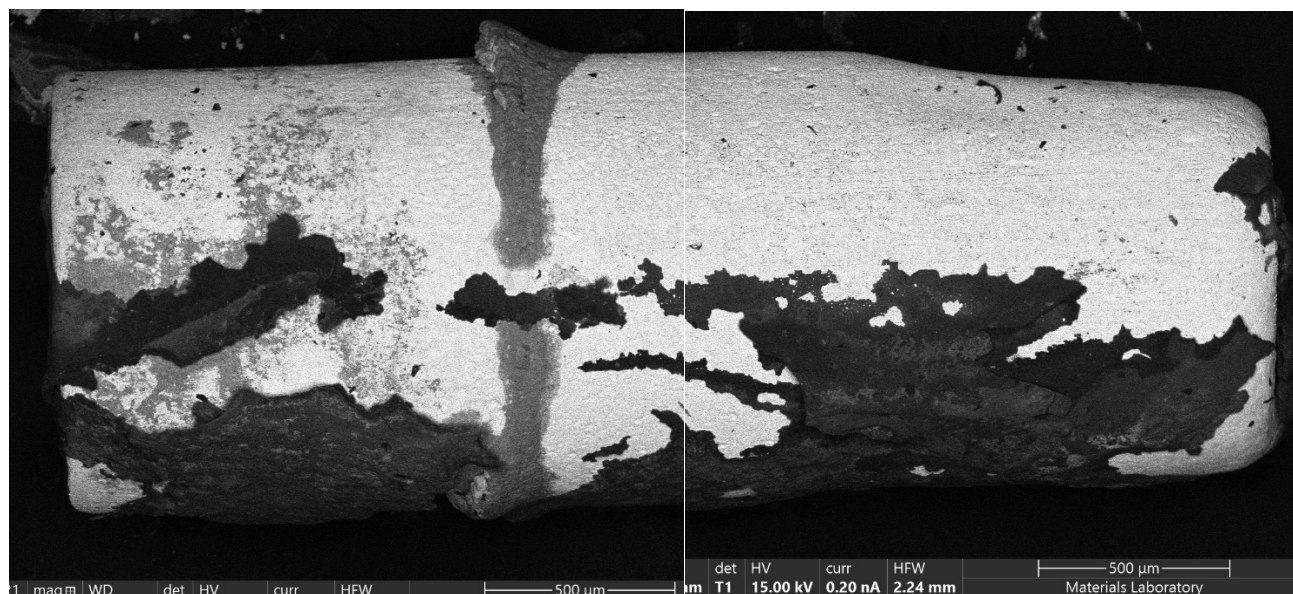
The electrode tip was examined using a scanning electron microscope (SEM). Figure 7 and Figure 8 show backscattered and secondary electron micrograph montages, respectively, of the electrode tip.<sup>5</sup> As shown in Figure 7, the tip exhibited different contrast intensities, consistent with different chemical compositions. The different areas of the tip were examined using energy dispersive x-ray spectroscopy (EDS) to determine the

Figure 7 – Montage of backscattered electron (BE) micrographs of the center electrode remnant, after multiple cleanings (the inner surface is to the left).

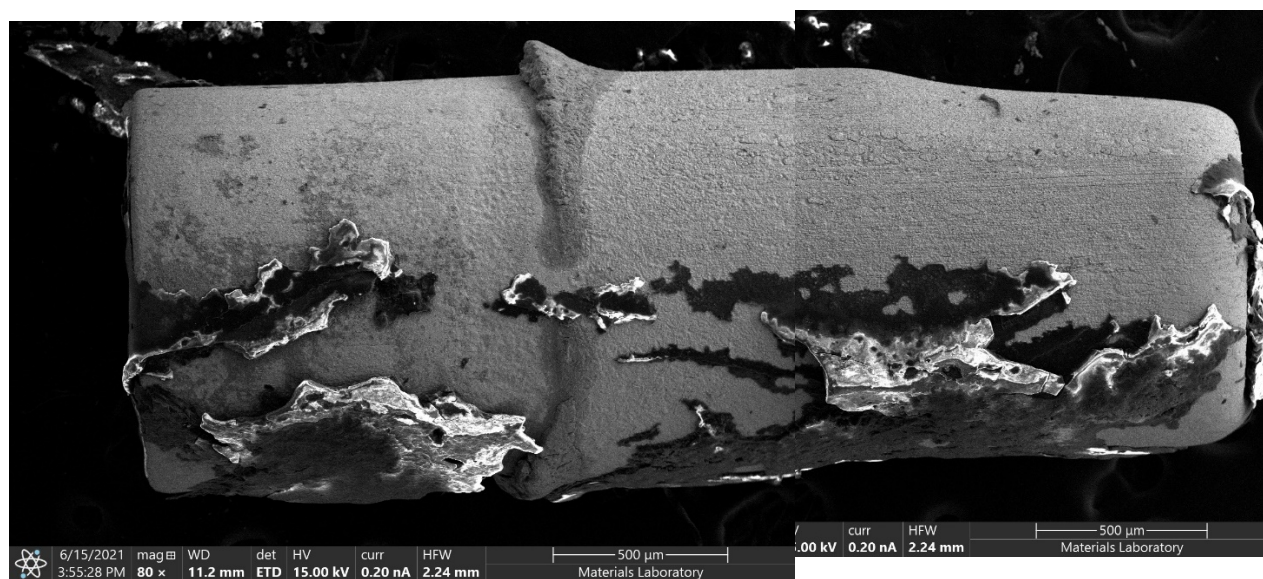
Figure 8 – Montage of secondary electron (SE) micrographs of the center electrode remnant, after multiple cleanings (the upward-facing tip is to the right).

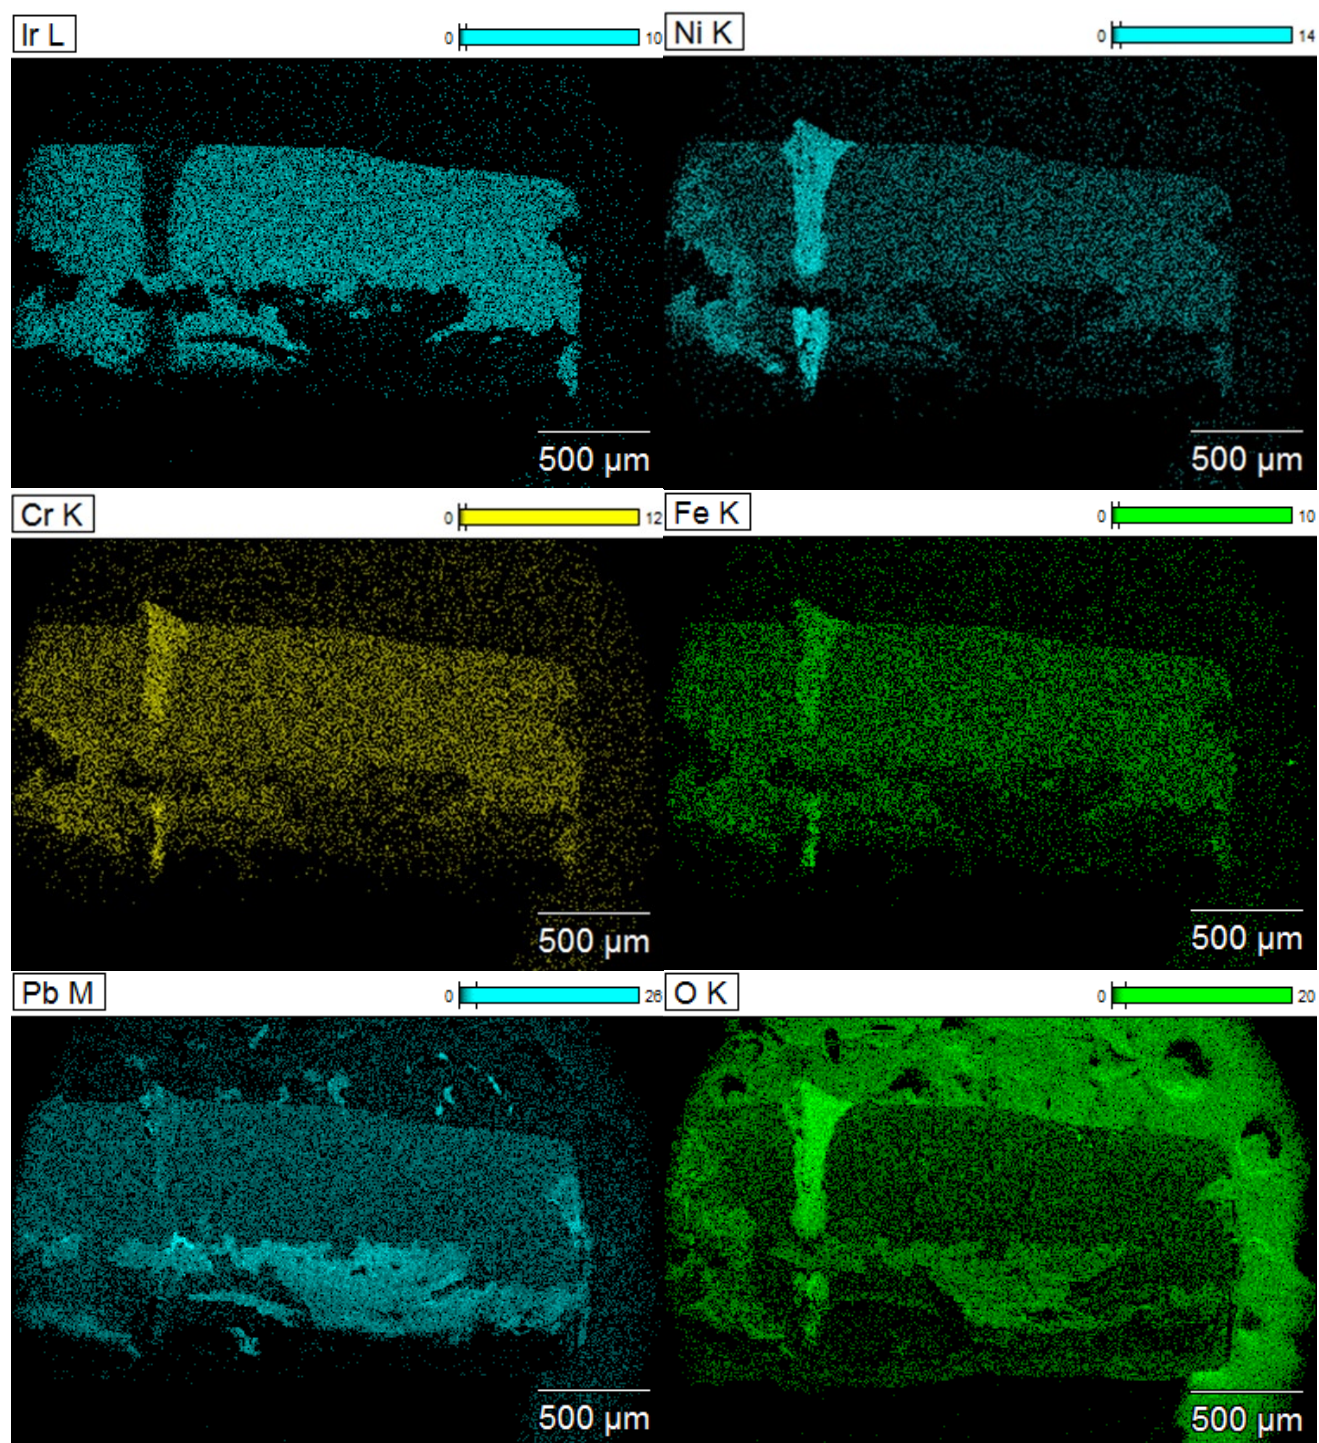
different chemical compositions. As illustrated using x-ray maps in Figure 9, different areas corresponded with heavier and lighter concentrations of various elements.

Figure 9 – X-rays maps of the upper half of the center electrode shown in Figure 7 and 8, displaying areas of concentrations of Ir, Ni, Fe, Cr, Pb, and O (brighter color equals higher concentration; darker color equals lower concentrations).

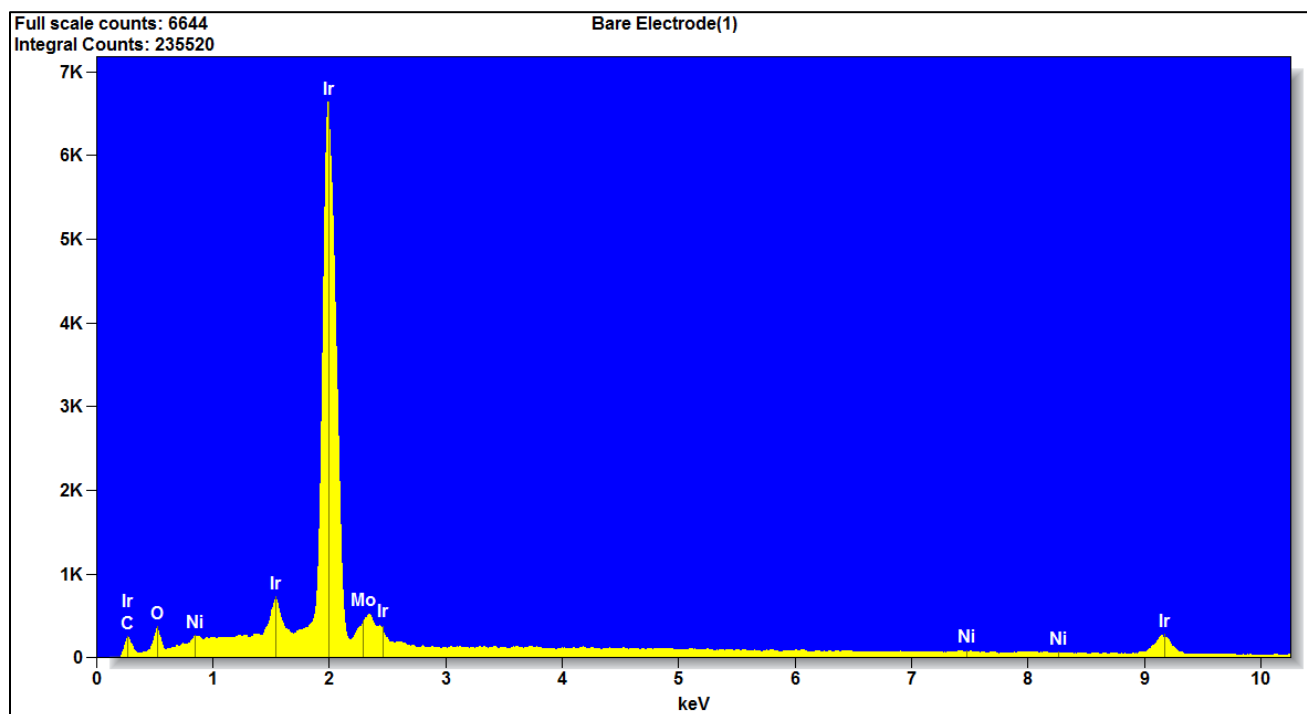
The exposed tip surface exhibited a composition of a nearly pure iridium (Ir) alloy, with minor additions of nickel (Ni), as indicated in Figure 10. The welding material was a Ni alloy with major concentrations of iron (Fe) and chromium (Cr), along with minor amounts of oxygen (O). The darker deposits were found to exhibit high amounts of lead (Pb), bromine (Br), and oxygen (see Figure 11). This composition was consistent with compounds produced from the combustion of brominated tetraethyl lead additives used in avgas. Carbon (C) and sulfur (S) were also found on much of the contaminated areas of the electrode.

Figure 10 – EDS spectrum of the electrode tip material, consistent with an iridium alloy.

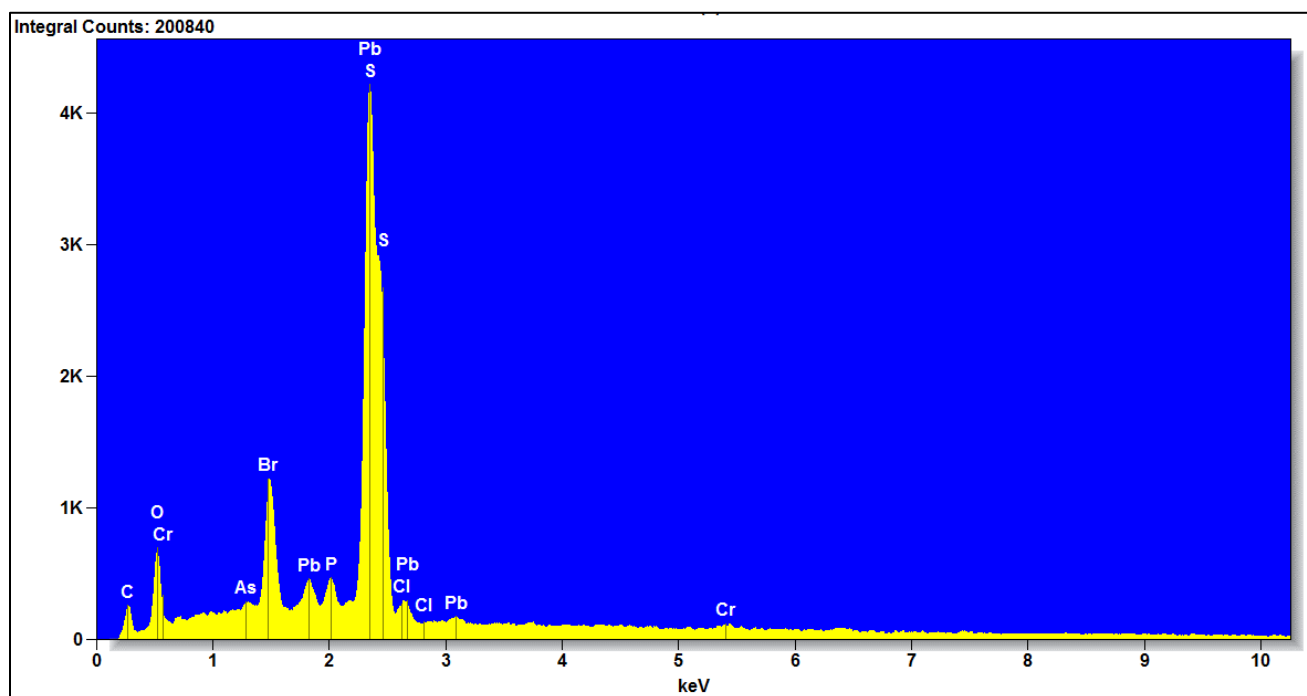
Figure 11 – EDS spectrum of the dark deposits, consistent with lead-based oxides.

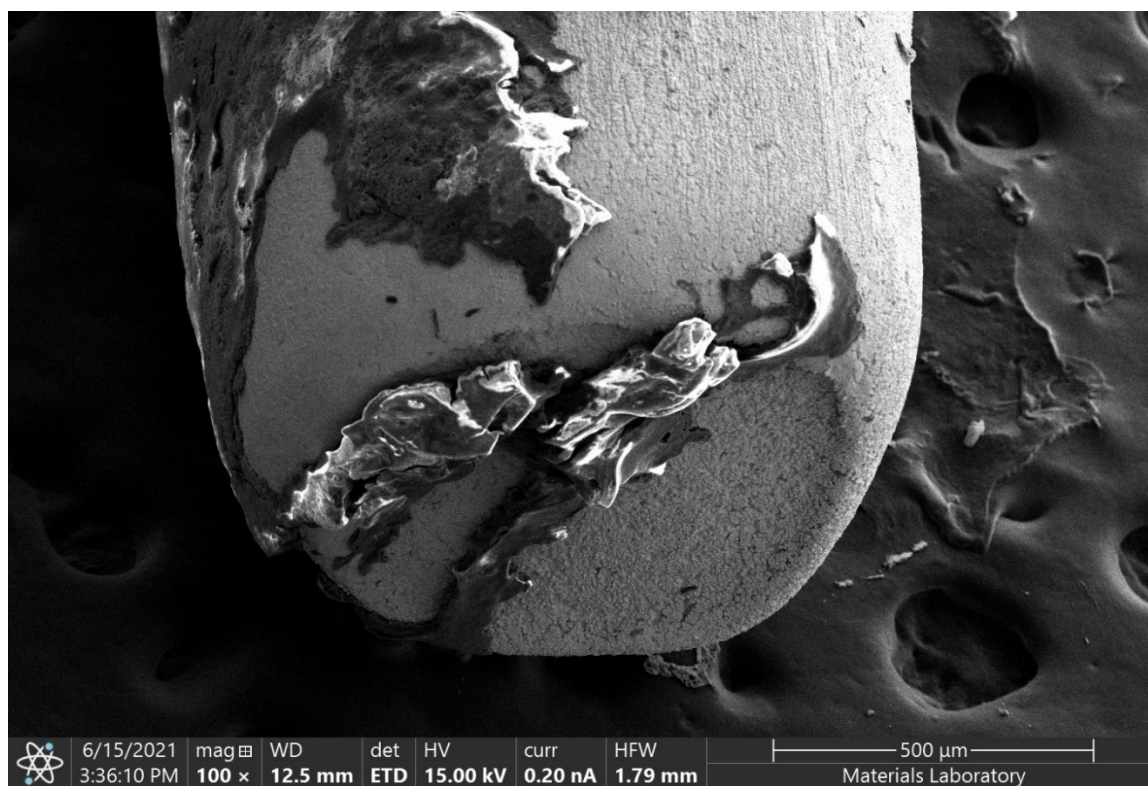
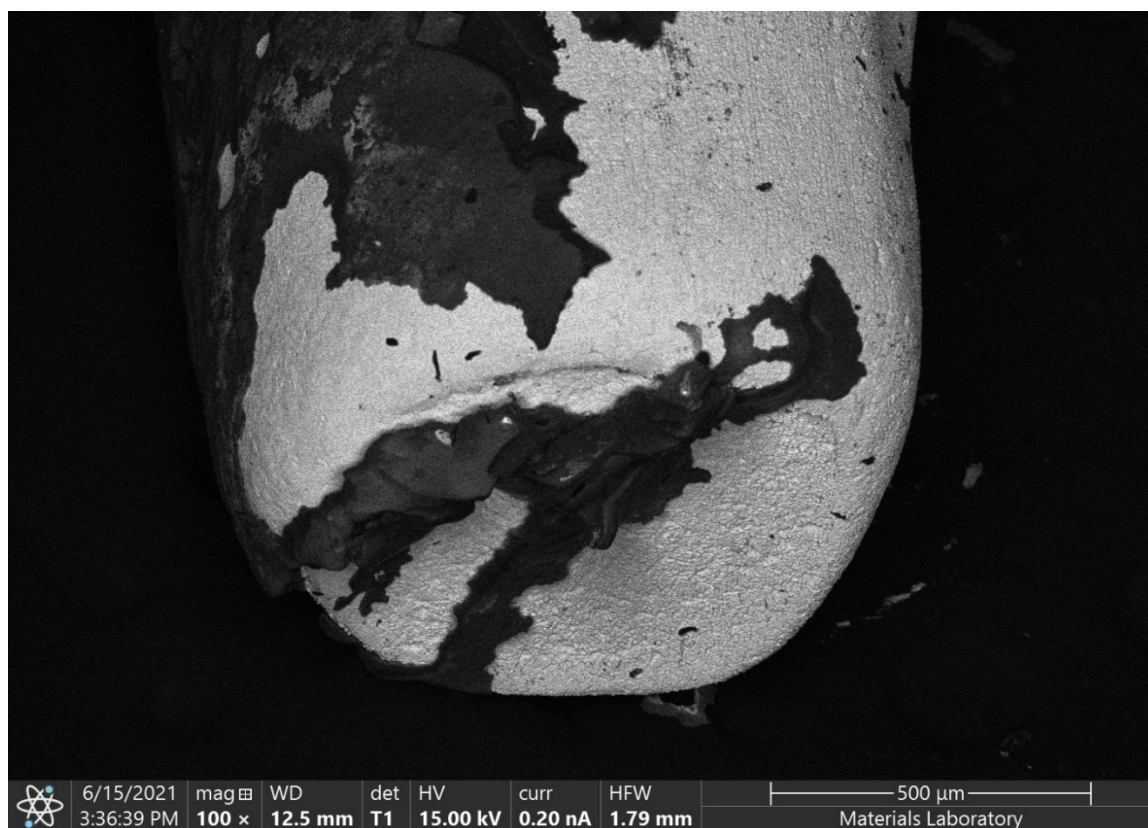
Figure 12 and Figure 13 show the upward face of the electrode tip, which functioned as a surface to create an arc between the lower surface of the ground electrode. The edges of the tip had been rounded upward, along with parallel longitudinal markings. These features were consistent with a machined tapering, visible in the side profile seen in Figure 8. Figure 13 also demonstrates the thickness of the remaining lead oxide deposits on the tip. Figure 14 and Figure 15 show a closer view of the tip upper surface. This surface exhibited equiaxed rounded features, with small cracks between them. These features were consistent with the sintered manufacturing process of iridium parts, as the high melting point makes its alloys difficult to forge or cast. While there was some rounding of the surface features, there were no large divots or spherical deposits suggestive of electrical arcing damage. No indications of Ni deposits were found on this surface, which would have been indicative of arcing. No indications of features consistent with fractures were observed.

Figure 12 – SE micrograph of the electrode tip, after multiple cleanings.

Figure 13 – BE micrograph of the electrode tip, after multiple cleanings.

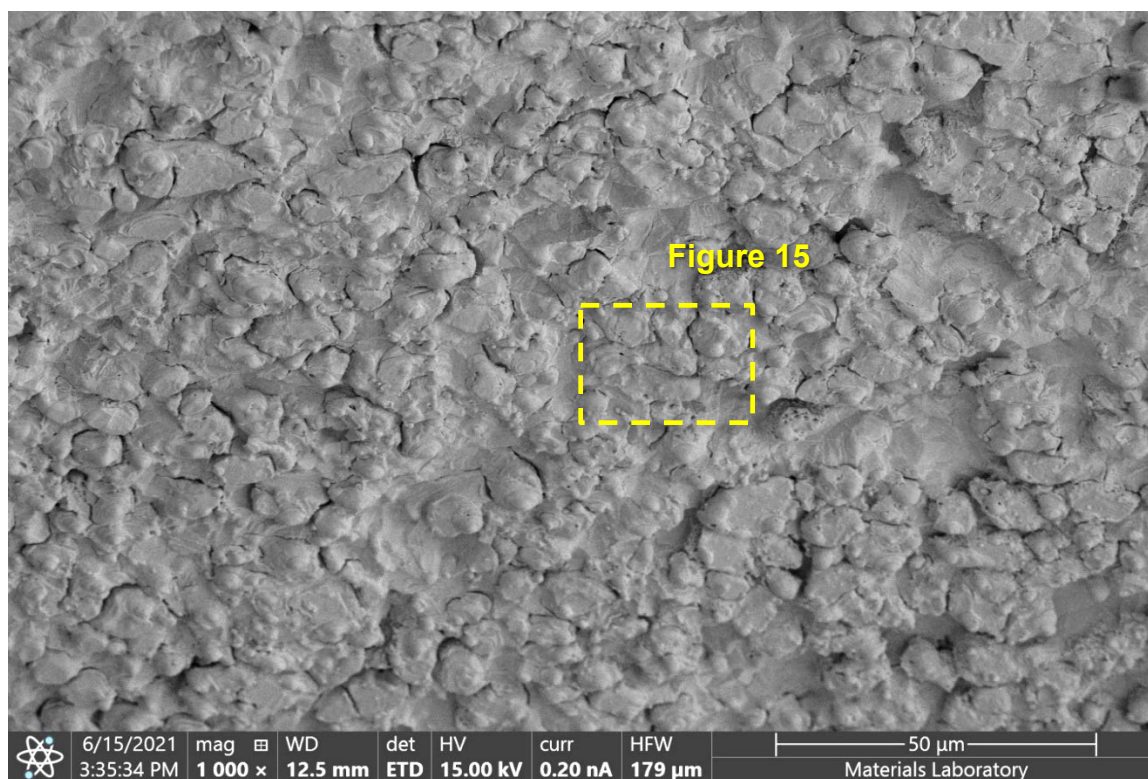
Figure 14 – SE micrograph showing a closer view of the electrode tip surface.

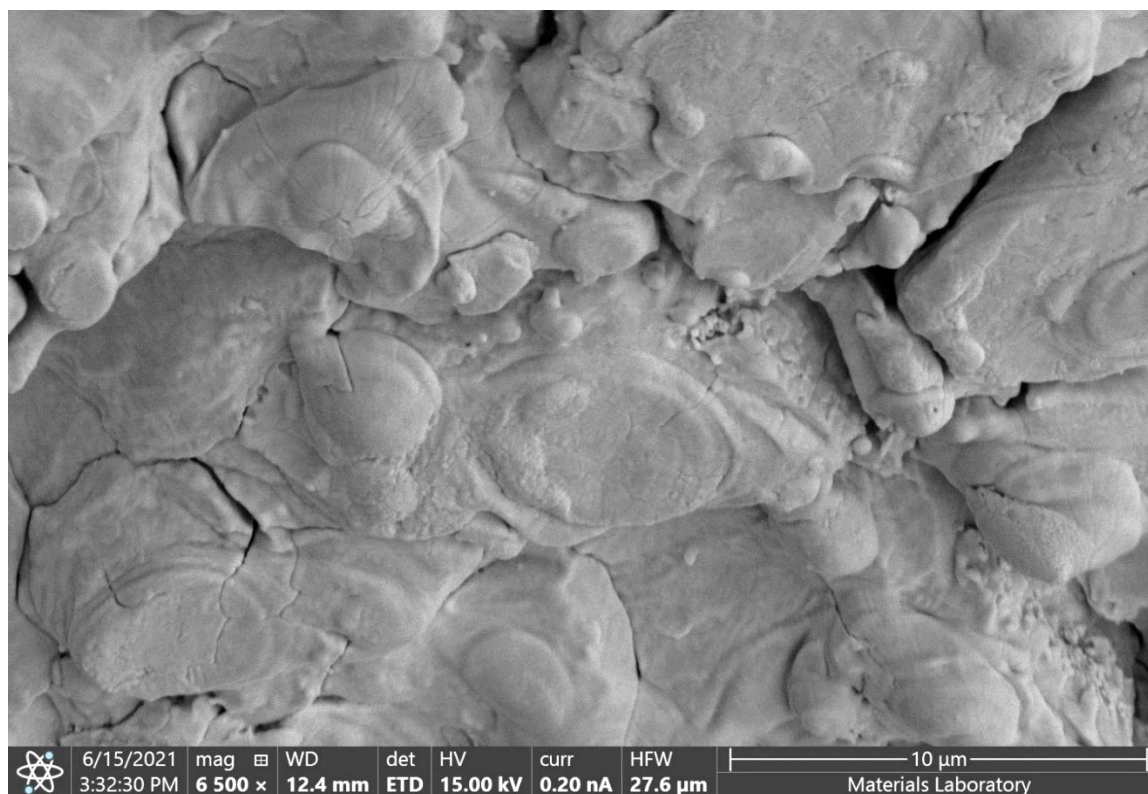
Figure 15 – SE micrograph of the boxed area in Figure 14, showing surface features.

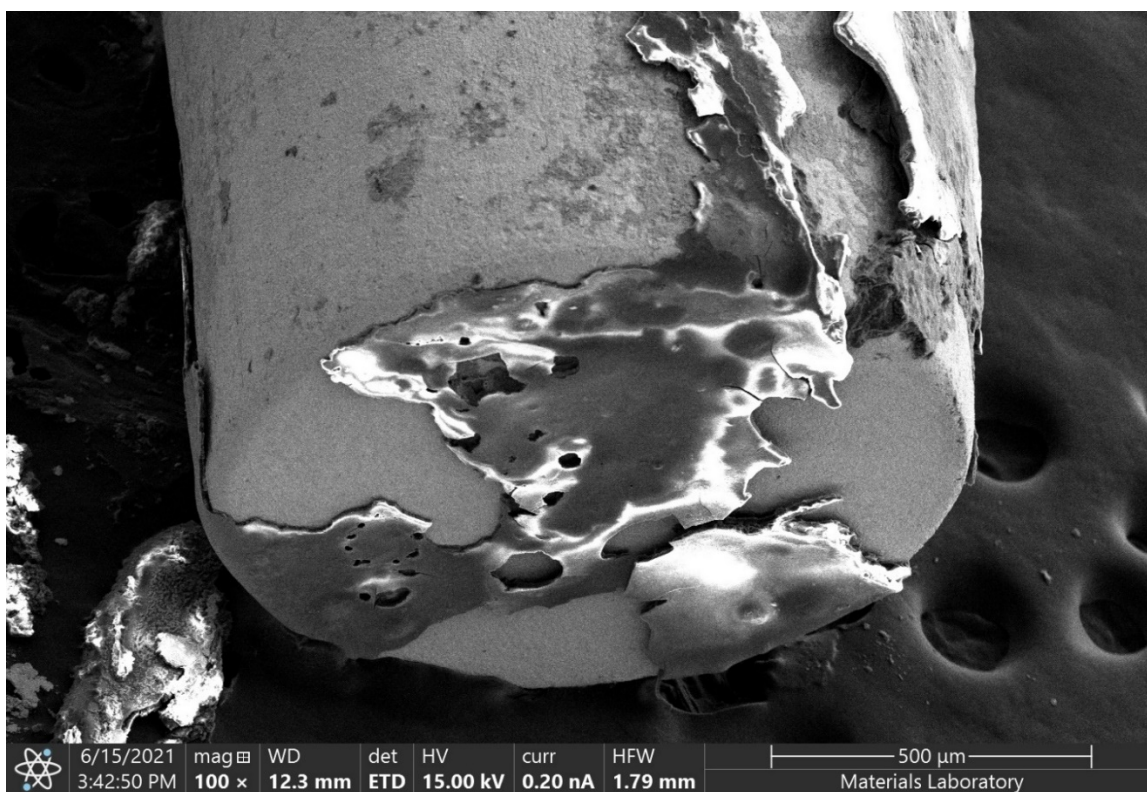
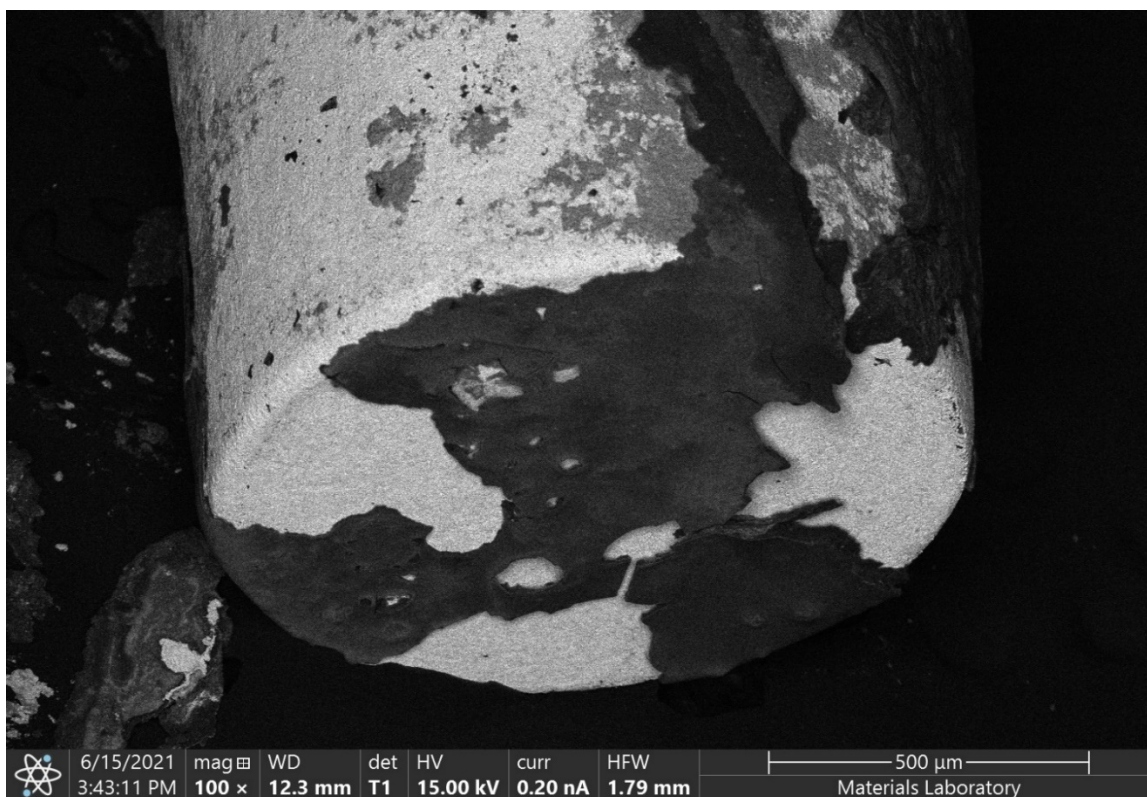
Figure 16 and Figure 17 show the base or inner surface of the electrode tip. Like the other areas of the electrode tip, this area exhibited lead oxide and carbon deposits. A closer view of the surface of the base is illustrated in Figure 18. This surface also exhibited multiple rounded protrusions, consistent with the surface morphology observed on the outward facing tip surface. The base surface did not exhibit comparable shallow cracking as seen on the opposite surface in Figure 15. No indications of fracture features were observed on this surface or along the edges of the base.

Figure 16 – SE micrograph of the electrode tip inner base surface, after cleaning.

Figure 17 – BE micrograph of the electrode tip inner base surface, after cleaning.

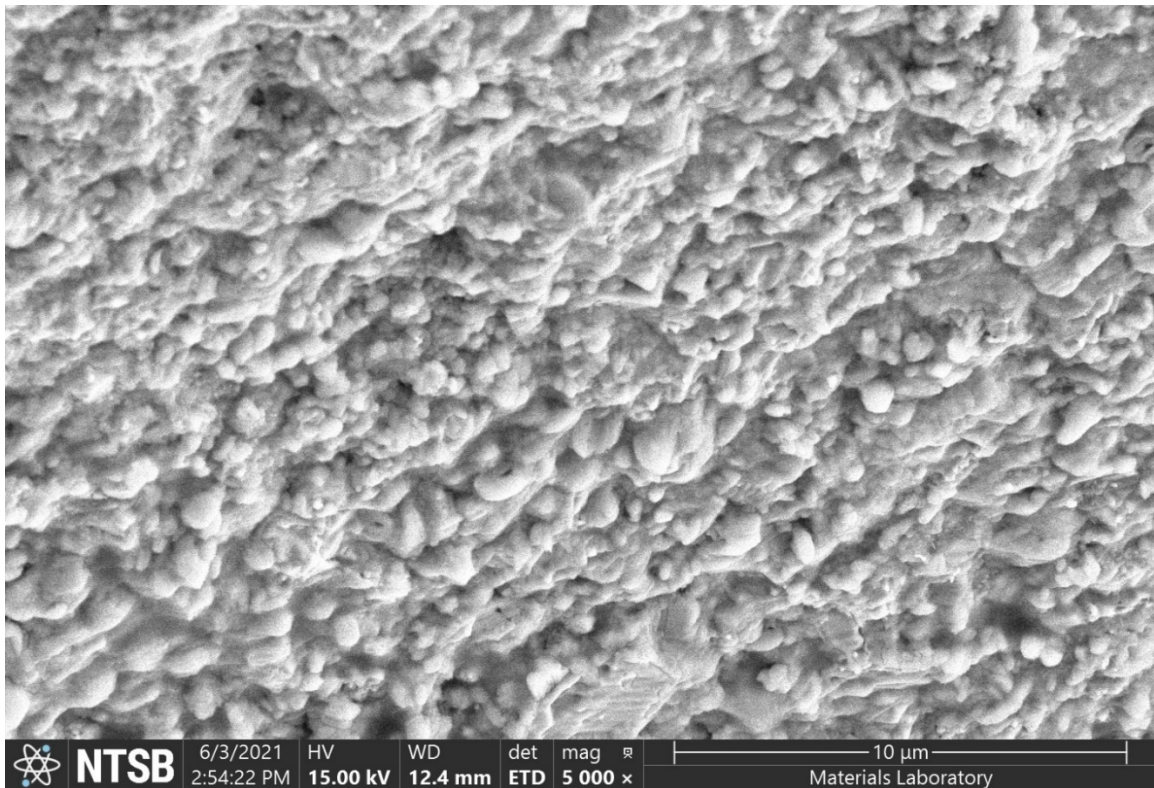
Figure 18 – SE micrograph of a closer view of the electrode tip base surface.

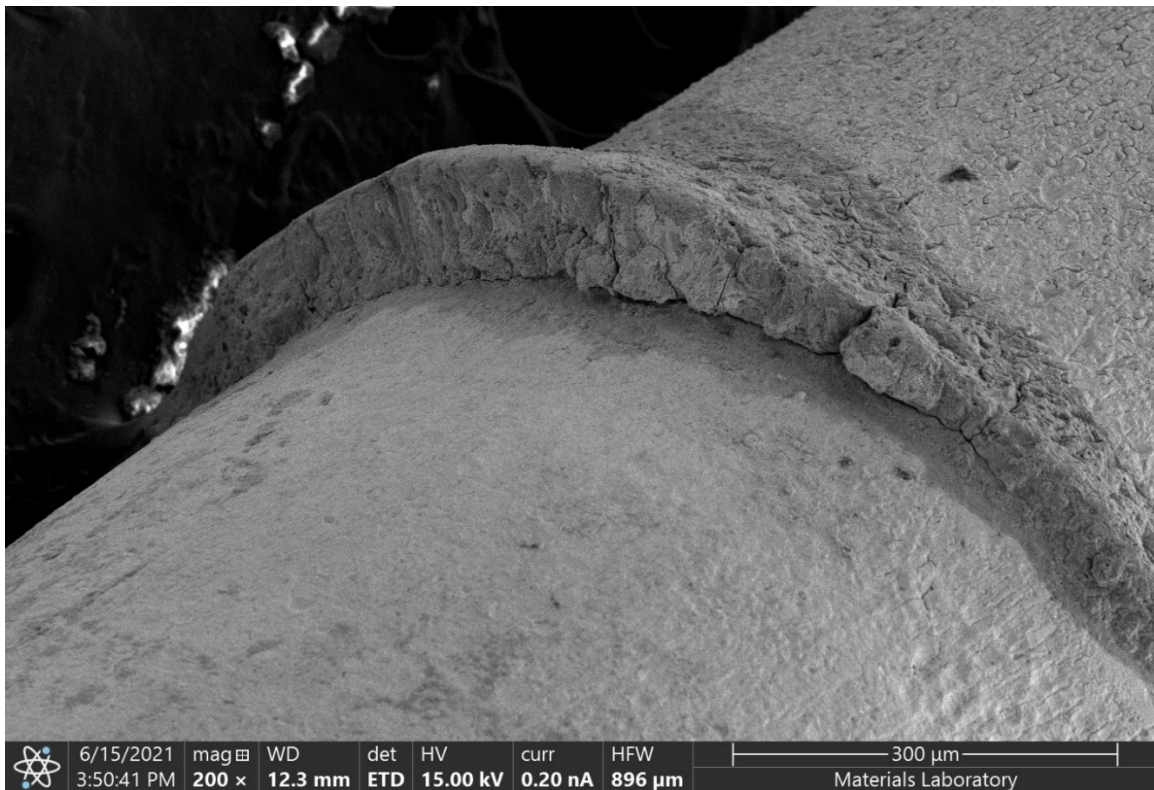
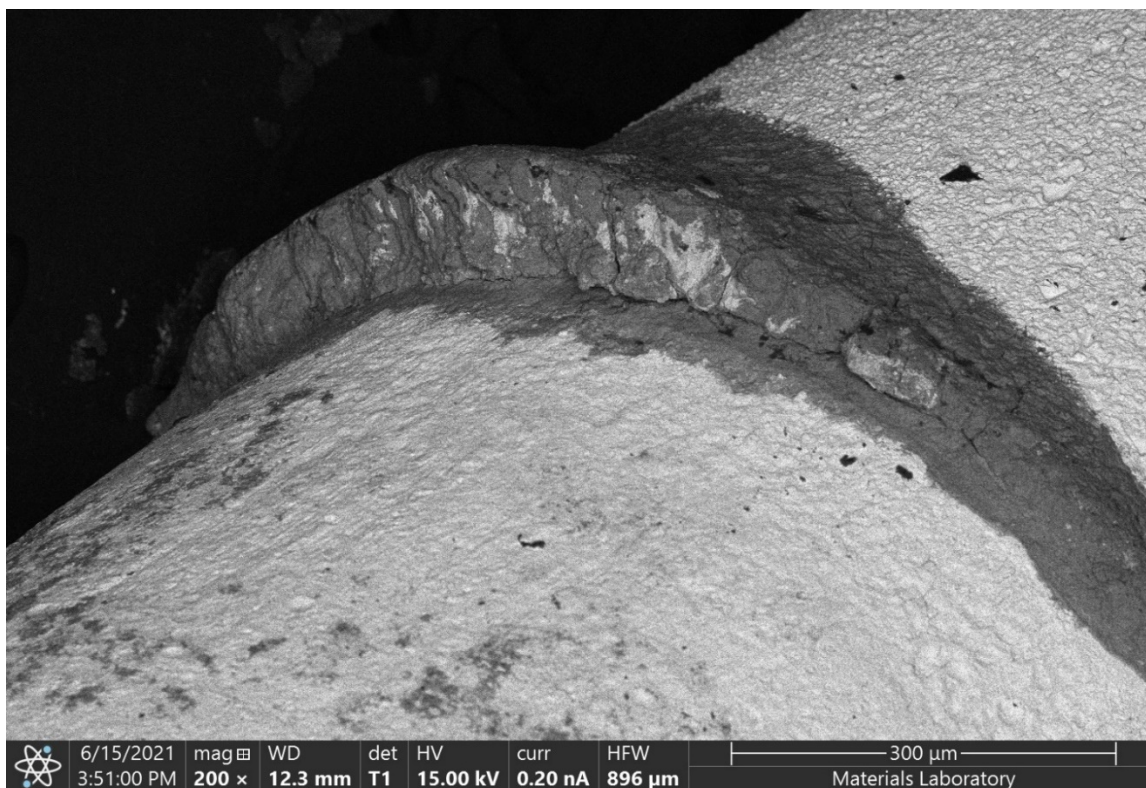
Figure 19 and Figure 20 shows the underside of the welding material remnant located along the middle of the electrode tip cylindrical surfaces. As shown from the electron charging in Figure 20, and the high oxygen content in Figure 9, much of the surfaces of this material had been oxidized and were non-conductive. The lower surface of the welding material was generally flat in orientation and protruded outward perpendicular to the electrode tip. The upper surface was tapered upward toward the electrode tip cylindrical exterior. These features were typical of a fillet weld process that would have been used to join the tip to the electrode base.

Figure 19 – SE micrograph of the fracture surface of the weld material underside on the middle of the tip cylindrical surface.

Figure 20 – BE micrograph of the underside of the tip weld material in Figure 19.
