# NATIONAL TRANSPORTATION SAFETY BOARD

## MATERIALS LABORATORY FACTUAL REPORT

Report No. 21-044

Place : Lake Tahoe, California  
Date : July 7, 2020  
Vehicle : Cessna 172N, N6328D  
NTSB No. : WPR20LA212  
Investigator : Maja Smith, AS-WPR

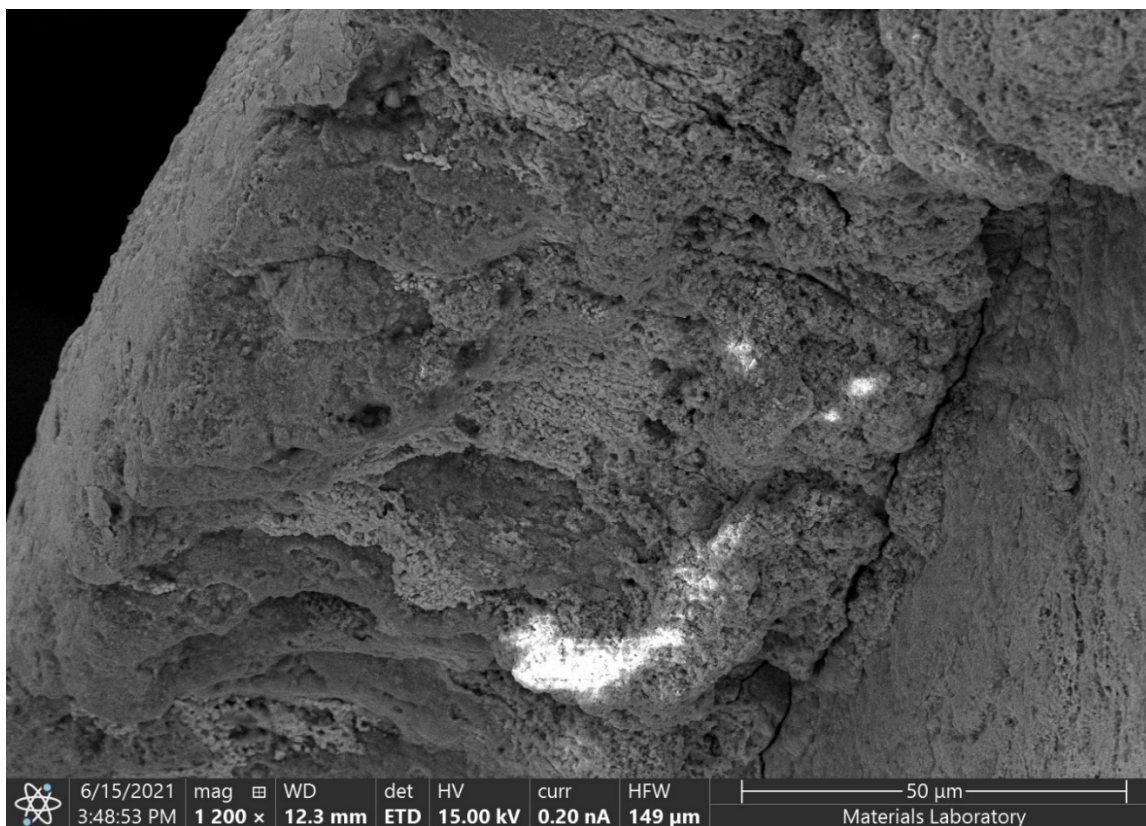
Figure 21 – SE micrograph of the weld material fracture surface.

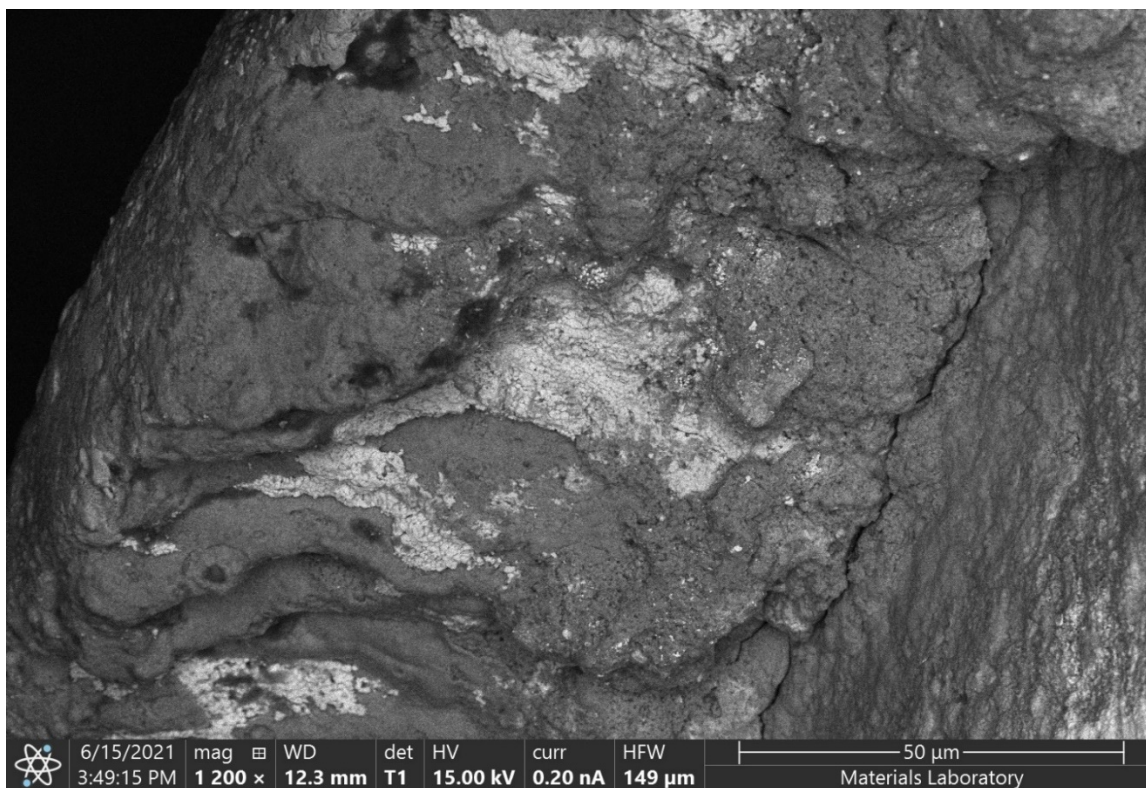
The underside of the weld material exhibited features consistent with fracture. The surface was generally rough in texture. However, the oxidation of the material obscured many of the features, as demonstrated by the lack of light areas in Figure 22. The fracture

Figure 22 – BE micrograph of the underside of the weld material fracture surface.

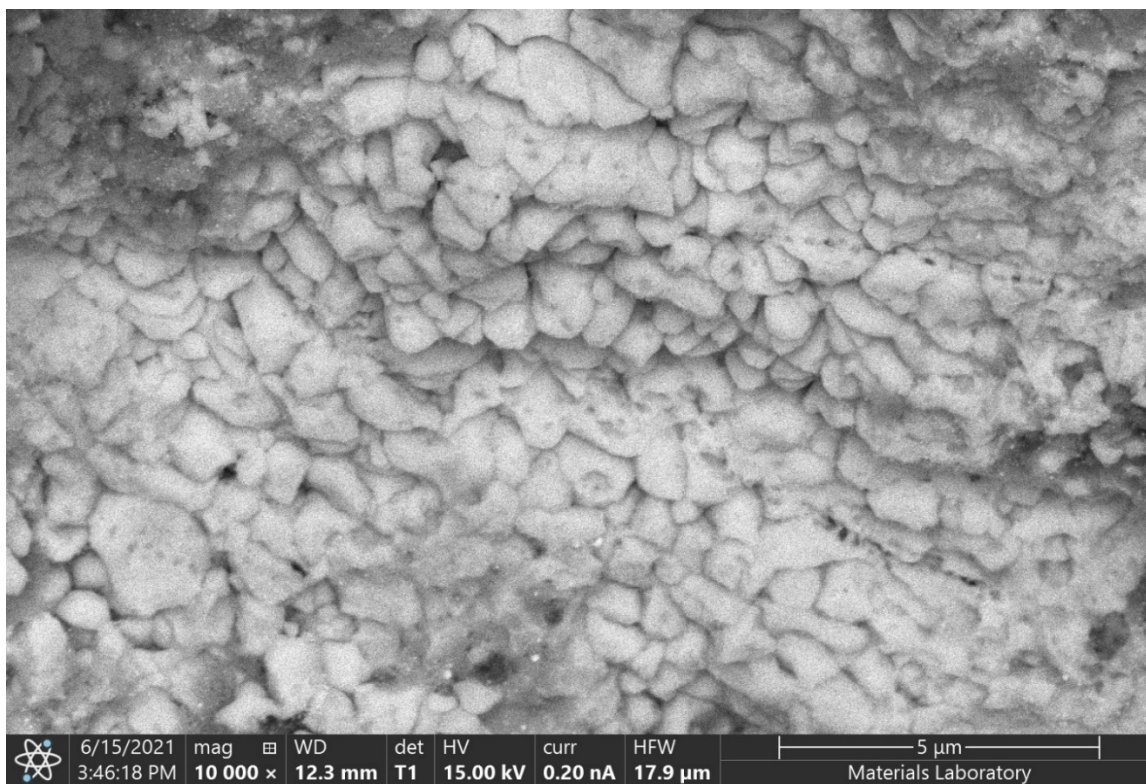
features that were able to be examined exhibited faceted features, as illustrated in Figure 23.

Figure 23 – BE micrograph of the weld material underside fracture surface.
