**NATIONAL TRANSPORTATION SAFETY BOARD**

**AIRFRAME AND ENGINE EXAMINATION**

**WPR20LA212**

Aircraft: Cessna 172

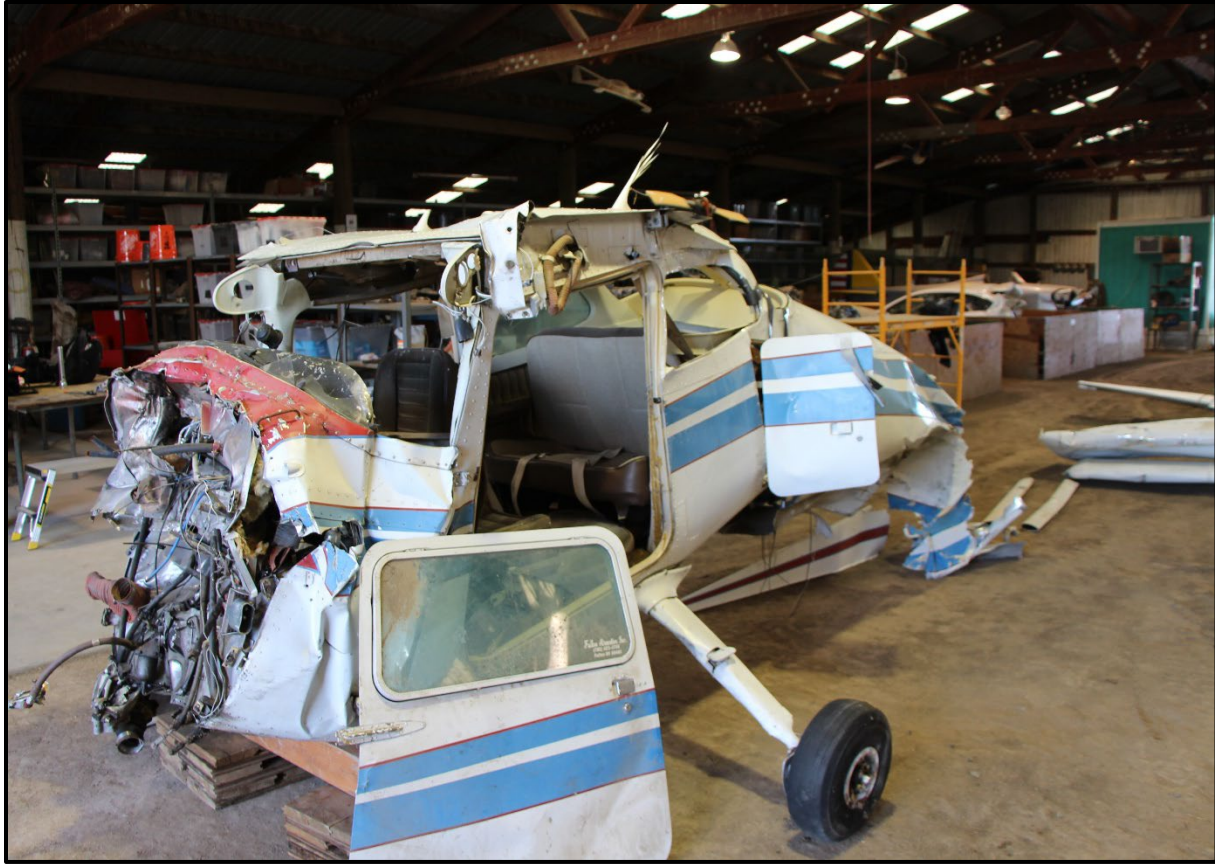
Photograph 1: Cockpit and Fuselage

All four corners of the airplane were accounted for prior to the commencement of the exam. The fuselage displayed compression wrinkling, buckling, and the airframe skin was torn aft of the cabin. The right wing was intact while the left wing had separated into two pieces about midspan with a large concave shaped depression along the midspan leading edge. The tail, which was comprised of the horizontal stabilizer, elevators, rudder, and vertical stabilizer, were intact. The vertical stabilizer was bent several degrees left and a depression was observed on the leading edge.

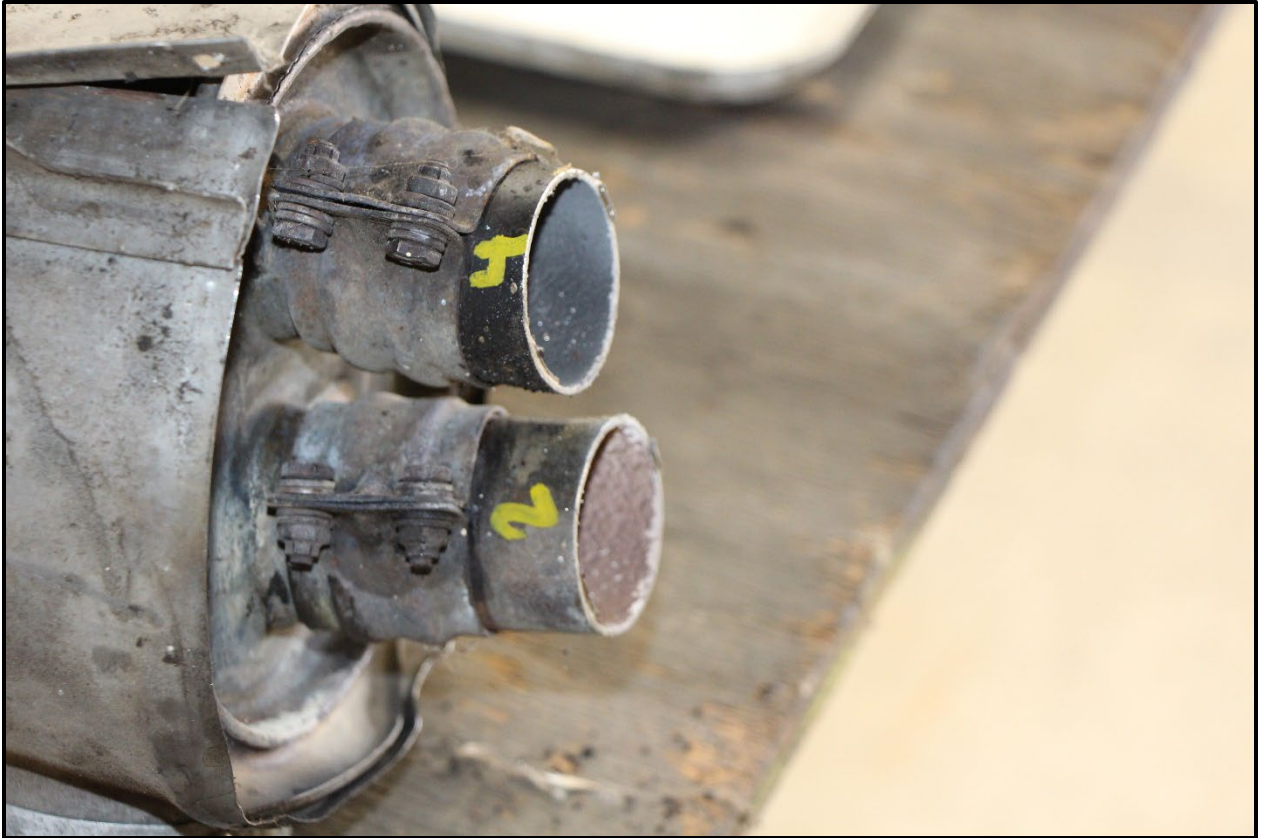
Photograph 2: Cylinder 2 and Cylinder 4 Exhaust Tubes at Exhaust Shroud

The engine exhaust baffling was not present, but the internal walls of the muffler and the inside of the cylinder 1, 2-3 exhaust tubes were brown in appearance, consistent with normal operation. The inside of the cylinder 4 exhaust tube was black, consistent with a rich fuel/air mixture operating setting.

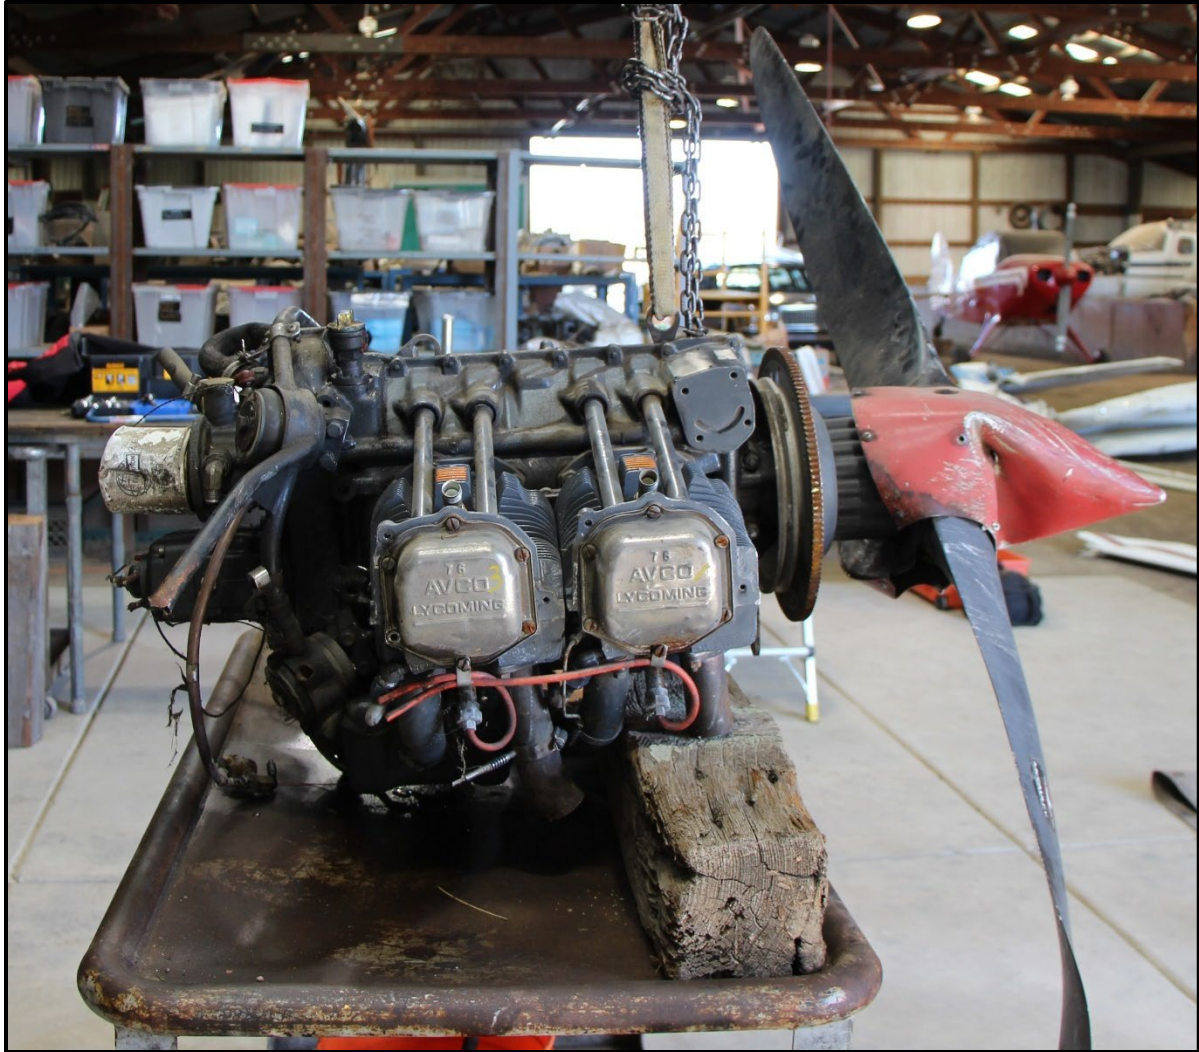
Photograph 3: Engine with Baffling and Exhaust Removed

The engine baffling, starter and alternator were removed prior to the engine examination. Mechanical continuity was established throughout the rotating group, valve train and accessory section as the crankshaft was manually rotated with the propeller. During rotation, thumb compression in the proper firing order was achieved for cylinders 1 and 2 with low compression at cylinders 3 and 4. A borescope examination of the cylinder 3 and 4 exhaust valves revealed carbon deposits around the exhaust valve seats at both cylinders. Thumb compression was subsequently achieved for these cylinders after the exhaust valves seats were staked. The rocker assemblies and rocker boxes at each cylinder were heavily varnished, but each rocker arm displayed normal lift when the crankshaft was rotated by hand. Examination of the interior components using a lighted borescope revealed no indications of catastrophic engine failure.

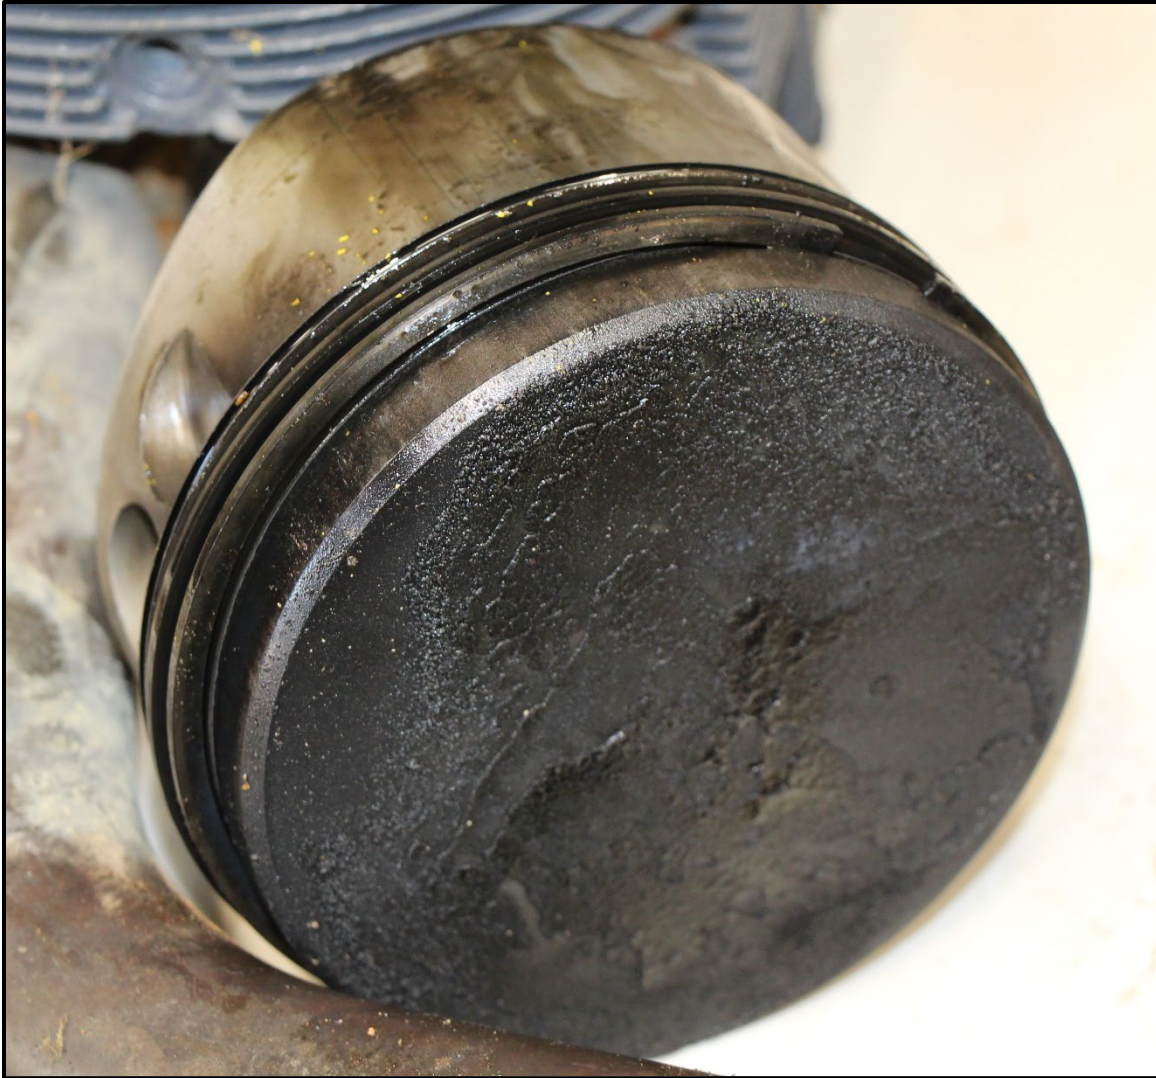
Photograph 4: Cylinder 4 Piston

Cylinder no. 4 was removed from the engine case. The cylinder barrel walls' appearance was characteristic of chrome cylinder plating. The piston face displayed significant carbon buildup, not consistent with a low time cylinder. The piston rings were intact and unremarkable.

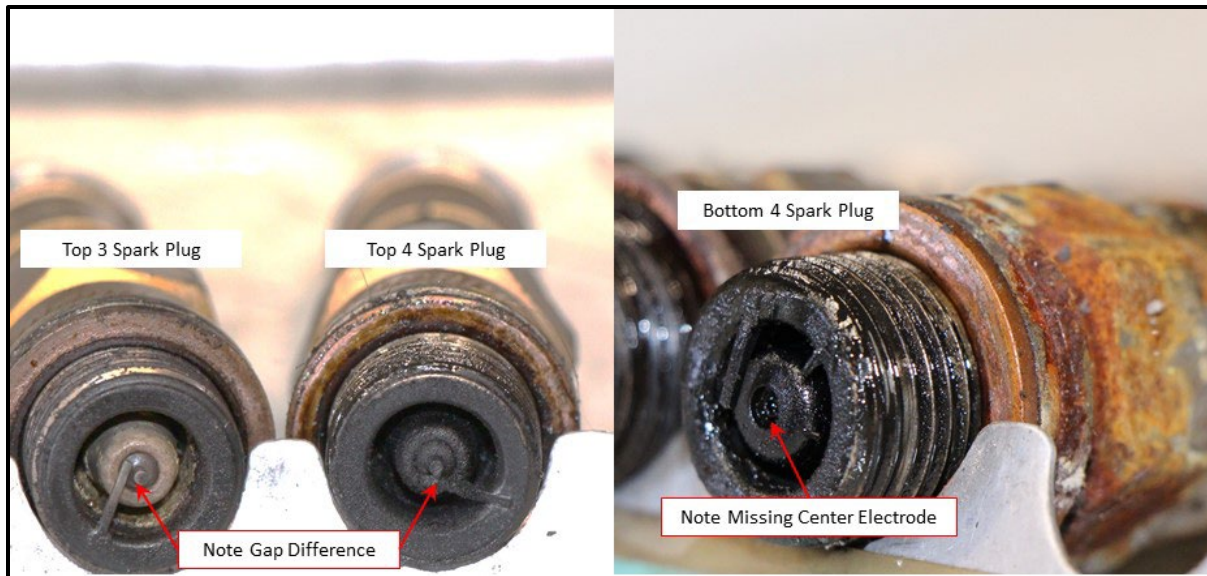
Figure 1: Cylinder 4 Spark Plugs with Top 3 Cylinder Spark Plug Reference

The top spark plugs were Champion RHM-38S and the bottom spark plugs were Tempest UREM-38S. Each spark plug was tightly secured to its respective cylinder and the plugs electrode did not exhibit any signs of mechanical damage, with exception of the cylinder 4 bottom spark plug, which had a separated center electrode. Both the top and bottom spark plugs to cylinder 4 were dark with heavy carbon soot, consistent with a rich fuel/air mixture. The cylinder 4 top spark plug did not show a visible electrode gap. Additionally, the top spark plug to cylinder no. 1 contained an oil film. The remaining spark plugs were gray in appearance, consistent with normal wear.
