## RECORD OF CONVERSATION

**Date: August 11, 2020**  
**Person Contacted: Mr. Bill Shinn (FAA Aviation Safety Inspector – Airworthiness)**  
**NTSB Accident Number: WPR20LA215**

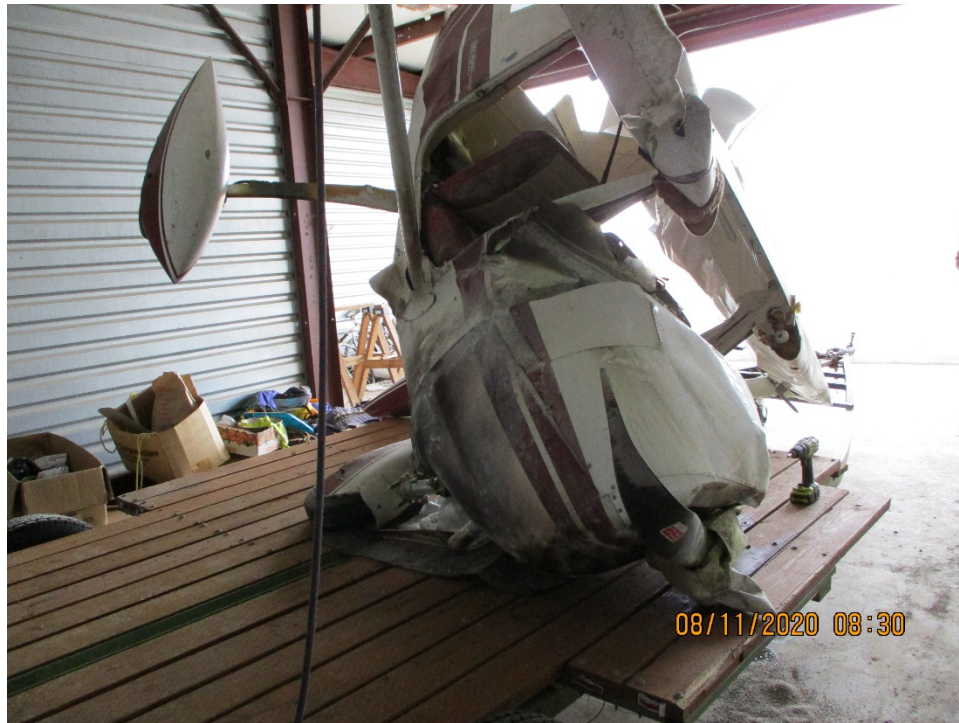
*Figure 1: Overall View of Airplane*

- The airplane exhibited extensive aft crush damage to the forward fuselage
  - The engine was pushed aft into the firewall and upward
  - Thermal damage was present to the cowling and accessory section of the engine.

- The engine was coated in fire suppressant residue (from first responders)
  - The cabin area remained mostly intact
  - The pilots shoulder harness upper attachment point showed signs of elongation or “pull through” at the bolt hole.

- The left and right wings were cut about midspan to facilitate recovery.
  - The aft fuselage was cut aft of the cabin for recovery.
- The fuel system continuity was established throughout the airplane.

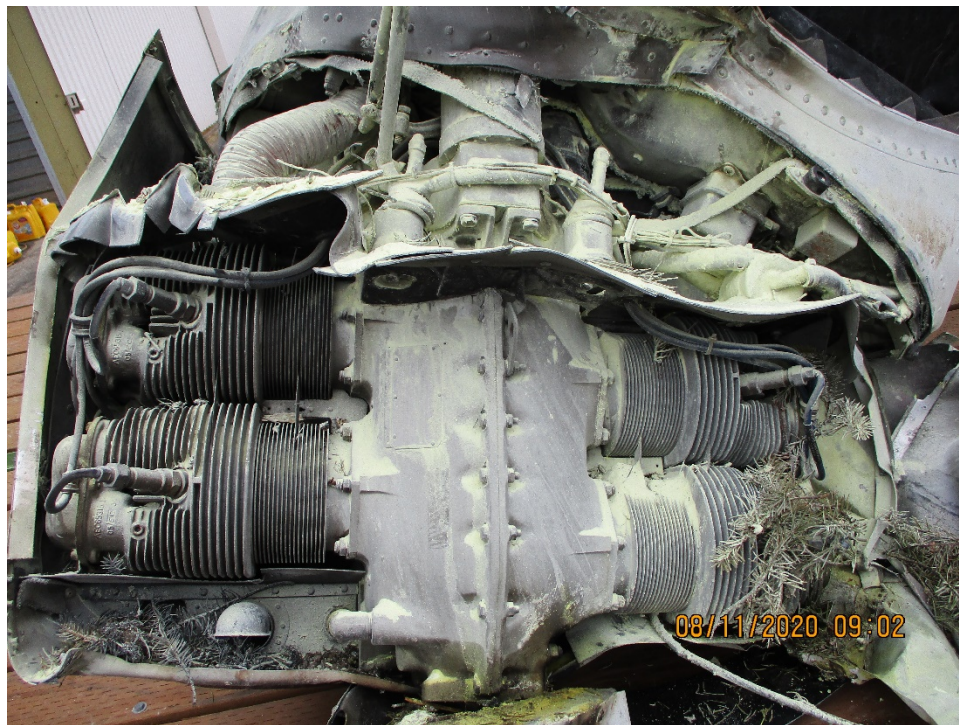
*Figure 2: Top of Engine*

- The ignition harness and leads exhibited wear consistent with normal operations.
- The spark plugs were removed and consistent with normal operations
- The engine was rotated, and compression was established on all cylinders

- The valves moved freely and evenly
  - The impulse couplings within the magnetos were heard clicking during engine rotation, however, no spark was obtained

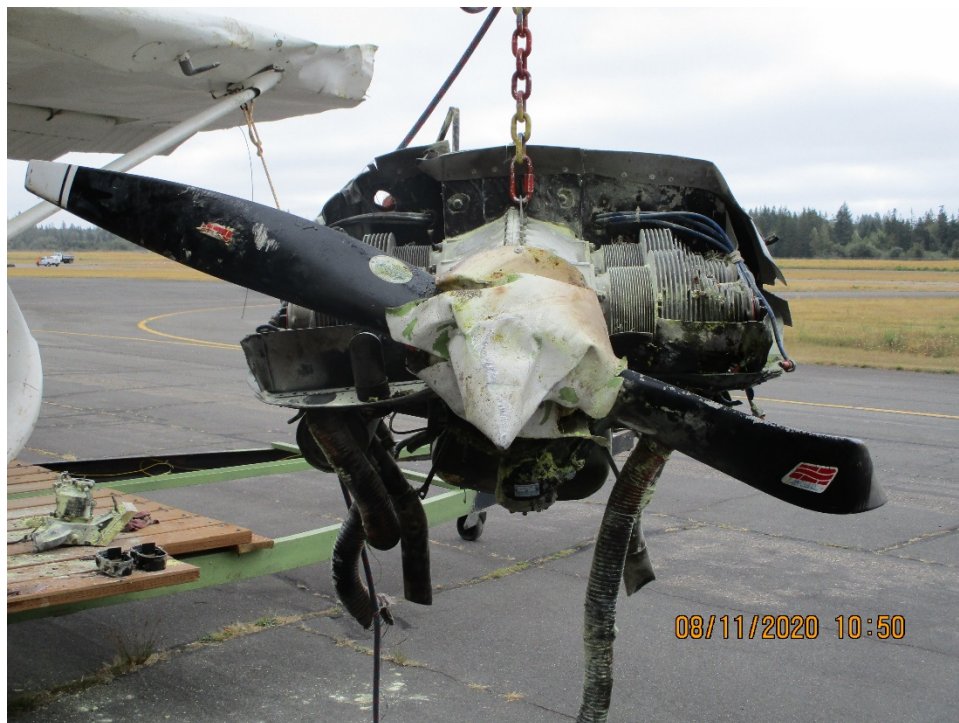
*Figure 3: Spinner and Propeller Blades*

- Flight control continuity was established throughout the airplane
  - The cables were cut for recovery purposes.
- Both propeller blades remained attached at the hub.

- One blade was bent aft and twisted upward.
  - The second blade was bent slightly aft about 1/4 from the blade root.
  - The spinner exhibited signs of rotation at the forward most tip, then compression.

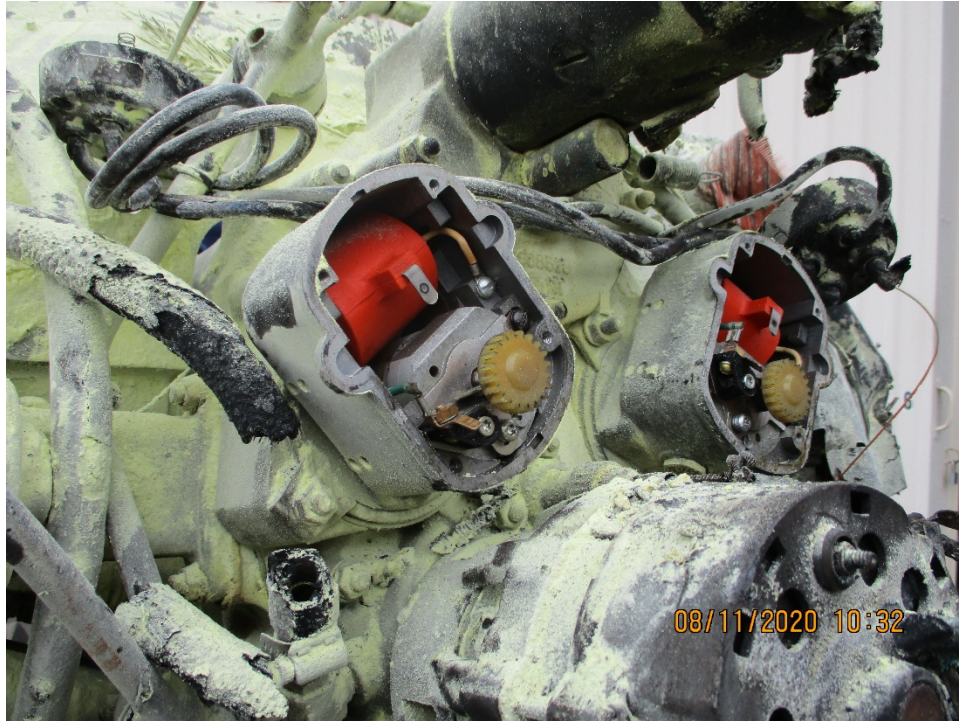
*Figure 4: Magnetos*

- The magnetos were removed from the engine and disassembled
  - The condensers were melted consistent with the post impact fire, but otherwise no anomalies were noted with the internal components.
- The throttle and mixture controls remained attached to their respective carburetor control arms but were seized consistent with impact damage to the airplane.
  - When the control cables were cut the throttle and mixture arms moved freely from stop to stop.
  - The carburetor bowl was removed and was empty.
  - No anomalies were noted with the internal carburetor components.
- Mr. Shinn shared the below photographs from the examination:
