## INTERVIEW SUMMARY

**Elliott Simpson**  
**Aviation Accident Investigator**  
**Western Pacific Region**

**Interview Date: July 8, 2020**  
**Person Contacted: Mr. Dale Harlan (Witness)**  
**NTSB Accident Number: WPR20LA215**

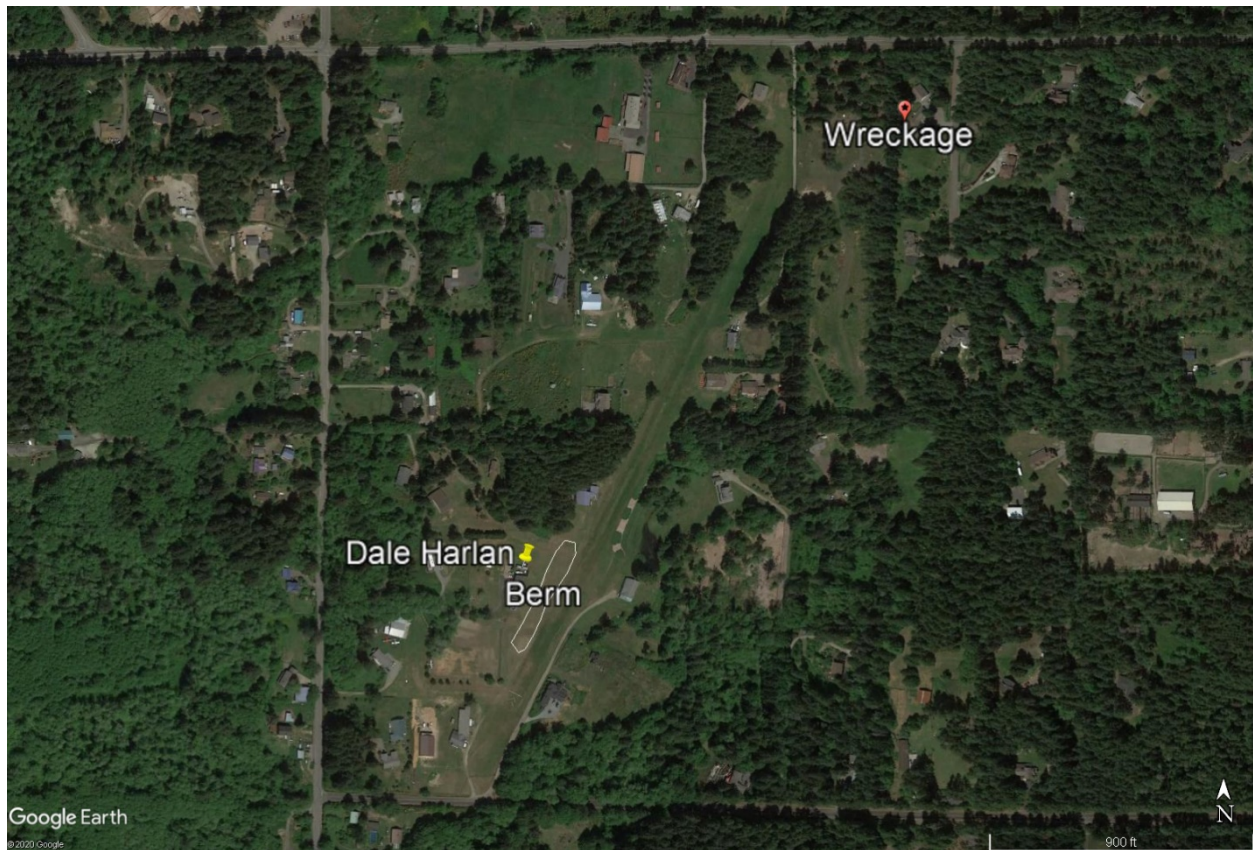
*Figure 1: Mr. Harlan's location in relation to the accident site*

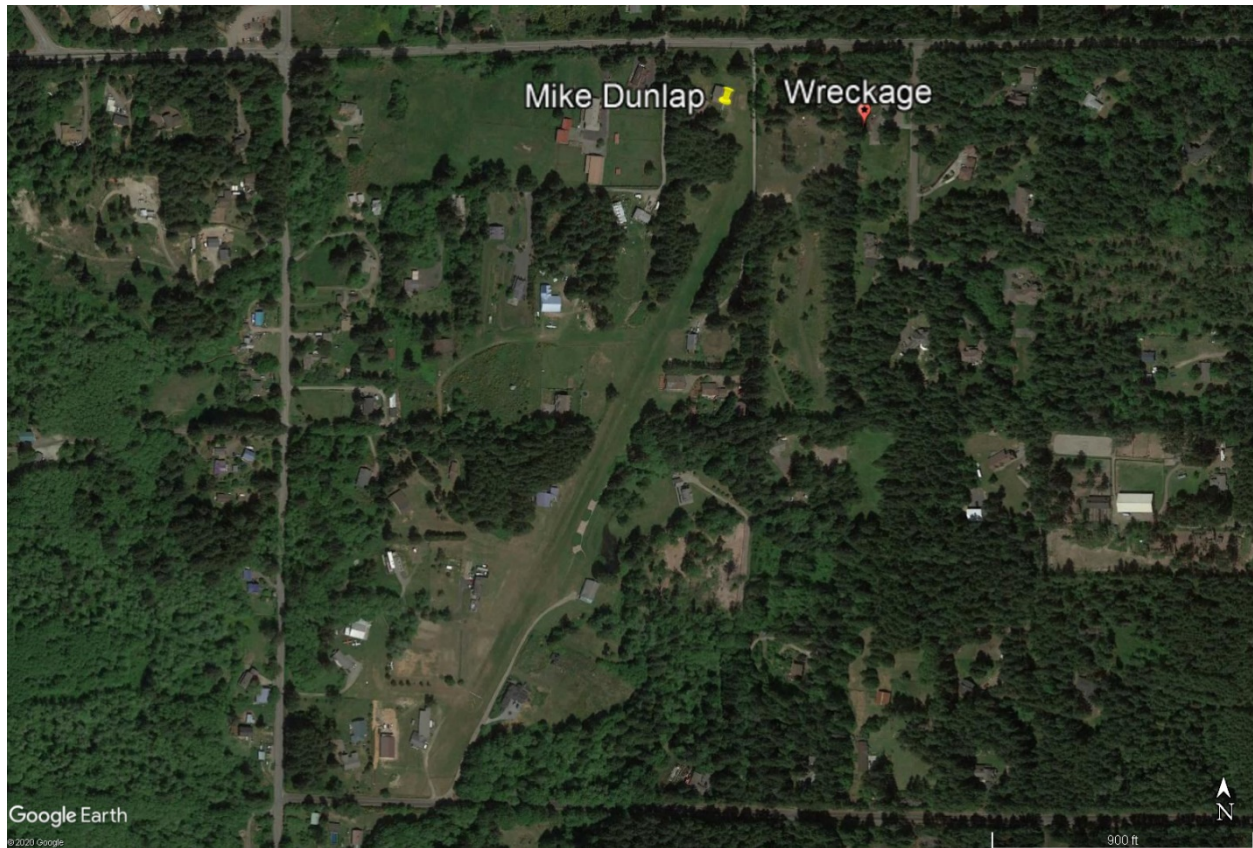
*Figure 1: Mr. Dunlap's location in relation to the accident site*
