# NATIONAL TRANSPORTATION SAFETY BOARD

## MATERIALS LABORATORY FACTUAL REPORT

Report No. 22-013

Place : Ely, Nevada  
Date : July 11, 2020  
Vehicle : ASW27-18 Glider, N167TM  
NTSB No. : WPR20LA216  
Investigator : Stephen Stein

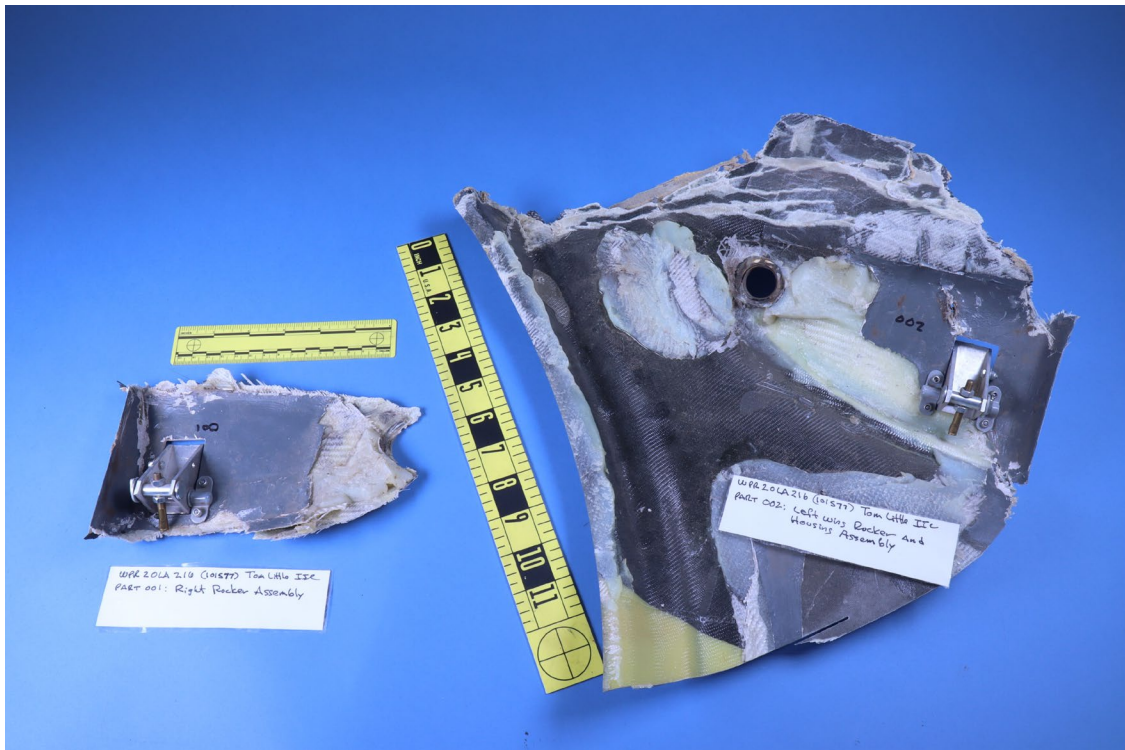
The right and left rocker assemblies remained attached to portions of the aircraft's structure (Figure 1). The rocker assemblies consisted of a metal plate that could pivot between two trunnions. The motion of the rocker would be caused by a pulling force from a Bowden cable attached to a brass end fitting attached to the rocker plate (Figures 5, 6). The brass end fittings had a hollow portion where the Bowden cable would have been inserted and crimped into place. The brass end fittings had a depth of approximately 0.47 inch of allowable insertion depth for the Bowden cable. The crimps on both brass end fittings appeared to have been made at similar locations and to a similar level of indentation based on a visual comparison (Figure 7). Examination of the open ends of the brass end fittings (the end where the stranded cable would have been inserted) revealed similar levels of constriction of the bore (Figure 8).

Figure 1: Right and left rocker assemblies with brass end fittings for Bowden cables attached to portions of fuselage (as received).

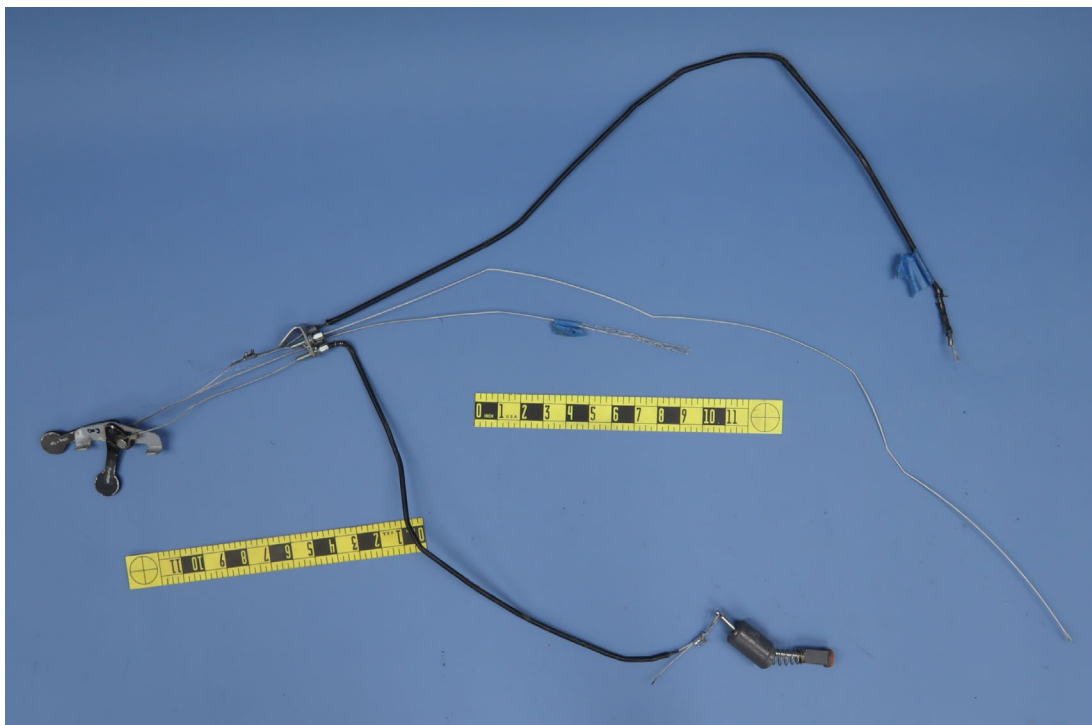
Figure 2: Water ballast release levers with portions of Bowden cables attached (as received).

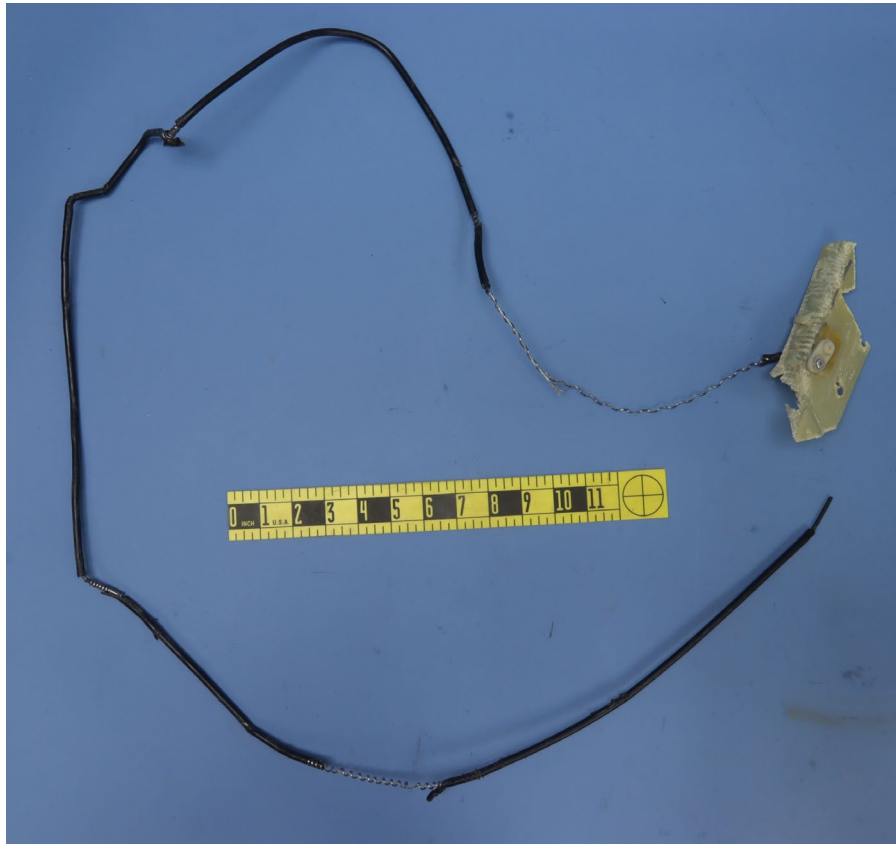
The portion of Bowden cable shown in figure 3 had portions of the sheath remaining and a small portion of fuselage structure attached. The stranded wire portion of this cable was approximately 45" long and did not extend the full length of the sheathing. The free end of the stranded cable near the portion of the attached fuselage fragment exhibited fracture features consistent with having been cut with a tool such as a pair of wire cutters.

Figure 3: Portion of Bowden cable with sheathing and a fragment of fuselage (as received).

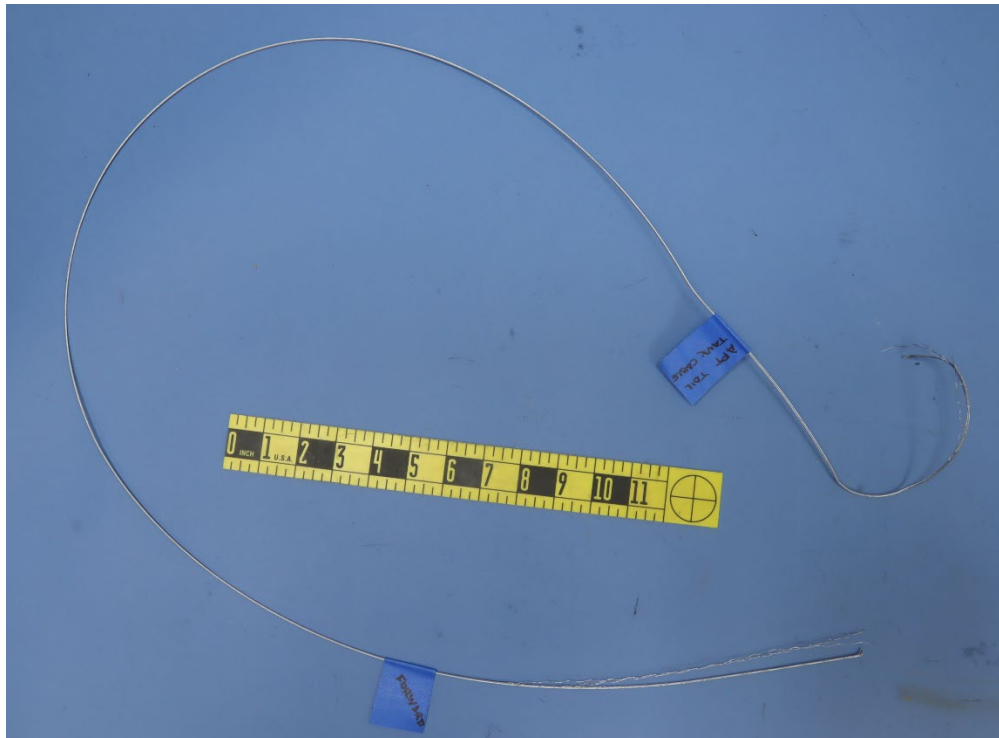
The portion of Bowden cable shown in figure 4 did not have any of the sheath present. The stranded cable was approximately 66" long. Both ends of the stranded cable exhibited fracture features consistent with a complex loading overstress fracture. No fatigue fracture features were observed.

Figure 4: Portion of Bowden cable without sheathing (as received).

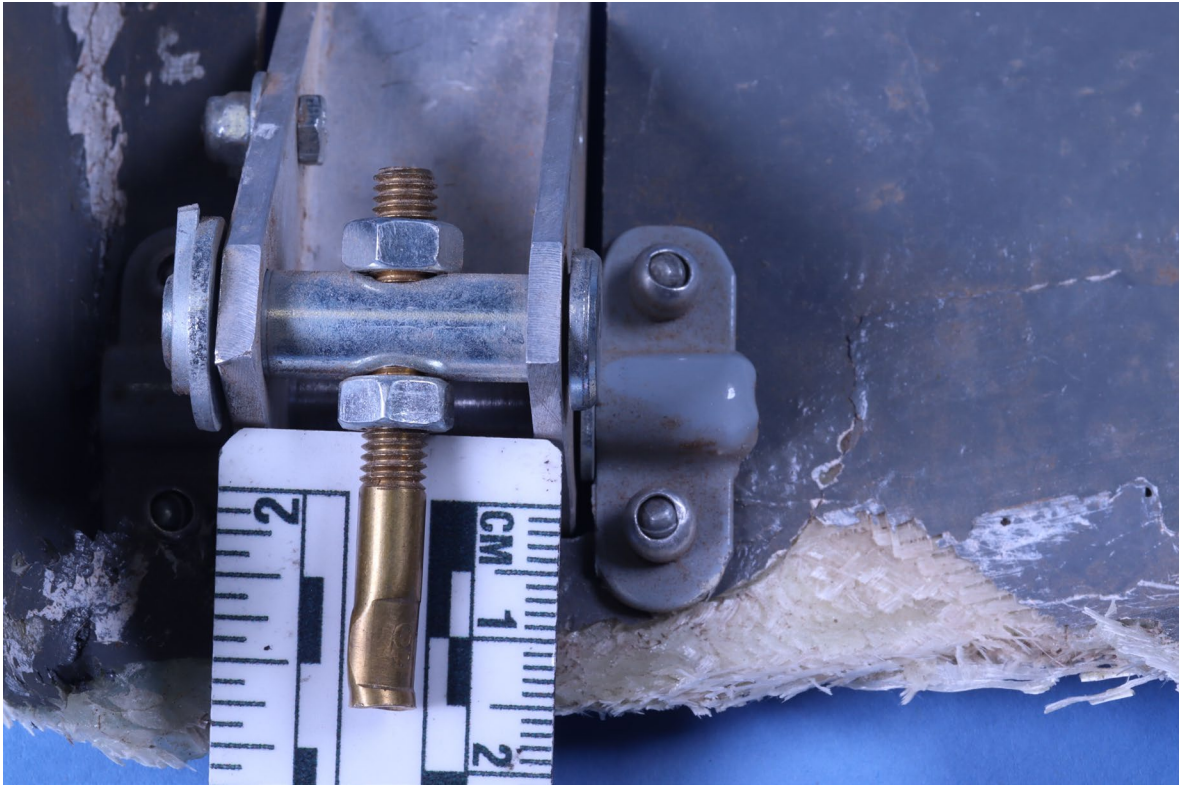
Figure 5: Right rocker end fitting.

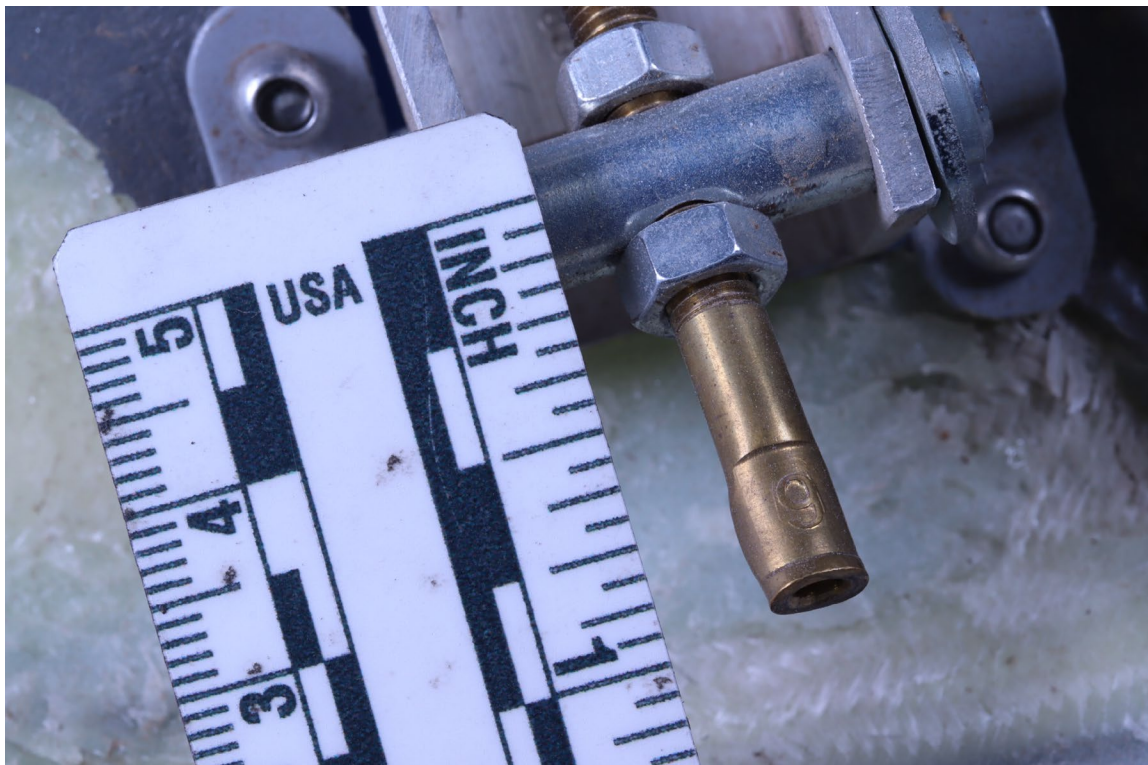
Figure 6: Left rocker end fitting.

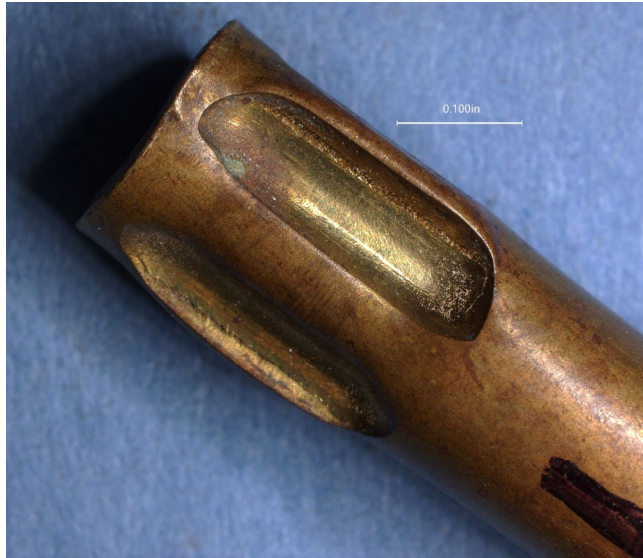
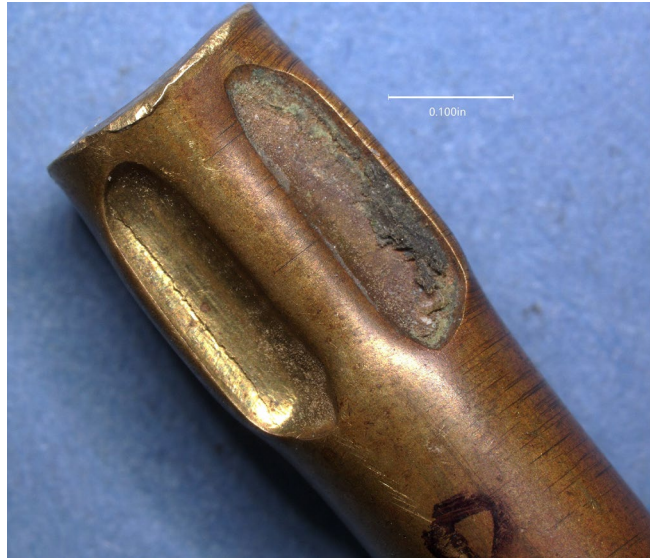
Figure 7: Crimps on left and right cable end fittings.

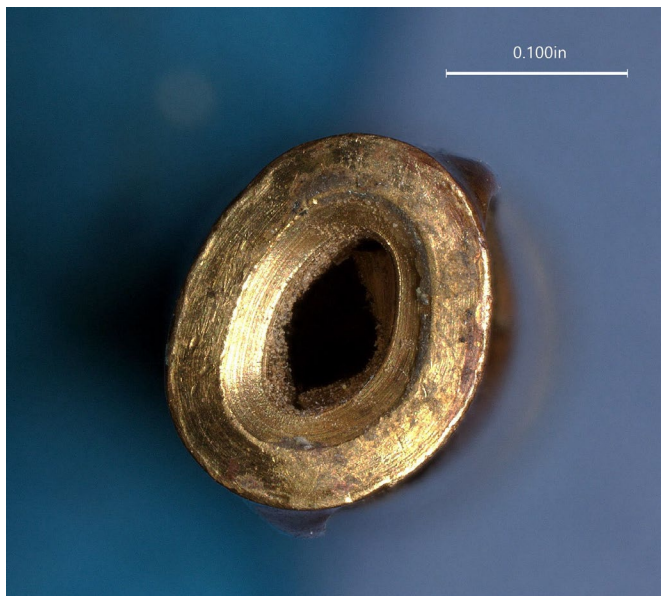
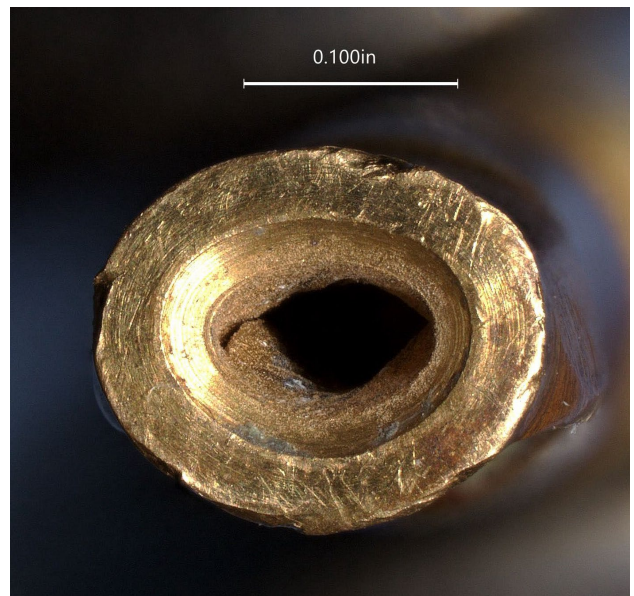
Figure 8: Crimped bores on left and right cable end fittings.

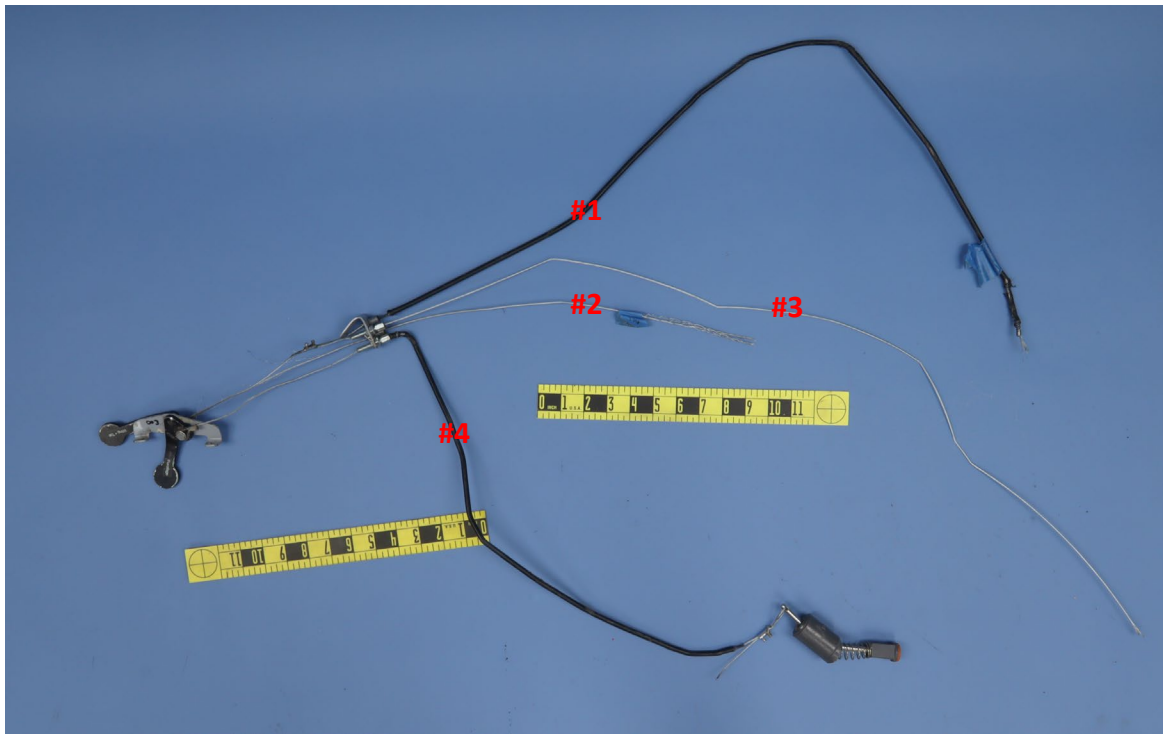
The Bowden cables attached to the water ballast release lever were numbered as shown in figure 9. The Bowden cables passed through a bracket with tensioning fittings (Figure 10) which are numbered in a consistent manner as the numbering of the cables shown in figure 9. Cable #4 was attached to the lever labeled "Fuselage". Cables #1, #2, #3 were attached to the lever labeled "Wing + Tail". All the stranded cables were the same diameter of approximately 0.060 inch. The free ends of these cables were examined with a stereo microscope to determine if the free ends were cut with a tool as might be done in the original assembly or wreckage recovery or if the ends were the result of fractures.

Cable #1 extended approximately 40" past the tensioning fitting. The strands of cable #1 exhibited fracture features consistent with a complex loading overstress fracture. Some of the strands exhibited deformation consistent with crushing. No fatigue fracture features were observed.

Cable #2 extended approximately 16" past the tensioning fitting. The strands of cable #2 exhibited necking down at the fracture consistent with tensile overstress fracture.

Cable #3 extended approximately 40" past the tensioning fitting. The strands of cable #3 exhibited fracture features consistent with a complex loading overstress fracture. Some of the strands exhibited deformation consistent with crushing. No fatigue features were observed.

Figure 9: Numbering convention of portions of Bowden cables attached to levers.

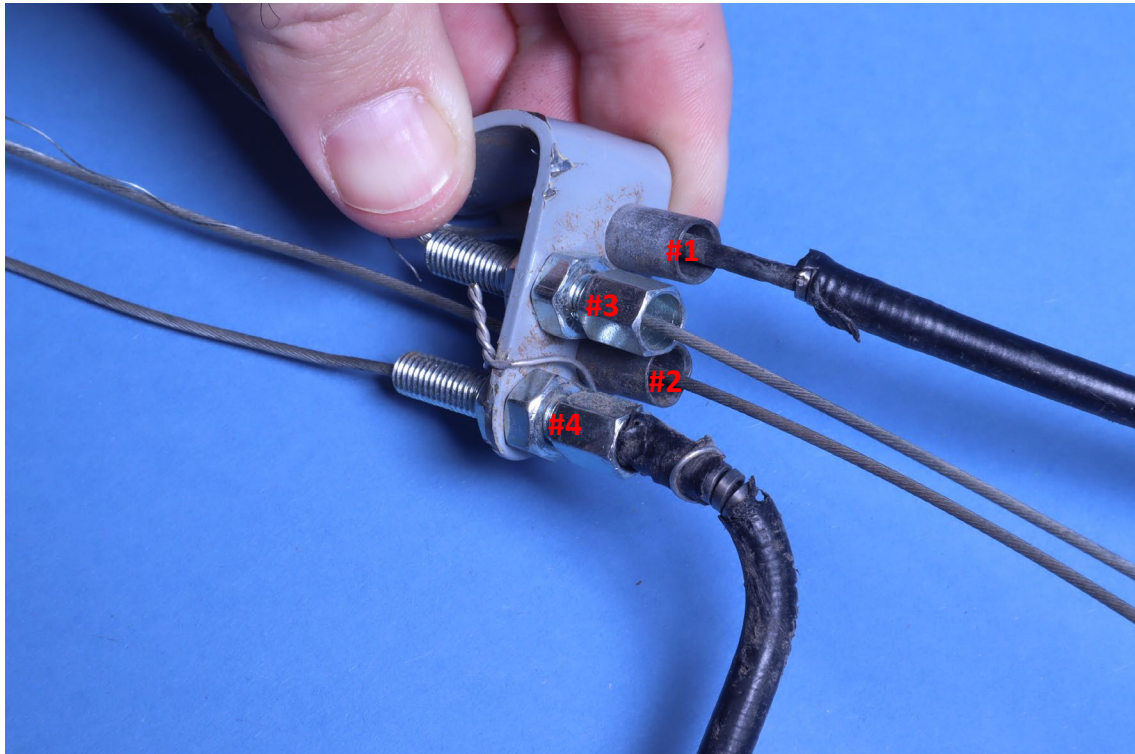
Figure 10: Numbering convention of cables at tensioning fittings (same numbering as in Figure 9).
