**NATIONAL TRANSPORTATION SAFETY BOARD**

**AIRCRAFT EXAMINATION**

**WPR20LA216**

Aircraft: ASW 27-18

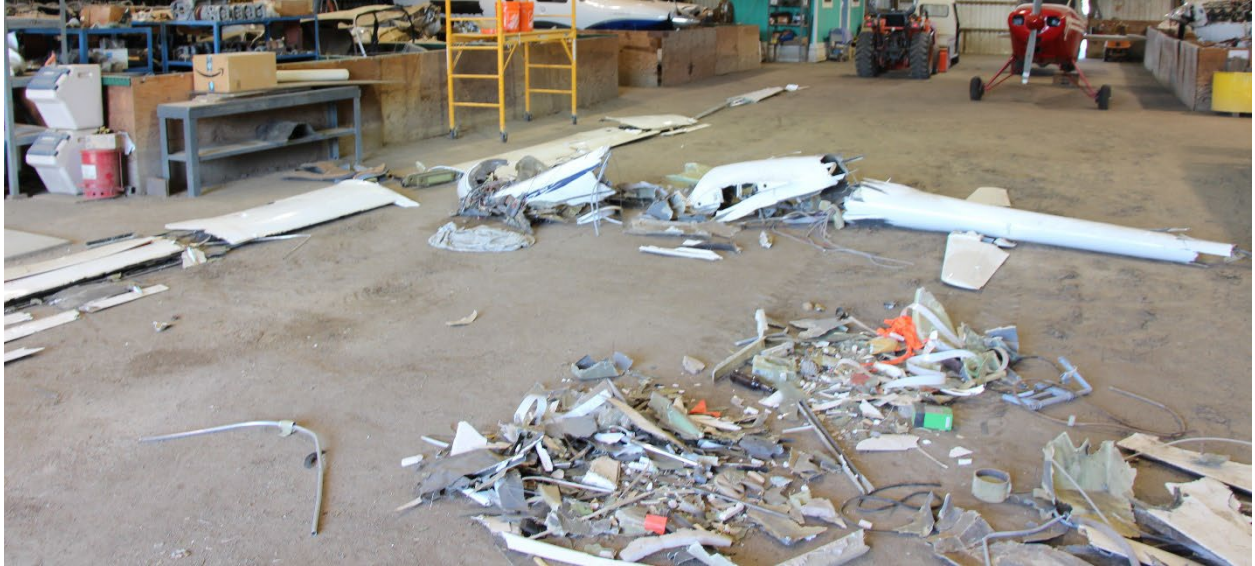
Photograph 1: Wreckage layout

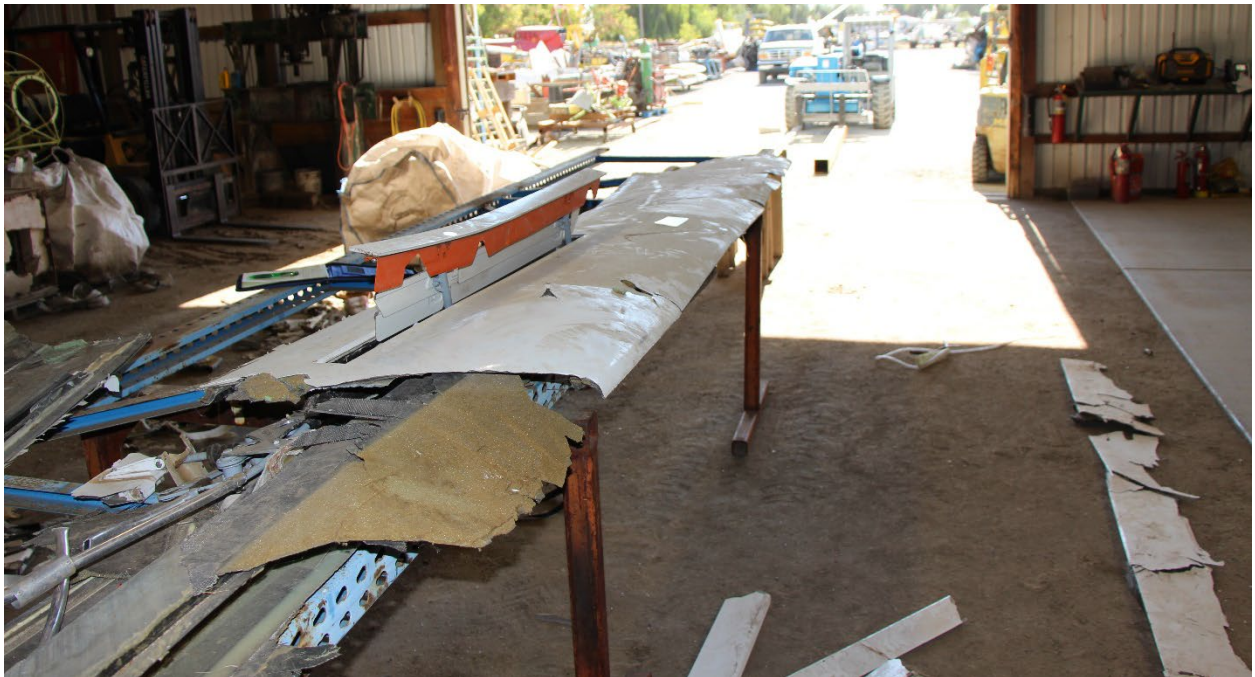
Photograph 2: Left wing

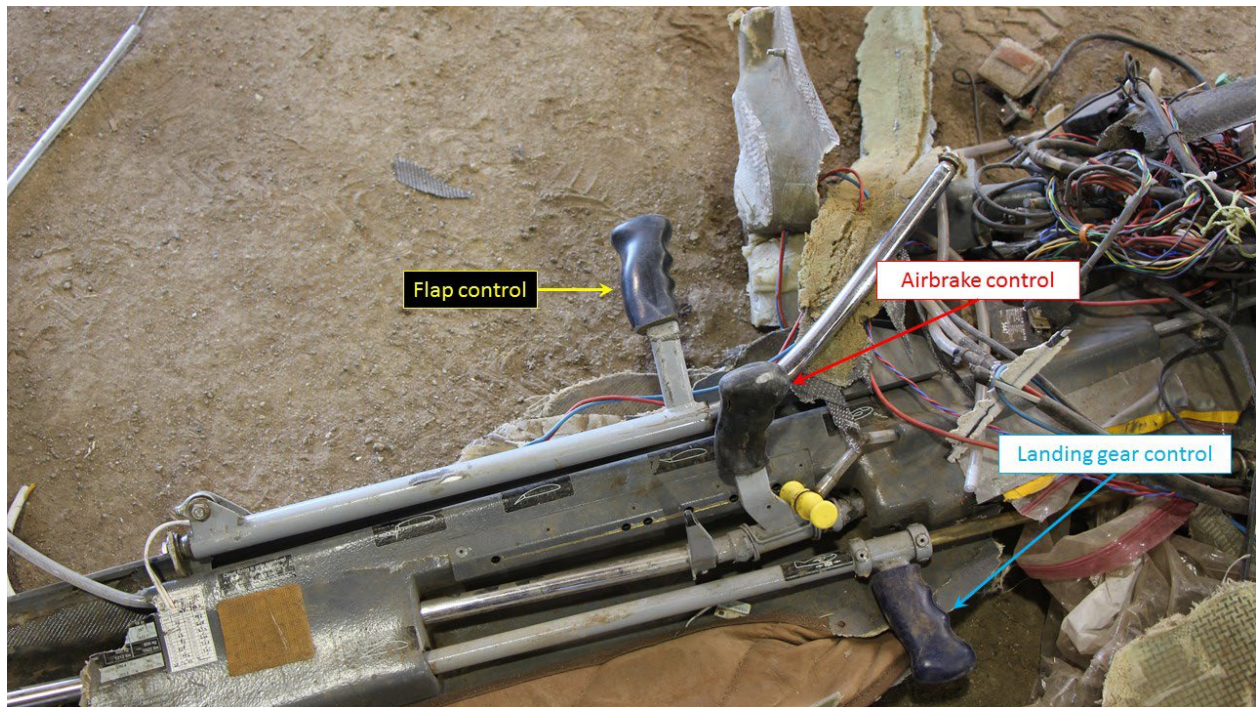
The cockpit was fragmented and deformed from the accident sequence. The flight control stick remained attached to the elevator and flaperon (aileron) control bellcrank and portions of the control tubes, which were separated with evidence of overload failure. The aileron control system was continuous from a separation of the control tube at the flight control bell crank to the fuselage bell crank and funnel-type connectors. Elevator control was traced from a separation of the control tube at the flight control bell crank to the empennage bell crank through multiple fractures; one small segment of the elevator control tube was not recovered. Elevator trim control was continuous from the bottom of the shift lever, which was fractured at the mount, to the elevator control. The trim locking brake remained attached to the elevator bellcrank and was not damaged. Rudder control was traced from the rudder pedals to the empennage through two separations in the right and left control cables. The right rudder pedal displayed broomstrawing at both separations, while the left rudder pedal cable was cut by recovery personnel at the cockpit separation and the cable separation at the empennage exhibited evidence of broomstrawing. The airbrake and landing gear control levers were attached to their push rods and push housings on the left side of the cockpit and were partially separated from their plastic sliders. Both the airbrake control rod and landing gear control rod separated at the rod end aft of the cockpit. The airbrake control lever was in the stowed position and landing gear control lever was in the gear up position. The flap control lever had separated from the plastic slider, but remained attached to the push rod and housing. The flap lever was in position 1 (see photograph 3). The canopy was

Photograph 3: Flap, airbrake, and landing gear controls

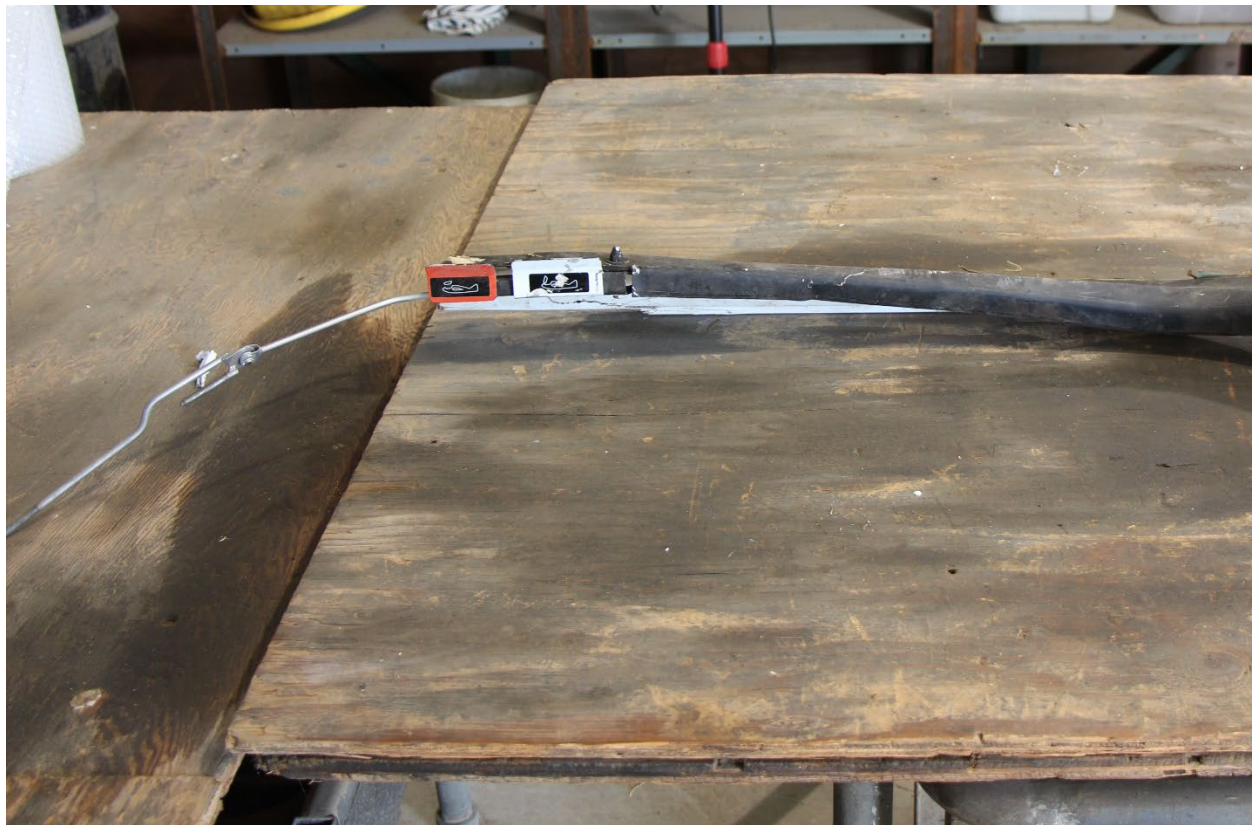
destroyed during the impact sequence. The canopy control assembly was comprised of two levers, which were in the closed position that remained attached to the assembly push rod. The lever operated normally when actuated by hand (see photograph 4).

Photograph 4: Canopy control

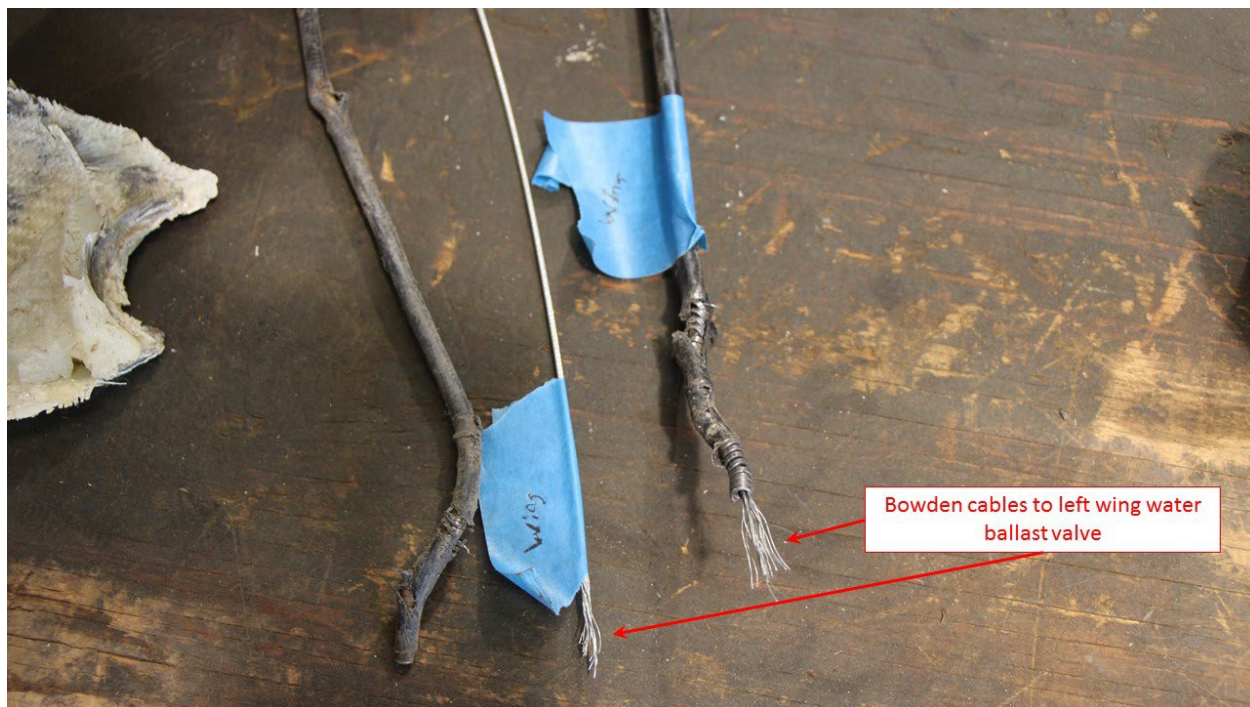
The water ballast control levers were attached to the cockpit with their bowden cables attached. The downstream ends of the wing (2 cables) and tail (1 cable) water ballast bowden cables had separated at the fuselage. One wing water ballast control cable exhibited broomstrawing and the other water ballast control cable end was undetermined (see photograph 5). The wing water ballast control cables normally move within sleeves and are connected to left and right swaged tubes that operate left and right wing levers, which move the push rods that open and close the wing water ballast valves. Both the left and right wing bowden cables had separated from their swaged tubes, which were both still connected to their levers. The tail water ballast control cable was traced from the cockpit lever to the tail water ballast tank through cable separations.

Photograph 5: Bowden cables and sleeve to left wing water ballast valve control assembly

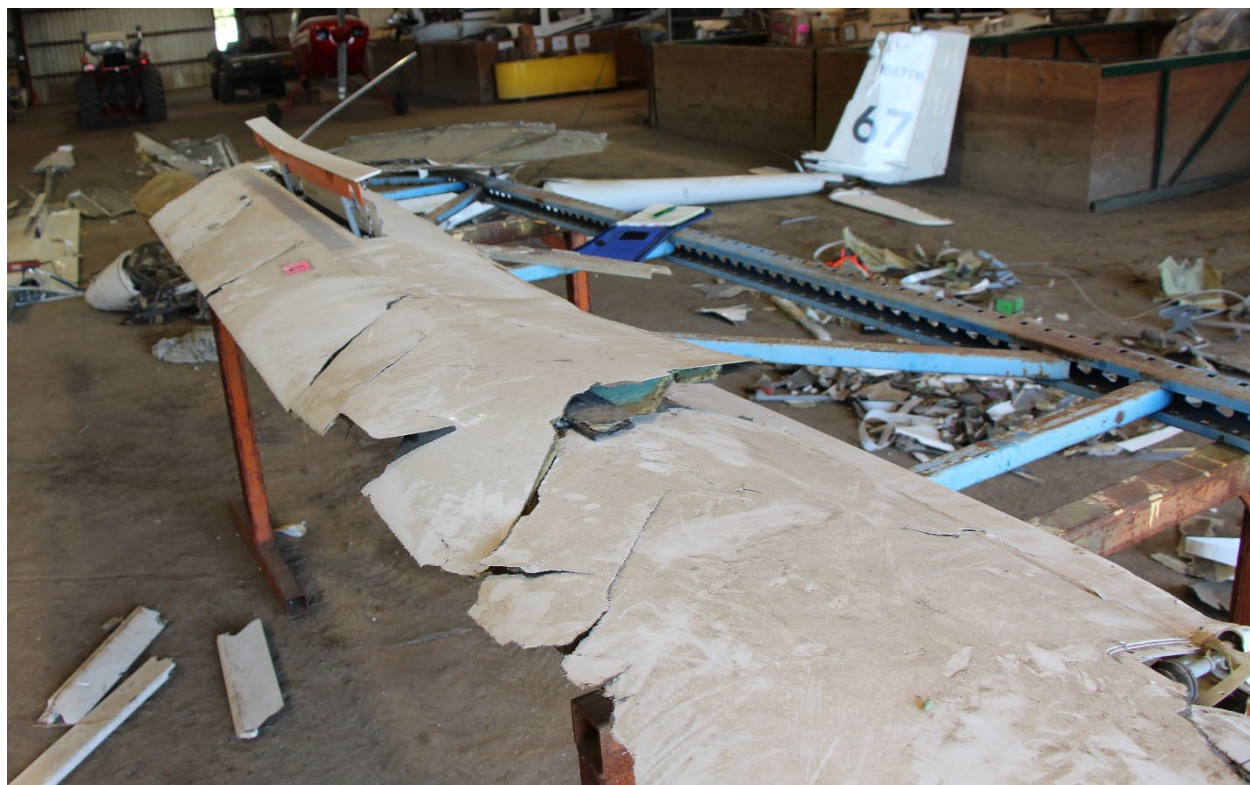
The left wing spar was intact about two-thirds of its full wingspan and the outboard wing was intact, but had separated at its spar connection. The lower skin had separated into several pieces. Most of the left wing top skin remained attached and was broken at 45° angles (see photograph 6). Control continuity of the flaperon (aileron and flap) was confirmed from the inboard and outboard push rods at the flaperon to separations in the control tubes at the wing root. The funnel-type connector at the left wing root was intact. The airbrake system was traced from a separation at the left wing root to the airbrake paddles, which functioned normally when actuated by hand.

Photograph 6: Left wing top skin

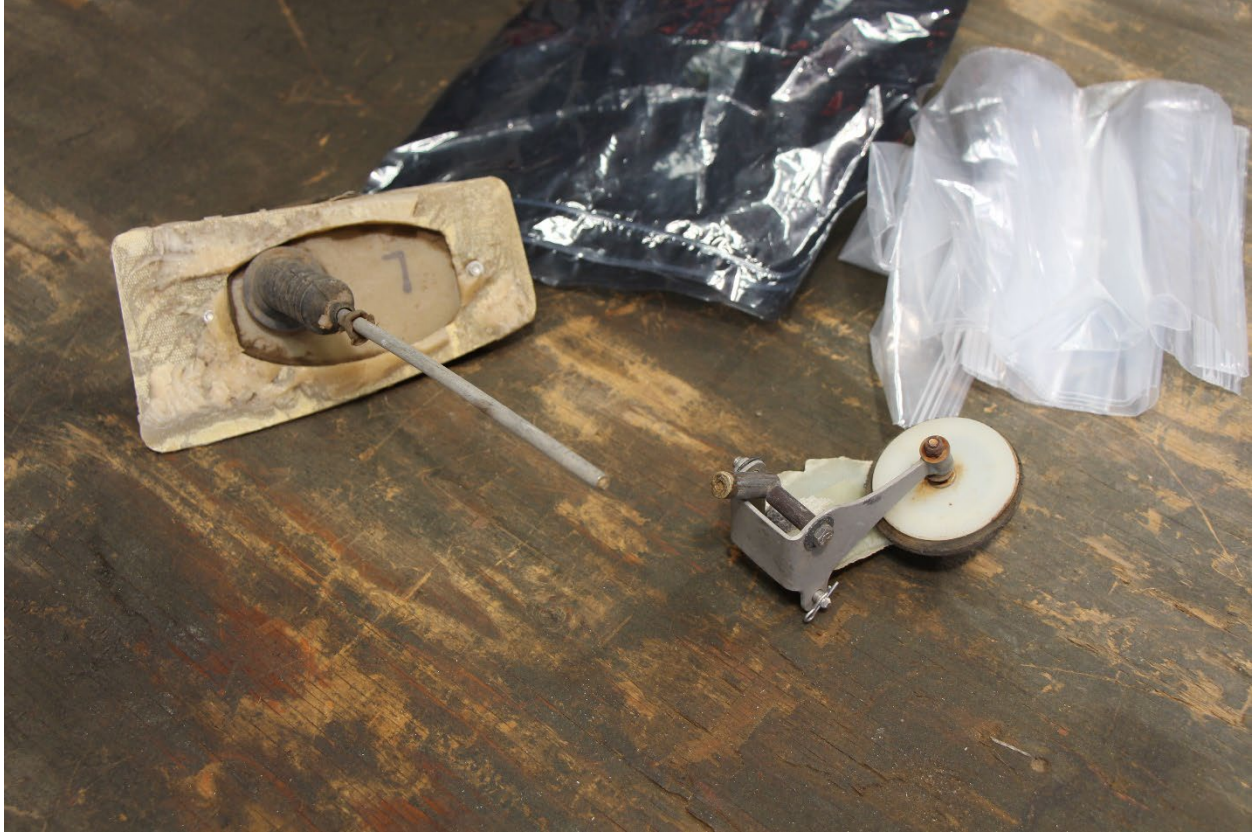
The left wing water ballast tank was destroyed and the water ballast valve had separated from the wing (see photograph 7). The brass rod remained within the stainless steel tube, which had

separated at the valve lever. The valve lever assembly was mostly intact, except for the spring, which remained attached to a wing fragment.

Photograph 7: Left wing water ballast valve

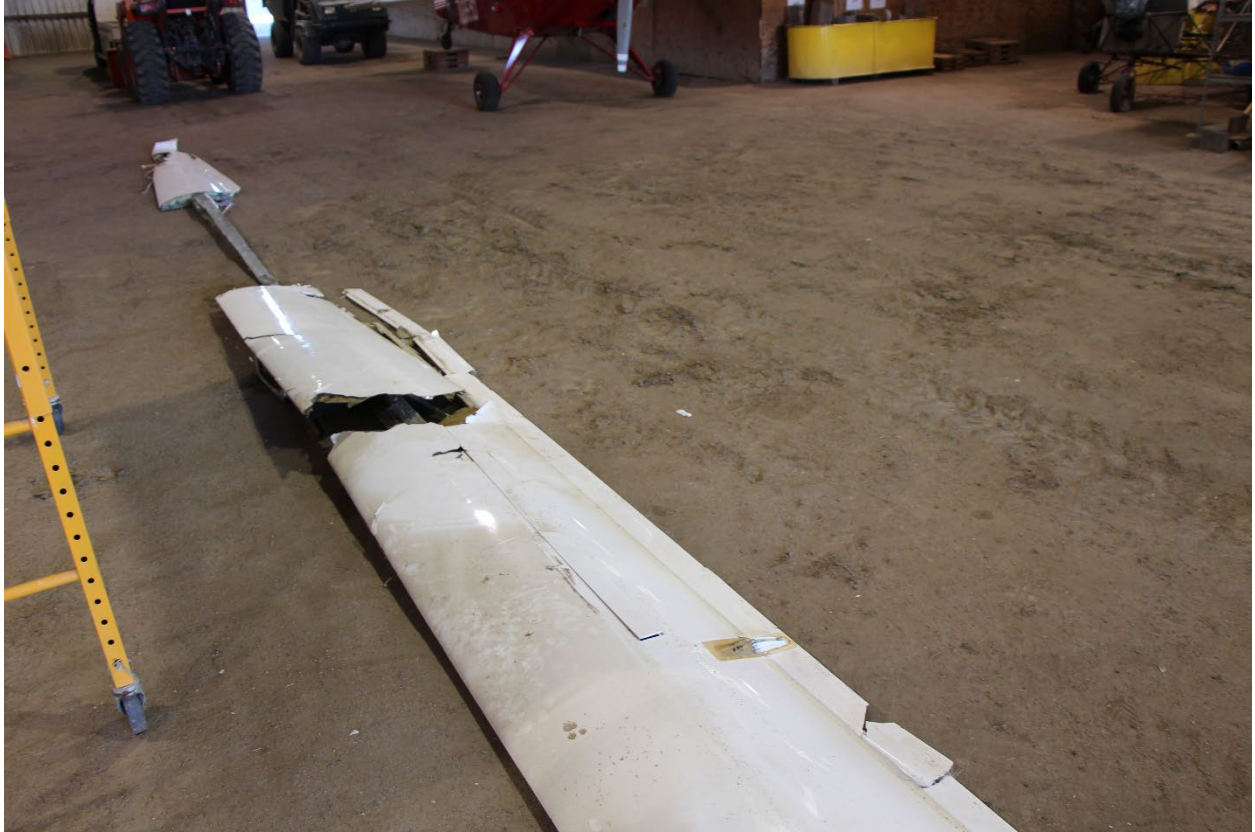
Photograph 8: Right wing from wing root leading edge

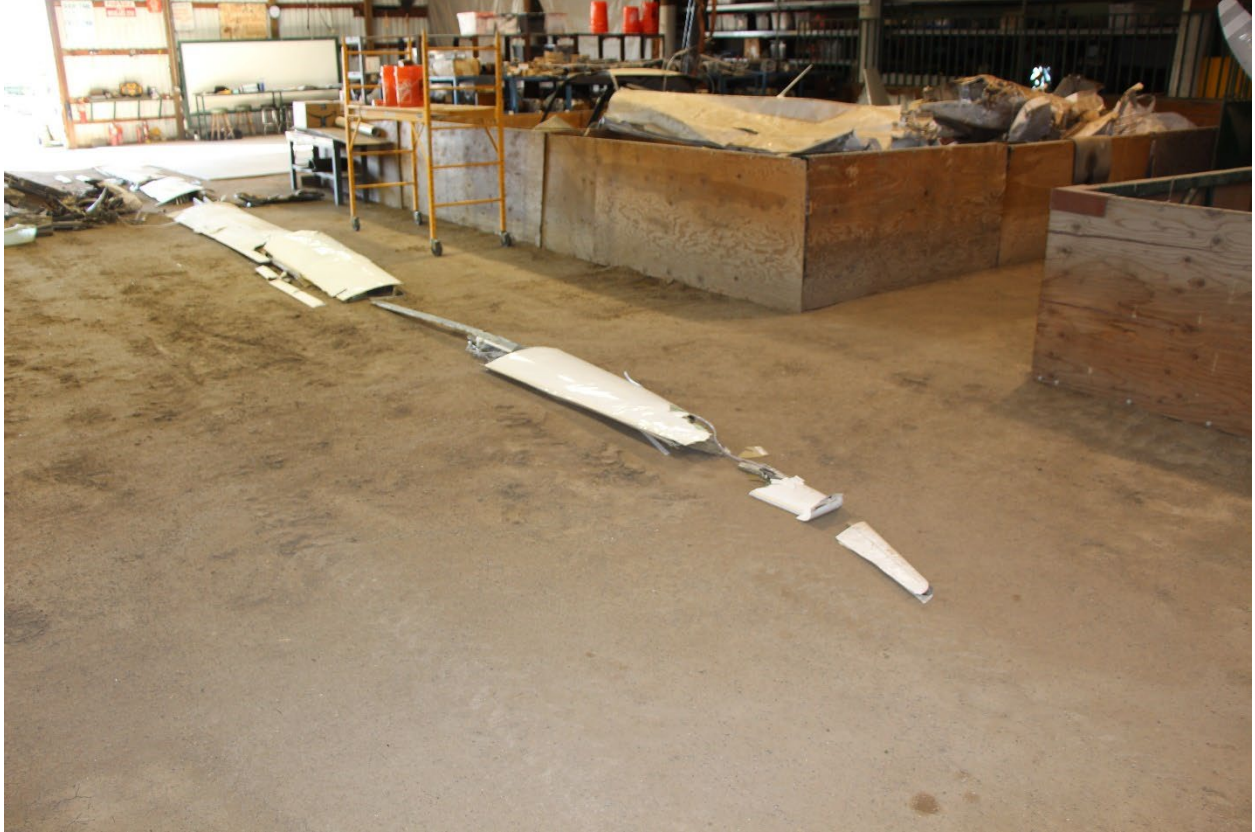
Photograph 9: Right wing from outboard trailing edge

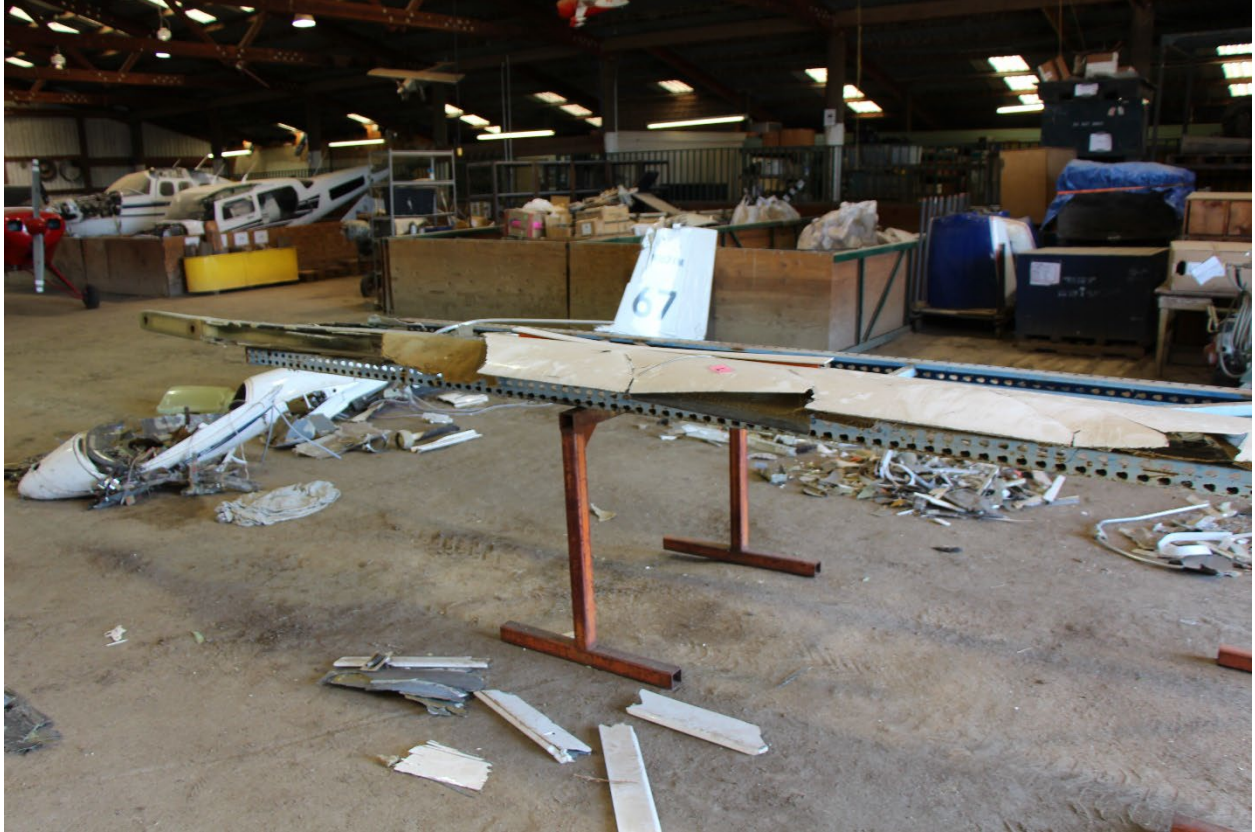
Photograph 10: Inboard left wing leading edge

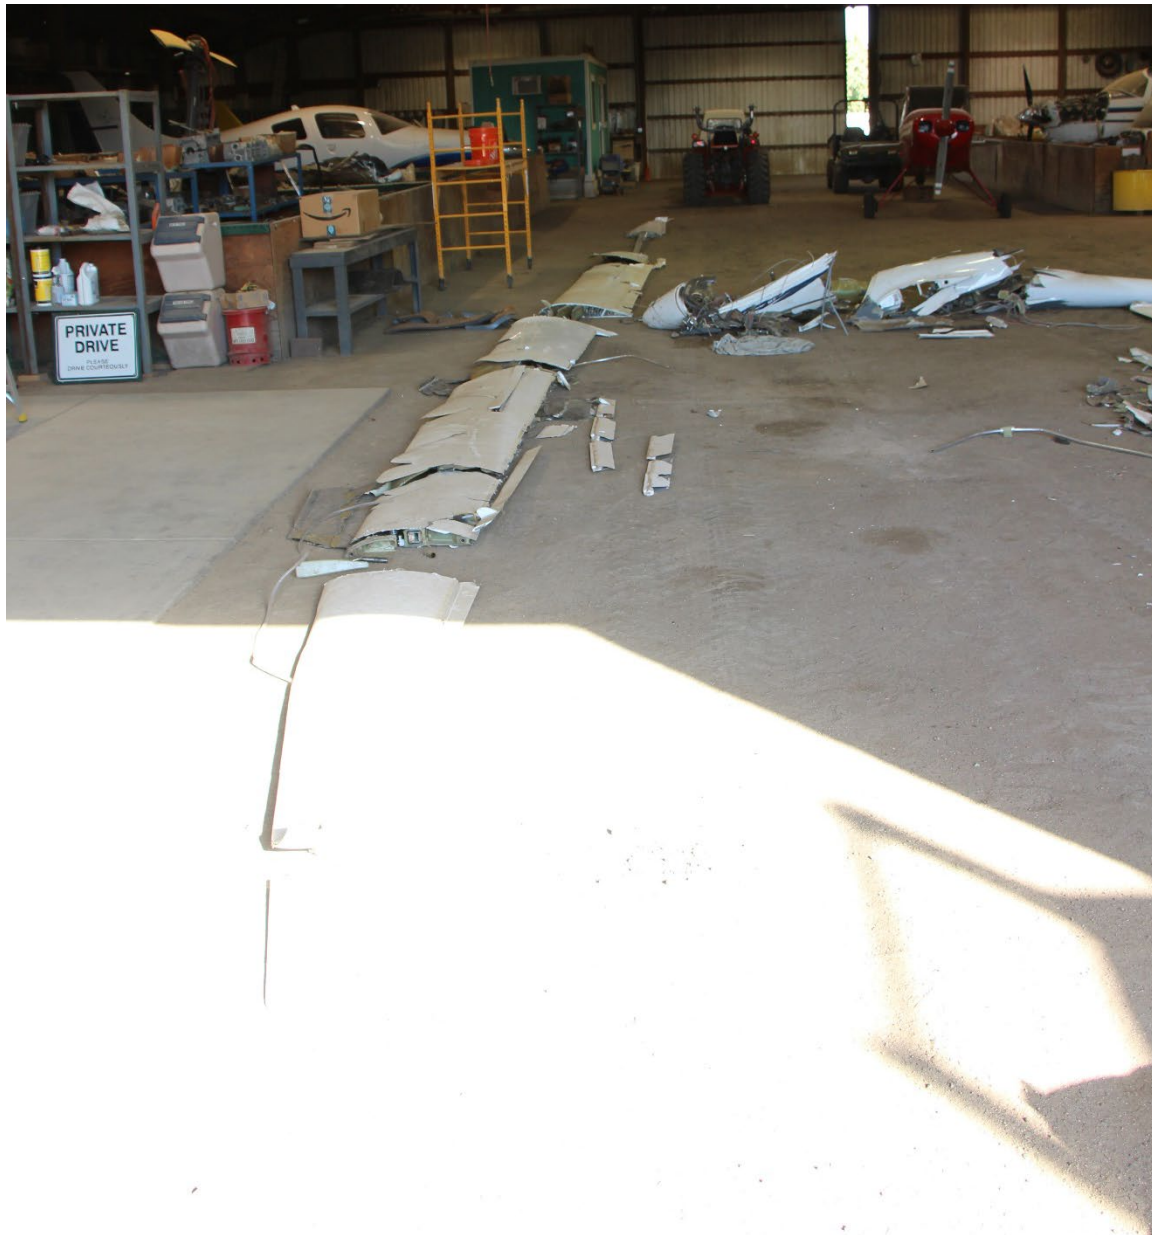
Photograph 11: View of wreckage from left wing
