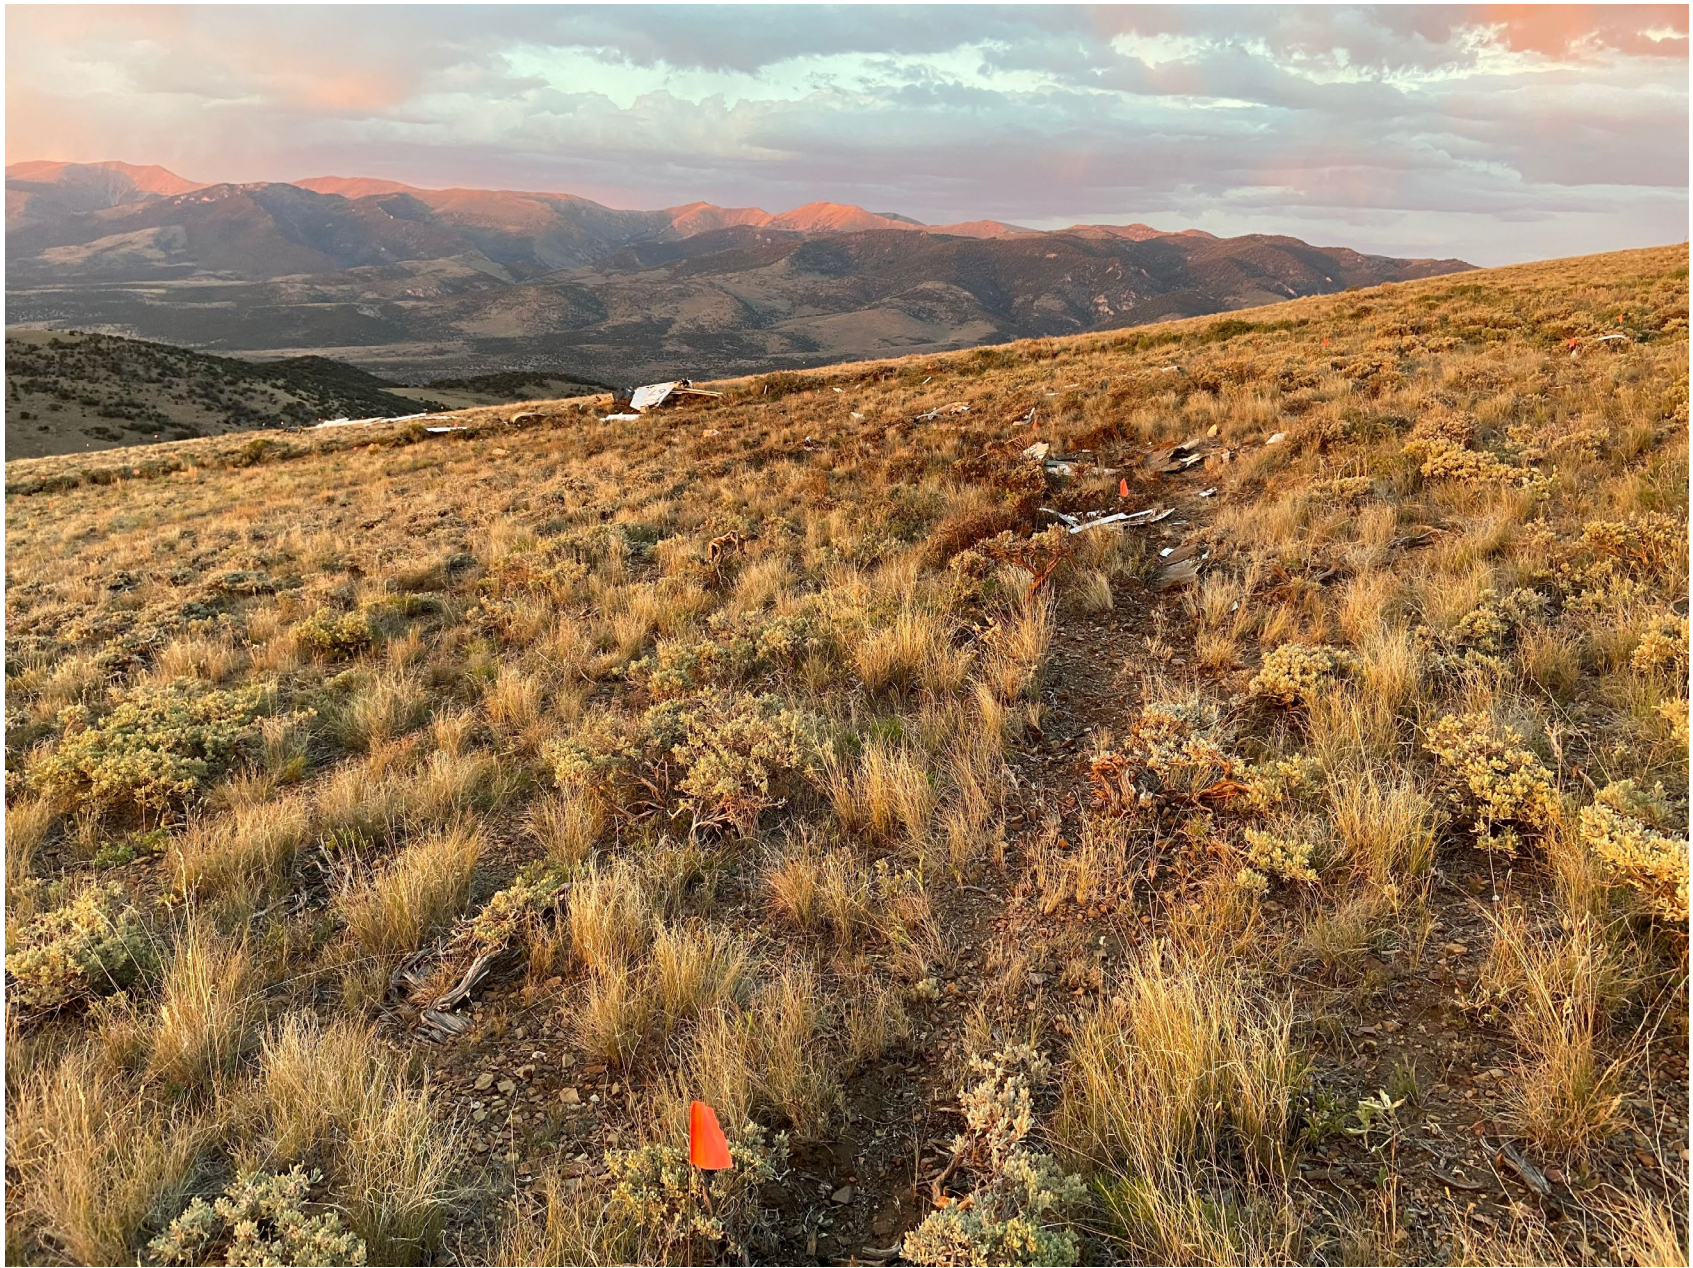
**Photo 1 – View of wreckage from first point of impact (courtesy of witness)**

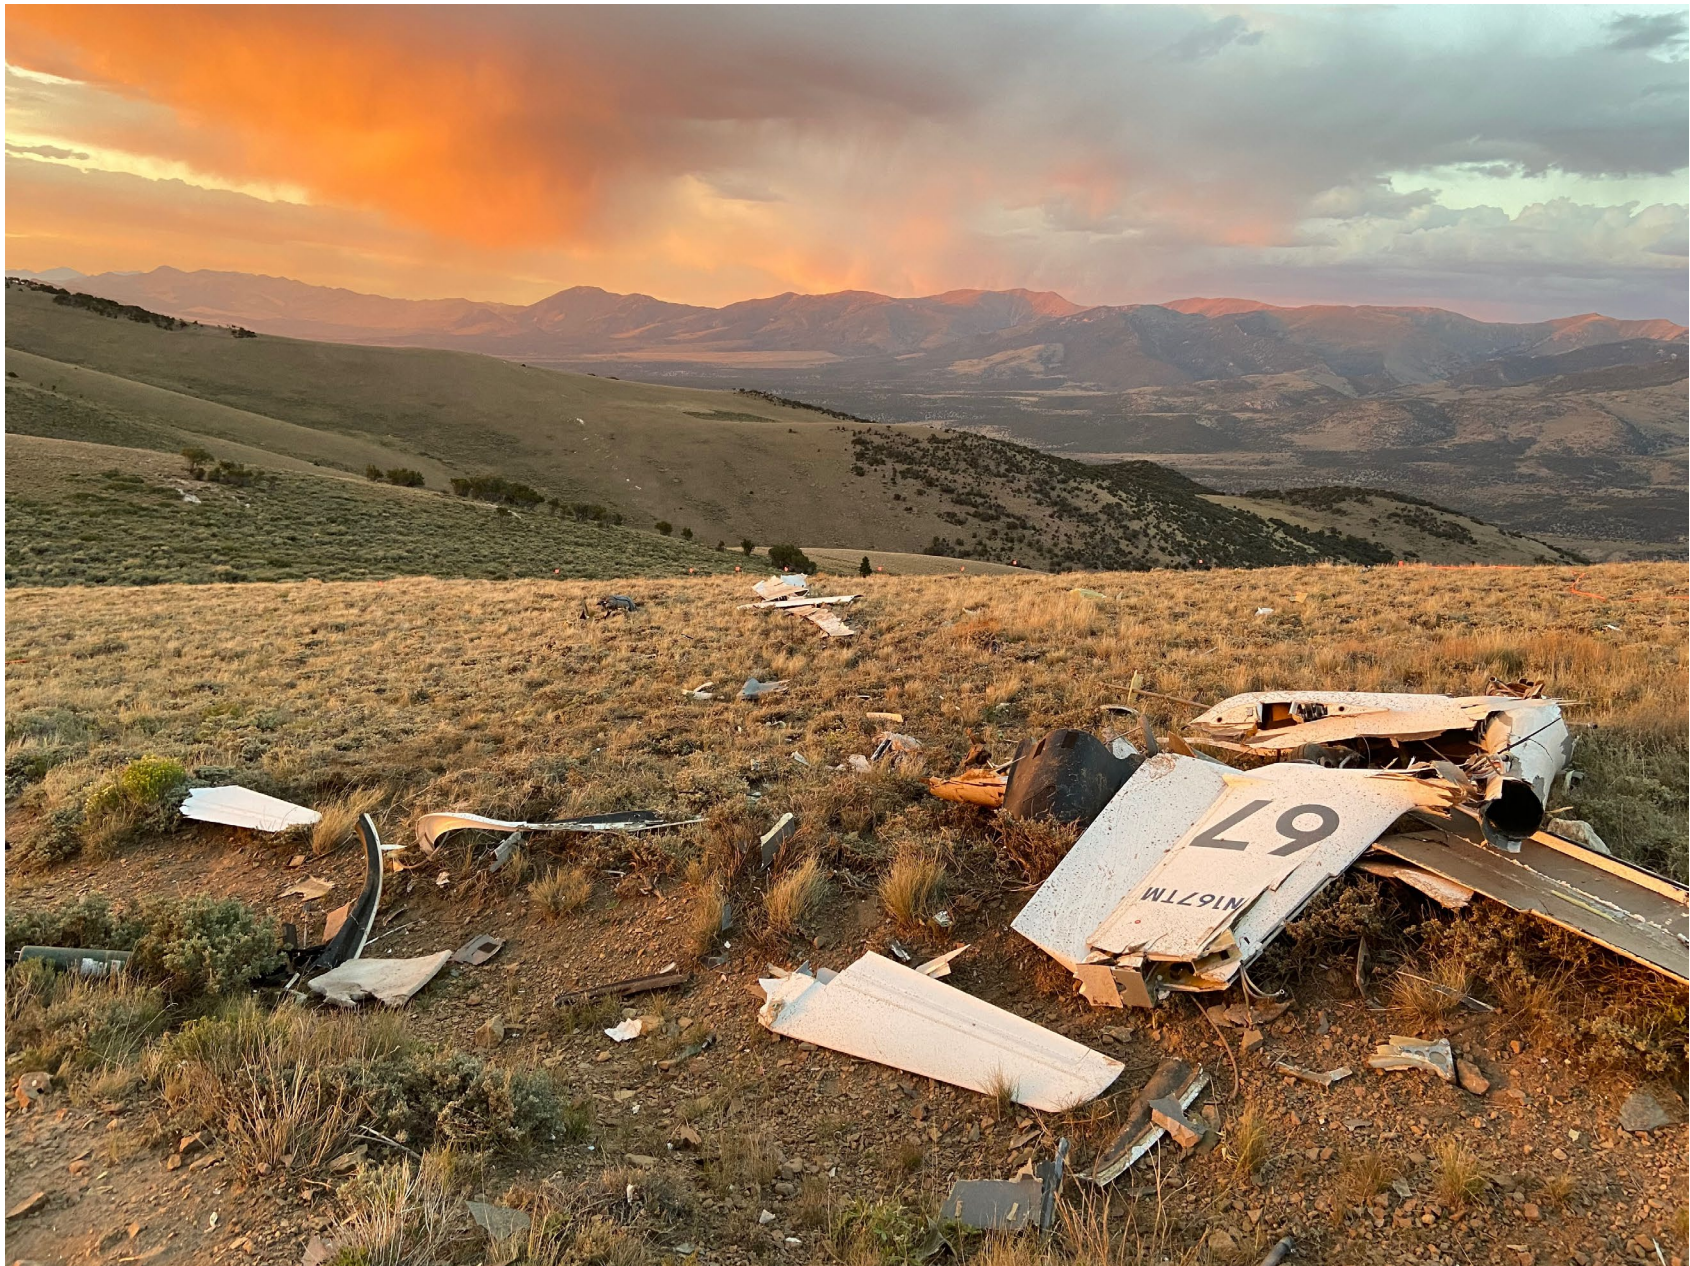
**Photo 2 – Fuselage and empennage at accident site (courtesy of witness)**

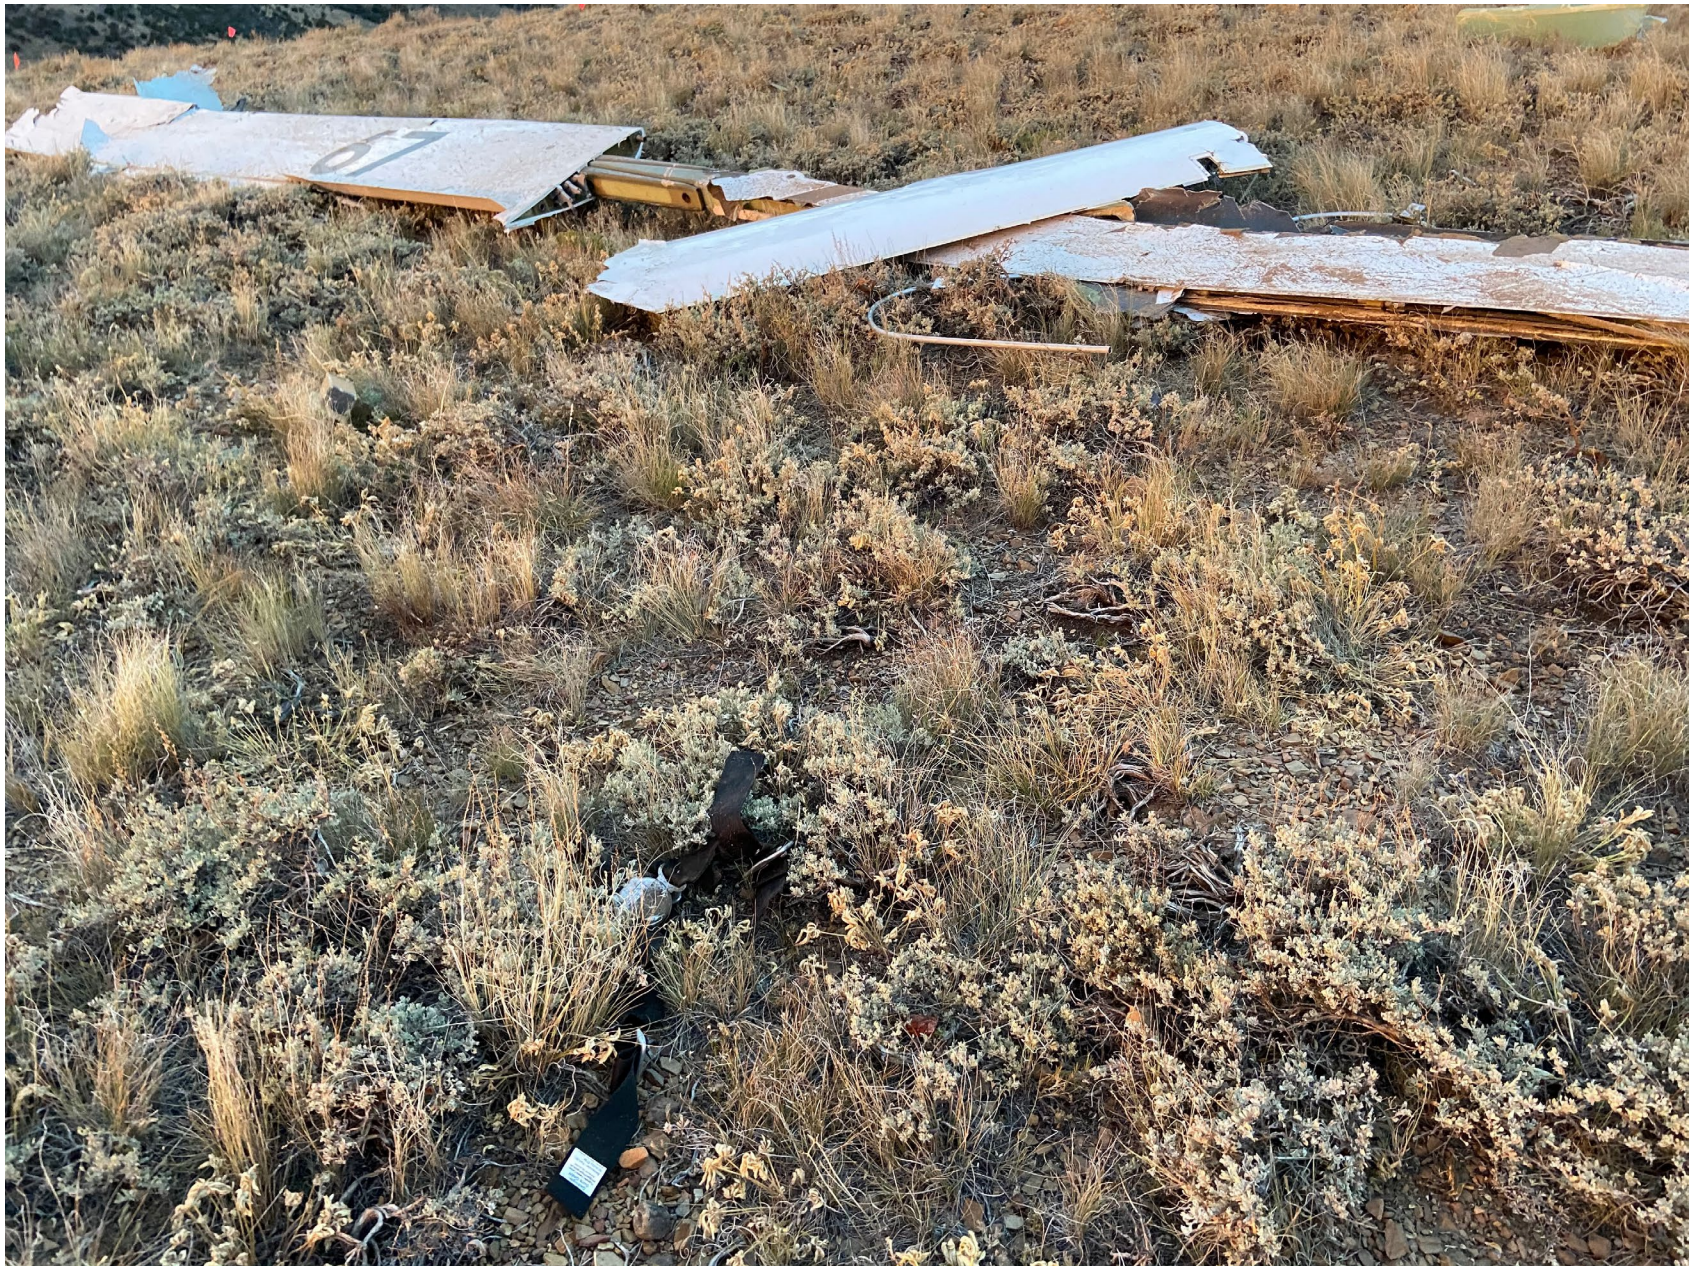
**Photo 3 – Right and portion of left wing at accident site (courtesy of witness)**
