# Party Submission

## Technical Analysis of ASG-29 Accident near Ely, Nevada on July 11, 2020

**September 18, 2022**

Andy Kanigowski

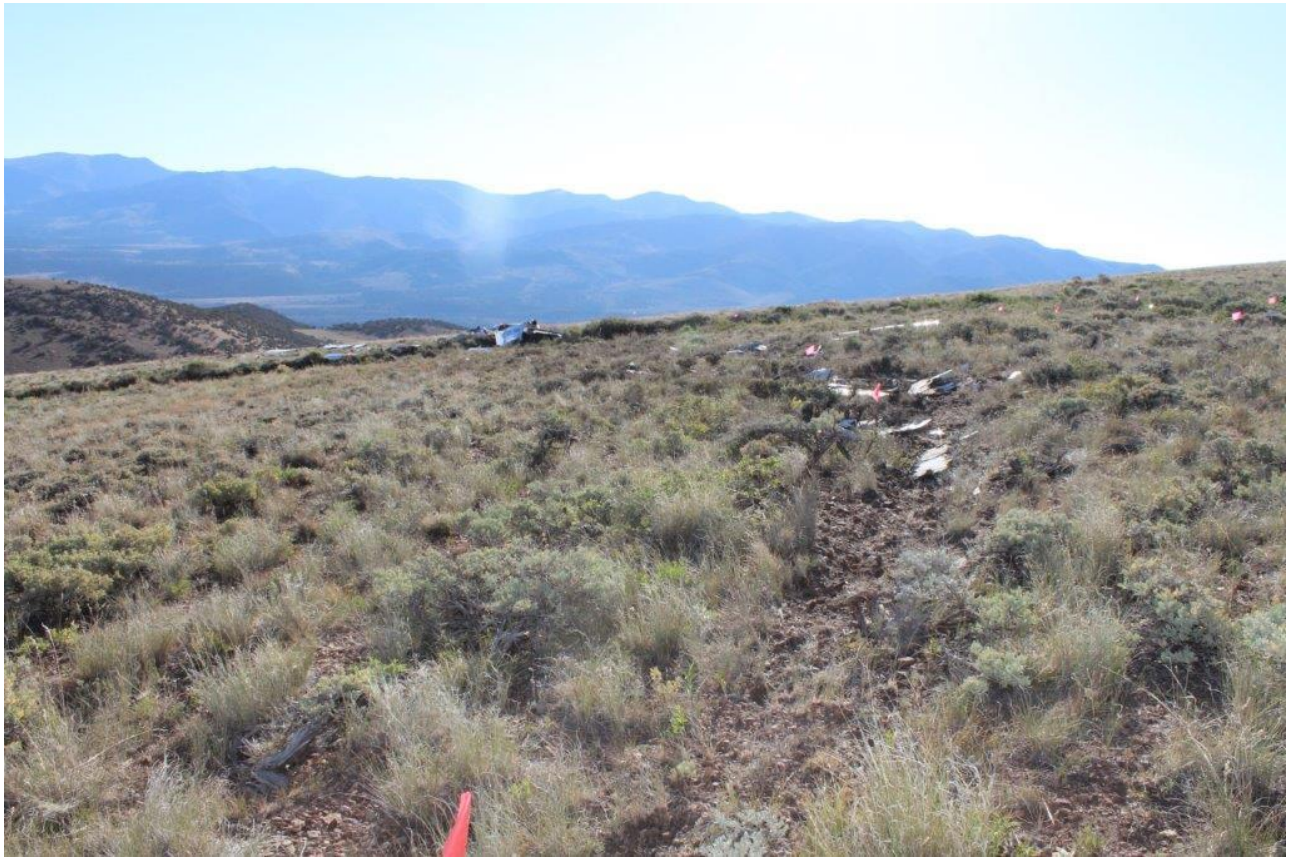
The debris field, stretching over 150 feet, is rather large for a glider accident. The debris field curves strongly to the left indicating that the glider was in a left spiral turn (as opposed to straight flight - which would have seen the debris distributed in a straight line).

The size of the debris field indicates a high-speed (high-energy) flight and impact. This type of debris field rules out a stall or spin which would result in a small, more contained, debris field.

**There is no doubt that the first point of impact was the glider's left wing hitting the ground.**

IMG\_5531: Crash site and debris field.

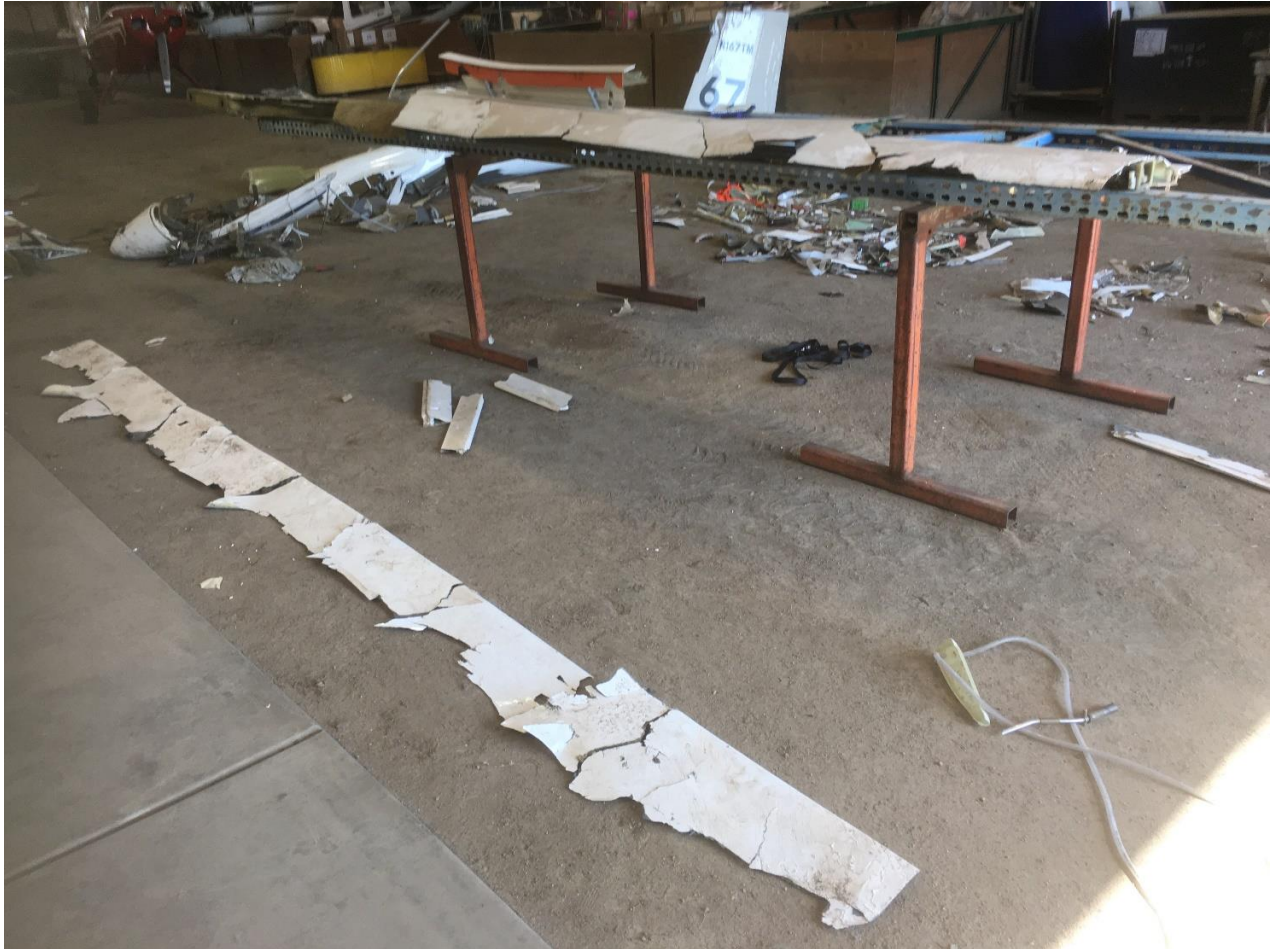
Image\_1985: Reconstructed fragments of lower and upper parts of left inner wing.

The re-assembled fragments of the left wing clearly demonstrate damage consistent with the outward expulsion of water contained in the wing inside the integrated water tanks.

This inner wing section houses the internal water tanks along its entire 5m span, in the forward first half of the wing chord (see appendix Figure 2.4-1). Observations show this section of the wing was broken into fragments along the entire 5m span, precisely along the forward half of the wing chord where the water tanks are located.

The damage observed indicates that the left wing was full of water ballast. Upon impact, the mass of the water inside the wing was propelled forward and exploded the wing into fragments from the inside-out.

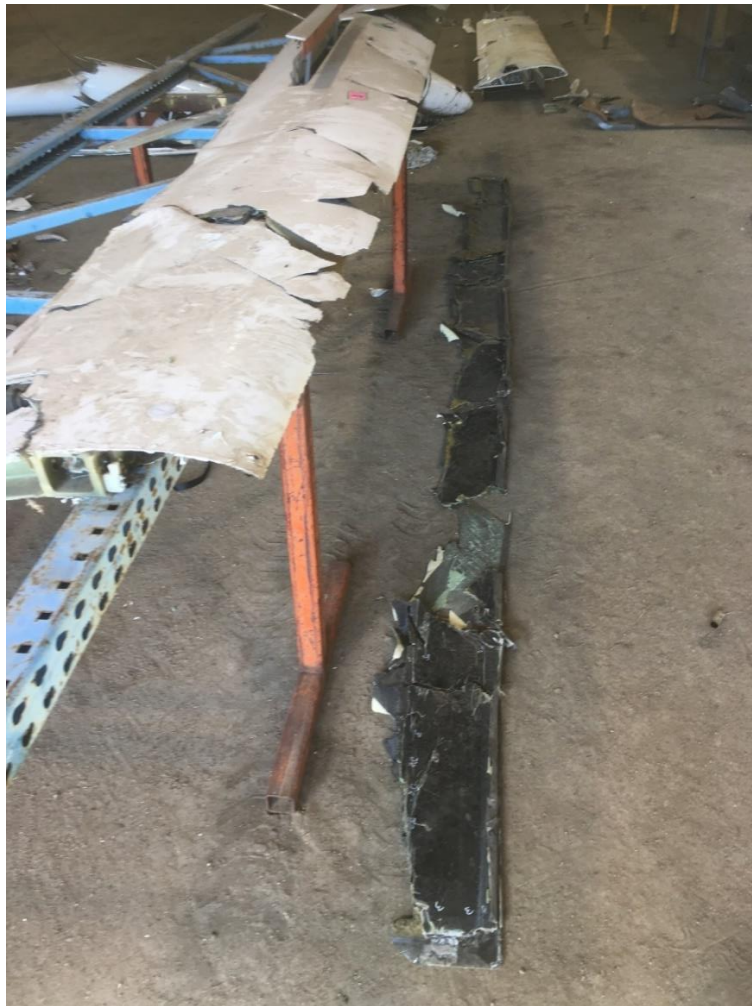
The water ballast had a downward and a forward component vector force, severely damaging the lower surface and upper surfaces of the wing. The forward component of the force of the water split open the leading edge of the wing, separating the wing into top and bottom wing surfaces along the entire leading edge of the inner wing section.

The top of the wing sustained damage from the forward force of the water as the water burst forward along the front half of the wing cord, tearing the top surface in a diagonal pattern consistent with its fiberglass construction.

The bottom of the wing received extensive damage as most of the water burst downward through the bottom of the wing, breaking the bottom wing surface it into small fragments.

This photo shows the top surface of the wing laid on top of a metal rack, while the bottom wing is shown on the floor, dark interior turned up (as would be the correct orientation for bottom of the wing).

Image\_1995: Left Wing (Top and Bottom)

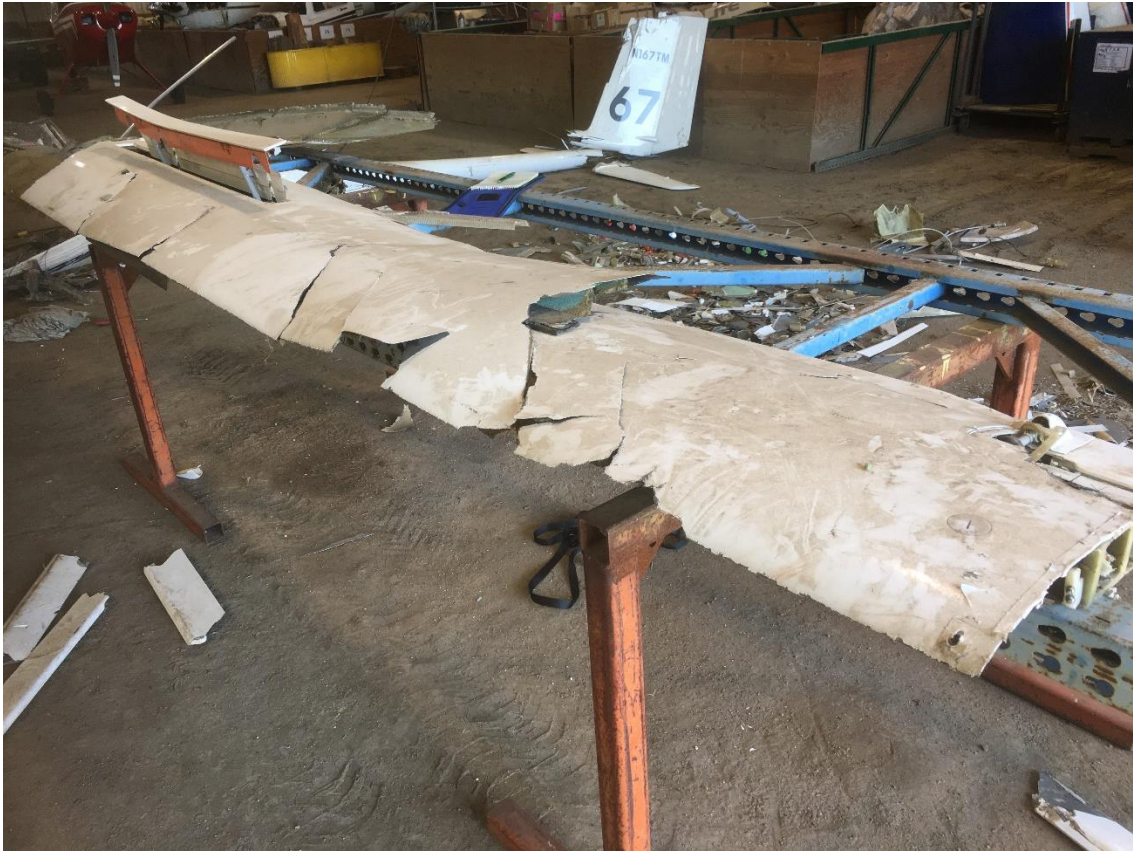
Image\_1983: Top of Left Inner Wing

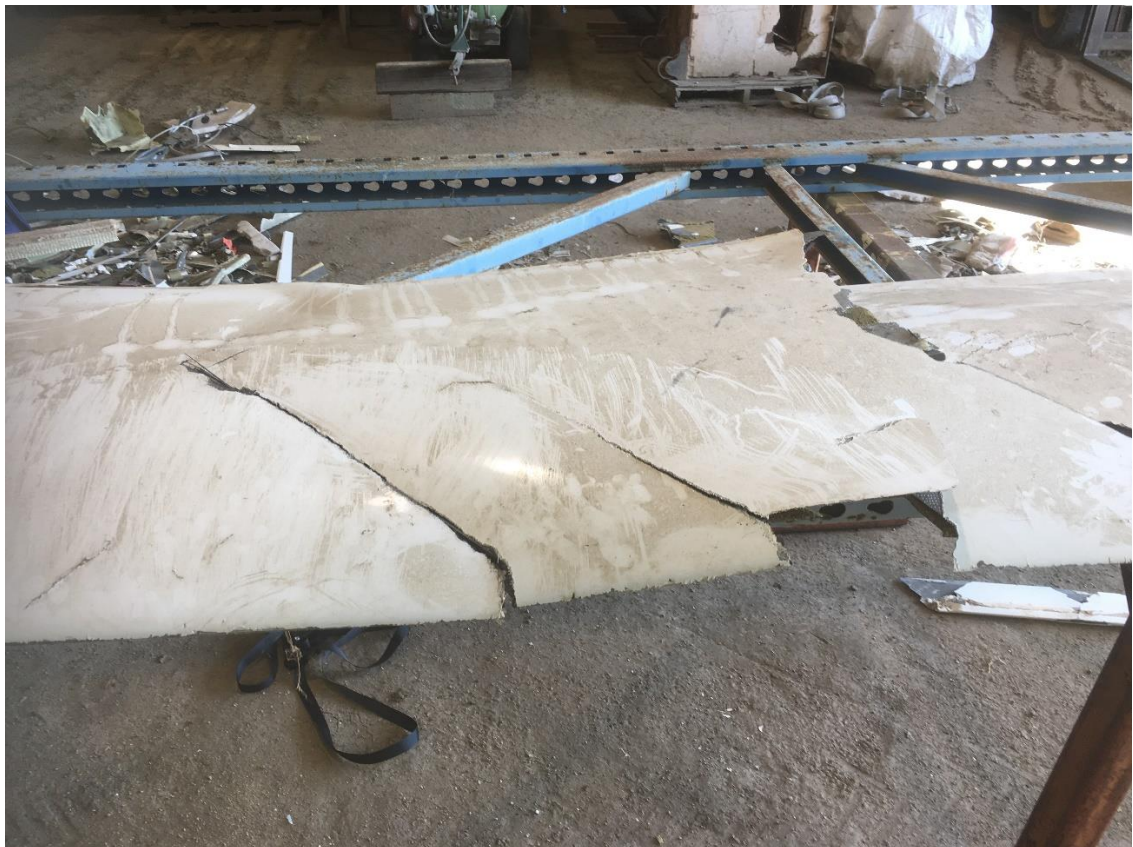
Image\_1982: Top of Left Inner Wing

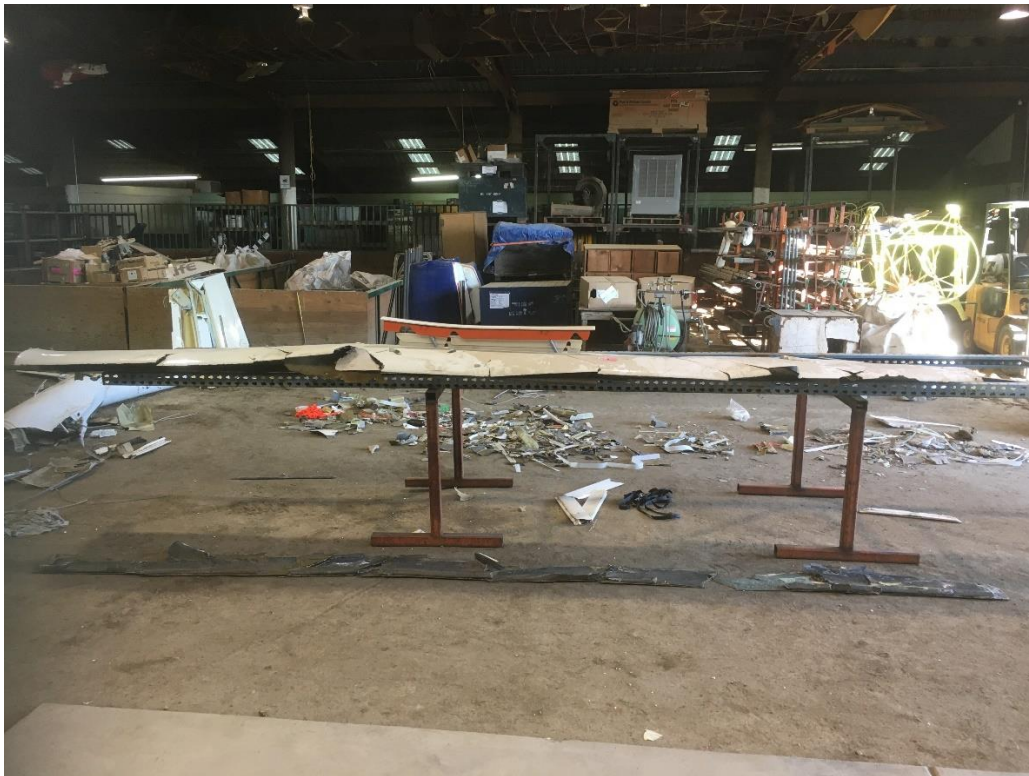
Image\_1994: Front View of Left Inner Wing

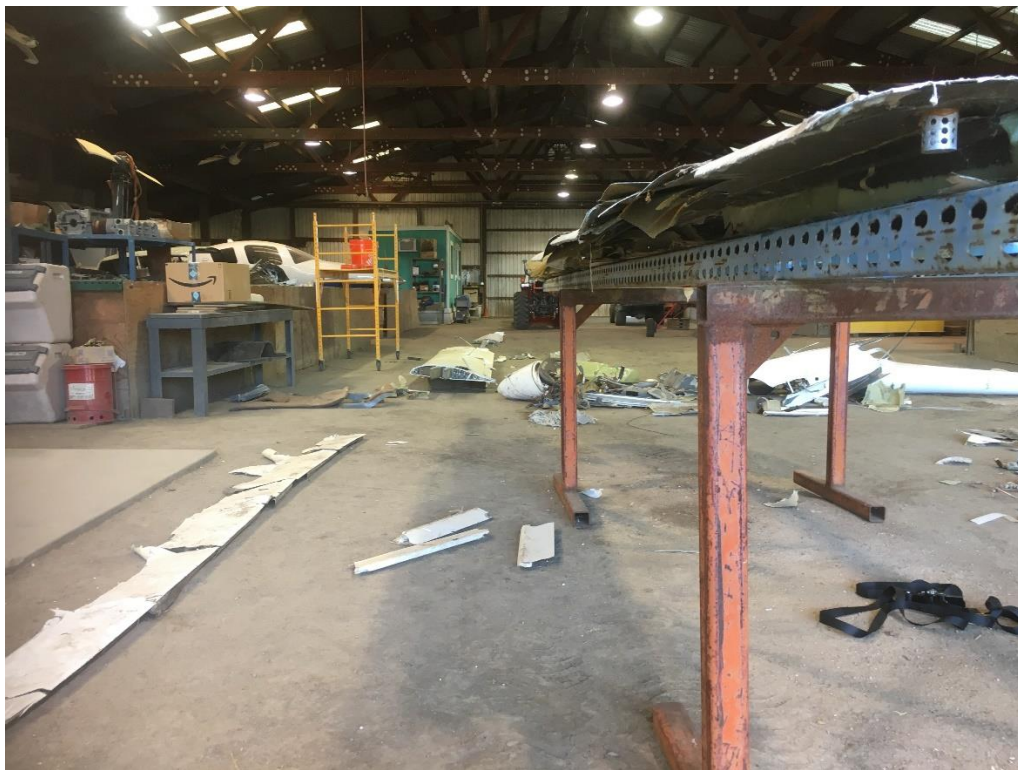
Image\_1989: Side View of Left Inner Wing

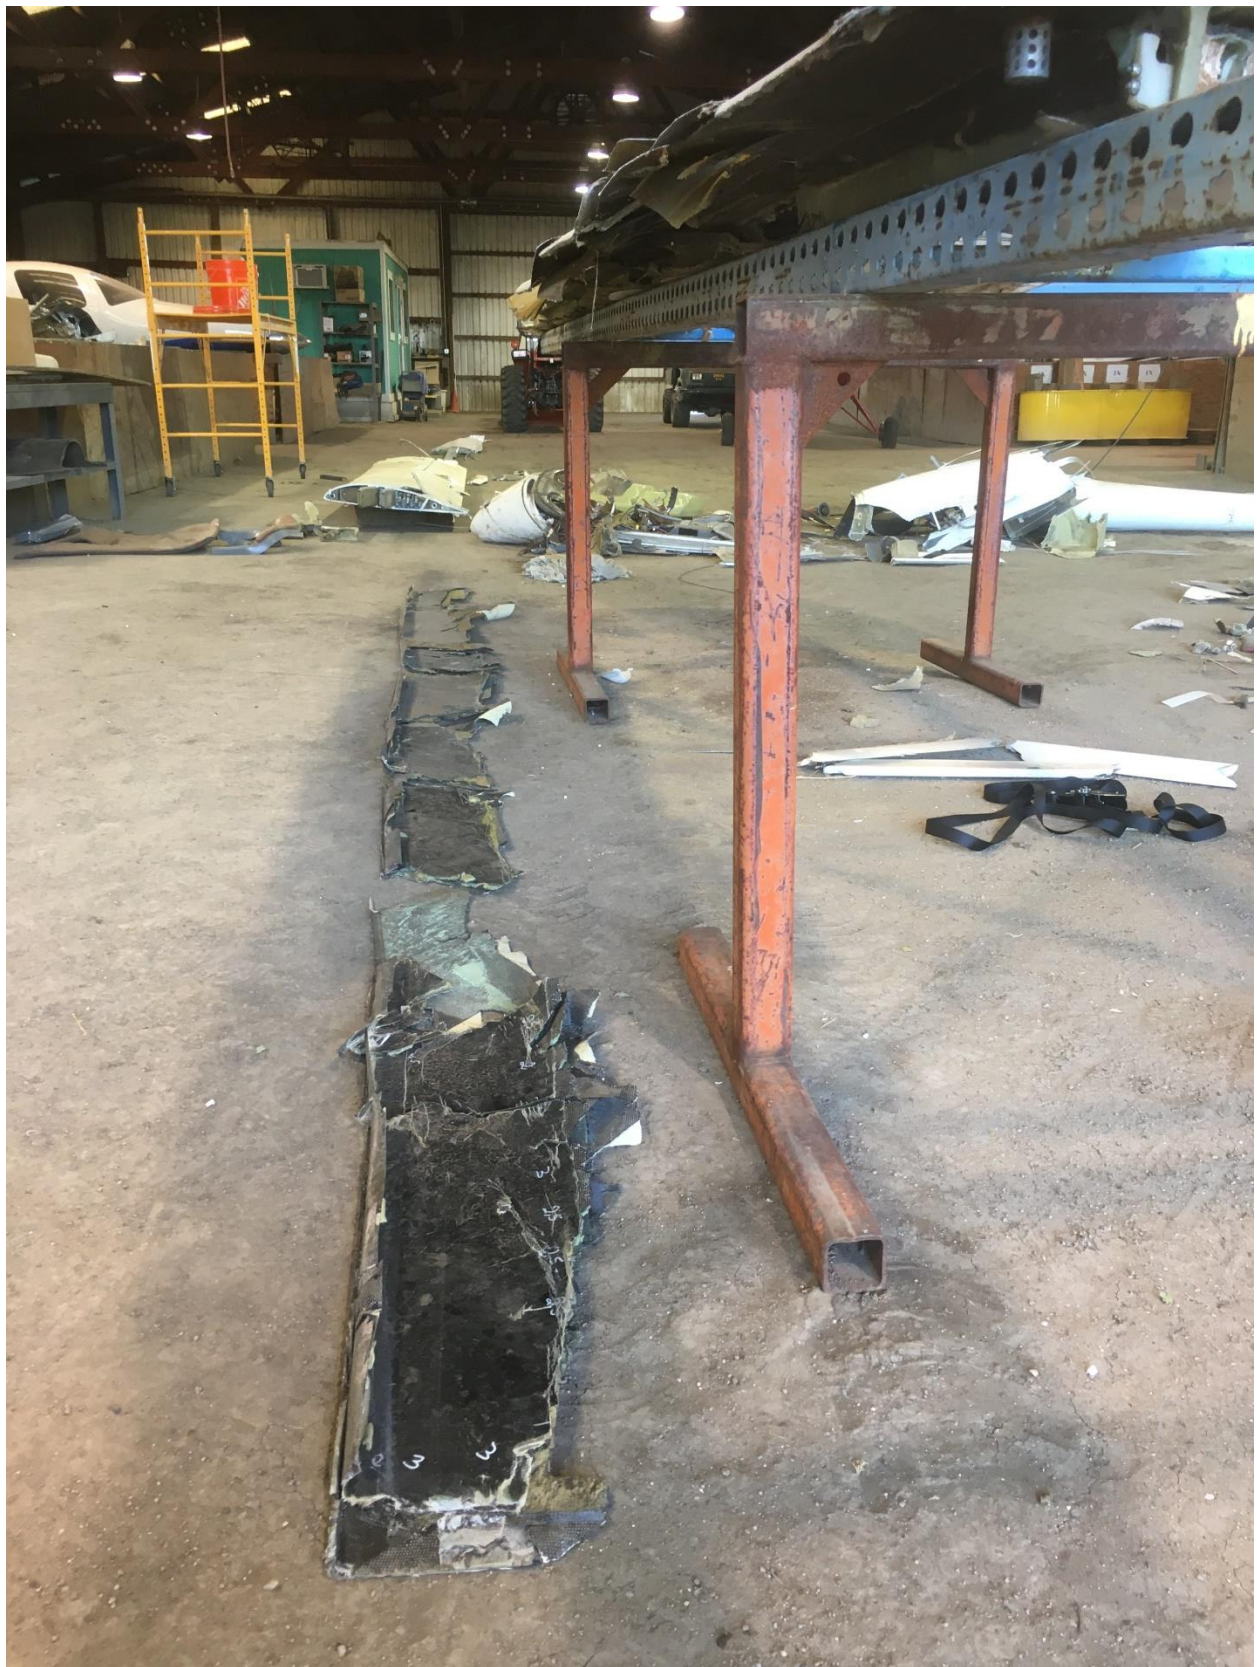
Image\_1992: Side View of Left Inner Wing

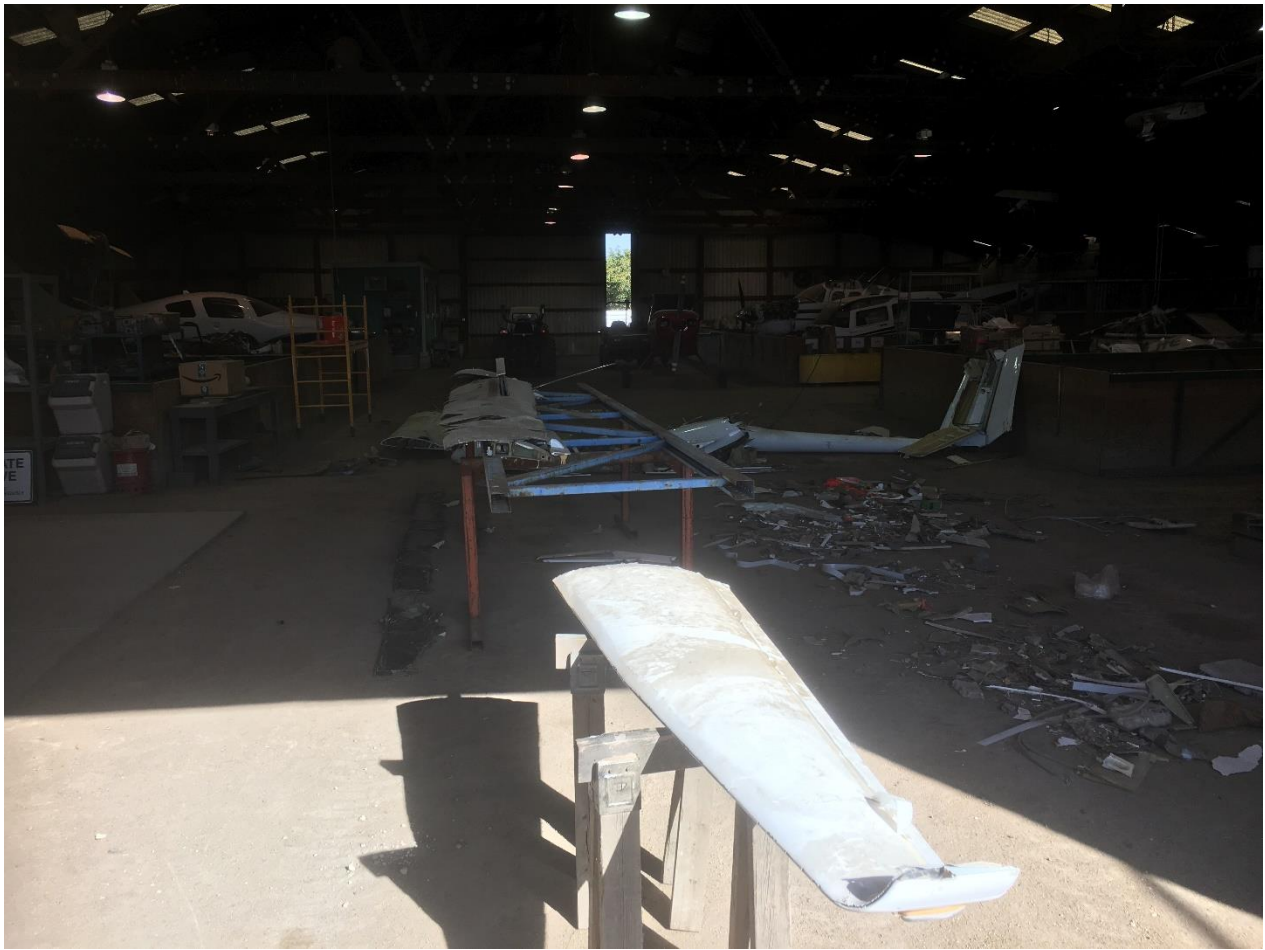
Image\_1997: Left Wing Extension

This image above shows the detached 1.5m left wing extension. The left wing extension was first part of the glider to impact the ground. The wing extension broke away from the inner wing section upon impact and sustained minor damage. This fiberglass wing section (without internal water) sustained little damage, even though it impacted the ground first.

This is consistent with the observation that the damage on the inner section of the wing was caused by the water contained inside the wing, rather than impact with the ground.

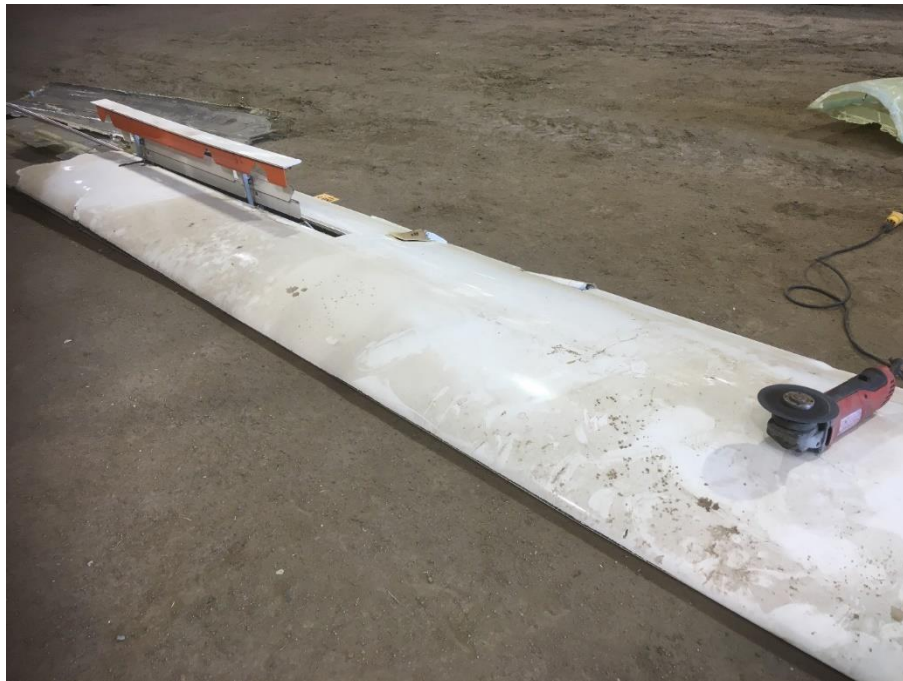
The photo below shows the right inner wing section in good condition (considering the high energy of the crash). The top surface is damaged slightly at the outer end (upper left corner), where a single piece of the upper surface has come loose (most likely when the outer wing section detached from it).

The entire leading edge of the right wing and both upper and lower surfaces from the (orange) airbrake to the wing root show very little damage.

Image\_1980: Right Inner Wing

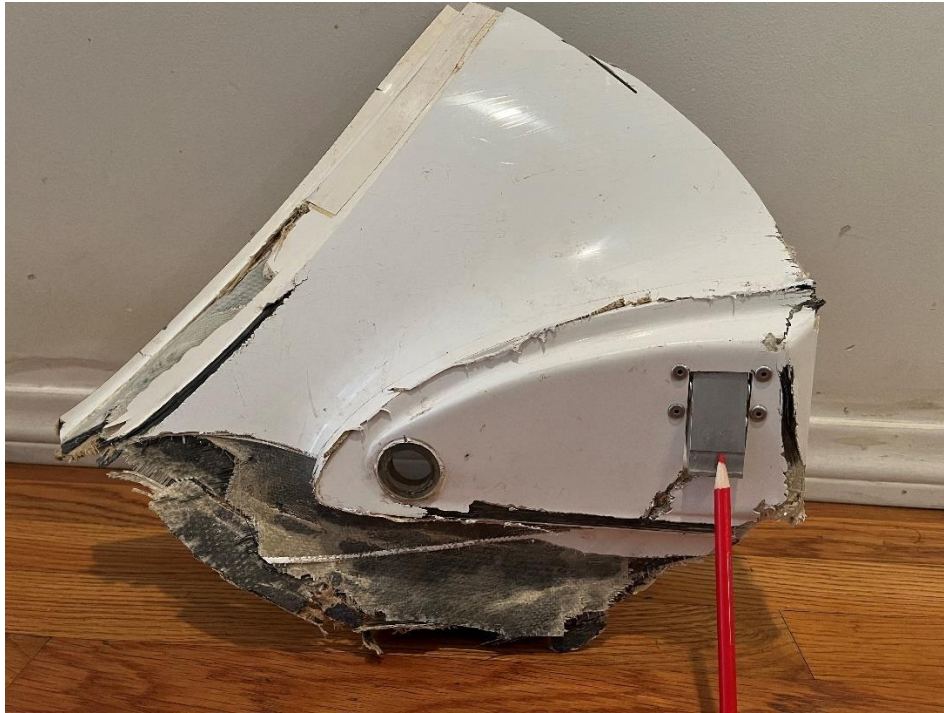
Image\_2829: L/H rocker view from outside.

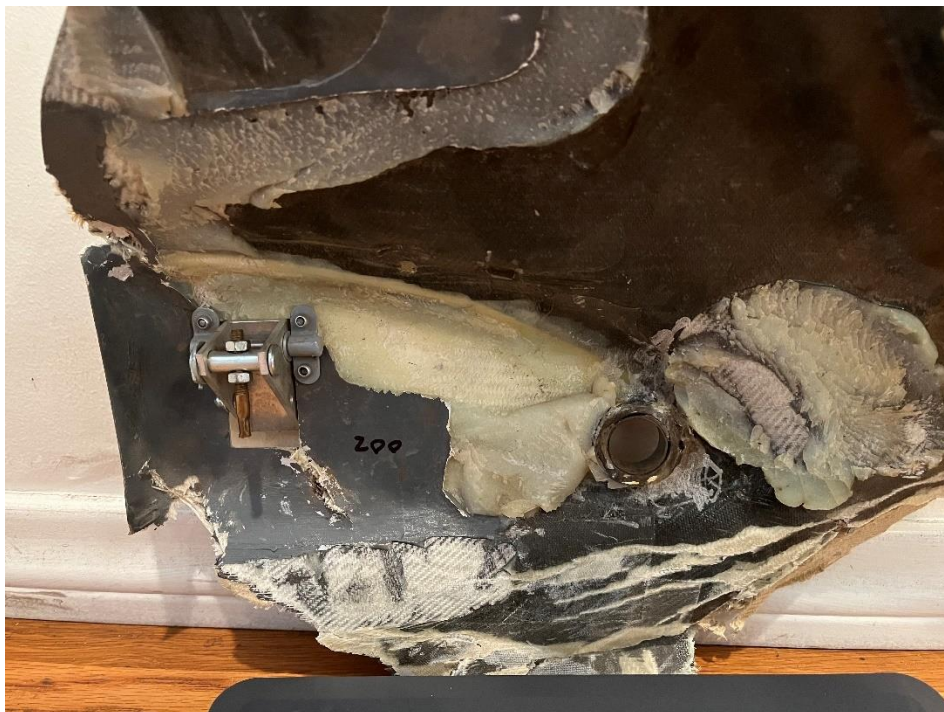
Image\_2832: L/H rocker view from inside.

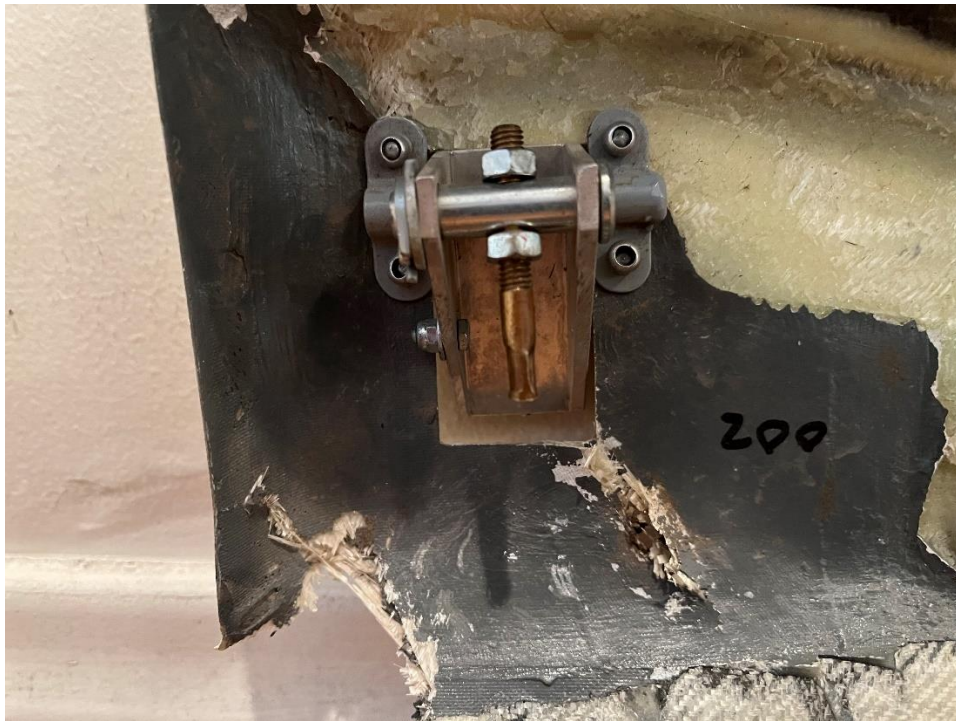
Image\_2833: L/H rocker close-up view showing side profile of crimp on brass tube.

The design of the cable termination is problematic in that the cable is secured in the brass female tube using only a crimp to hold it in place. This termination method lacks ANY safety feature or fail safe to prevent the cable from coming loose or detaching from the female housing. The crimp-style termination is not suitable for a critical aircraft assembly. This design is susceptible to manufacturing defects and fatigue. The cable termination should be made safer using a full-loop attachment to ensure that the cable cannot pull free with repeated use.

1. Change the crimp-style termination of Bowden cable to a fail-safe design which ensures the cable cannot pull free from the housing. The existing crimp-style termination, without additional safety feature, presents a potentially life-threatening hazard and should be rectified.
2. Provide indicator to verify when water release valve fails to open.

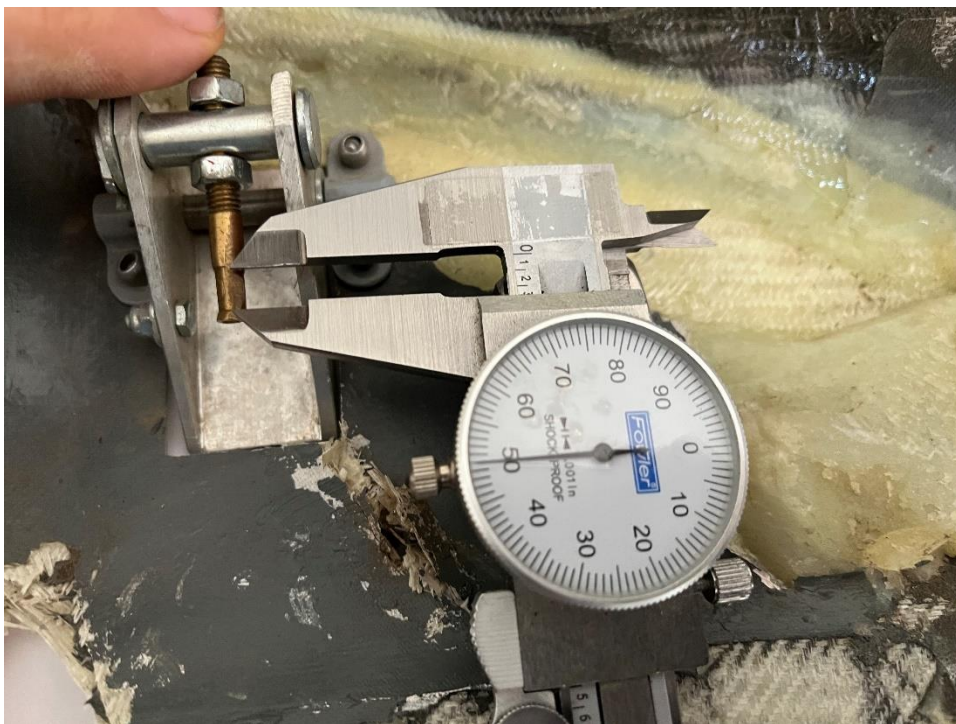
Image\_2836: Crimp on brass tube measures 0.25 inches (6mm) in size.

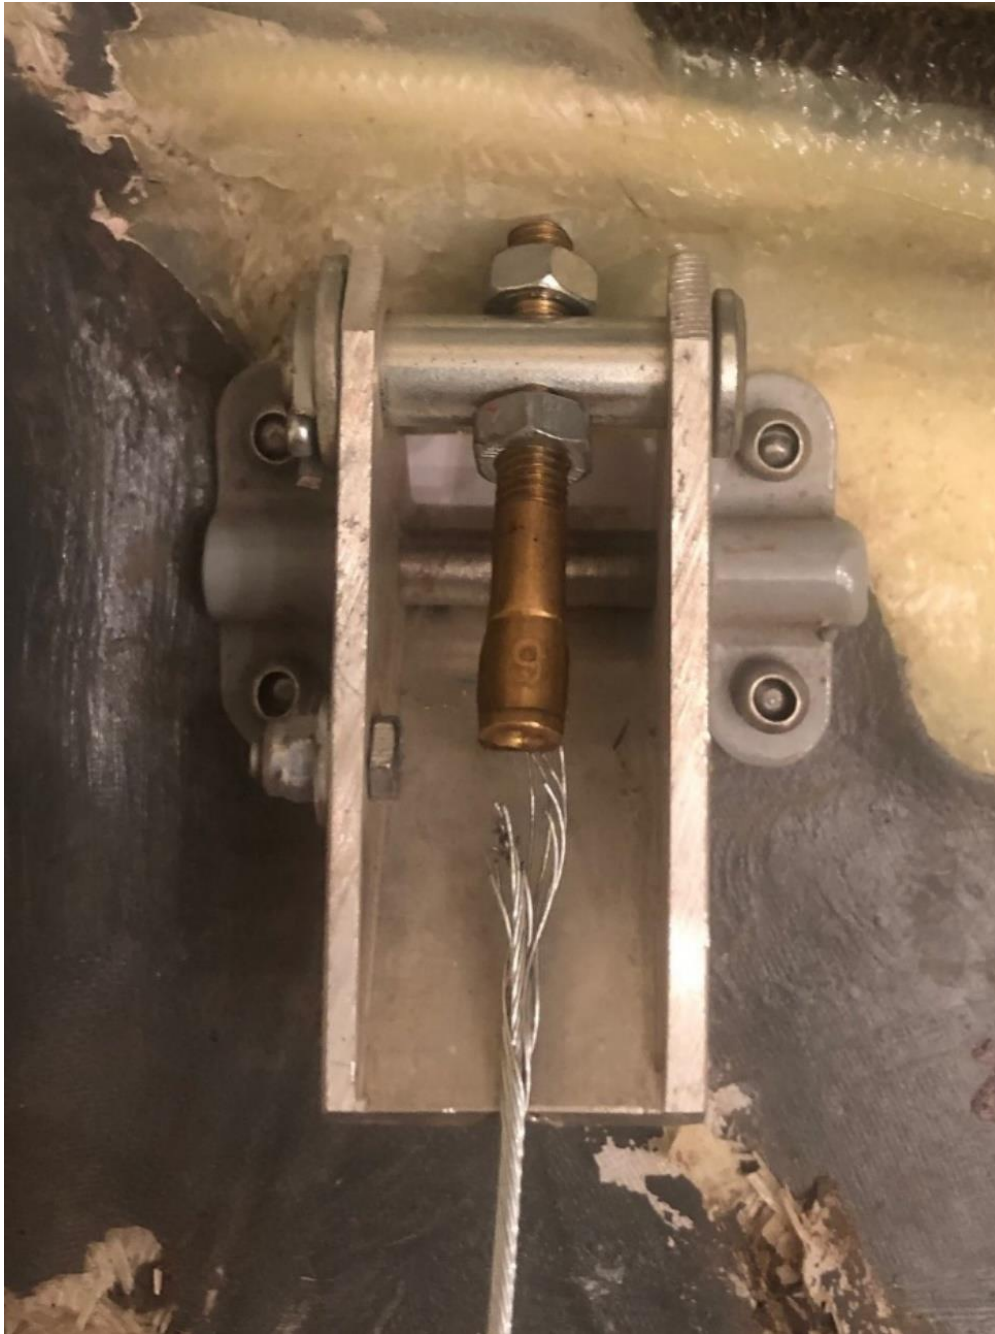
Image\_6094: L/H Bowden cable pulled out from the brass tube.

Observations show that the cable to the left wing does NOT show signs of stress or breaking under tensile force. The evidence suggests that the cable termination failed prematurely (during flight).

Evidence suggests that the left cable disengaged from the female brass tube, not under the stress of impact, but when the crimp termination failed. This failure occurred in-flight causing the left wing water release valve to remain closed (the valve is spring loaded and normally closed). The left valve remained closed and prevented the jettison of water from the left wing, meanwhile the right valve was opened, releasing all the water from the right wing.

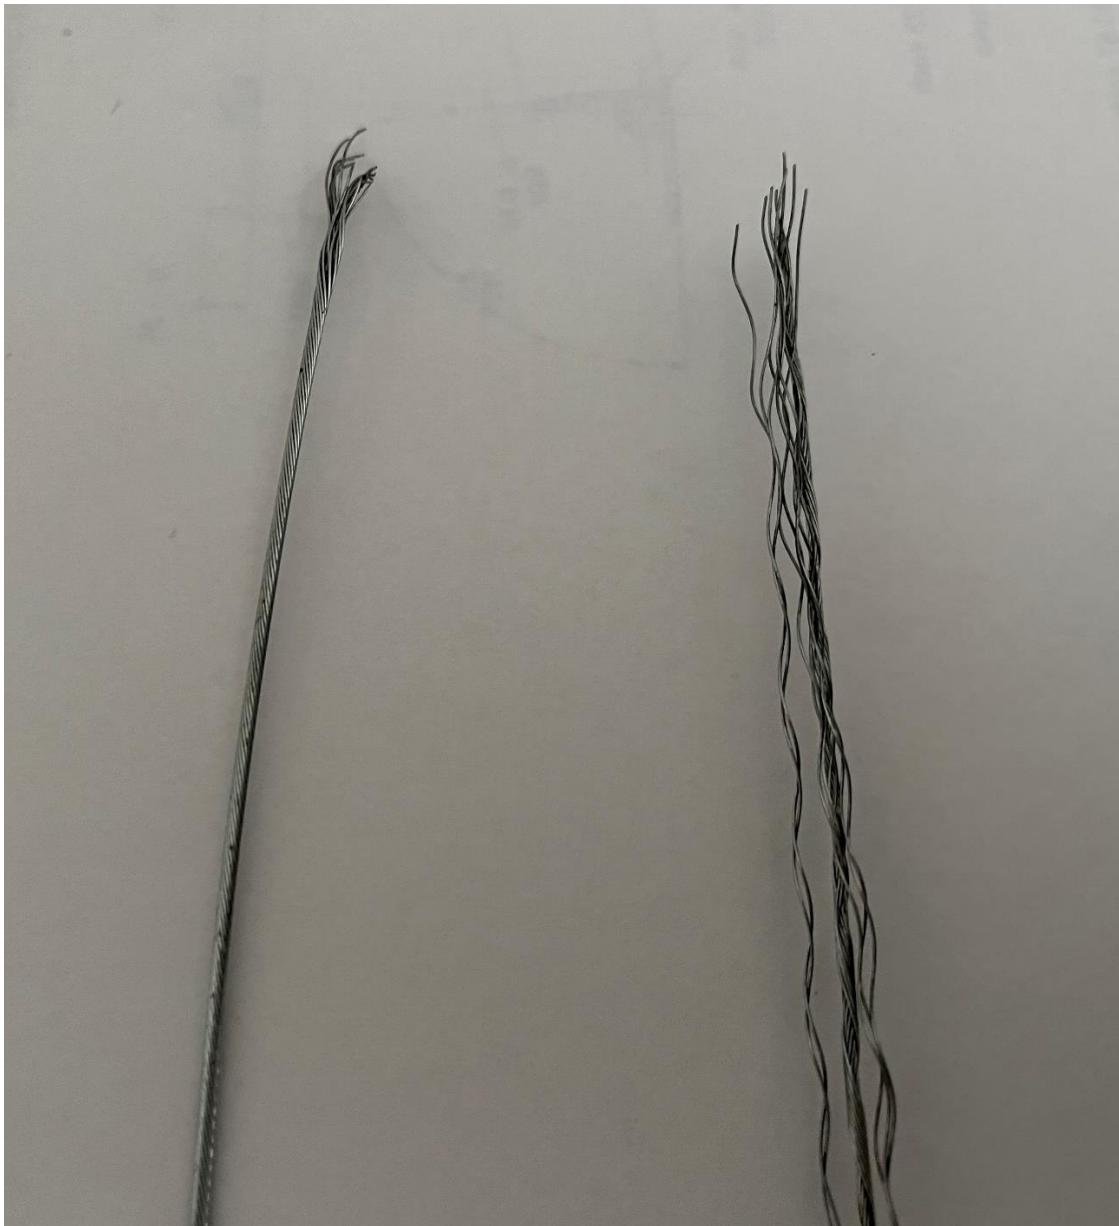
Image\_2837: Difference observed between Left Cable and Right Cable showing tensile forces.

Observations show that cable to the right wing is broken in a manner which shows signs of tensile stress. The ends of the cable are frayed due to tensile force pulling on the cable during impact. This indicates that the cable termination was secure during flight and broke

under significant load during impact. This evidence suggests that the right valve was operational during flight, allowing the water from the right wing to be jettisoned.

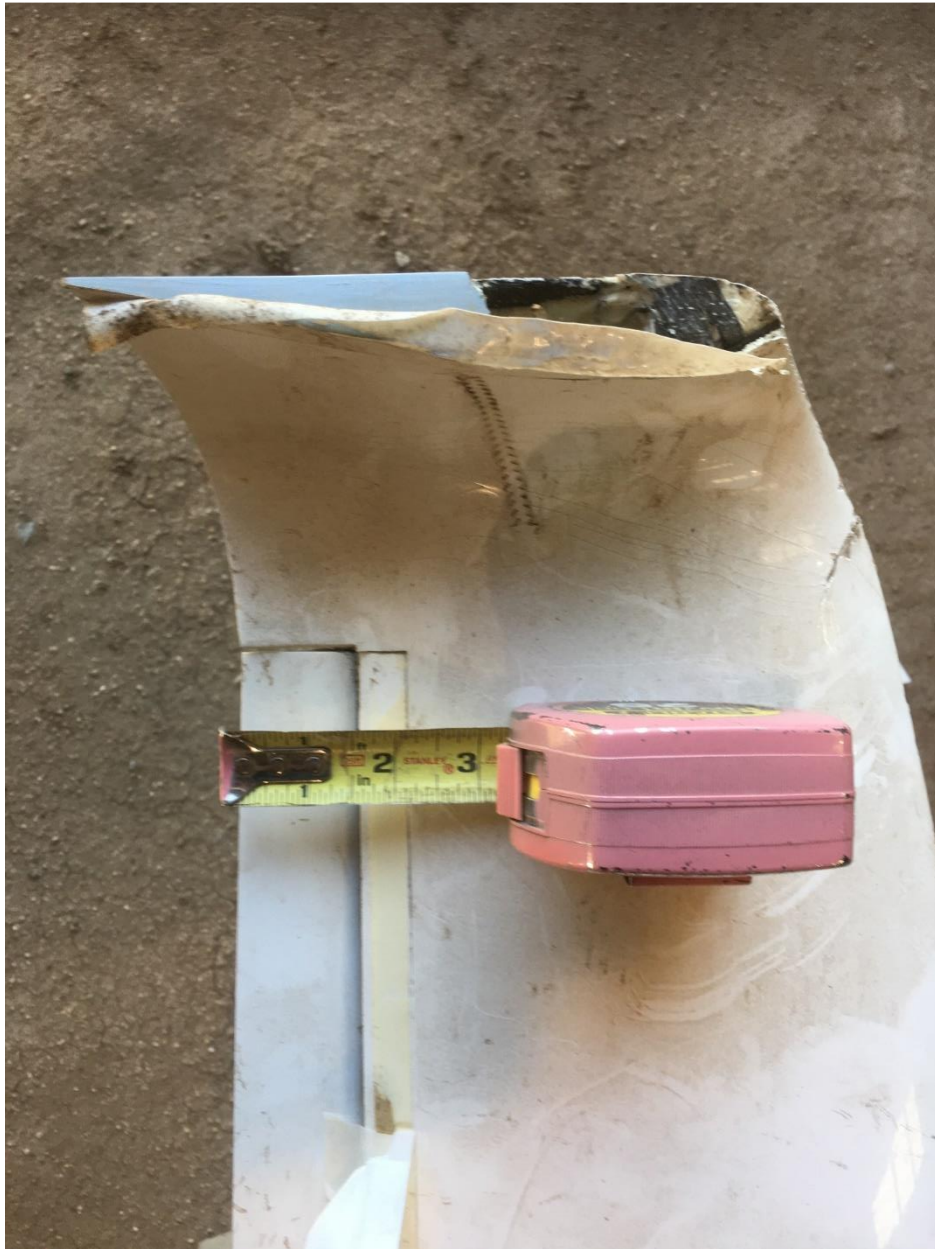
**The ASG-29, when configured for 15m wingspan, lacks sufficient aileron force to recover from such a flight attitude under asymmetrical water ballast load.**

IMG\_1988: Width of aileron on 15m wing tip extension ("mini-aileron")

**Factor 3:** In the 15-meter wingspan configuration, the aileron design at the outer tip of the aileron is only 1.5in. wide (chord-wise). The 15m aileron is half the length compared to the 18-meter aileron. This could be called “mini” aileron. It lacks sufficient force to lift an excessively heavy wing from a banked turn to return to level flight. In this attitude, the aircraft will quickly accelerate into a high-speed spiral dive (within seconds) resulting in uncontrollable aircraft.

1. Decrease permissible water ballast in 15-meter wing configuration of ASG-29.

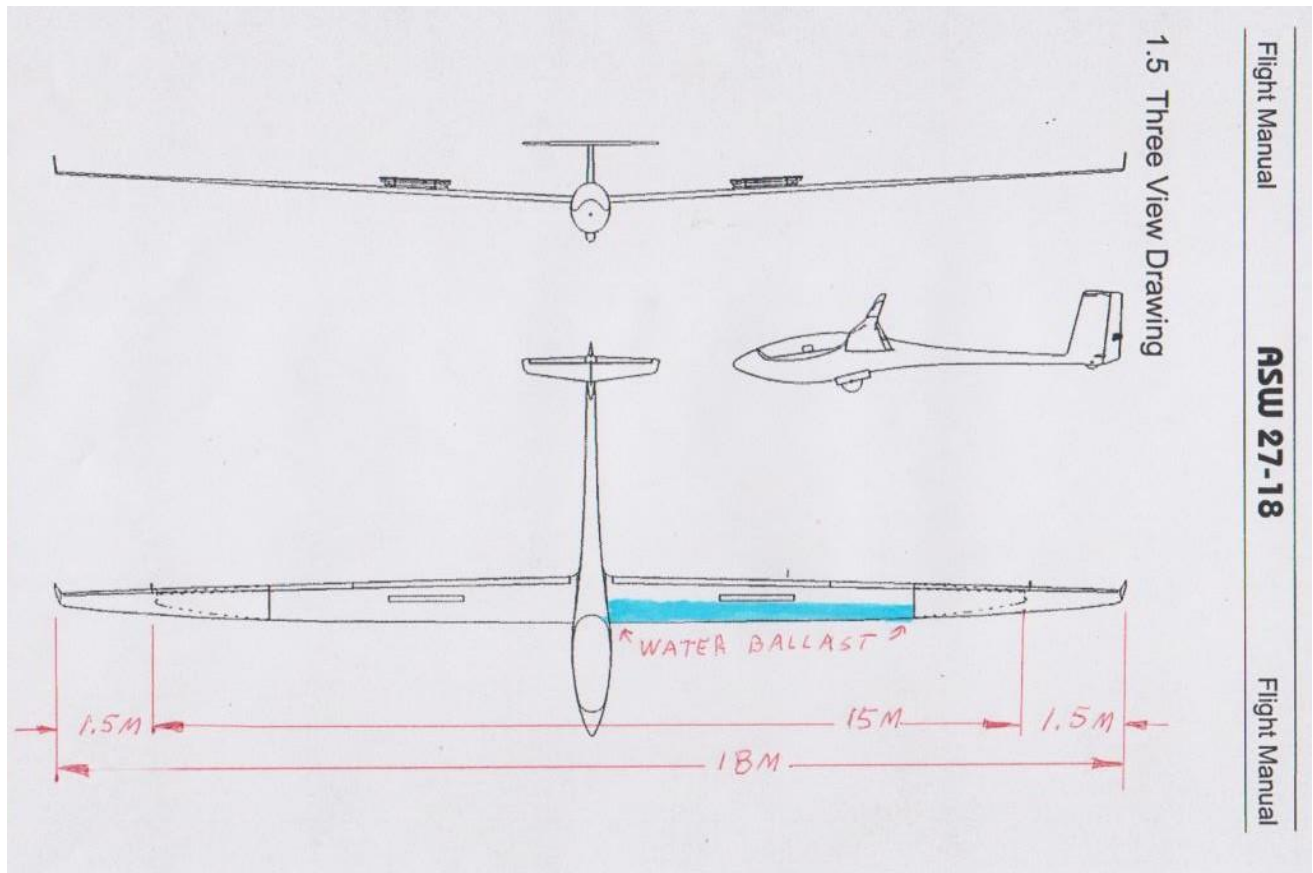
Figure 1.5: Three View Drawing showing water ballast and difference in wing extensions.

There is a difference in the aileron size between the 15m and 18m wing extensions. Each aileron on the 15m tip is 1.5m shorter (50%) at their outer most location, where the leverage is most effective. This has significant impact during asymmetrical wing ballast loading, decreasing the aileron force.

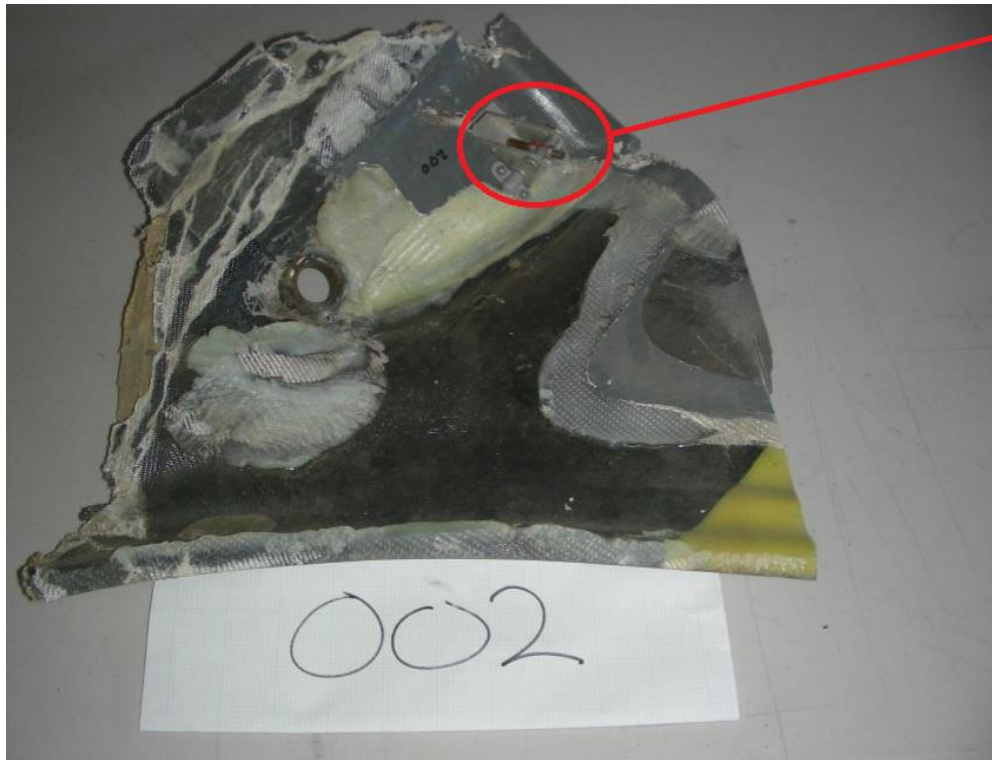
002: Left Wing Rocker and Housing Assembly (inside view)

The left side brass female housing and cable termination is suspected of failure.

This is the "root cause" of the accident.

The faulty termination allowed the cable to pull free in flight.

Check for LACK of evidence of cable break from impact forces (unlike the right side)
