**NATIONAL TRANSPORTATION SAFETY BOARD**

**Airframe and Engine Exam**

**WPR20LA223**

Aircraft: Piper PA-30 / N8488Y

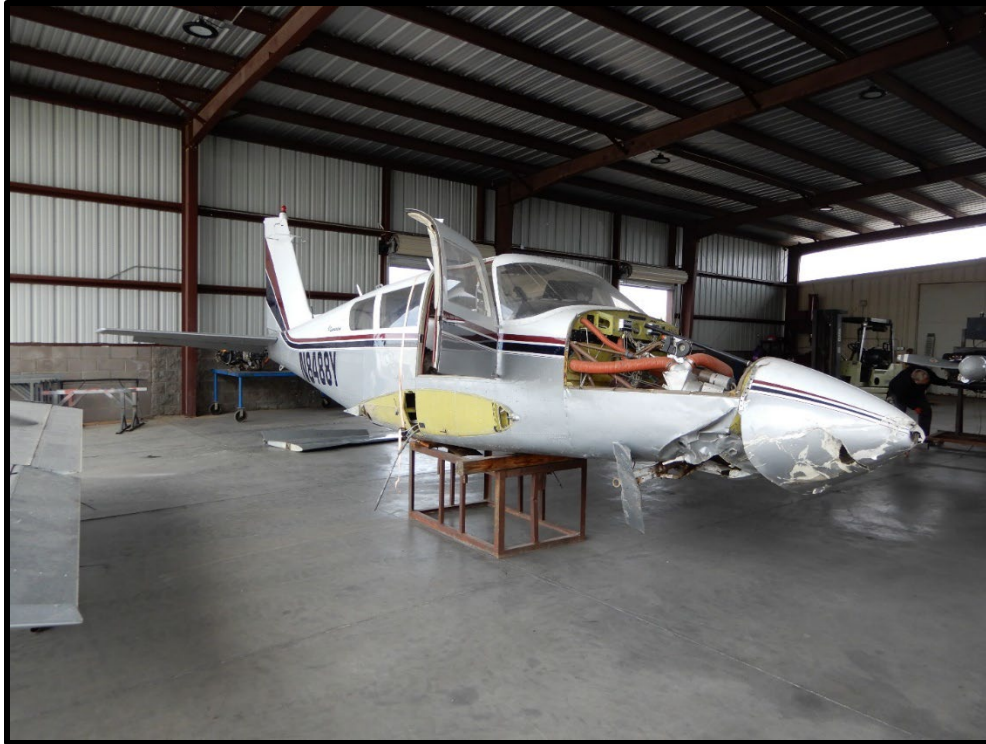
The right nose area exhibited substantial damage just aft of the composite material nose cap. The damage ran from the mid-section down to the nose wheel bay. The remaining right-side fuselage exhibited only minor damage back to the empennage, except for an area just aft of the trailing edge of the wing where there was substantial damage to the fuselage running underneath the fuselage to the left side. The right-side door remained attached to the fuselage at the hinges.

Photo 1. Front right view of fuselage.

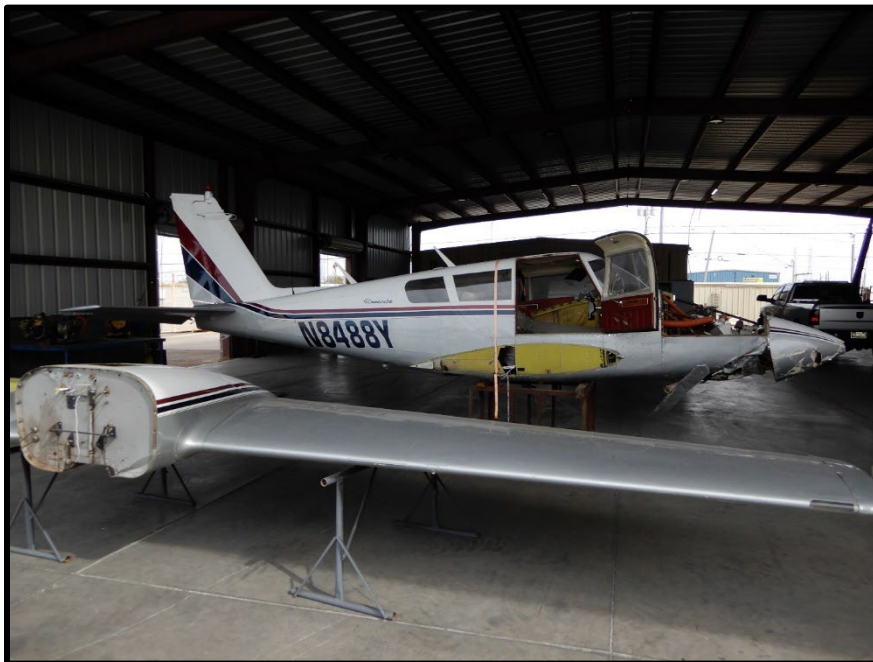
Photo 2. Right view of fuselage and left wing.

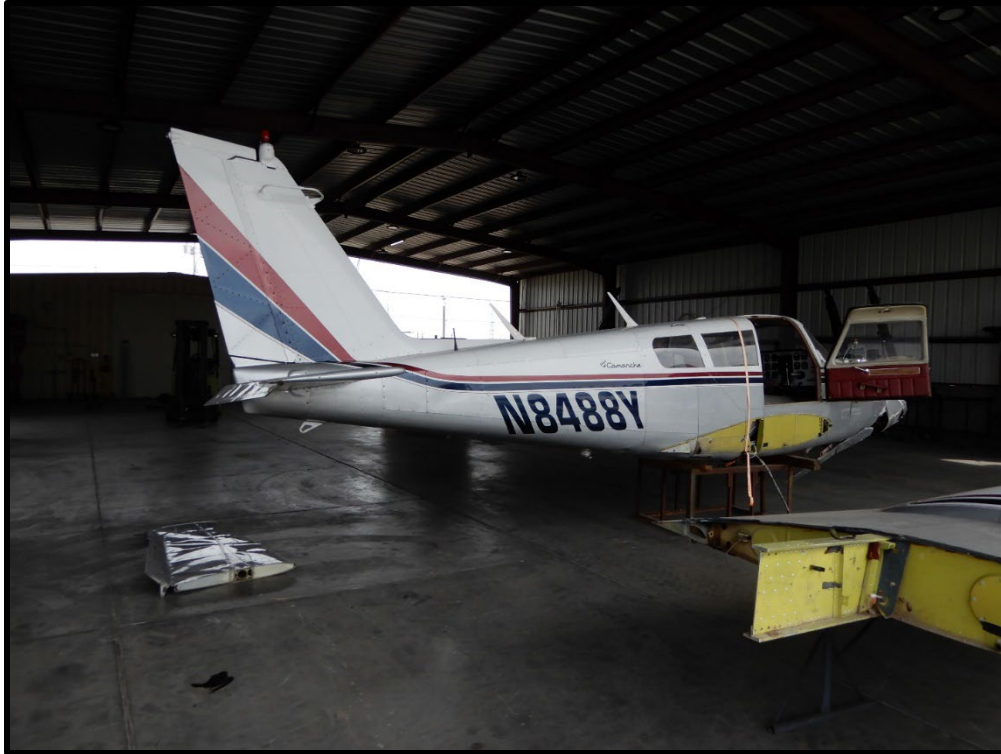
Photo 3. Right-rear view of the fuselage and left- wing spar.

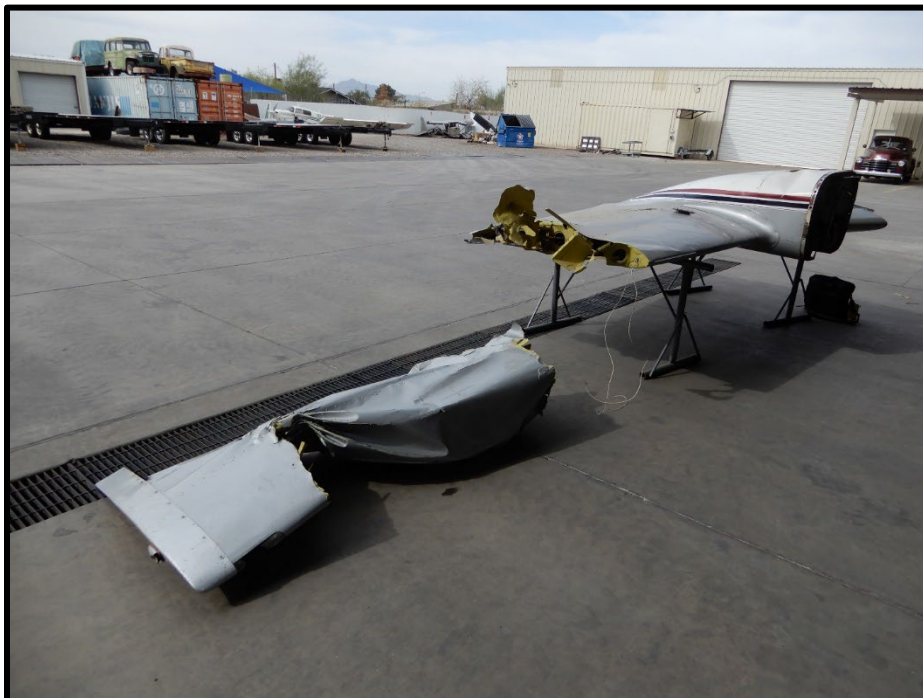
The right wing sustained substantial damage about 48 inches from the engine nacelle. The outer 48 inches of wing and the aileron separated from the wing and sustained substantial damage. A large contact point was observed that crushed the wing material aft beyond the wing spar. The right aileron separated from the wing segment at the hinges. The tip of the wing sustained minor damage. The aileron control tube remained attached to the aileron bell crank. The right flap remained attached to the wing section that remained attached to the fuselage. The flap appeared to be in the full up position. The right fuel tank cap remained secured to the tank. The rubber seal was present but did not provide the security necessary to remain in place. It was easy to remove the cap after it had been secured. The sheet metal cover kept the cap secure to the plane. The engine nacelle sustained minor damage with dents and scratches on the top side.

Photo 4. Right wing.

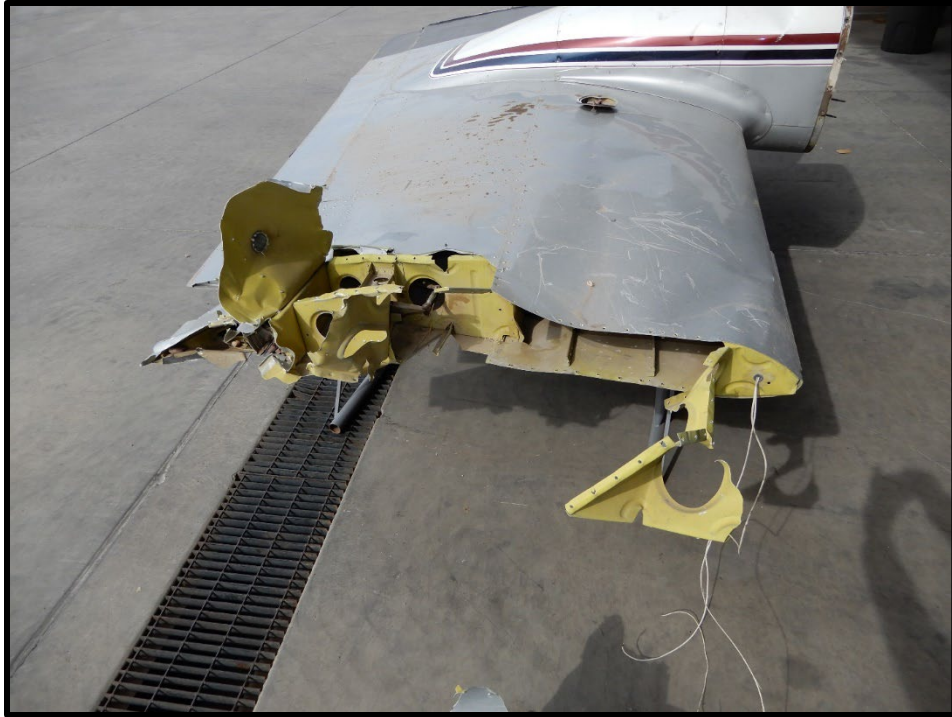
Photo 5. Right wing, outboard end.

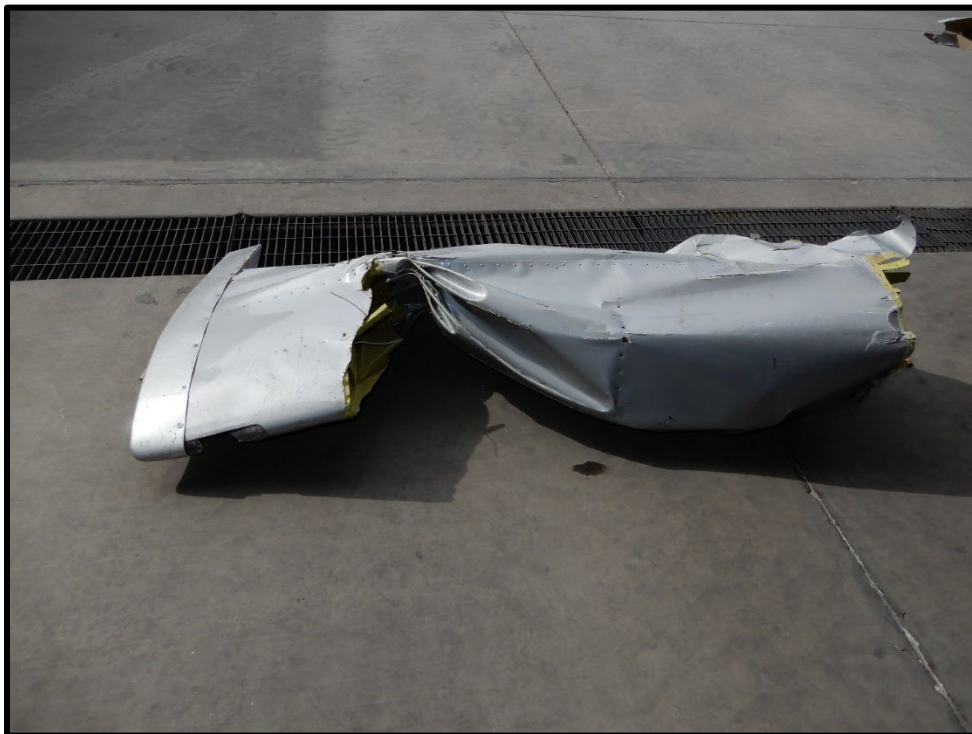
Photo 6. Right wing and tip.

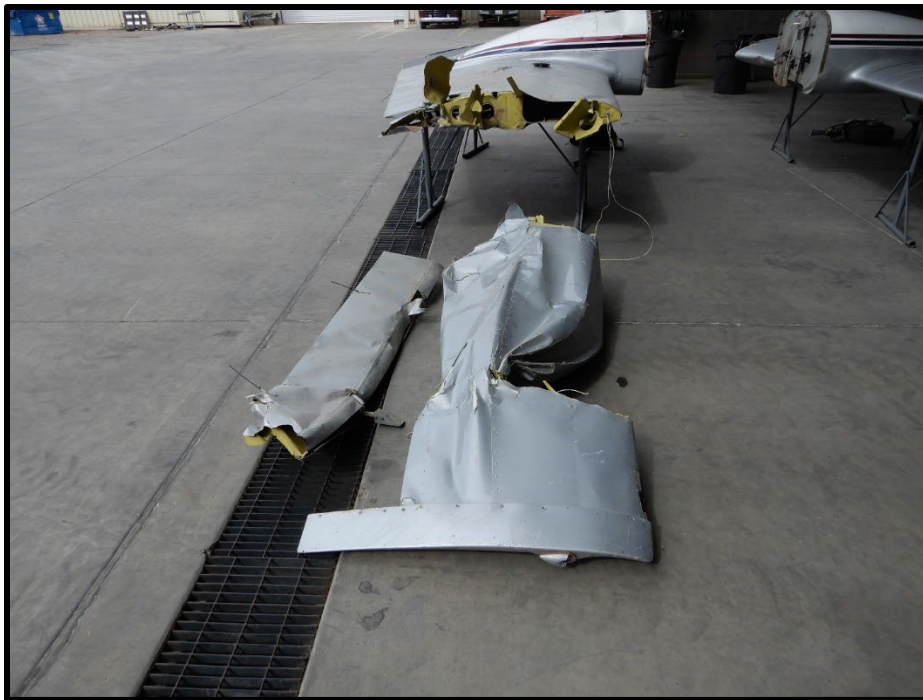
Photo 7. Right wing with aileron.

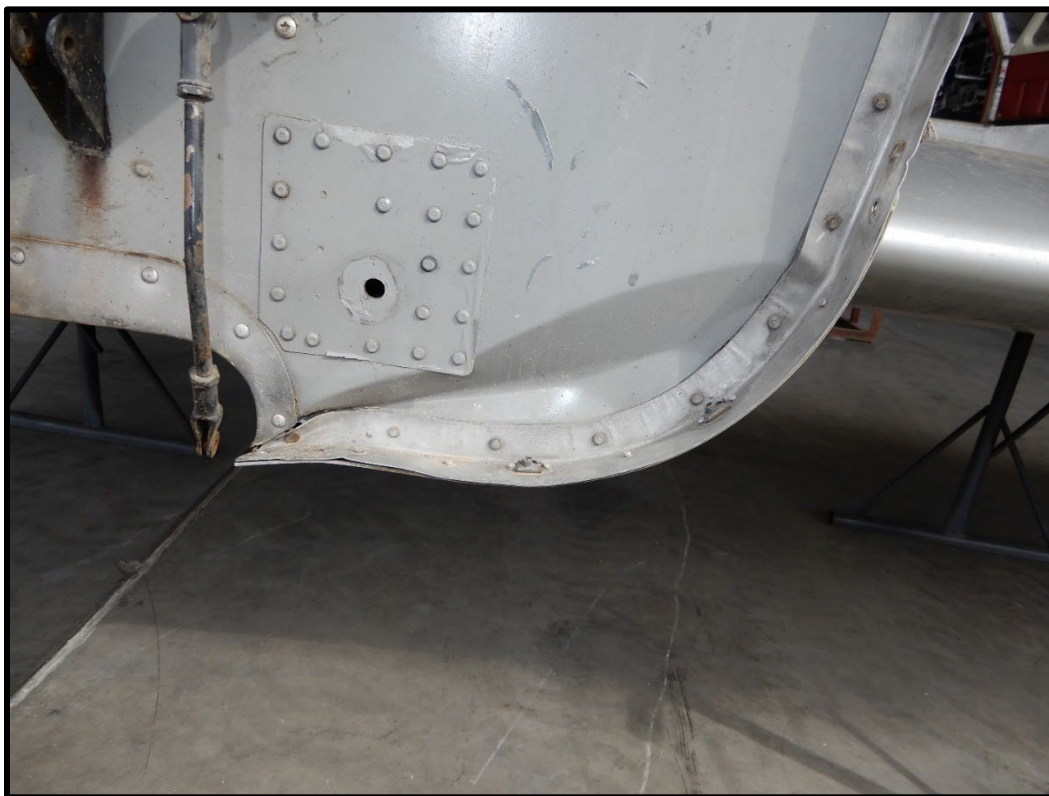
Photo 8. Left wing engine firewall.

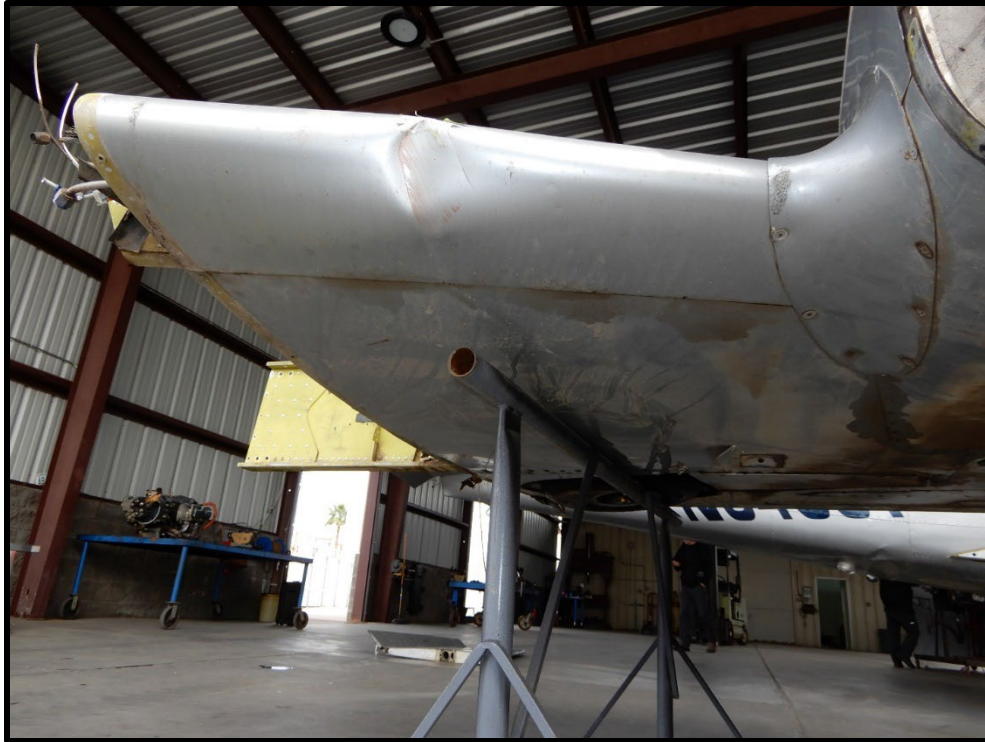
The left wing sustained minor damage throughout. There was a minor dent located on the leading edge inboard of the engine nacelle. There was a dent to the firewall of the left engine nacelle at the bottom left area. The flap remained attached to the wing at the hinges and appeared to be in the full up position. The aileron remained attached to the wing at the hinges and moved up and down to the limits. The engine nacelle appeared to have sustained little to no damage.

Photo 9. Left wing with damage to the leading edge.

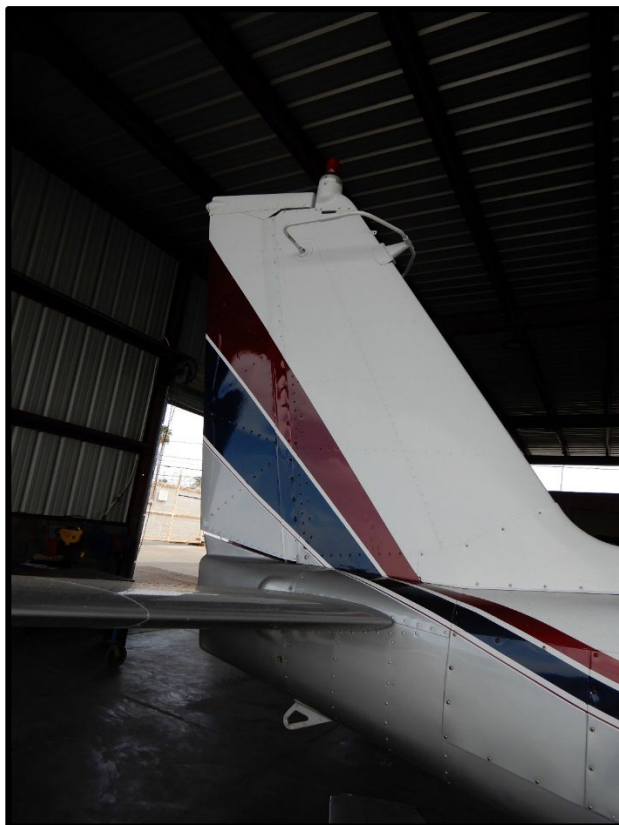
The right side of the empennage exhibited minor damage. The right stabilator remained attached to the empennage and exhibited minor damage to the underside. The right trim remained attached to the right stabilator, exhibited no damage, and appeared in the full down position. The vertical stabilizer remained attached to the fuselage and exhibited no damage to the right or left side. The rudder remained attached to the vertical stabilizer and exhibited no damage to the right or left side. The rudder moved to the left and right limits. The left stabilator was separated from the empennage and recovered. The stabilator exhibited substantial damage to the leading edge on the underside running chordwise. The left trim remained attached to the stabilator at the hinge and was removed from the trim control tube at the attachment point. It was not confirmed that the left stabilator may have been removed for recovery.

Photo 10. Empennage, right side.

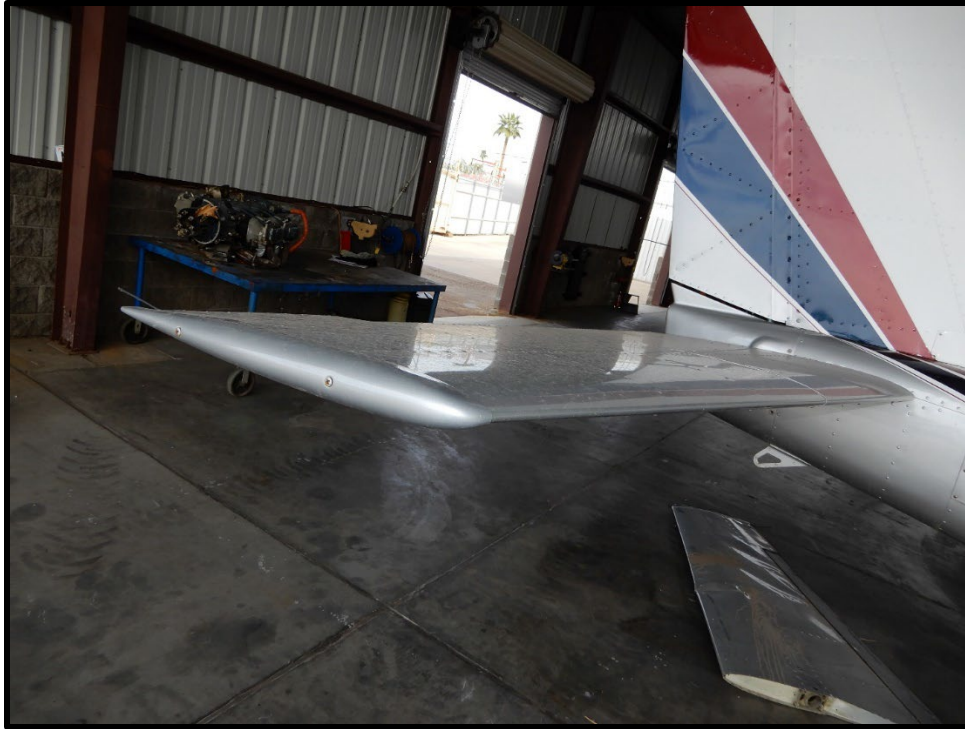
Photo 11. Right stabilator

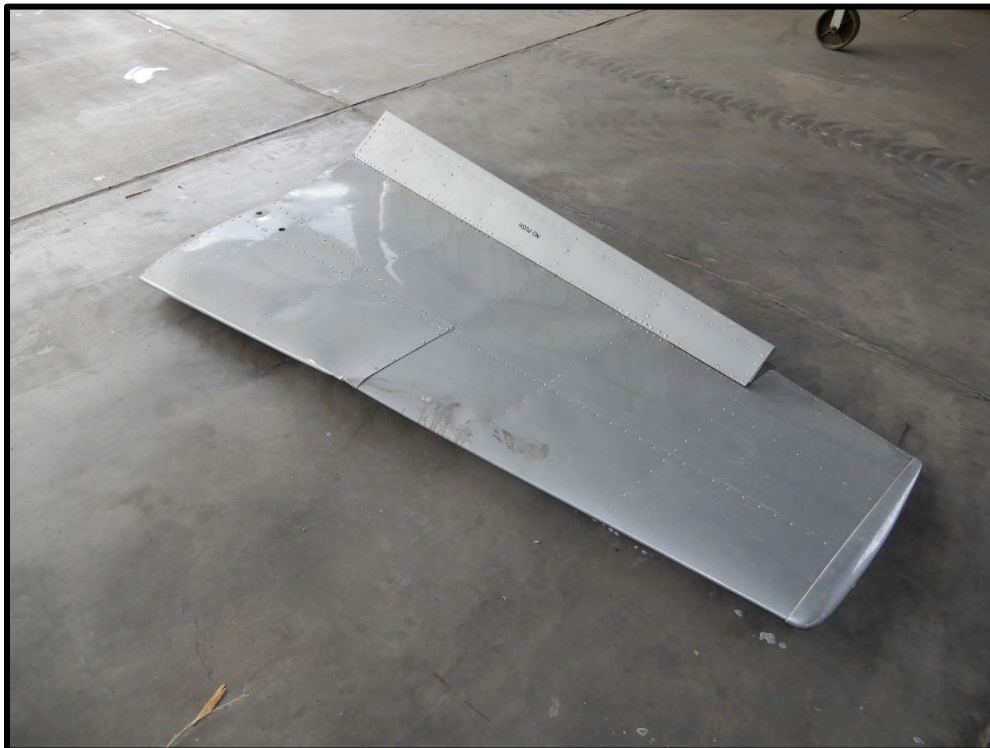
Photo 12. Left stabilator, top side.

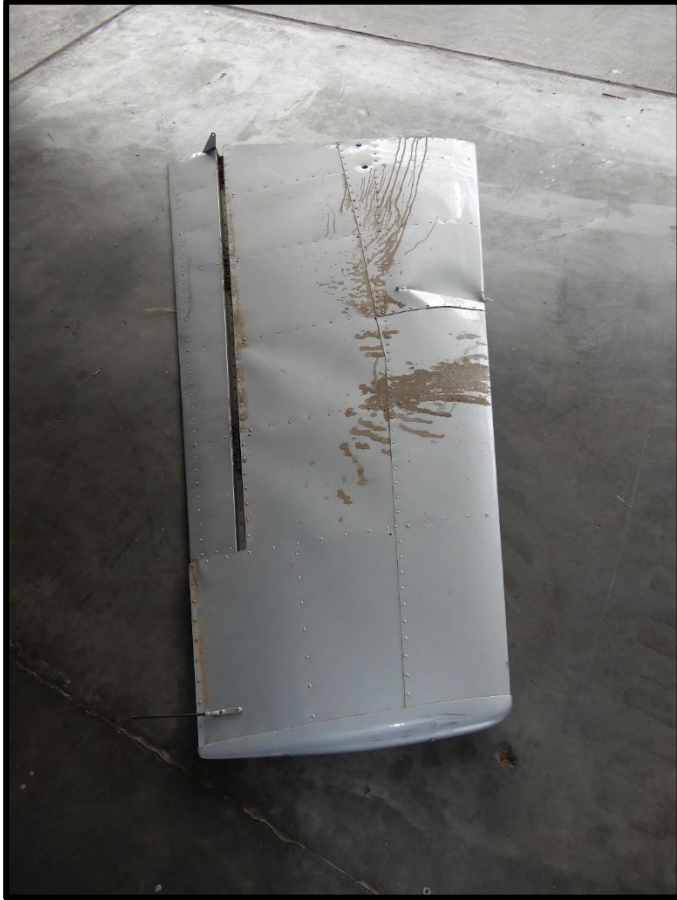
Photo 13. Left stabilator, under side.

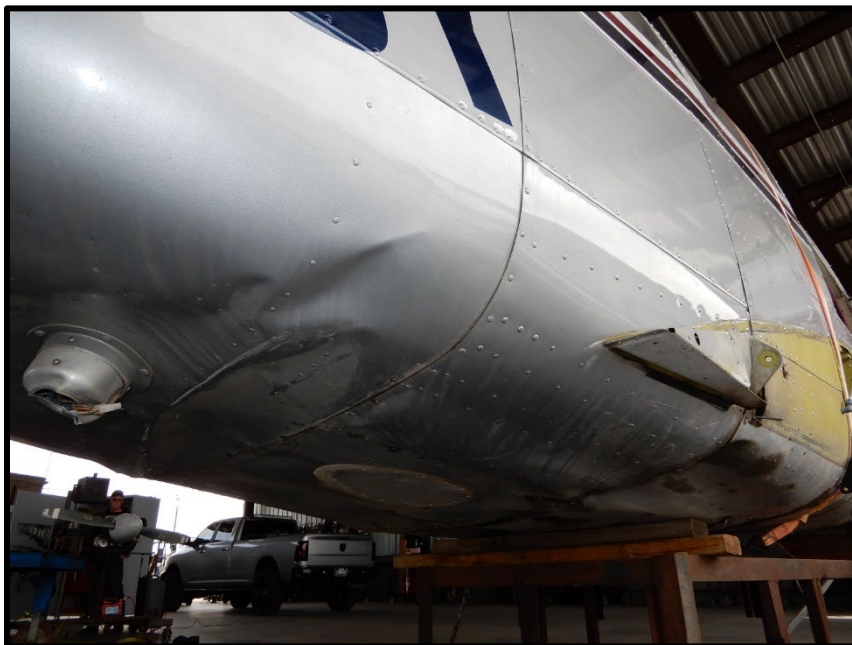
Photo 14. Right side of fuselage, showing damage to underside.

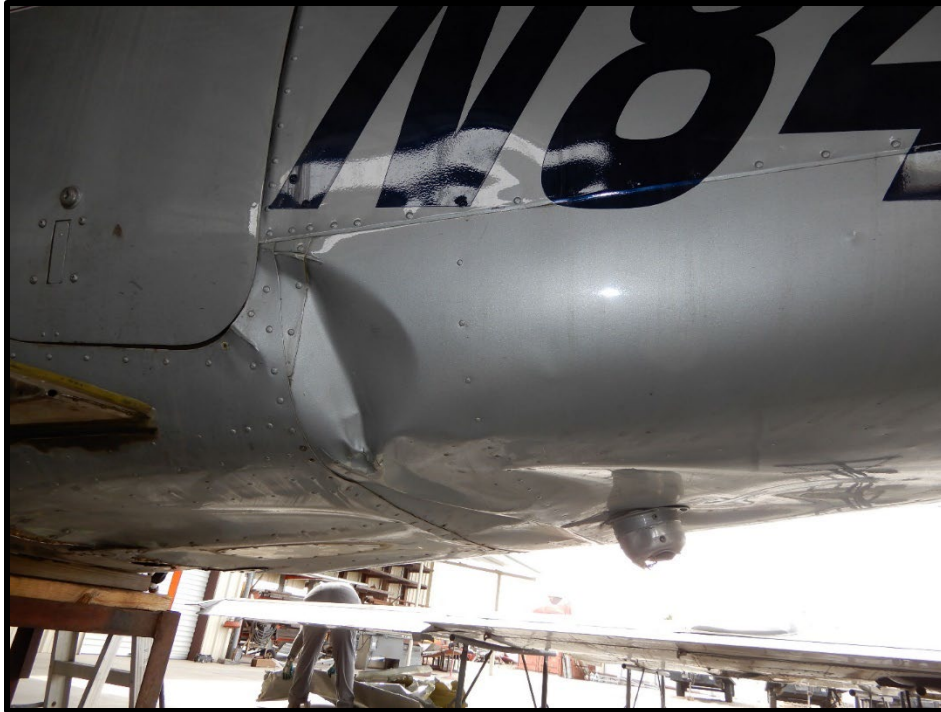
The left side of the fuselage from the empennage to the nose of the airplane exhibited little to no damage, except for an area of substantial damage just aft of the cargo door, that ran underneath the fuselage to the right side.

Photo 15. Left side of fuselage, showing damage to underside.

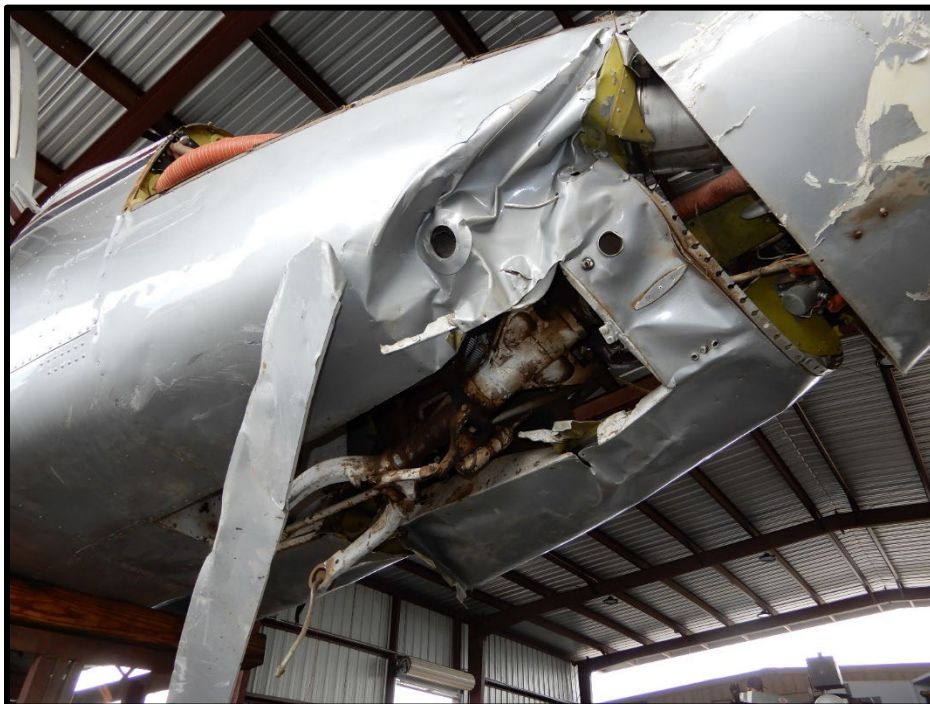
The underside of the fuselage exhibited an area of substantial damage running from left to right, as described in earlier paragraphs. The nose wheel area sustained substantial damage with fracturing of the composite nose cone and crushing of the fuselage around the nose wheel well. The left nose wheel door separated from the fuselage and the right nose wheel door remained partially attached by one hinge.

Photo 16. Right side of fuselage, showing damage to the nose cone and nose gear bay.

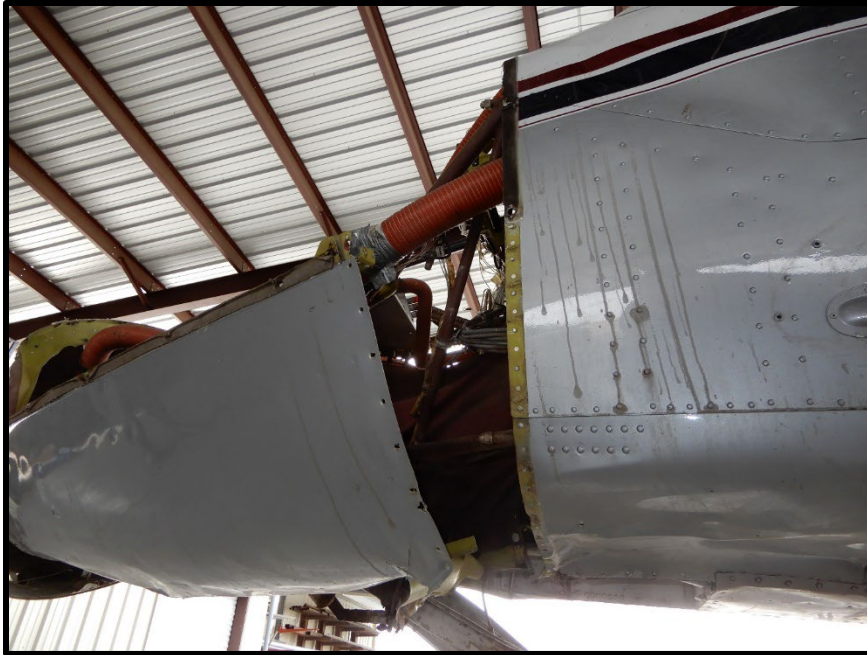
Photo 17. Left side, showing damage to the nose gear bay area.

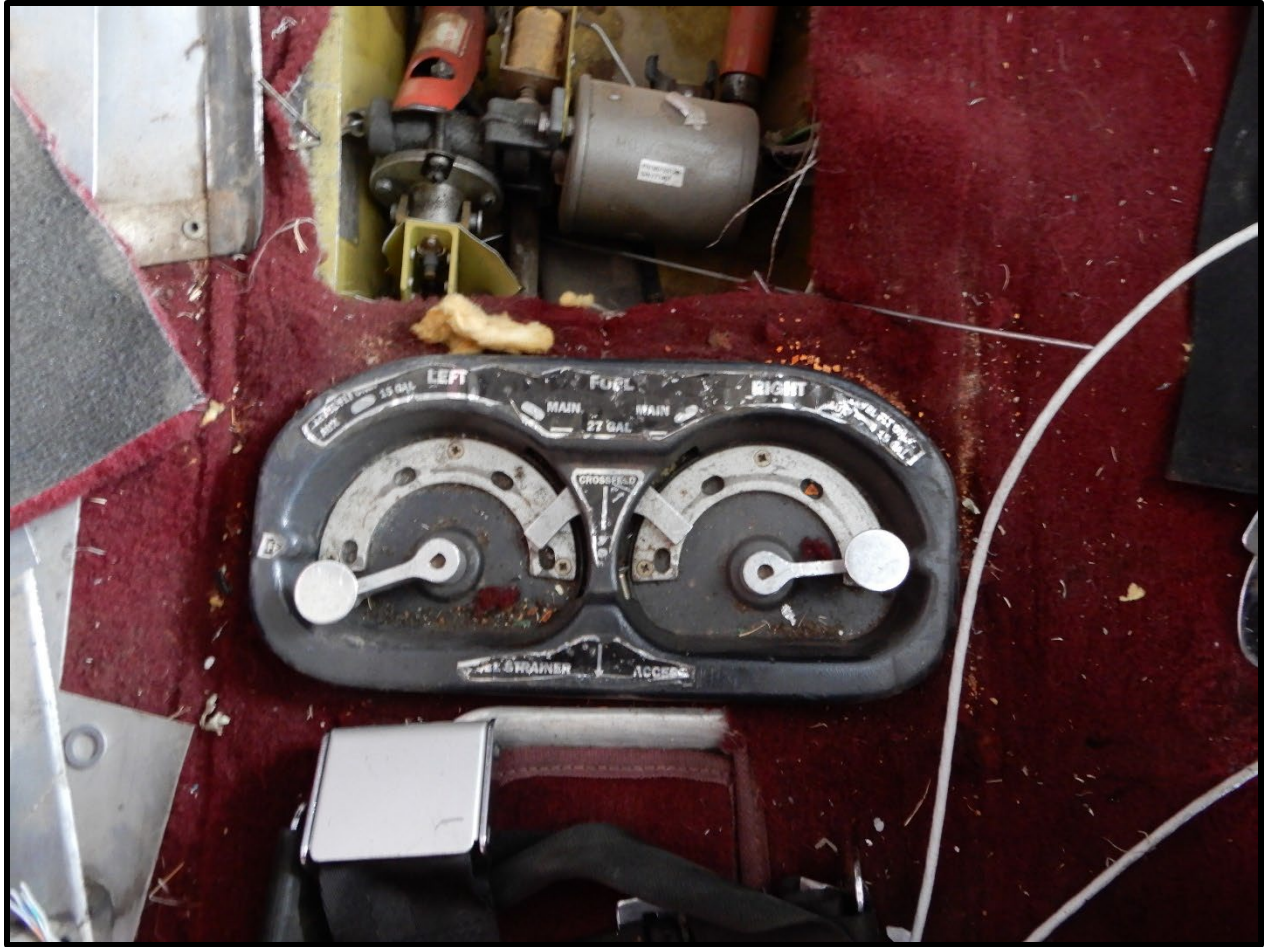
Photo 19. Fuel selector switches.

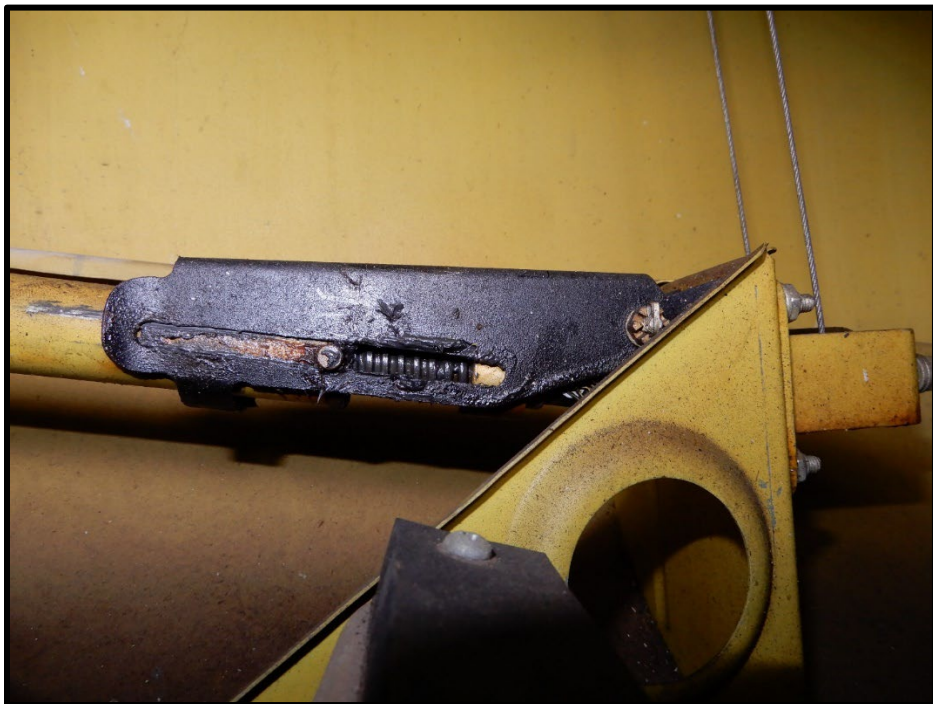
The stabilator was trimmed partially nose down.

Photo 21. Elevator trim jackscrew.

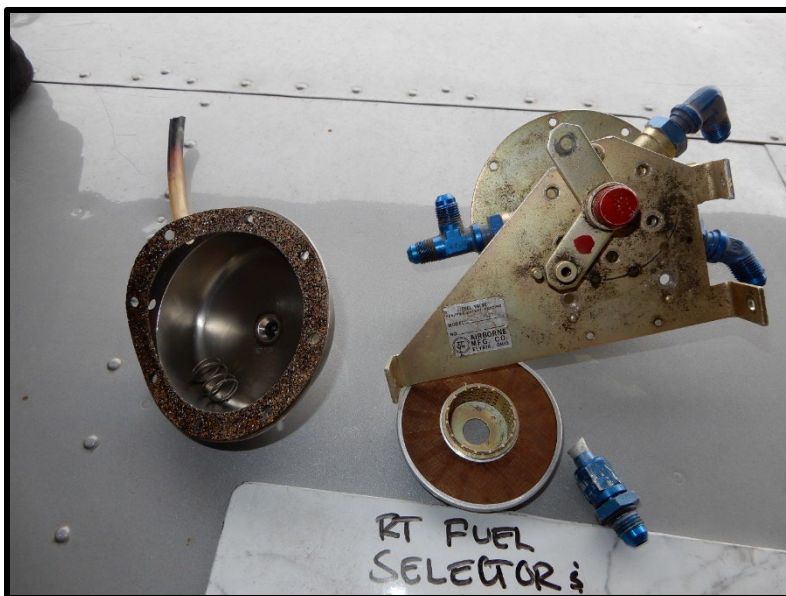
Photo 22. Right-side fuel selector.
