# NATIONAL TRANSPORTATION SAFETY BOARD

## MATERIALS LABORATORY FACTUAL REPORT

Report No. 22-026

Place : Mehama, Oregon  
Date : July 17, 2020  
Vehicle : Hiller UH-12D, N2297W  
NTSB No. : WPR20LA224  
Investigator : Samantha Link, AS-WPR

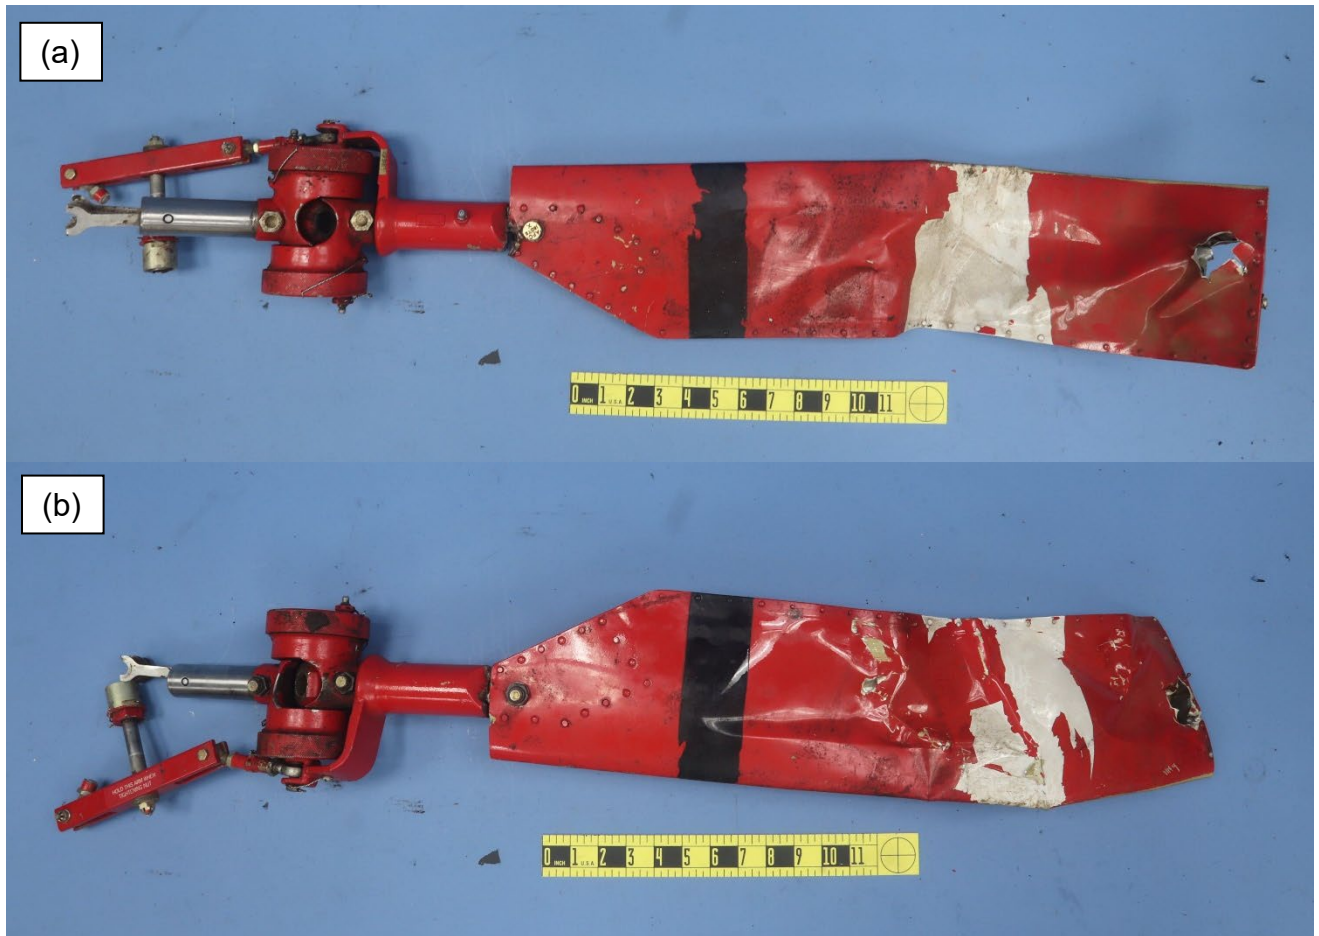
Figure 1 shows one of the tail rotor blade assembly remnants, as received. The red painted blade exhibited a through hole near the blade tip, with crumpling and buckling in the location. This blade assembly remnant was still attached to the yoke and hub assembly, depicted on the left in Figure 1a and 1b.

Figure 1 – Opposite views of the tail rotor blade assembly that was still attached to the hub and yoke assembly (left).

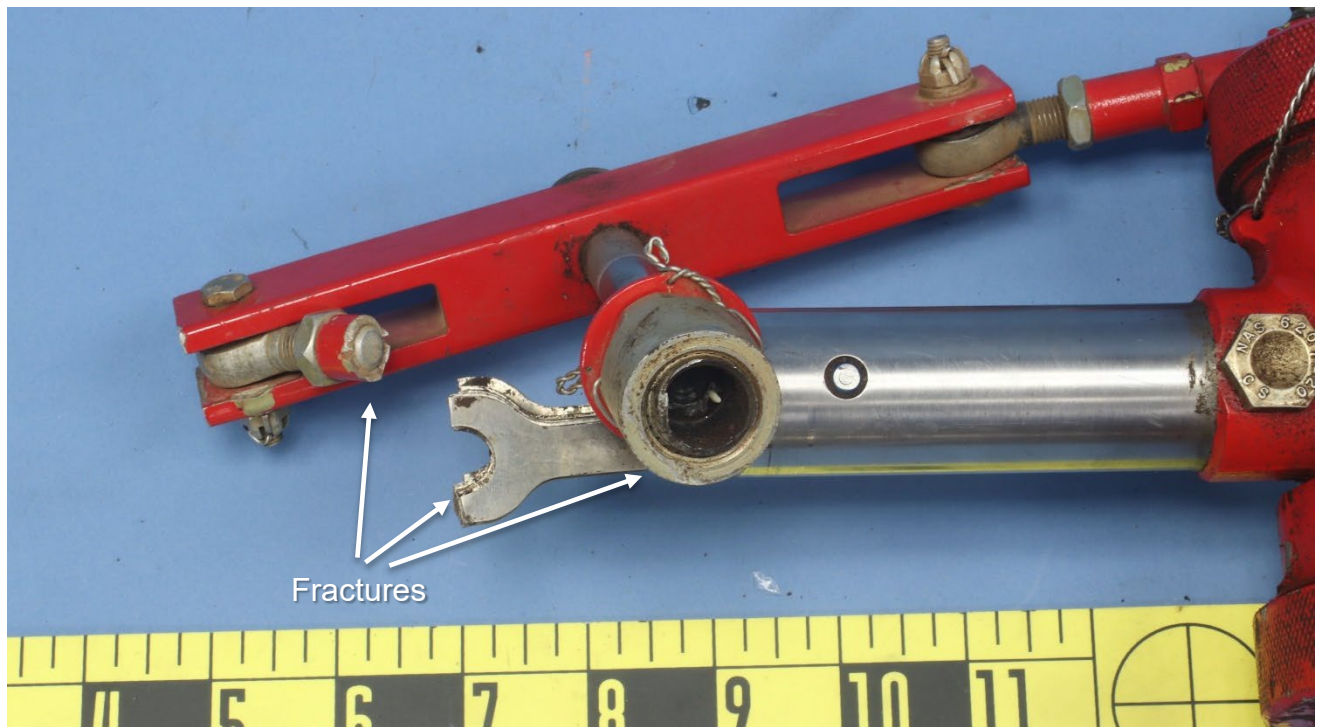
Multiple connections facing the yoke and hub assembly had fractured, as depicted in Figure 2. These included the pitch change link rod end, a center coupling, and the bundle of tension-torsion (TT) straps. In addition, the joint between the cylindrical fitting and the inboard blade surface was loose, as depicted in Figure 3 and Figure 4. These mating surfaces had ground on each other such that no features could be discerned between the two components.

Figure 2 – Views of the fractured coupling, tension-tosion straps, and rod end from the assmebly in Figure 1, as received.

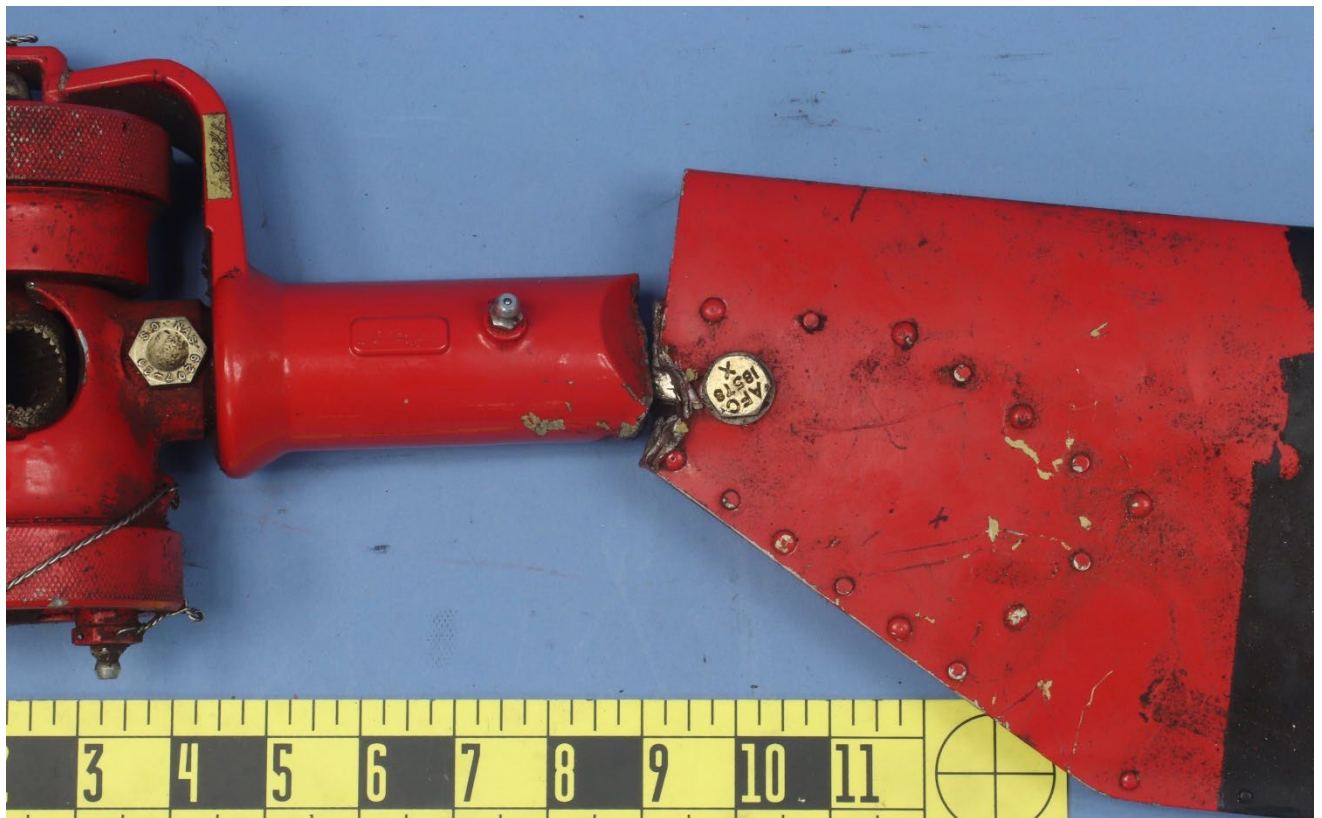
Figure 3 – View of the joint between the tail rotor fitting assembly and the blade, showing wear and grinding between the parts.

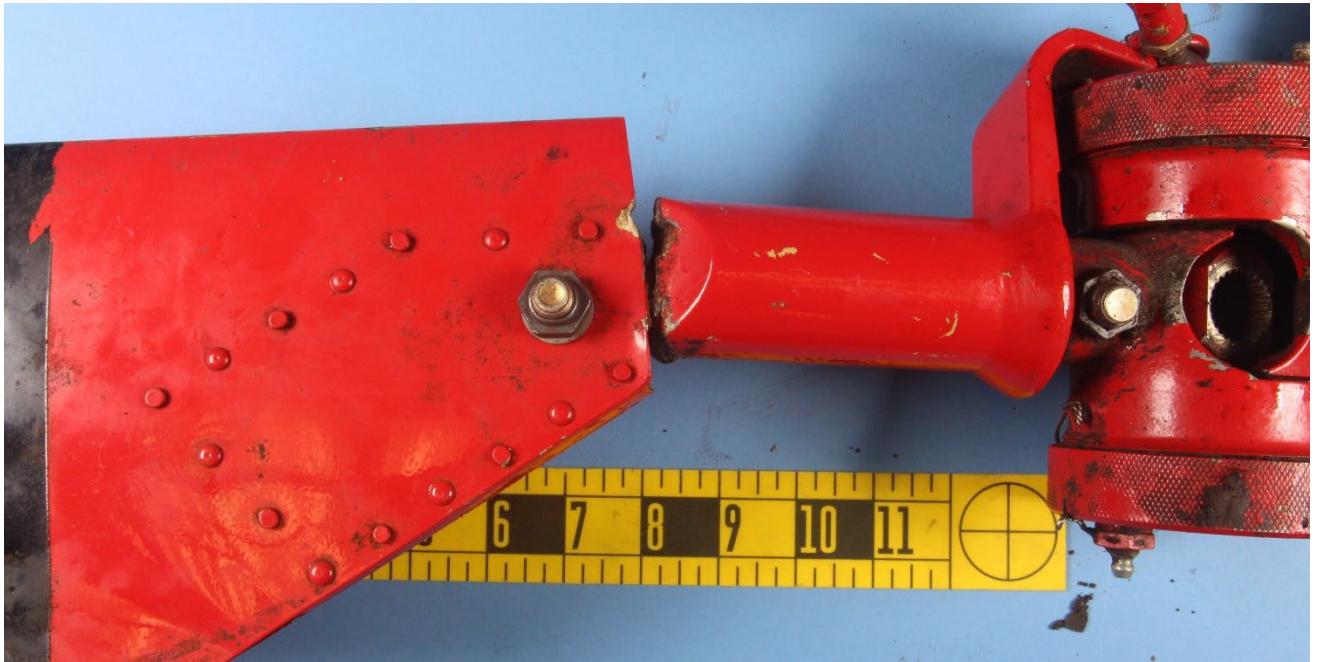
Figure 4 – Opposite view of the fitting and blade joint in Figure 3.

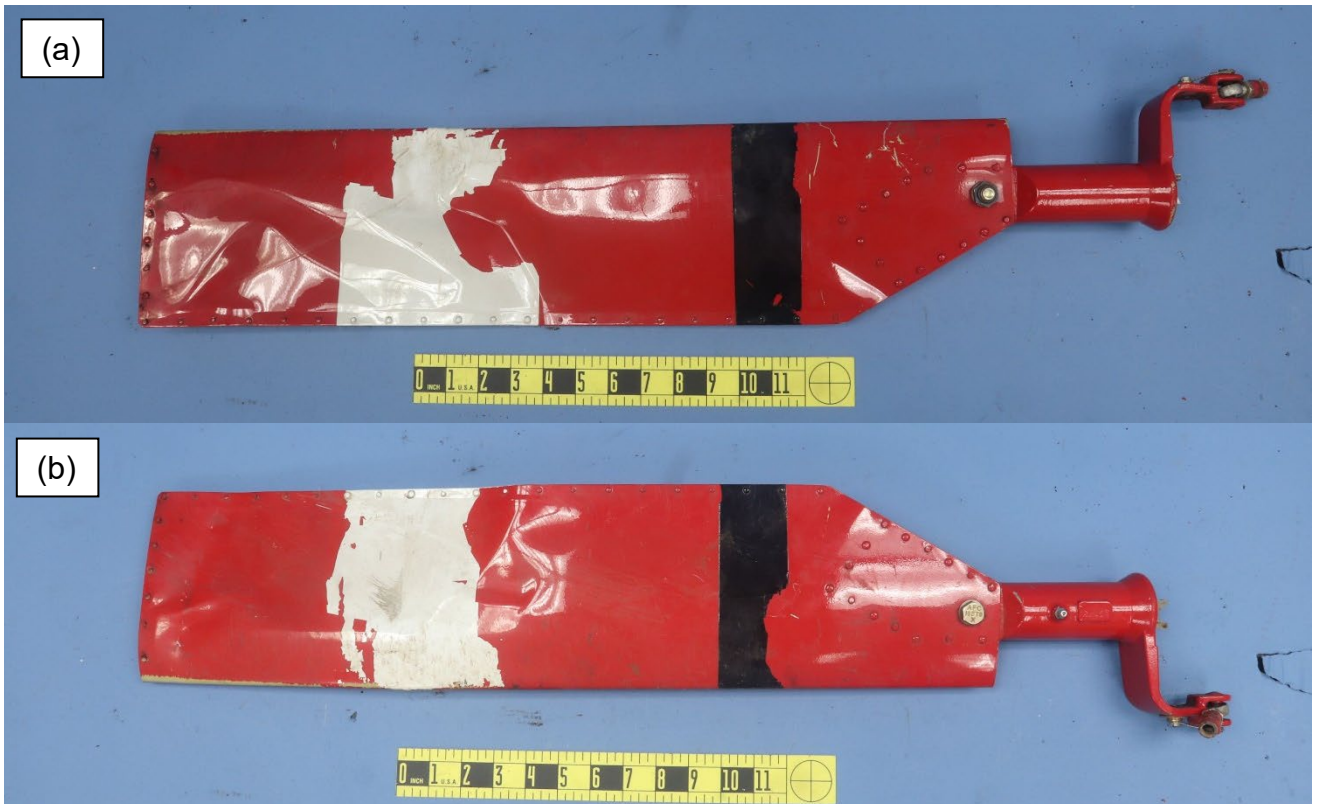
Figure 5 shows the opposite tail rotor blade assembly, which was no longer attached to the yoke and hub assembly. This blade also exhibited buckling, although to a lesser degree than the blade in Figure 1. There was also no indication of penetration or fracture of the blade. Further, the connection between the fitting and the blade was tight, with no indications of wear or grinding between the parts. The TT strap bundle in this blade was intact but cracked and bent, as discussed later. The pitch change link had also fractured on this assembly.

Figure 5 – Opposing views of the tail rotor blade assembly not attached to the hub and yoke assembly, as received.

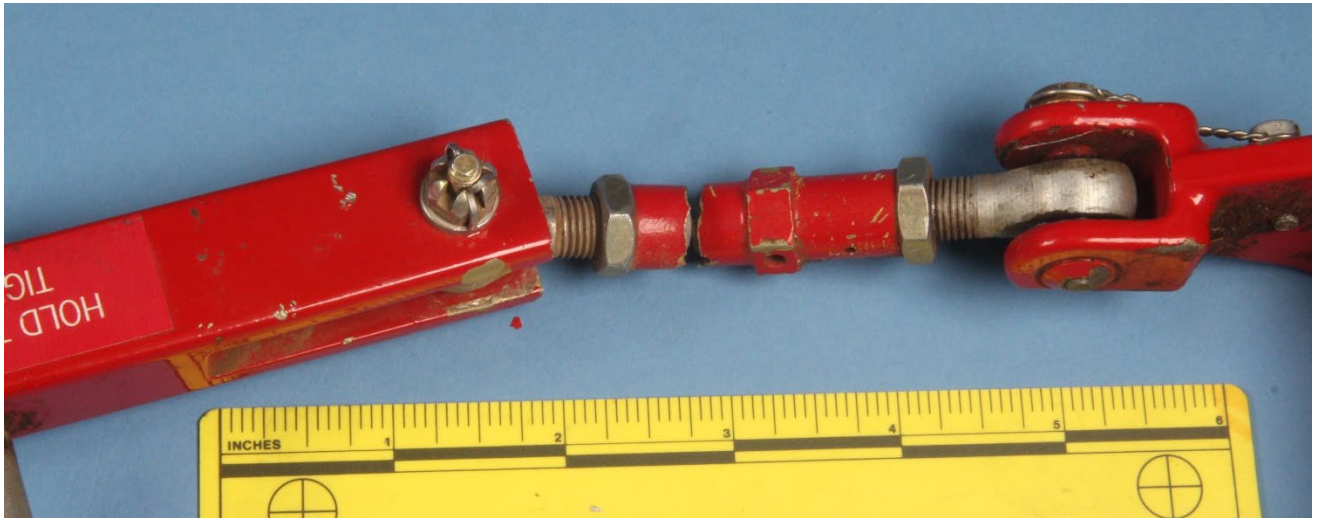
Figure 6 shows the fractured pitch change link remnants of each blade assembly, positioned to show the mating fracture surfaces. After disassembly, the fractured assembly with the outward-facing rod ends are shown in Figure 7. The fracture occurred in the housing cylinder at the end of the base of the right-facing rod end. There were no indications of buckling or out-of-plane deformation of this part.

Figure 6 – Views of the fractured remnants of a pitch change link, as received.

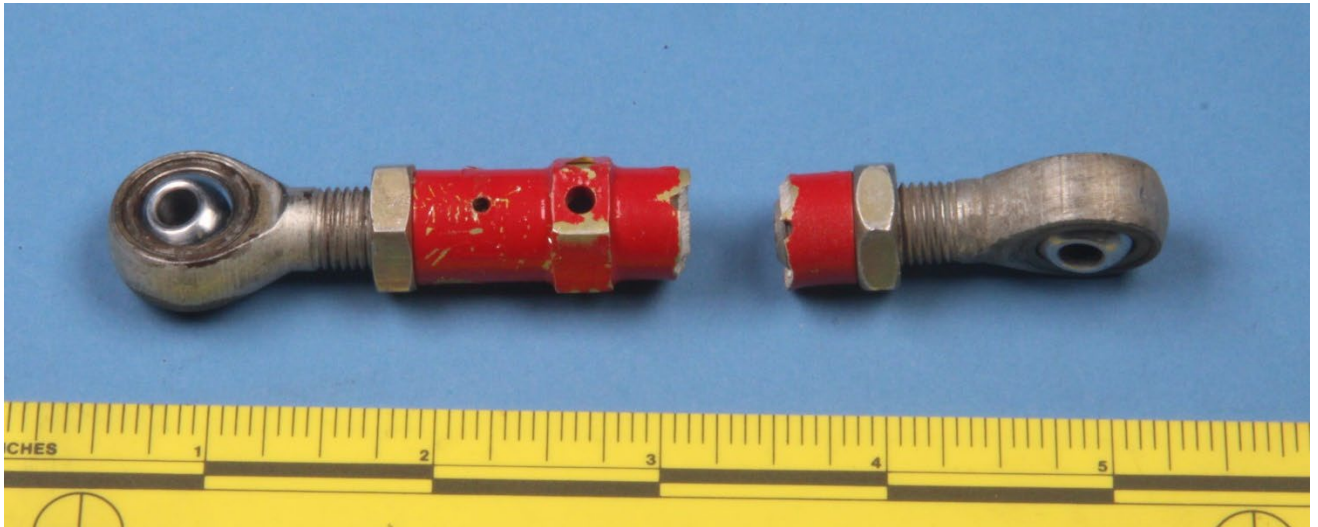
Figure 7 – Views of the fractured pitch change link rod ends from Figure 6, after disassembly and removal.

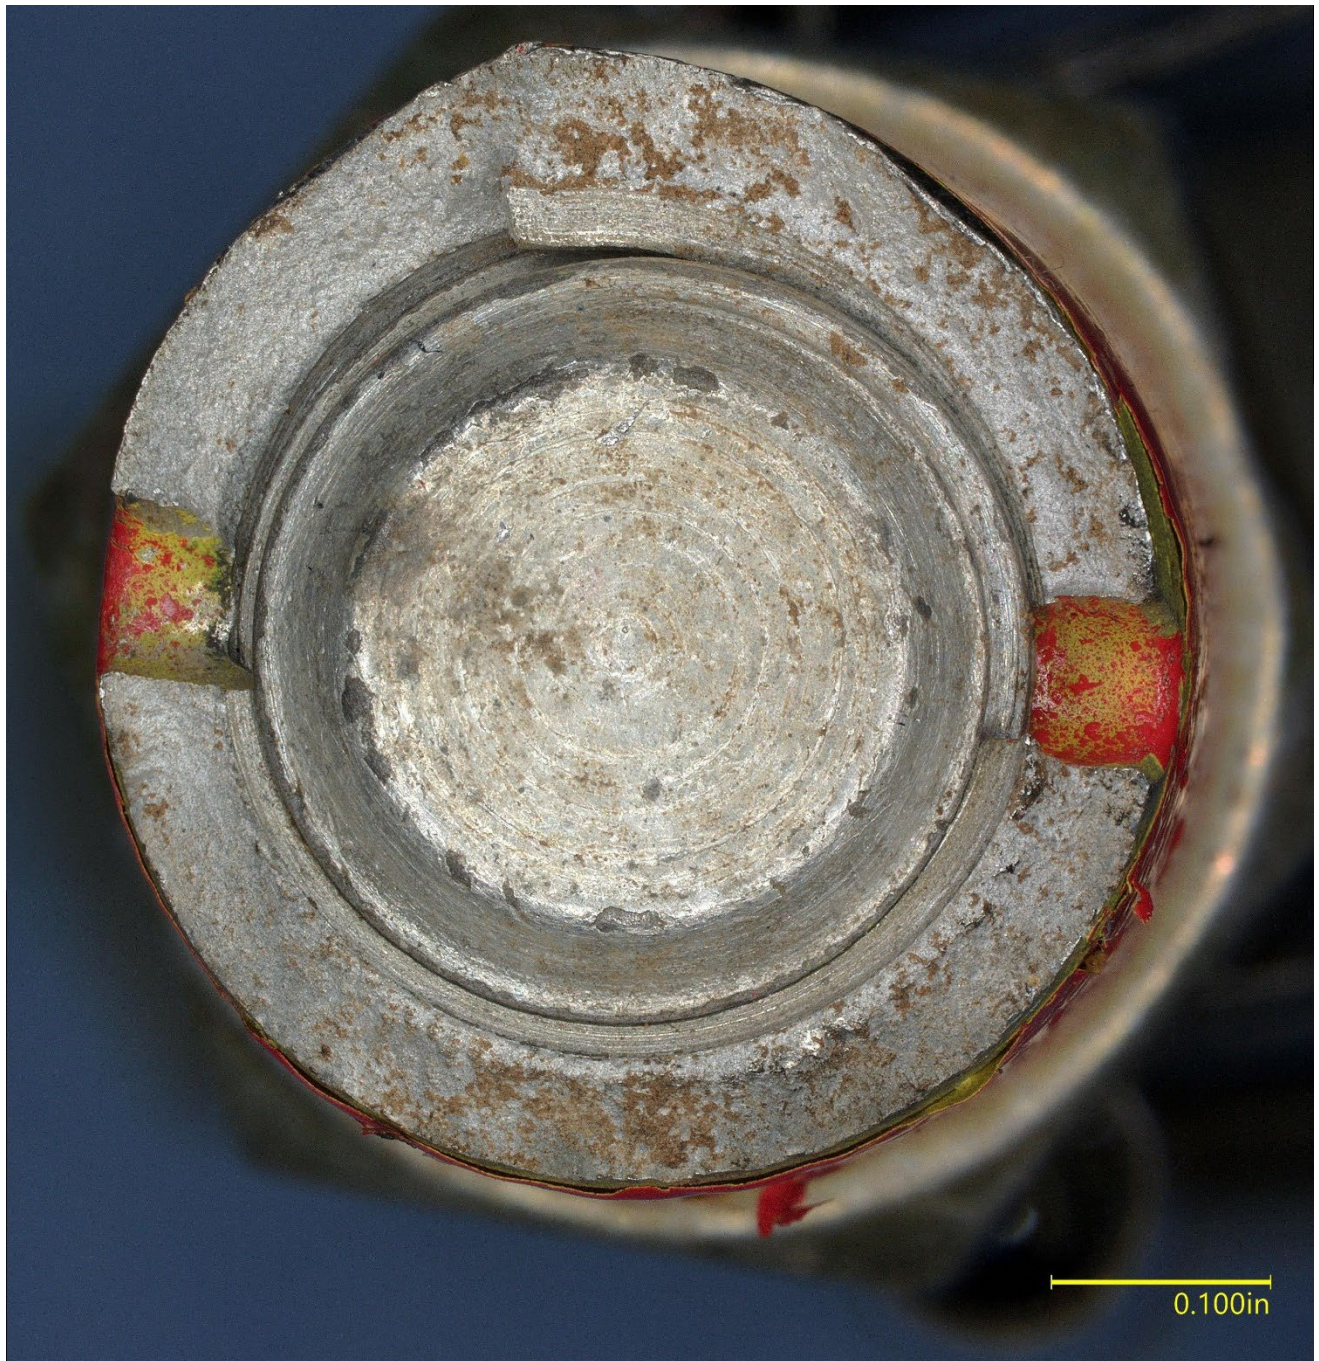
One of the pitch change link fracture surfaces is shown in Figure 8. The fracture surface generally exhibited a 45° outward-facing slant. The surface itself was rough in texture and exhibited a dull luster. Flow lines and chevron marks were observed, consistent with fracture emanating from the safety wire holes. These features were consistent with overstress fracture of the link in tension.

Figure 8 – View of the rod end fracture surface.

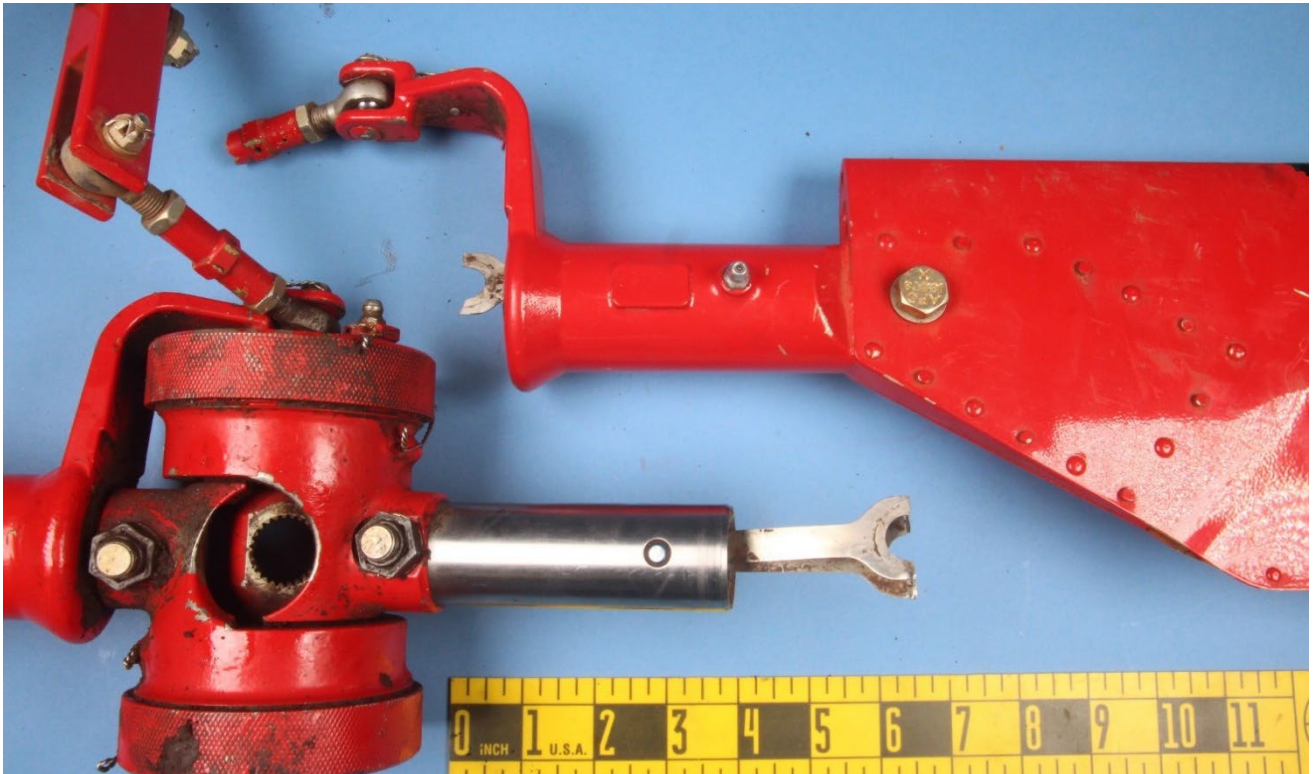
As stated earlier, the tail rotor blade assembly that was still attached to the hub exhibited a fractured series of TT straps protruding out of the opposite fitting. This bundle consisted of 10 of the 11 straps. The mating tail rotor blade assembly contained one TT strap. These fractured remnants of each blade assembly are depicted in Figure 9 to demonstrate their positions at fracture. One of the straps had fractured at the inboard bolt, whereas the other 10 had fractured at the outboard bolt.

Figure 9 – Views of the fractured tension-torsion straps, positioned from the hub and blade assembly sides.

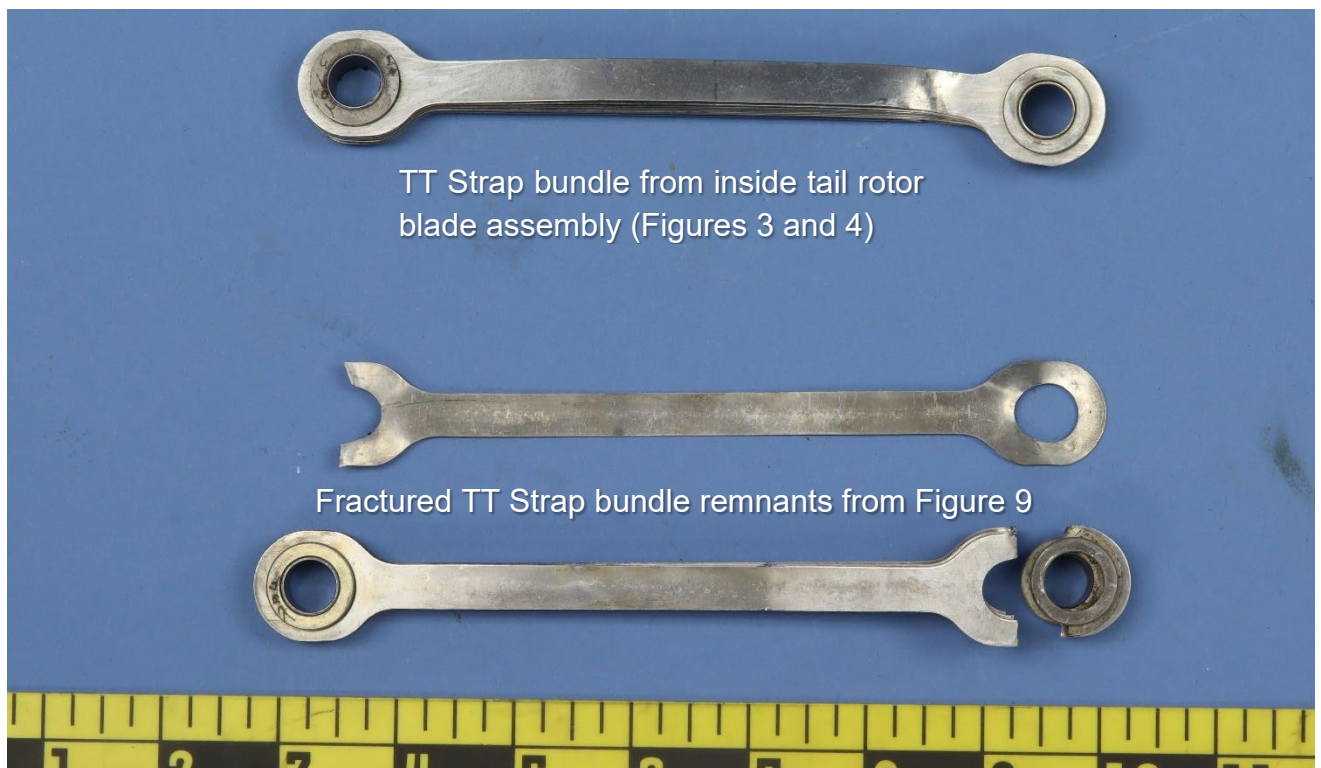
This fractured TT strap bundle, as well as the strap bundle from the inside the loose blade/fitting assembly in Figure 3, are depicted side-by-side in Figure 10. As mentioned earlier, the fractured bundle exhibited fracture surfaces perpendicular to the bar direction at the fastener bore, whereas the intact bundle had exhibited only one fractured strap.

Figure 10 – Views of the sets of tension-torsion straps, after disassembly and removal.

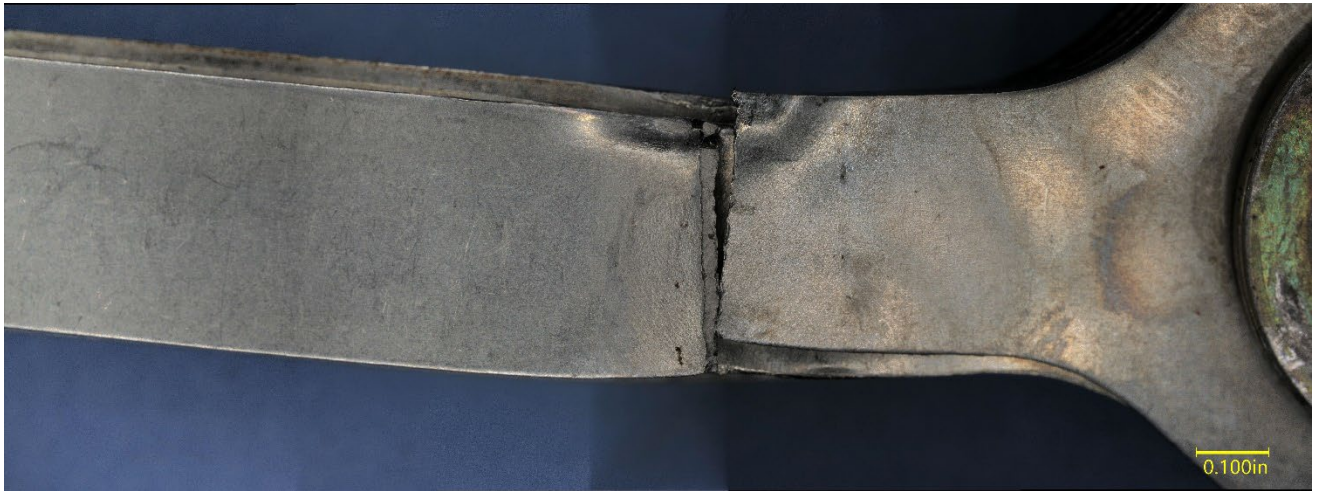
This one fractured strap on the upper bundle in Figure 10 had broken at the neck (Figure 11) along the location of a bend in all of the straps (see the side view in Figure 12). The series of straps exhibited a concave upward facing curve in Figure 12, consistent with upward bending. The fractured strap was located on the side with the maximum tension. This strap also exhibited necking and deformation adjacent to the fracture surface (see Figure 11). The upper edge in Figure 11 exhibited pronounced necking on the bottom surface, with S-shaped buckling on the upper edge. These features were consistent with an additional bending axis towards the upward direction in Figure 11.

Figure 11 – View of the deformed and fractured TT strap bundle from the second blade assembly, showing necking and buckling near the fracture of the outer strap.

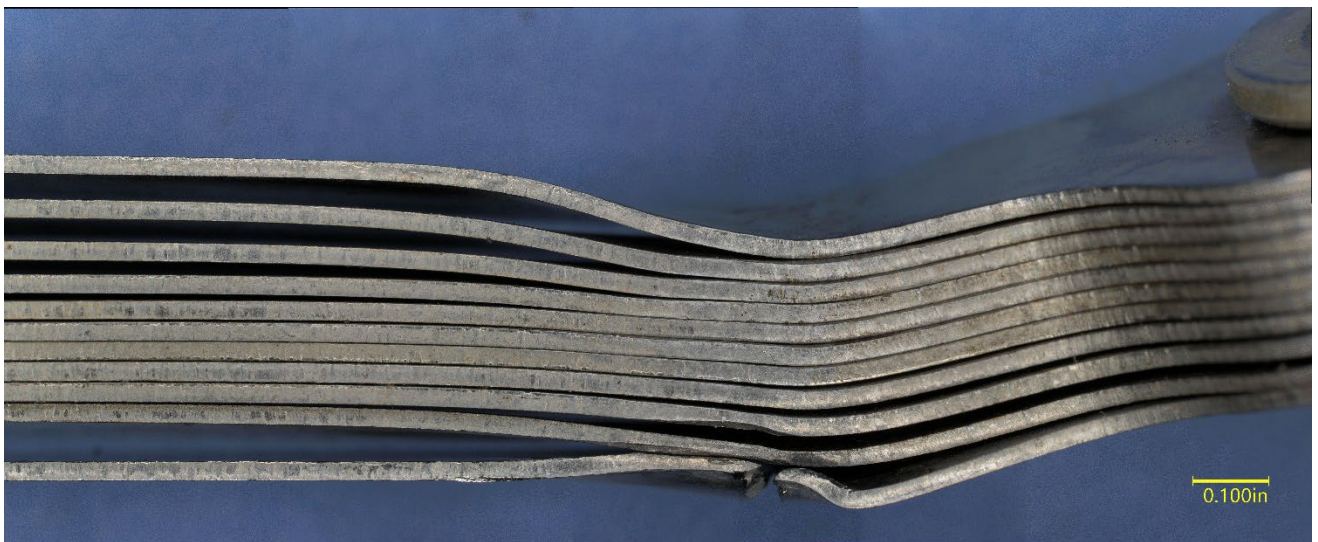
Figure 12 – Side view of the TT strap bundle in Figure 11, showing the fractured strap facing downward at the bend in the set.

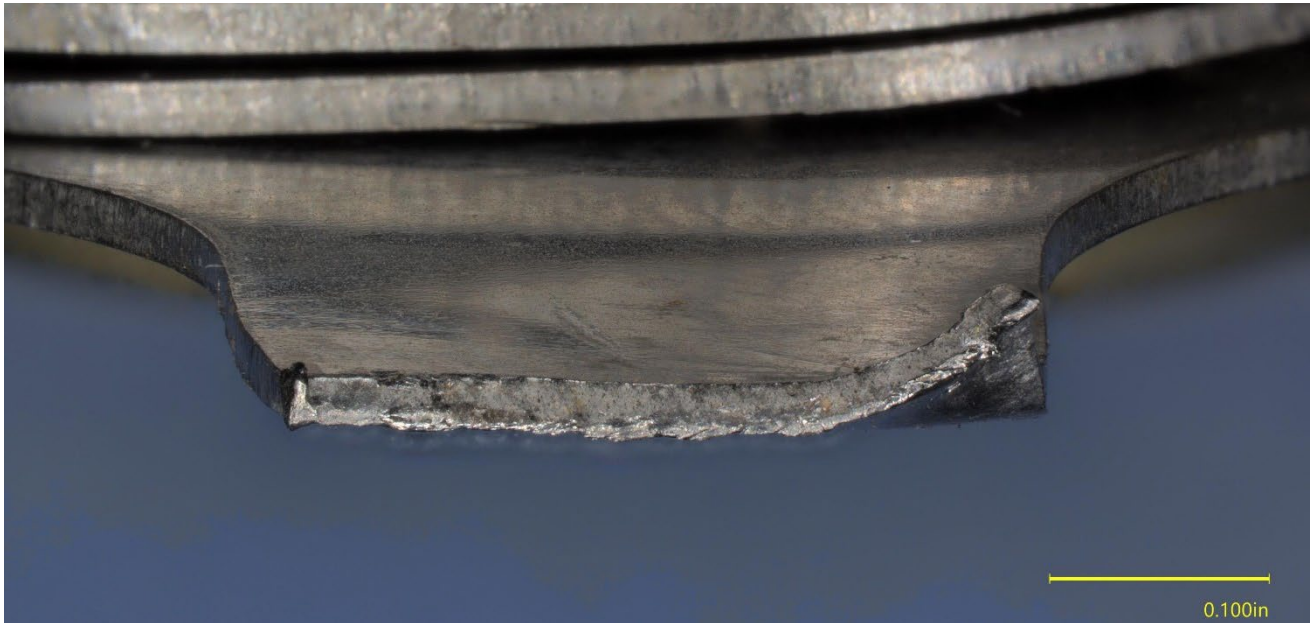
Figure 13 shows a closer view of one of the mating strap fracture surfaces. This surface exhibited a slanted 45° orientation. While the bottom long edge exhibited a more reflective luster, this was consistent with post-fracture damage from smearing and wear—the mating fracture surfaces were still in contact at disassembly. The undamaged areas of

the strap fracture surface exhibited a dull, rough texture. These features were consistent with fracture from tensile overstress of this strap.

Figure 13 – View of the fracture surface of the fractured strap in Figure 11, showing a slanted orientation.

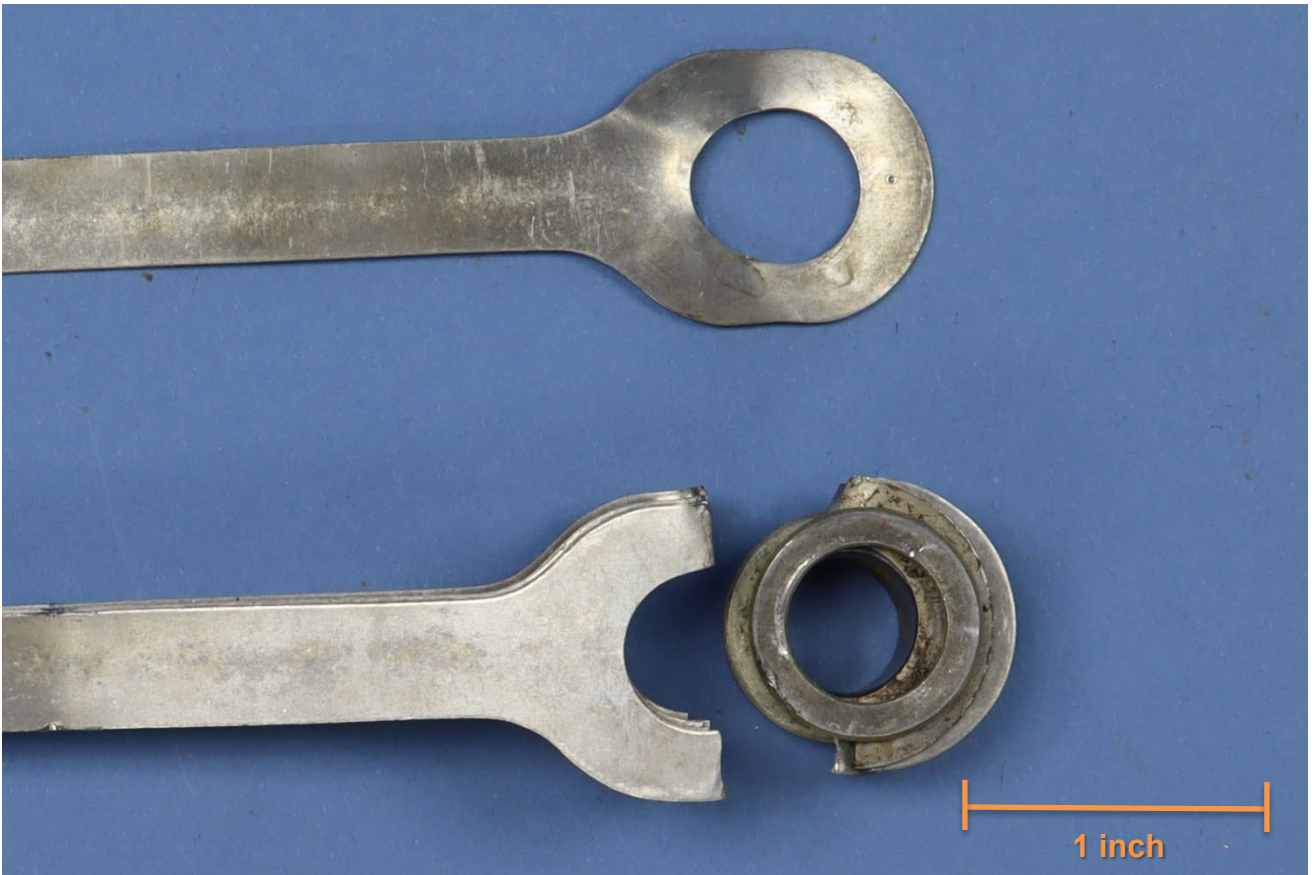
Figure 14 shows the end where most of the straps had fractured at the plain bearing, with the one strap that was still intact upon receipt. The straps that had fractured did so approximately 0.41 inches from the rounded end. The intact strap exhibited a diameter of 0.561 inches along the longitudinal direction, and 0.505 inches along the transverse (perpendicular) direction.

Figure 14 – The fractured ends of 10 of the 11 TT straps in the bundle, along with the one intact strap, exhibiting elongation.

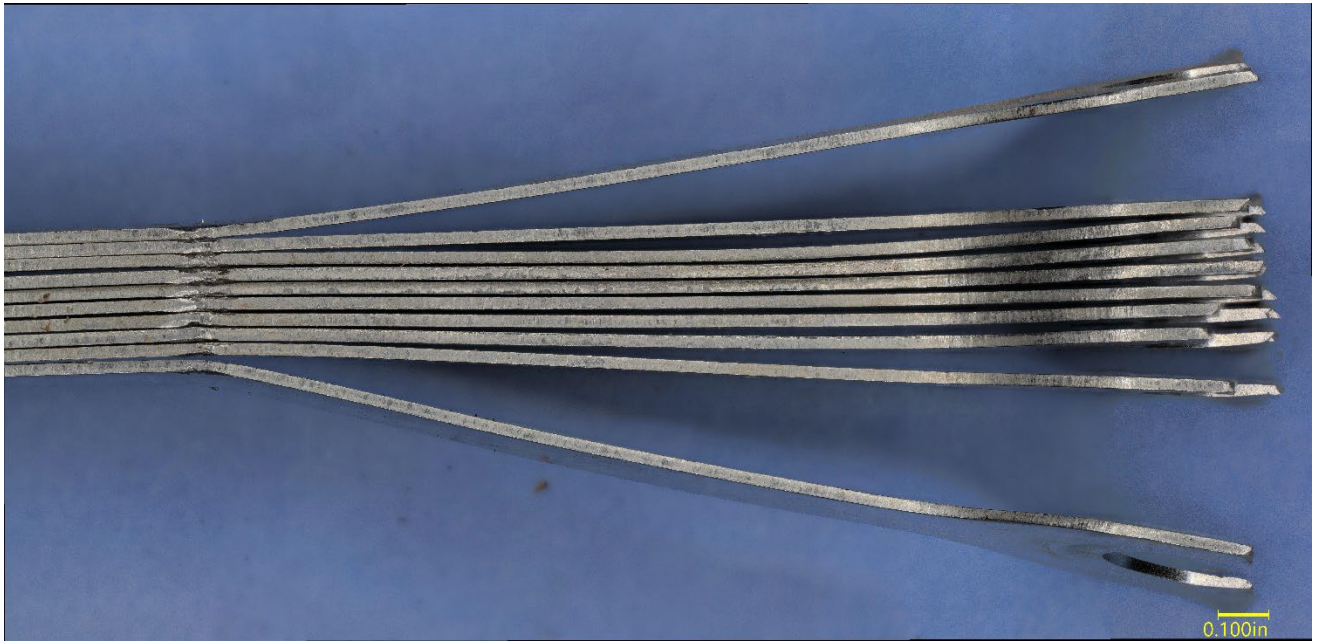
The fractured set of TT straps are shown from the side in Figure 15. Approximately 1.25 inches from the fracture at the fastener bore, there were sideways pinch marks. This left of this location, the straps were adjacent to and parallel with each other. To the right in the figure, the outer straps flared outward on either side of the bundle.

Figure 15 – Side view montage of the TT strap bundle from the rotor blade assembly in Figure 1, showing spreading at a bend, with 10 of the straps having fractured.

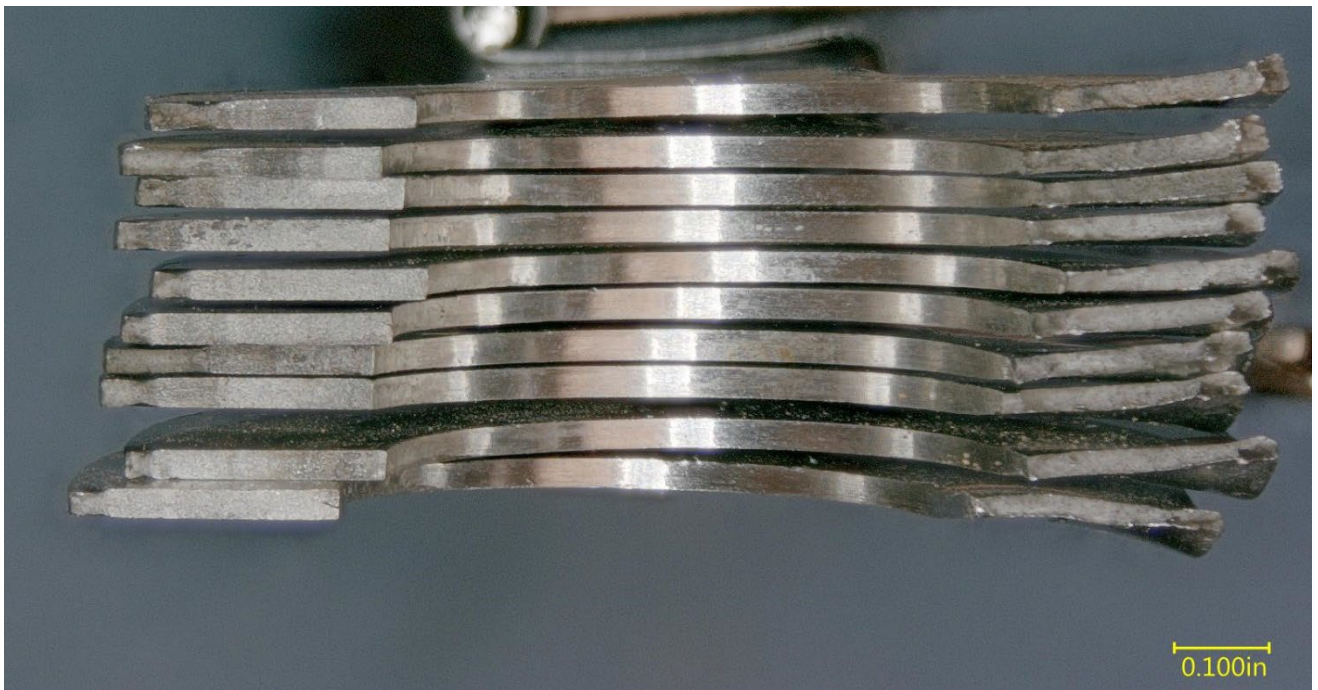
Figure 16 shows the collective fracture surfaces of the bundle from Figure 15. The straps were clamped together to facilitate the positioning in Figure 16. Collectively, the fracture surfaces on the right exhibited features similar to that of the singular fractured strap in Figure 13—the fracture surfaces were dull in luster and rough in surface texture, with necking and twisting deformation near the fracture surface. The features of the right side fracture surfaces in Figure 16 were consistent with overstress fracture.

Figure 16 – View of the fracture surfaces of the bundle of TT straps in Figure 12.

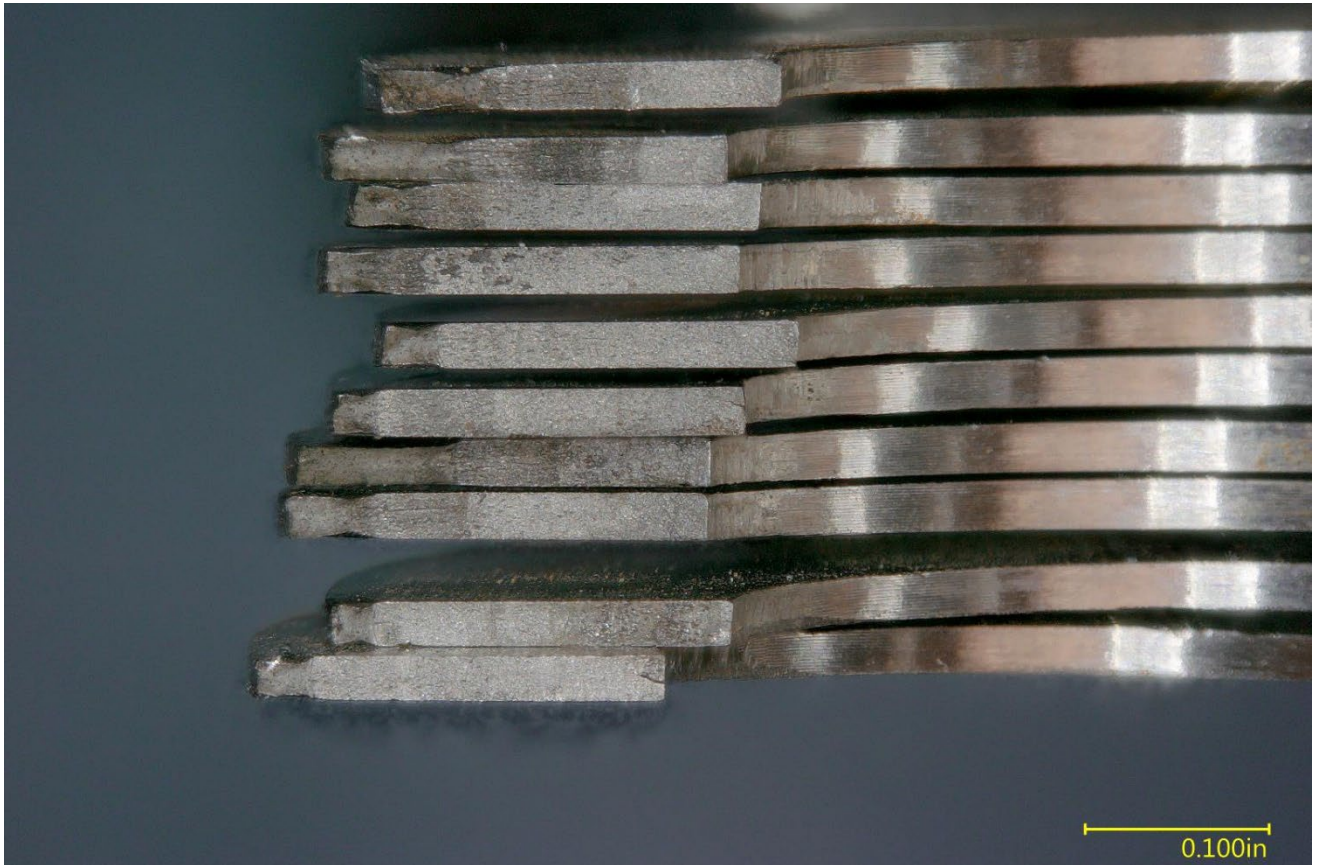
The left side fracture surfaces of the TT straps, highlighted in Figure 17, exhibited a different surface morphology. Towards the fastener bore, the fracture surfaces exhibited a flat surface, oriented perpendicular to the rolling direction of the strap. Opposite or outboard of the fastener bore, the fractures were rougher, with inward pinching or necking. The outboard areas of the fracture were generally duller in luster and rougher in texture than the inboard regions.

Figure 17 – Closer view of the left fractures on the TT straps in Figure 16, showing flat features inward and necked features outward.

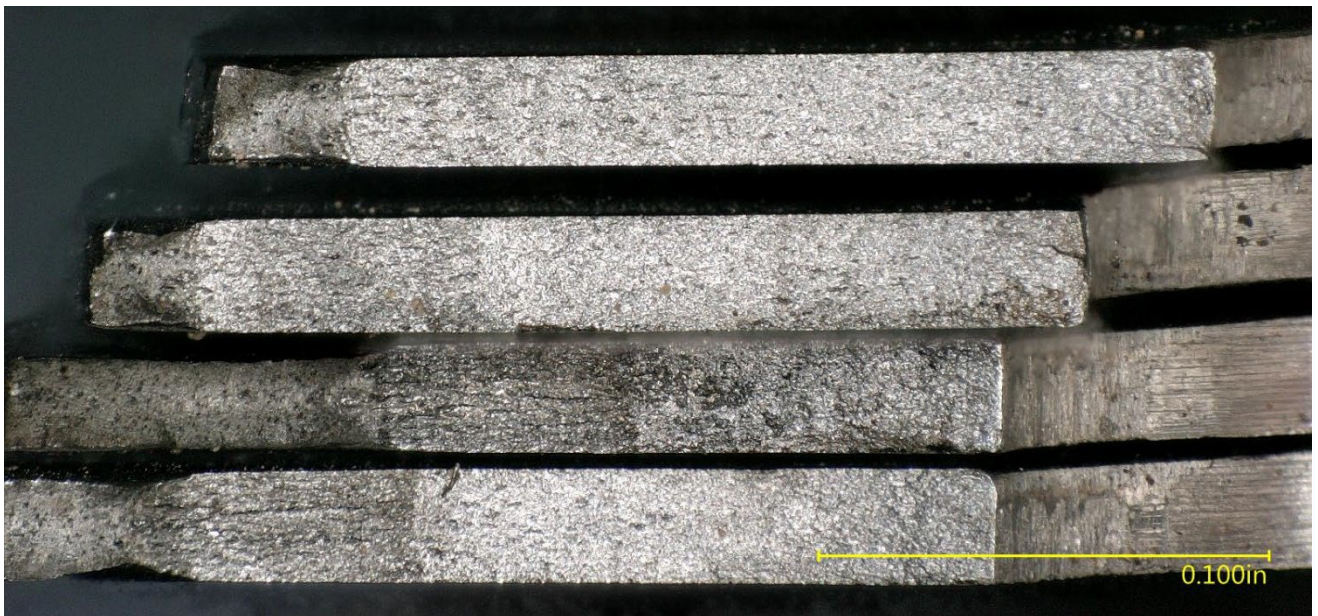
Highlighted in Figure 18, the flatter, inboard areas of the TT strap fracture surfaces exhibited repeating features consistent with crack arrest marks. Towards the edge with the bore, the surfaces exhibited horizontally-oriented linear features consistent with ratchet marks. These features were consistent with progressive cracking, later determined to be fatigue, propagating from multiple initiation sites along the bore.

Figure 18 – Closer view of several of the TT strap fracture, showing faint crack arrest marks emanating from the bushing bore.

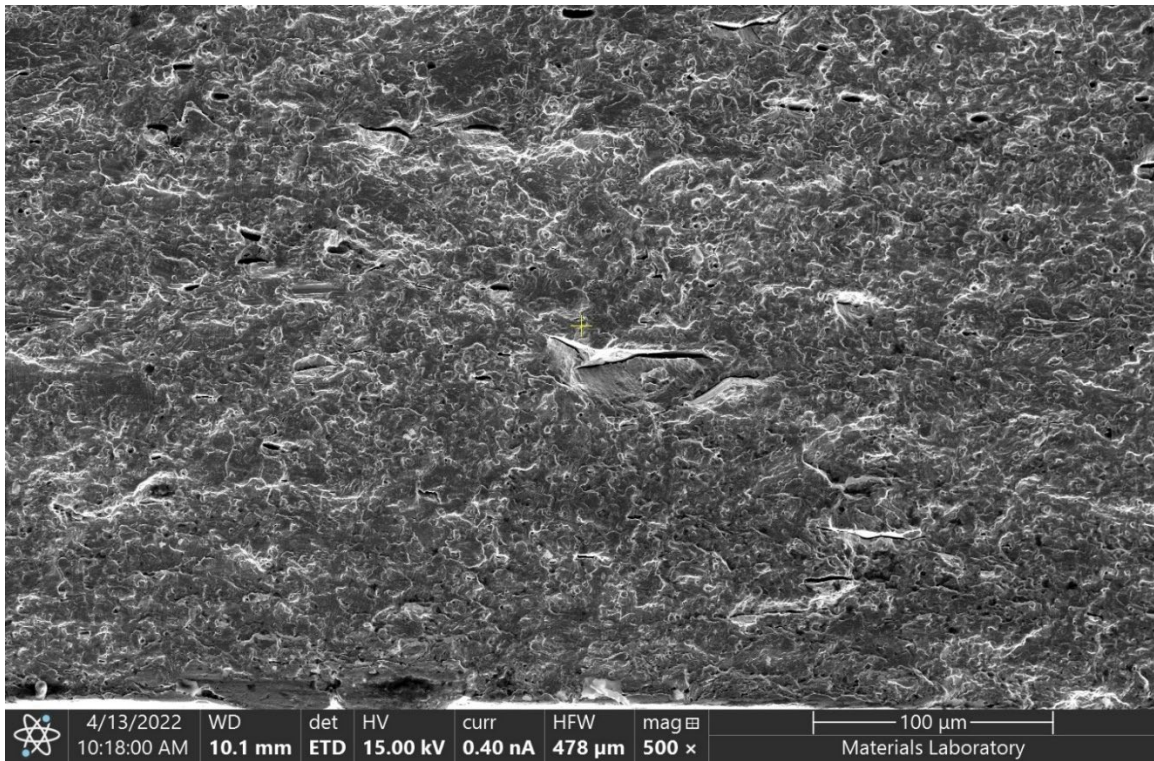
One of the outermost straps in this bundle was sectioned and cleaned with acetone for examination in a field emission scanning electron microscope (SEM). Figure 19 shows a typical area of the fatigue fracture. Closer examination of this area revealed fatigue striations, consistent with fatigue crack propagation, as typified in Figure 20. The nature of the striations was consistent with crack propagation from the inboard fastener bore outward.

Figure 19 – Secondary electron (SE) micrograph of one of a typical area of the flat fracture on a TT strap in Figure 18.

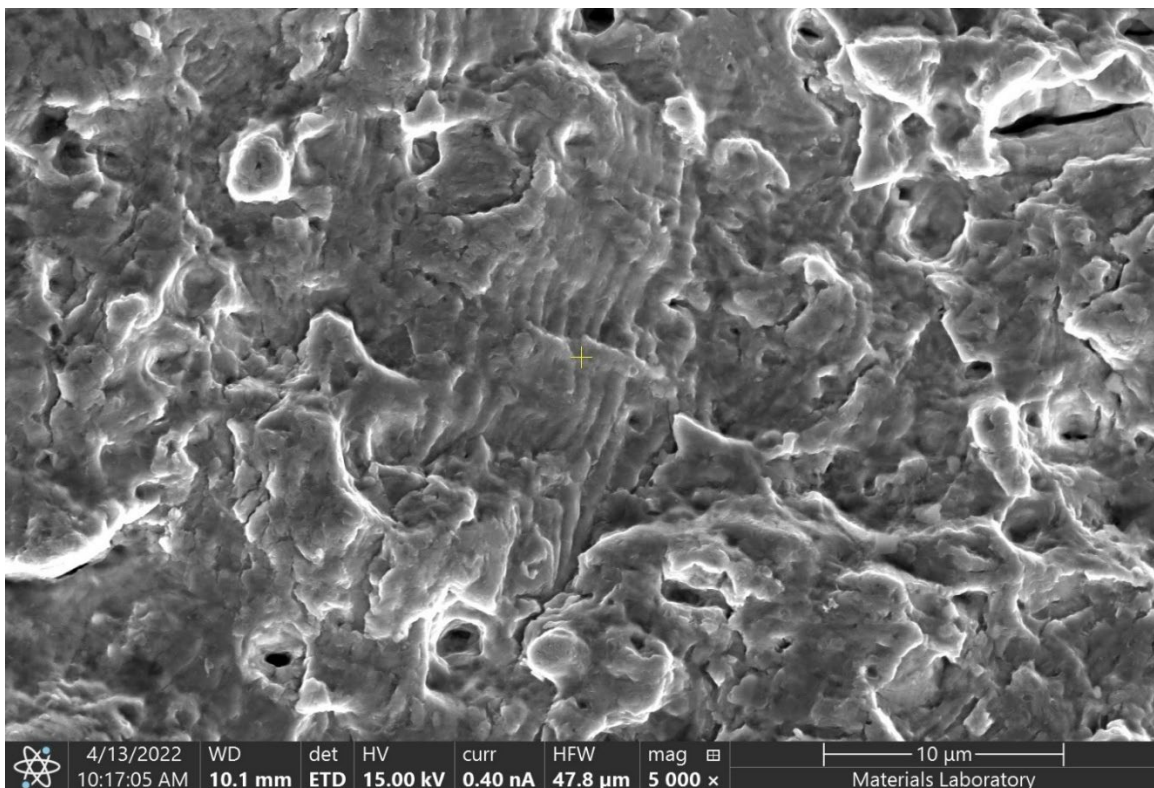
Figure 20 – SE micrograph of a closer view in Figure 19, showing fatigue striations.

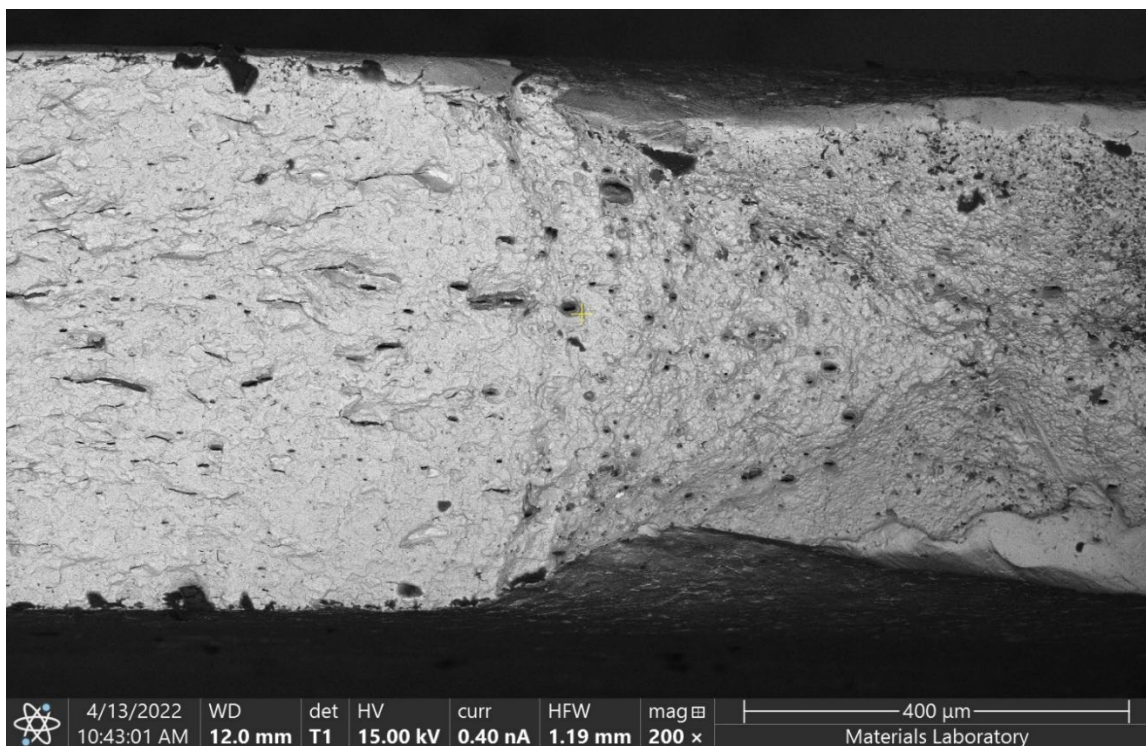
All of the fractured straps exhibited fatigue cracking that had progressed part way through the part cross section. At the transition to the end of the crack, as depicted in Figure 21, the fracture surface transitioned from a relatively flat surface to an angled and curved orientation, with localized necking along the edges.

Figure 21 – Backscattered electron (BE) micrograph of the transition from fatigue to overstress fracture of a TT strap.
