# NATIONAL TRANSPORTATION SAFETY BOARD

## MATERIALS LABORATORY FACTUAL REPORT

Report No. 22-026

Place : Mehama, Oregon  
Date : July 17, 2020  
Vehicle : Hiller UH-12D, N2297W  
NTSB No. : WPR20LA224  
Investigator : Samantha Link, AS-WPR

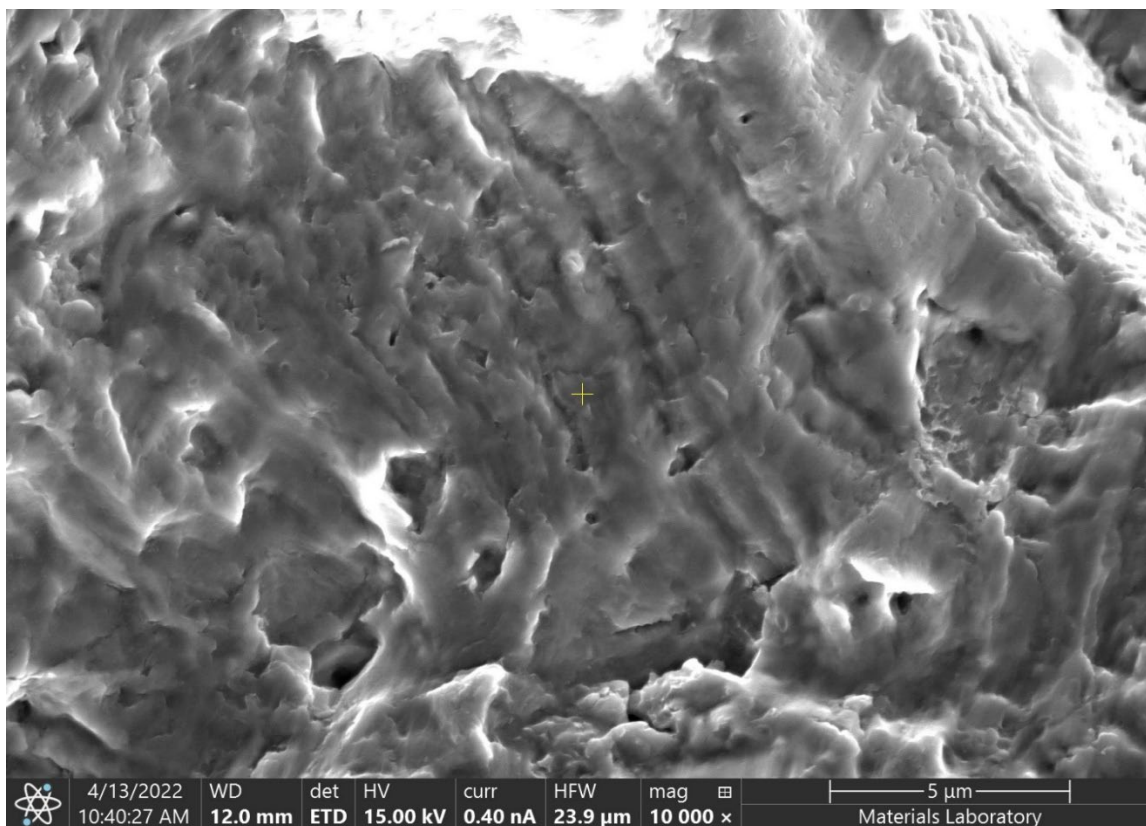
At higher magnifications, the flat area still exhibited fatigue striations (see Figure 22), whereas the area outboard exhibited dimpled rupture (see Figure 23). These features were consistent with fatigue propagation through each strap cross section, until the remaining material could no longer withstand the stresses, fracturing in subsequent overstress.

Figure 22 – SE micrograph of striations on the fatigue region of the TT strap.

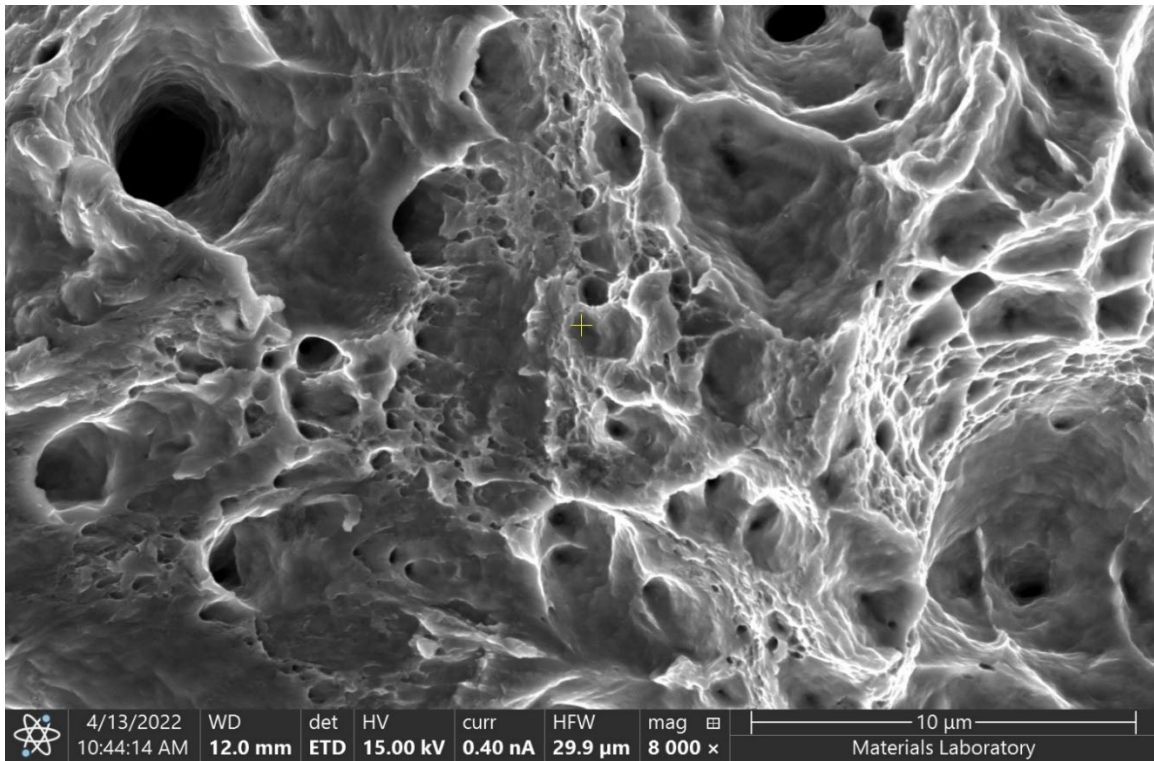
Figure 23 – SE micrograph of dimpled rupture in the overstress region of the TT strap.

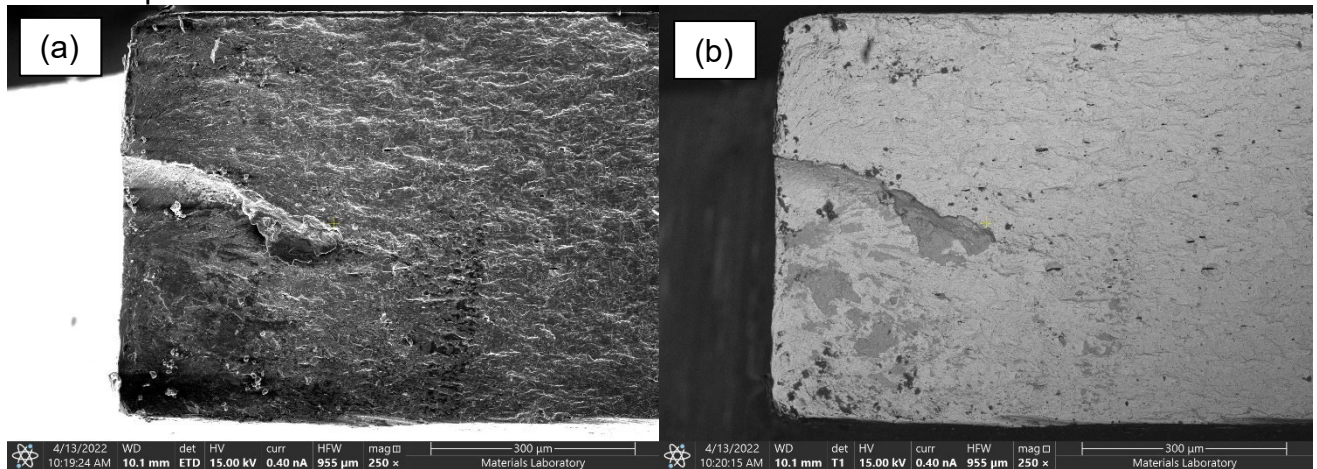
Figure 24 shows the crack initiation site(s) of this fracture strap in secondary and backscattered electron modes. The initiation of the fatigue crack occurred on the edge with the inside fastener bore. As shown in both figures, there was a pronounced ratchet mark along the center, consistent with separate cracks joining during propagation after initiation at multiple initiation sites. Figure 25 shows a closer view of the more pronounced initiation site, along the edge, and Figure 26 shows an angled view of the initiation site edge with the bore surface. This area exhibited some dissimilar material, with the darker gray being consistent with post-fracture oxides of the metal alloy, and the dark material being consistent with post-fracture contamination.

Figure 24 – Views of the fatigue crack initiation sites of a TT strap in (a) secondary and (b) backscattered views.

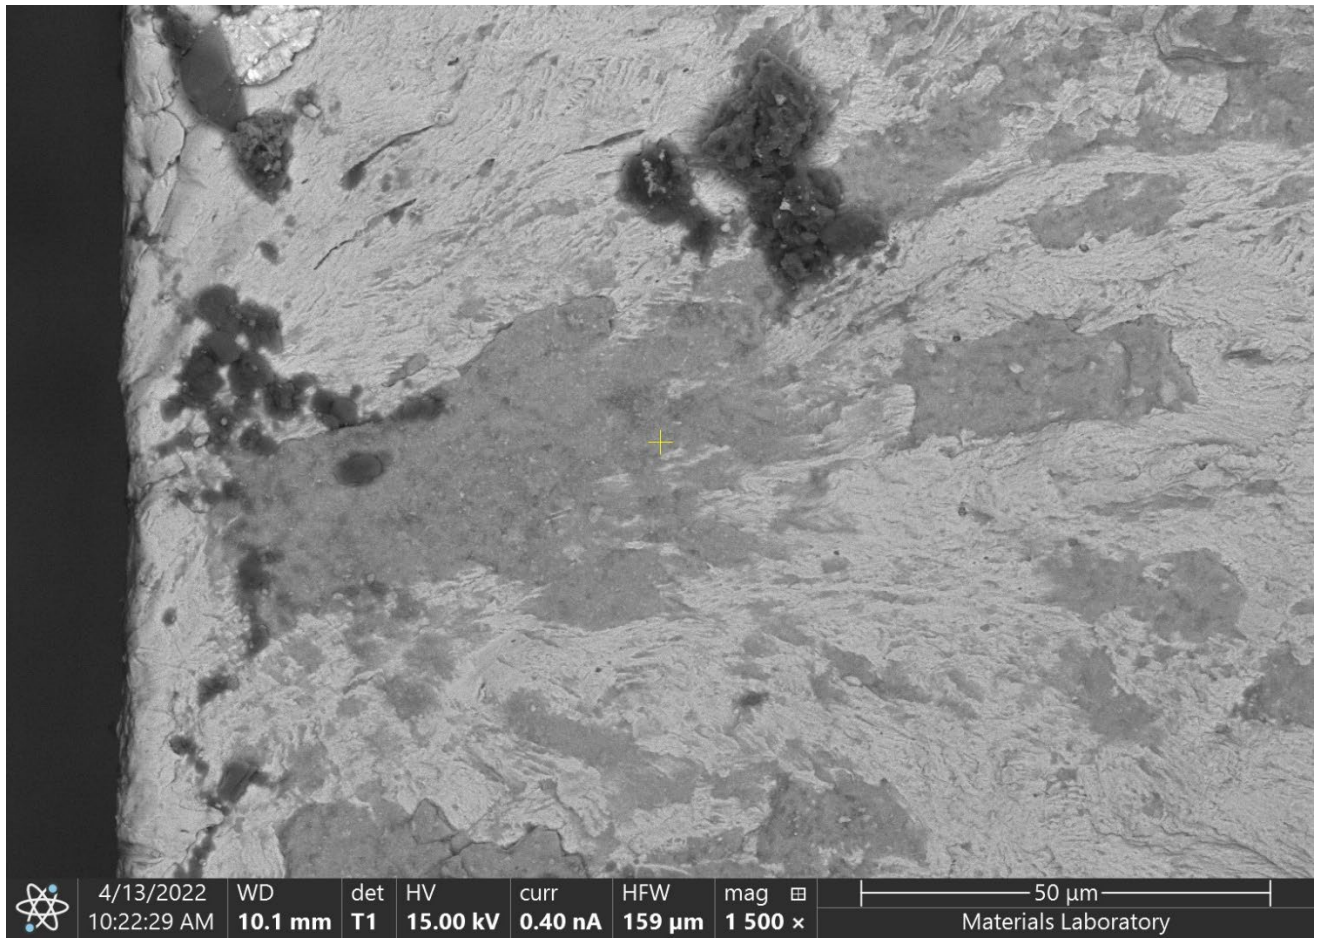
Figure 25 – BE micrograph of a closer view of the primary (larger) fatigue crack initiation site on the TT strap.

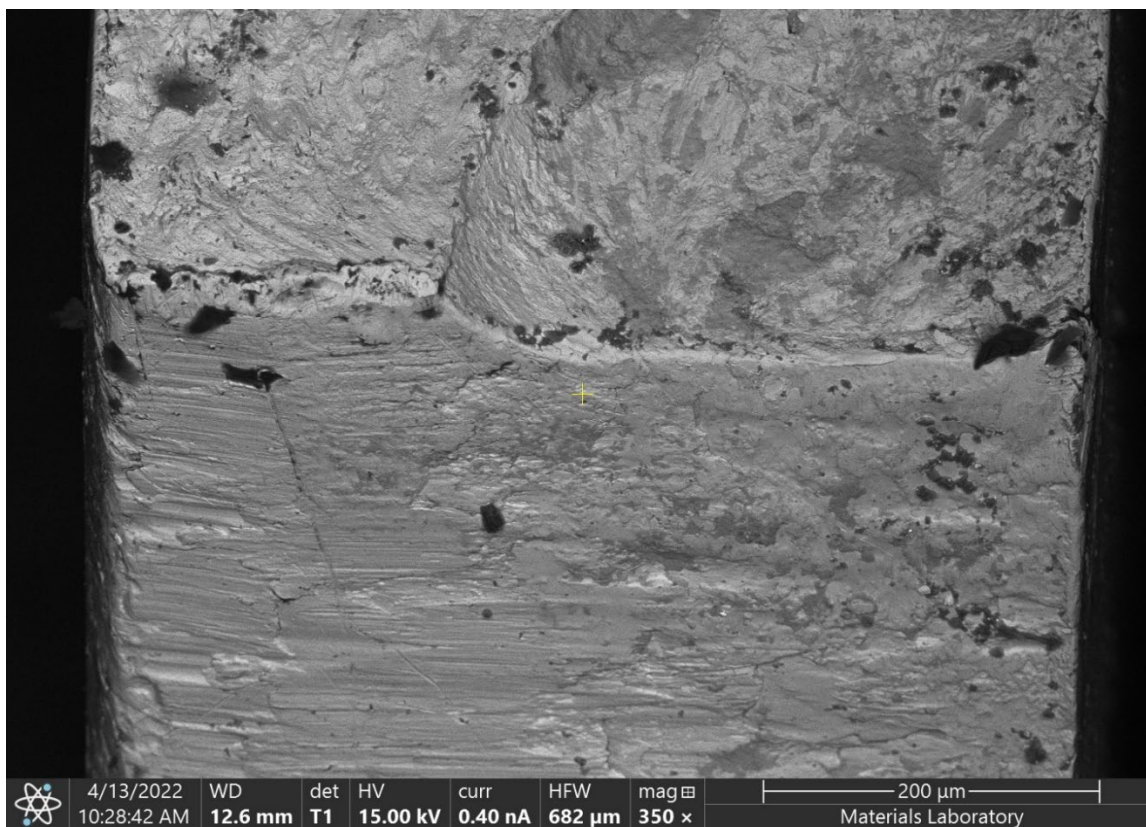
The view in Figure 26 shows propagation flow lines emanating primarily from two points along the edge, which exhibited some smearing and rounding. There were no indications of pitting or inclusions along the fatigue crack initiation sites. However, below and adjacent to the crack initiation sites were areas of wear, manifest as horizontal lines in Figure 26, oriented parallel to the fracture surface. As also seen visually in Figure 18, these marks were consistent with wear of the straps along the cylindrical surface of the adjacent fastener. There were also areas with flaky divots, as typified in Figure 27. These features were consistent with features common in spalling and galling of faying surfaces.

Figure 26 – BE micrograph of an angled view of the crack initiation sites.

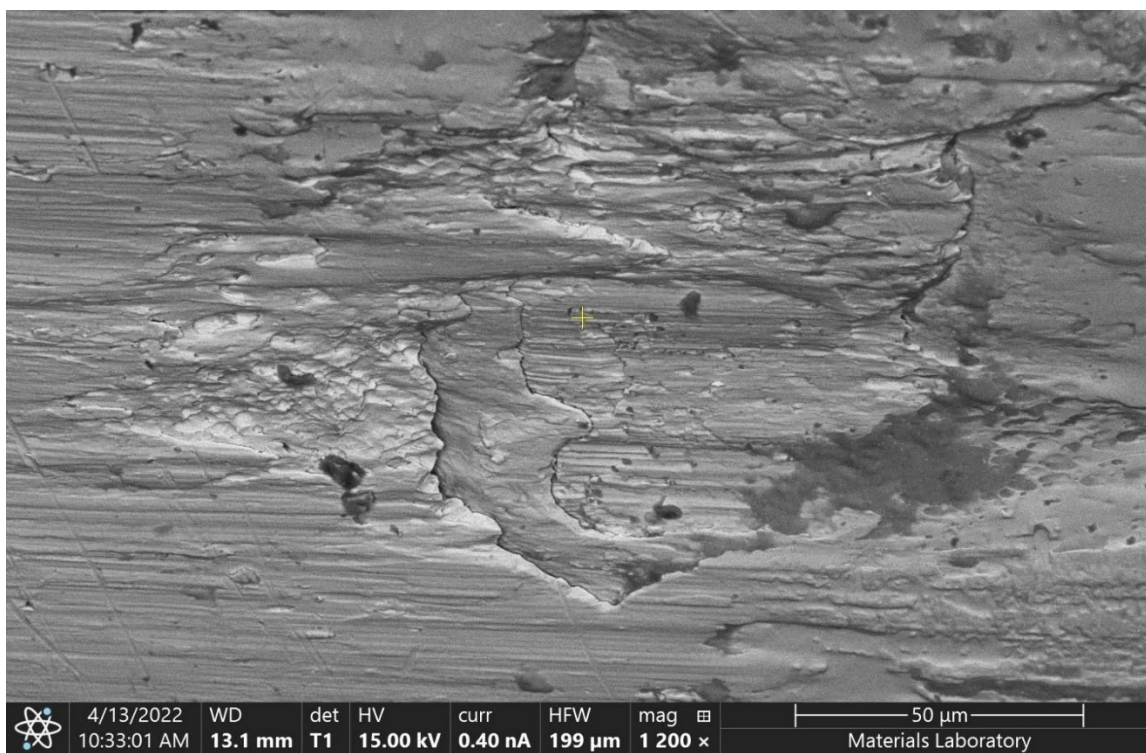
Figure 27 – BE micrograph of wear, spalling, and dissimilar material along the bore of the TT strap.

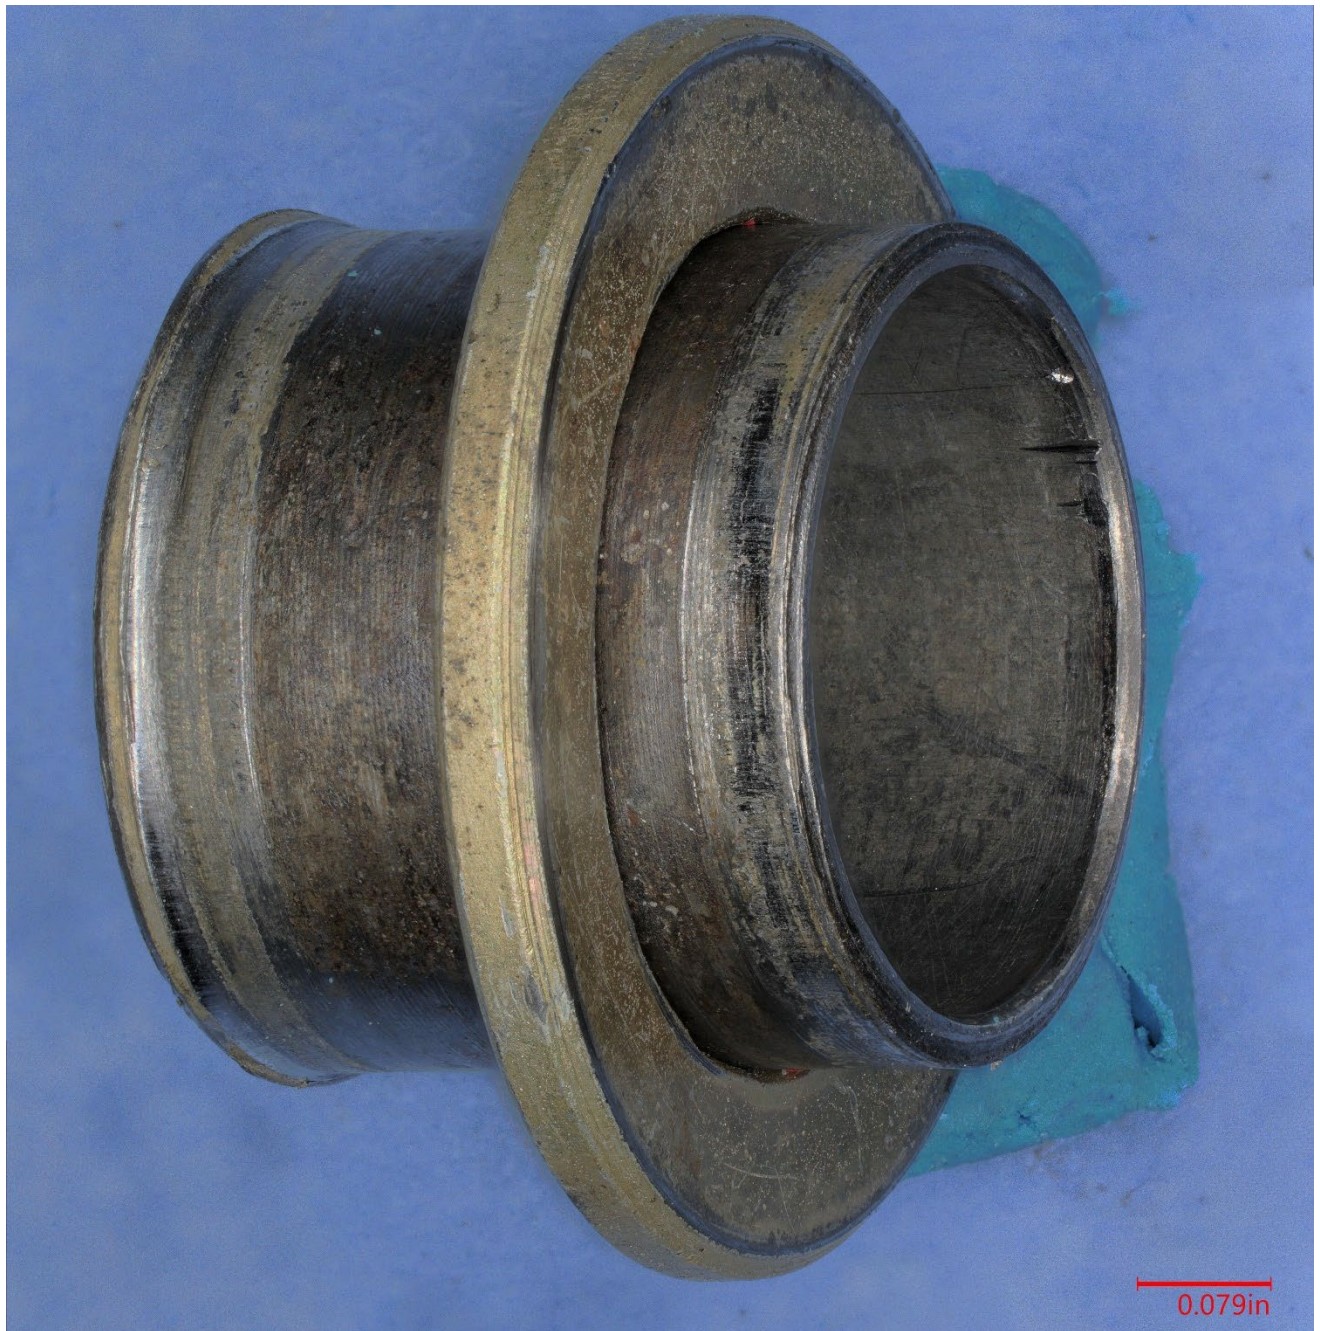
The plain bearing at the location of the fractured TT strap location is illustrated in Figure 28, which also shows one of the washers that was outside the bundle stack. The bearing exhibited outward flaring on one side. Near the flaring was a circumferential worn area, along with a worn area near the opposite edge. These worn areas were consistent with the thickness of the washers. The central cylindrical surface also exhibited areas of wear, as illustrated in Figure 29. This showed circumferential as well as pronounced longitudinal wear. In areas consistent with spalled material, fine dimpled rupture was observed, as illustrated in Figure 30.

Figure 28 – View of the bearing and a washer from the fractured TT strap bundle.

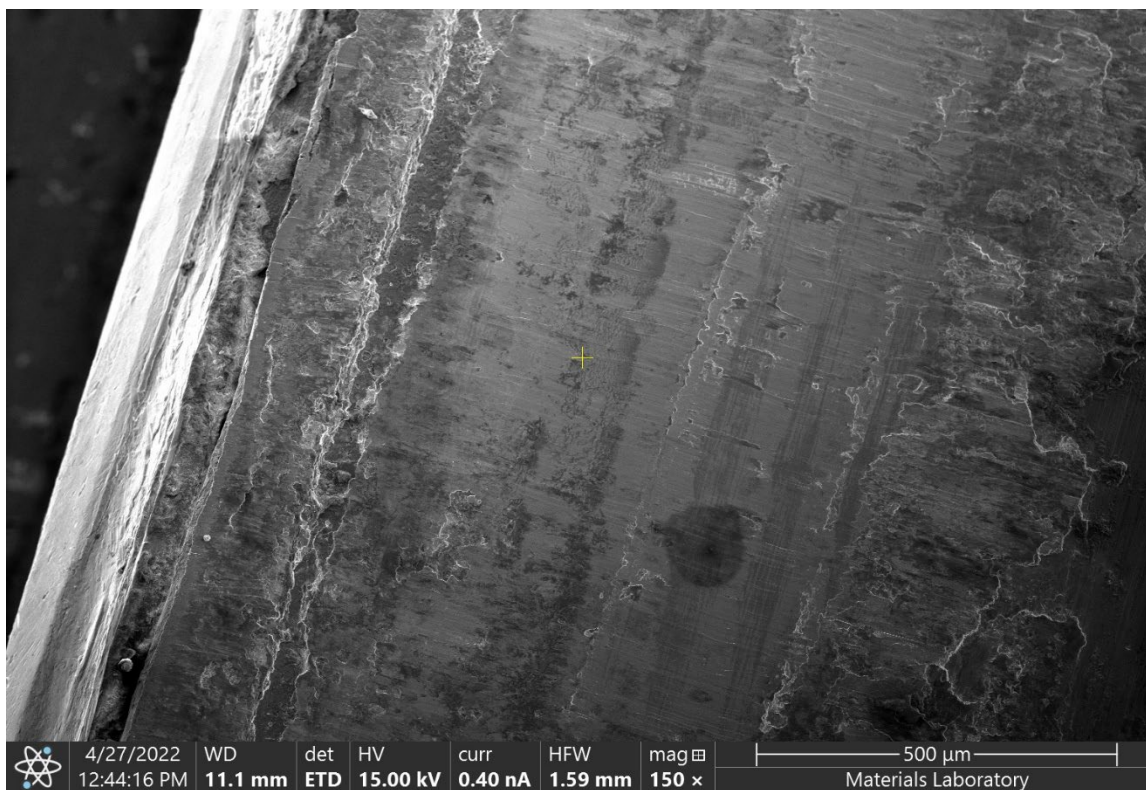
Figure 29 – SE micrograph of the bearing surface near an edge, showing longitudinal wear and smearing.

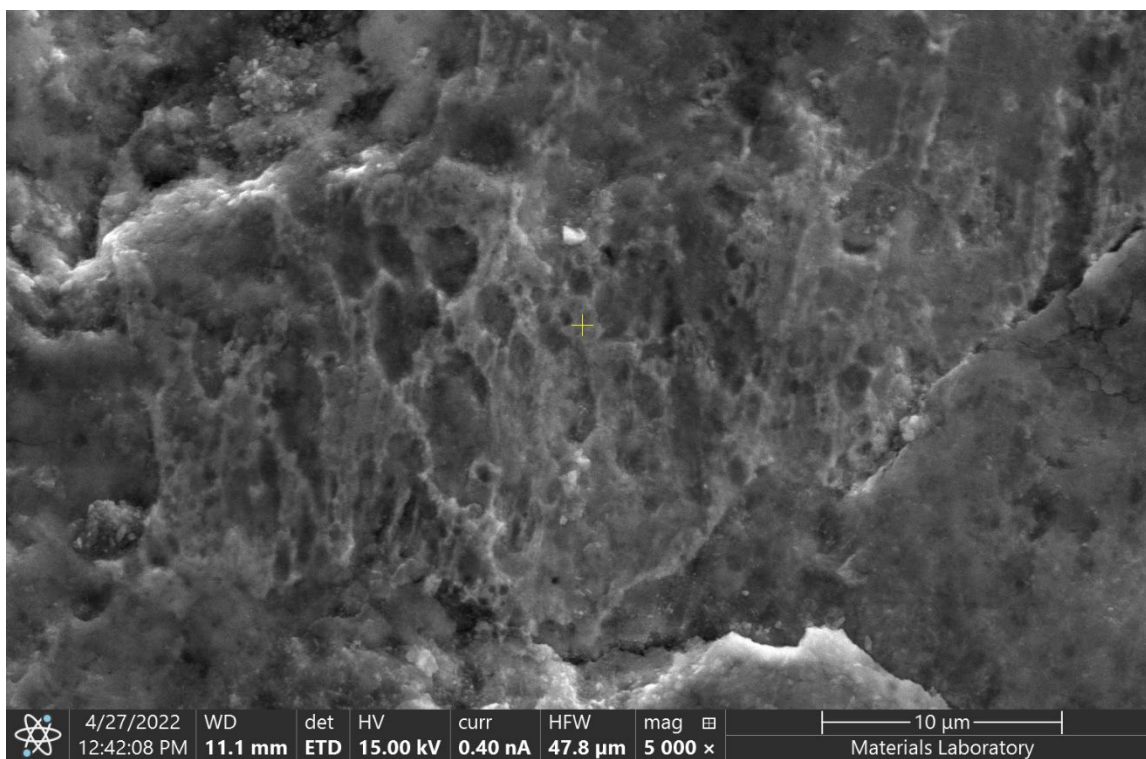
Figure 30 – SE micrograph of localized dimpled rupture in a spalled area of the bearing surface.

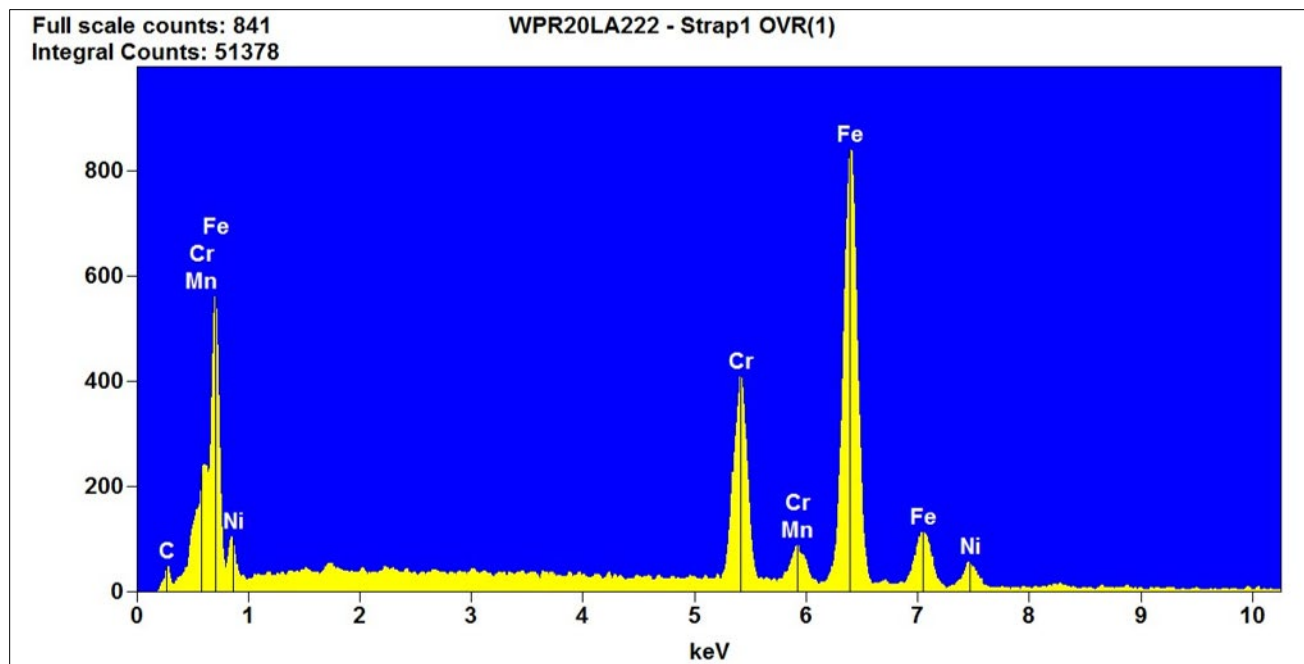
These areas were inspected using energy dispersive x-ray spectroscopy (EDS). Figure 31 shows a typical EDS spectrum of a clean and polished area of the strap—the composition of the TT strap was consistent with an austenitic stainless steel. The area of the spalled divot and dissimilar material in Figure 26 was also examined using EDS. This was found to be a dissimilar composition, consistent with an aluminum alloy (see Figure 32). The aluminum alloy was inconsistent with the composition of the plain bearing, which was consistent with alloy steel. EDS examination of the bearing and washer found them both to be consistent with cadmium-coated steels and were absent any indications of aluminum alloys.

Figure 31 – EDS spectrum of a typical area of the sectioned TT strap.

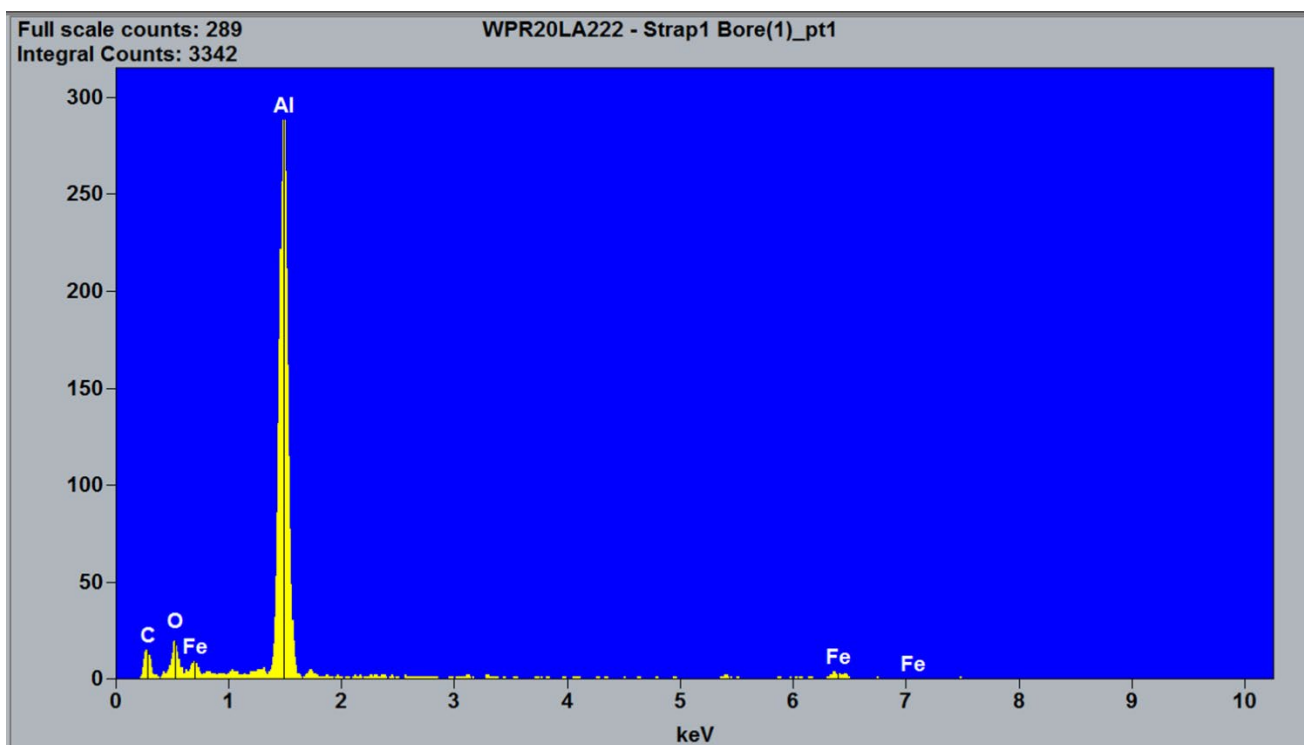
Figure 32 – EDS spectrum of the dissimilar material on the fractured TT strap bore in Figure 27.

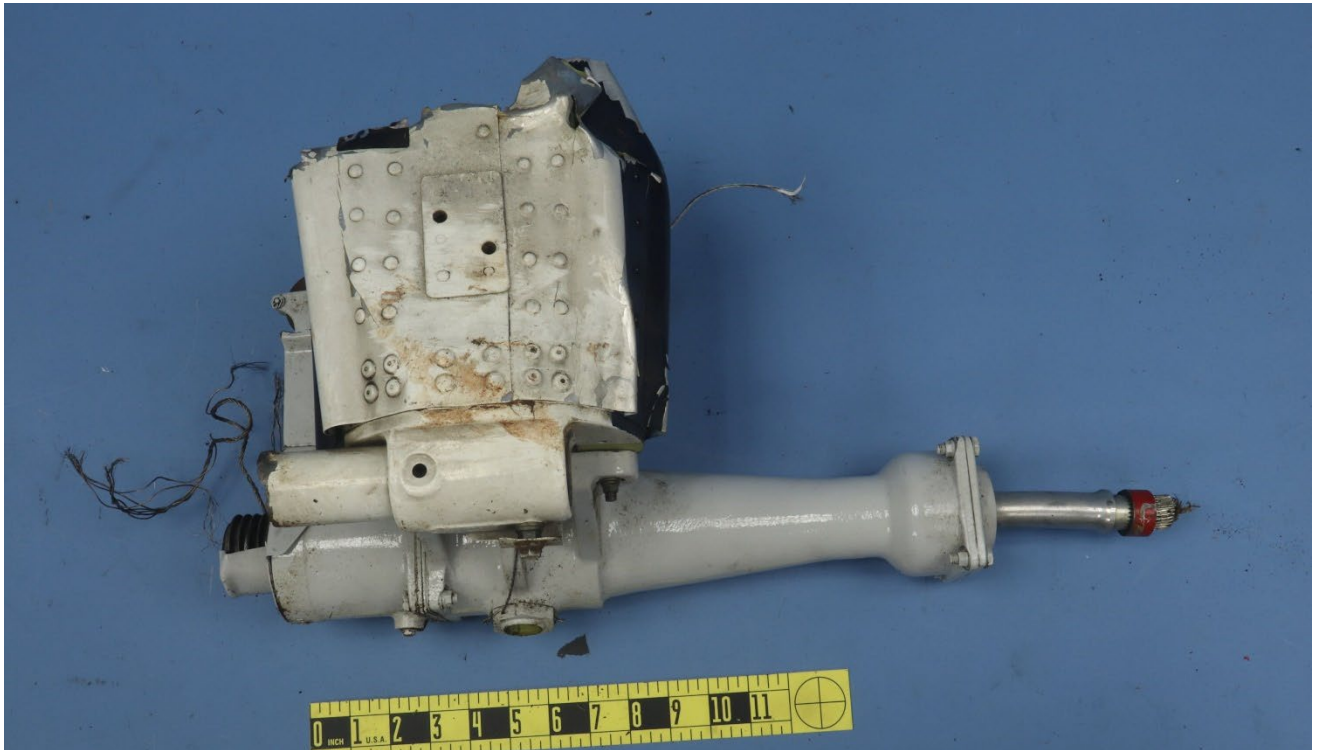
In addition to the tail rotor blade and hub assemblies, the remnants of the tail rotor gear box were also received by the NTSB Materials Lab. The gear box assembly remnant is shown in Figure 33 and Figure 34, as received. The housing with the gearing components was still intact. However, the skin of the adjacent housing had fractured in multiple locations, with tearing, deformation and buckling around the fractures. These features were consistent with later overstress fracture.

The connection cables and wires to the left in Figure 33 and Figure 34 were frayed and fractured. In addition, the shaft towards the right of the gear box had bent, but not fractured, in the figures. Several of the pinion teeth had also been deformed and worn.

Figure 33 – View of the tail rotor gear box assembly, as received.

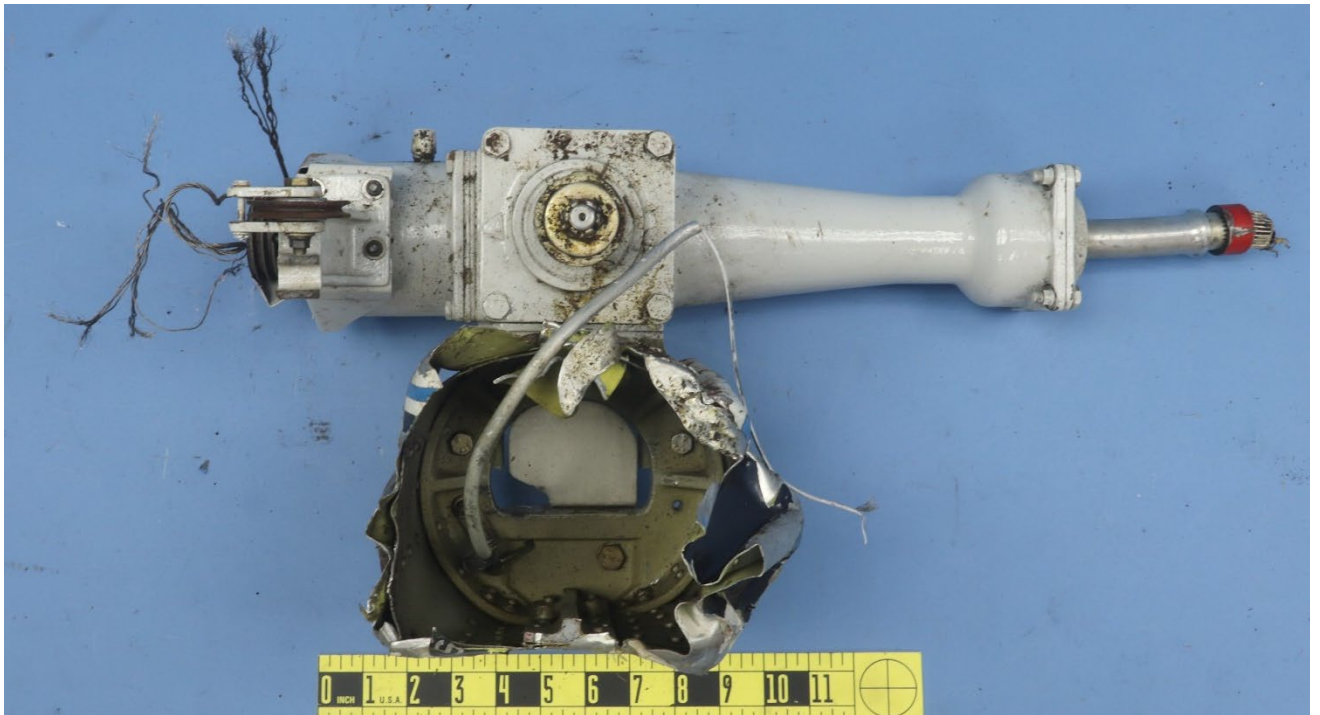
Figure 34 – View of the fractured areas of the tail rotor gear box assembly.
