**On Scene Photos**  
Courtesy of Western Helicopters

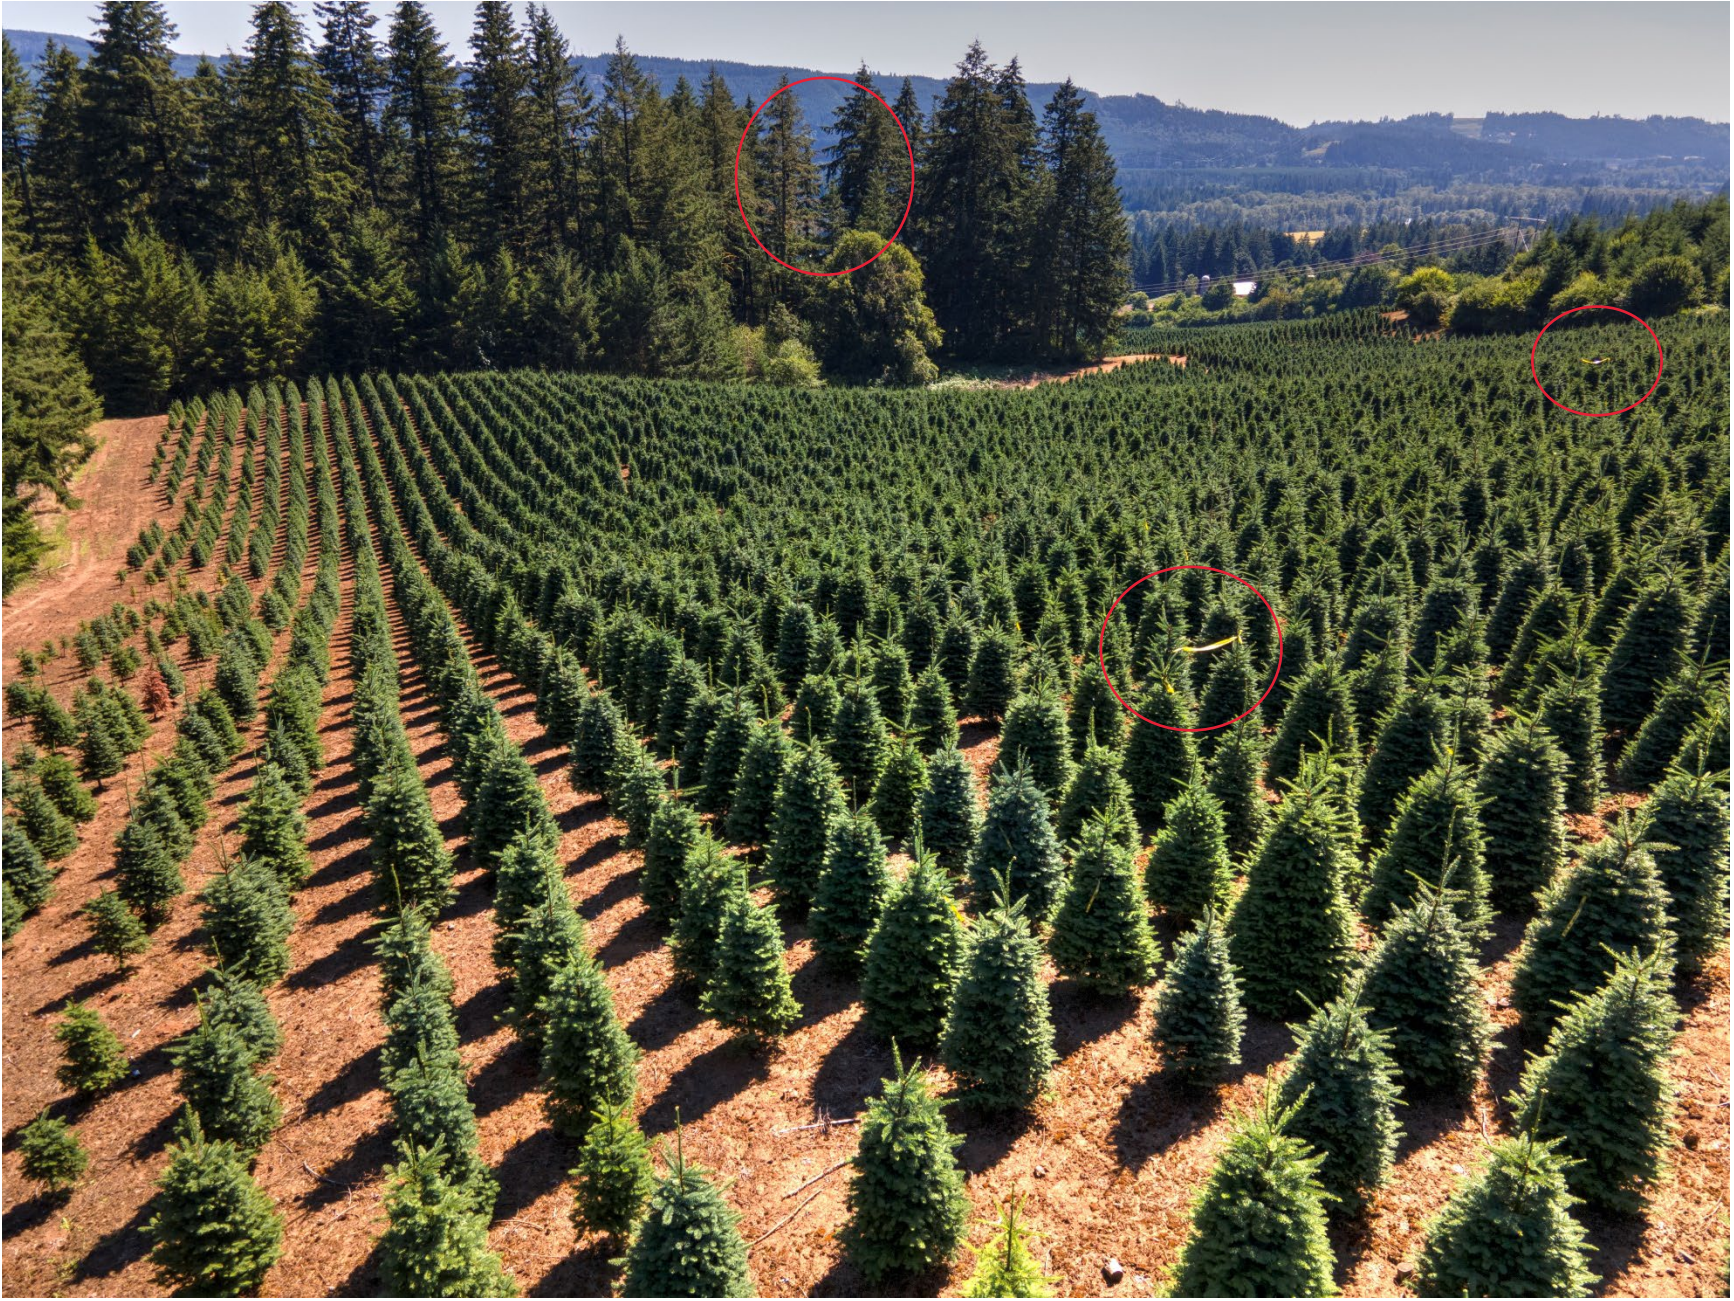
*Figure 1: Overview of Debris Path*

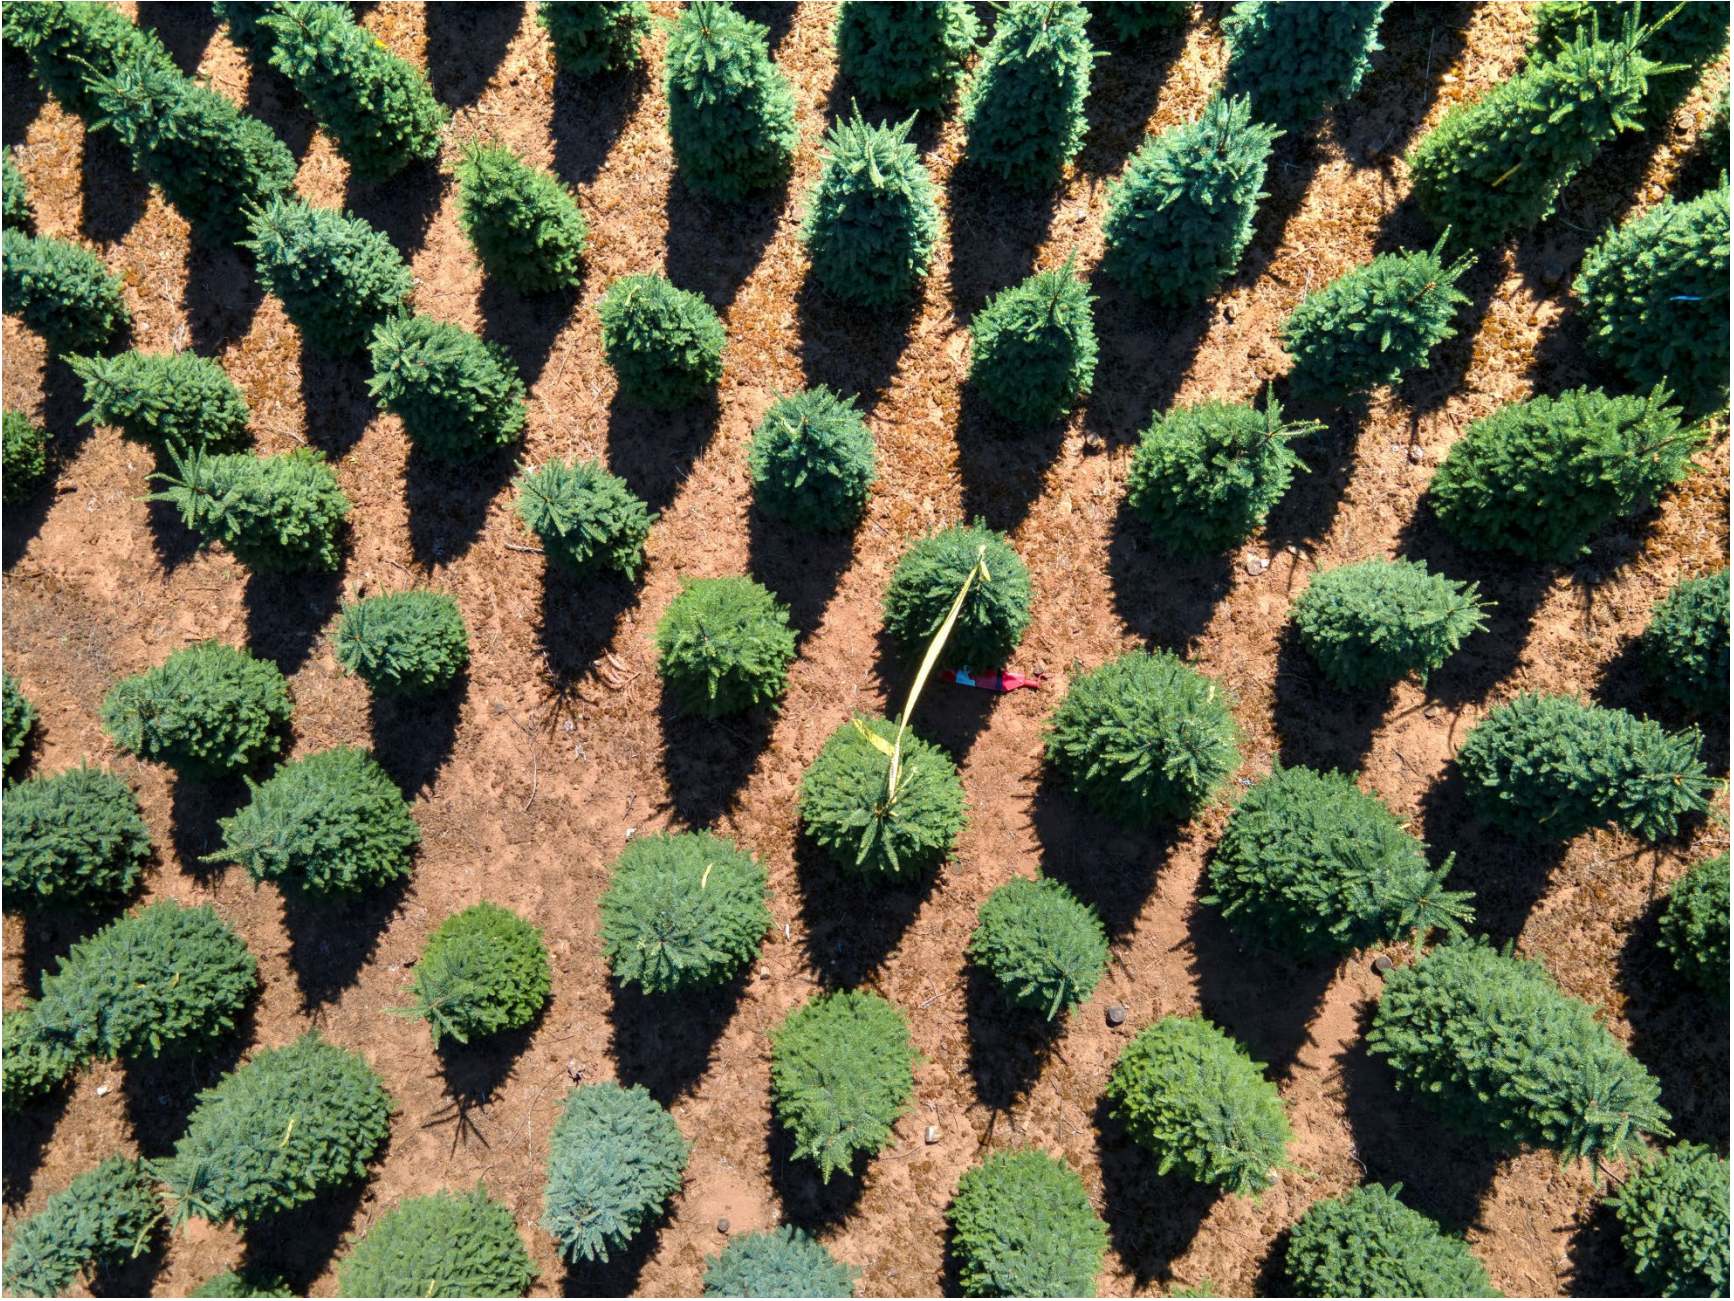
*Figure 2: Tail Rotor Blade from Above*

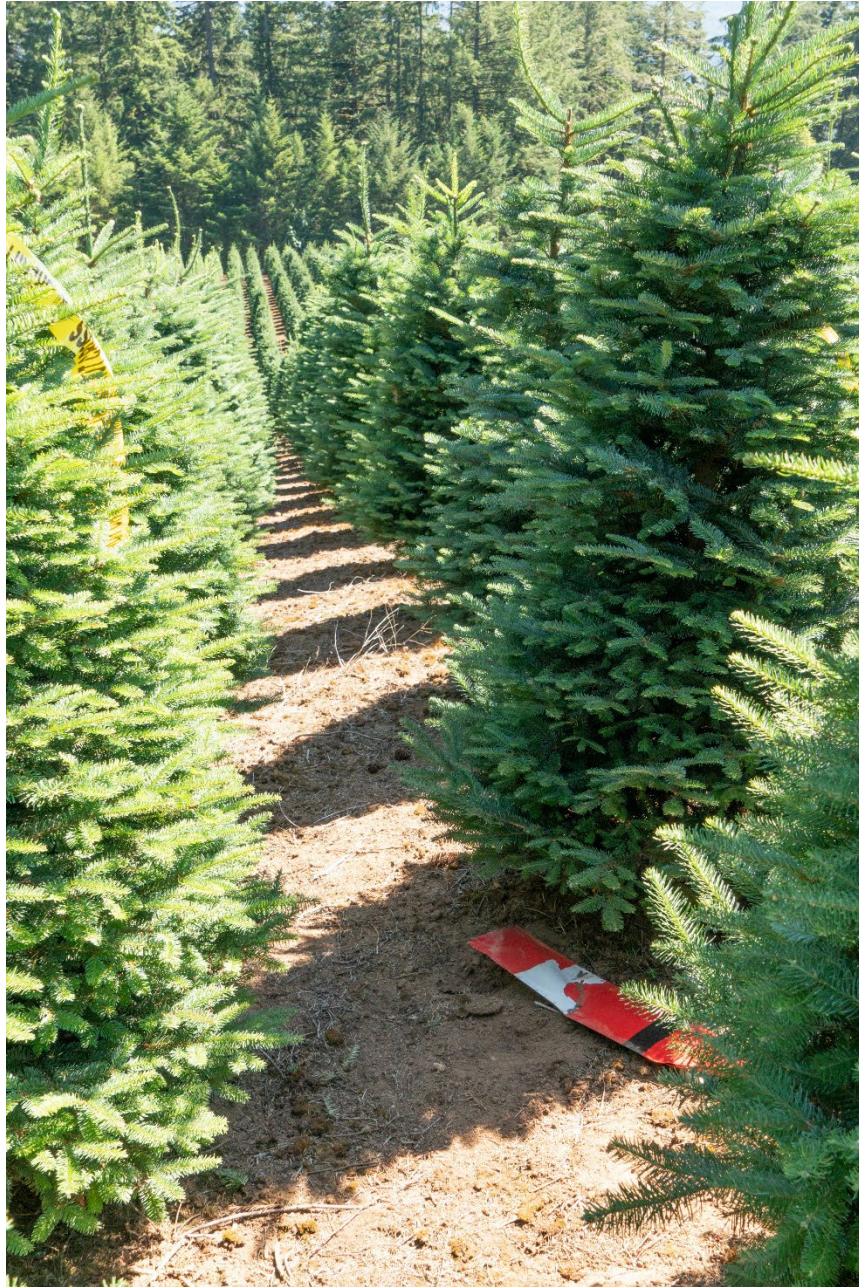
*Figure 3: Close up of Tail Rotor Blade*

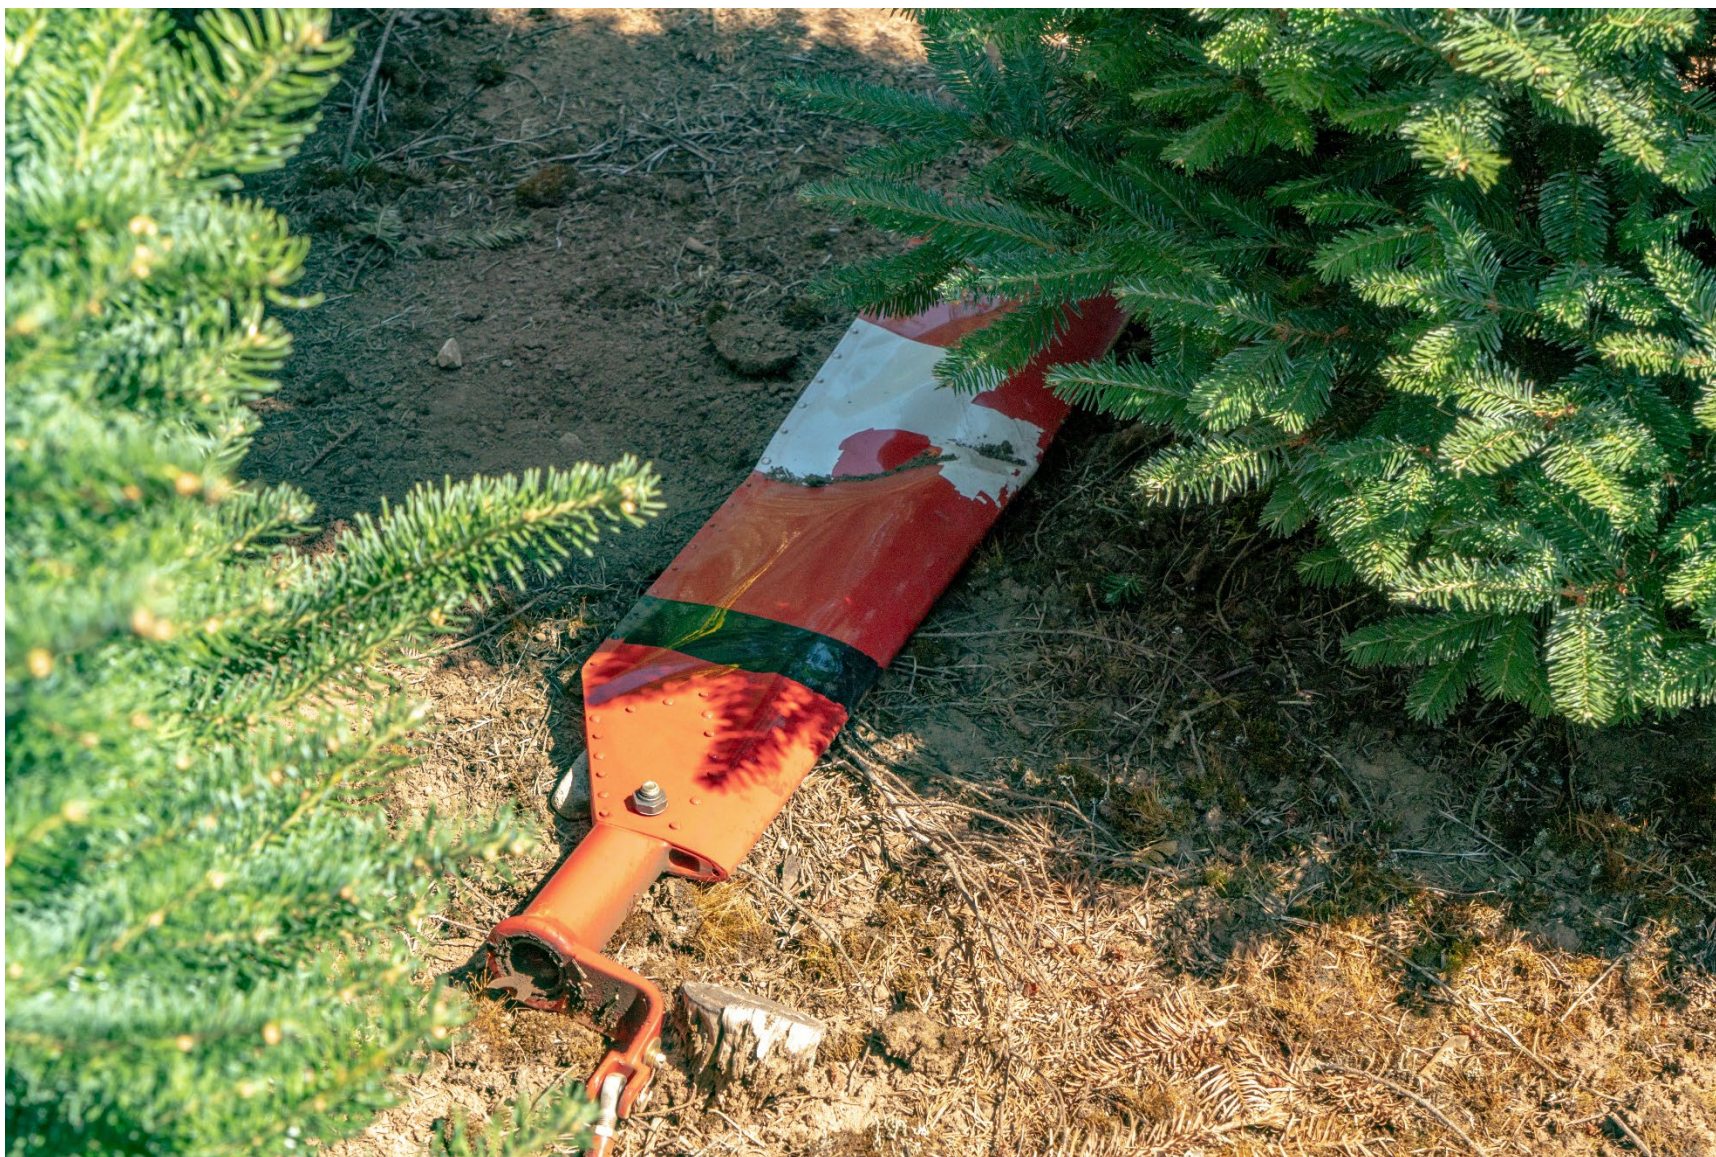
*Figure 4: Tail Rotor Blade*

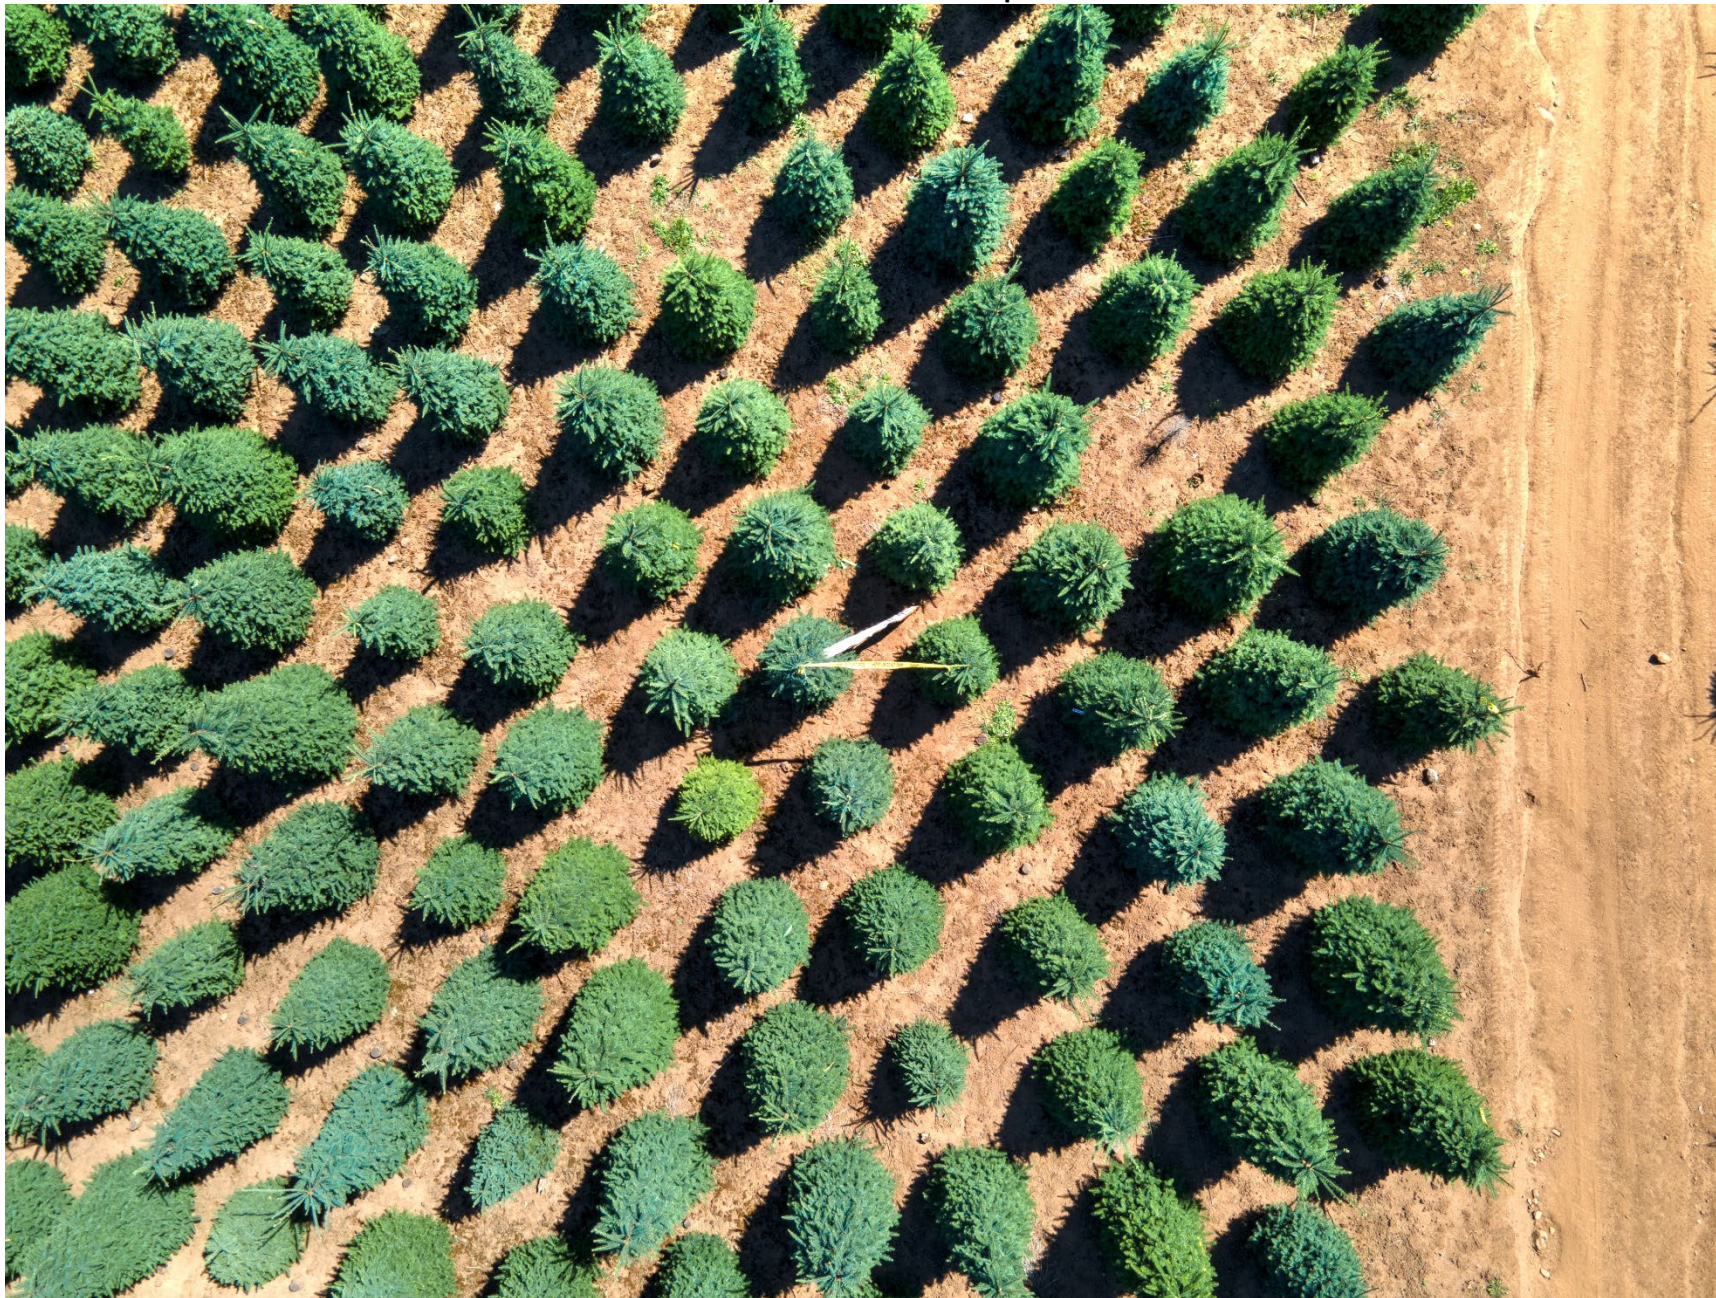
*Figure 5: Main Rotor Blade Fragment Location*

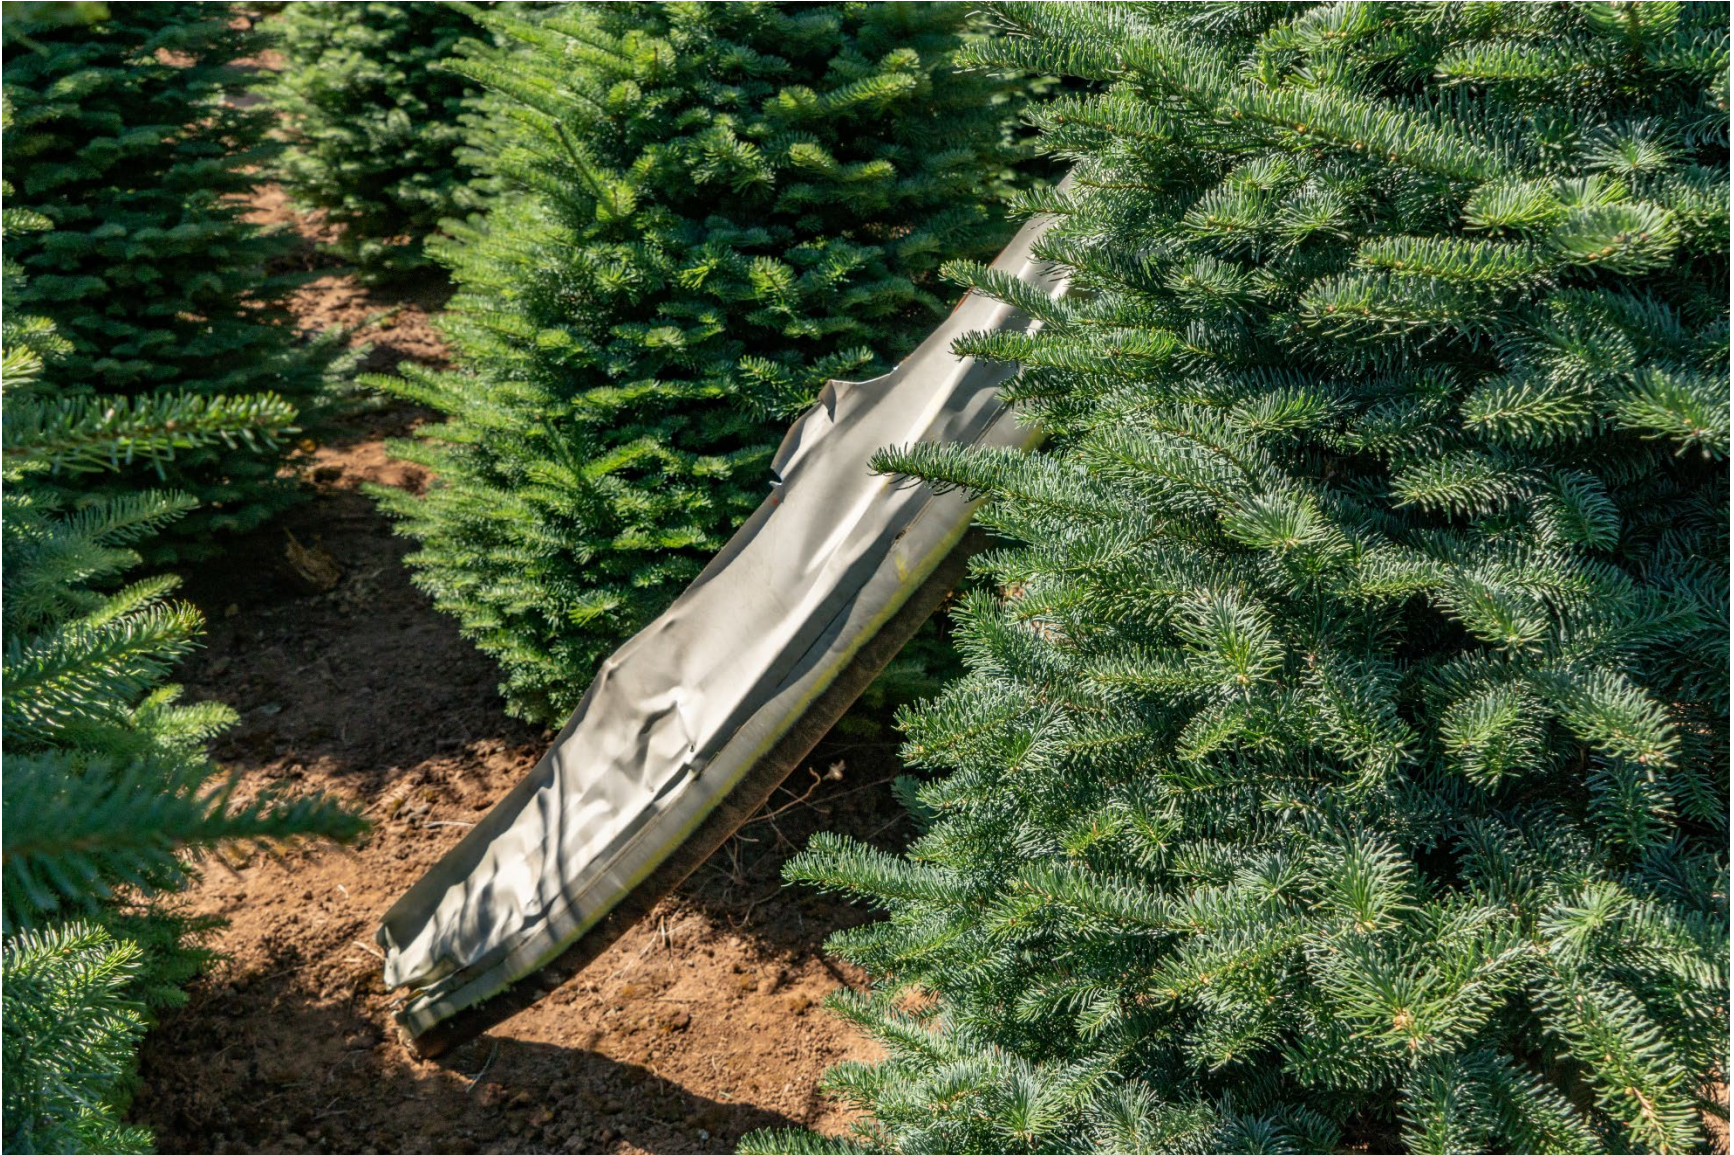
*Figure 6: Main Rotor Blade Fragment*

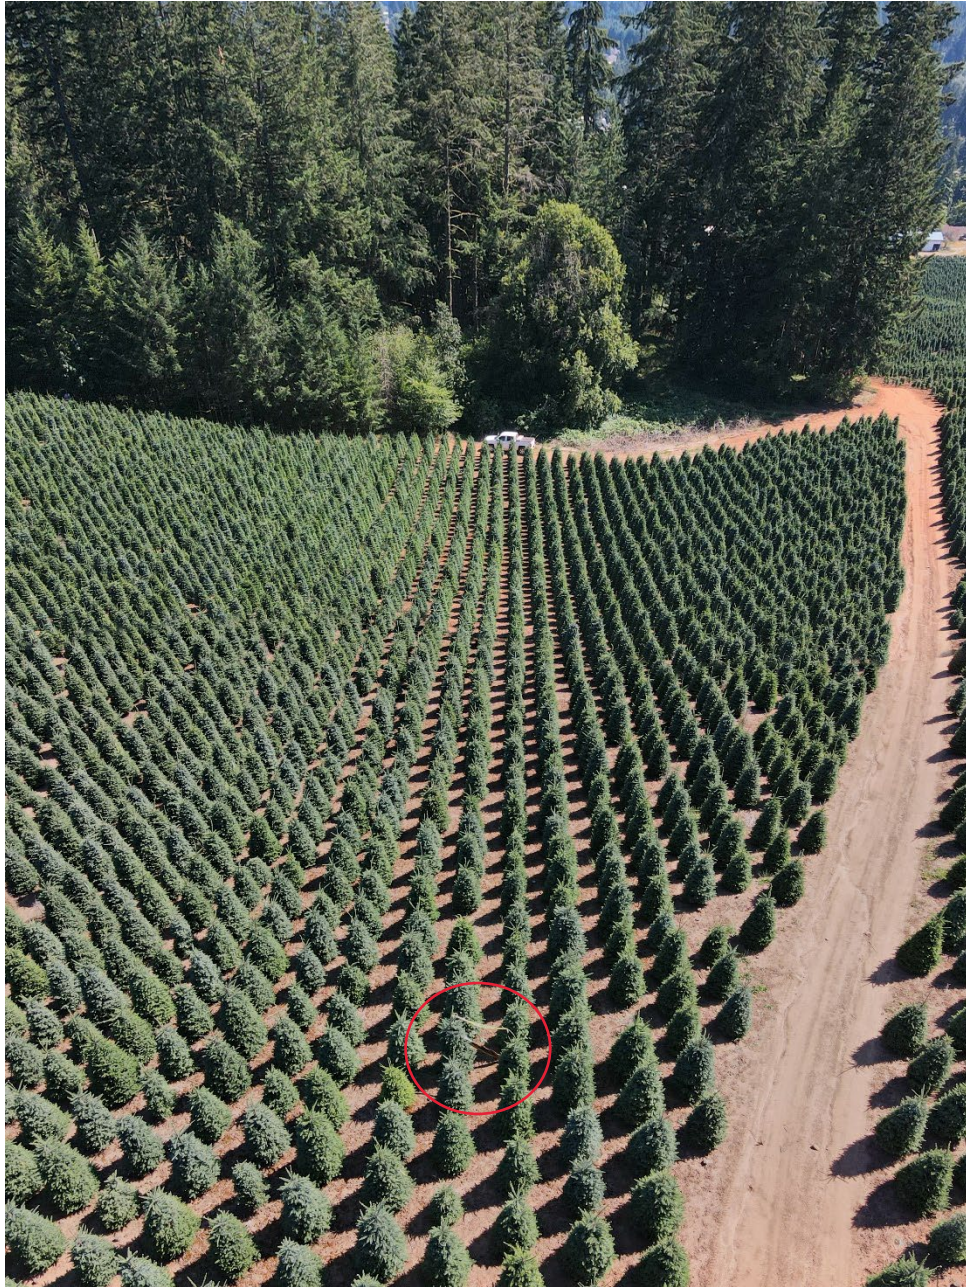
*Figure 7: Debris Path from Main Rotor Blade Fragment*

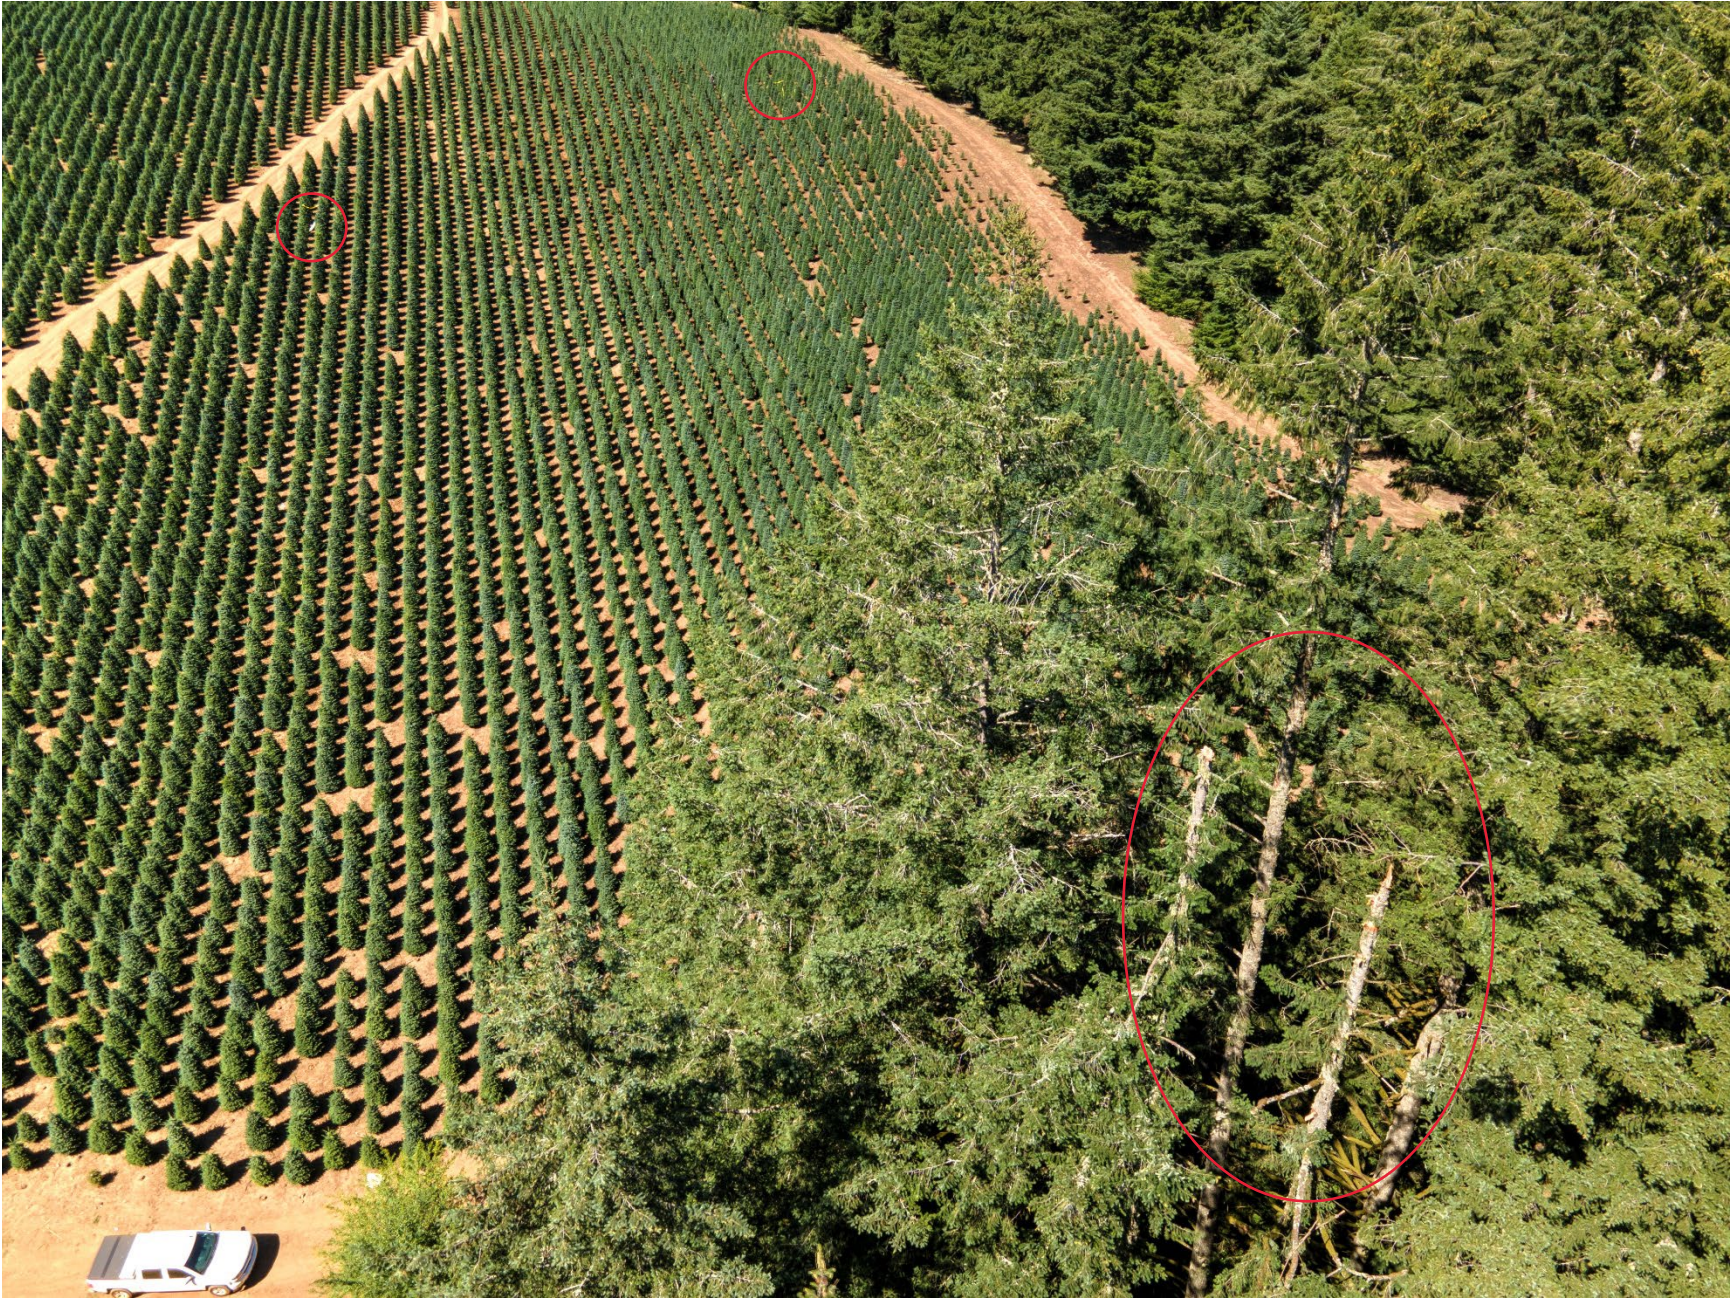
*Figure 8: Debris Path in Relation to Damaged Trees*

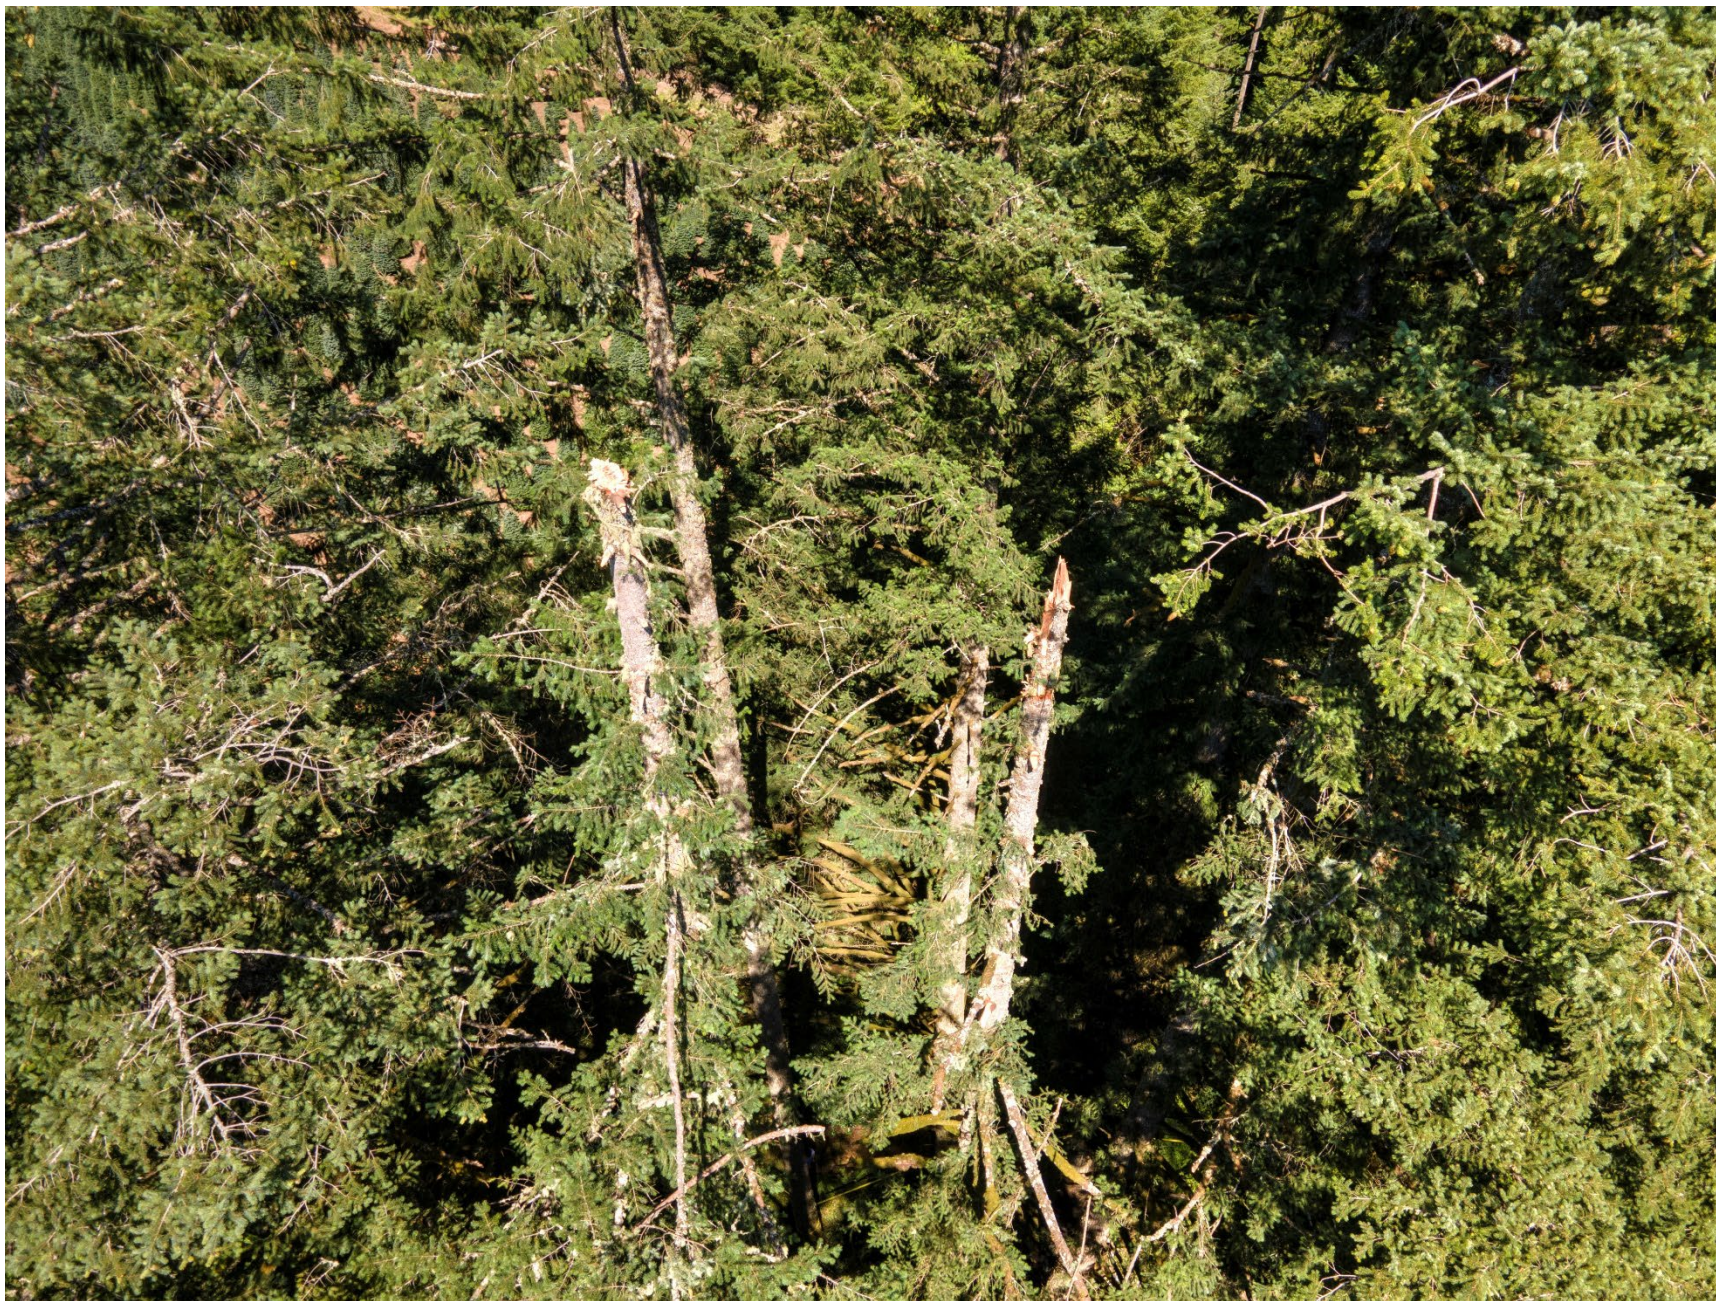
*Figure 9: Damaged Trees Above the Main Wreckage*

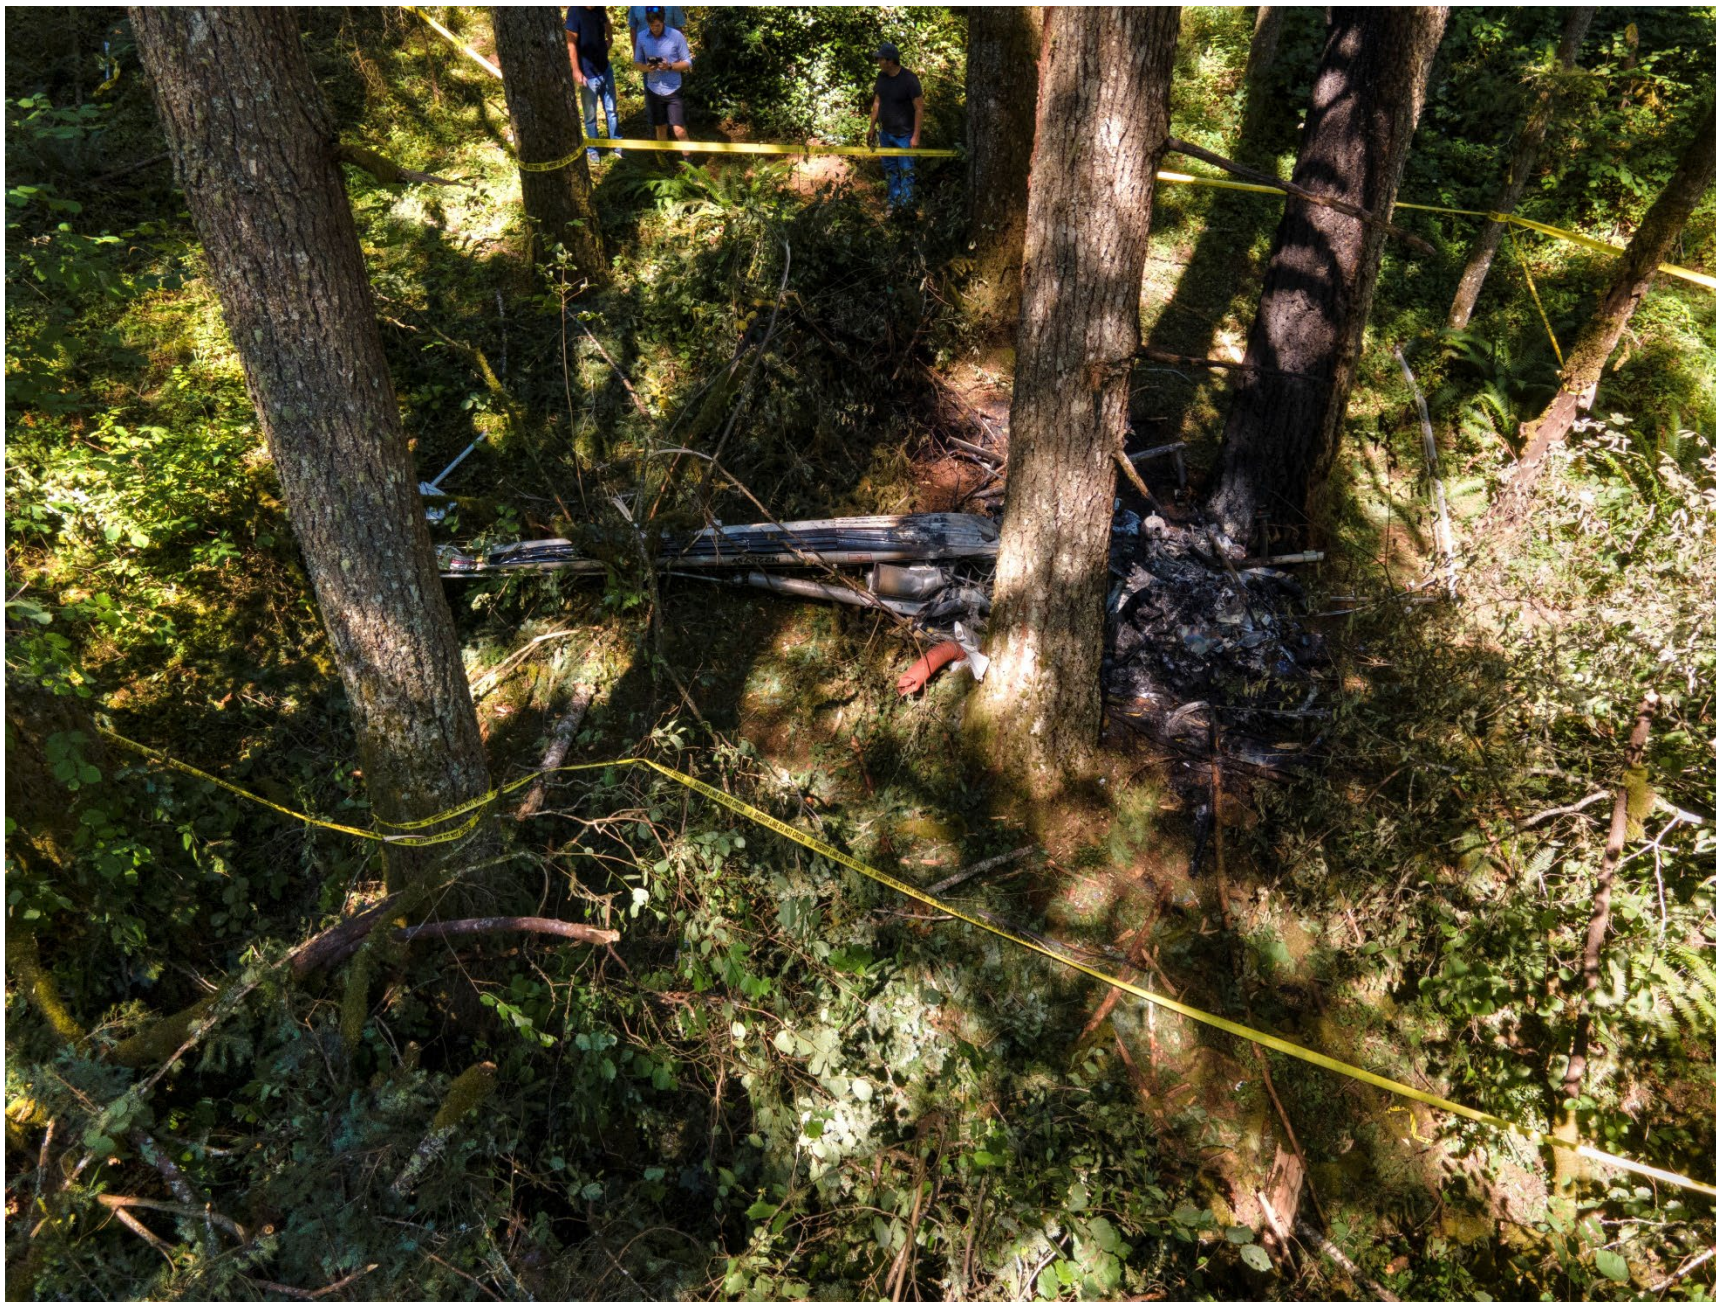
*Figure 10: Overview of Helicopter*

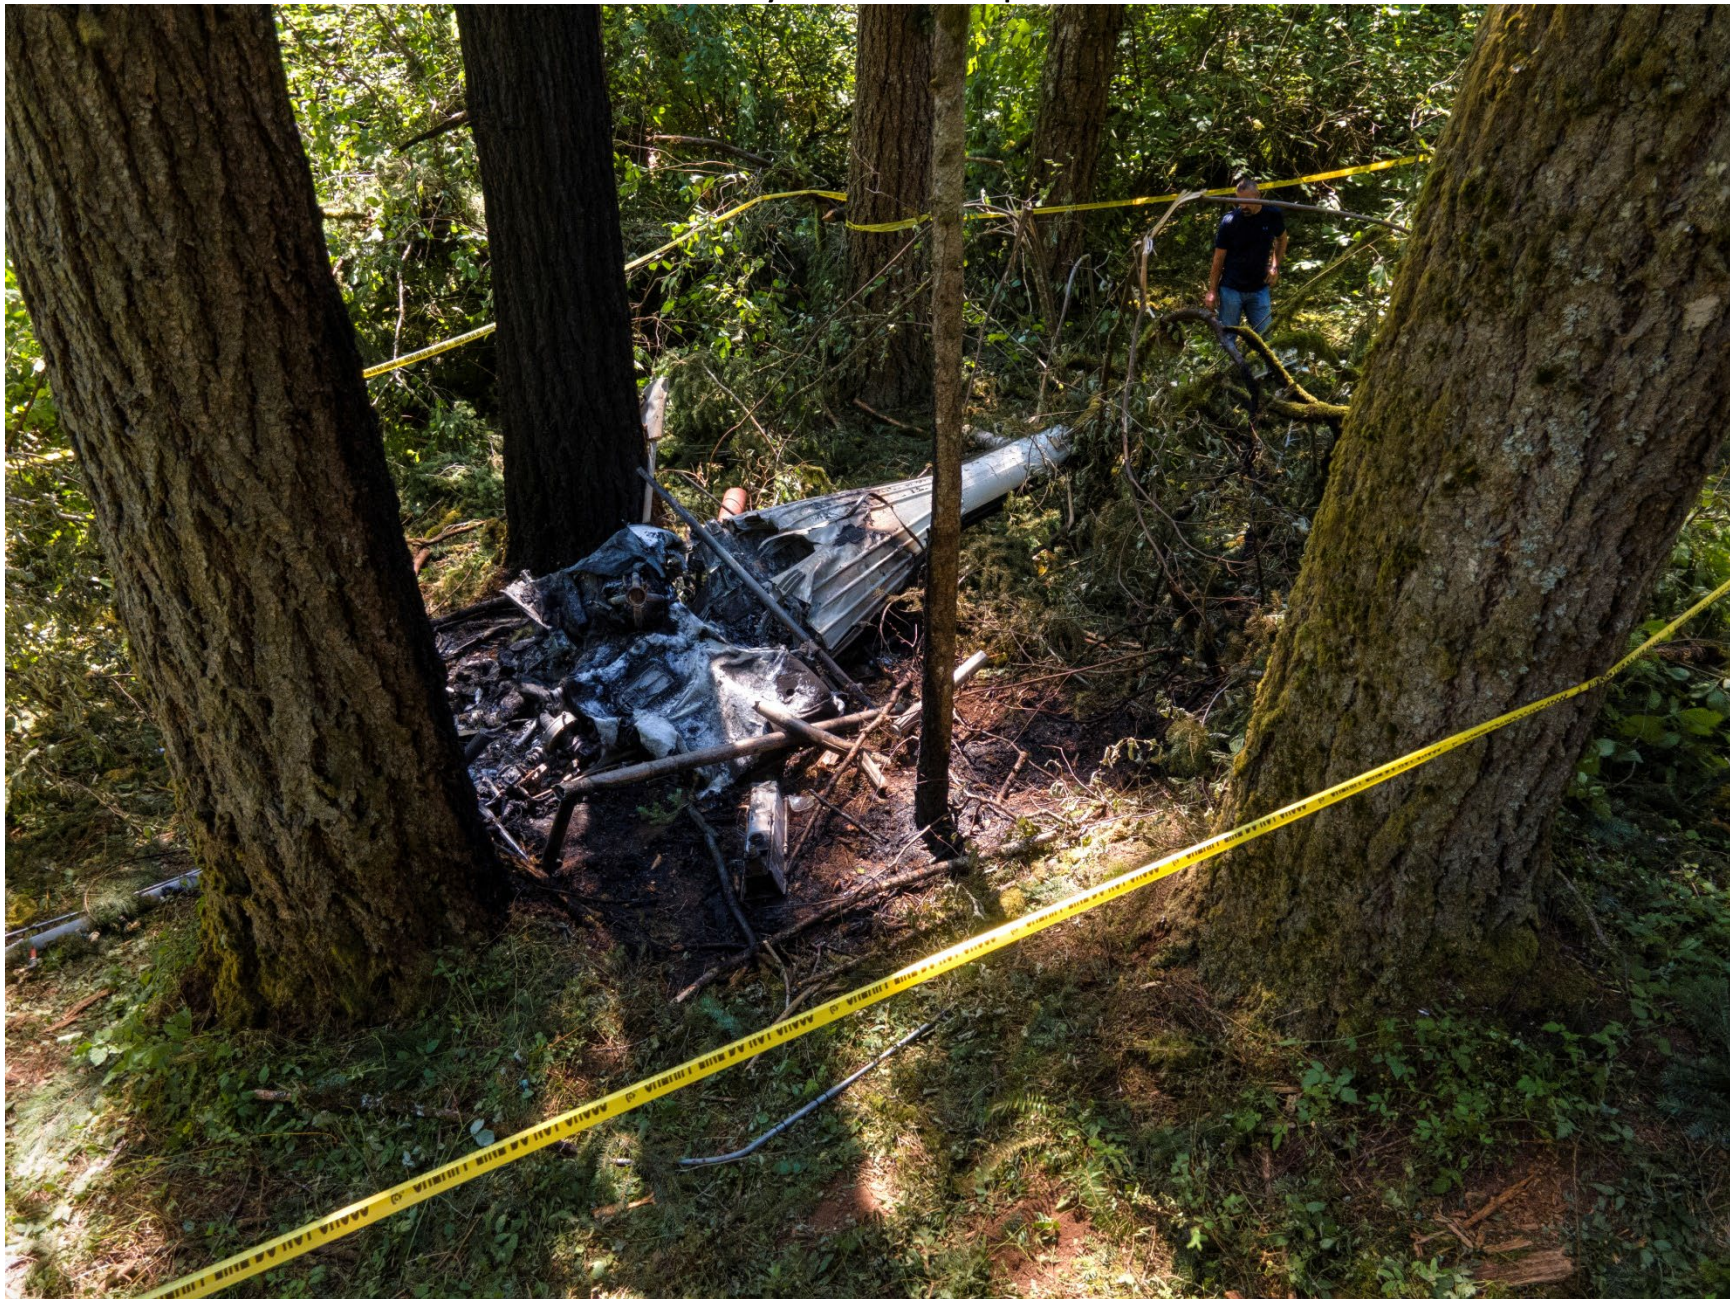
*Figure 11: Underside of Fuselage*
