**On Scene Photos**  
Courtesy of Western Helicopters

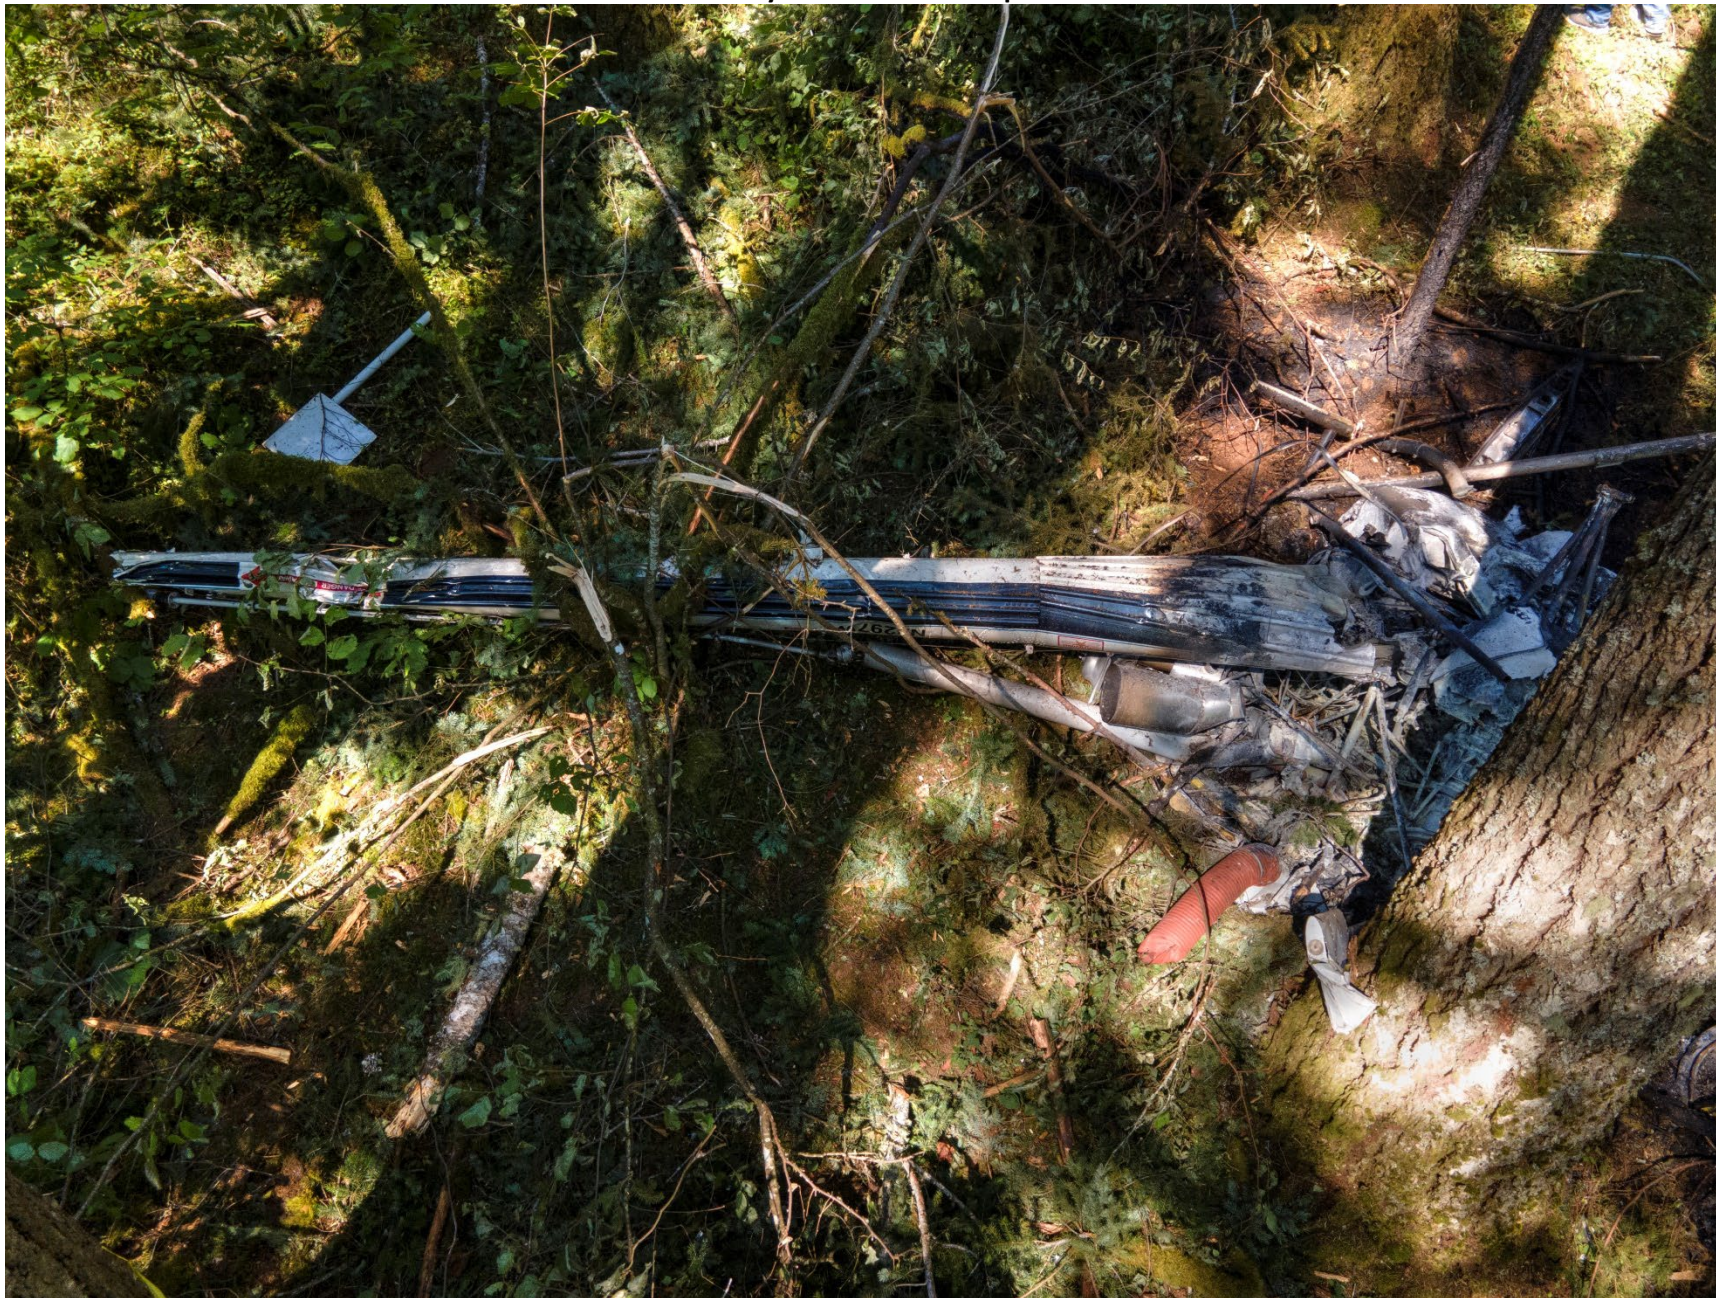
*Figure 12: Overview of Tail Boom*

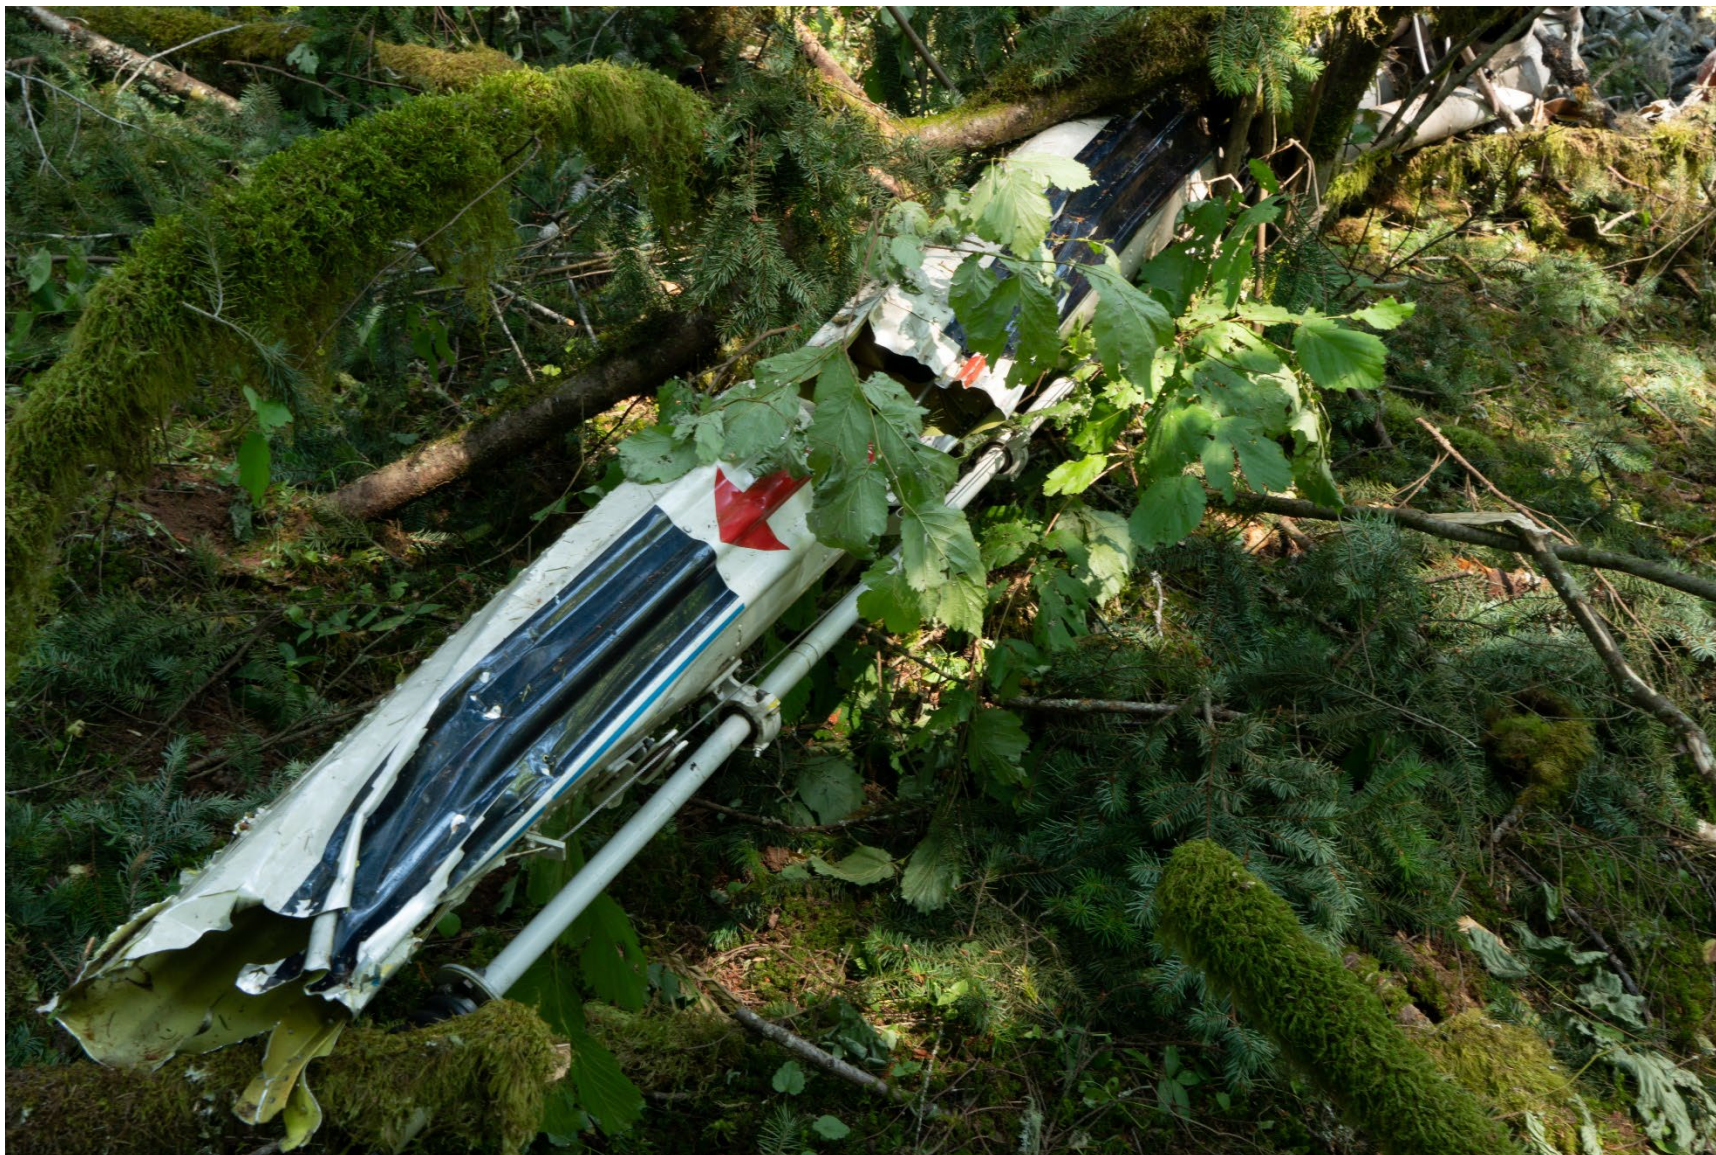
*Figure 13: End of Tail boom*
