## RECORD OF MEMORANDUM

**Date: October 2, 2020**  
**Person Contacted: Mr. Ken Bradshaw (Federal Aviation Administration)**  
**NTSB Accident Number: WPR20LA224**

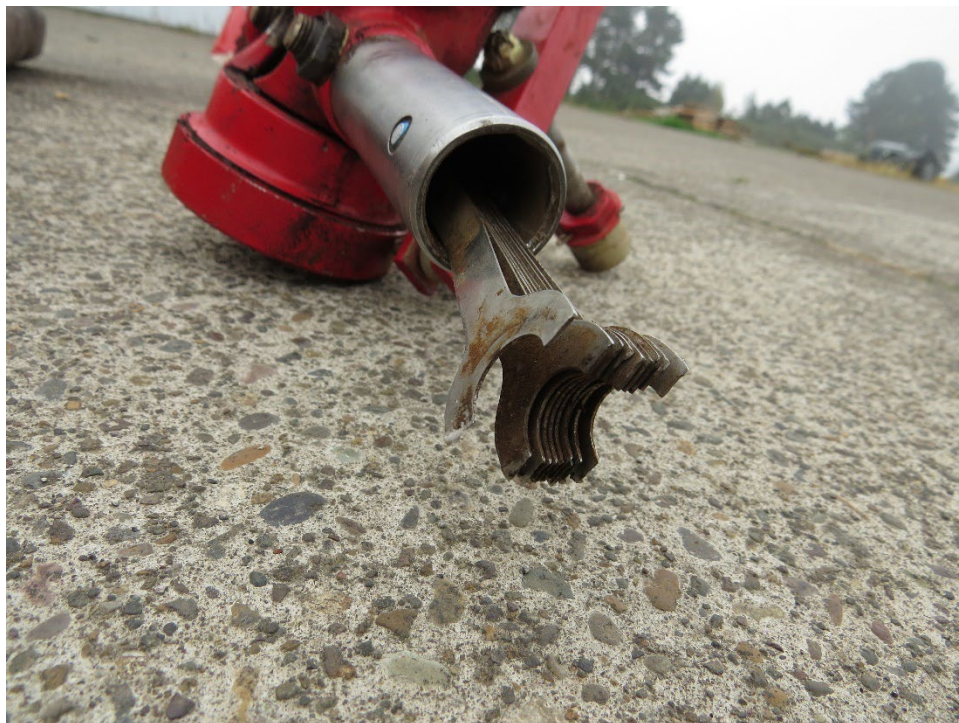
*Figure 2: TT Strap Stack*

- The engine showed some rotational damage, and there was dirt and debris buildup around some of the guide vanes in the engine.
- The tail rotor blade retention strap (TT Strap) on one of the blades was out in the field away from the main wreckage. It failed with a clean break up the strap stack, except for one individual strap layer.
