## **NATIONAL TRANSPORTATION SAFETY BOARD**

### **Airframe and Engine Exam**

**WPR20LA237**

Location: Tehachapi, CA.  
Date: July 24, 2020  
Aircraft: Rans RV-8 / N138PM  
IIC: Samantha Link

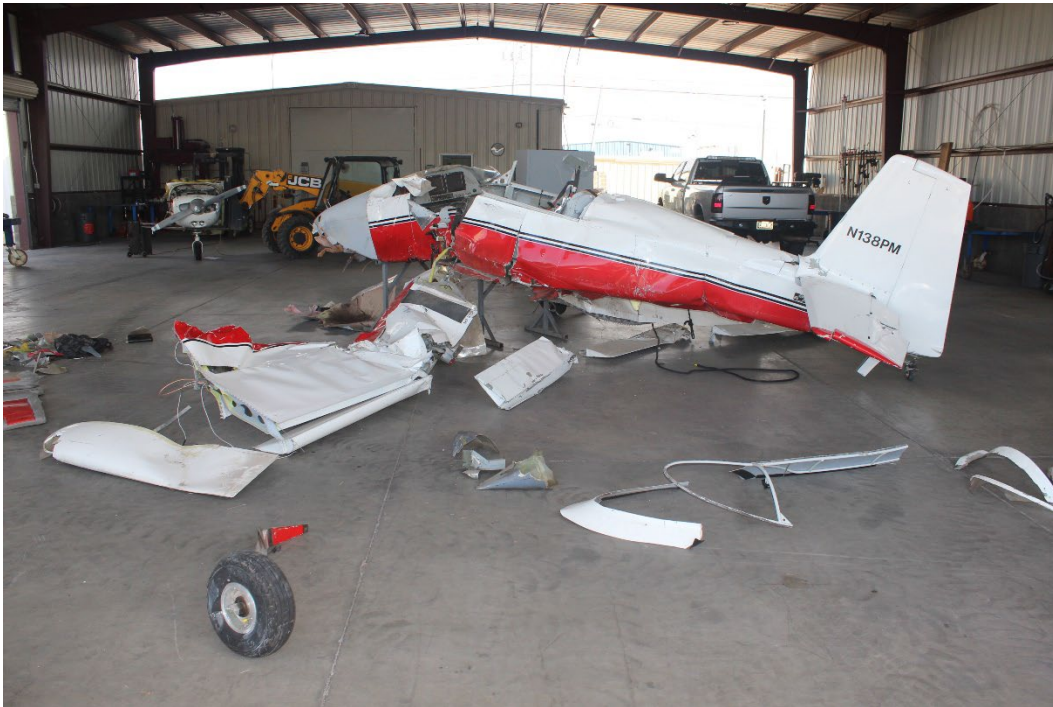
**Figure 2: Left Side of Airplane**

The left side was not as extensively damaged as the right. There is not as much heavy damage on the bottom of the fuselage. There was heavy scratching in the paint about mid-span between the elevator and the wing. The top of the aft fuselage was dented. The rail for the canopy remained attached to the fuselage, but the canopy separated from the top of the fuselage. There were several dents along the top of the fuselage from the aft canopy area toward the empennage. There was a large tear in the sheet metal about 18 inches forward of the trailing edge of the wing. The tear runs from the bottom of the fuselage to the canopy rail.

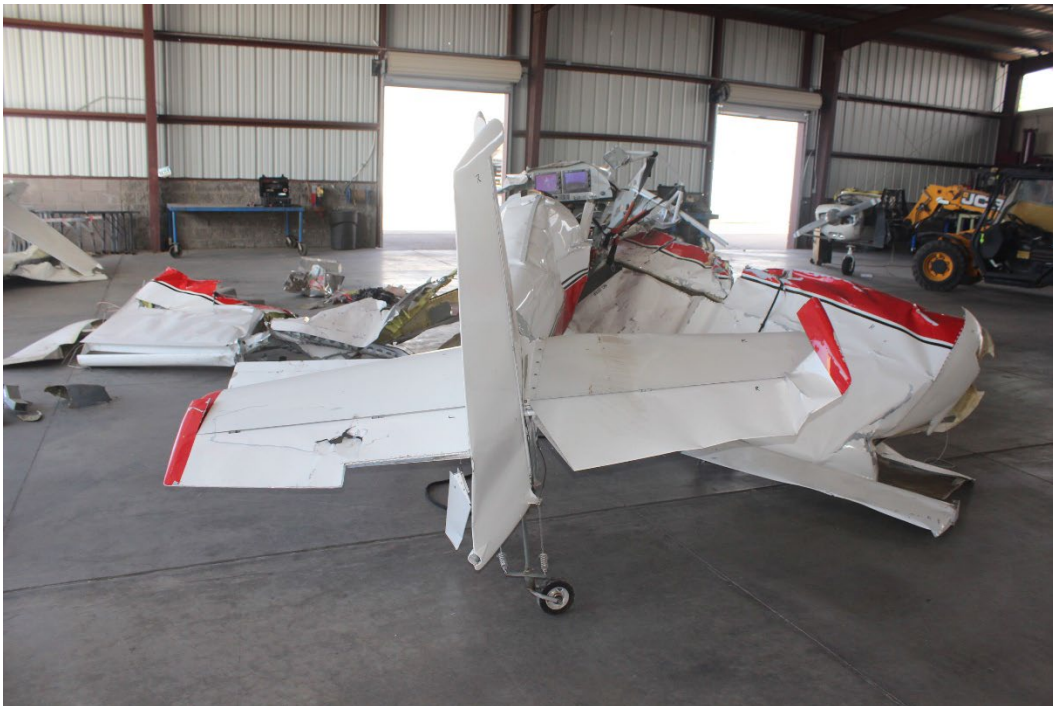
**Figure 3: Empennage**

The right horizontal stabilizer had damage to the leading edge throughout its span, with wrinkling and dents on the sheet metal and scratches running fore to aft. The right elevator

remained attached at the hinges and articulated up and down to full travel. About ten inches of the outboard tip of the right elevator and the counterweight was bent upwards to about a 45° angle. The right side of the vertical stabilizer displayed minor damage. The fiberglass at the base of the vertical stabilizer was damaged, cracked, and some sections were separated. The right side of the rudder displayed minor damage and remained attached to the vertical stabilizer and the tailwheel articulated with the rudder movement.

The left side of the vertical stabilizer displayed minor damage with dents near the leading edge. The left horizontal stabilizer had minor damage on the top and bottom. The left elevator remained attached to the empennage, articulated up and down to full travel and had a large fracture and crack about mid-span on the top surface. The trim tab on the left elevator separated but remained partially attached by the trim control cable.

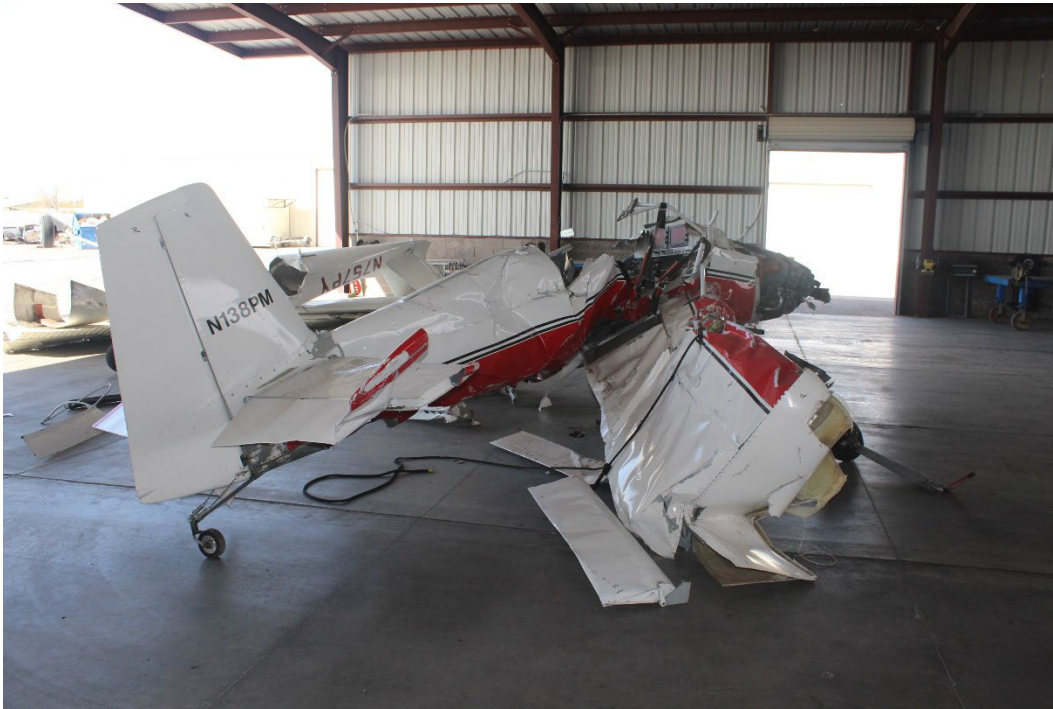
**Figure 4: Aft Right Side of Airplane**

The right side of the fuselage, from just aft of the engine nacelle to the empennage displayed extensive wrinkling and buckling. A large tear in the sheet metal was evident about mid-way of the tandem cockpit area. The tear in the sheet metal extended from the canopy area down to the belly of the airplane. Aft of the cabin area was extensive sheet metal deformation with wrinkling and bending of the fuselage. Extensive damage was noted to the belly of the fuselage with large tears in the sheet metal, dents, and wrinkling from the nose to the tail.

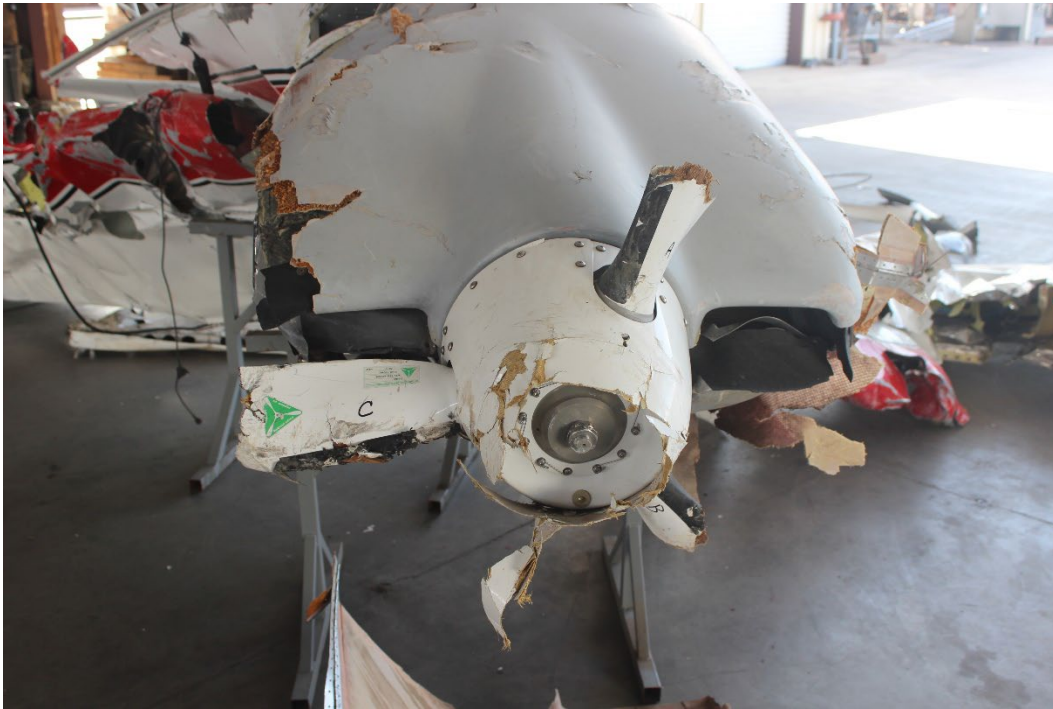
**Figure 6: Propeller Assembly**

The three-blade propeller hub remained attached to the engine. The propeller blades had fracture separated from the hub at their roots. The hub retained about 8 inches of the A blade, 6 inches of the B blade and about 7 inches of the C blade. The separated section/fragments of the propeller blades were not present. The composite spinner remained attached to the hub.

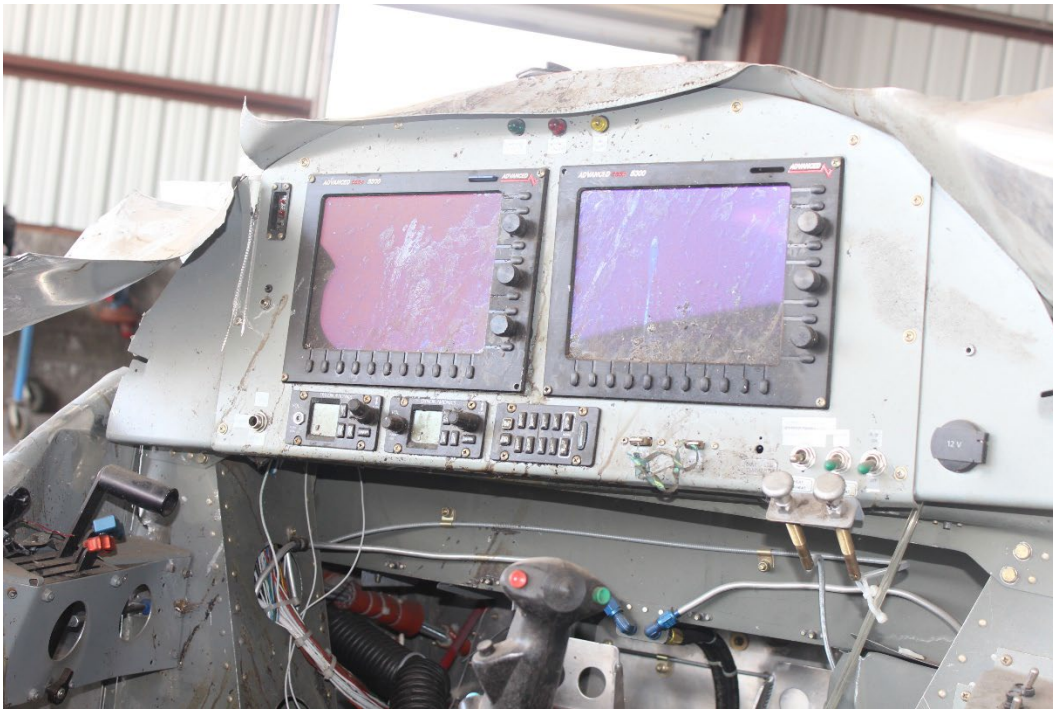
**Figure 7: Instrument Panel**

The instrument panel contained an Advanced Flight Systems AF-5500, which includes two multi-function displays. Both MFD's remained attached to the instrument panel. The MFD's were removed and sent to the NTSB Recorders Laboratory for download.

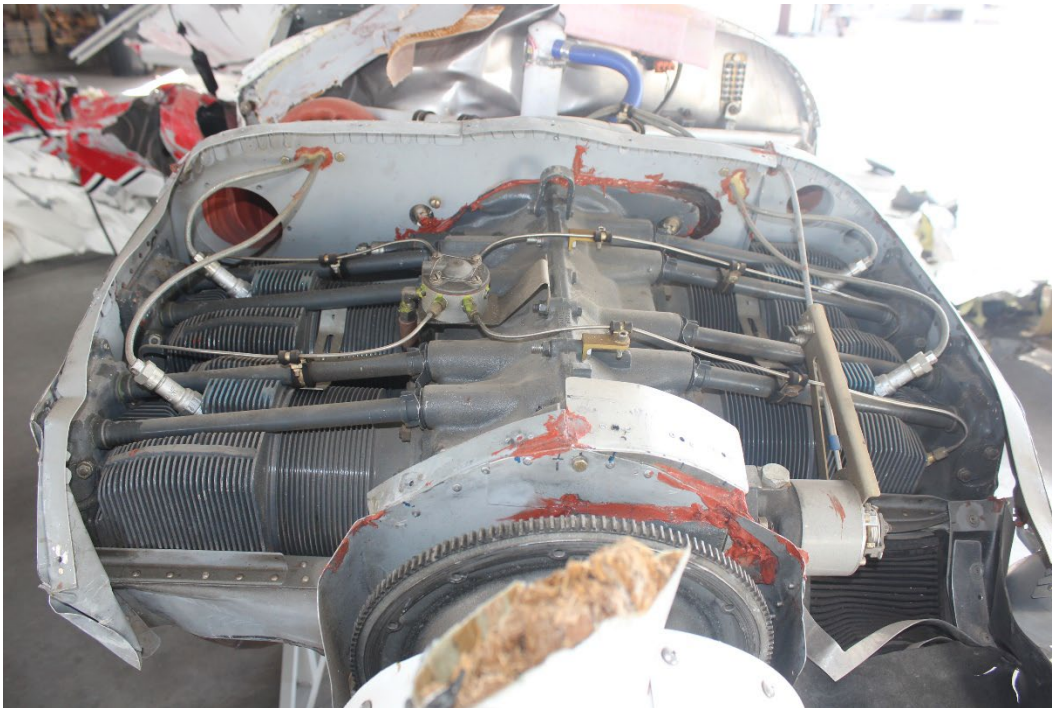
**Figure 9: Top of Engine**

The engine remained secured to the firewall; the number two cylinder sustained damage consistent with impact. Visual examination of the engine did not reveal any catastrophic pre impact failures or malfunctions.

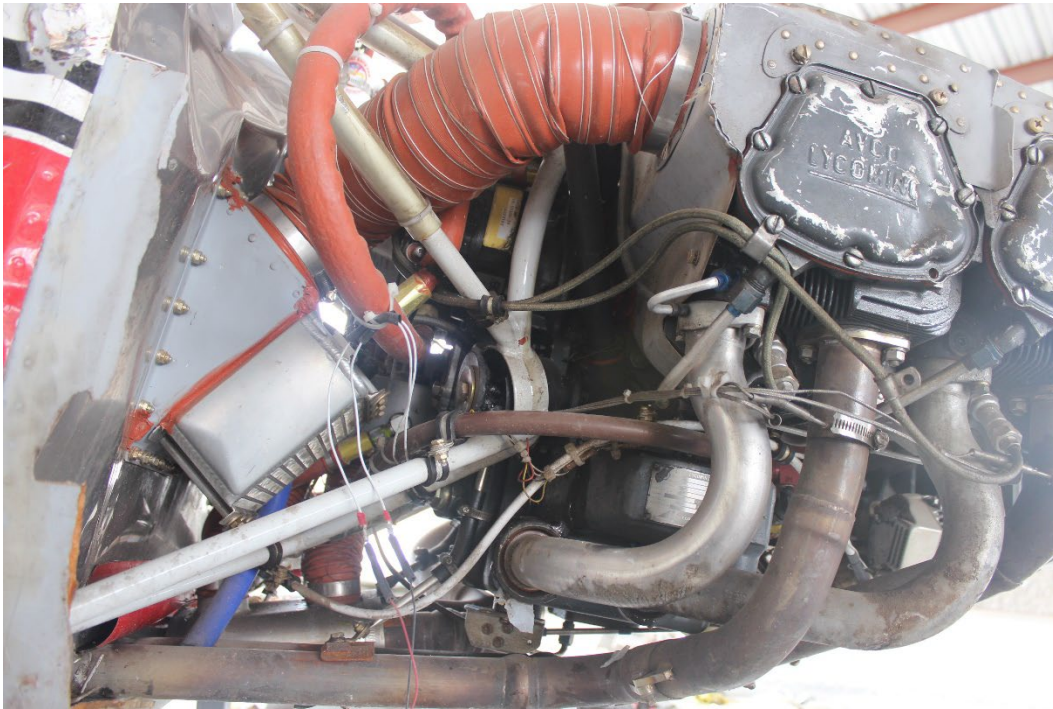
**Figure 12:Accessory Section**

The engine was rotated by hand at the propeller hub. The valves moved accordingly, and drivetrain continuity was established to the accessory section of the engine. In addition, thumb compression was established on all cylinders, and spark was obtained on each ignition lead.

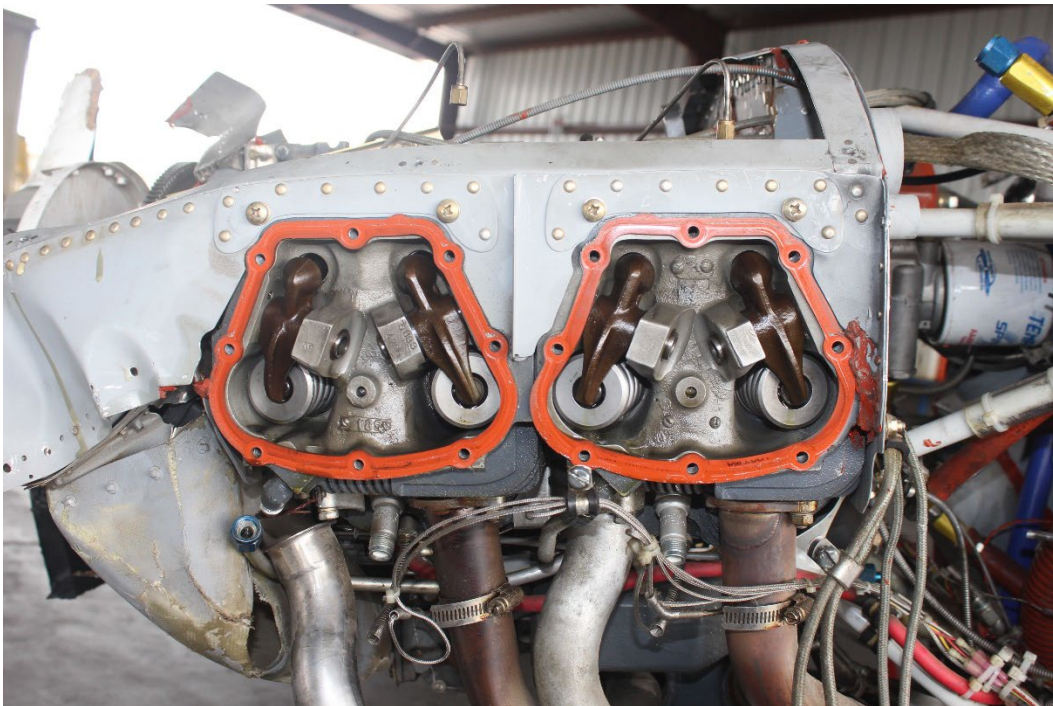
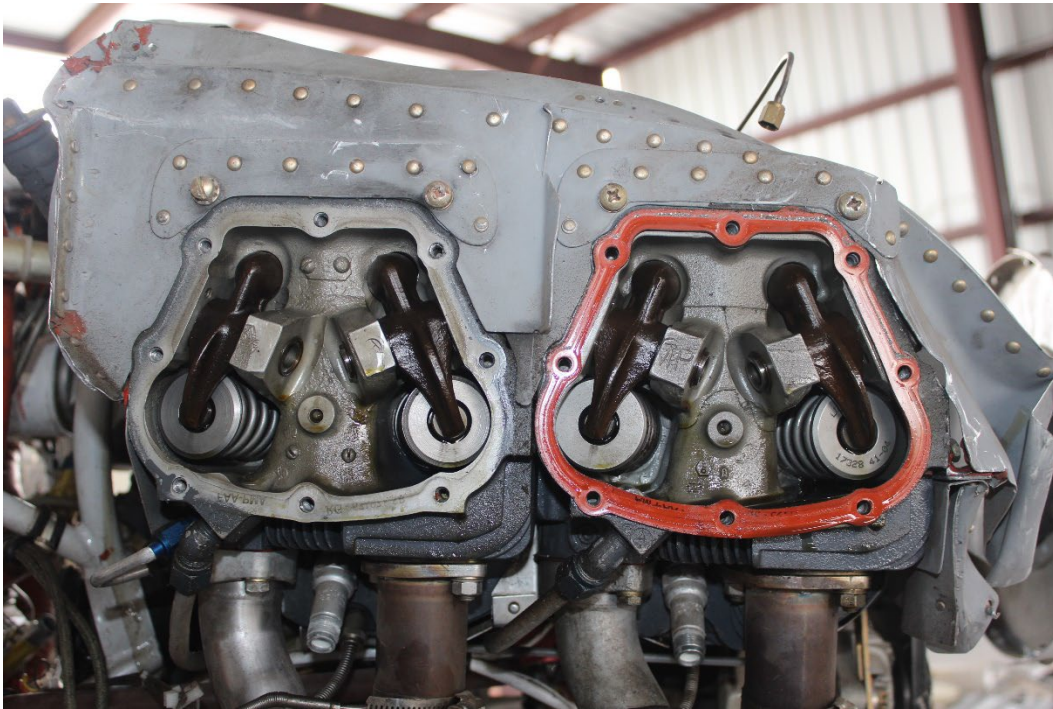
The engine was borescoped; the valves, cylinder walls, and piston heads were all consistent with normal operation. The lower spark plugs were also consistent with normal operations.

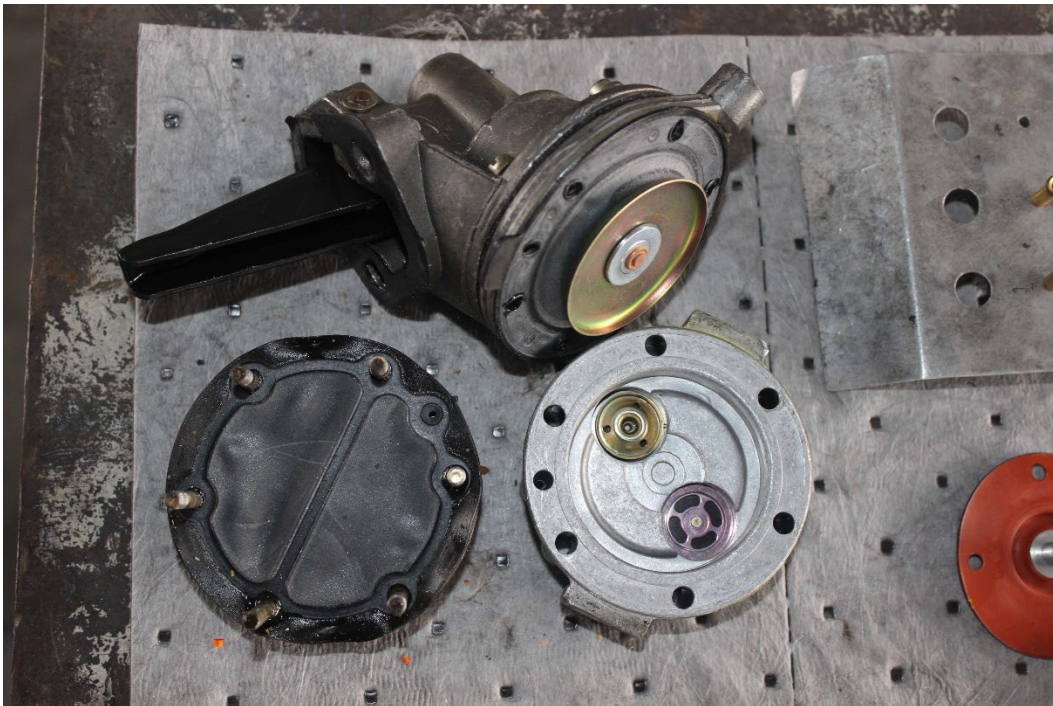
**Figure 15: Fuel Pump**

The fuel divider remained secured on the top of the engine. It was disassembled and no anomalies were noted. The diaphragm remained intact, pliable, and undamaged. Each line remained secured to each nozzle/cylinder. Each nozzle was removed and were free of debris the fuel pump remained attached to the engine and the fuel lines remain secure at their respective fittings the fuel pump was removed and disassembled no anomalies were noted with the internal components.

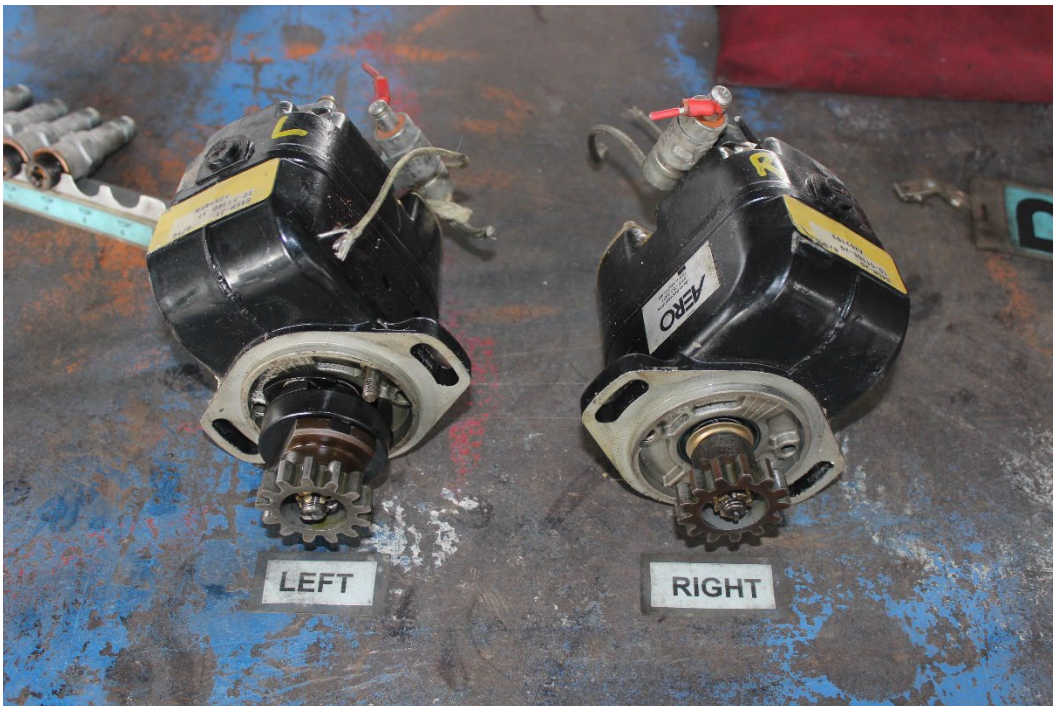
Figure 17: Magnetos

The upper spark plugs were removed and were consistent with normal operations. Both magnetos remained secured to their mounting pads and the ignition harness was secured to each spark plug/cylinder.
