## **NATIONAL TRANSPORTATION SAFETY BOARD**

### **AIRFRAME AND ENGINE EXAMINATION**

**WPR20LA238**

Location: West Jordan, Utah  
Date: July 26, 2020  
Aircraft: PA-32R-300  
NTSB IIC: Fabian Salazar

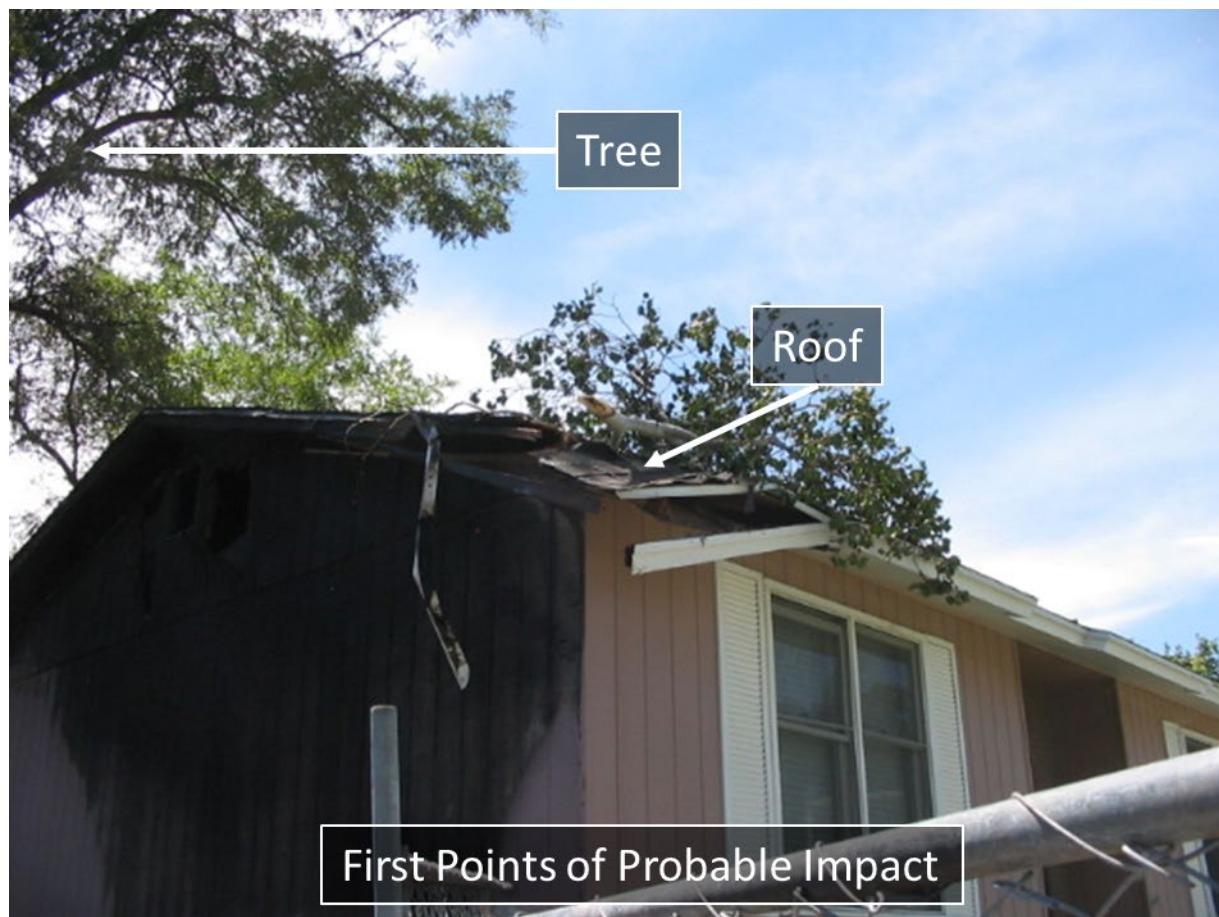
**Airframe Examination.** The airplane came to rest in a back yard of a private residence. The airplane was found resting on its left side. A post-accident fire destroyed much of the airplane. The first point of probable impact was a tree and a roof edge on a house northwest of the main wreckage.

Figure 1. First points of probable impact, a tree, and a roof. Photo courtesy of Piper Aircraft.

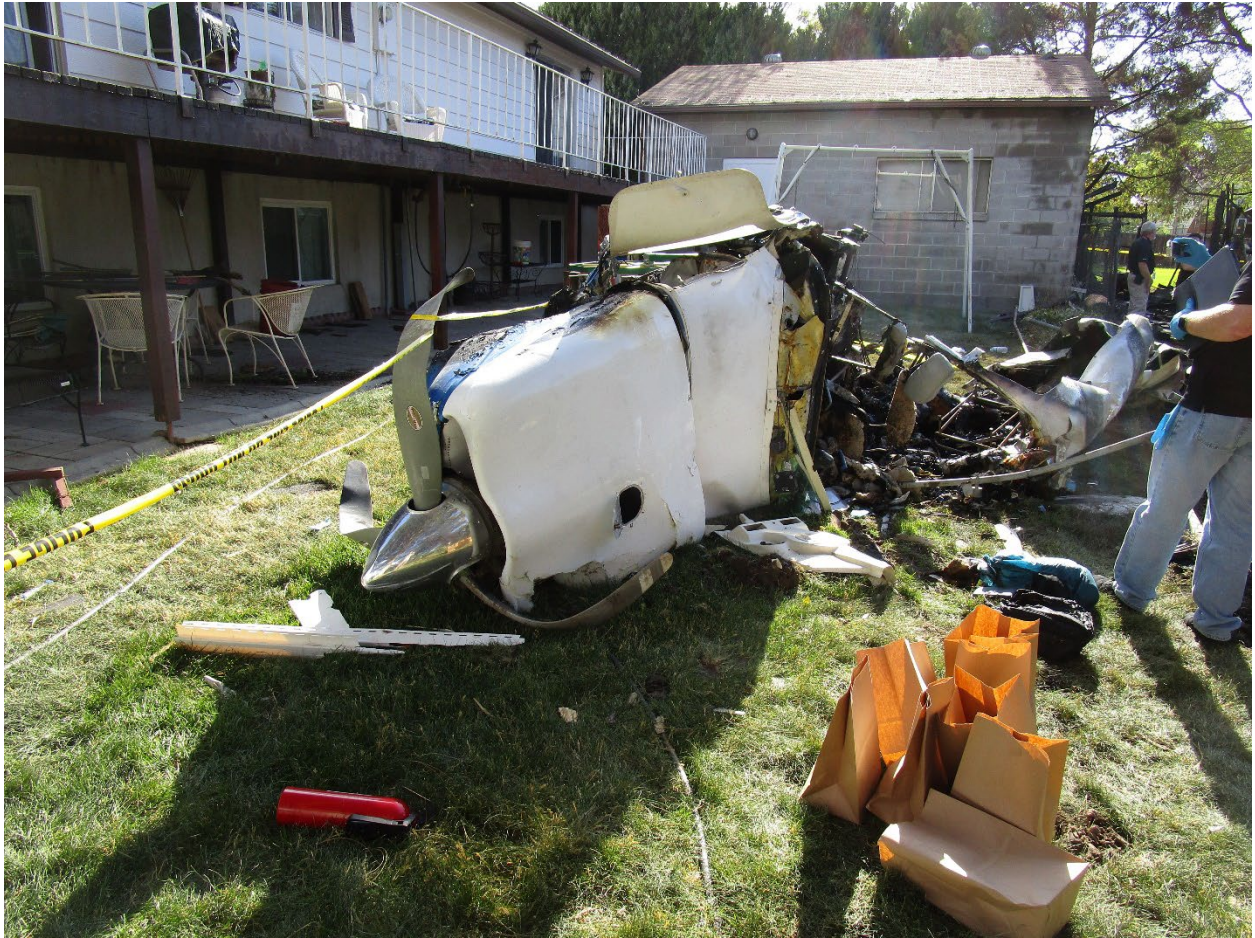
Figure 2. Front-top view of N7677C at accident site. Photo courtesy of Piper Aircraft.

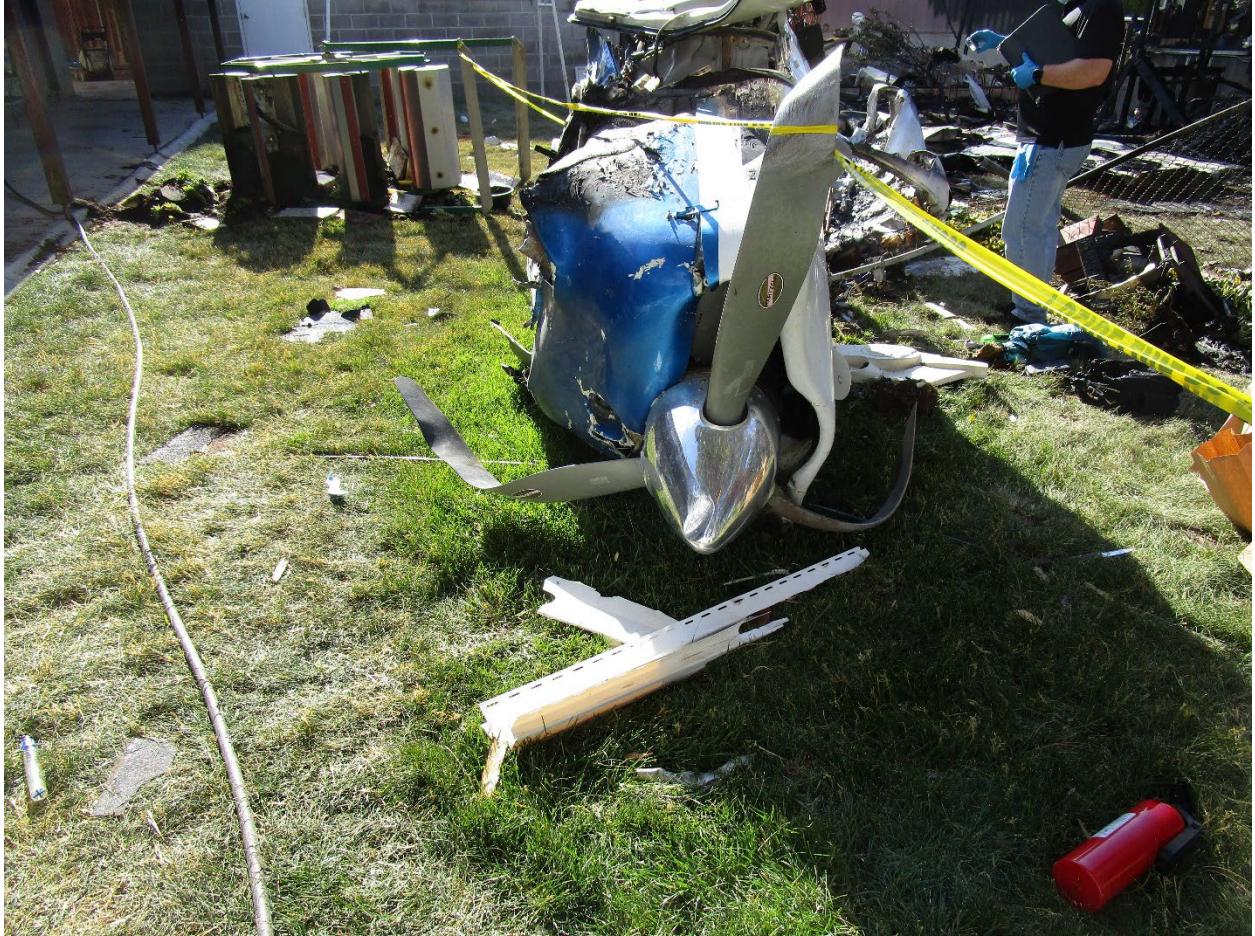
Figure 3. Front lower view. Photo courtesy of Piper Aircraft.

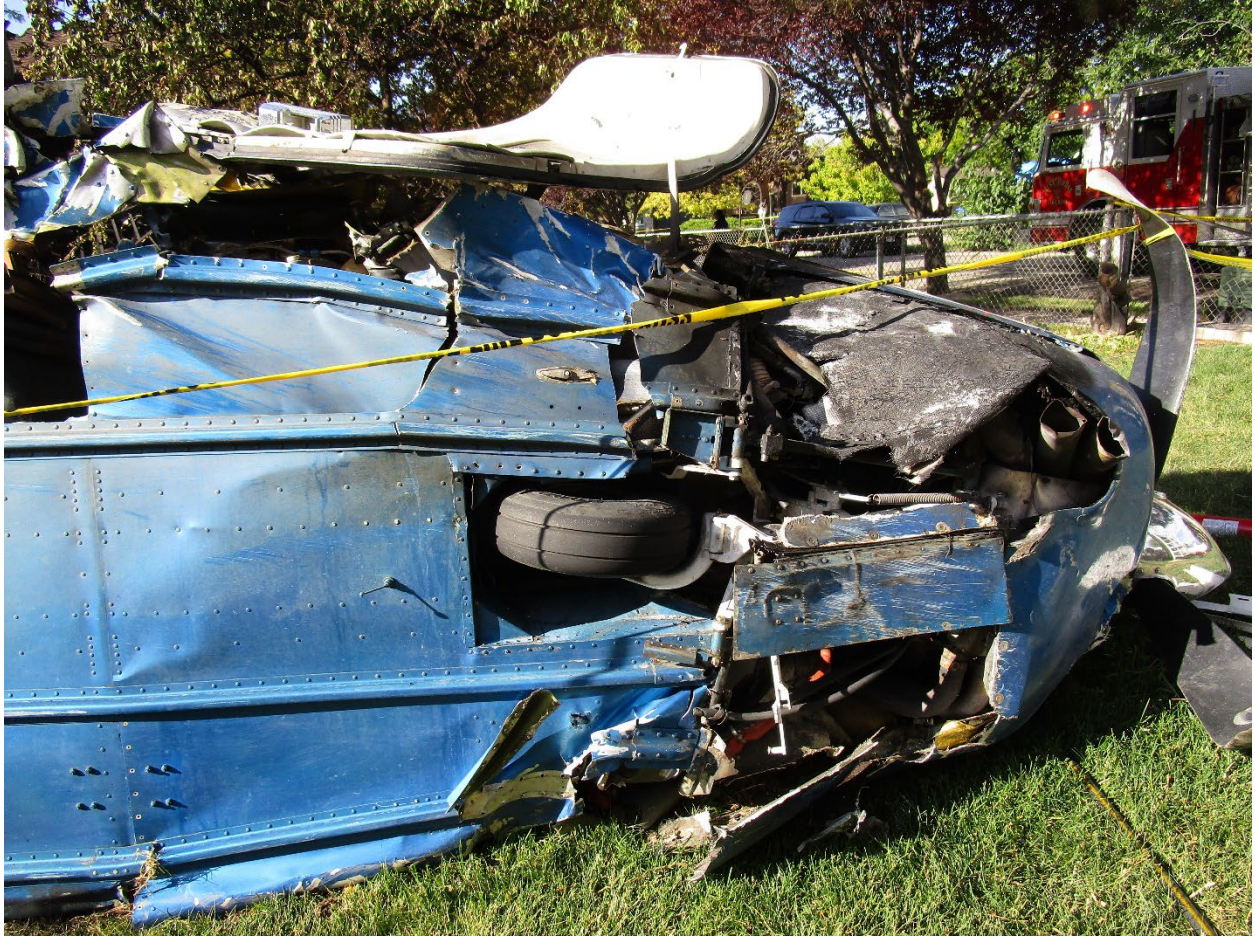
Figure 4. Underside view. Photo courtesy of Piper Aircraft.

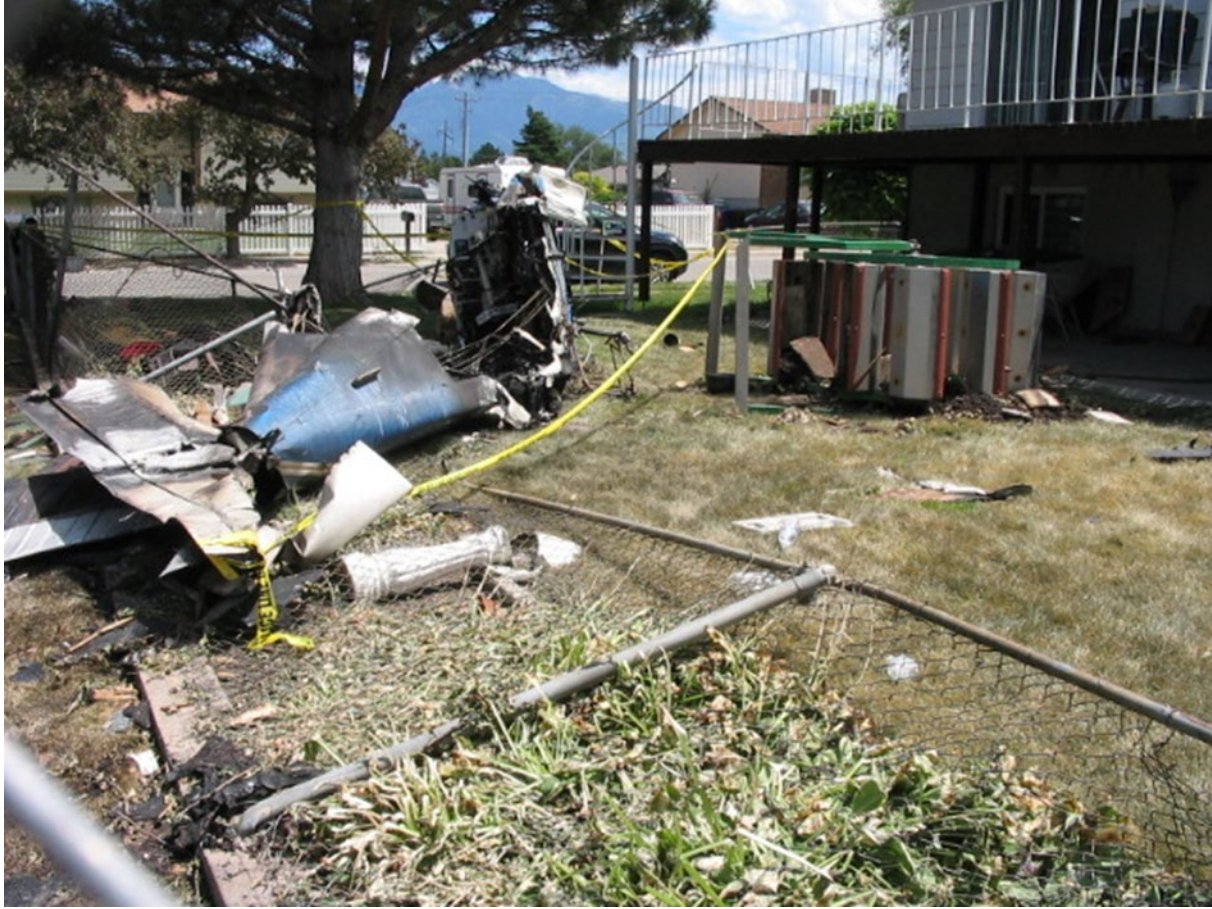
Figure 5. Rear view. Photo courtesy of Piper Aircraft.

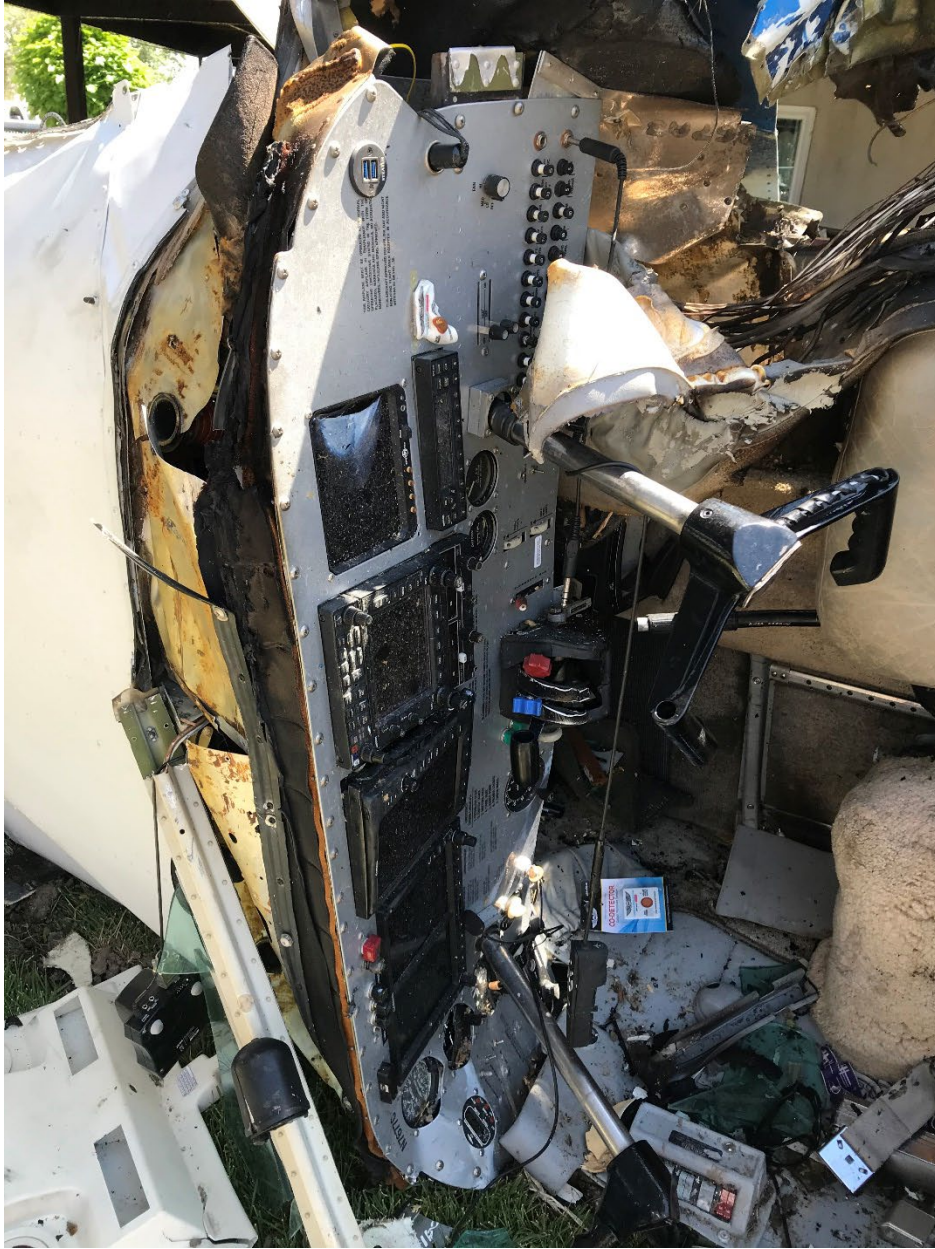
Battery/alternator: Off  
Electric fuel pump: On  
Strobes: On  
Landing light: On  
Pitot heat: Off  
Avionics master switch: On  
Autopilot: Off  
Electric trim: Off  
Magneto switch: Off  
Cabin fan: Off  
Throttle quadrant: Throttle: forward/open, Mixture: forward/rich, propeller: forward/high  
Hobbs meter: 3107.3 hours  
Airspeed indicator: Missing the dial. No witness marks.  
Attitude indicator: about 25°nose down and about 45°left turn.  
Altimeter: 950 ft msl, 30.10" hg  
Landing gear handle: Up  
Most circuit breakers were open/out  
Flap handle: 10°/first notch

Figure 6. Cockpit view, showing the throttle quadrant and the flap handle. Photo courtesy of Piper Aircraft.

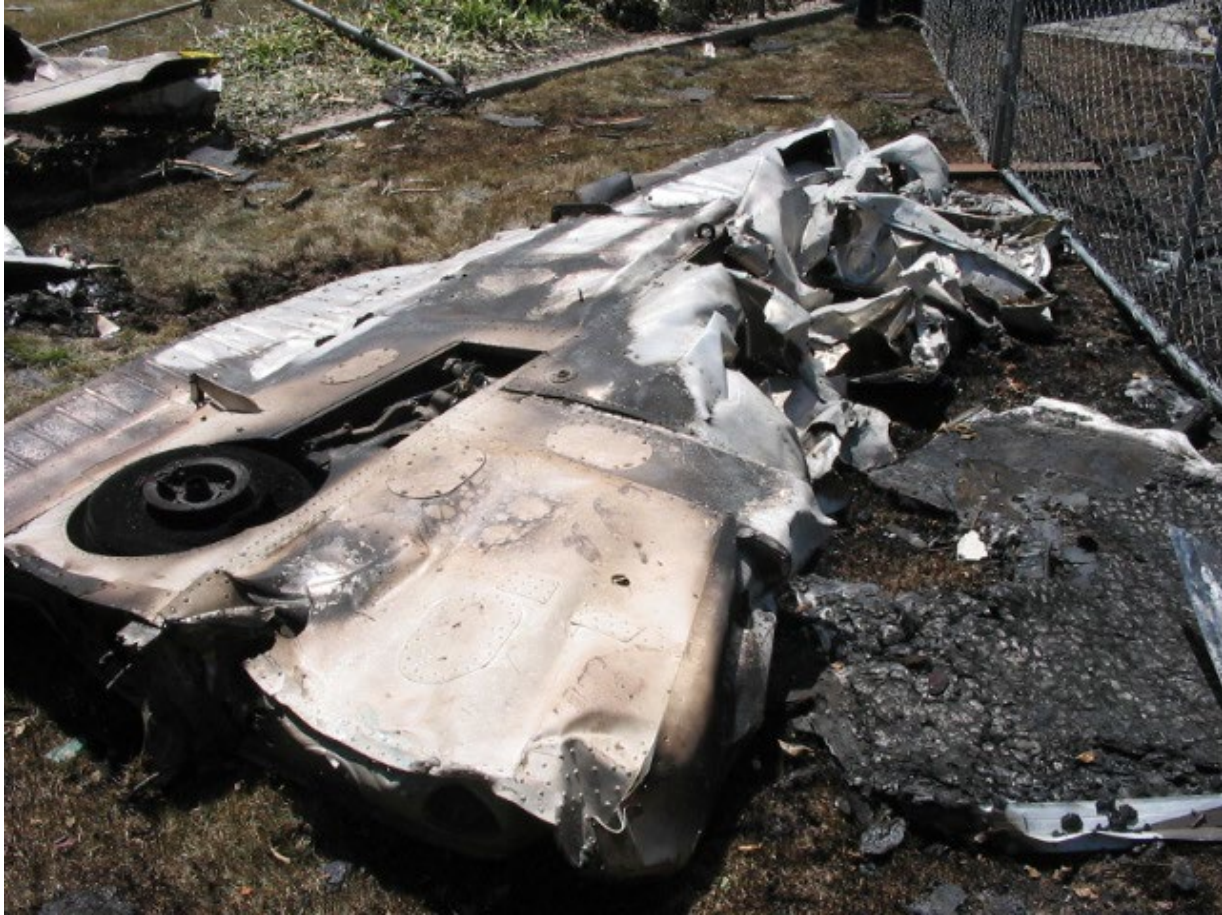
The right wing separated from the fuselage at the root and was in the wreckage area about 30 feet from the main wreckage. The right wing was thermally damaged throughout with the most thermal damage near the mid-section outboard. The aileron remained to the wing at the mounts. The aileron control cables remained attached to the aileron bellcrank and exhibited broomstraw separation at the wing root. The flap remained attached to the wing and the position could not be determined. The right main landing gear remained attached to the wing and appeared in the up/retracted position. The fuel cap was secured in the receptacle.

Figure 7. Underside of the right wing, showing leading edge, landing gear, and flap. Photo courtesy of Piper Aircraft.

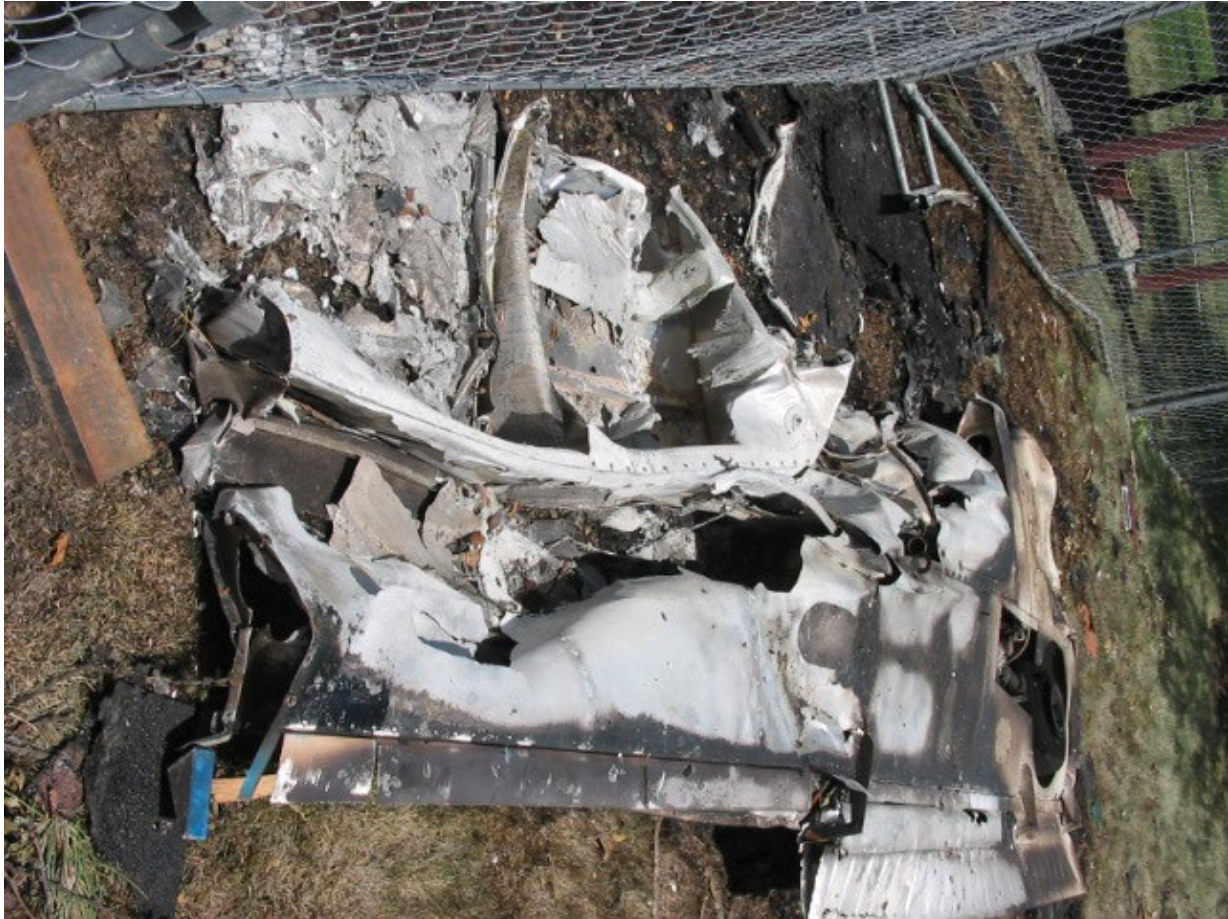
Figure 8. Under side of the right wing, showing the flap. Photo courtesy of Piper Aircraft.

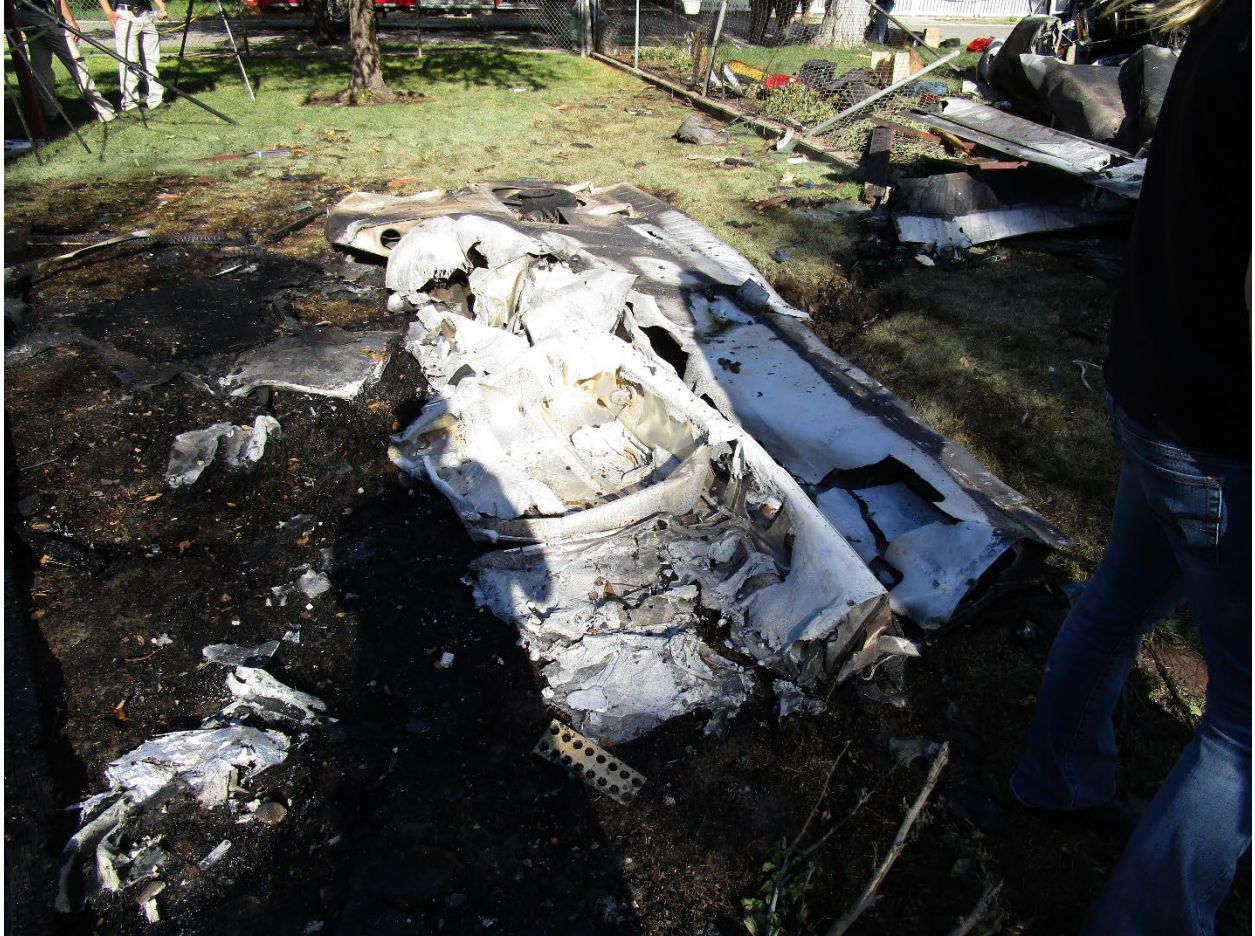
Figure 9. Right wing, as seen from the wing tip. Photo courtesy of Piper Aircraft.

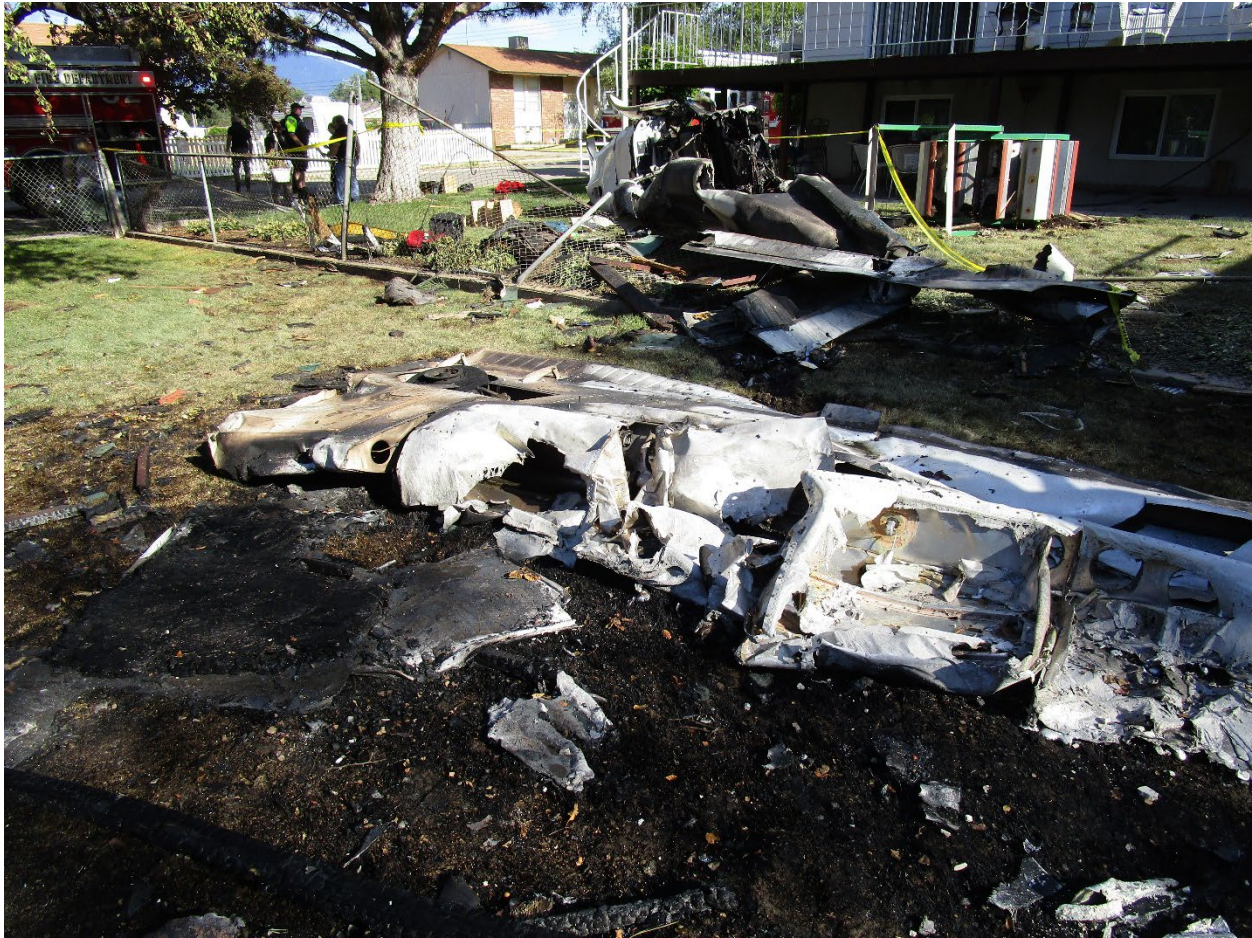
Figure 10. Right wing and rear-view of the empennage. Photo courtesy of Piper Aircraft.

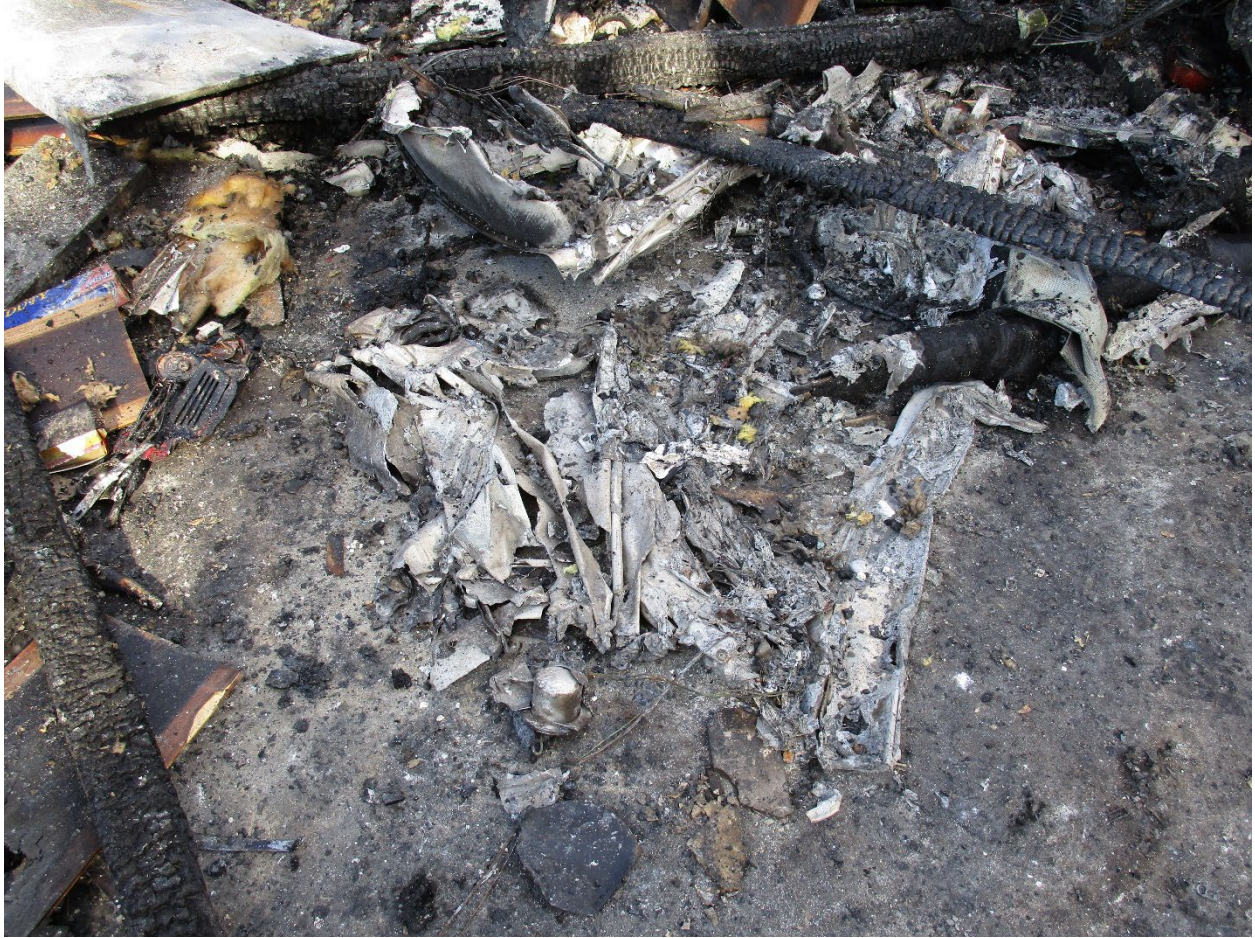
The left wing separated from the fuselage at the root and was thermally destroyed. The wing was located about 40 feet from the initial tree contact. The landing gear was in the up position. The aileron and flap were thermally destroyed. The aileron control cable remained attached to the bellcrank and was separated at the wing root. The aileron control cables exhibited a broomstraw appearance.

Figure 11. Left wing. Photo courtesy of Piper Aircraft.

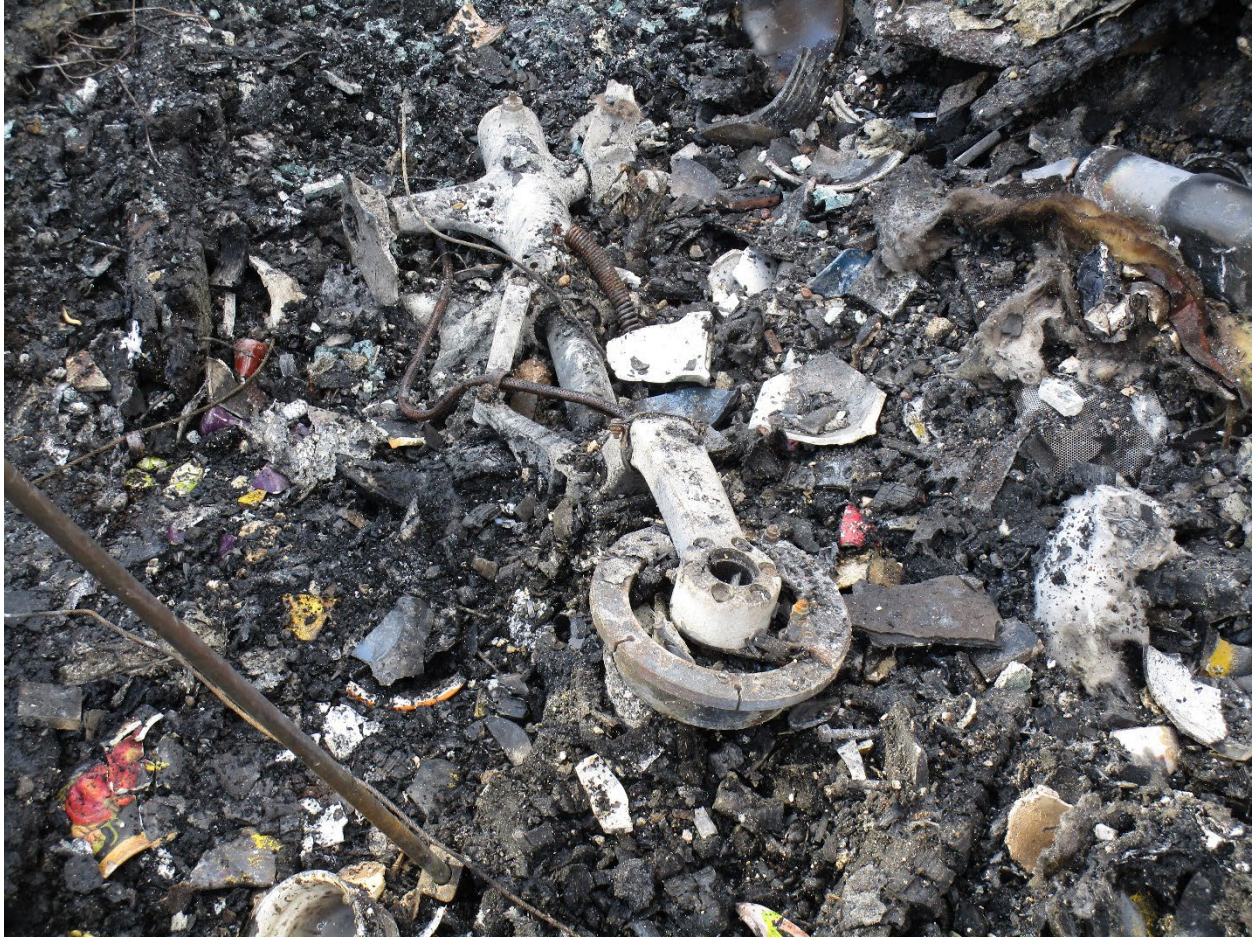
Figure 12. Left main landing wheel brake assembly. Photo courtesy of Piper Aircraft.

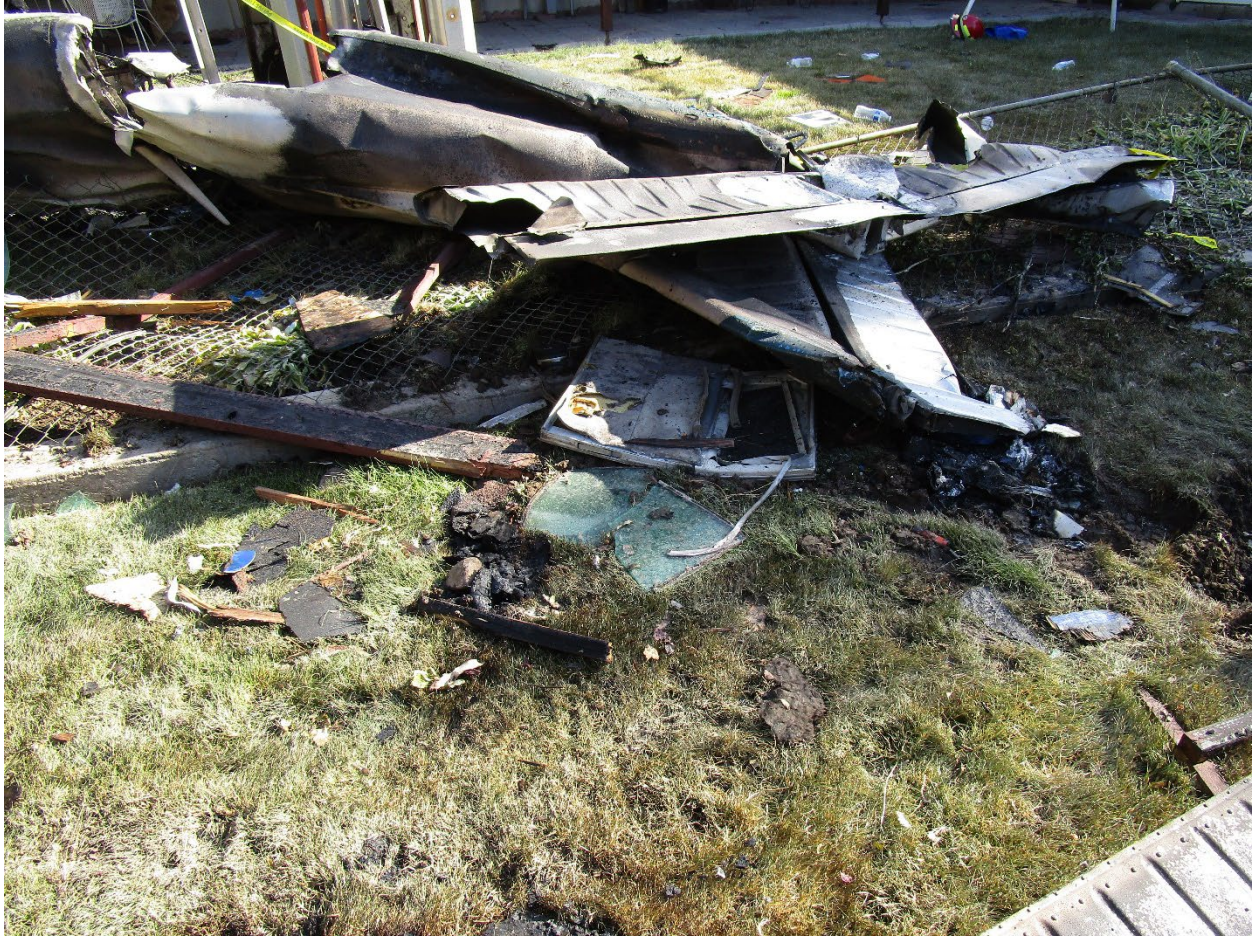
Empennage. The vertical stabilizer remained attached to the fuselage and was thermally damaged. The rudder remained attached to the vertical stabilizer and was thermally damaged. The rudder control cables remained attached to the rudder and continued to the rudder pedals. The stabilator remained attached to the fuselage and exhibited damage to the mount. Damage to the leading edge was noted. The stabilator control cables remained attached to the balance weight mast and continued to the T-bar. The trim barrel exhibited nine threads, consistent with a

Figure 13. Rear view of the empennage. Photo courtesy of Piper Aircraft.

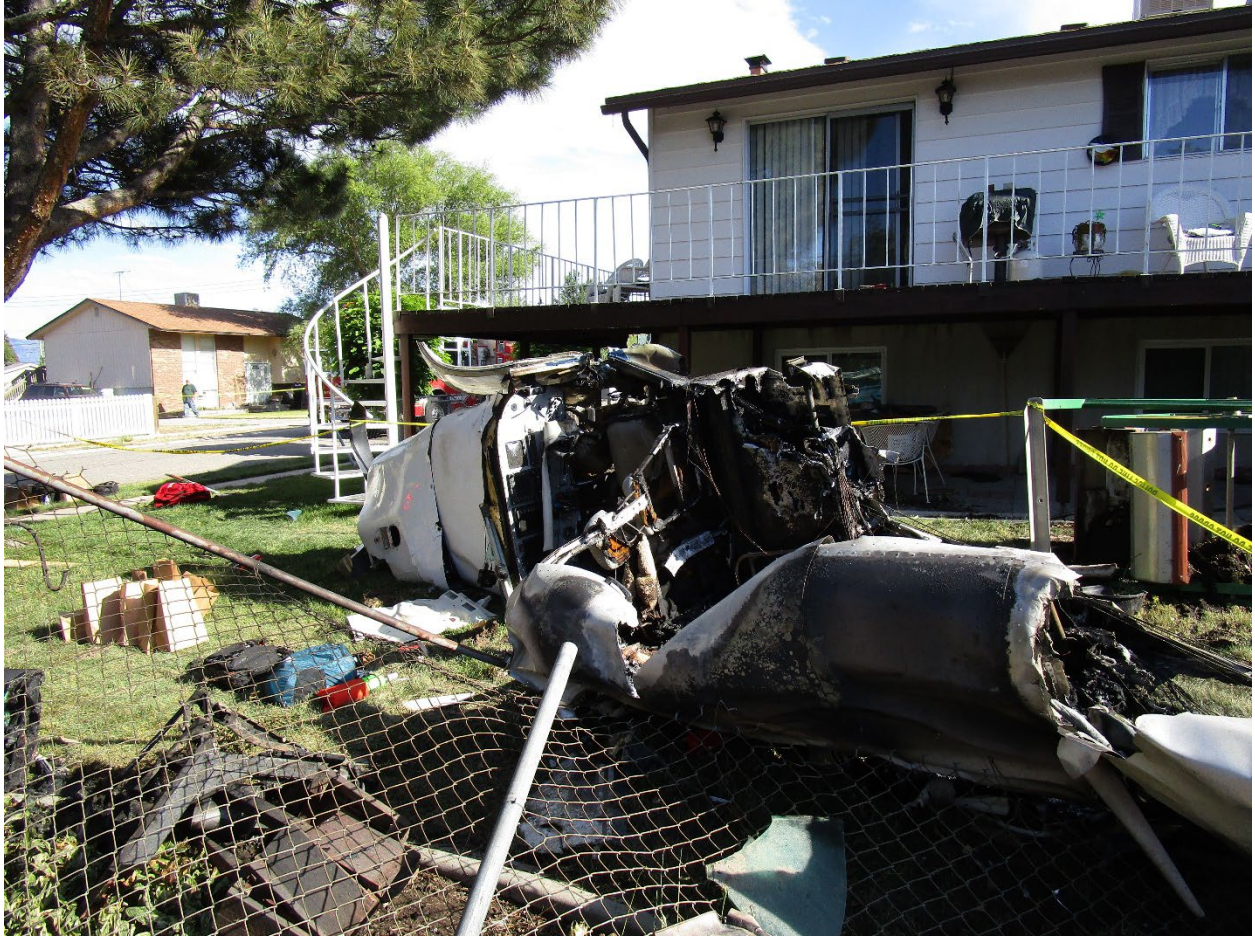
Figure 14. Rear view of the top-side of the airplane. Photo courtesy of Piper Aircraft..

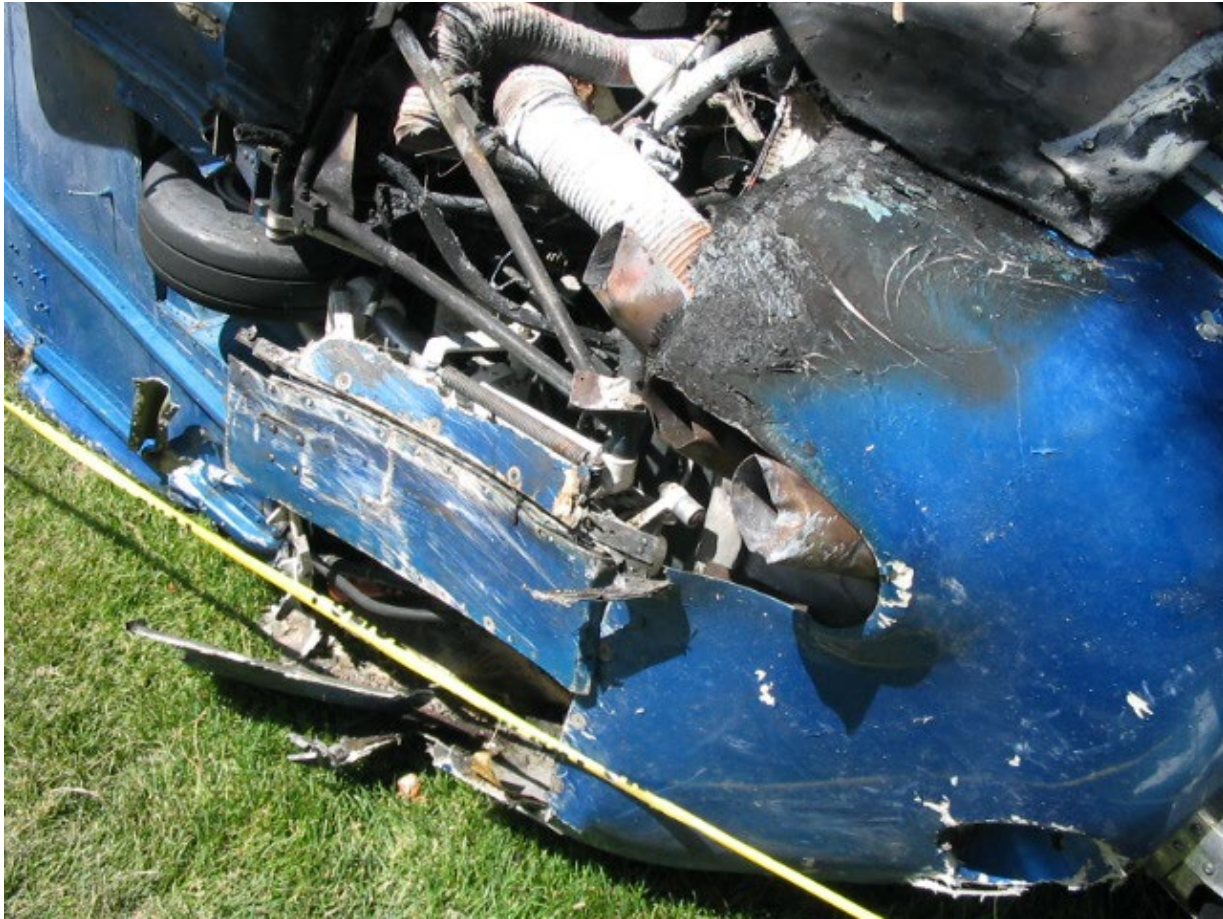
Figure 15. Underside view, showing the retracted nose landing gear. Photo courtesy of Piper Aircraft.

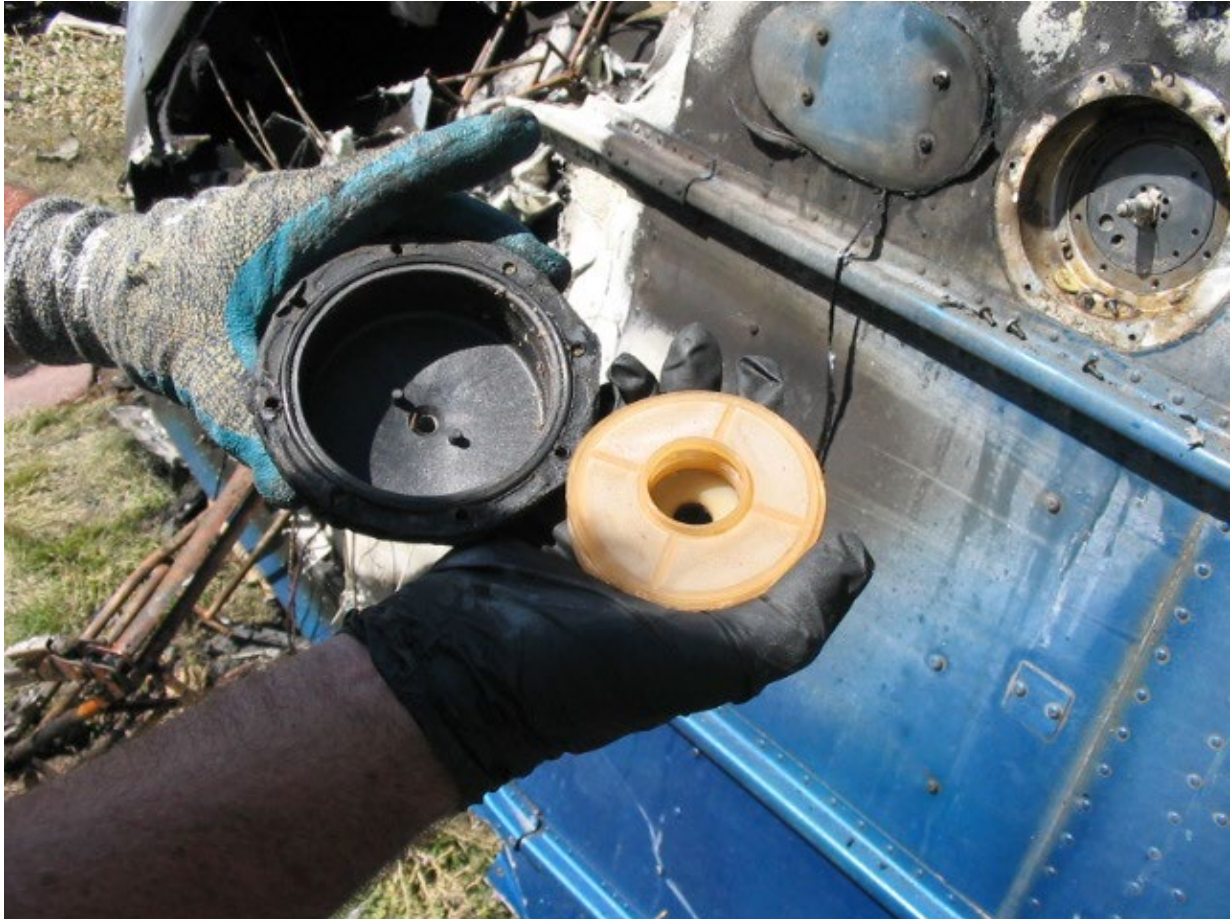
The injector inlet and the main fuel strainer were clear of contaminants. The flow divider exhibited no fuel evidence, and the diaphragm was intact. Fuel injector lines were secure. The fuel servo remained attached to the plenum. The serrated interface at the throttle and mixture arm remained secure. The fuel servo inlet screen was properly installed and contamination free. The fuel servo and induction system were free of obstruction.

Figure 16. Fuel filter screen. Photo courtesy of Piper Aircraft.

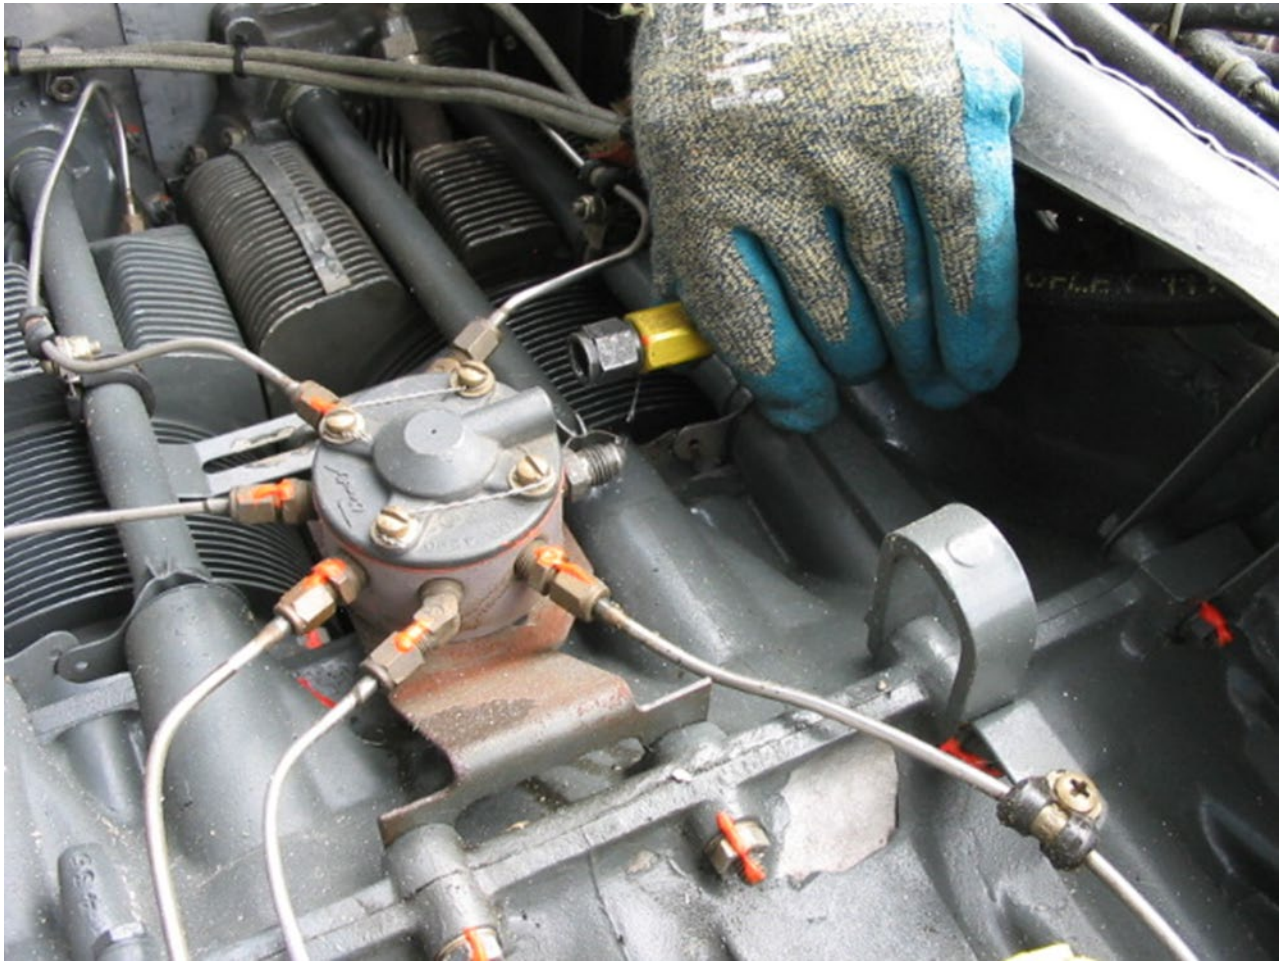
The fuel flow divider remained attached to its mount. The fuel lines remained secure at each fitting and fuel injector on each cylinder. There was no evidence of any internal malfunction or obstruction. The diaphragm was soft and pliable. The fuel pump remained attached to the engine at the mount. The fuel lines remained secured at their fittings. The fuel pump remained free of internal mechanical failure and obstruction.

Figure 17. Fuel flow divider. Photo courtesy of the Piper Aircraft.
