Tealeye Cornejo  
Air Safety Investigator (Field)  
AS-WPR

**Subject:** WPR20LA244; Airbus Field Report

**Contact:** Seth Buttner; Sr. Manager, Accident Investigations, Airbus Helicopters

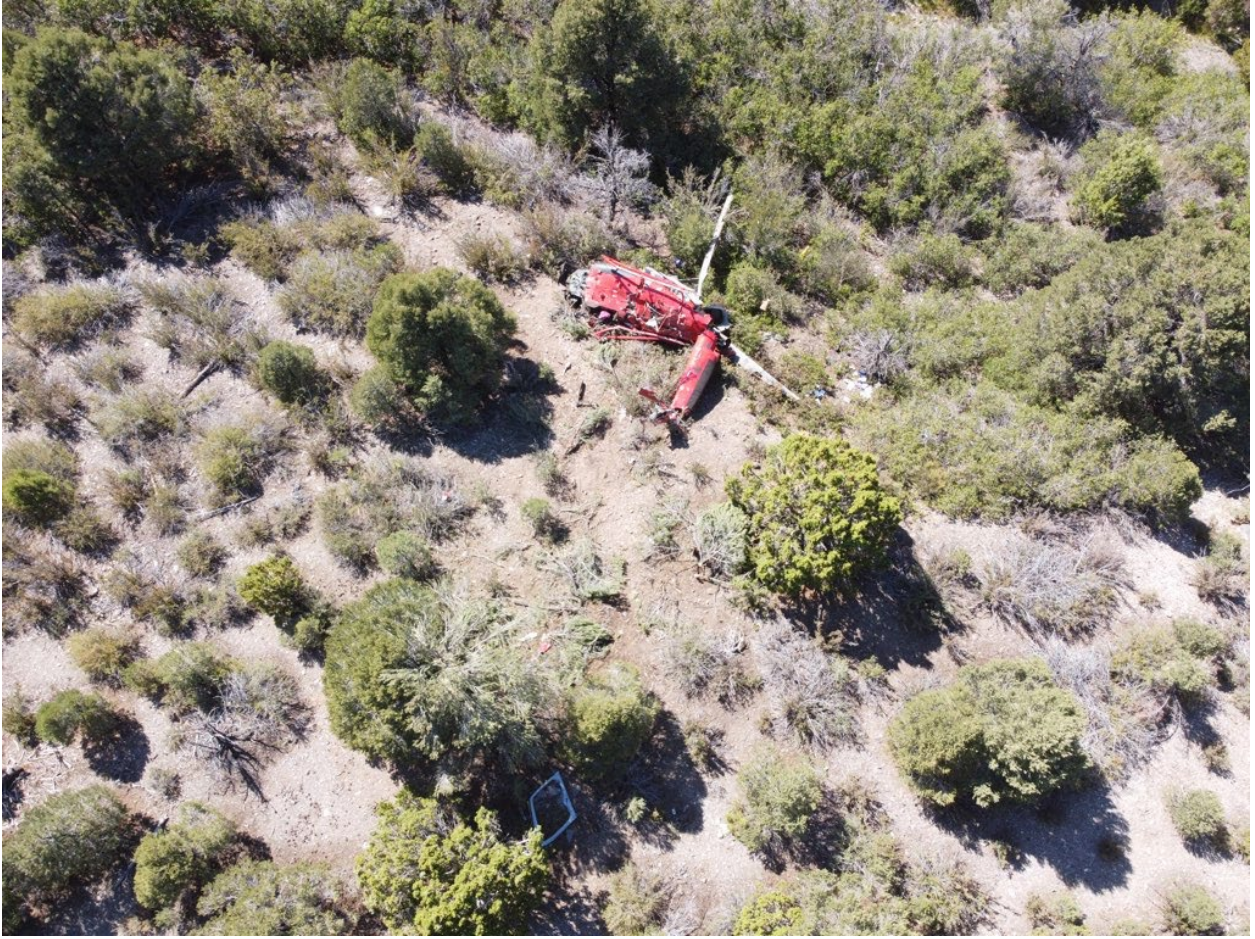
Photo 1 – Aerial View of Accident Site

The helicopter came to rest in the forested terrain on its right side, with the nose of the aircraft facing west (from the direction the aircraft departed from). The forward windshield and cabin area was broken open from the impact with the ground. The right-side landing gear skid was damaged/broken, and the right-side cabin floor area was crushed up. Each door was broken off from impact damage and separated from the main wreckage.

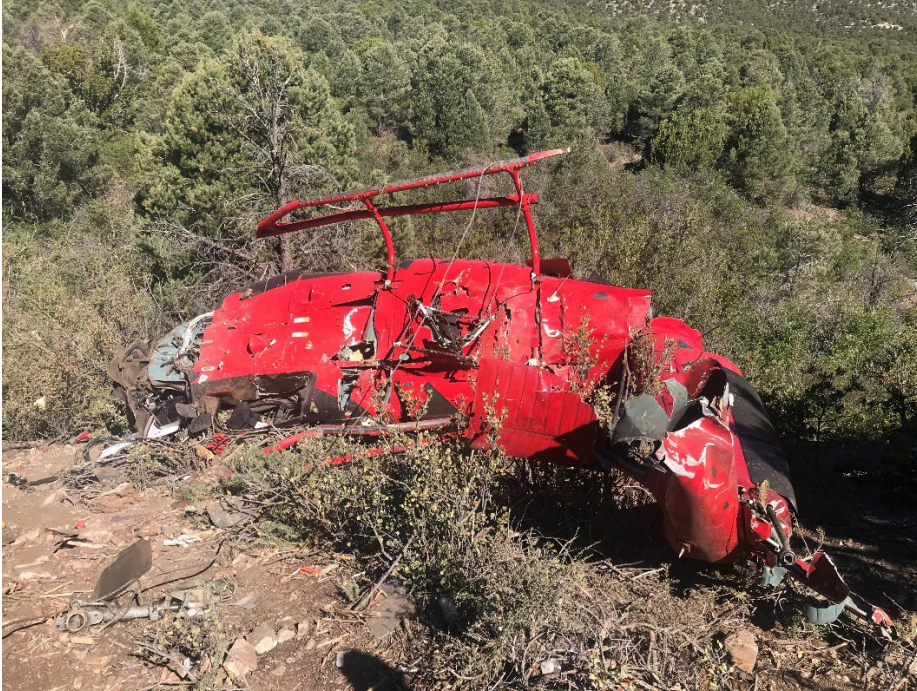
Photo 2 – Close up View of Undercarriage Note Long Line Cable wrapped around the upper skid

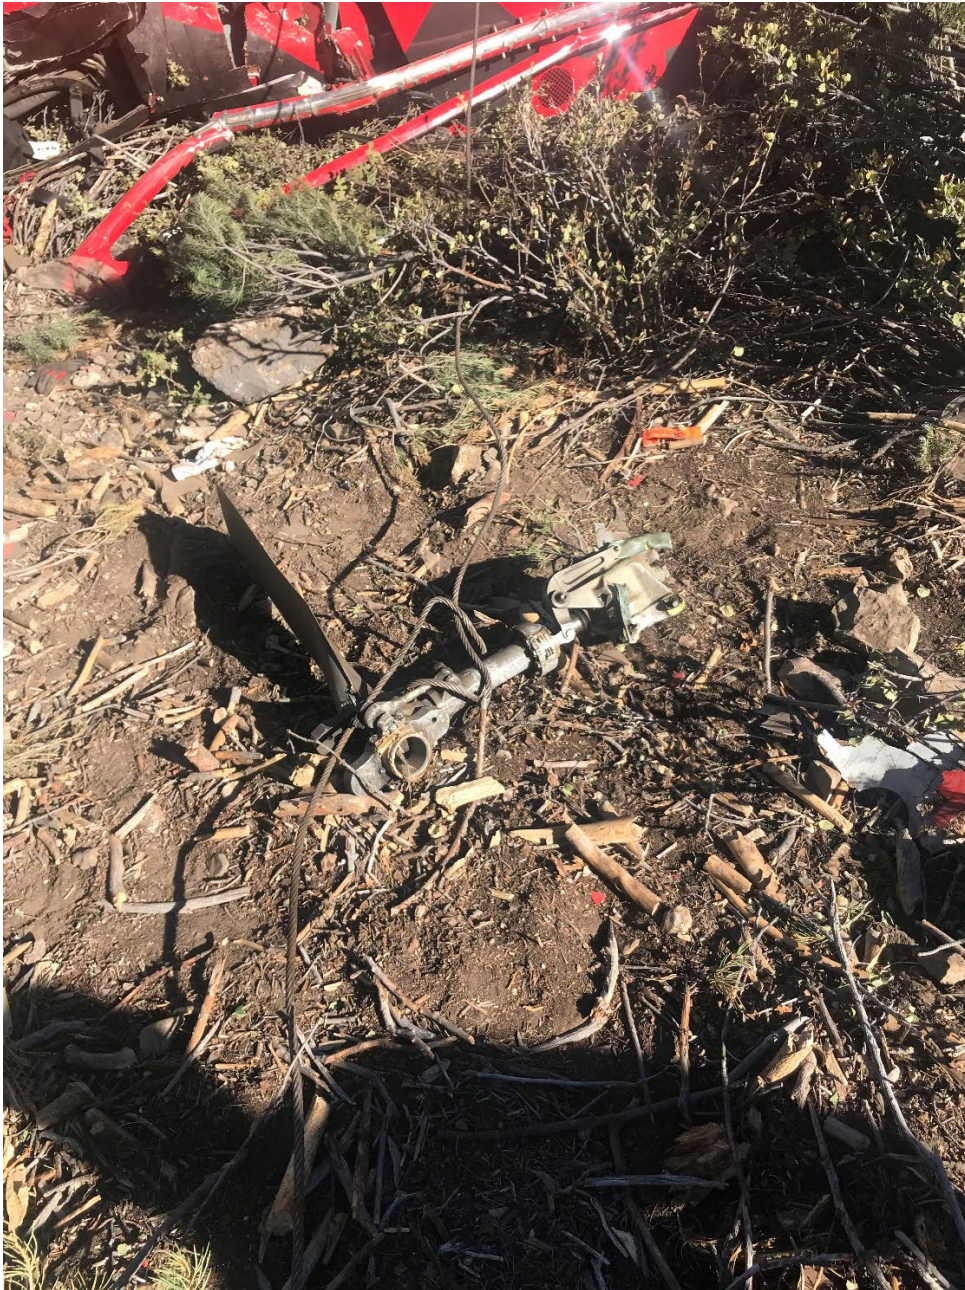
Approximately 21 ft of steel long line cable impacted the main rotor blades and was found entangled in the separated tail rotor system. The tail rotor had one blade attached the other broken off and not found. Approximately 30 ft. of long line and one tail rotor blade were not located. The cable end that was separated exhibited broom strawed broken ends, and some red paint transfer on cable.

Photo 4 - Long Line wrapped around Tail Rotor

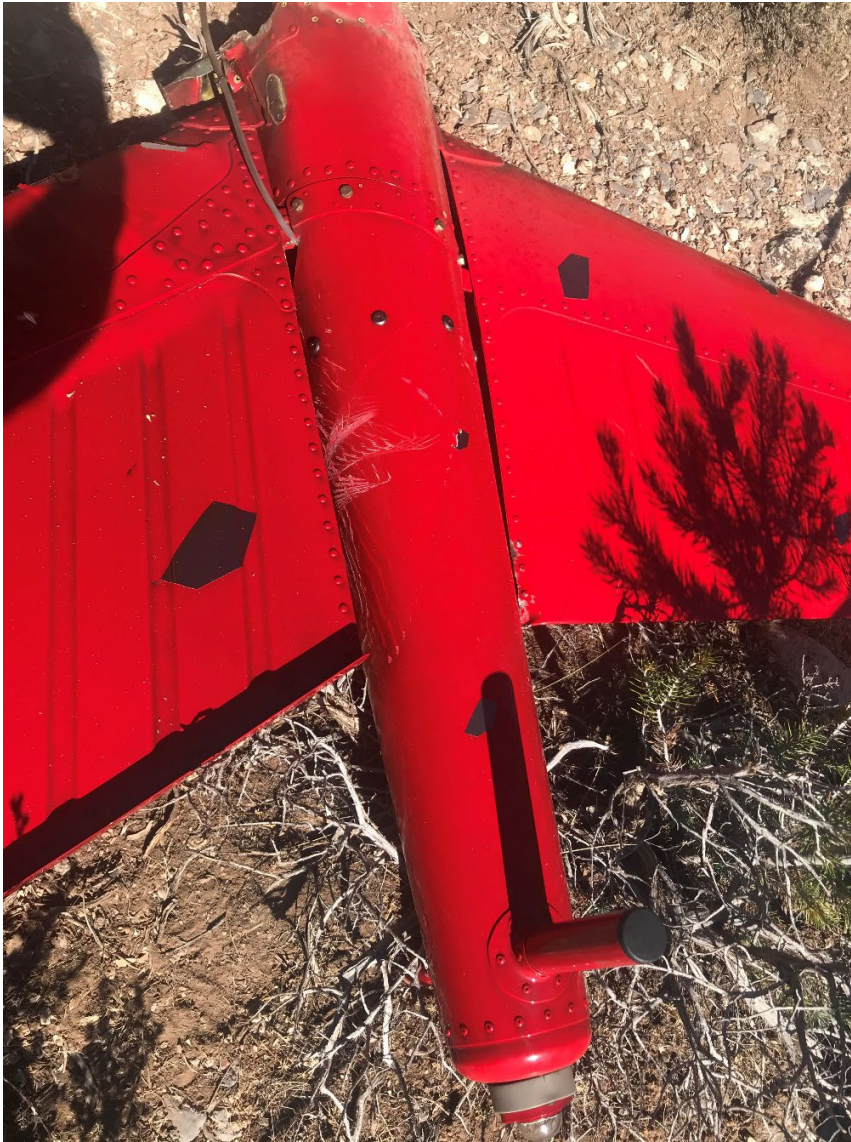
The aft tail-cone was separated just forward of and with the vertical and ventral fin still attached and found the furthest south of the wreckage debris path (the tail cone and the vertical fin trailing edge exhibited cable braiding indication marks). The vertical stabilizers were approximately 365 ft. from the main wreckage.

Photo 5 Vertical Fin Note cable braiding signatures on the left side

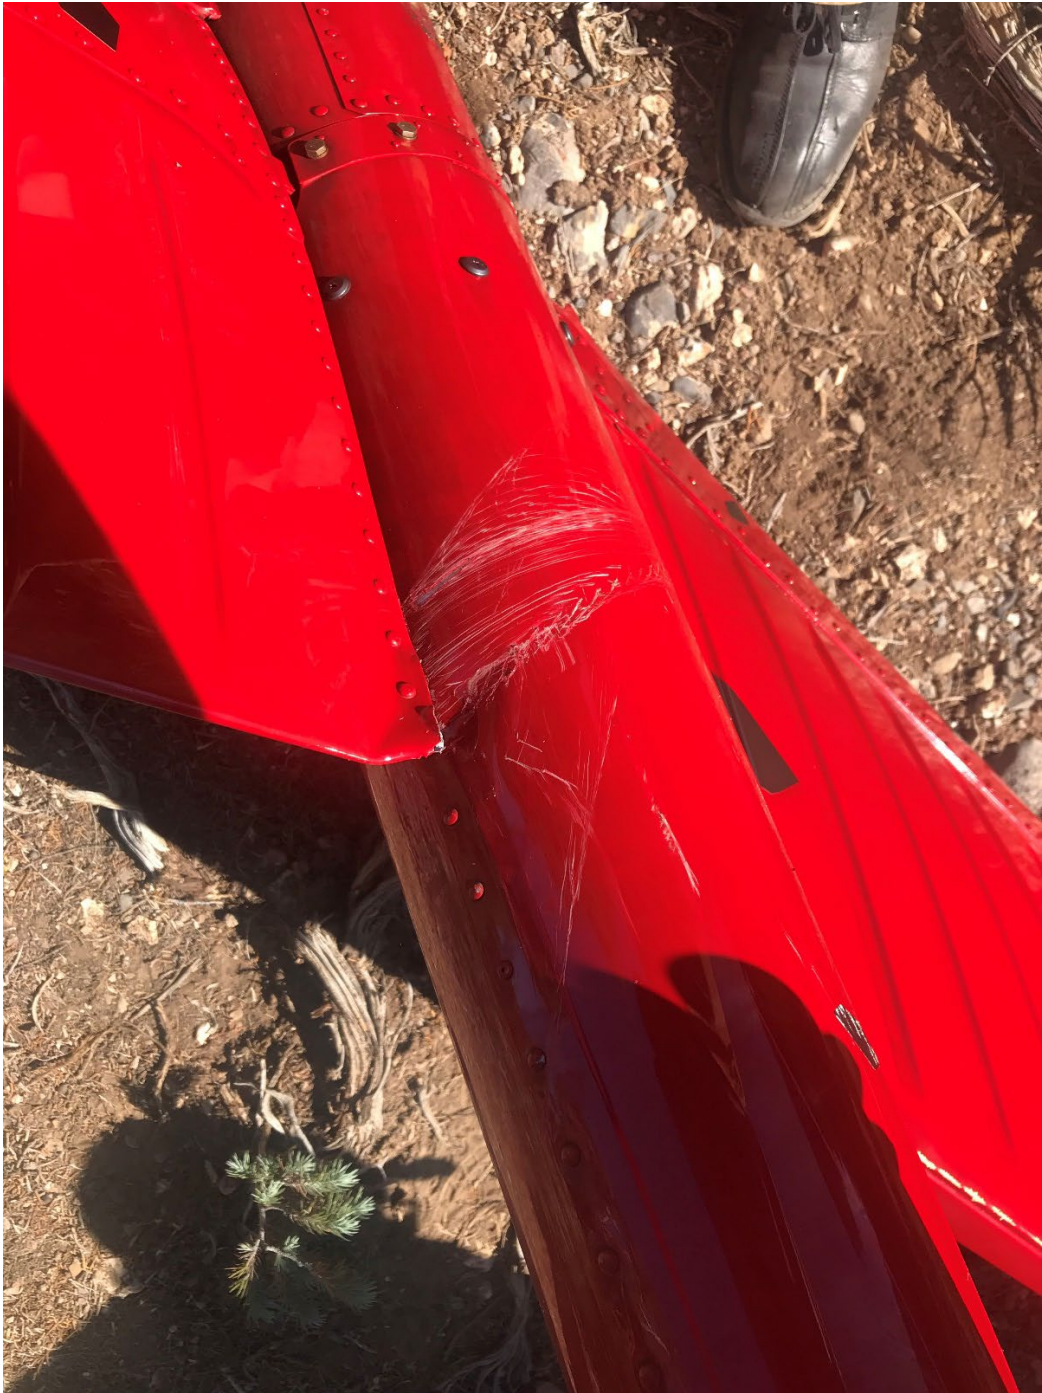
Photo 6 Close up View of the Cable Braiding Signatures

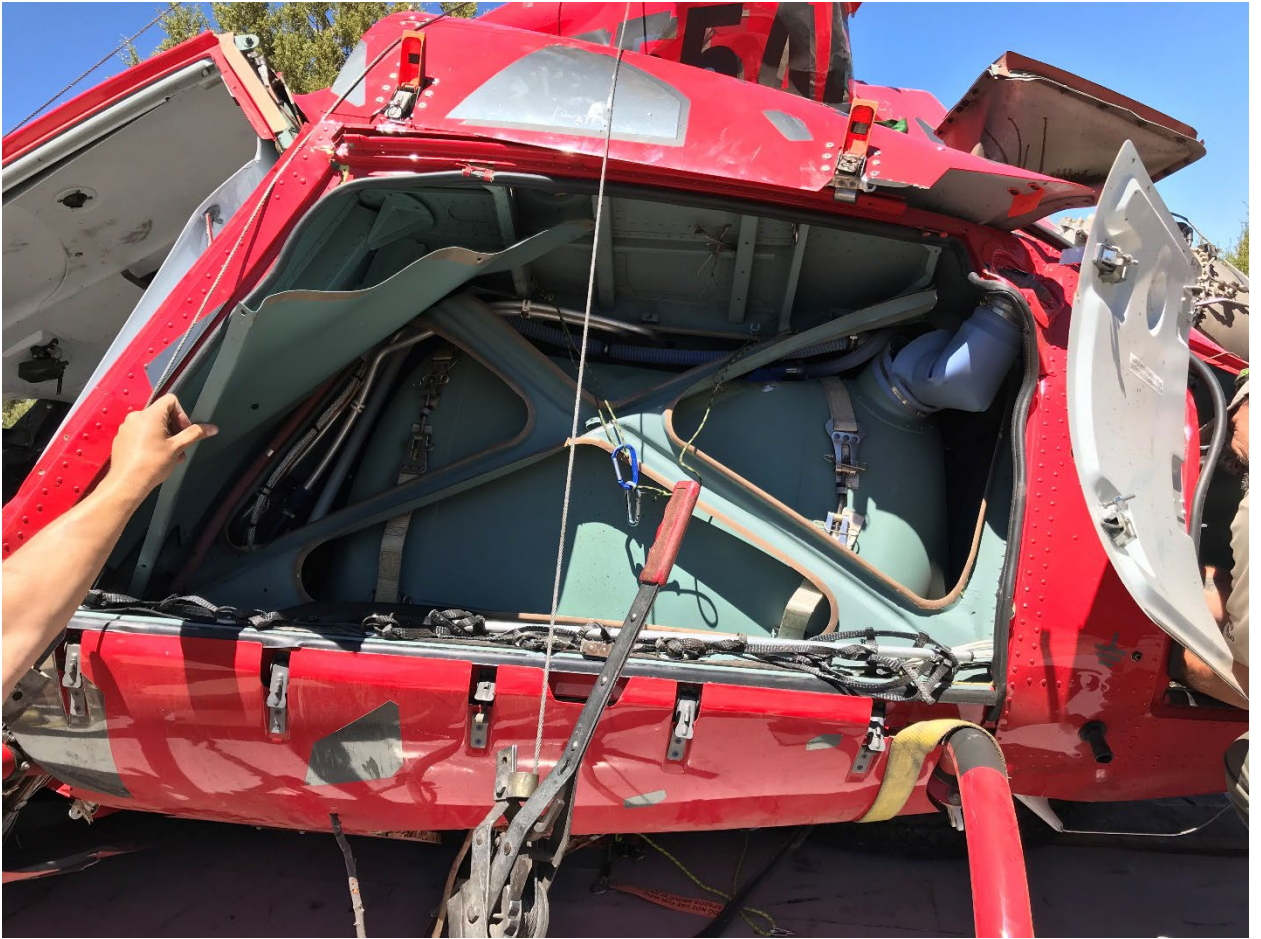
Photo 7 View of Fuel Tank

The aircraft was equipped with a CRFS, which exhibited some impact damage, but this investigator did not smell fuel at the mishap site and did not notice any fuel leaking.
