## EXAMINATION

The initial examination revealed a disconnect of the compressor rotor from the N1 drive train. A complete engine teardown followed.

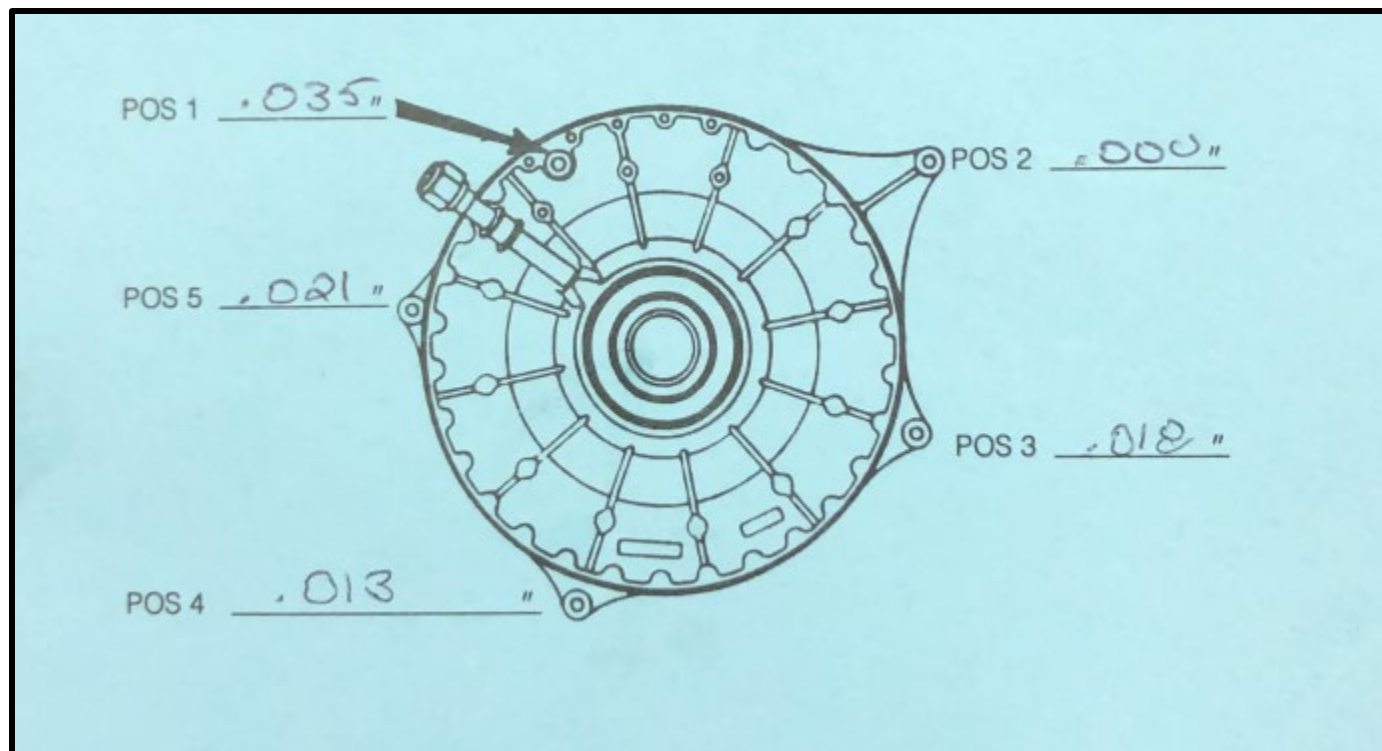
Figure 2: Shims as Measured at Examination

The rear compressor diffuser shims at teardown were found to not match the shims that should have been in place according to the last compressor overhaul records. According to the overhaul records, two of the shims recorded at teardown were each off by 0.02 inch. Based on these findings the investigation concluded that the engine was operating in a misaligned condition that was not permitted by the overhaul manual.

Removal of the compressor also revealed an unusual number of shims present on the compressor to- accessor gearbox mounts. Per the Rolls-Royce Maintenance Manual, a maximum of 0.020" of shimming is permissible on any single mount. One mount was found to have 0.036" shim, while another mount had 0.022" shim. There was no record of shimming in the engine's log book. A standard "shim card" is included in all Rolls-Royce M250 engine log books. It is standard practice to record the compressor's shimming during module installation.

Additionally, the compressor shim thickness on the pads that mate together the gearbox and compressor noted during the engine teardown was found non-conforming. Per the OMM alignment build procedures, the total thickness of shims at any one location must not exceed 0.020 inch. Shimming of the compressor assembly provides correct alignment of the compressor rotor and the gas producer turbine rotor. As the height of the mounting pads varies, the angle of the compressor relative to the gearbox also changes; this change in angle changes the alignment of the engine. The alignment build procedures in the OMM must be followed to prevent misalignment conditions.

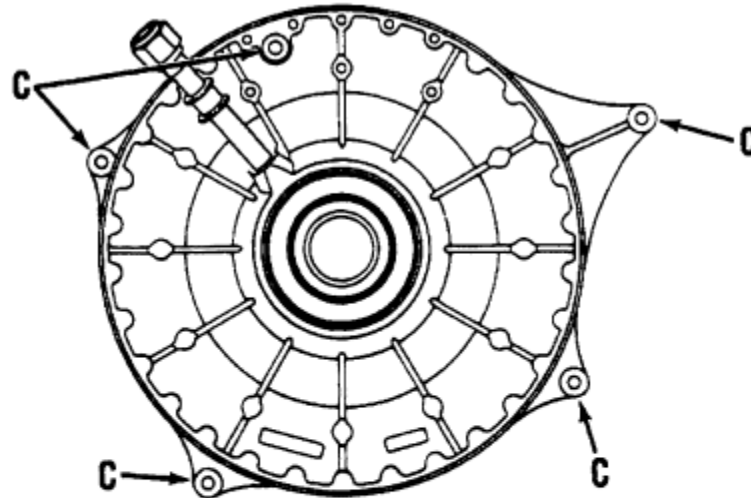
MEASURE SQUARENESS OF DIFFUSER PADS MARKED **C** WITH RELATION TO ROTOR AXIS. ELECTROCHEMICAL ETCH (AS478-7A1) THE THICKNESS OF SHIMS REQUIRED AT EACH BOLT HOLE FOR COMPRESSOR INSTALLATION AND COAT ETCHED AREA WITH METCOSEAL.

NOTE: THE TOTAL THICKNESS OF SHIMS AT ANY ONE LOCATION SHALL NOT EXCEED 0.020 IN.(0.51 mm).
