# NATIONAL TRANSPORTATION SAFETY BOARD

## MATERIALS LABORATORY FACTUAL REPORT

Report No. 21-003

Place : Salem, Oregon  
Date : June 4, 2020  
Vehicle : Piper PA-30, N8244Y  
NTSB No. : WPR20LA252  
Investigator : Tealeye Cornejo, AS-WPR

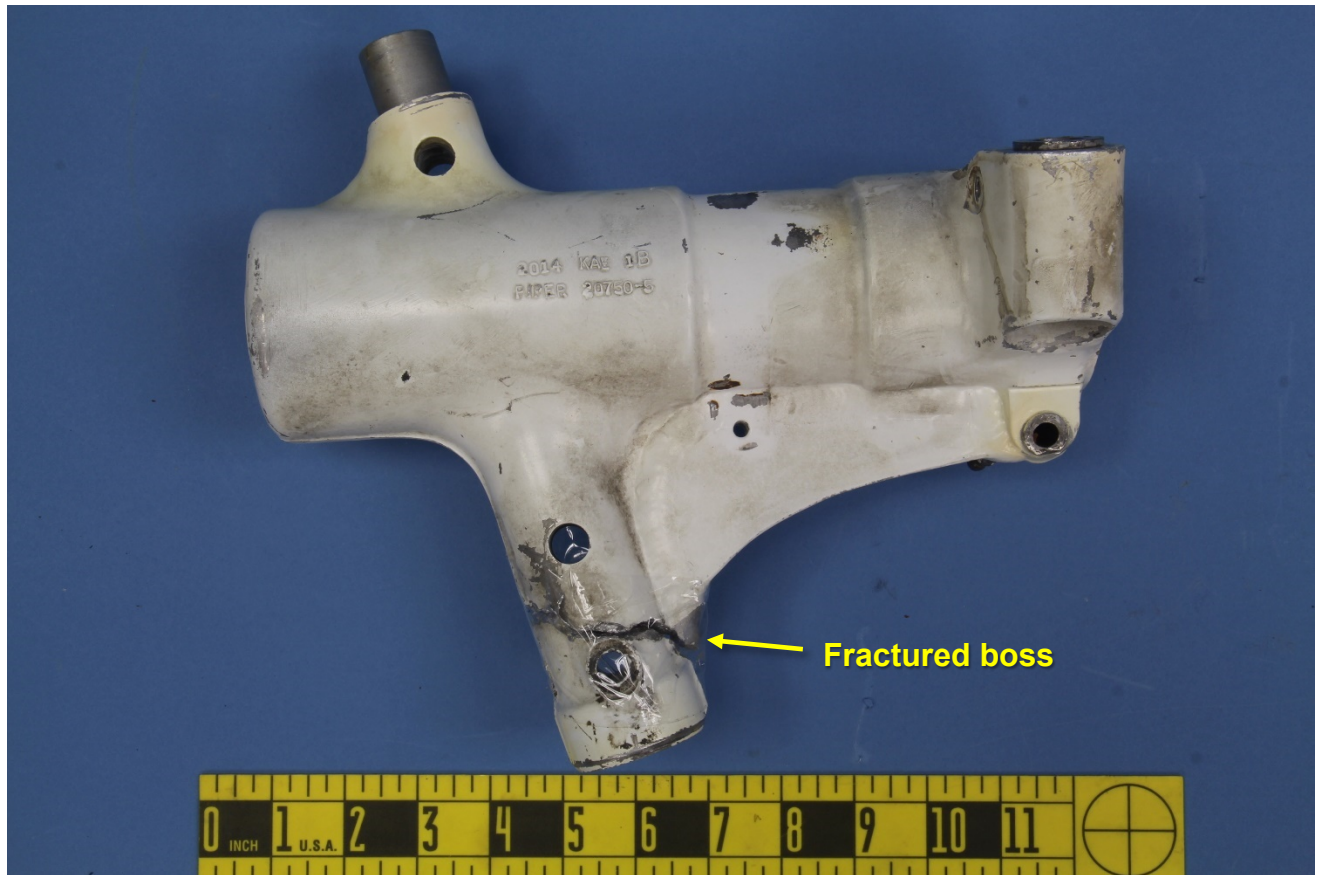
Figures 1 through 3 show the trunnion fragments as received. Of most significance, was a fractured boss on the side—the mating faces of the fracture surface had been forced back and taped together prior to receipt by the NTSB Materials Laboratory. As illustrated in Figure 4, the mating fracture surfaces exhibited large areas of streaky and reflective features, consistent with post-fracture damage. Since the mating fracture surfaces had been in contact, it could not be determined if the post fracture damage was due conditions during or following the accident sequence, rubbing of the surfaces during shipping, or both.

Figure 1 – Side view of the trunnion remnants, showing the fractured boss that was taped together, as received.

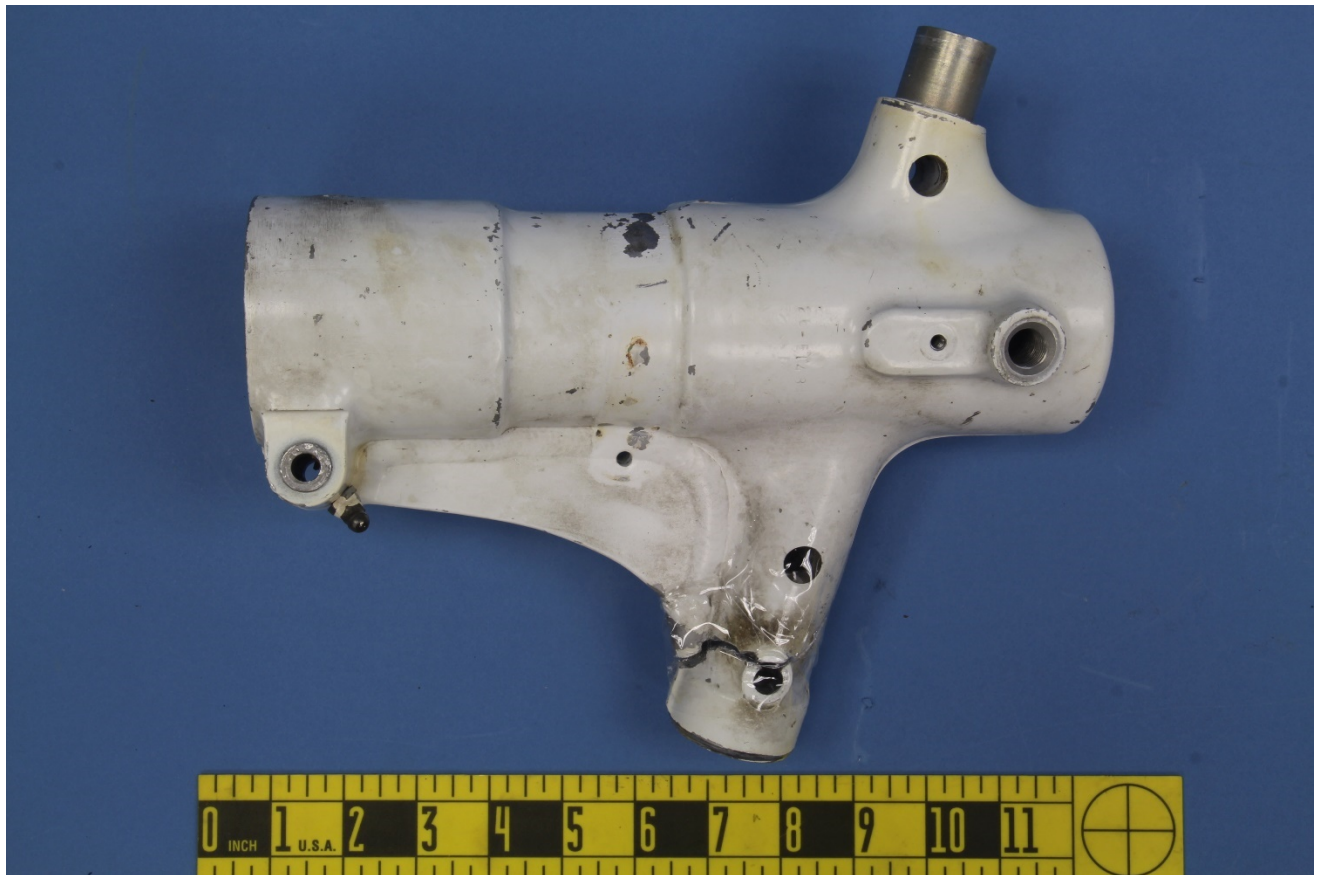
Figure 2 – View of the trunnion from the reverse side of Figure 1, as received.

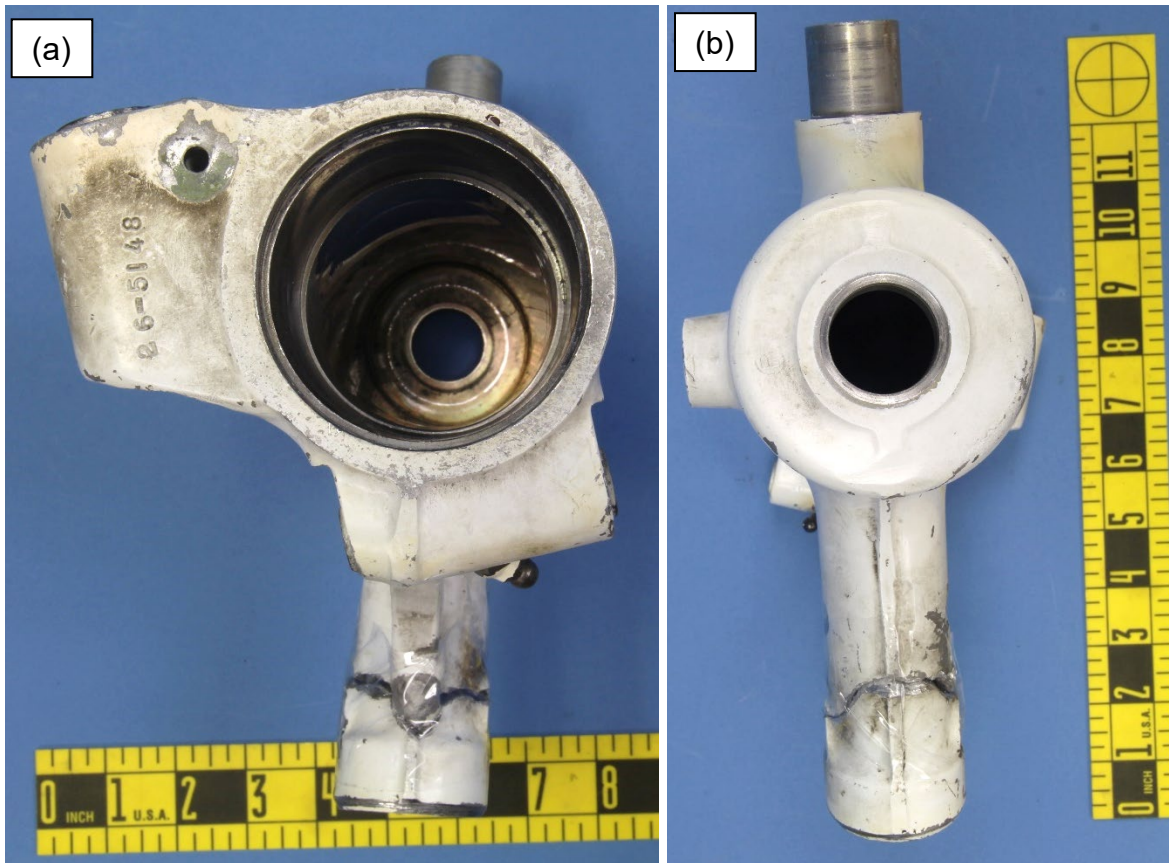
The markings on the trunnion body stated, "2014 KAE 1B" and "PIPER 20750-5". There were additional markings on the rear of the trunnion, as shown in Figure 3. These stated "26-5148".

Figure 3 – View of the trunnion from the (a) piston side and (b) the opposite side.

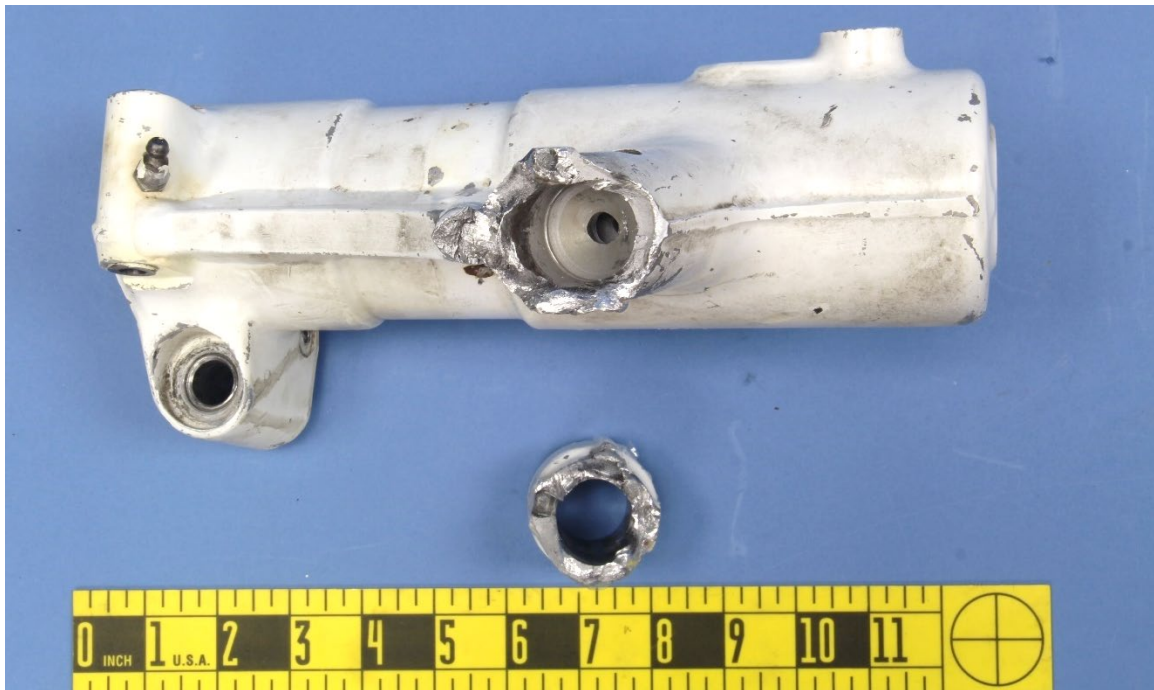
Figure 4 – View of the two fracture surface of the fractured trunnion boss, after removal of tape and separation.

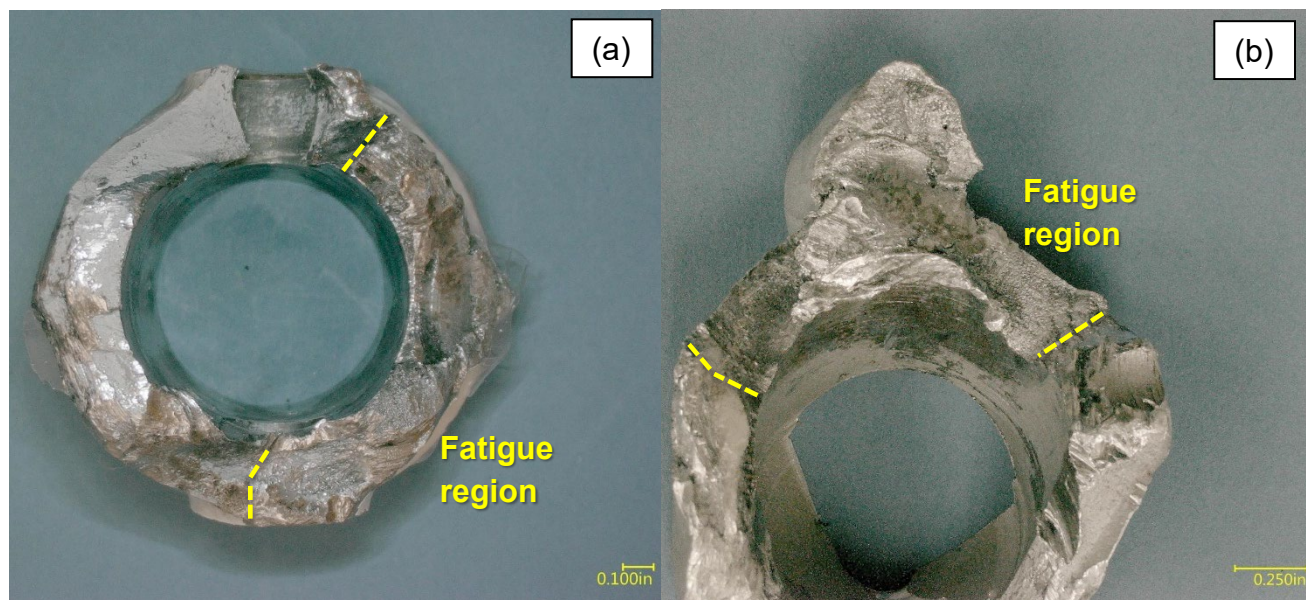
The boss, which extended orthogonally from the main trunnion body, had fractured approximately 2 inches from the end. The mating fracture surfaces are shown in Figure 5 from both sides. There were select areas of both fracture surfaces with relatively undamaged regions still exhibiting apparent fracture features. The inner mating fracture surface was less damaged than the outer one, and so it was sectioned 0.5 inches below the fracture surface to facilitate further examination.

Most of the undamaged portions of the fracture surfaces exhibited a rough, fibrous texture with a dull luster, as best demonstrated in the upper left of Figure 5a. There were two opposite facing areas that exhibited flatter and darker features. These features were located near the narrow neck-shaped area in the upper part of Figure 5b.

Figure 5 – Views of the (a) outer fracture surface of the boss and (b) the sectioned inner surface of the boss, annotated to show the progressive cracks on the surface.

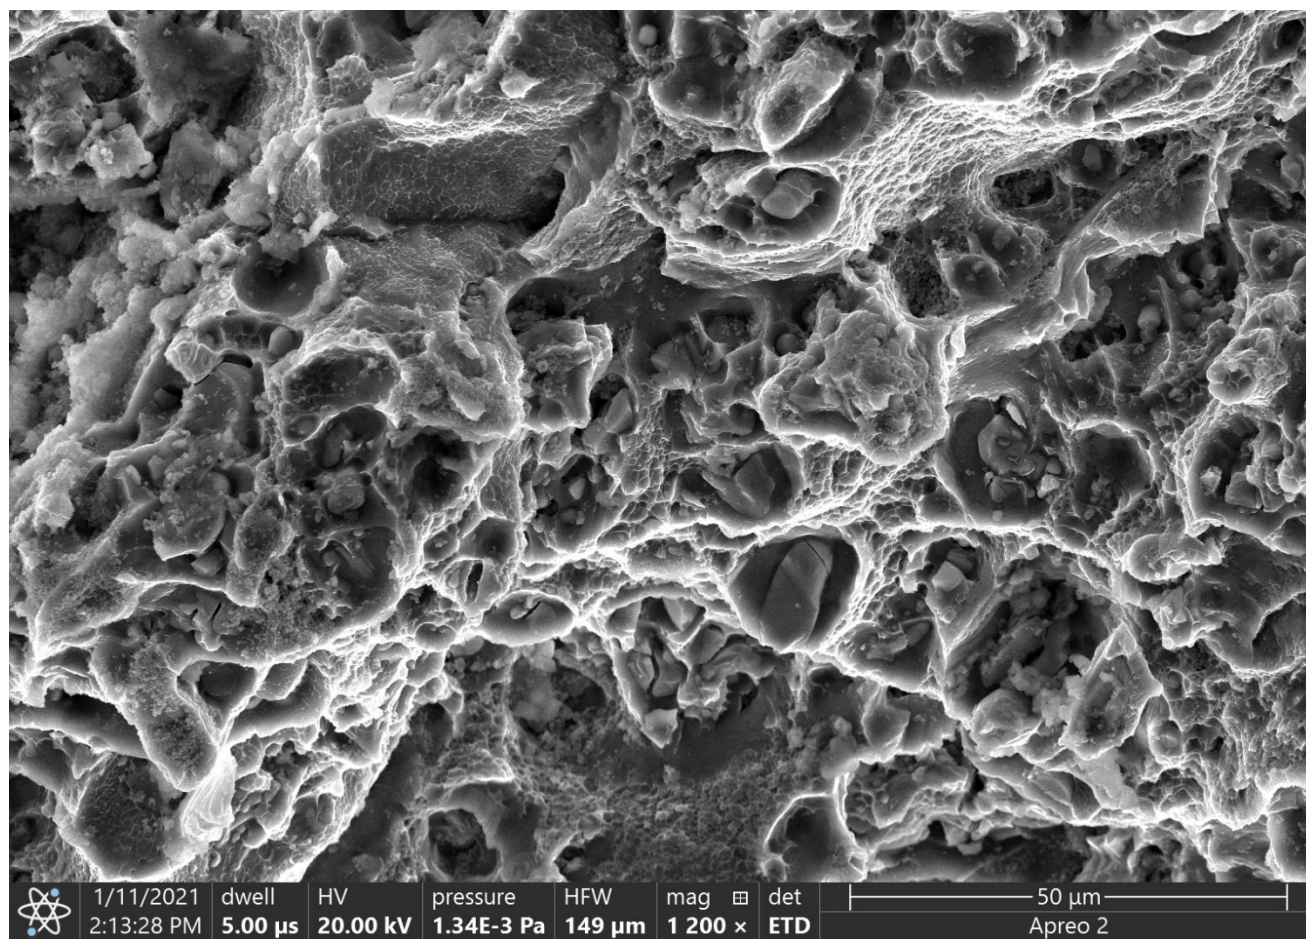
The sectioned fracture surface was examined using a scanning electron microscope (SEM). Most of the fracture surface exhibited features consistent with dimpled rupture as typified in Figures 6 and 7. These features were consistent with overstress fracture and corresponded with the dull, fibrous regions observed over the majority of the undamaged portions of the fracture surface.

Figure 6 – Secondary electron (SE) micrograph of dimpled rupture on the inner boss fracture surface.

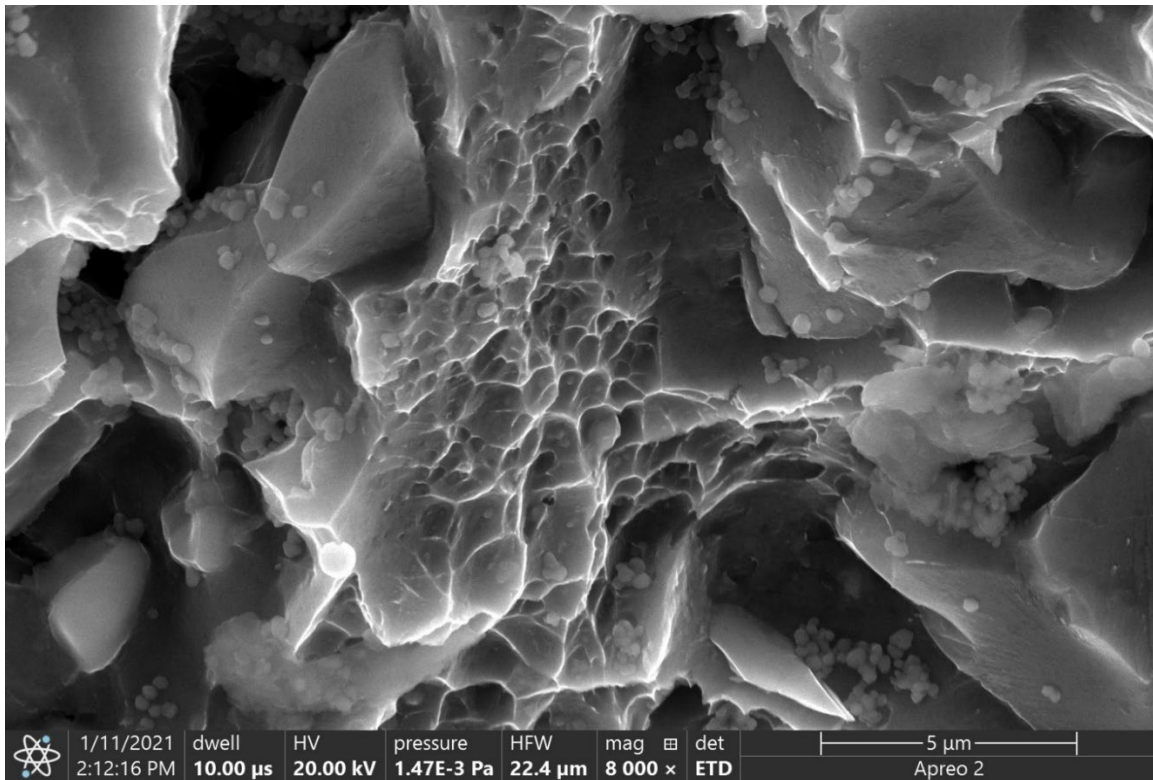
Figure 7 – SE micrograph of a closer view of dimpled rupture in Figure 6.

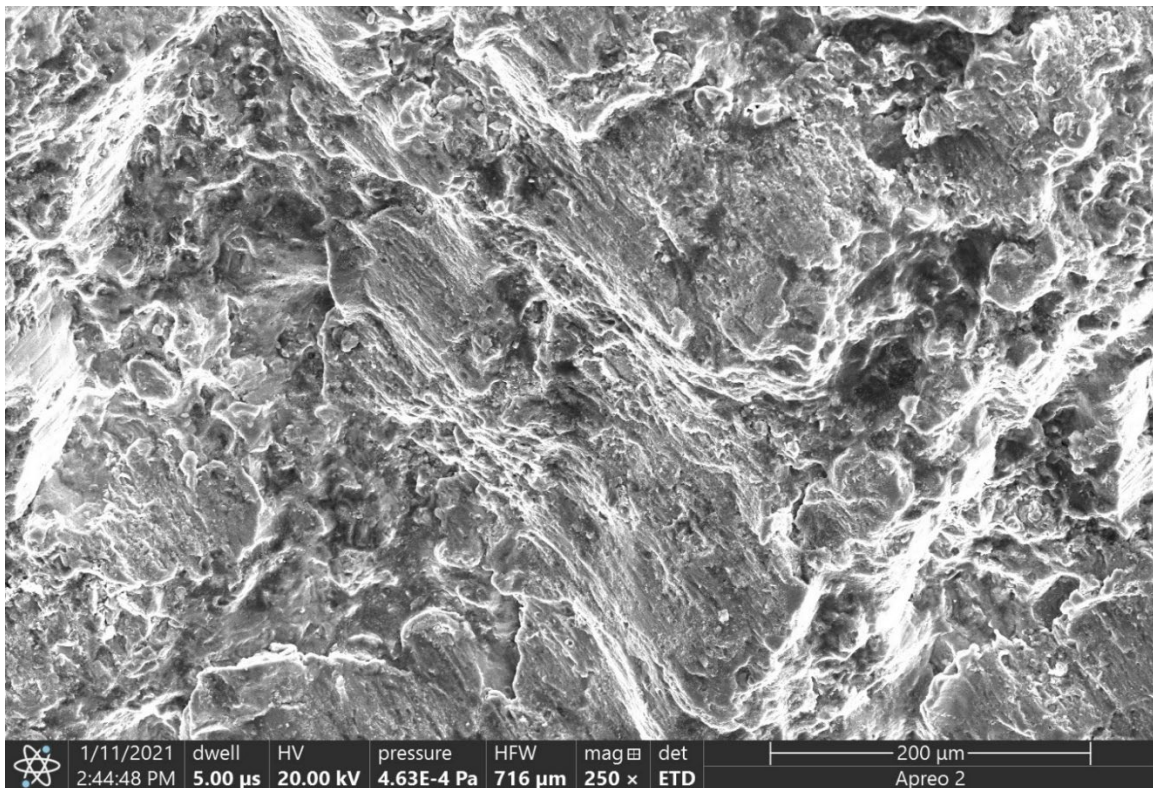
The flatter, darker regions of the fracture surface exhibited distinctly different features, as demonstrated in Figure 8. These regions exhibited a stepped morphology with ridges. Closer examination found fatigue striations in these areas, as typified in Figure 9. These striations were consistent with having propagated from the outside surface inward.

Figure 8 – SE micrograph of an area consistent with fatigue features on the inner fracture.

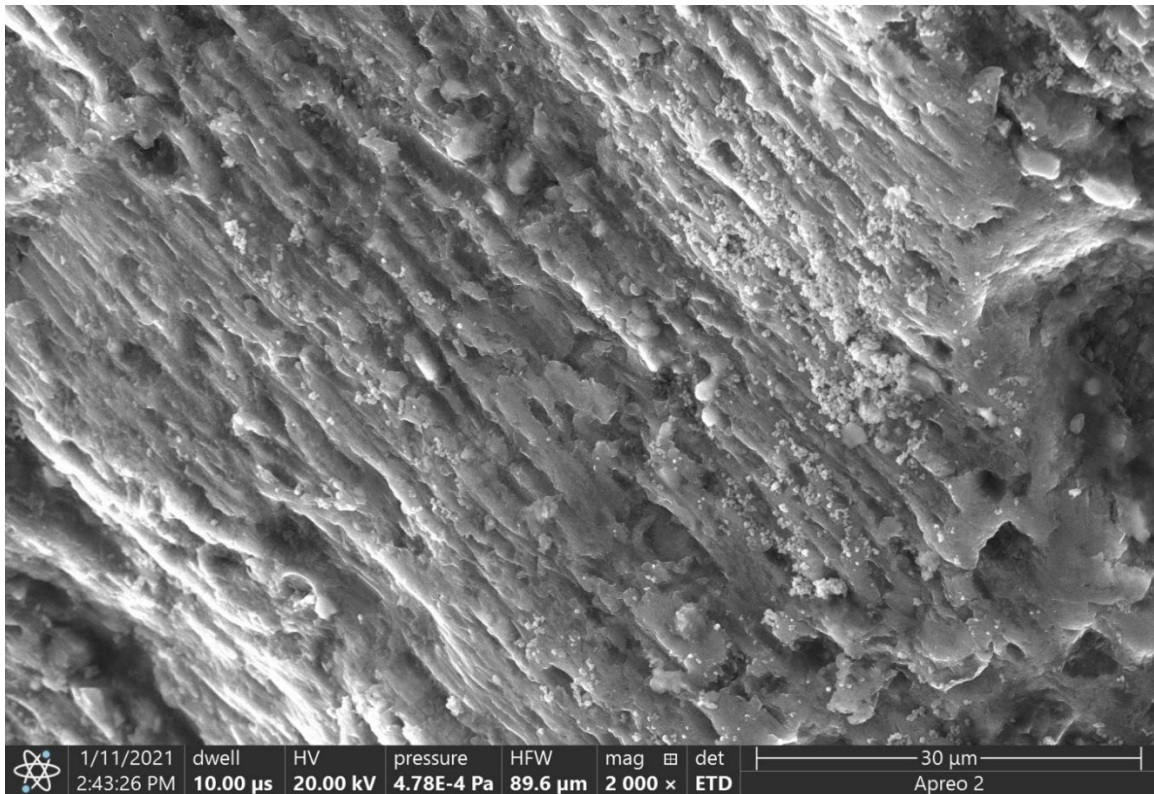
Figure 9 – SE micrograph of a closer view of fatigue striations from Figure 8.

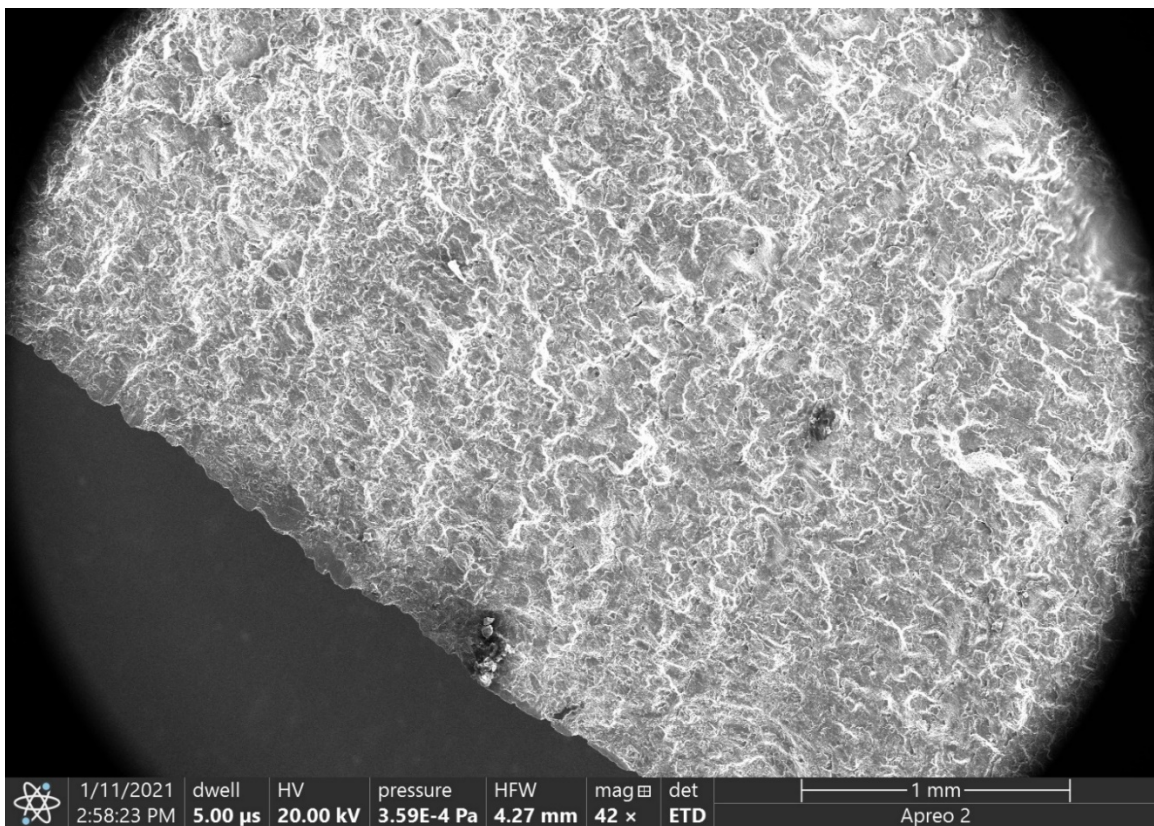
Due to the post-fracture damage, only one crack initiation site was able to be observed, as shown in Figure 10. The surface near this feature exhibited fatigue striations consistent with crack propagation away from the location. Figure 11 shows a closer view of the fatigue crack initiation site. This figure shows striations emanating from a point along the surface. While the site exhibited an inward concave geometry, this feature was inconsistent with a corrosion pit or pore. Rather, the site was consistent with a geometrical inward shape.

Figure 10 – View of a crack initiation site of one of the fatigue cracks.

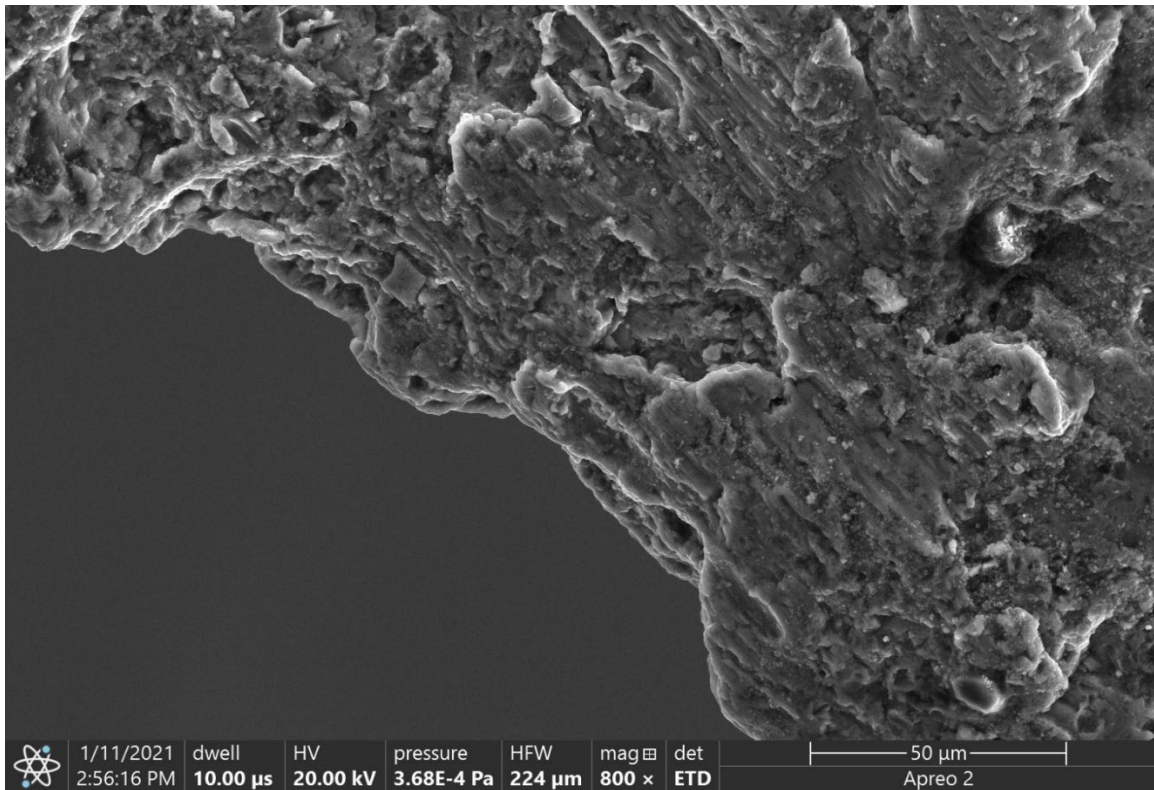
Figure 11 – SE micrograph showing a closer view of the crack initiation site of one of the fatigue cracks on the inner boss surface.

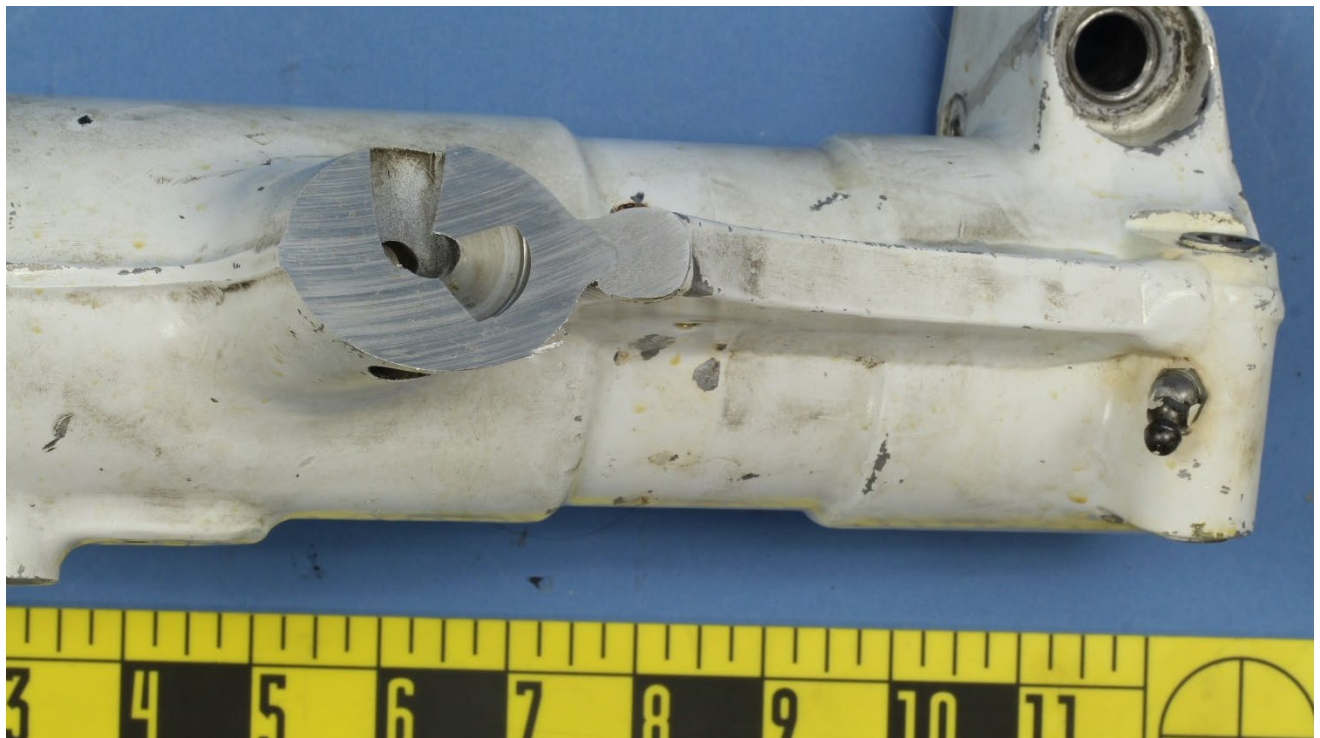
Returning to a macroscopic view, the location of the fracture of the boss can be seen to have consisted of a boss to which a gusset or web that had been joined by welding. This was exemplified in the sectioned boss view of the trunnion in Figure 12. Viewing the mating section with the boss fracture, the geometry tapered to a narrowed neck shape, as shown in Figure 13. This tapered area correlated with the locations of the 2 opposite facing fatigue cracks.

At this tapered area, the cross-sectional thickness was measured thin as 0.4 inches. In contrast, the welded gusset was 0.8 inches thick, and the boss exhibited a diameter (side to side) of 1.75 inches. This configuration would introduce a stress concentration at the locations of the fatigue cracking. Further, the presence of two opposite-facing fatigue cracks was consistent with reverse bending fatigue, suggestive of the gusset bending back and forth at the interface. Once these fatigue cracks had propagated far enough into the boss cross section, the remainder of the part fractured by overstress during the last landing.

The welded gusset however, exhibited a different chemical composition. The composition was consistent with an aluminum casting or welding alloy. The electrical conductivity was higher, averaging 42.9 % IACS. The hardness was softer than the Rockwell B scale, and was therefore not measured conclusively. The hardness of the boss material was found to decrease as it was probed closer to the weld. These data were consistent with the boss being locally softened due to the heat inputs from the welding process.

Figure 12 – View of the trunnion after sectioning of the inner fracture surface of the boss, showing the general cross-section dimensions of the joint.

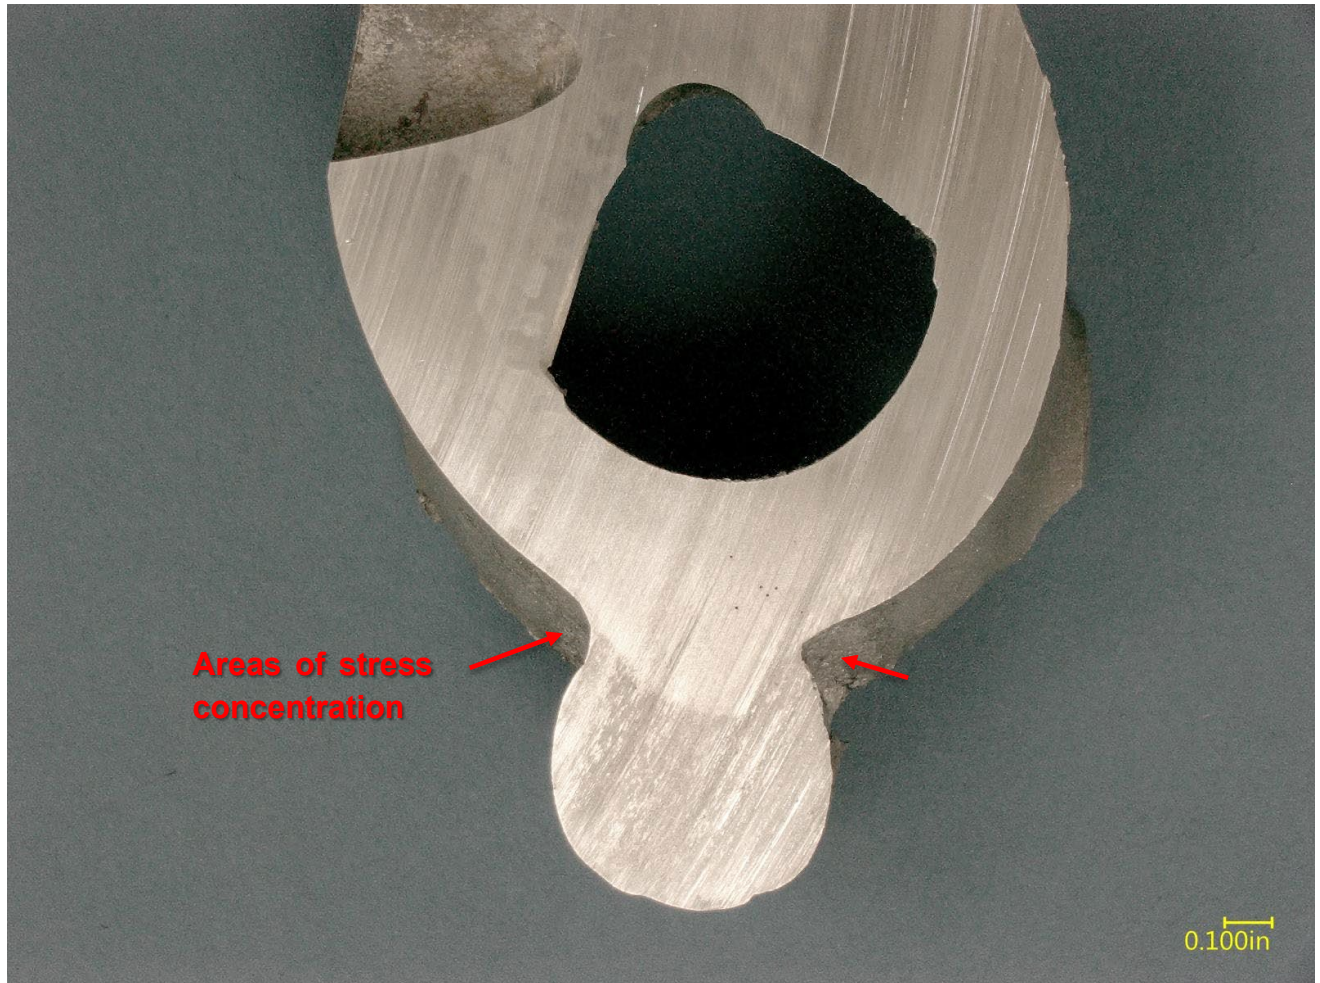
Figure 13 – Closer view of the sectioned inner boss piece, viewed from the cut surface, showing the two stress concentration regions at the weld joint.

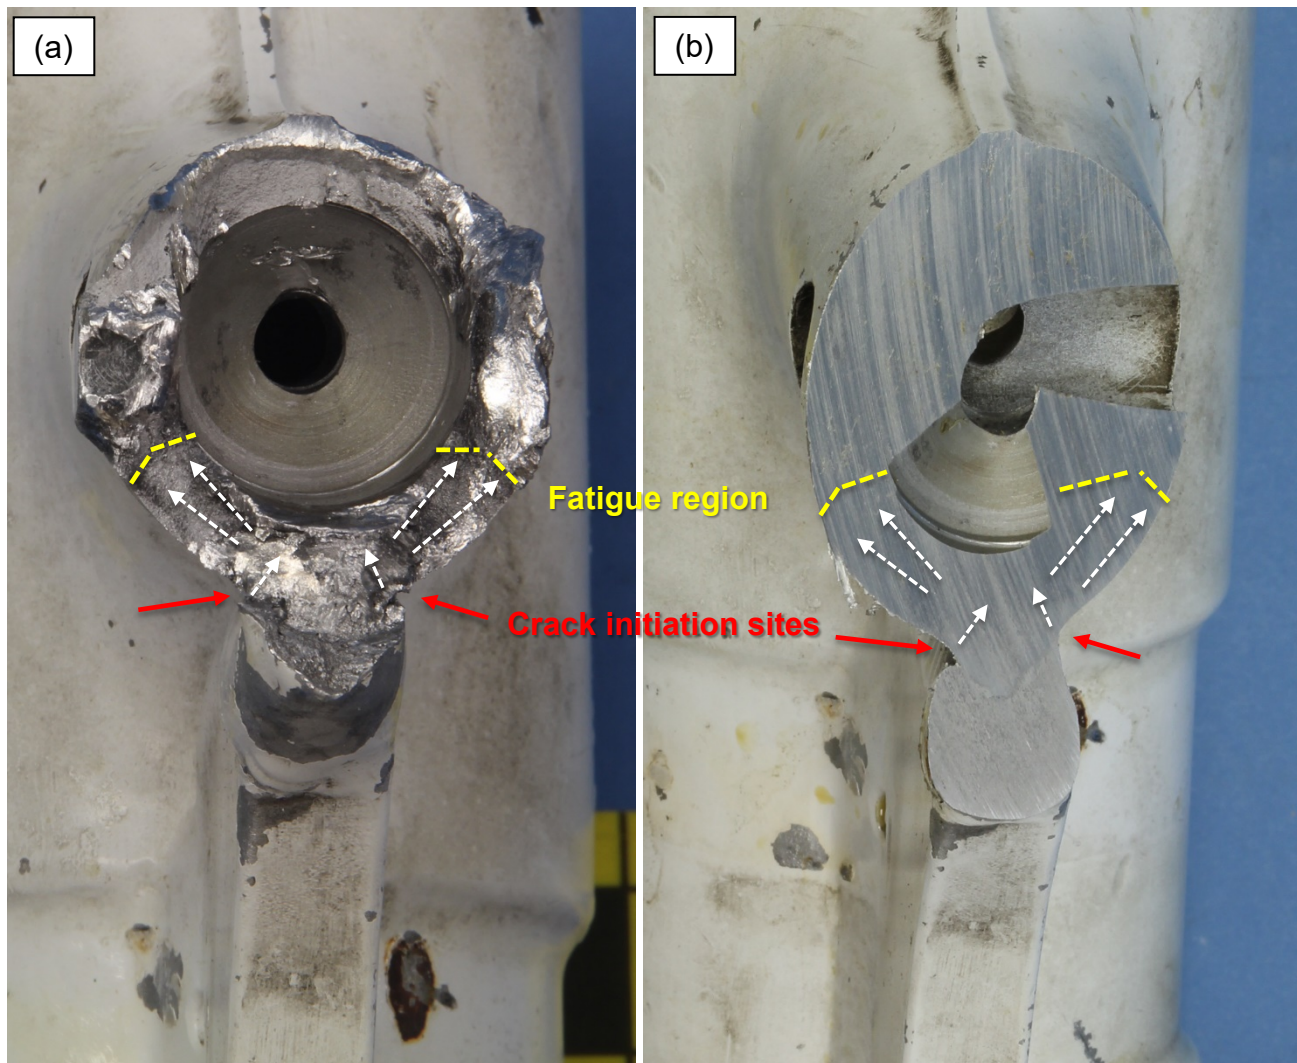
The generalized location of the fatigue cracks, and their propagation directions, are demonstrated on the annotated figures in Figure 14. These figures show the relative size of the fatigue crack propagation depth, and the crack growth direction from the fatigue crack initiation sites. As the fracture surface was heavily damaged, and Figure 14b is a section below the actual fracture surface, the annotations in Figure 14a and 14b are for illustrative purposes and are not necessarily accurate delineations.

Figure 14 – Annotated views of (a) the boss fracture surface and (b) the sectioned boss surface, showing the relative locations of the extent of fatigue crack propagation (yellow dashed areas), the generalized crack growth direction (white dashed arrows) and the crack initiations sites (red arrows).
