## SUMMARY OF FINDINGS

### **Tealeye Cornejo**

NTSB Accident Number: WPR20LA252

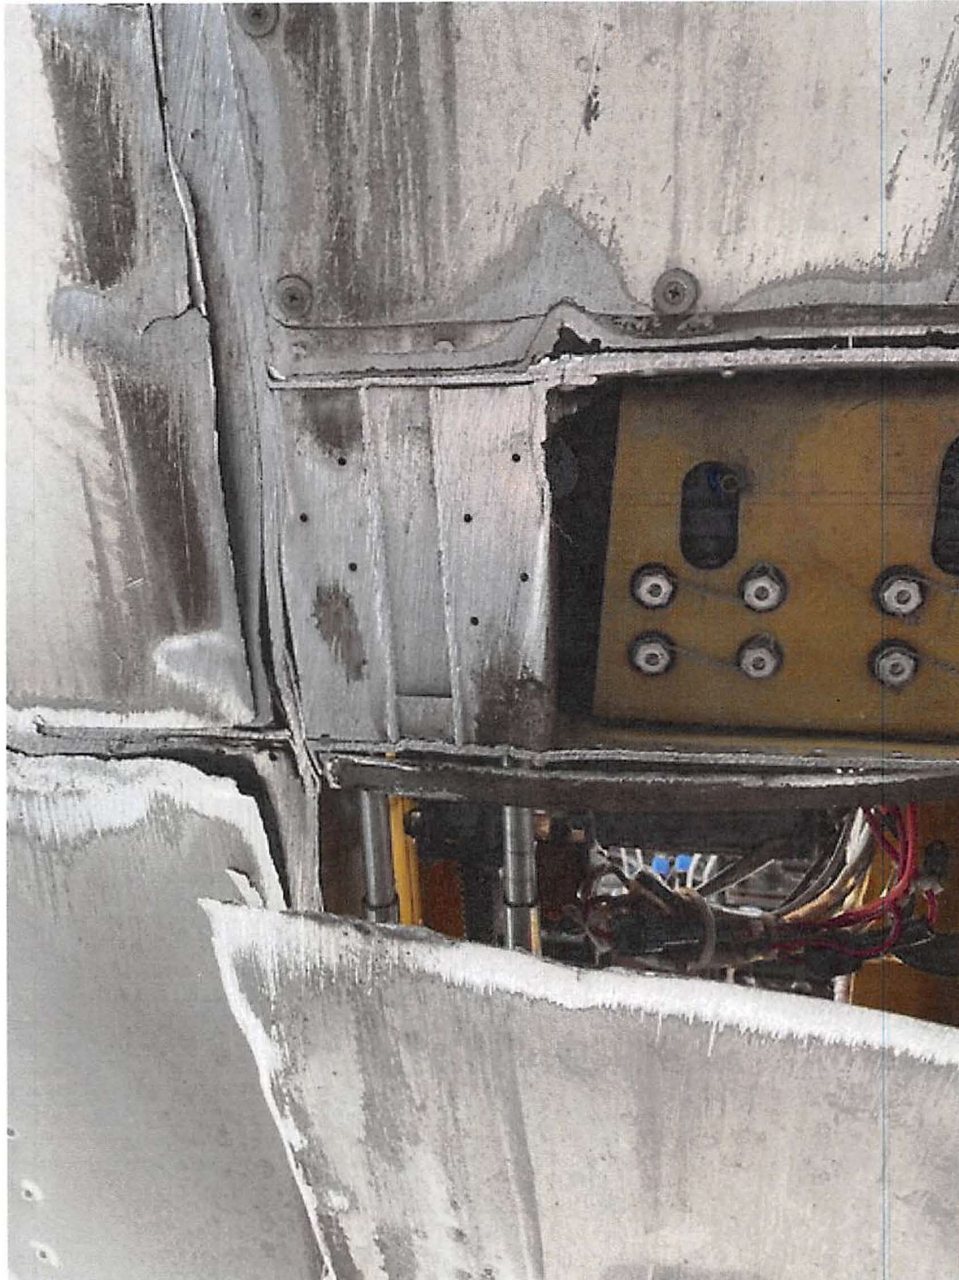
As you can see by the photos, not only did the trunnion break at a weld point, [but] the subsequent landing also damaged the fuselage keel, and the broken gear trunnion took a divot out of the right front spar. It is now our conclusion the damage is substantial due to the structural nature of it.

Photo 1 - Structural damage to the undercarriage keel beam

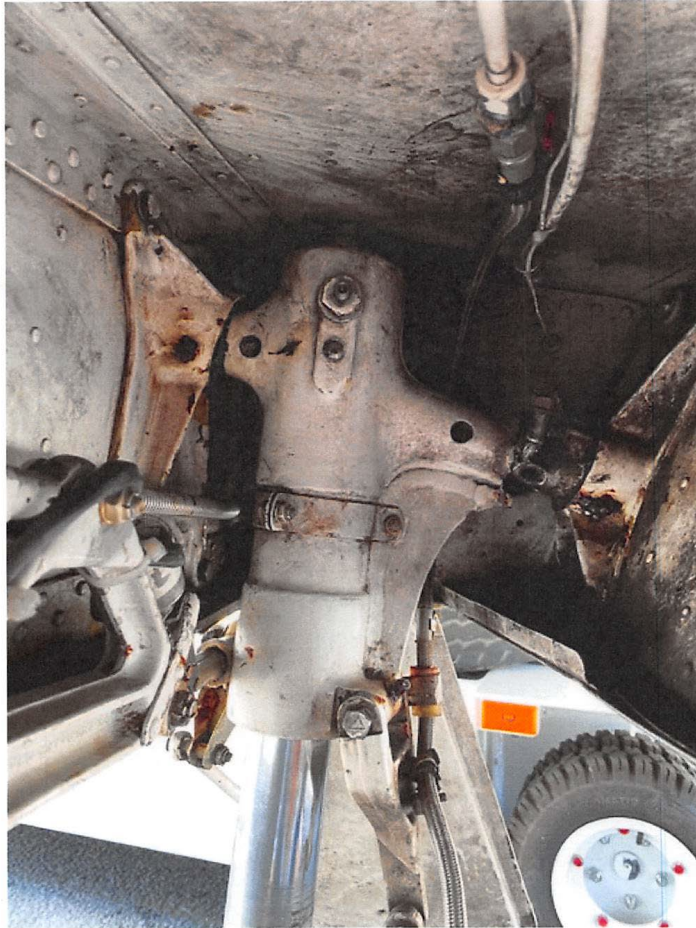
Photo 2 - Full View of Trunnion

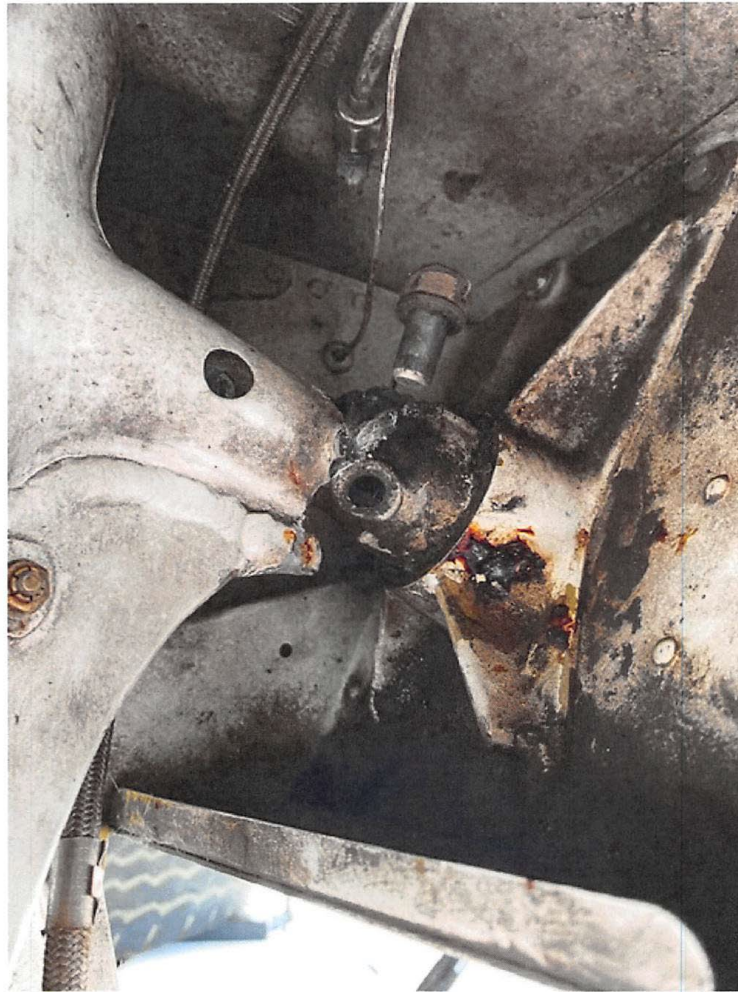
Photo 3 - Close up View of Separated Trunnion
