## **NATIONAL TRANSPORTATION SAFETY BOARD**

# **WRECKAGE EXAMINATION SUMMARY**

**WPR20LA257**

Location: Lake Port, California  
Date: August 7, 2020  
Aircraft: N290MH, Sportine Aviacija Lak-17B

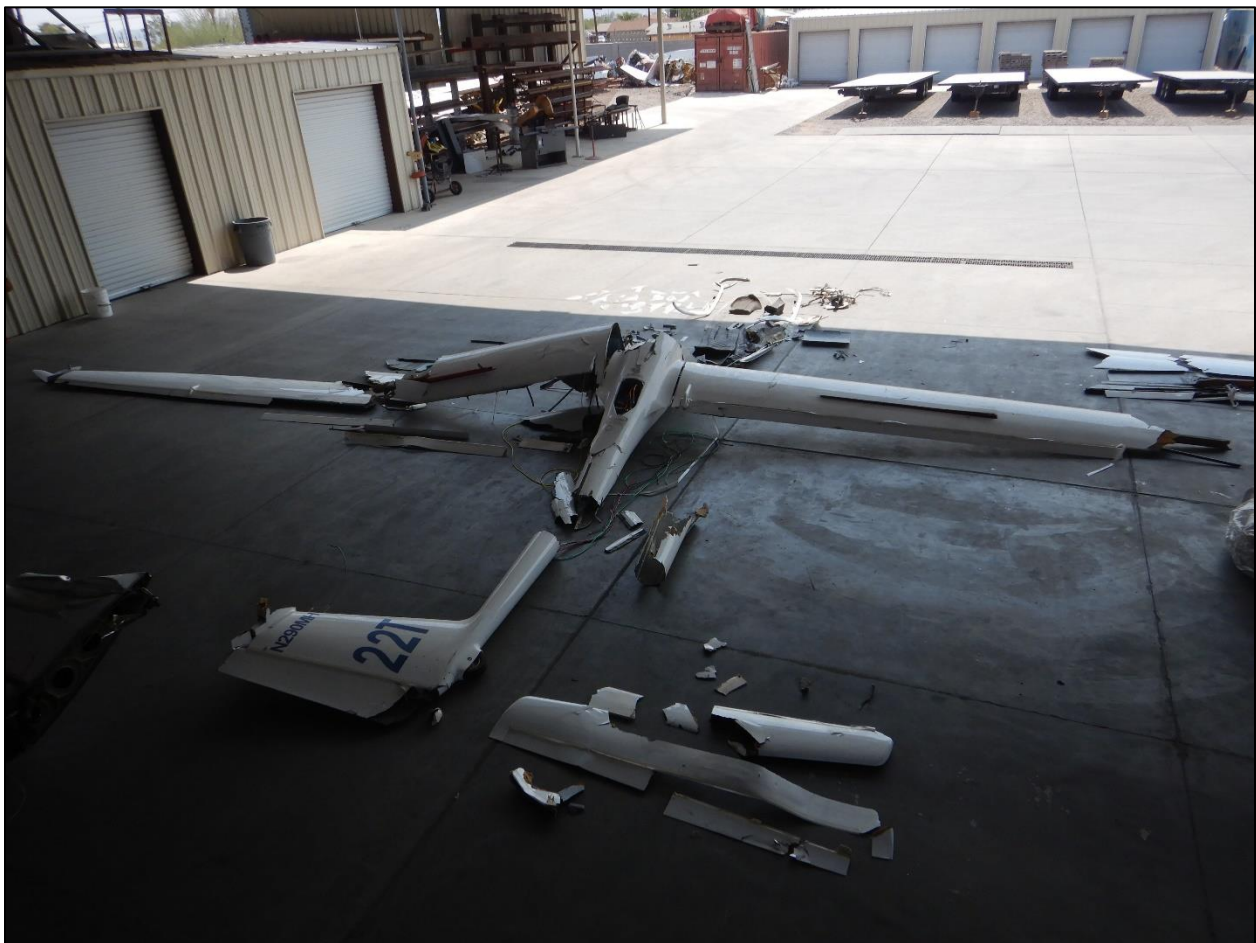
The wreckage was displayed on the ground in an examination area. Both wing spars remained attached at their attach points and the spar pins were attached and secured. The right wing remained attached to the fuselage and about 8 ft of the outboard end separated. The left wing remained partially attached to the fuselage with impact damage to the spar and inboard wing surfaces. The left wing separated about midspan revealing the internal surfaces of the water ballast tank. The left wing spar splintered near the wing root. The left wing inboard flight control linkage was loose from its support and all control tube attachments were secure. All flight controls and control tubes were found for both wings. The flap bellcranks worked normally by hand. Flight control continuity was established from both wings to the cabin area. The left airbrake was found in several sections along the wing separation. Linkage connecting the left airbrake worked normally by hand. The right airbrake was intact and moved normally from the wing root area.

Figure 1-Wreckage displayed during the examination.

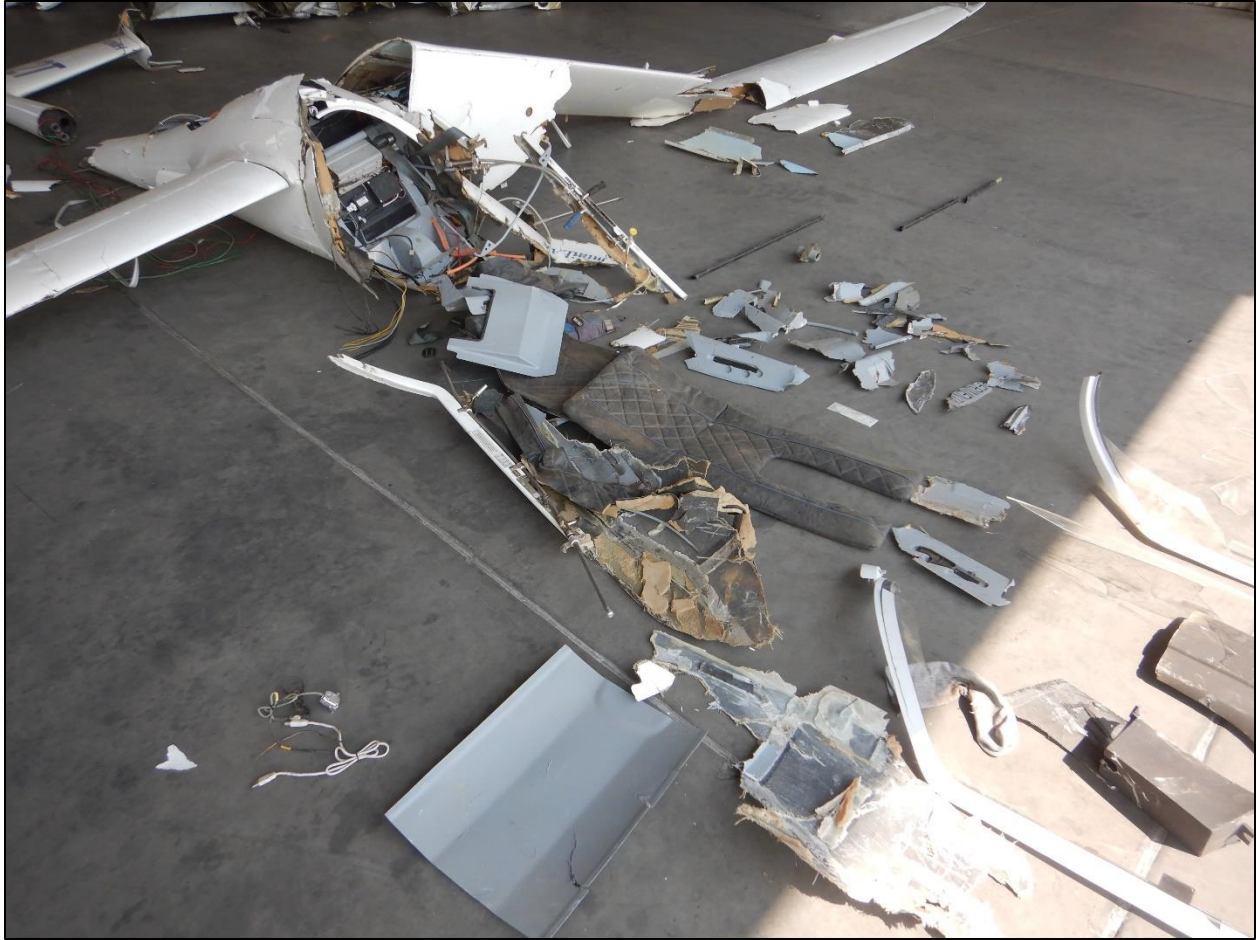
**Figure 2-Forward fuselage and cabin area.**

The forward fuselage had excessive impact damage and was found in multiple sections. The motor, forward support structure (canopy holder) and instrument panel was separated from the main wreckage during the recovery of the wreckage. The rudder pedal assembly was also separated from the main wreckage during the recovery of the wreckage.

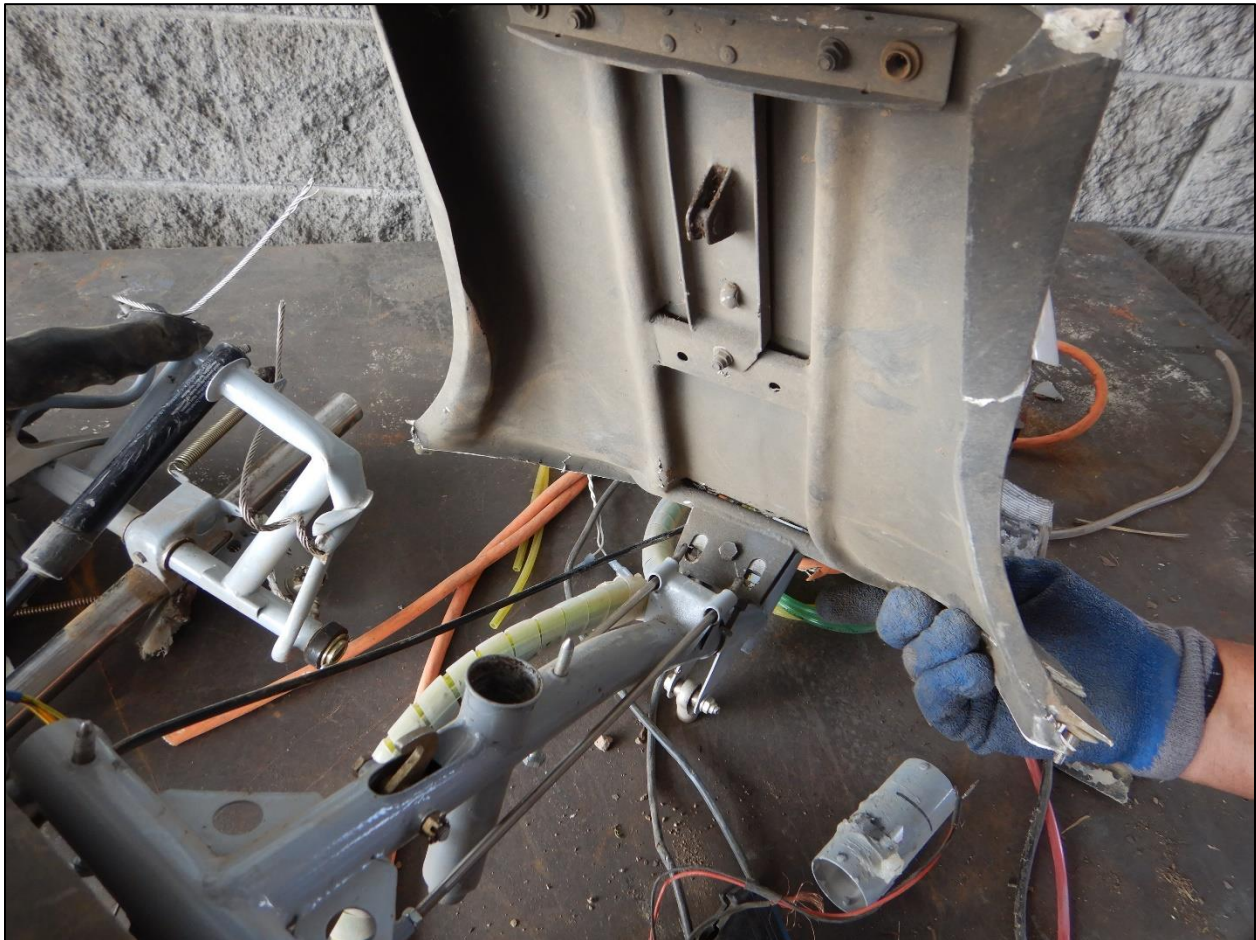
The plexiglass canopy and the frame were found in several sections. The canopy side locking pins were found in the engaged [aft] positions. The forward canopy panel separated from the frame. (See figure 3) The emergency jettison handle and linkage was found in the activated [out] position. The pins at the ends were bent in the up position. The fixator latch was in the retracted [unhooked] position. The canopy release spring and handle [handle of the spring type mechanism] were not found with the wreckage. A locking pin was found in the wreckage attached with a remove before flight tag. The locking pin shaft was bent and had metal deformation. (See figure 4)

Figure 3-Canopy jettison assembly.

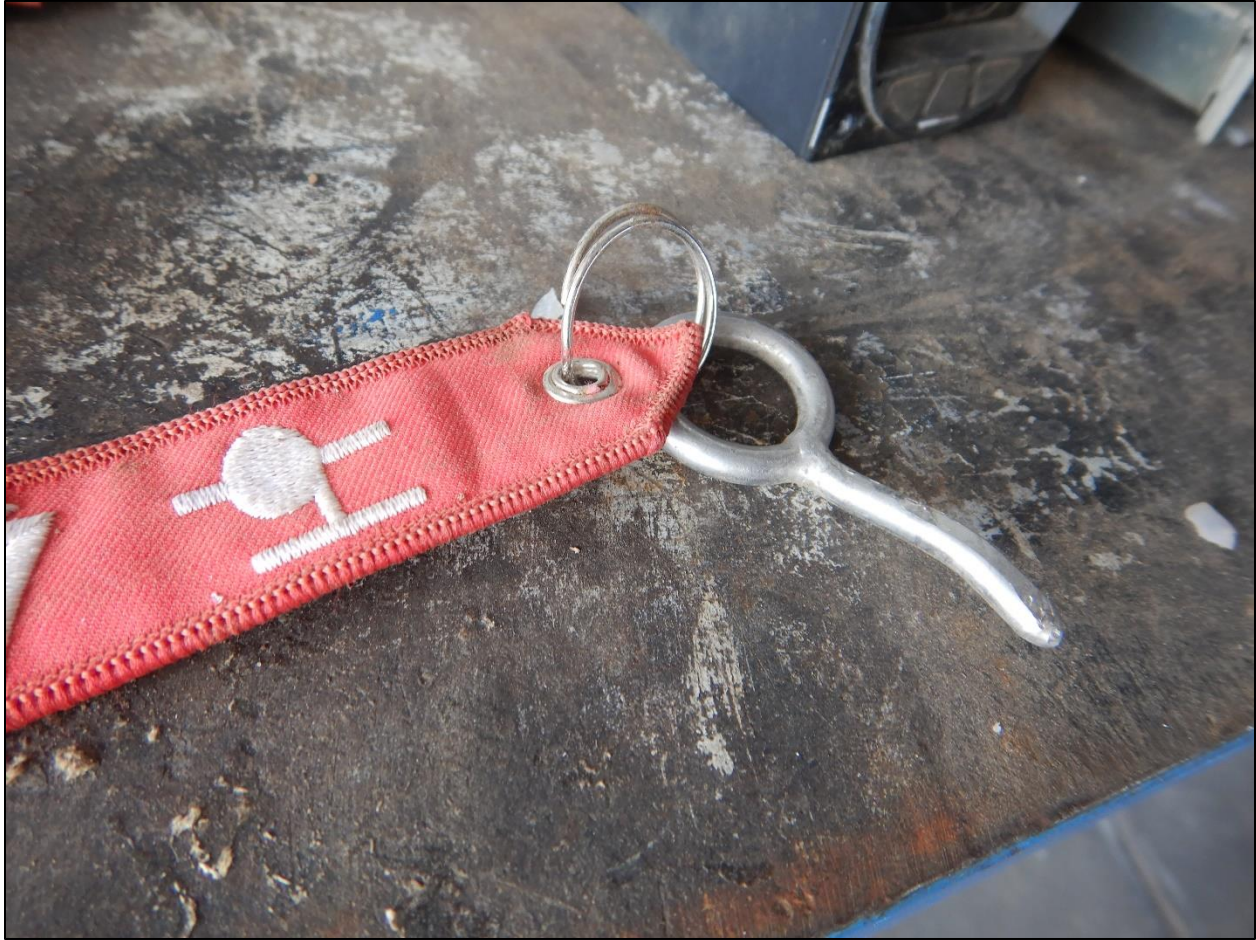
Figure 4-Locking pin and remove before flight tag.

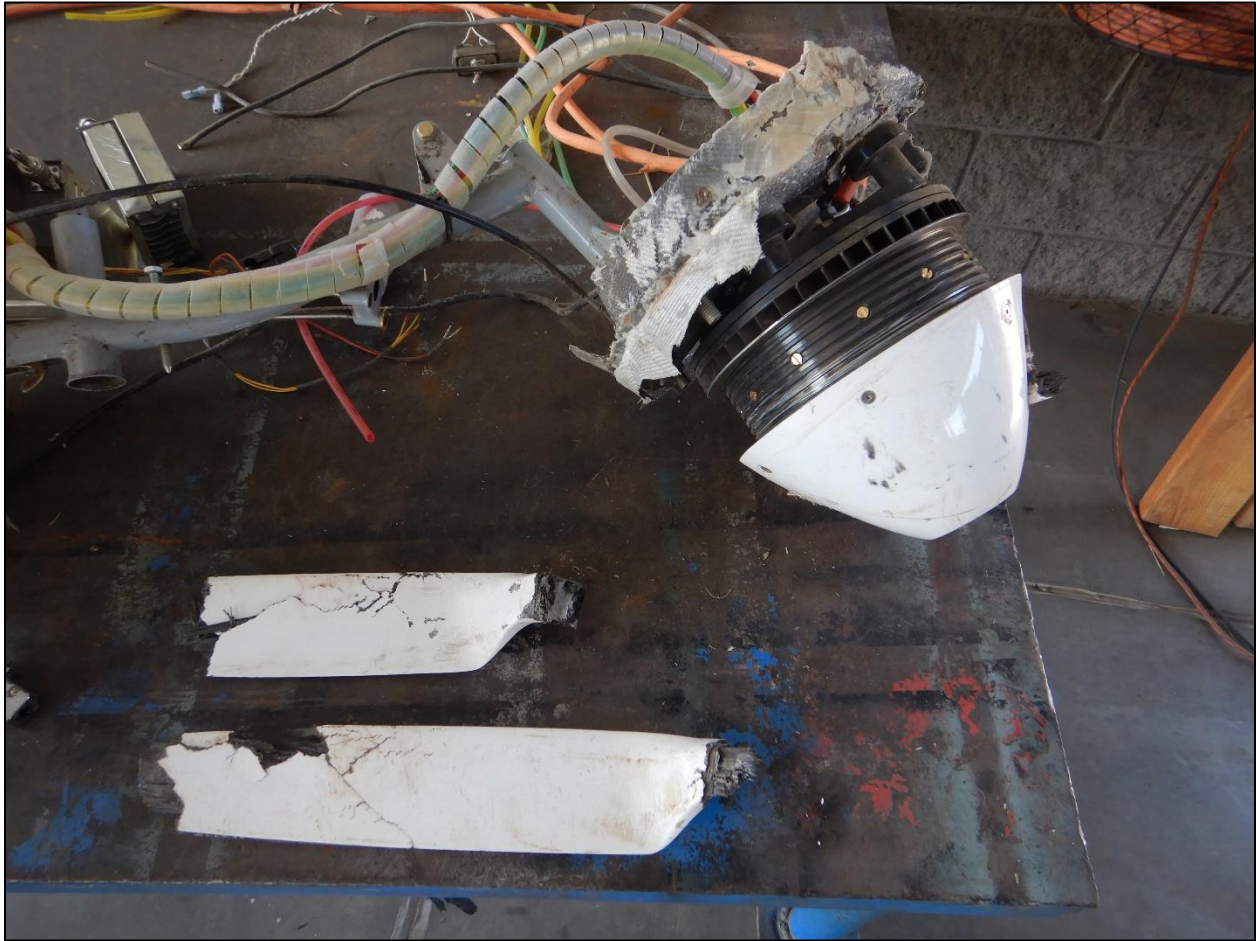
Figure 5-Propeller blades and motor assembly.

The propeller blades separated from the motor hub and were found with impact damage to the blades and to the mounting ends. The missing blade material was not found with the main wreckage. The cambered sides of the propeller blades had rotational scuff marks. Both propeller blades mounting-end-sections remained attached to the hub. The spinner had impact damage near the blade mounts that is consistent with the blades in the deployed [forward] position. The spinner had rotational scoring near the aft edge. (See Figure 5) The motor housing had rotational scoring. The propeller blades scuff marks, propeller blade positions, spinner and motor housing rotational scoring are consistent with the motor rotating at the time of impact with the ground.

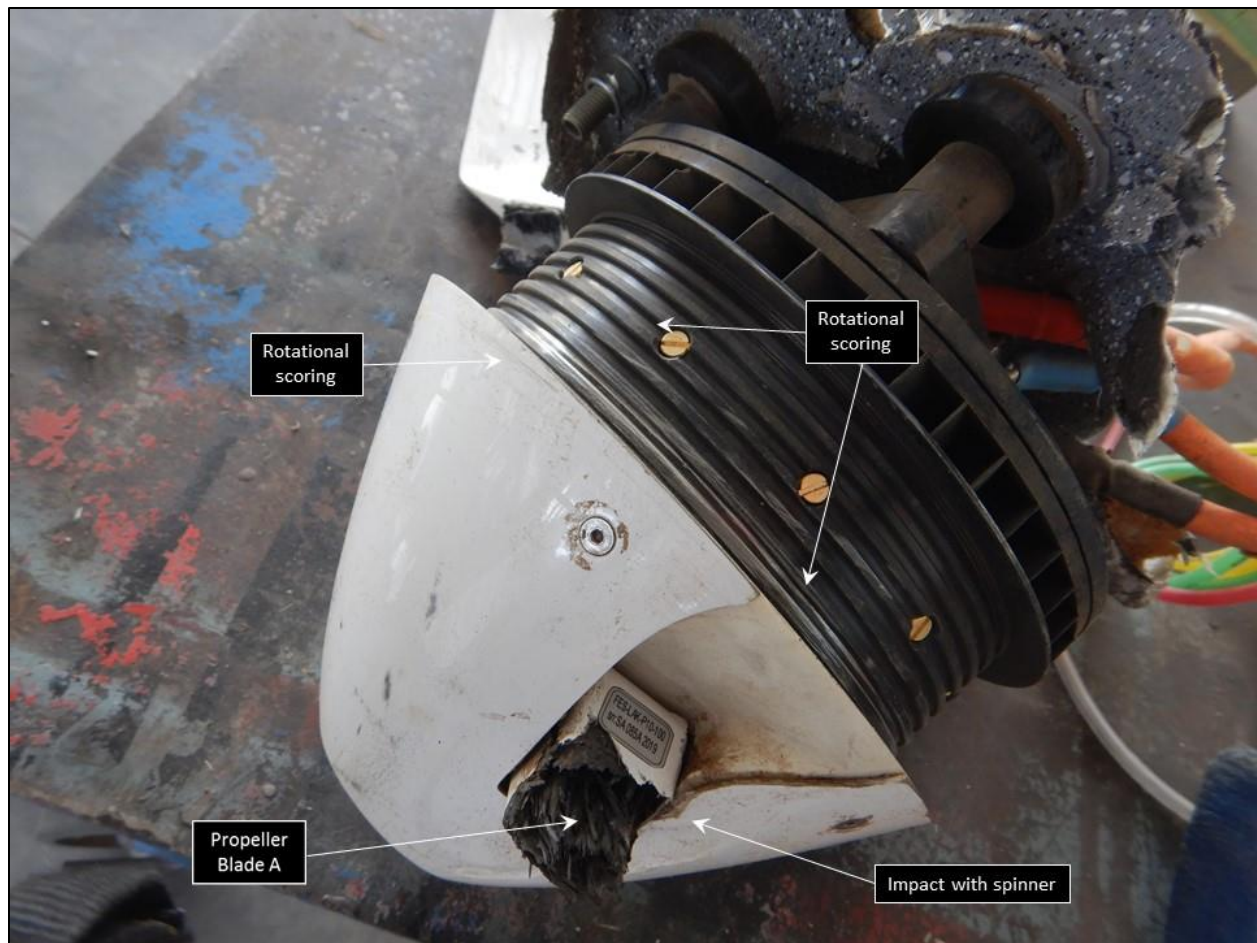
**Figure 6-Motor assembly and impact marks.**
