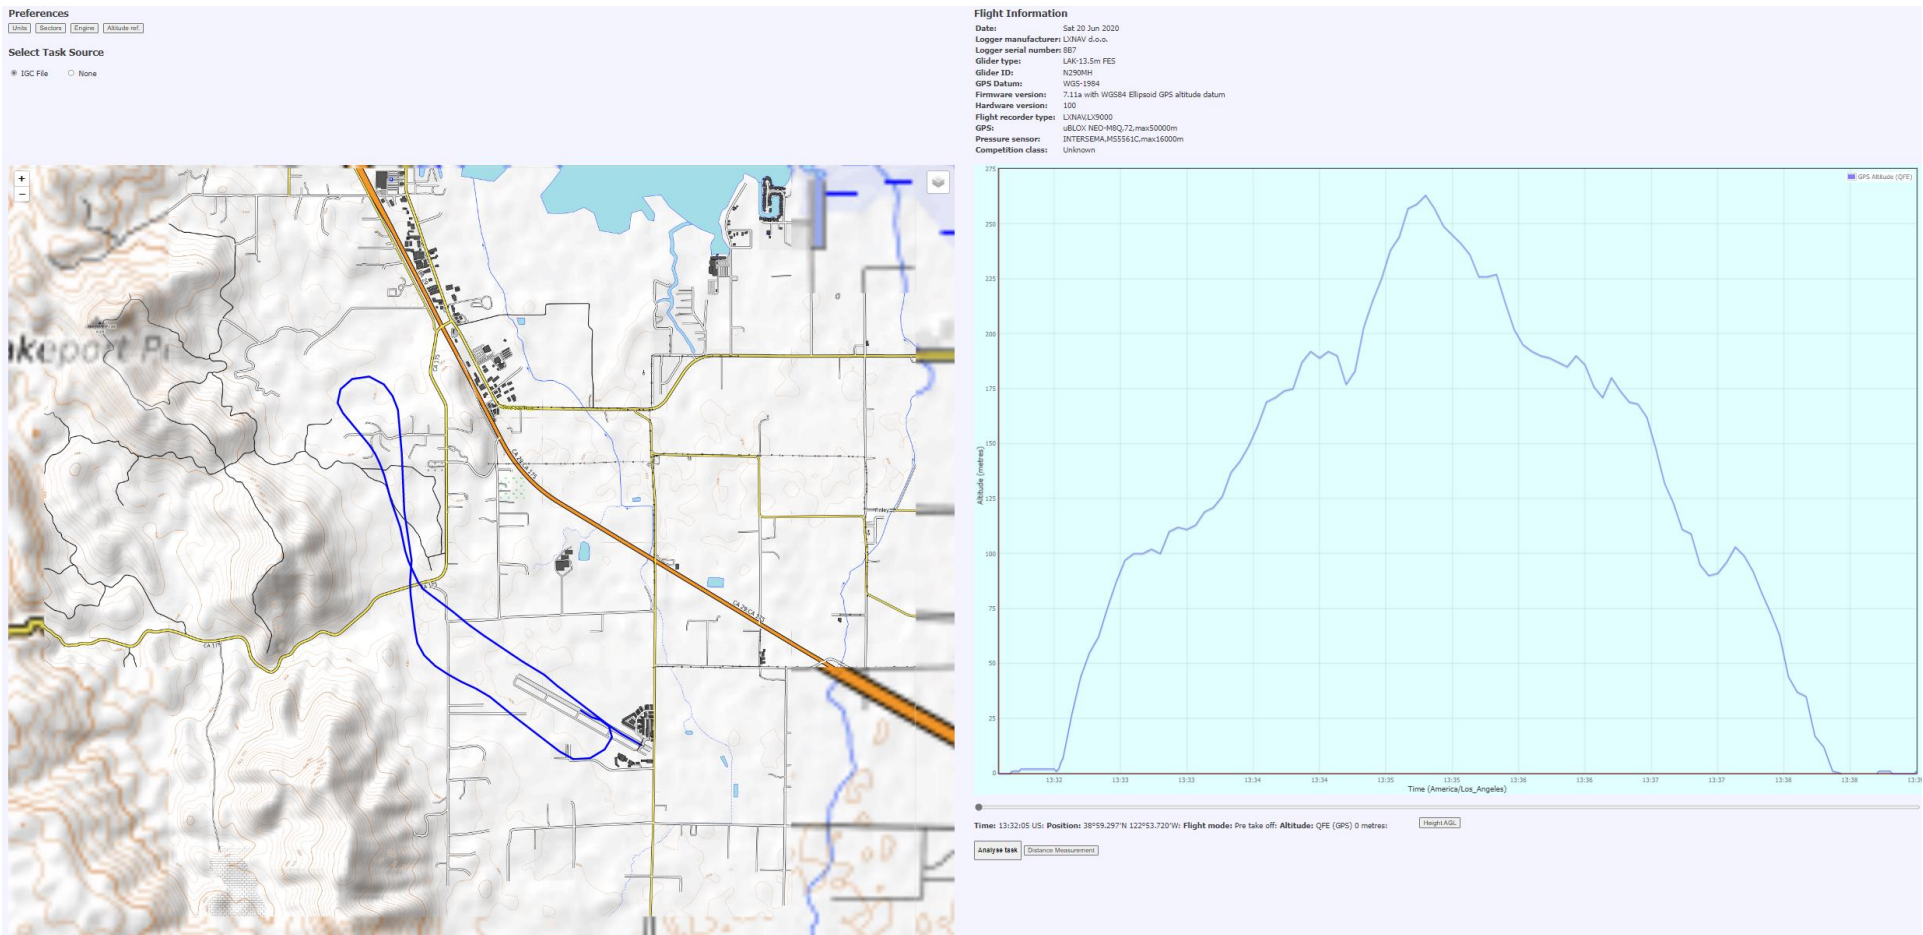
Figure 2-Flight track.

~6 min flight at Lampson Field Airport, Lakeport, California. (FES was shutdown on ascent and uncommand FES start in flight followed by unusual landing)

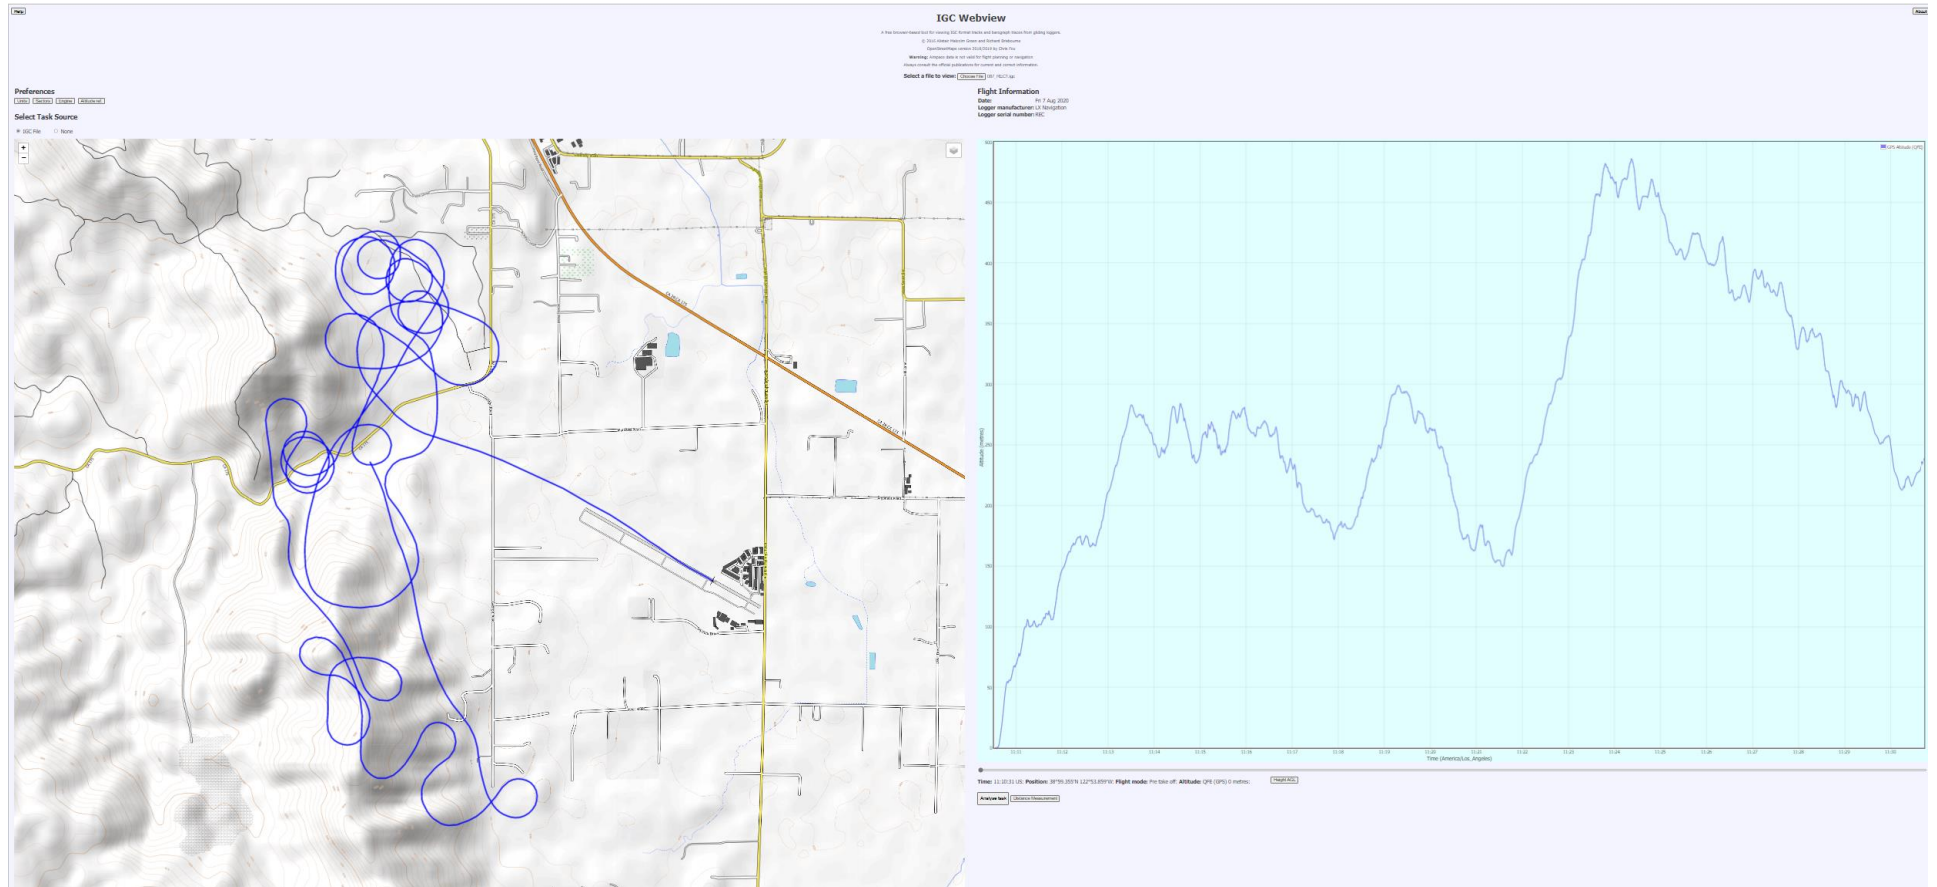
Figure 5-Flight track.

08/07/2020- (Accident Flight)

~20 min flight at Lampson Field Airport, Lakeport, California

Data from the LX9000 (file incomplete)

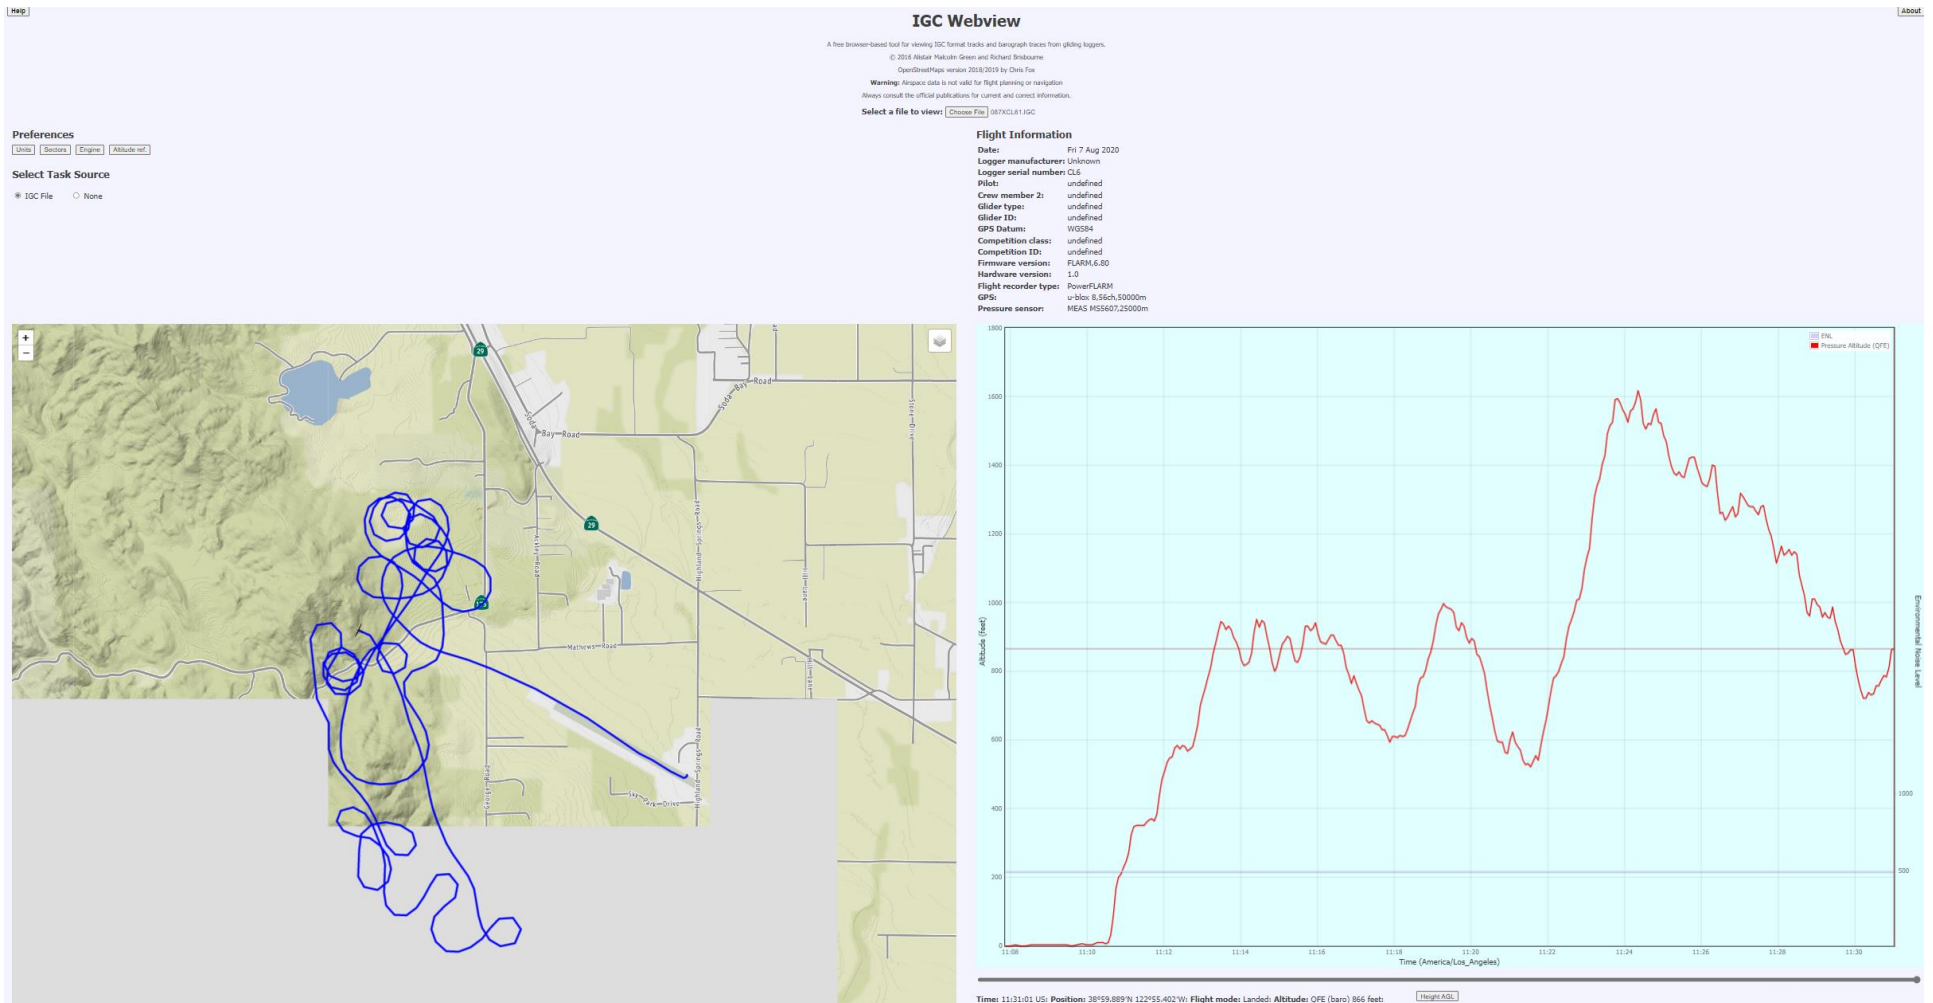
08/07/2020 (Accident Flight)

~20 min flight at Lampson Field Airport, Lakeport, California

Data from the Powermouse (completed file)

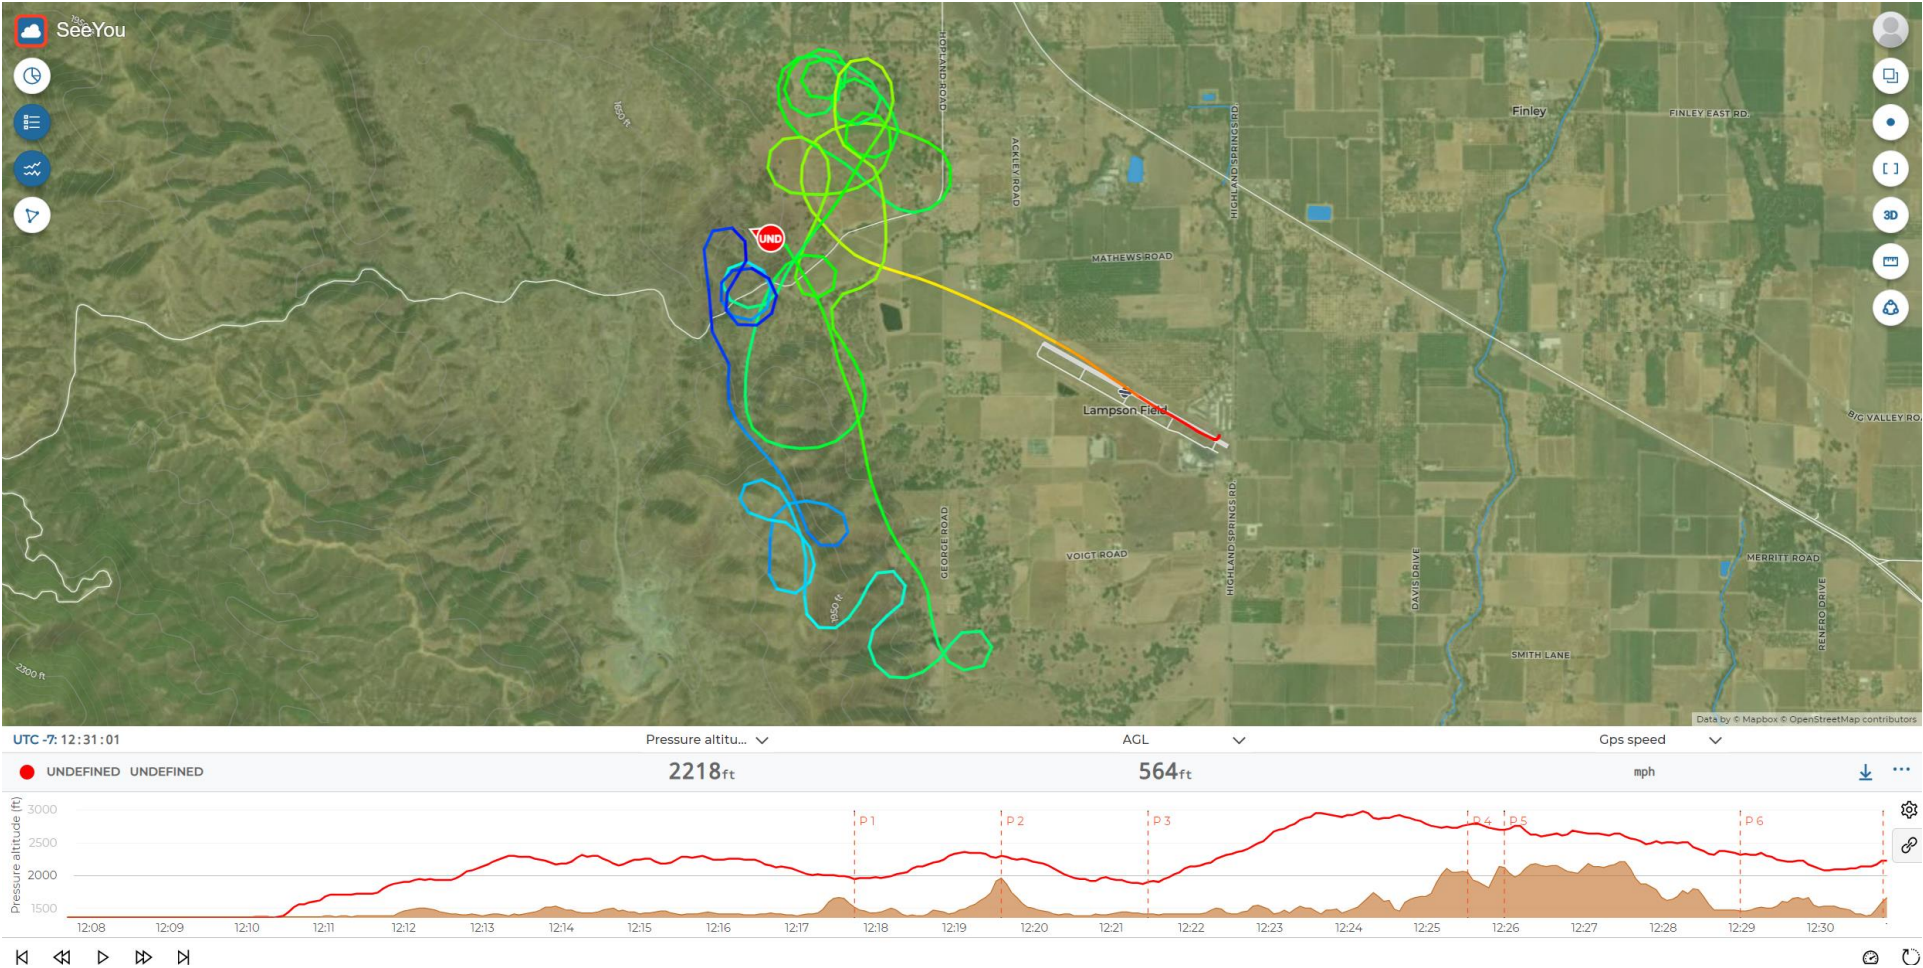
08/07/2020 (Accident Flight)

~20 min flight at Lampson Field Airport, Lakeport, California

Data from Powermouse (completed file) viewed on SeeYou website.
