**NATIONAL TRANSPORTATION SAFETY BOARD**

**Sound Spectrum Study**

**NTSB Case Number:  
WPR20LA258**

Location: Hanna, Utah  
Date: August 7, 2020  
Time: 1145 mountain daylight time (MDT)  
Aircraft: Cessna T210M

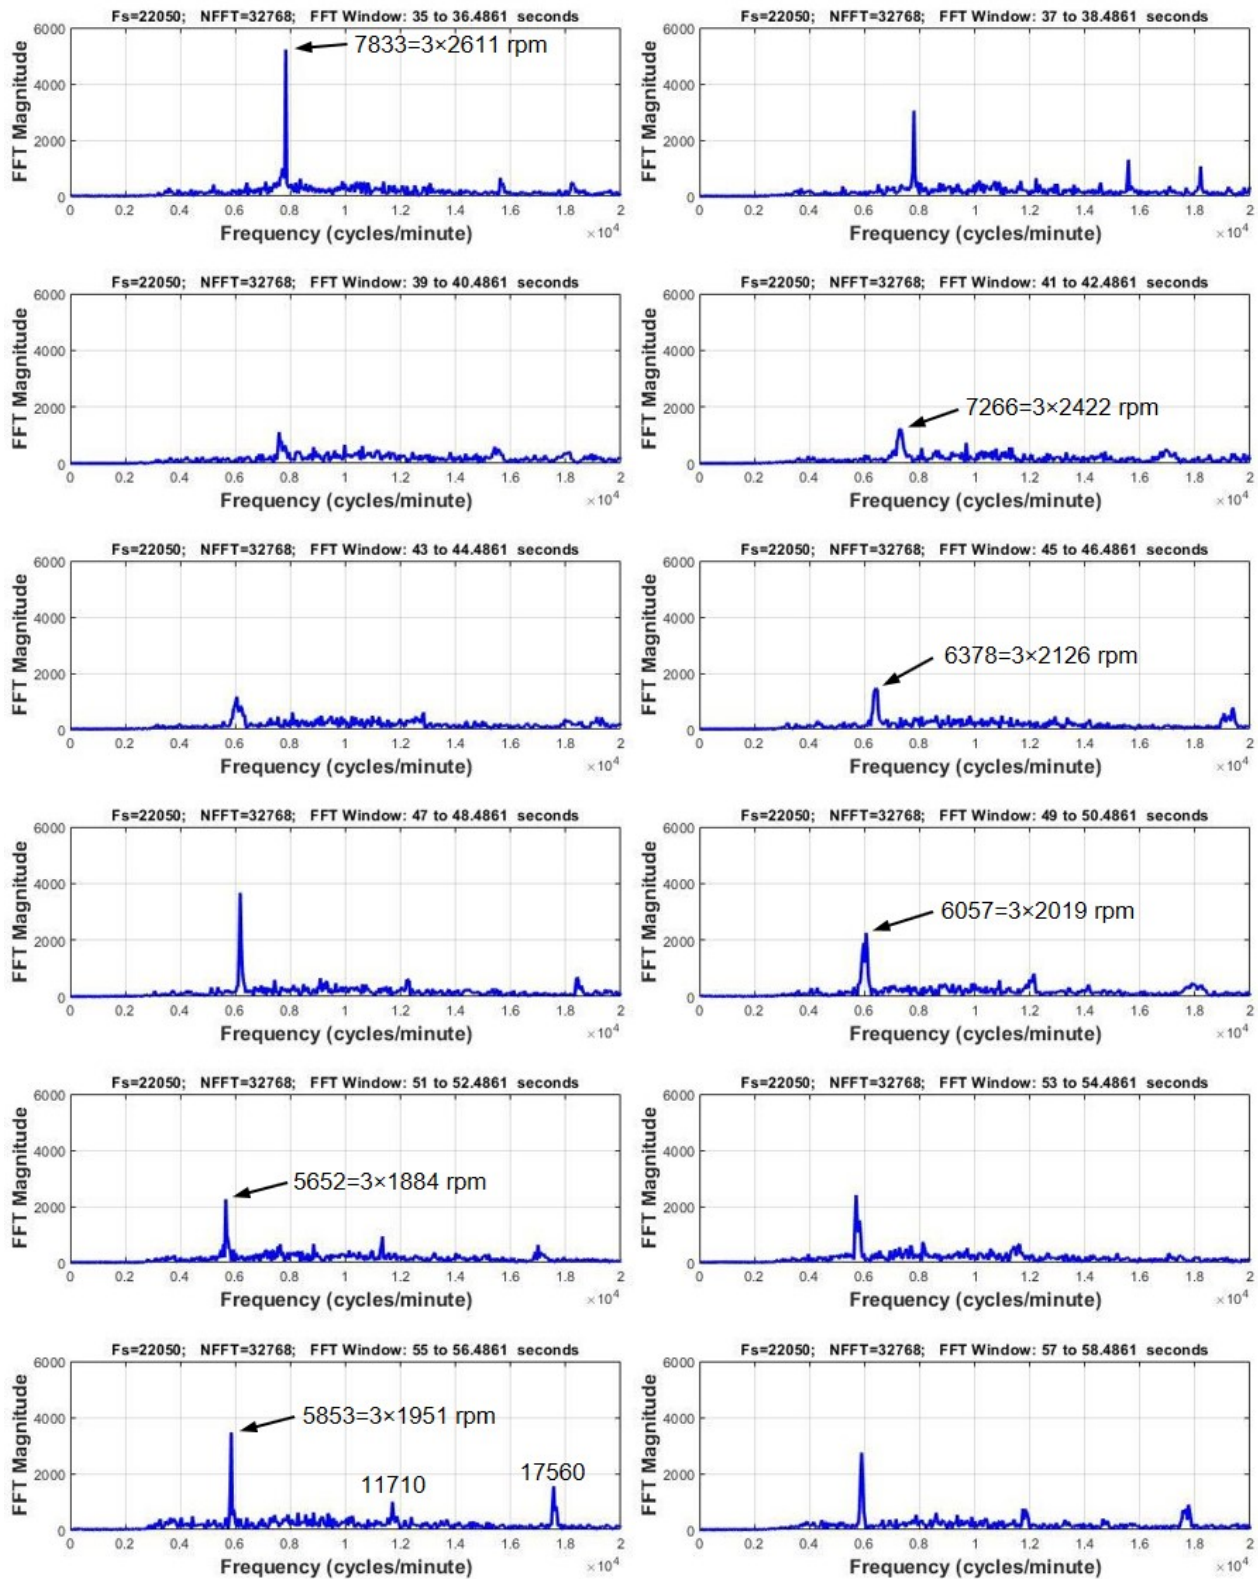
Figure 1. Sound Spectra between Time 35 seconds and Time 57 seconds

Figure 1 shows 12 spectra computed in windows that started at times 35 seconds through 57 seconds into the video, in 2-second increments. At time 35 seconds, the large spectral peak is at 7833 cpm (cycles/minute). Since the propeller had three blades, the estimated engine speed is  $7833/3=2611$  rpm, close to the engine rated speed of 2700 rpm. It is possible that the recorded sound included a contribution from the sound generated inside the 6-cylinder Continental TSIO-520 engine.

Figure 1 shows that the engine speed was decreasing past time 35 seconds, going as low as 1884 rpm at time 51 seconds. Some of the spectra show small spectral peaks at the harmonics of the estimated engine speed, as marked on the spectrum starting at time 55 seconds.

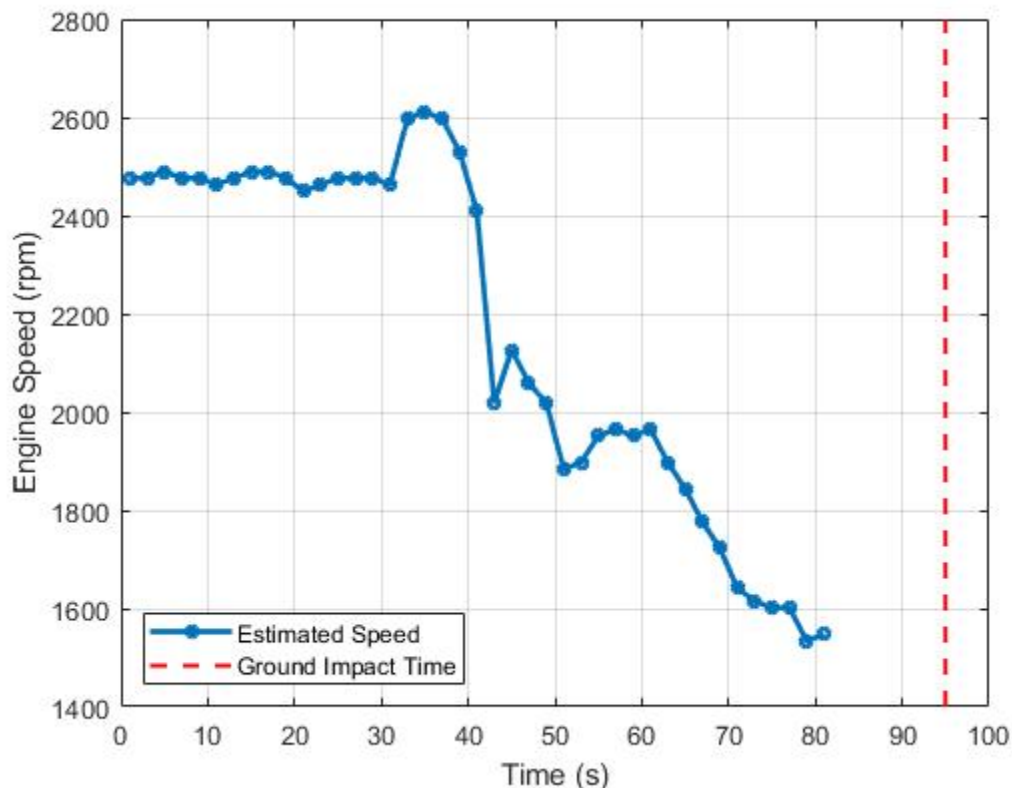
**Figure 2. Estimated Engine Speed**

The figure shows an approximately constant engine speed of about 2500 rpm for about 30 seconds, followed by an increase toward 2600 rpm for about 10 seconds. Between 41 seconds and 43 seconds, the speed decreased by about 400 rpm, from about 2400 rpm to about 2000 rpm. At the last time where analysis was performed, in a time window between 81 seconds and 82.49 seconds, the engine speed was down to 1550 rpm.

Both time-domain analysis and spectral analysis were performed in an attempt to determine if the engine speed decrease past time 41 seconds was due to a complete lack of combustion or if the engine continued operating but at a reduced speed. It was concluded that the information in the video sound channel is insufficient to make such determination.
