Andrew Swick  
Aviation Accident Investigator  
NTSB AS-WPR

**Subject:** WPR20LA258-Phone Conversation with Pilot

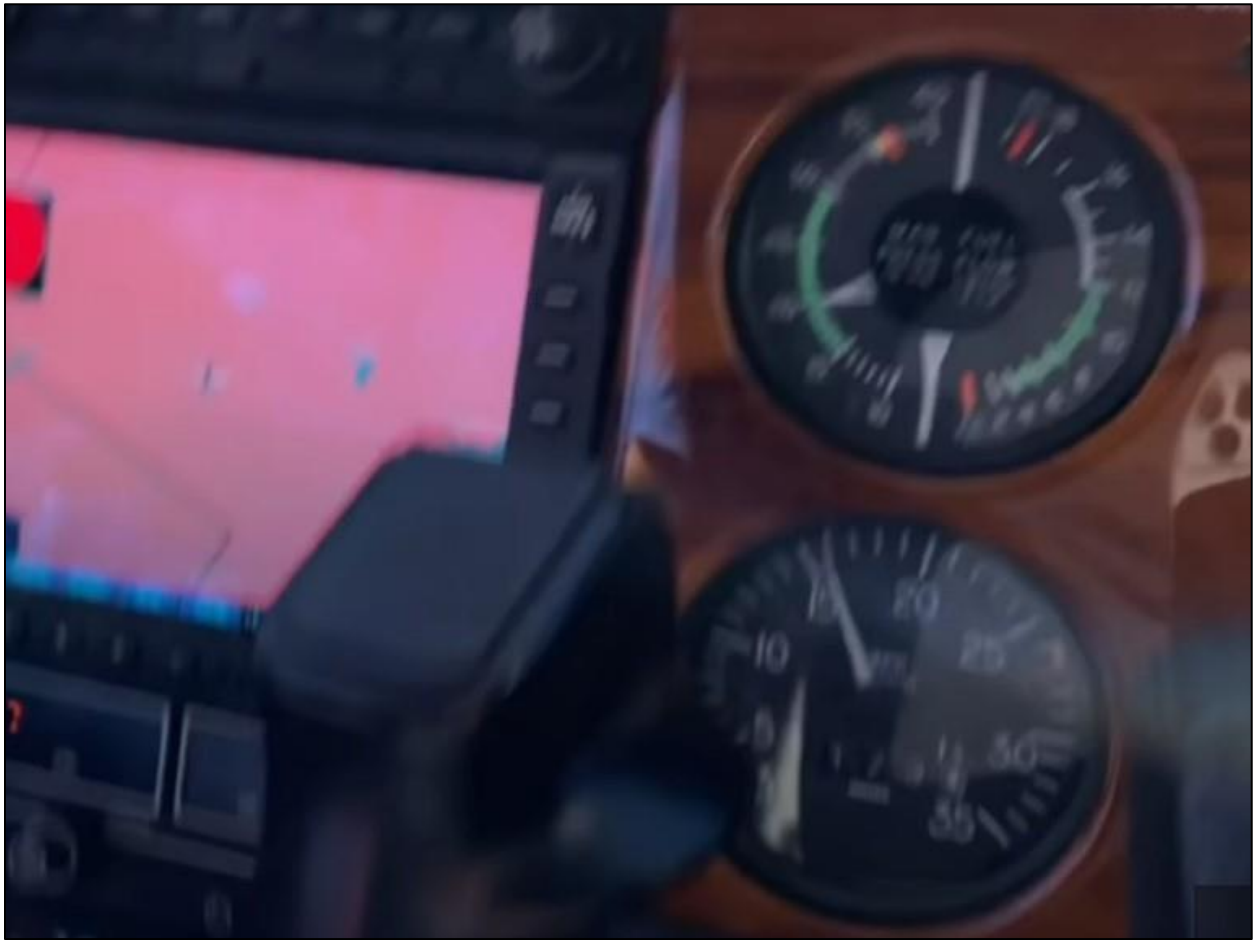
that the rpm gauge indicated about 1,600 rpm, manifold pressure gauge was at about 19 inches of Hg, and the fuel flow needle was off scale. (See Figure 1) Also, the throttle, propeller and mixture levers were all in the full forward position. Fuel selector and fuel quantity gauges were not visible during the accident sequence.

*Figure 1-Image of the instrument panel from the onboard video of the flight.*
