## **NATIONAL TRANSPORTATION SAFETY BOARD**

# **ENGINE EXAMINATION SUMMARY REPORT**

**WPR20LA258**

Location: Hanna, Utah  
Date: August 7, 2020  
Aircraft: N761RG  
NTSB IIC: Andrew Swick

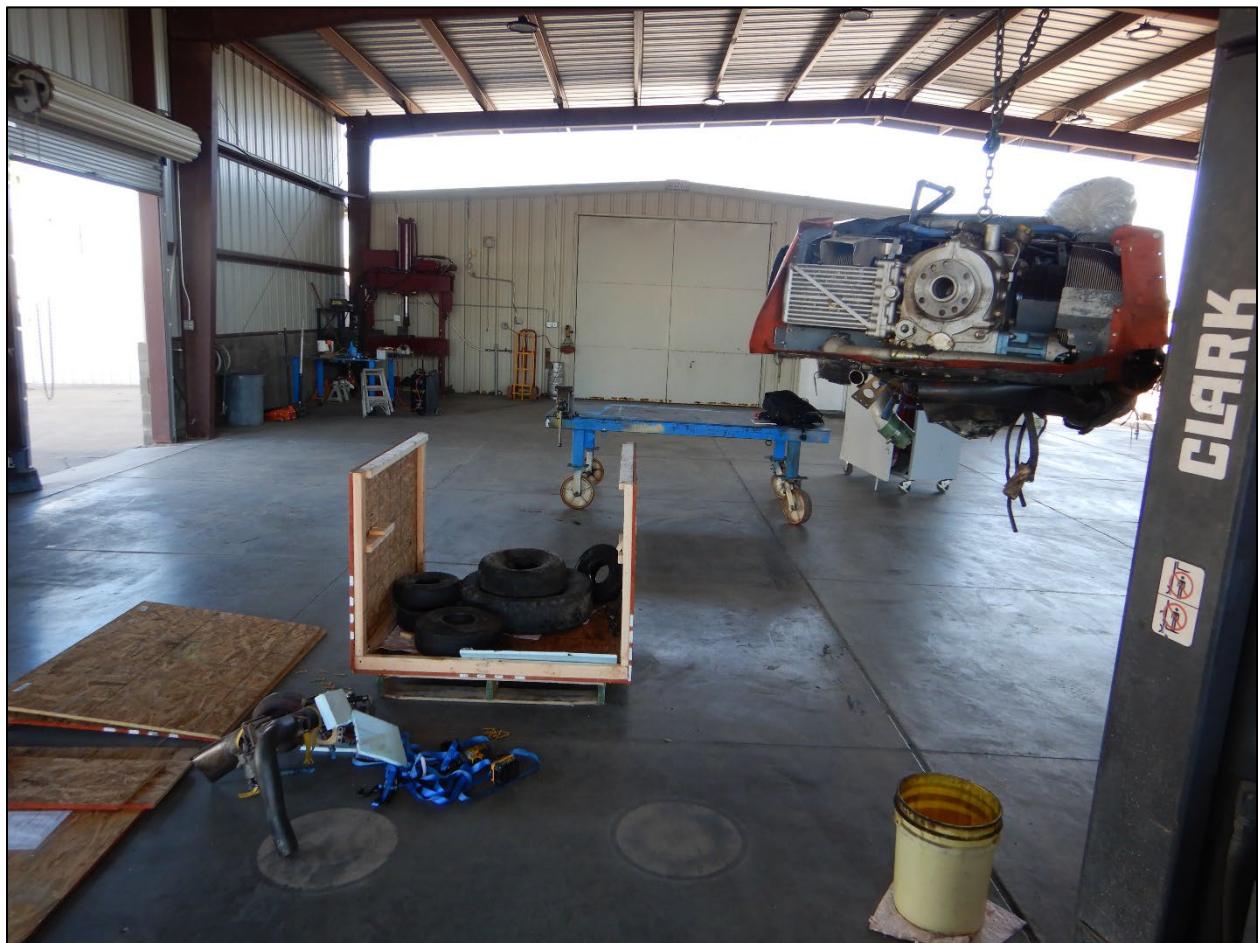
The engine was removed from the crate and hoisted with a forklift. The turbocharger, wastegate and sections of exhaust piping were removed from the engine for shipment. The exhaust assembly and various hoses were also found in the crate and were damaged.

The engine oil sump had impact damage and was breached near the oil drain port. The exhaust assembly was cut from the right side cylinder stacks during the preparation for shipment. The exhaust muffler was crushed and remained attached to the left side cylinders. Various lines and tubing had impact damage and were cut during the removal from the airframe and the removal from the turbocharger. The magnetos and ignition leads were undamaged and secured. The accessory section was undamaged and all accessories remained attached. The crankcase backbone area and oil filler neck were covered in an oil and dirt residue.

Figure 1-Engine and crate.

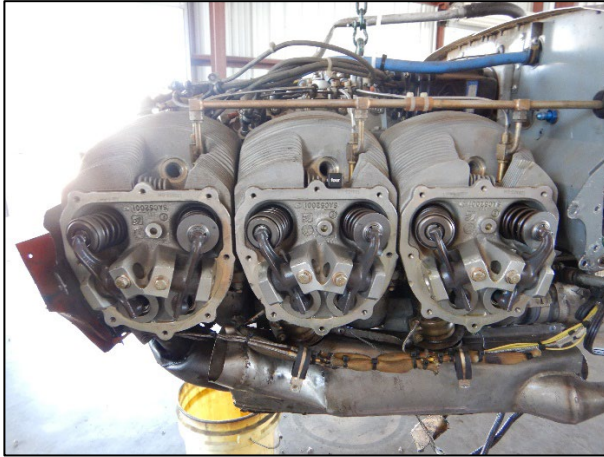
The baffling assembly was removed from the engine. The cylinder rocker covers were removed and the overhead components were covered in a clear residual oil. The cylinders were undamaged.

Figure 2-Left cylinder's overhead components.

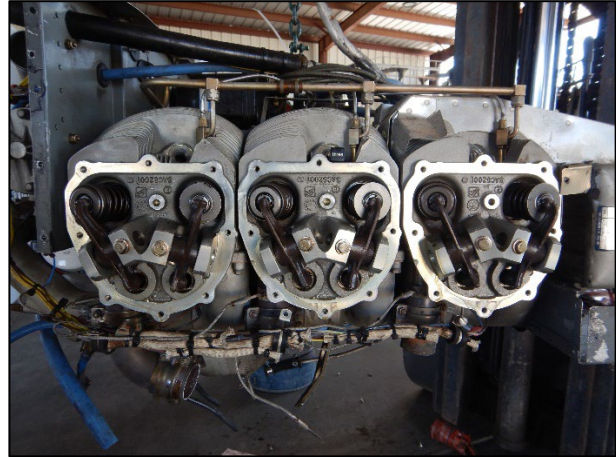
Figure 3-Right cylinder's overhead components.

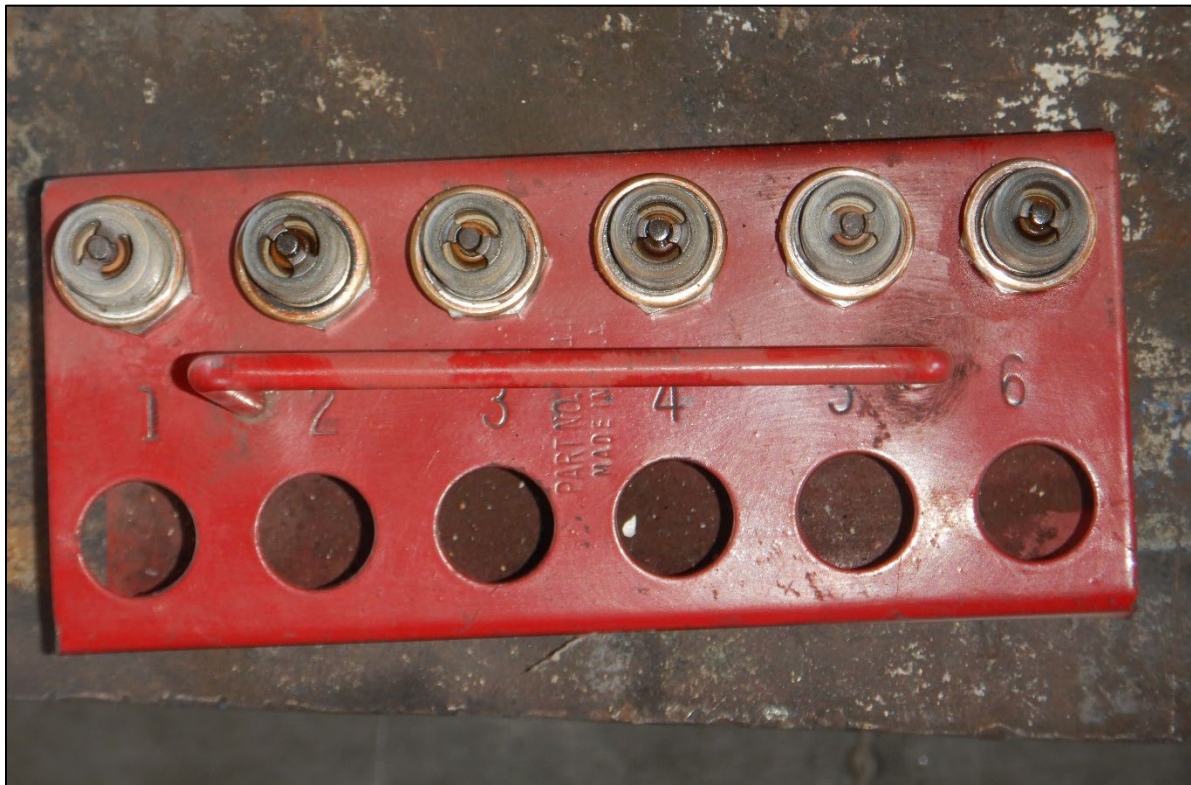
The upper sparkplugs were removed and displayed in a rack. The sparkplugs had a normal amount of combustion deposits and the electrodes had normal wear. The No. 2, 4 and 6 electrode areas had a light residue of oil.

Figure 4-Upper sparkplugs.

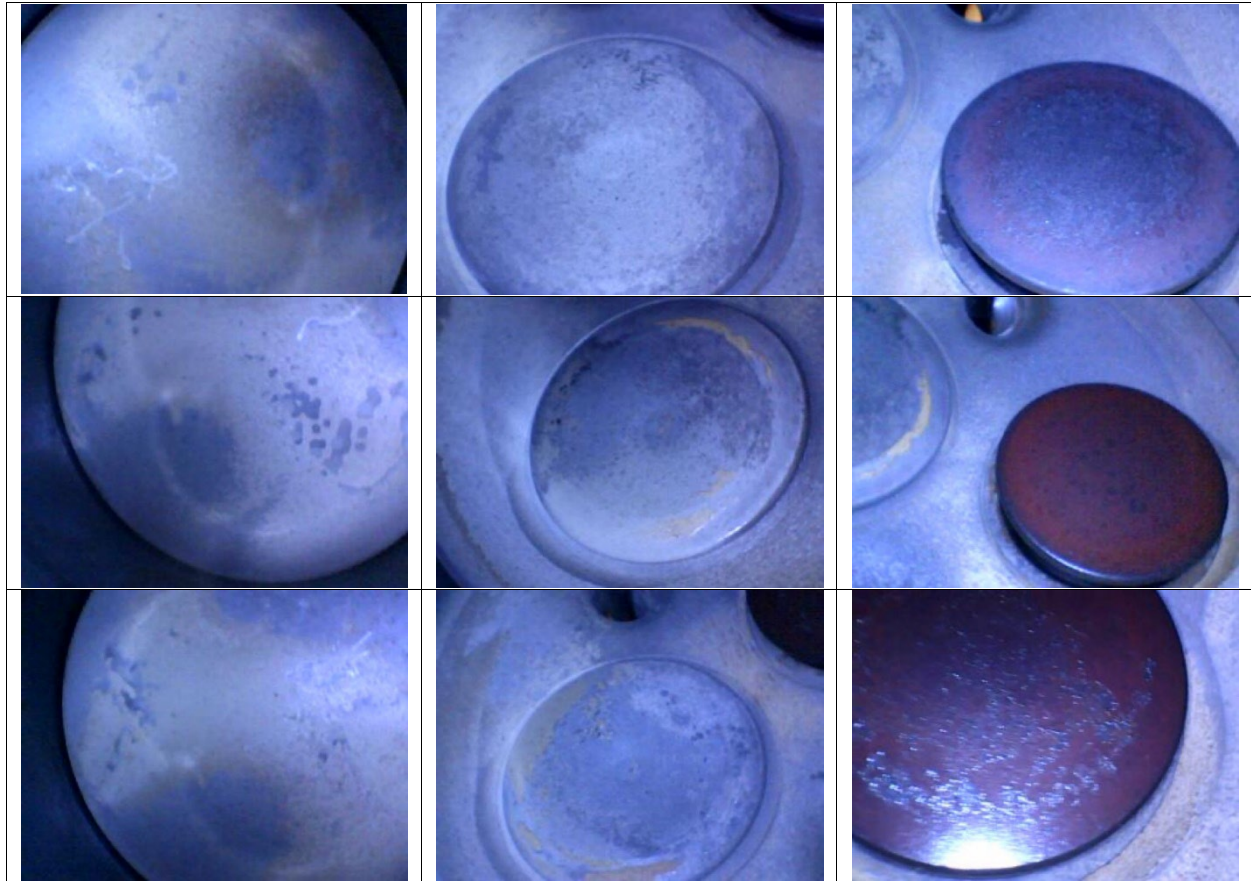
The cylinders were boroscoped and all cylinder combustion chambers had normal operating signatures. The amount of combustion deposits was minimal.

Figure 5-Cylinder Nos. 1, 3 and 5 piston domes and valve heads.

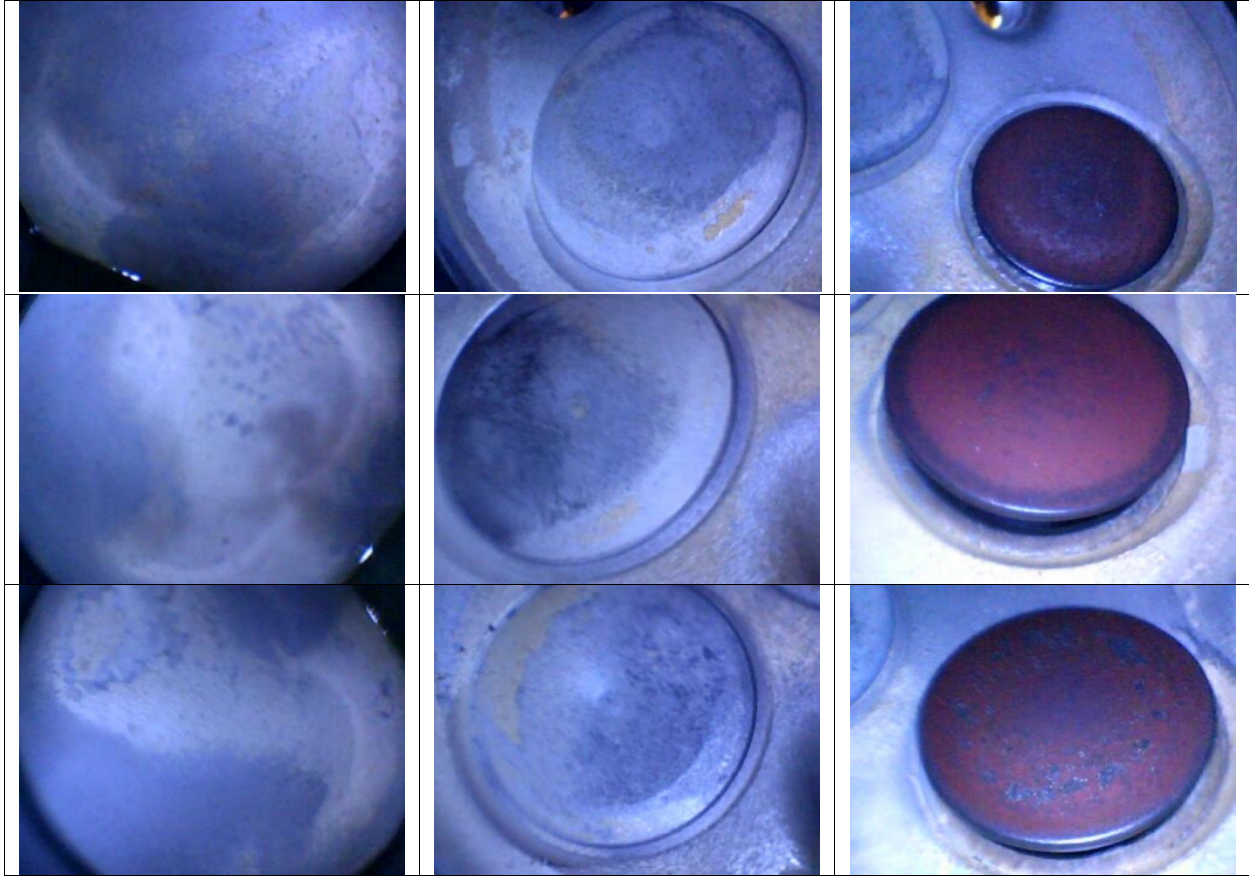
Figure 6-Cylinder Nos. 2, 4 and 6 piston domes and valve heads.

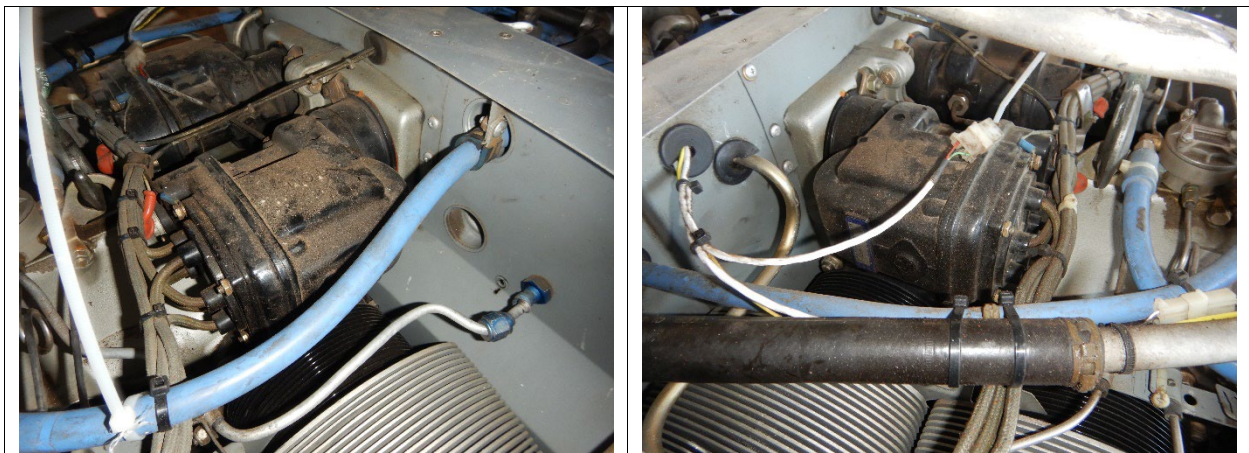
The magnetos were undamaged and not removed from the engine during the examination. The magneto P-lead wires remained secured to the magnetos and were cut near the firewall during the shipment process. During the crankshaft rotation, spark was observed at each ignition lead end (12).

Figure 7-Magnetos.

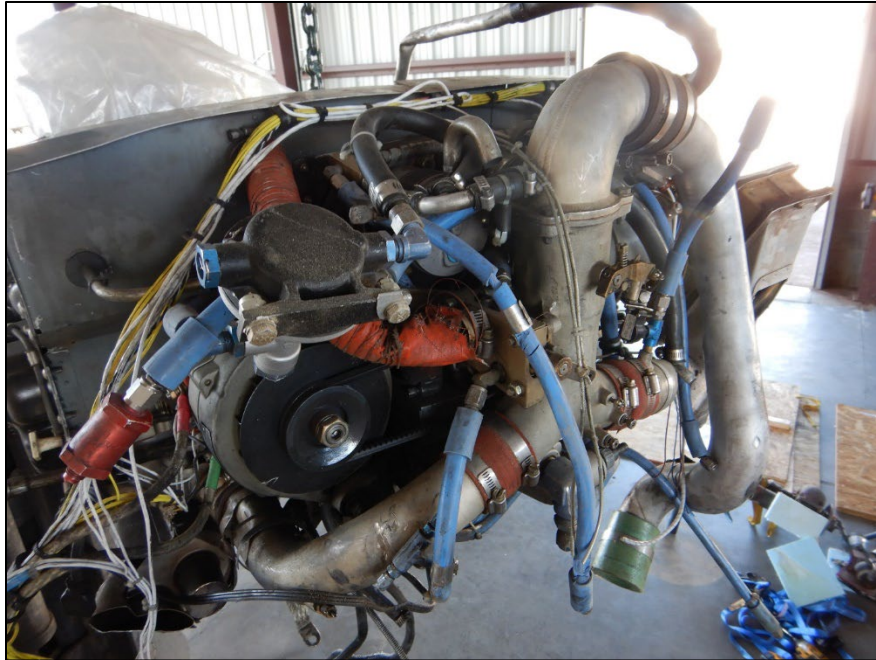
The induction risers below the forward cylinders had impact damage. The right induction tube rubber coupling connecting to the wye duct, had impact damage. The throttle body and connecting tubing was removed from the engine. The rubber couplings and band clamps were properly attached.

Figure 8-Accessory section.

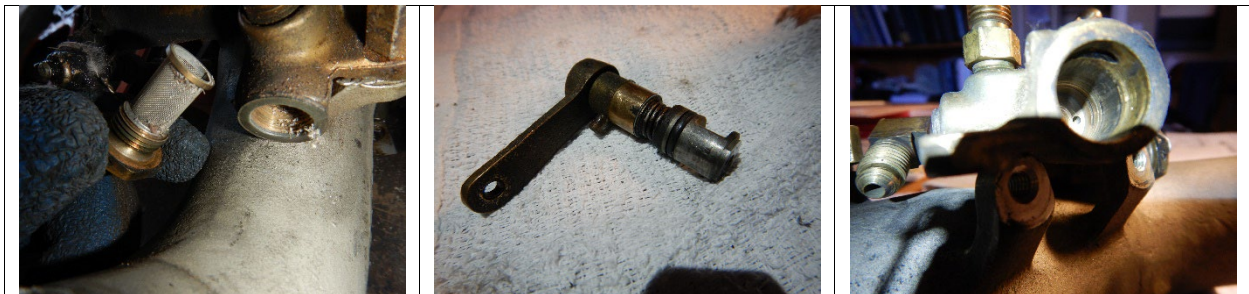
The fuel control throttle and mixture linkage arms were bent and both control cables were removed during the shipment of the engine. The linkage arms moved freely by hand. The fuel control unit was undamaged and the inlet screen was removed and contained a light amount of fibrous debris. The connecting fuel line b-nut fittings were secure. The fuel control unit was disassembled. The fuel control shafts and cavities showed normal operating signatures and the o-rings were intact and undamaged. An oily grey deposit material was found on both shaft spring assemblies.

Figure 9-Fuel control disassembly.

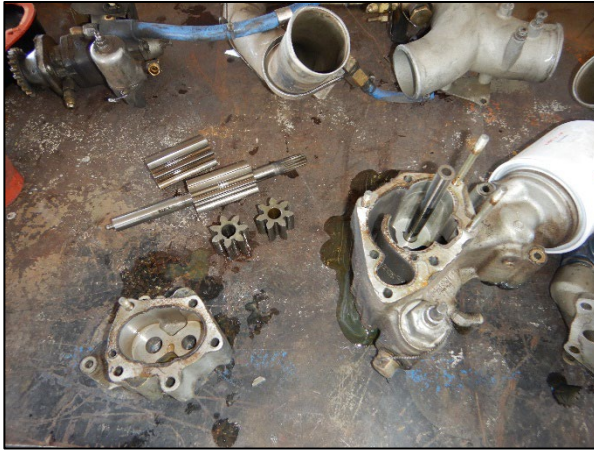
The oil pump was removed from the engine and disassembled. The gears of both the scavenge pump and oil pump cavities showed normal operating signatures with some hard particle passage. The oil filter was removed from the engine and disassembled. The filter can and element pleats were clear of debris.

Figure 10-Oil pump and scavenge pump disassembled.

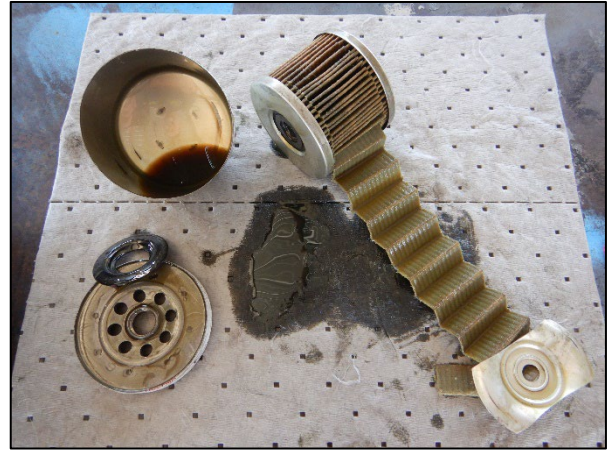
Figure 11-Oil filter disassembled.

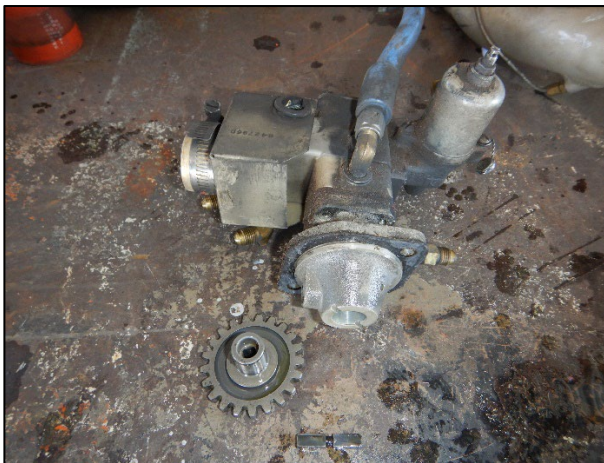
The fuel pump was removed from the engine and attached fuel line fitting were secured. The fuel pump was undamaged, and the drive coupling was intact. The pump was rotated with a hand drill and the pump flowed fuel normally.

Figure 12-Fuel pump and drive coupler.

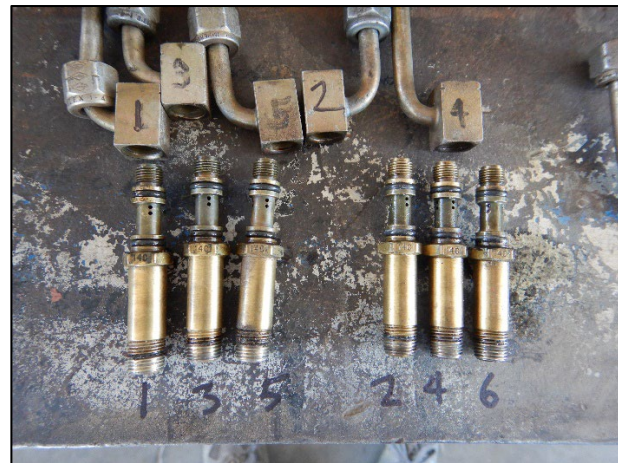
The fuel injectors were removed from the engine and were clear of debris.

Figure 13-Fuel injectors.

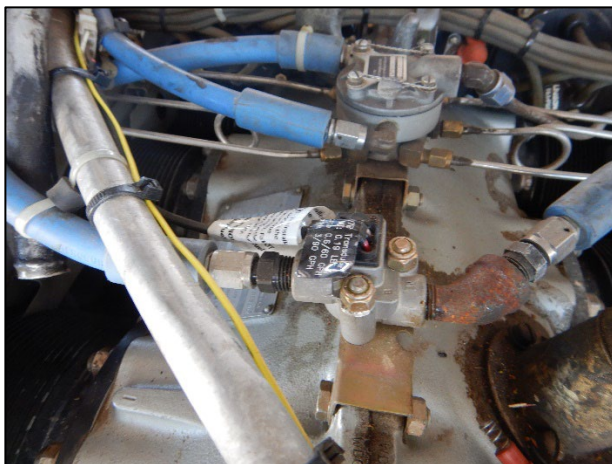
The fuel flow transducer was undamaged, and the fuel line b-nut fittings were secure. A 45-degree cast iron 'street' fitting was attached to the inlet side of the fuel flow transducer. The fittings were removed and were clear of debris. Pressurized air through the transducer caused the internal turbine to spin up momentarily.

Figure 14-Fuel flow transducer.

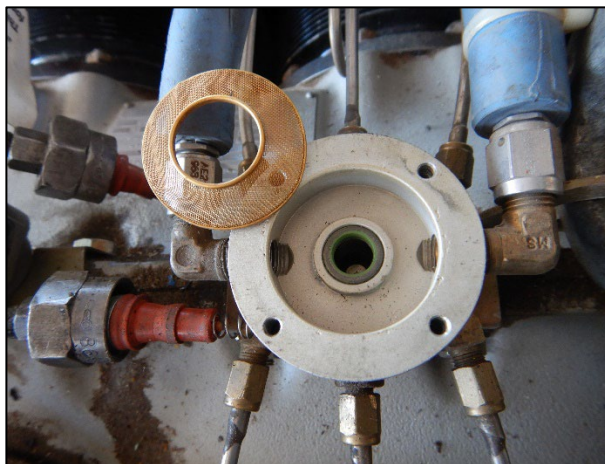
The fuel manifold valve was disassembled, and no anomalies were noted. The fuel manifold screen was clear of debris.

Figure 15-Fuel manifold valve.

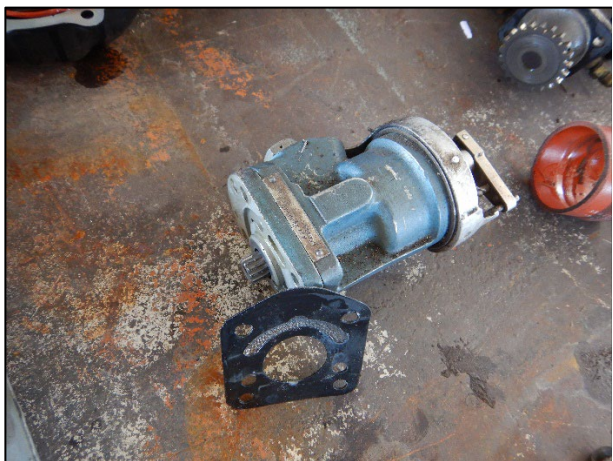
Figure 16-Propeller governor and seal/screen.

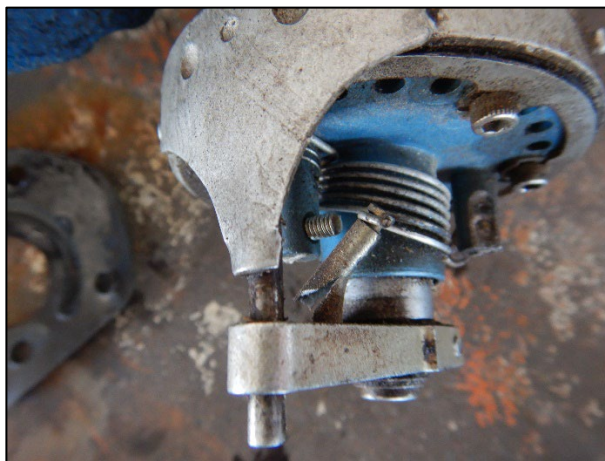
The propeller governor was removed from the engine and the spring attachment rod on the moveable linkage was bent to one side. The damage was consistent with impacting the adjustment screw end. The propeller governor linkage moved freely by hand. The seal screen was removed and was clear of debris.

Figure 17-Propeller governor linkage damage.

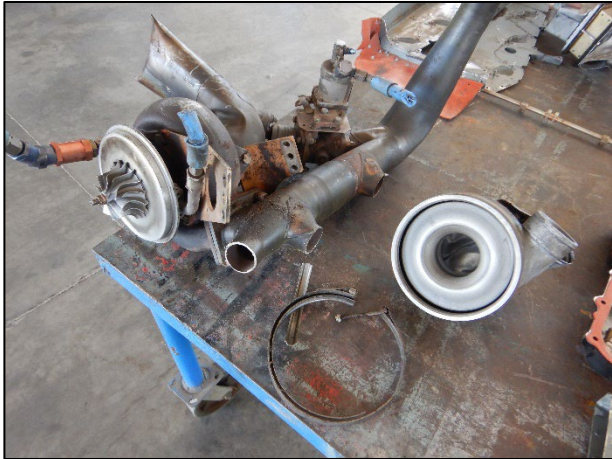
The turbocharge induction side was removed from the assembly prior to the examination. The turbine shaft moved freely, and the compressor blades and scroll were undamaged. The exhaust pipe was impact damaged and was removed from the turbocharger. The turbine blades were undamaged. The turbocharger attached oil b-nut fittings were secure.

Figure 18-Turbocharger assembly.

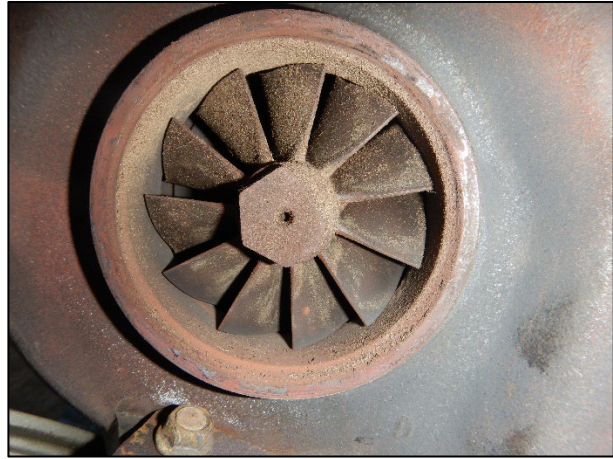
Figure 19-Turbocharger turbine blades.

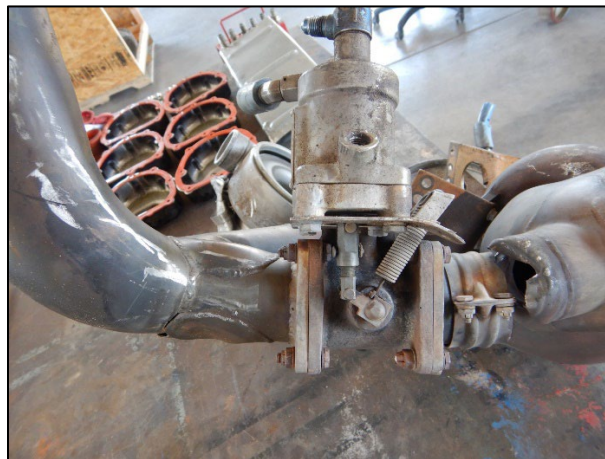
The wastegate assembly inlet line fitting separated from the housing. The other b-nut fittings were secure to the wastegate assembly. The wastegate valve linkage was undamaged and moved freely under spring tension.

Figure 20-Wastegate assembly.
