## **NATIONAL TRANSPORTATION SAFETY BOARD**

# **AIRFRAME EXAMINATION SUMMARY**

**WPR20LA258**

Location: Hanna, Utah  
Date: August 7, 2020  
Aircraft: N761RG; Cessna T210M

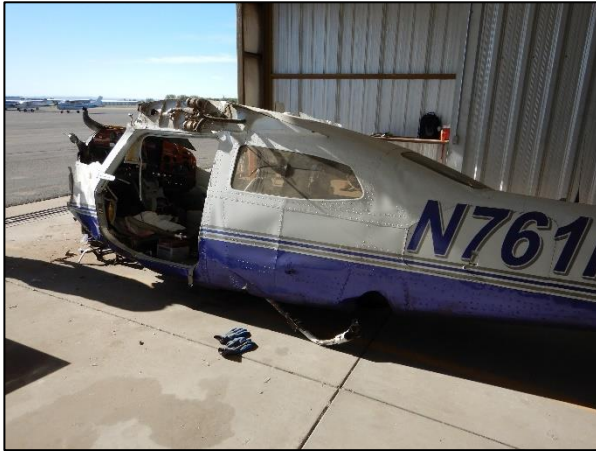
The wings, stabilizers, elevators, and rudder were removed during the recovery process. The main wreckage had impact damage to the firewall and forward fuselage. Bucking of the fuselage was found throughout and the forward cabin floor was crushed upwards.

Figure 1-Main wreckage, view of the left side.

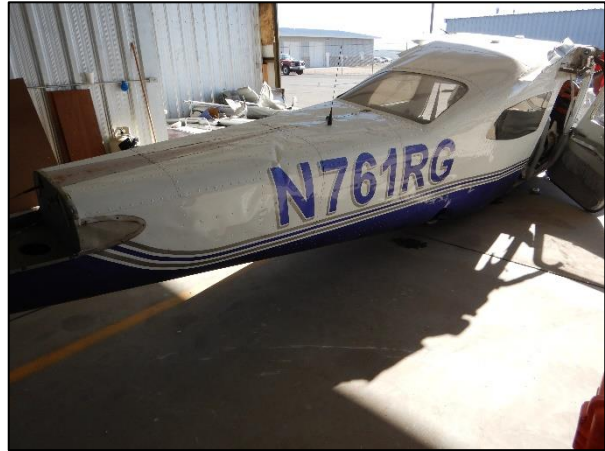
Figure 2-Main wreckage, view of the right rear side.

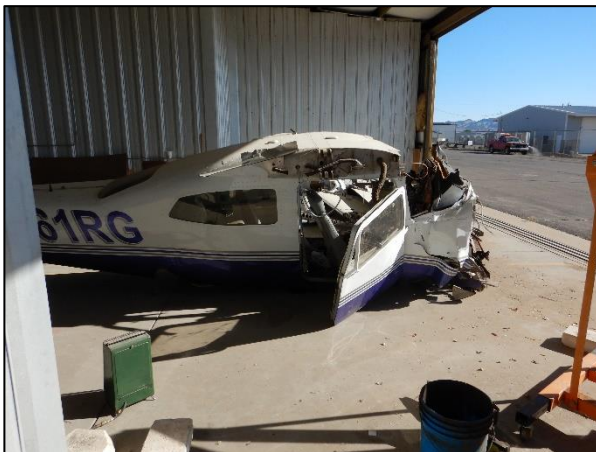
Figure 3-Main wreckage, view of the right side.

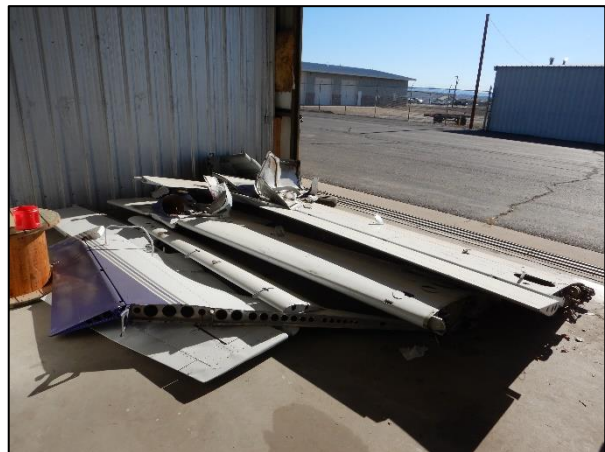
Figure 4-Separated wings, stabilizers, elevators, and rudder.

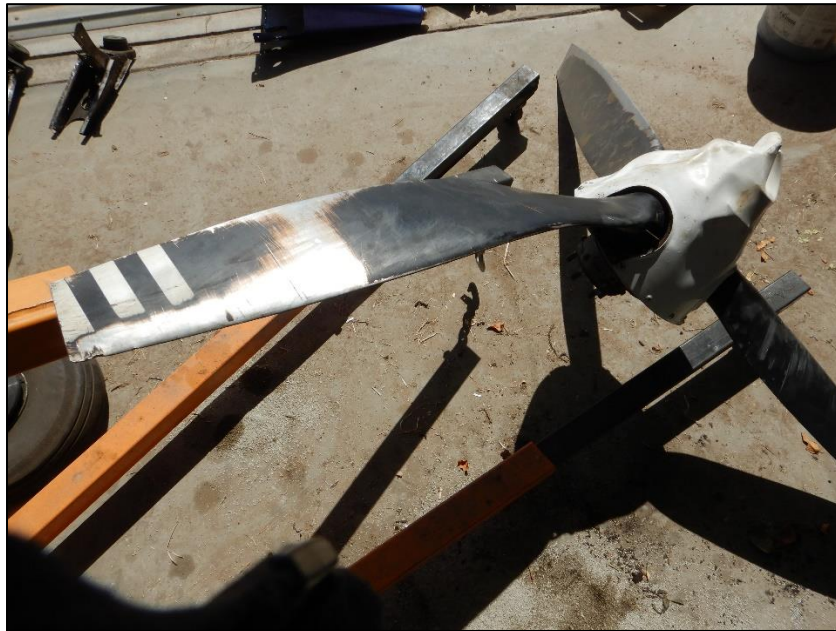
The propeller blades were loose in the hub and the spinner had impact damage. The blades surfaces had scuffing of their cambered side and leading-edge gouging.

Figure 5-Propeller assembly.

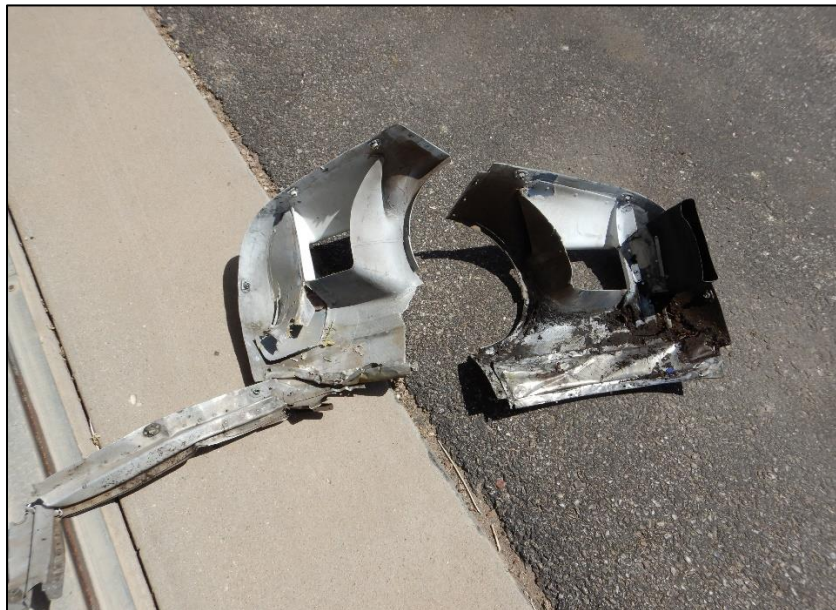
Figure 6-Forward engine cowling.

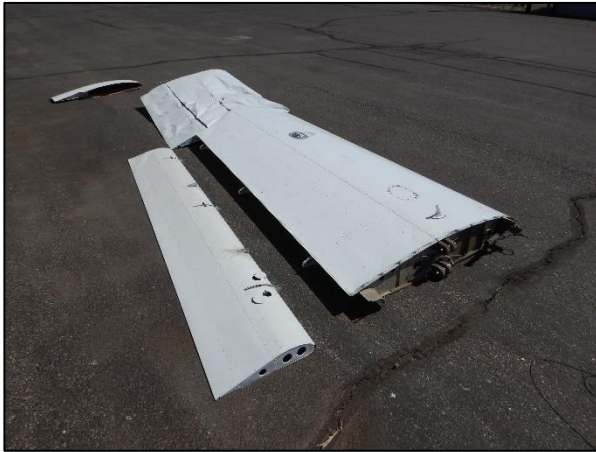
The wings were displayed on the ground and revealed buckling near the outboard areas. The wing tank caps remained intact and undamaged. Flight control cable continuity was established throughout the wings and fuselage.

Figure 7-Left wing.

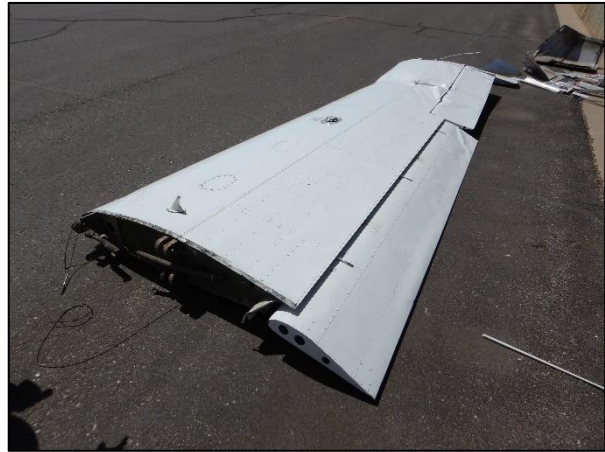
Figure 8-Right wing.

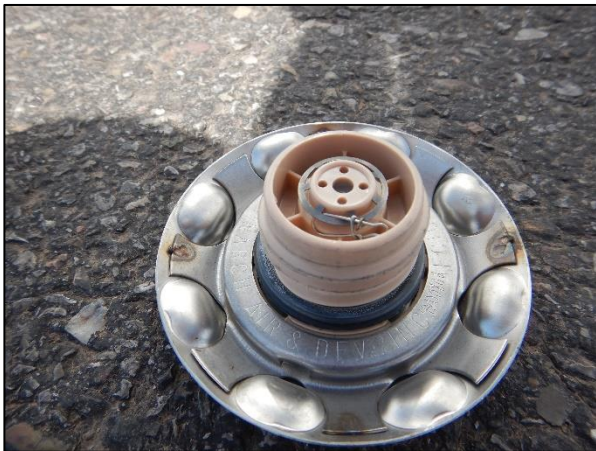
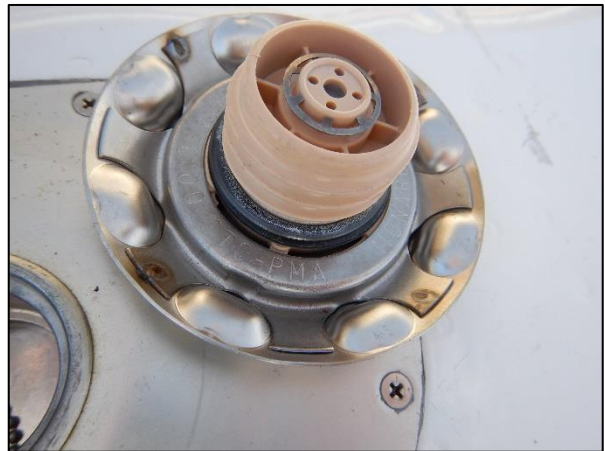
Figure 9-Wing tank fuel cap.

Figure 10-Wing tank fuel cap.

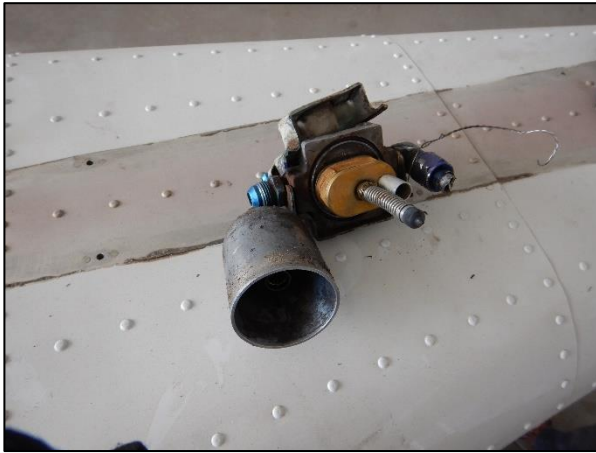
The fuel strainer was removed from the firewall area and disassembled. A large amount of blue colored fuel was found in the strainer bowl. The strainer had a light amount of debris and the bowl was clear of contaminants.

Figure 11-Fuel strainer.

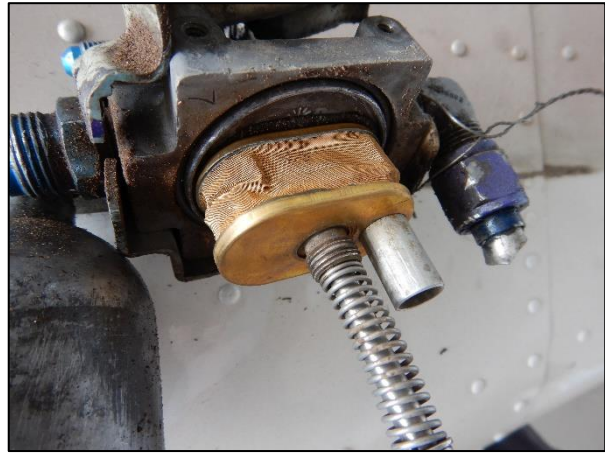
Figure 12-Fuel strainer screen.

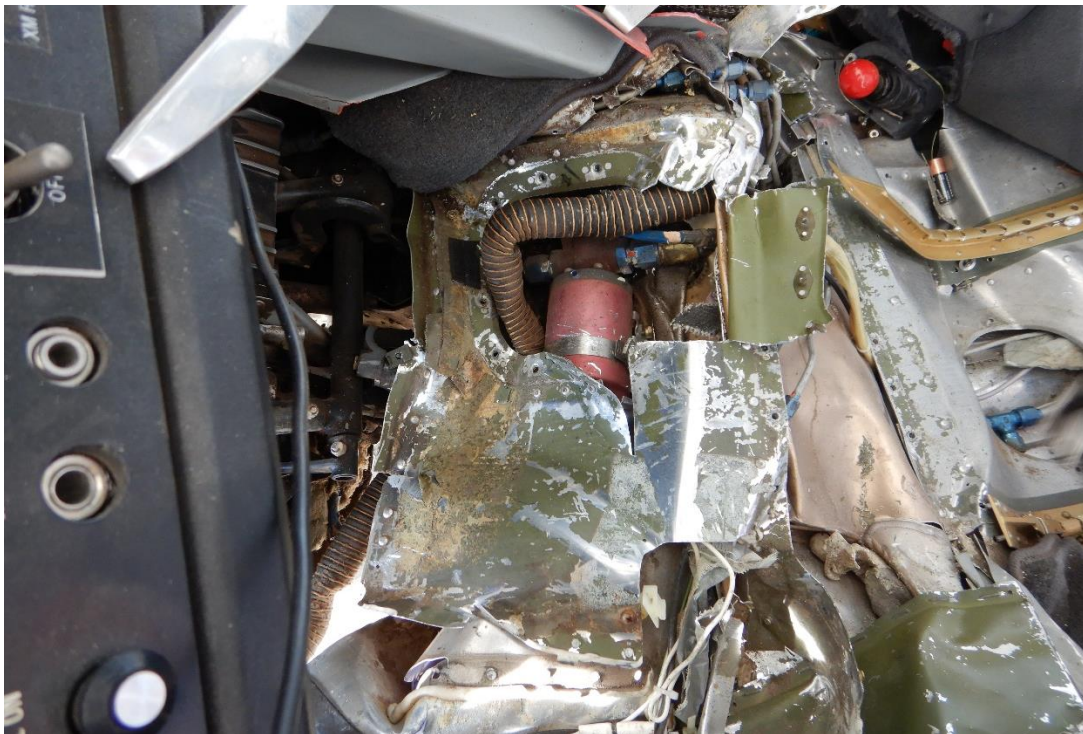
The electric boost pump was removed from the damaged forward fuselage. The pump was connected to a battery and operated normally.

Figure 13-Electric boost pump.
