## **NATIONAL TRANSPORTATION SAFETY BOARD**

# **AIRFRAME EXAMINATION SUMMARY REPORT**

**WPR20LA270**

Location: Susanville, CA  
Date: Aug 15, 2020  
Aircraft: N91449  
NTSB IIC: Stephen Stein

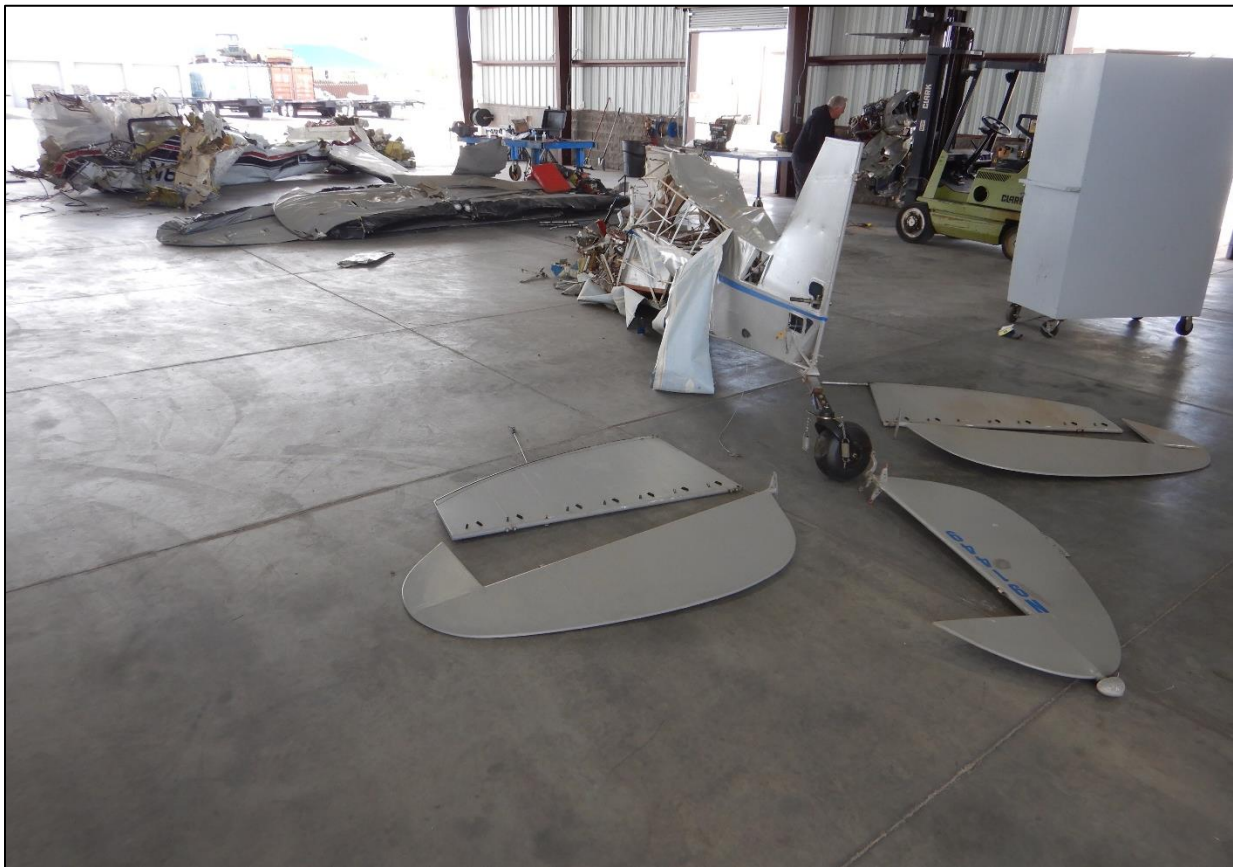
**Figure 1-Main wreckage displayed in the examination area.**

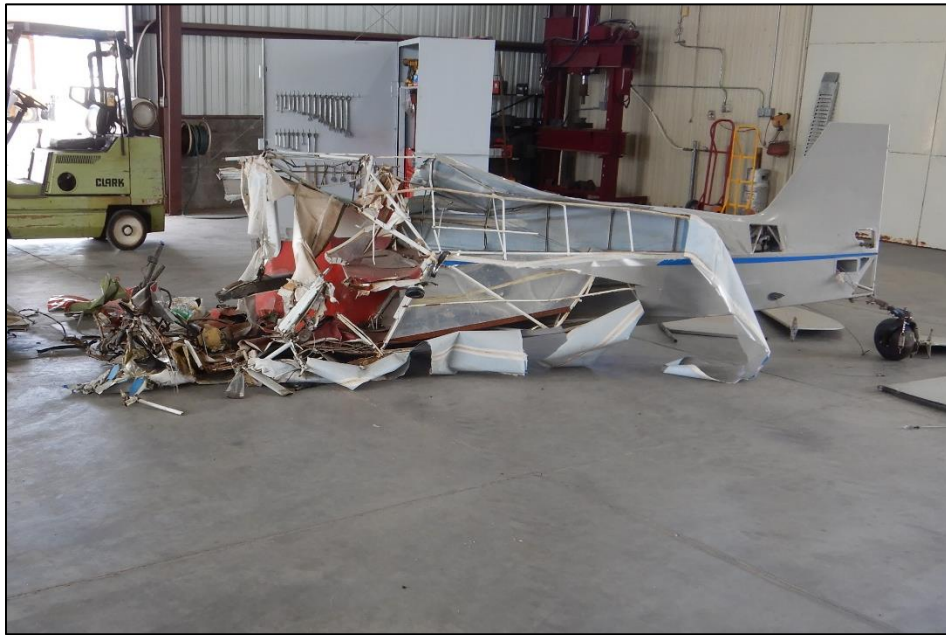
The forward left side of the fuselage (left cabin area) had extensive impact damage. The lower fuselage fabric was removed revealing control cables and structure. The fuselage tubing structure had corrosion deposits throughout. Many of the areas of the undamaged tubing's structure joints had bubbled and chipped paint revealing corrosion deposits. The cabin control sticks remained attached to their linkage and all flight control cables remained attached and secured to the control stick linkage.

**Figure 2-Fuselage displayed in the examination area.**

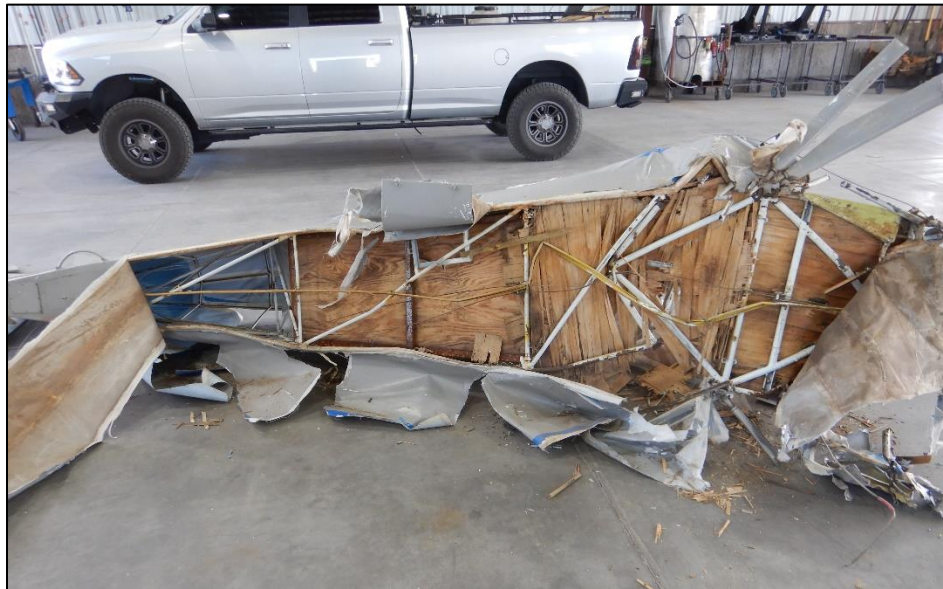
**Figure 3-Lower side of fuselage with the fabric removed.**

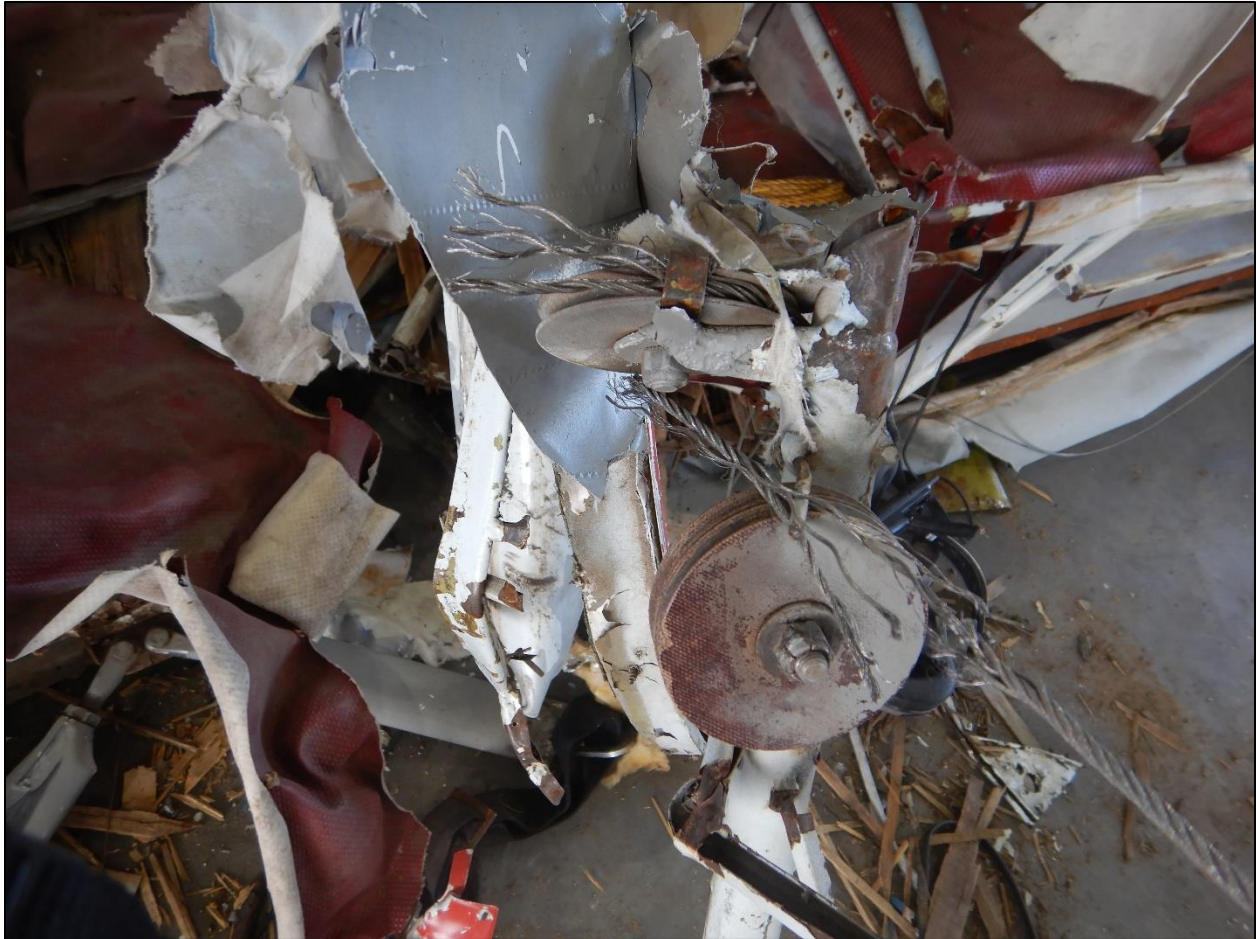
Flight control cable continuity was attained through the fuselage, from the elevators and rudder to the control stick linkage. The right aileron cable continuity was attained through cuts made during the recovery process. The left aileron cable continuity was attained through separations consistent impact damage and overload. A cable pulley for the left aileron cable, located at the top left side of the fuselage, revealed signatures of cable wear and would not easily rotate by hand.

**Figure 4-Left aileron cable and pulley assembly.**

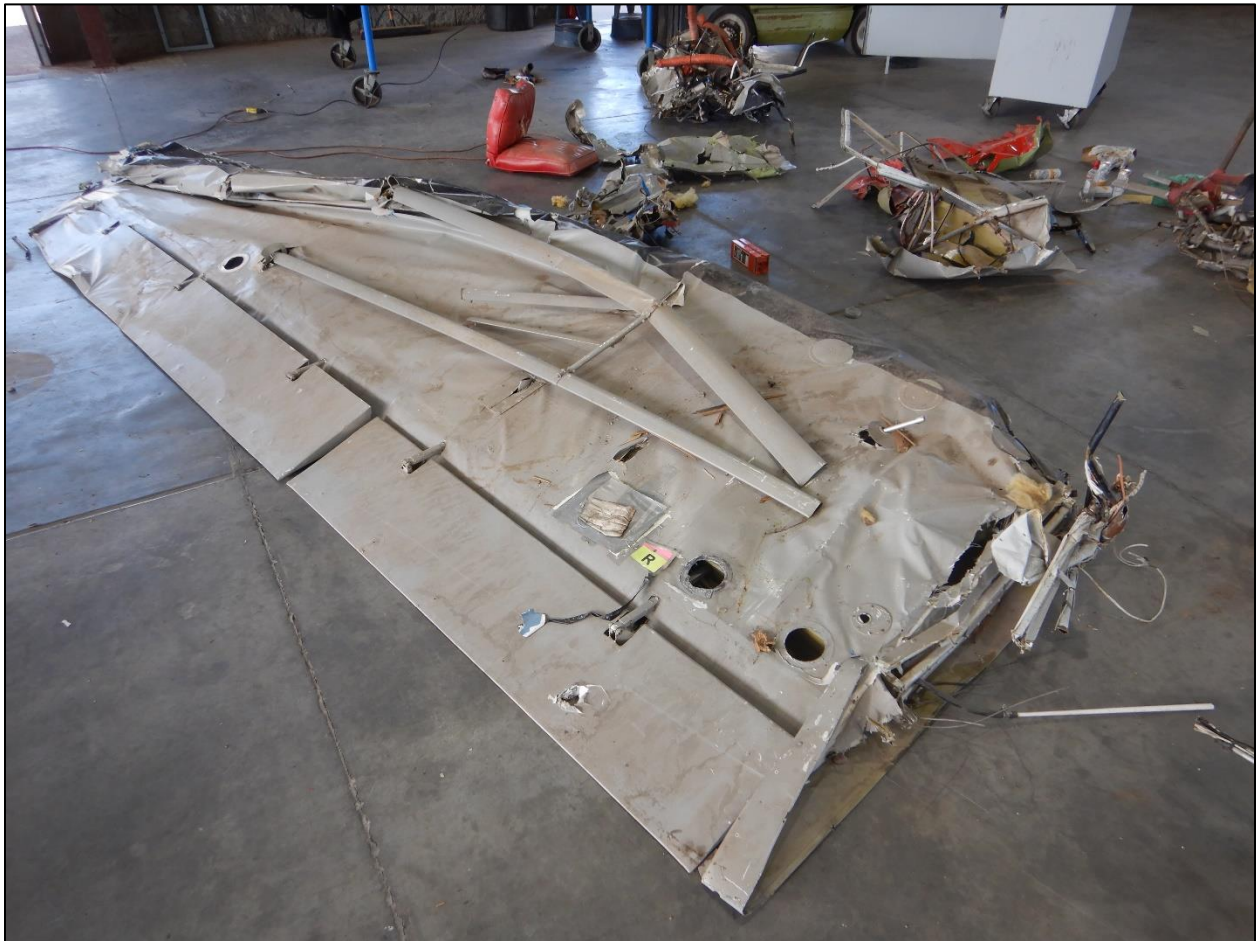
The right wing leading edge had impact damage with extensive crush damage to the leading edge outboard end. The fabric was removed from the wing and buckling was noted to the internal structure. The flap and aileron remained attached to their attach points. The aileron and flap control cable continuity were attained from their respective bellcrank, to the wing root area. The aileron bell crank separated from the aileron control rod. Impact damage was noted to the surrounding area. An inspection panel area was sealed off with silver duct tape near the flap's bellcrank.

**Figure 5-Right wing lower surface.**

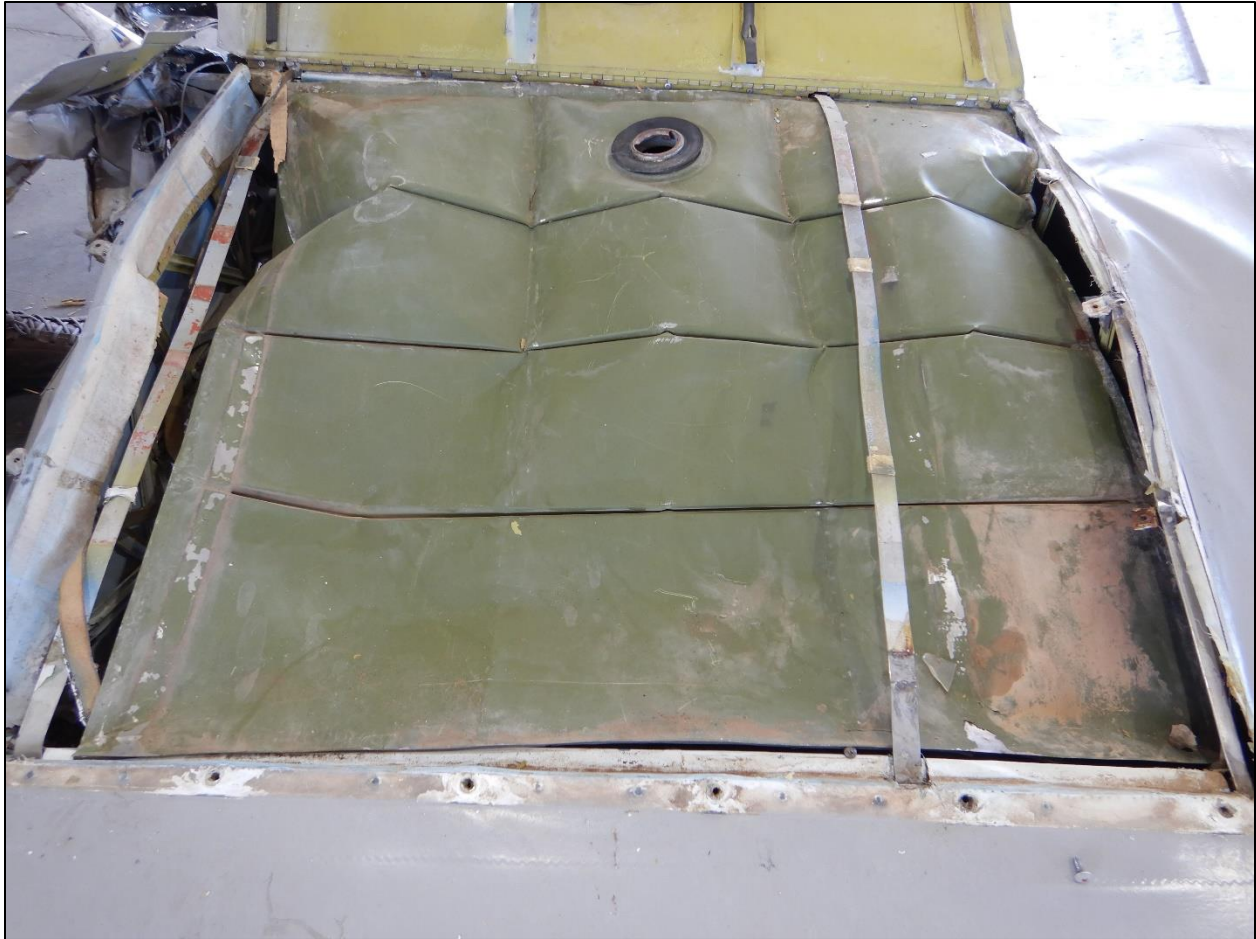
The right wing fuel tank was removed from the wing. The tank was breached on the forward right corner and hydraulic deformation was noted. The vented fuel tank cap had impact damage and the cap seal was undamaged. The fuel tank indicator mount was damaged from its wing mount and separated from the tank. The fuel sump separated from the tank.

**Figure 6-Right wing fuel tank.**

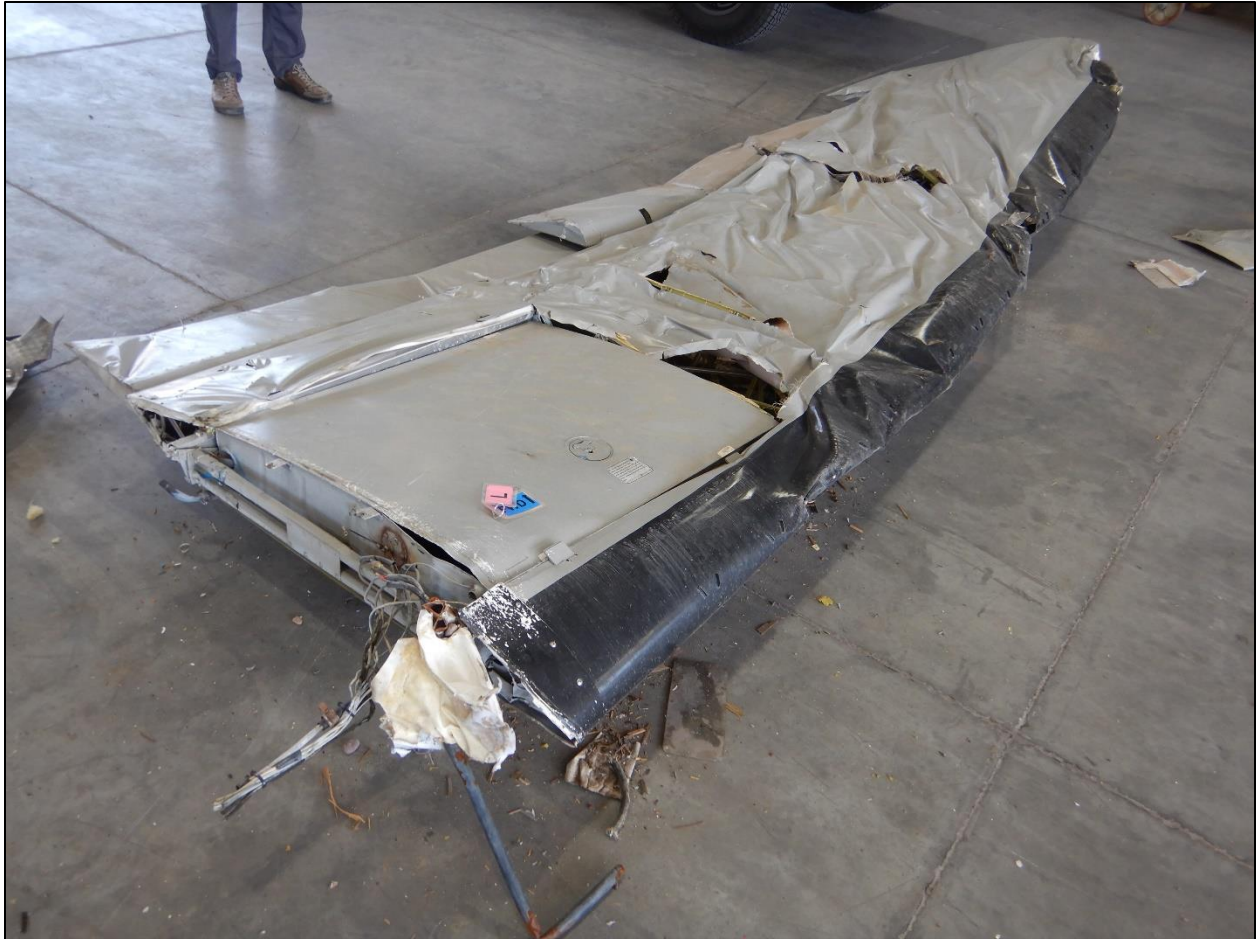
The left wing leading edge had impact damage. The wing had buckling throughout. The aileron had impact damage and separated from the wing's attach points. The flap remained attached to its attach points. The aileron and flap control cable continuity were attained from their respective bellcrank, to the wing root area.

**Figure 7-Left wing upper surface.**

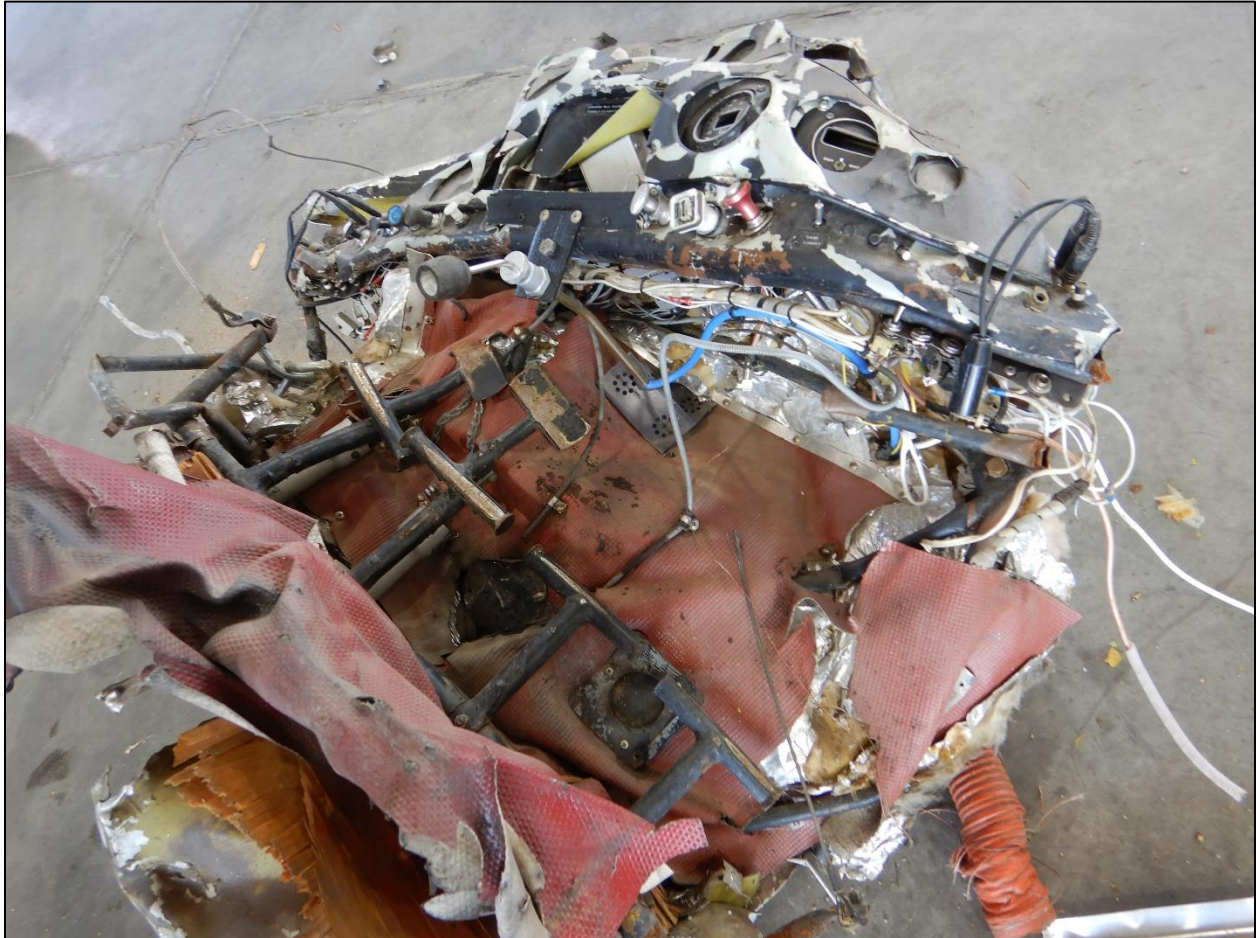
The firewall was removed from the engine and had impact damage. The muffler, sections of the engine mount assembly, the instrument panel and forward fuselage remained attached to the firewall. The rudder pedal assembly remained attached to the forward fuselage and the rudder control cables were cut during the recovery process. The instrument panel had impact damage and contained most of its instruments. The throttle knob was pulled out about 4 inches from its full forward position and was bent downward.

**Figure 8-Firewall and the forward fuselage section.**

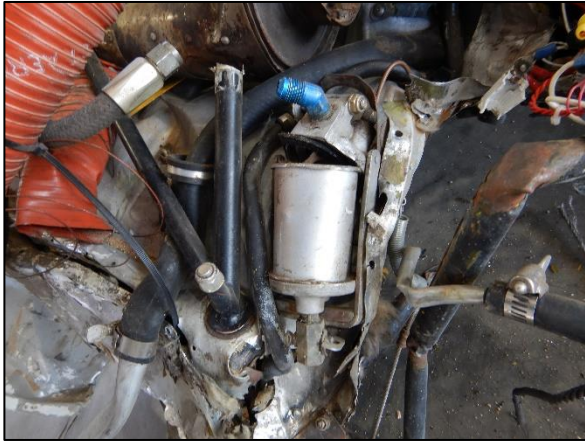
Fuel lines from the wing tanks to the fuel selector valve and from the fuel selector valve to the gascolator were found in damaged sections throughout the wreckage. The fuel selector valve separated from the main wreckage and remained attached the cabin's interior panel. The fuel selector valve handle was found in the left wing tank position and all fuel lines connecting to the valve had impact damage and separated near the valve. Pneumatic pressure was used to verify the valves internal position and the operation of each of the valve's positions. The selector valve and handle were found in the left wing tank position. The fuel gascolator remained attached to the firewall and had impact damage. The gascolator bowl partially separated from the gascolator revealing the internal screen. Dirt and debris were noted in the bowl and surrounding area.

**Figure 9-Fuel gascolator.**

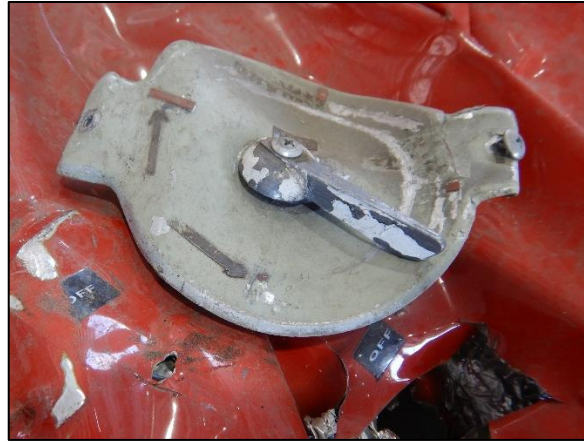
**Figure 10-Fuel selector valve.**

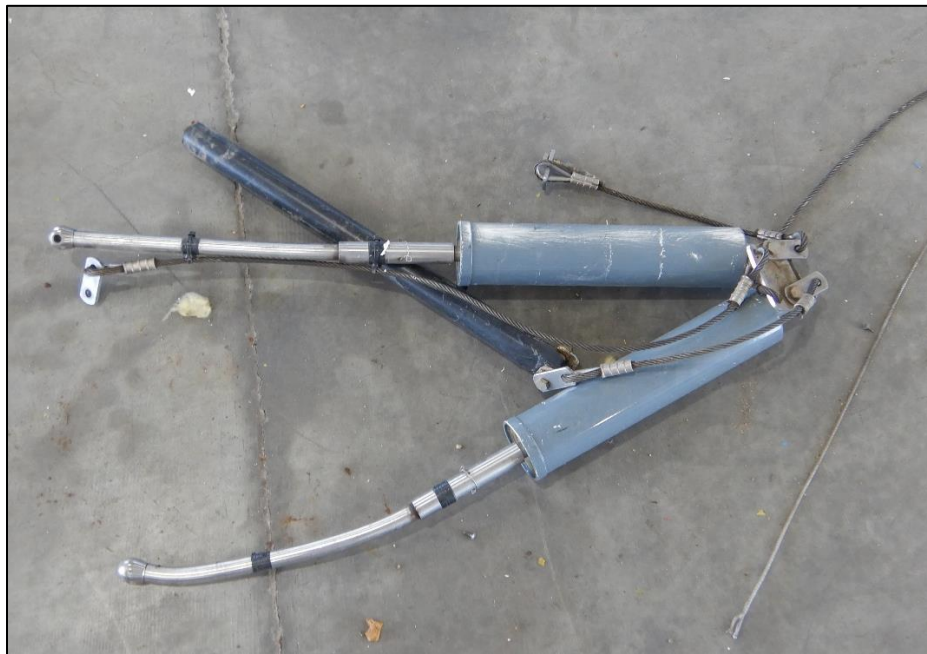
The main landing gear shocks separated from the main wreckage and had impact damage.

**Figure 11-Main landing gear shocks.**
