## FACTUAL REPORT - ATTACHMENT 1

Annunciator Panel Lightbulb Examination

# WRECKAGE EXAMINATION

WPR20LA280

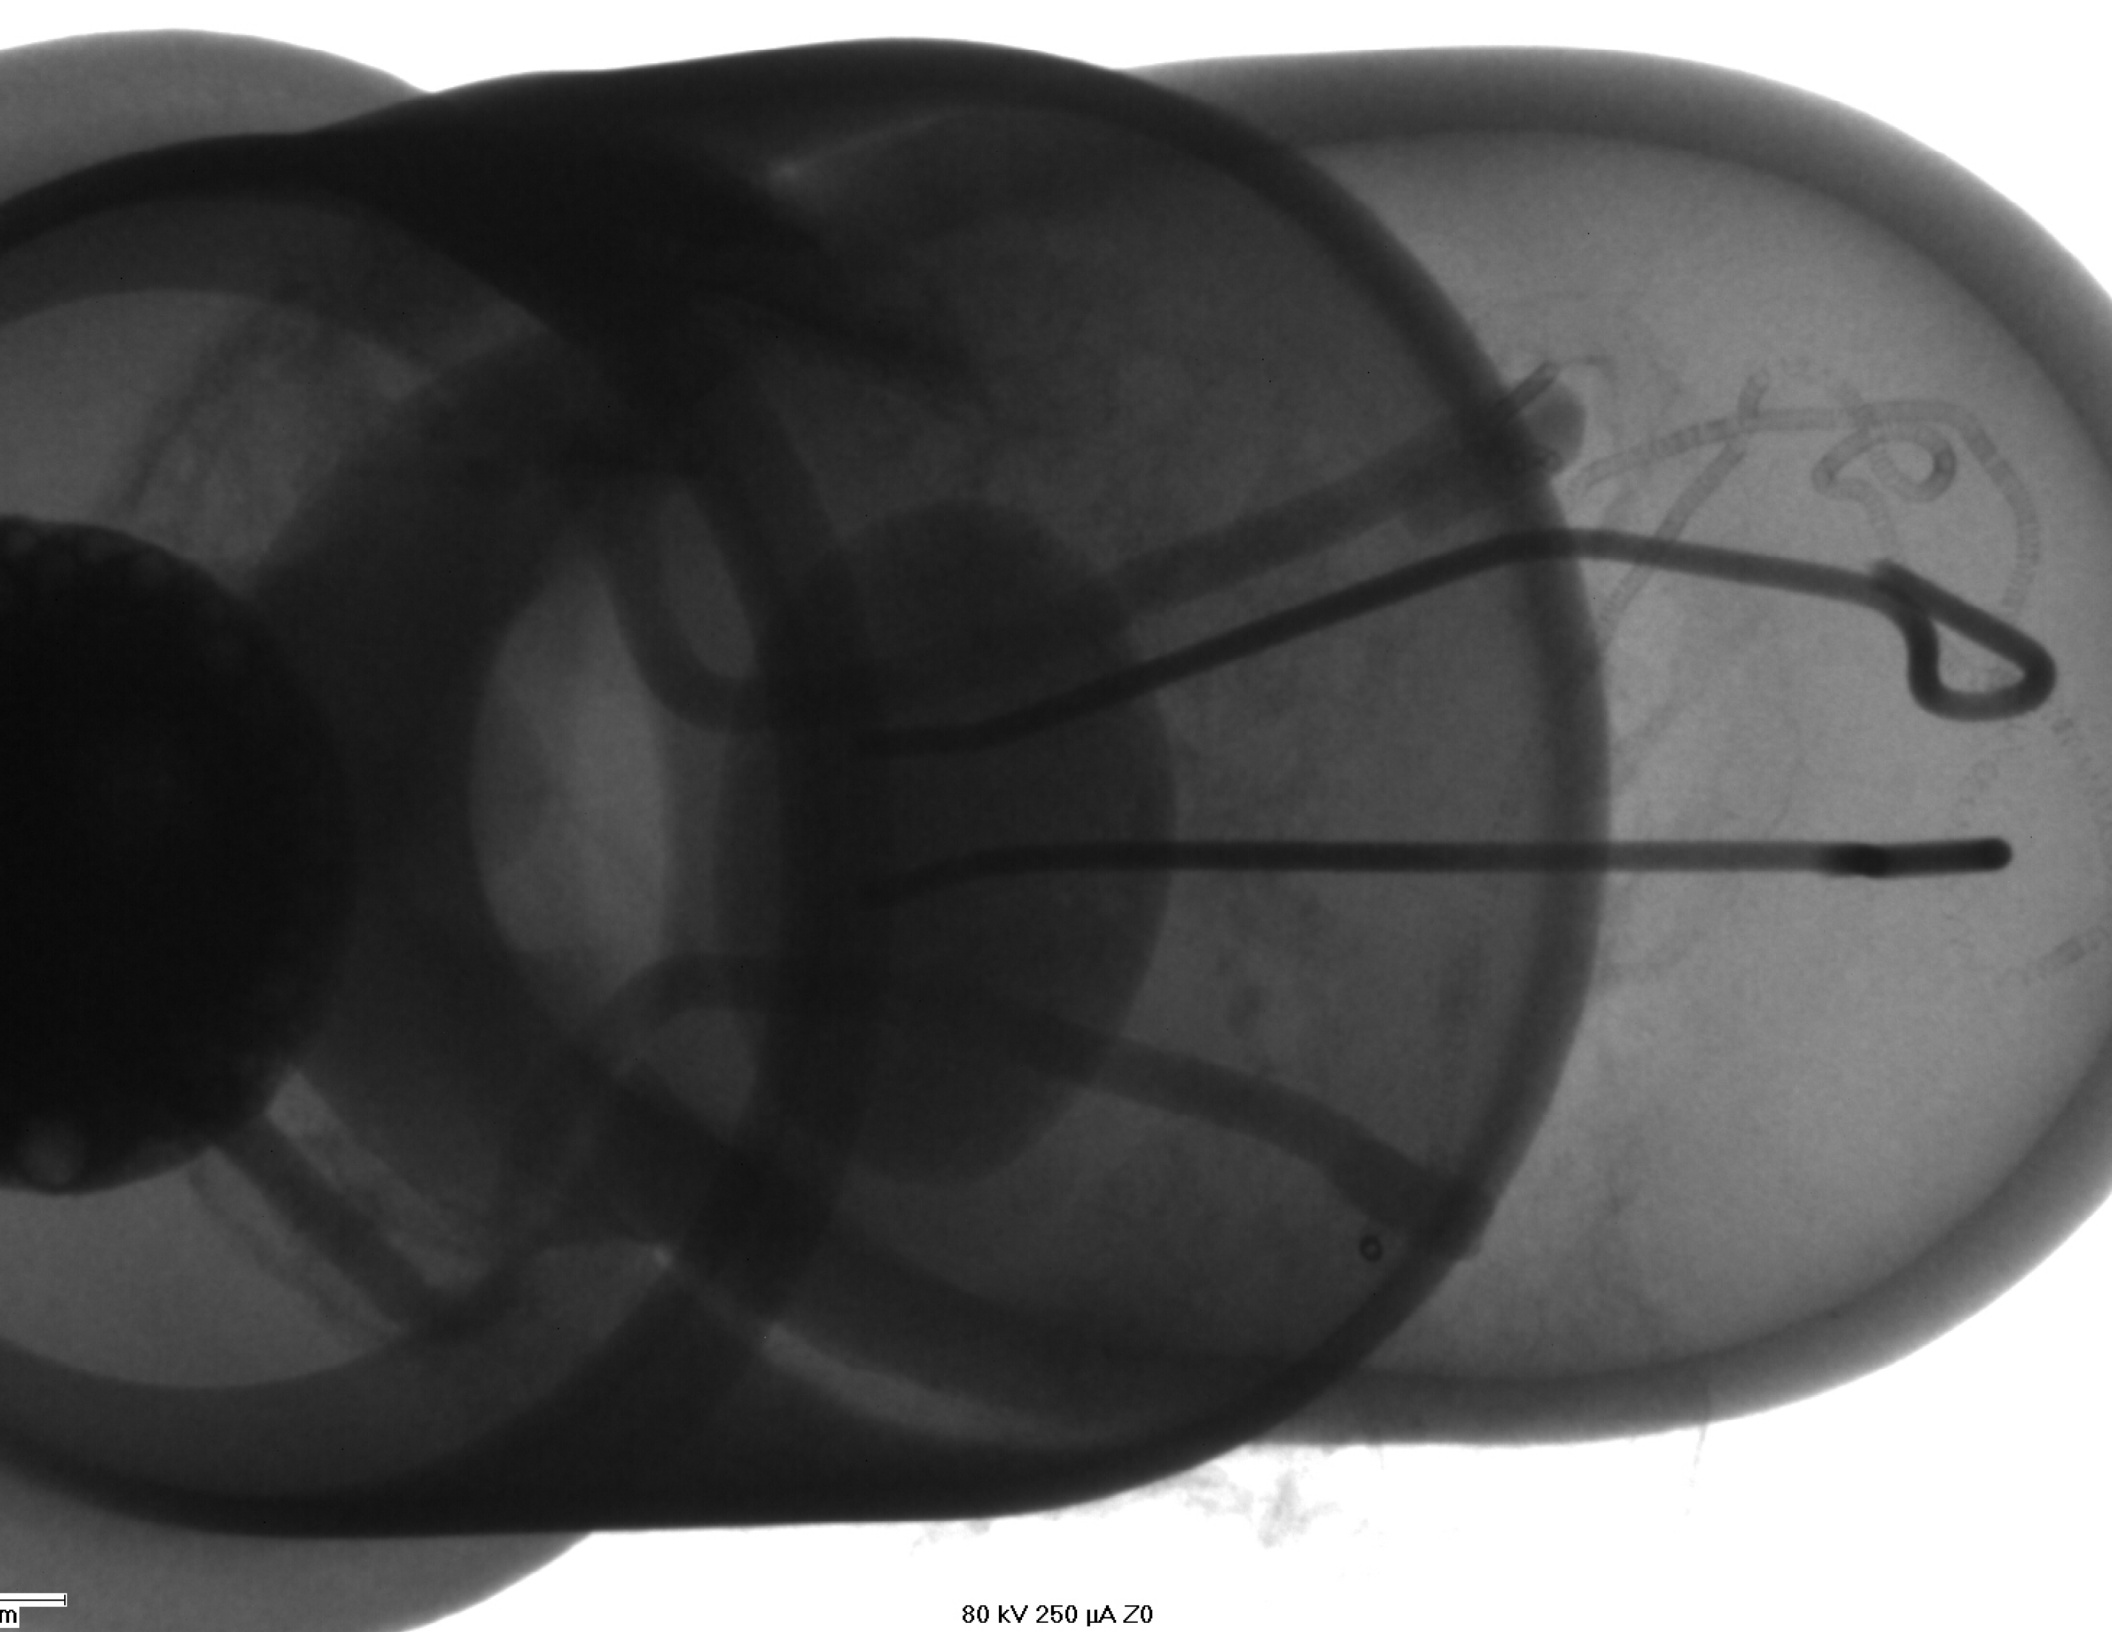
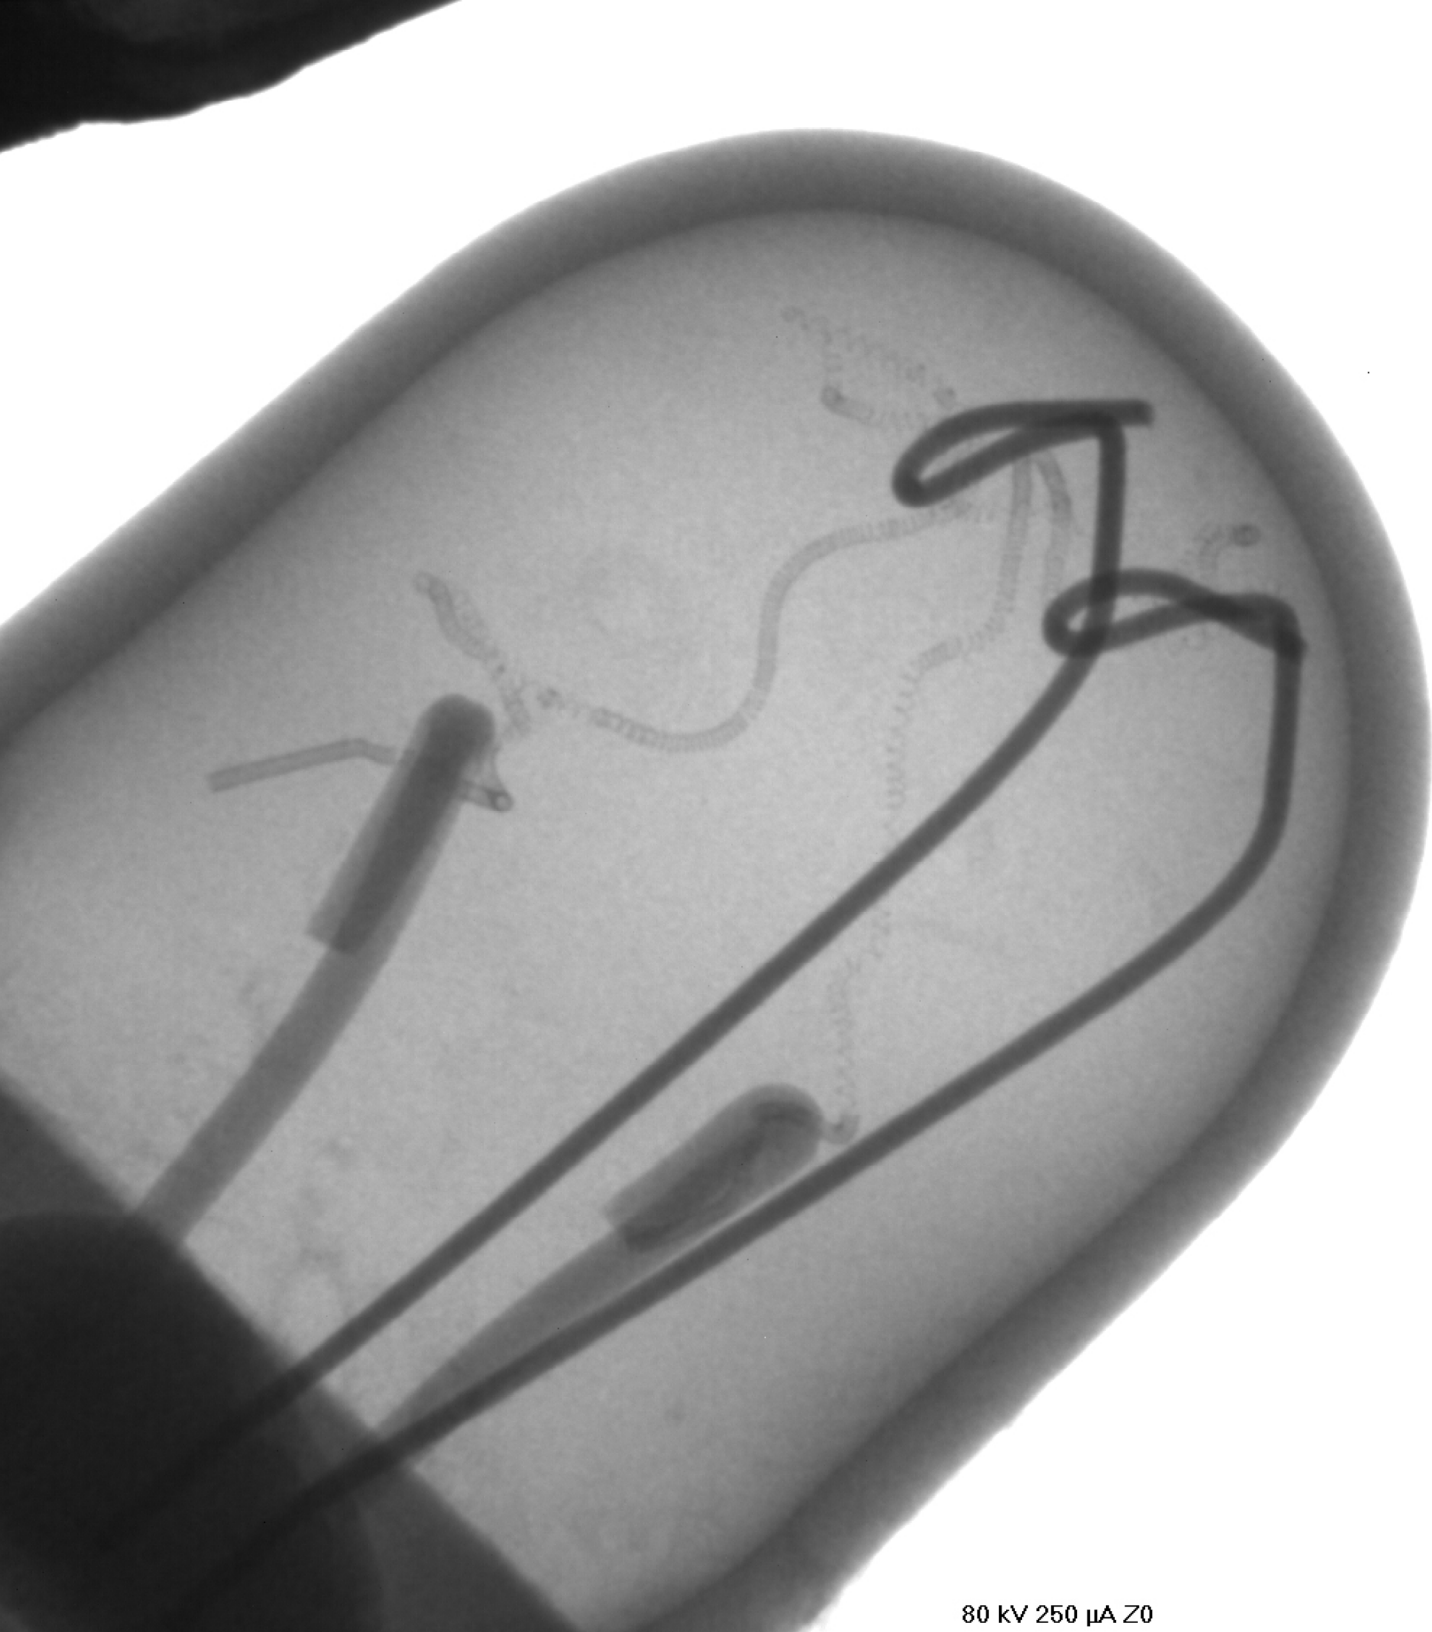
The cockpit caution/warning panel from the accident aircraft was submitted to the Materials Laboratory for examination to determine the status of light bulb filaments from the individual annunciators. The panel sustained significant fire damage and the front plate was illegible due to sooting and melting. The interior of the panel exhibited similar damage and the individual annunciator position had shifted as a result so the original location of individual bulbs could not be determined. Nine (9) intact bulbs with filaments were removed from the remnants of the panel. Two bulbs exhibited hot filament stretching. As previously stated, the location of these bulbs could not be determined. Radiographs of the stretched filaments are attached to this email. If you have any questions or need addition information, please let me know.
