**NATIONAL TRANSPORTATION SAFETY BOARD**  
**Office of Aviation Safety**  
**Washington, D.C. 20594**

**HELICOPTER WRECKAGE EXAMINATION REPORT**

**NTSB No: WPR20LA280**

Operator Guardian Helicopters USA  
Aircraft: Bell UH-1H (Huey) / N711GH  
Location: Coalinga, California  
Date: August 19, 2020  
Time: 0945 Pacific daylight time (PDT)

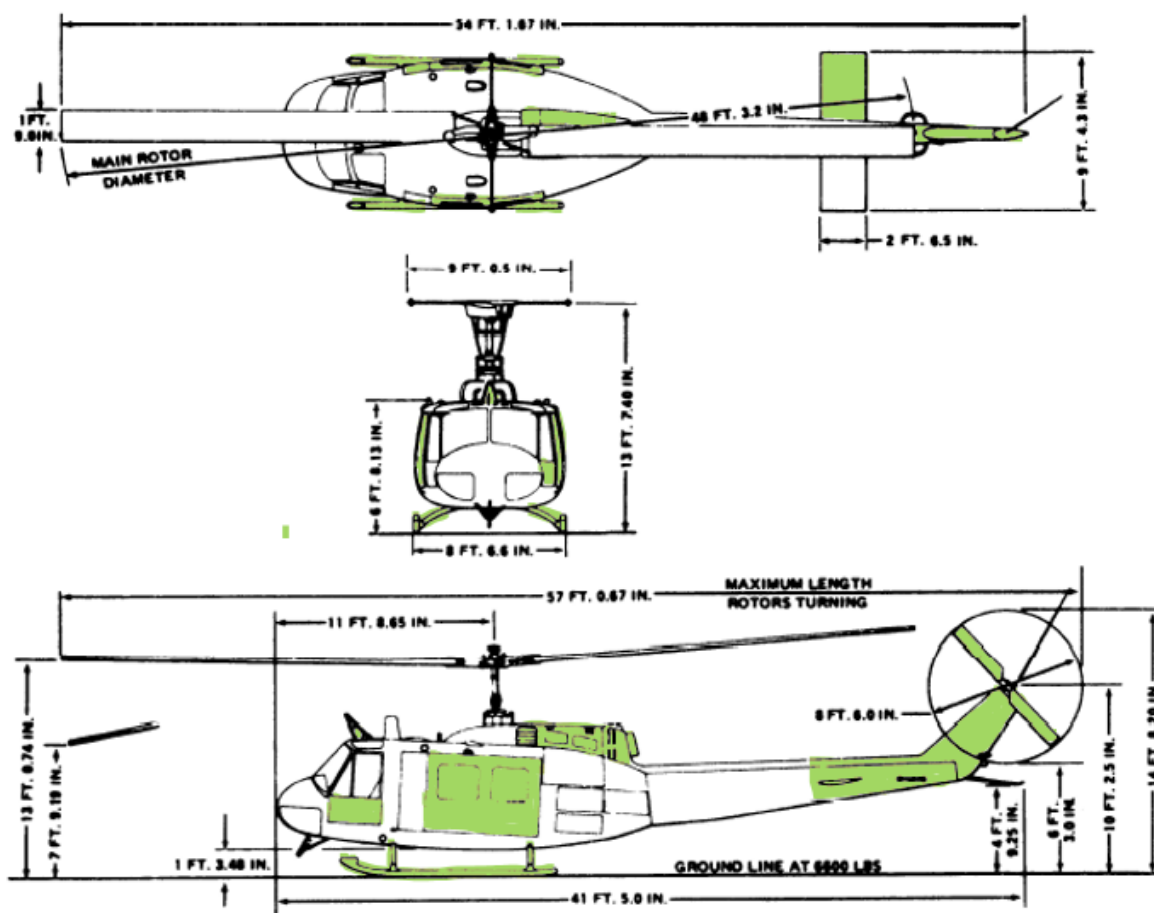
The wreckage examination was conducted at Air Transport, 3011 W Buckeye Rd, Phoenix, AZ, on October 29 and 30, 2020. Representatives from Honeywell, California Department of Forestry and Fire Protection (Cal Fire), and Guardian Helicopters USA participated in the wreckage layout and examination (figure 1).

**Figure 1.** UH-1H Principal Dimensions Diagram. Colored areas indicate airframe sections available for examination (Source: US Army TM 55-1520-210-10).

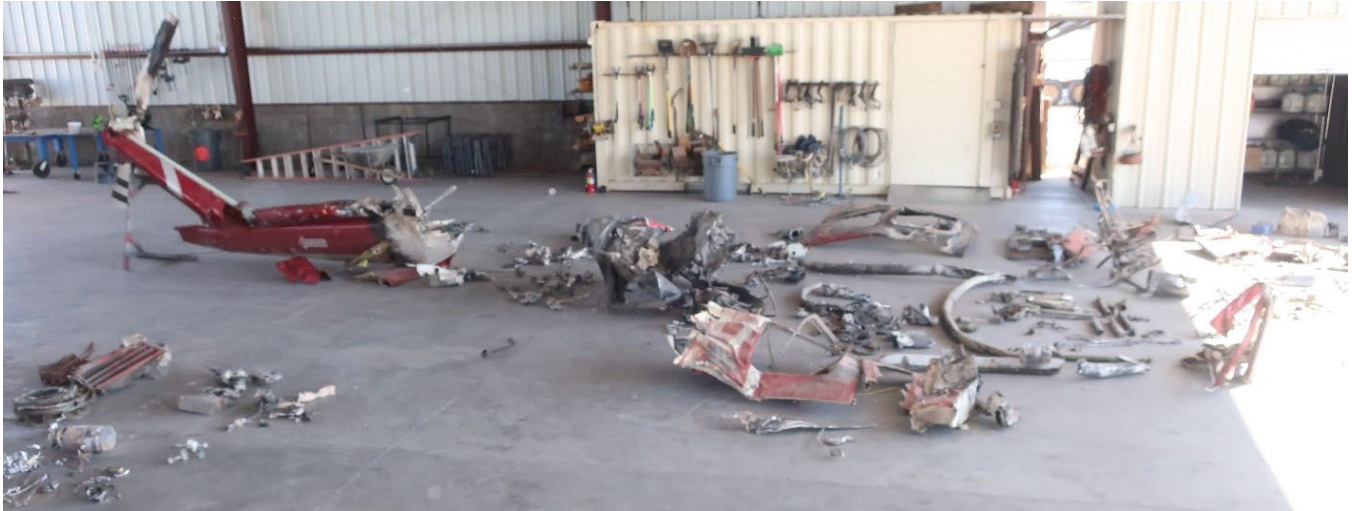
The wreckage was highly fragmented and consumed by a post-crash fire (photo 1). The airframe elements that remained were the tail boom aft of the elevator, tail rotor, engine deck, left and right main cabin doors, pilot's left door, sections of the left and right landing skid tubes, one cross tube, and the engine. The helicopter had a BLR Fast Fin & Strake modification (supplemental type certificate (STC): SR01470SE). The main rotor head, main rotor blades, stabilizer bar, and upper transmission including the rotor mast were not present for examination. Wreckage recovery personnel reported that those items were lost during the helicopter lift of the wreckage from the crash site.

**Photo 1.** Wreckage layout overview.

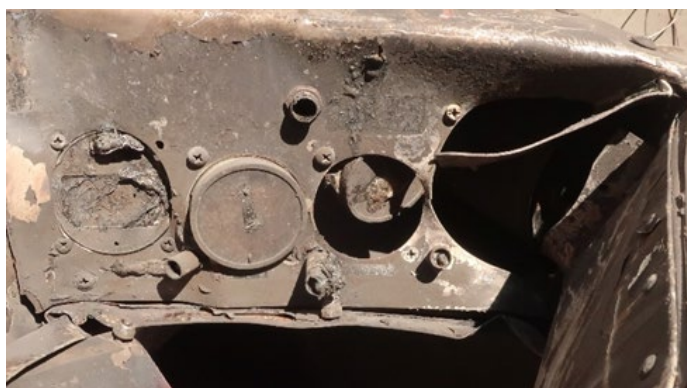
A group of instruments had been installed in the lower portion of the left door (photo 2). The purpose of these instruments allows the pilot to view critical helicopter systems information while looking left and below the helicopter when conducting external load operations. The engine control panel (photo 3) had been separated from the center console, all the switches on the panel had been deformed downward.

**Photo 2.** Left door instrument cluster.

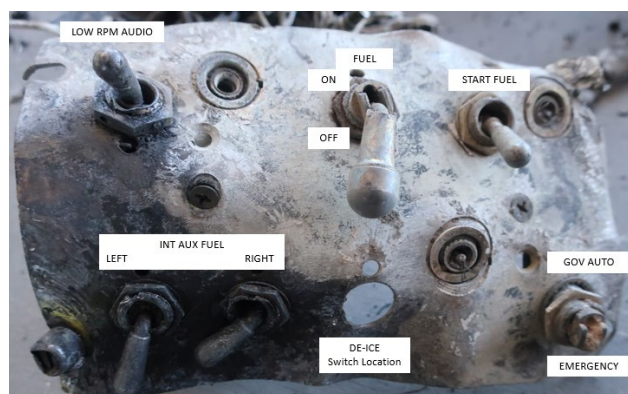
| Engine Control Panel (Photo 3) | Fuel switch in OFF (down) position. All other switches deformed downward. |

**Photo 3.** Engine Control panel.

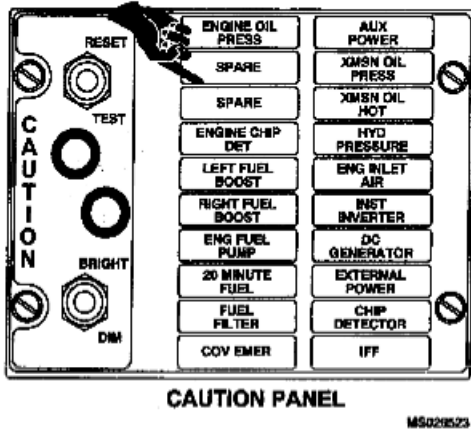
**Figure 2.** Caution panel configuration (Source: US Army TM 55-1520-210-10).

Each caution light capsule should contain 2 light bulbs, for a total of 40 possible bulbs in the panel assembly. An illustration of the caution panel configuration is in Figure 2. The materials laboratory specialist that examined the caution panel reported<sup>2</sup> that the interior of the panel exhibited similar damage as the exterior and the individual annunciator positions has shifted as a result, the original position of the light bulbs could not be determined. Nine (9) intact bulbs with filaments were removed from the remnants of the panel. Two (2) bulbs exhibited hot filament stretching. It was not possible to identify the original location of these bulbs within the caution panel.

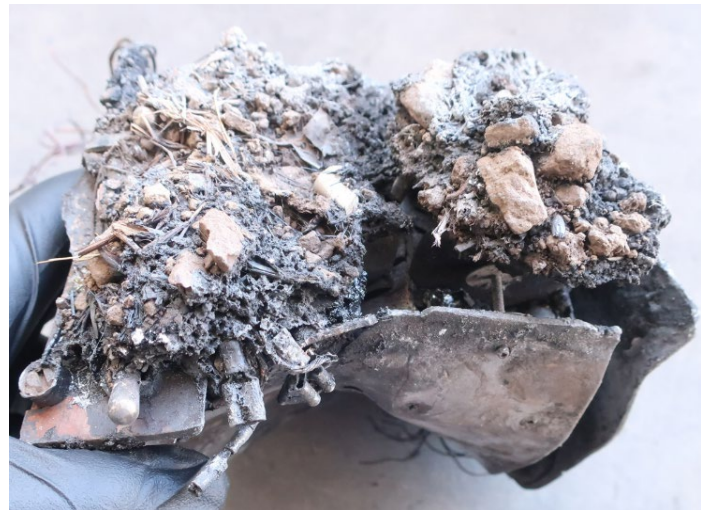
The caution warning panel was located within the wreckage debris and had been liberated from the instrument panel (photo 4). The caution panel had been exposed to extreme heat. Soil, rock, and organic debris had adhered on the face of the panel, obstructing view of the individual warning light capsules. The caution panel was sent to the NTSB Materials Laboratory for examination to determine if a lightbulb analysis could be performed.

**Photo 4.** Caution panel as found in the wreckage.

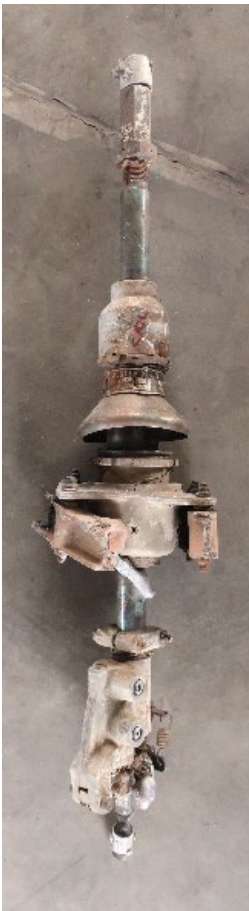
Portions of the cockpit flight controls were identified. Both of the collective jack shaft tubes were present with no control arm or connecting elbow hardware. Portions of both left and right pedal adjustor assemblies were identified as well as portions of two control force gradient mechanisms. Ten control rod ends (clevises) were collected, each one had connecting hardware in place. The main flight control servos (Photos 5, 6, and 7) had separated from their input and output control rods.

**Photo 5.** Collective servo.

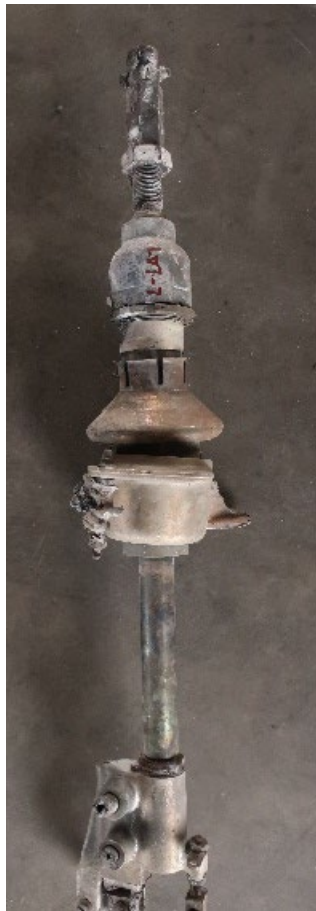
**Photo 6.** Left lateral servo.

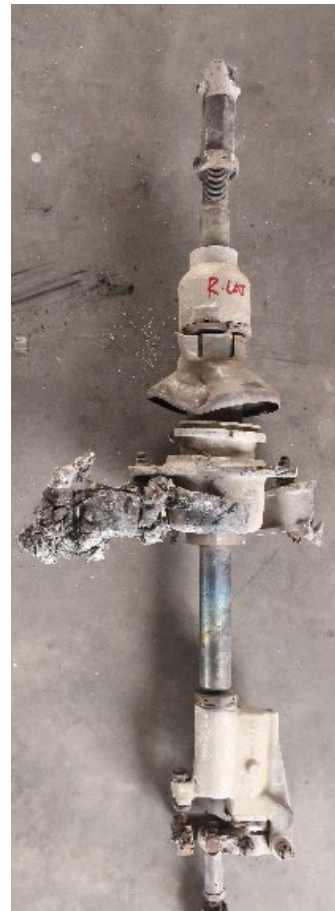
**Photo 7.** Right lateral servo.

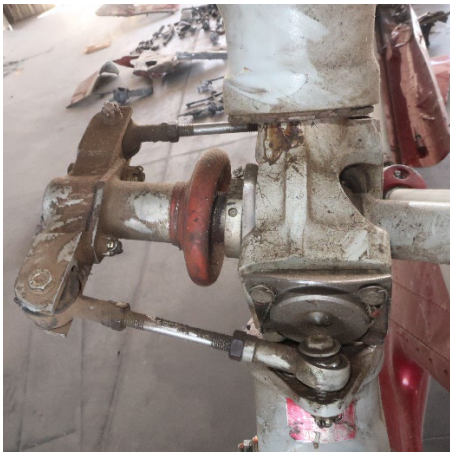
The cables ran continuously to the tail rotor gear box pitch change sprocket (photo 8 and 9). The tail rotor control chain moved freely and tail rotor blades changed pitch in concert.

**Photo 8** .Tail rotor pitch links and cross head.

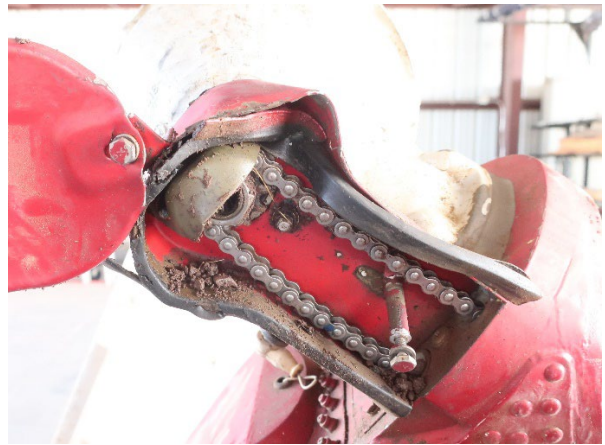
**Photo 9** .Tail rotor pitch change control chain & sprocket.

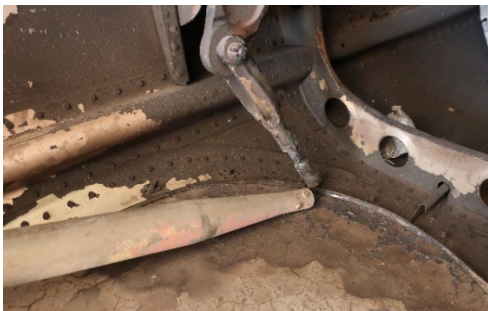
The elevator spar remained in the tail section. The right-side elevator airfoil remained intact but had been sawed off near the root by recovery personnel. The left spar extended out the left side of the tail boom, the entire air foil was not present on the spar. The elevator control horn assembly was in place in the tail section, the control rod clevis was attached, and a control rod laid near the clevis, the fastening rivets were sheared off (photo 10). Three elevator control bell cranks were identified, and all had connecting hardware attached (photo 11).

**Photo 10** .Elevator pitch horn and control tube.

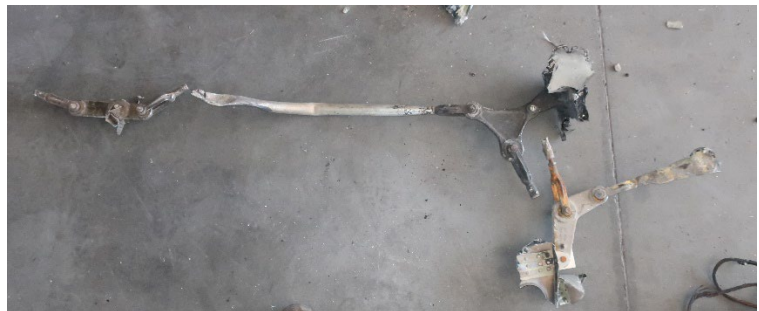
**Photo 11** .Elevator control linkages.

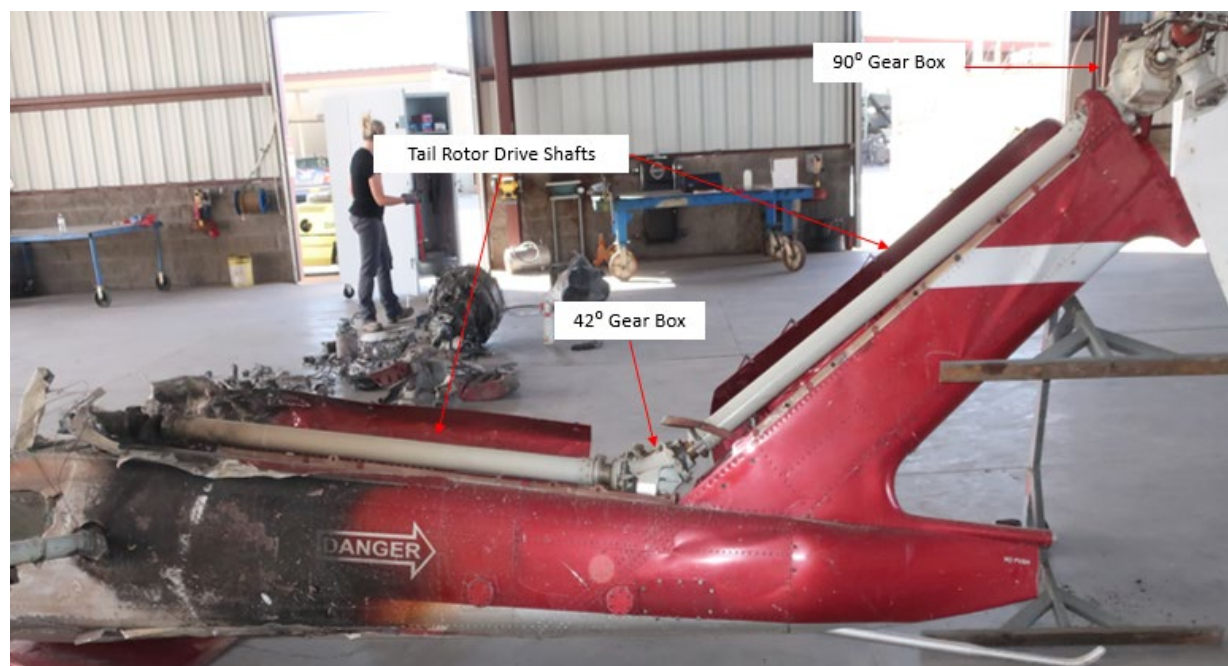
Tail rotor drive shaft segments were numbered (No.) 1-6 starting at the tail rotor drive output of the lower transmission. Drive shafts Nos. 1-3 were not recovered and presumed consumed by post-crash fire. However, the drive shaft bearing end that connects to the transmission tail rotor drive quill was identified as well as the drive shaft ends that mate with the support bearings for shafts Nos. 1-3. The aft end of drive shaft No. 4 was connected to shaft No. 5 through the support bearing. Drive shaft No. 5 was connected to the 42° gear box. Drive shaft No. 6 was connected from the 42° gear box to the tail rotor 90° gear box (photo 12). The 42° and 90° gear boxes rotated smoothly in concert with no binding.

**Photo 12.** Remnants of the tail boom, vertical fin, tail rotor drives shafts, and tail rotor.

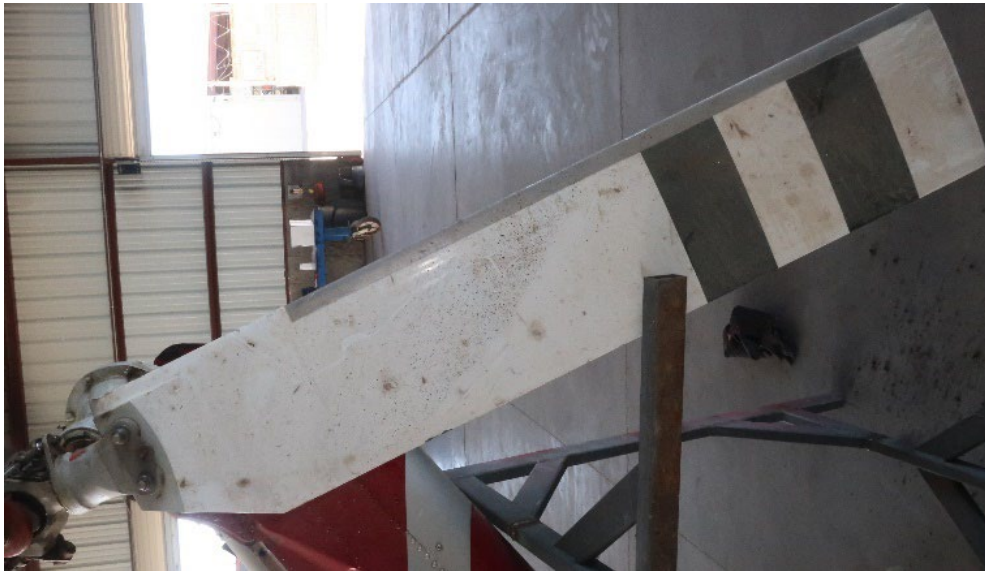
No observable damage noted on blade A.

**Photo 13.** Tail rotor blade "A"

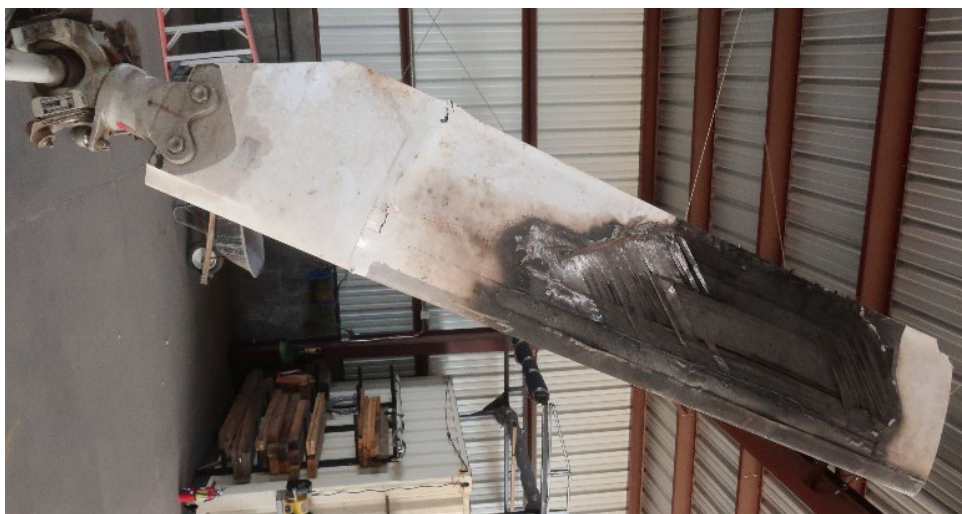
Chord wise dirt streaks observed on blade B. The outboard half trailing edge had heat damage and the reverse side 2/3 outboard of blade had fire damage to skin and underlying layers. The blade had a crease in the chordwise direction about 8 inches from the root.

**Photo 14.** Tail rotor blade "B"

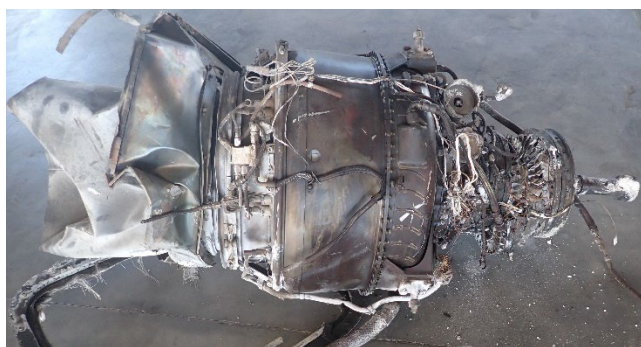
**Photo 15.** External view of the engine.

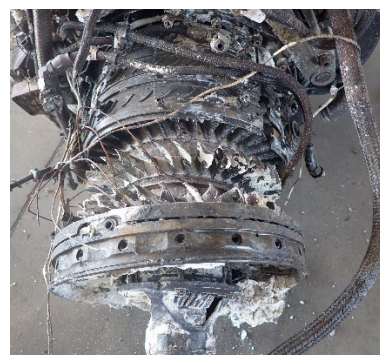
**Photo 16.** Engine compressor case was consumed by the post-crash fire, revealing the compressor rotor and stator rings.

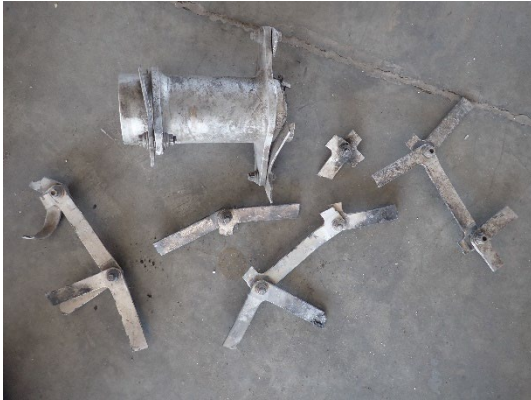
The air inlet housing, compressor housing, and accessories were not present on the engine. The KAflex coupling on the transmission side and engine side was fractured in multiple locations (Photo 17). The KAflex coupling center section (drive shaft) exhibited some punctures and tearing (photo 18).

**Photo 17.** KAflex coupling segments and main drive shaft.

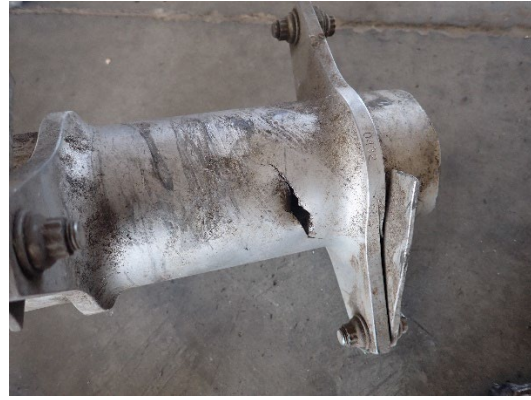
**Photo 18.** Main drive shaft with puncture indentation.
